THE **BOEING** COMPANY, *Seattle, Wash 2*  
AERO-SPACE DIVISION  
*2* LAUNCH SYSTEMS BRANCH *3*

*29B*  
DOCUMENT NO. T5-6539-78 - END

TITLE *3* INVESTIGATION OF X-RAY INDICATIONS IN GOX LINE WELD *6*

MODEL NO. SAT V/S-IC CONTRACT NO. NAS8-5608 - 29ACV

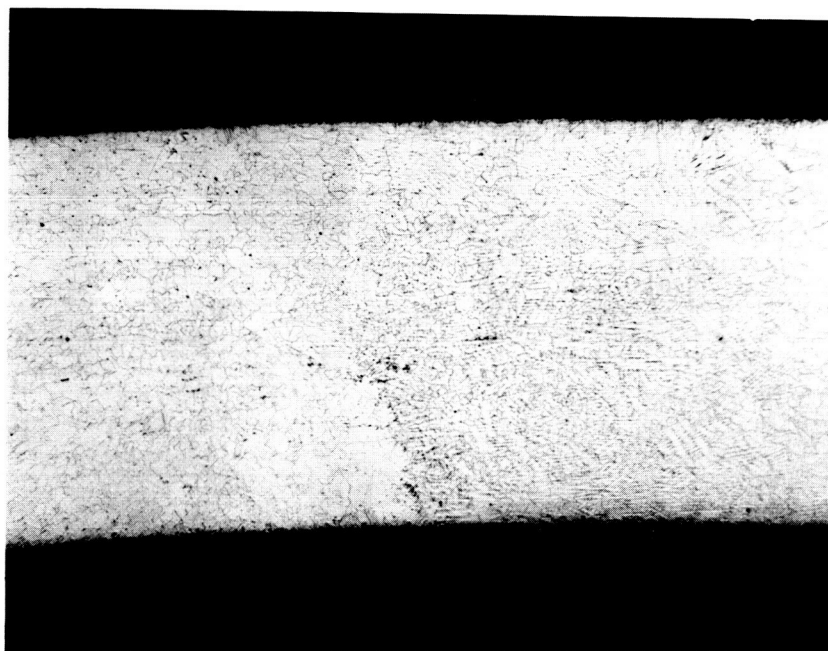
A section of tubing containing defects was delivered to the M&P Lab accompanied by x-rays of the longitudinal seam welds. "Worst areas" were removed and they in turn were x-rayed to accurately locate the defects. (Figure #1). Sections were cut exposing the cross sections of several defects and these were mounted and given a metallographic examination. This examination revealed an anomaly in the structure of the weld in the area of the weld fusion. (Fig. # 2, 3). These anomalies were located in the first 1/4 to 1/3 of the distance from the inside of the tubing.

Fig. # 2 Typical Tubing Cross Section in X-Ray  
Defect Area

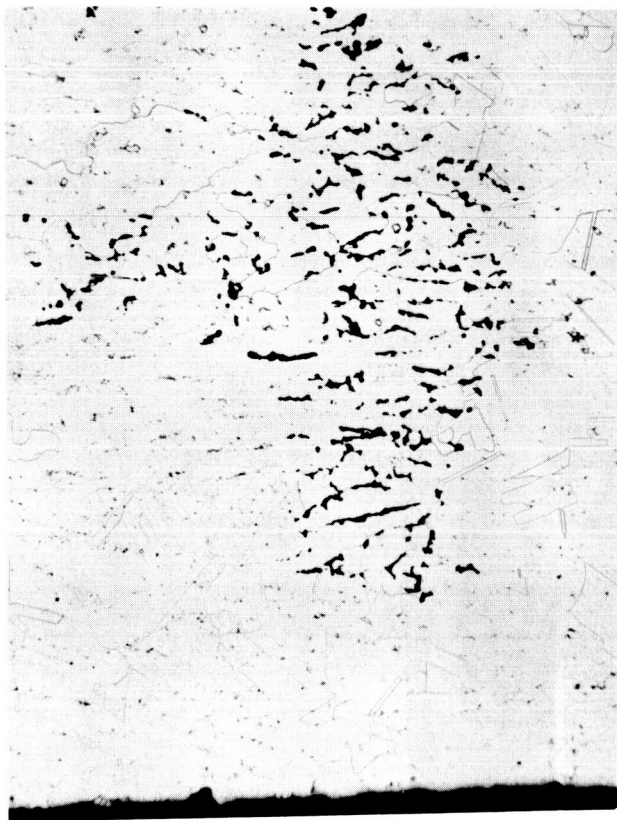
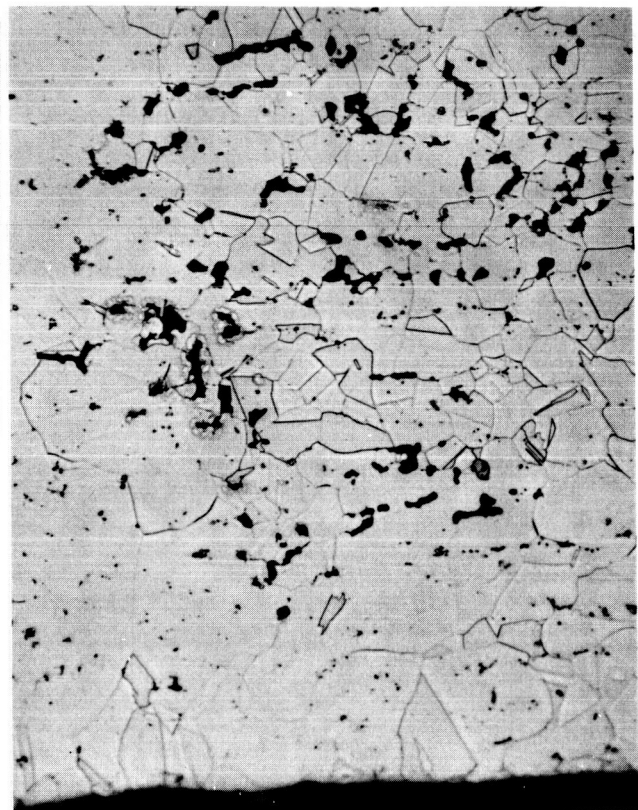
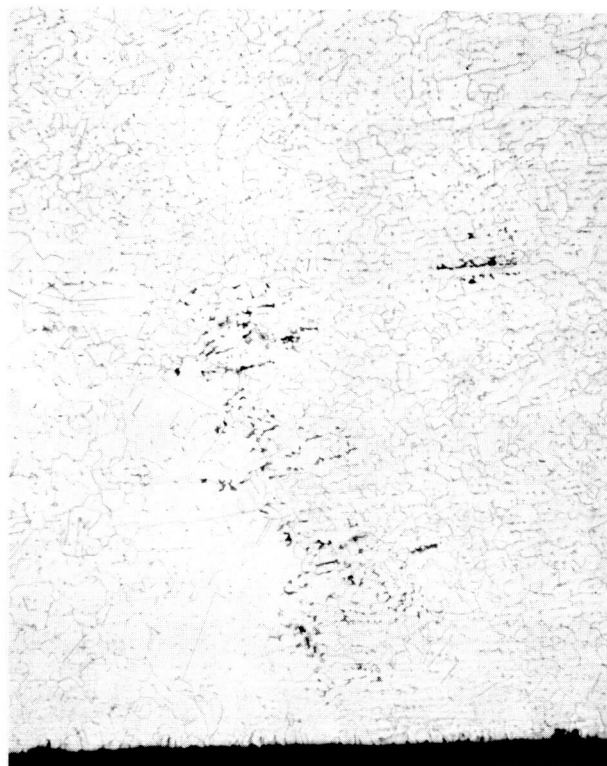
Fig. # 3 Higher Magnification of Figure # 2 Area

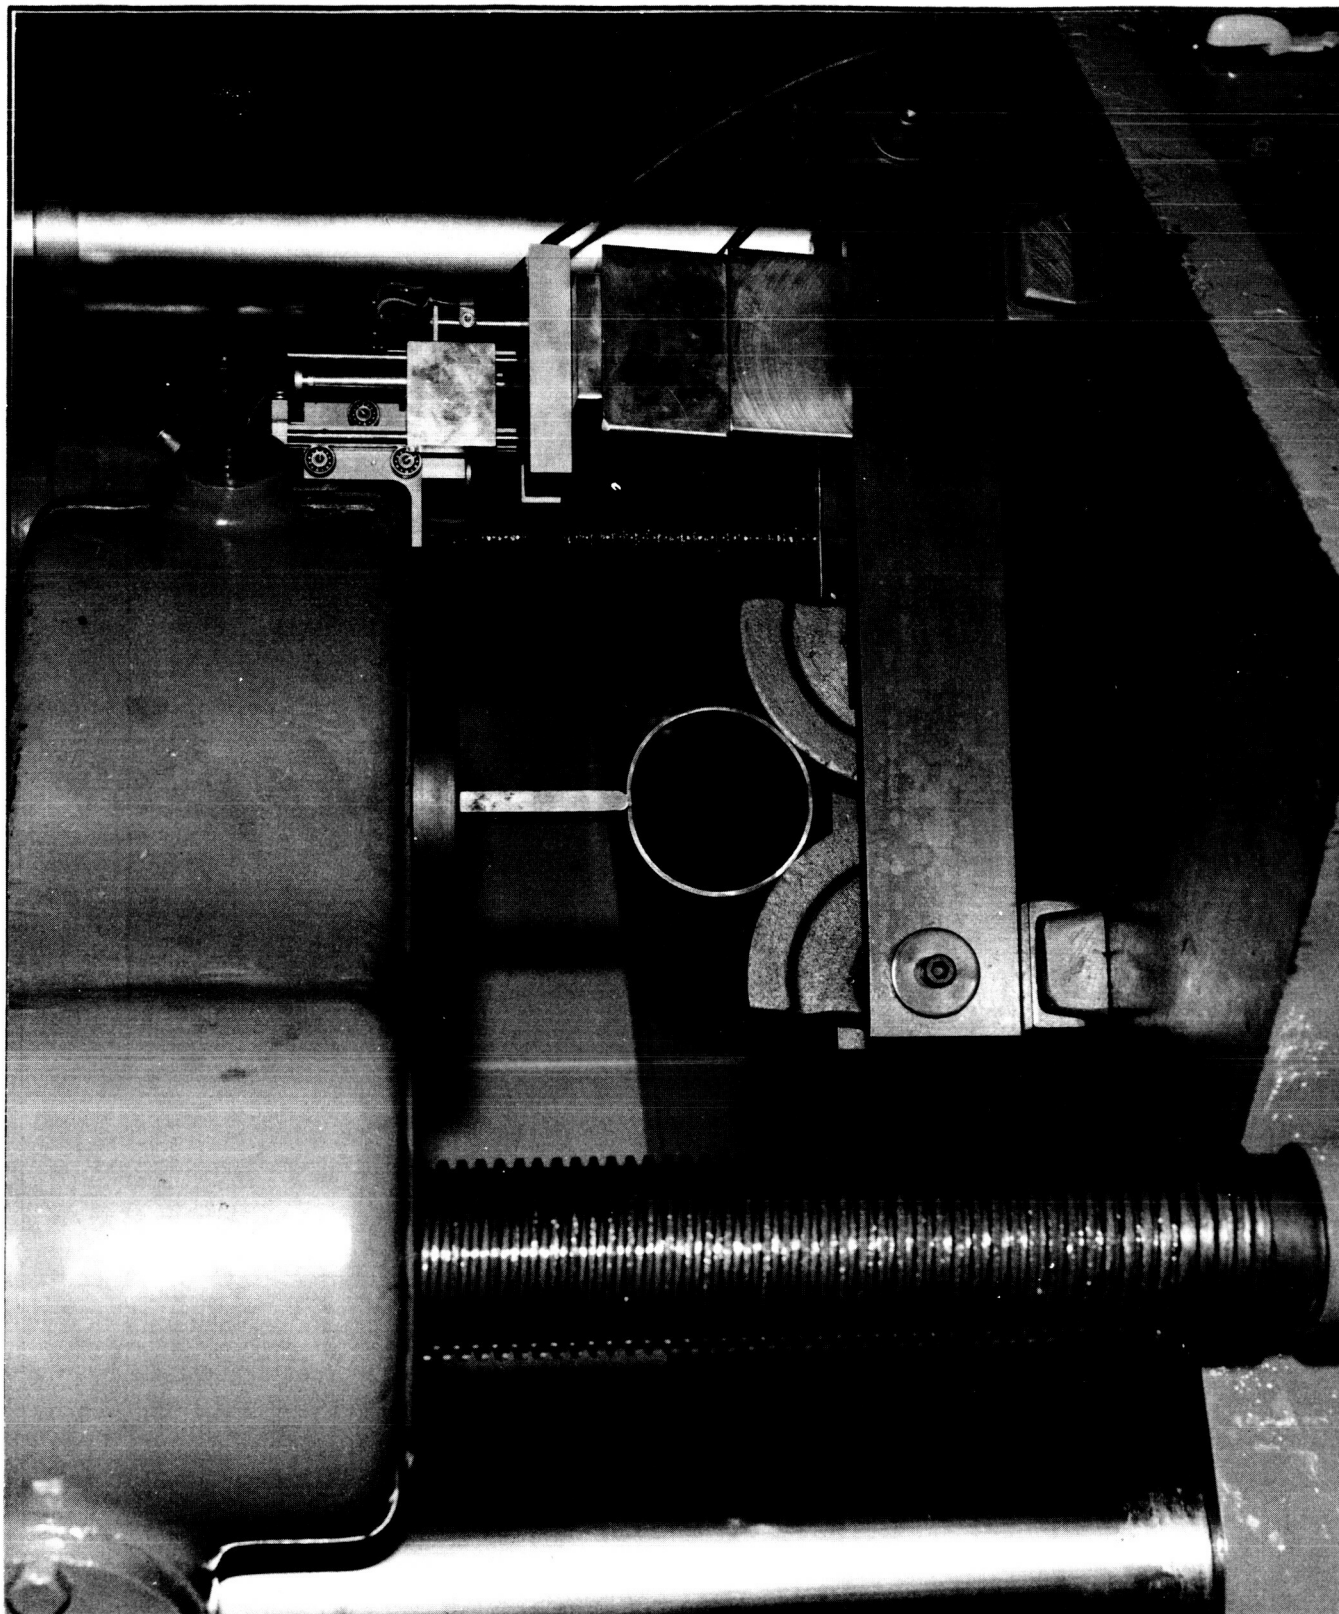
Fig. # 4      Test Set For Bending of Tube Ring Specimens

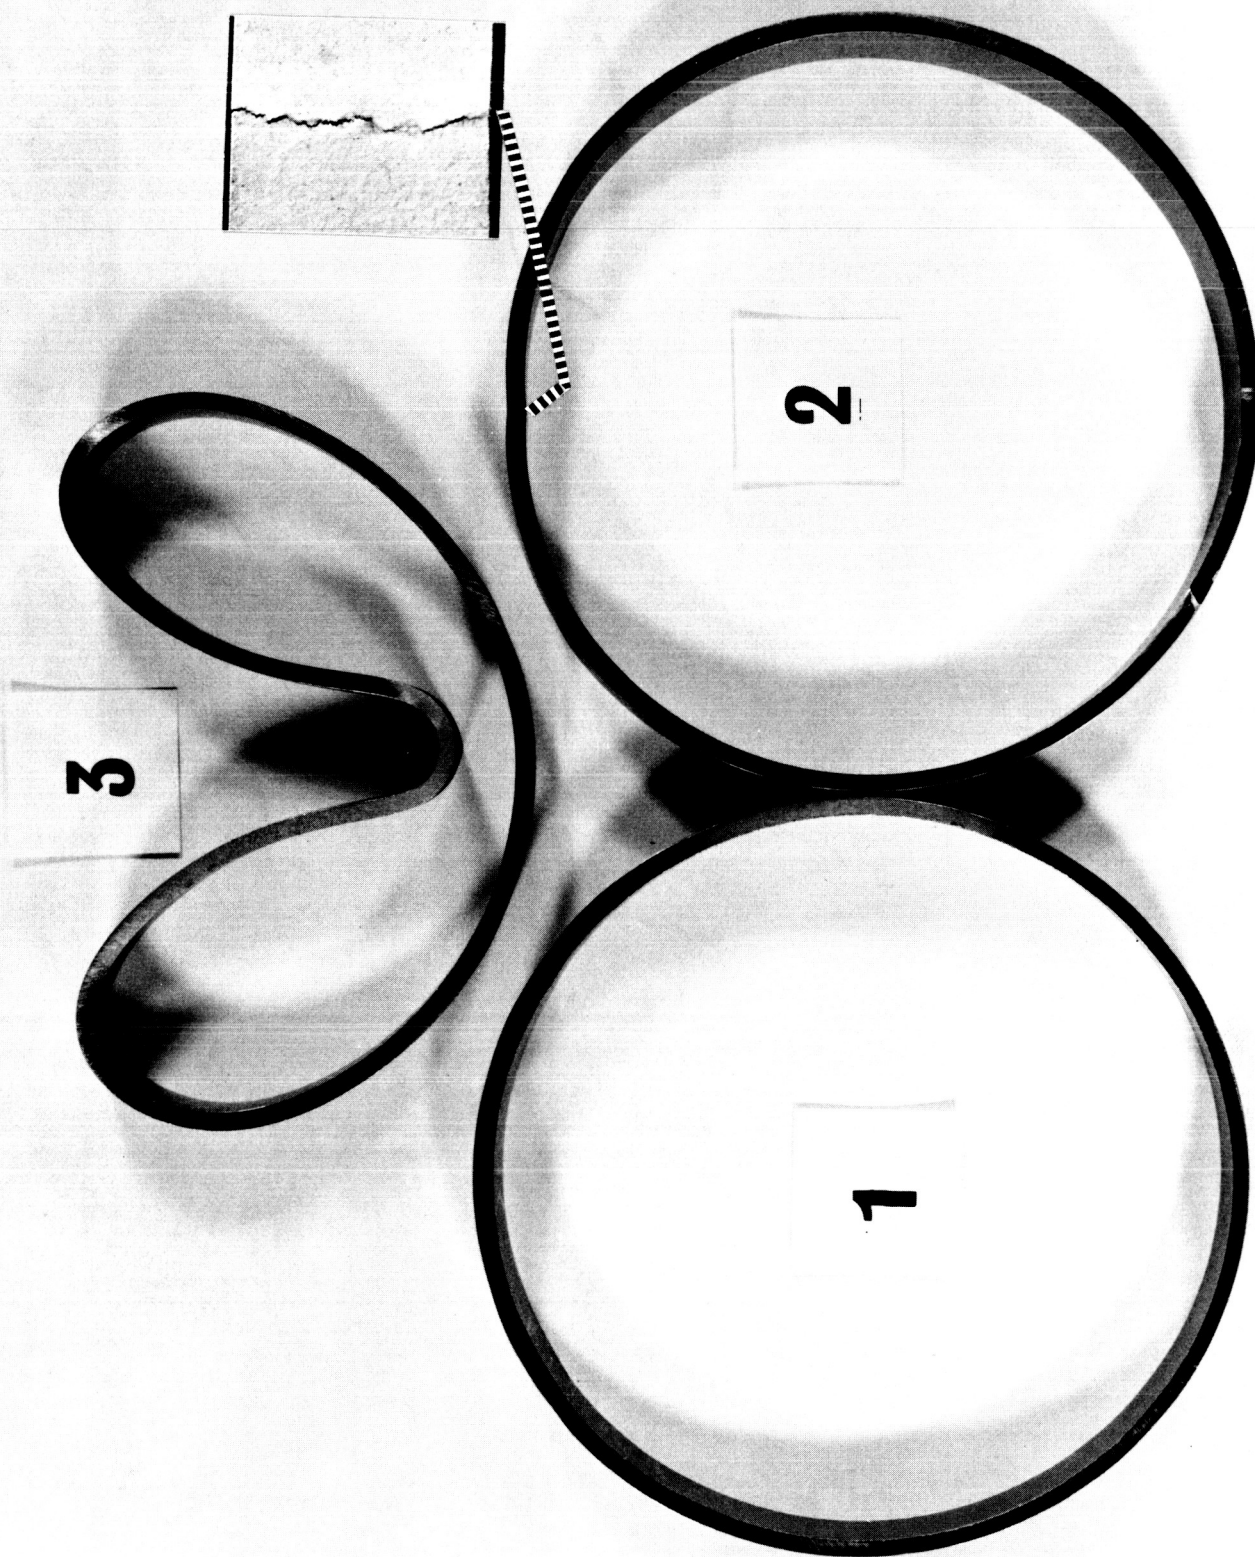
To determine the effect of these anomalies on the integrity of the tube, a part was obtained that showed one end free of indication and one end heavy with indications. Six 1/2" wide ring sections were removed from each end. (Each set of six representing defect containing and defect free material respectively). A bend test (across the weld) was performed on these rings. (See Figure #4 for test setup) the ring was set in a jig in a standard test machine and a penetrator with a 1/4" diameter head was placed against the weld center and the ring was compressed. The defect free rings were bent until the inside surfaces of the rings touched. No failure occurred. The rings containing defects were compressed 1/2" maximum when definite failure occurred, (See Figure #5).

Fig. # 5    #1    Untested Ring  
              #2    Typical Defect Containing Ring with Crack Detail  
              #3    Typical Defect Free Ring

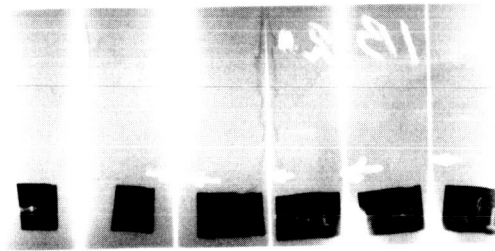
Boeing personnel (Project, M&P, Materiel, Manufacturing Development and Quality Control) then visited the tube vendor to observe tube production. X-rays were taken after welding, planishing, heat treating and sizing. The defects were first reproduced in the ends of the tubes that got excessively overheated during induction heating, (See Figure #6). This pointed to incipient melting as the cause of the defect. To confirm this condition, tubes were processed by the vendor at 1750°F, 1950°F, 2225°F and 2400°F. X-rays of these test tubes showed clear at 1750°F, minor indication at 1950°F (furnace used was improperly controlled and was probably not 1950°F in defect areas). Continuous defects at 2100°F, continuous and extremely heavy defects at 2225°F and tube melting at 2350°F and 2400°F. In order to confirm improper furnace control at 1950°F four tubes were sent to Los Angeles to be heat treated in a properly certified furnace at 1950°F. X-rays of these welds showed no defects in the four tubes.

Fig. # 6 X-ray Positive Print Showing Defects Reproduced  
in Hot Ends of Tubing During Production

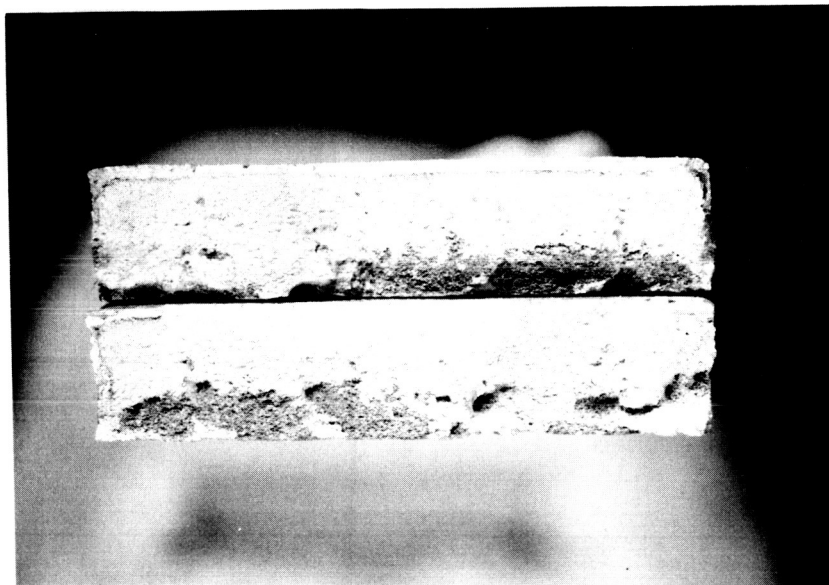
Fig. # 7 Fracture Face of Failed Ring 6X

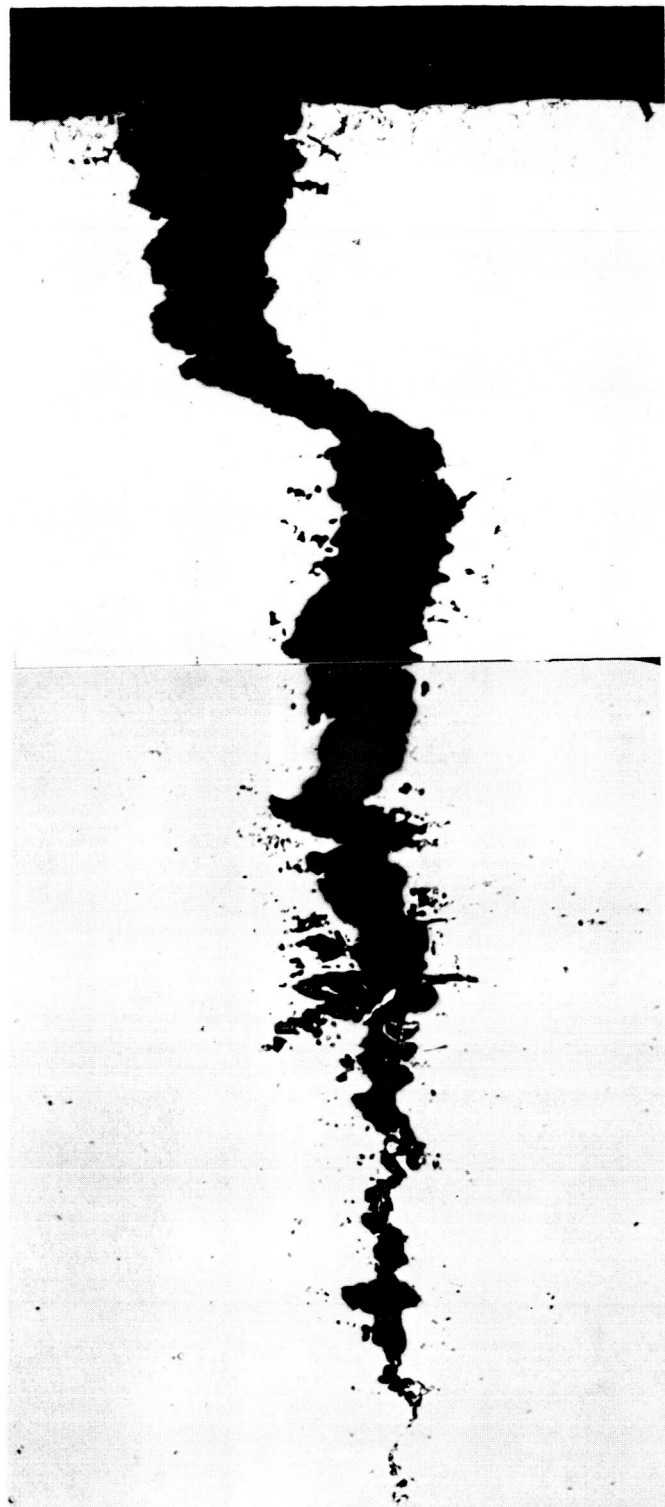
Fig. # 8 Metallographical Crossection of Failed Ring - Note Crack Propagates Through Defect Area
