# TECHNICAL HISTORY OF THE ENVIRONMENTAL CONTROL SYSTEM FOR PROJECT MERCURY

*by Frank H. Samonski, Jr.  
Manned Spacecraft Center  
Houston, Texas*

## ABSTRACT

This report presents a technical history of the environmental control system for Project Mercury. Significant system changes and flight experience with the environmental control system are described. Attention is also given to the structure of test programs employed to satisfy the mission objectives.

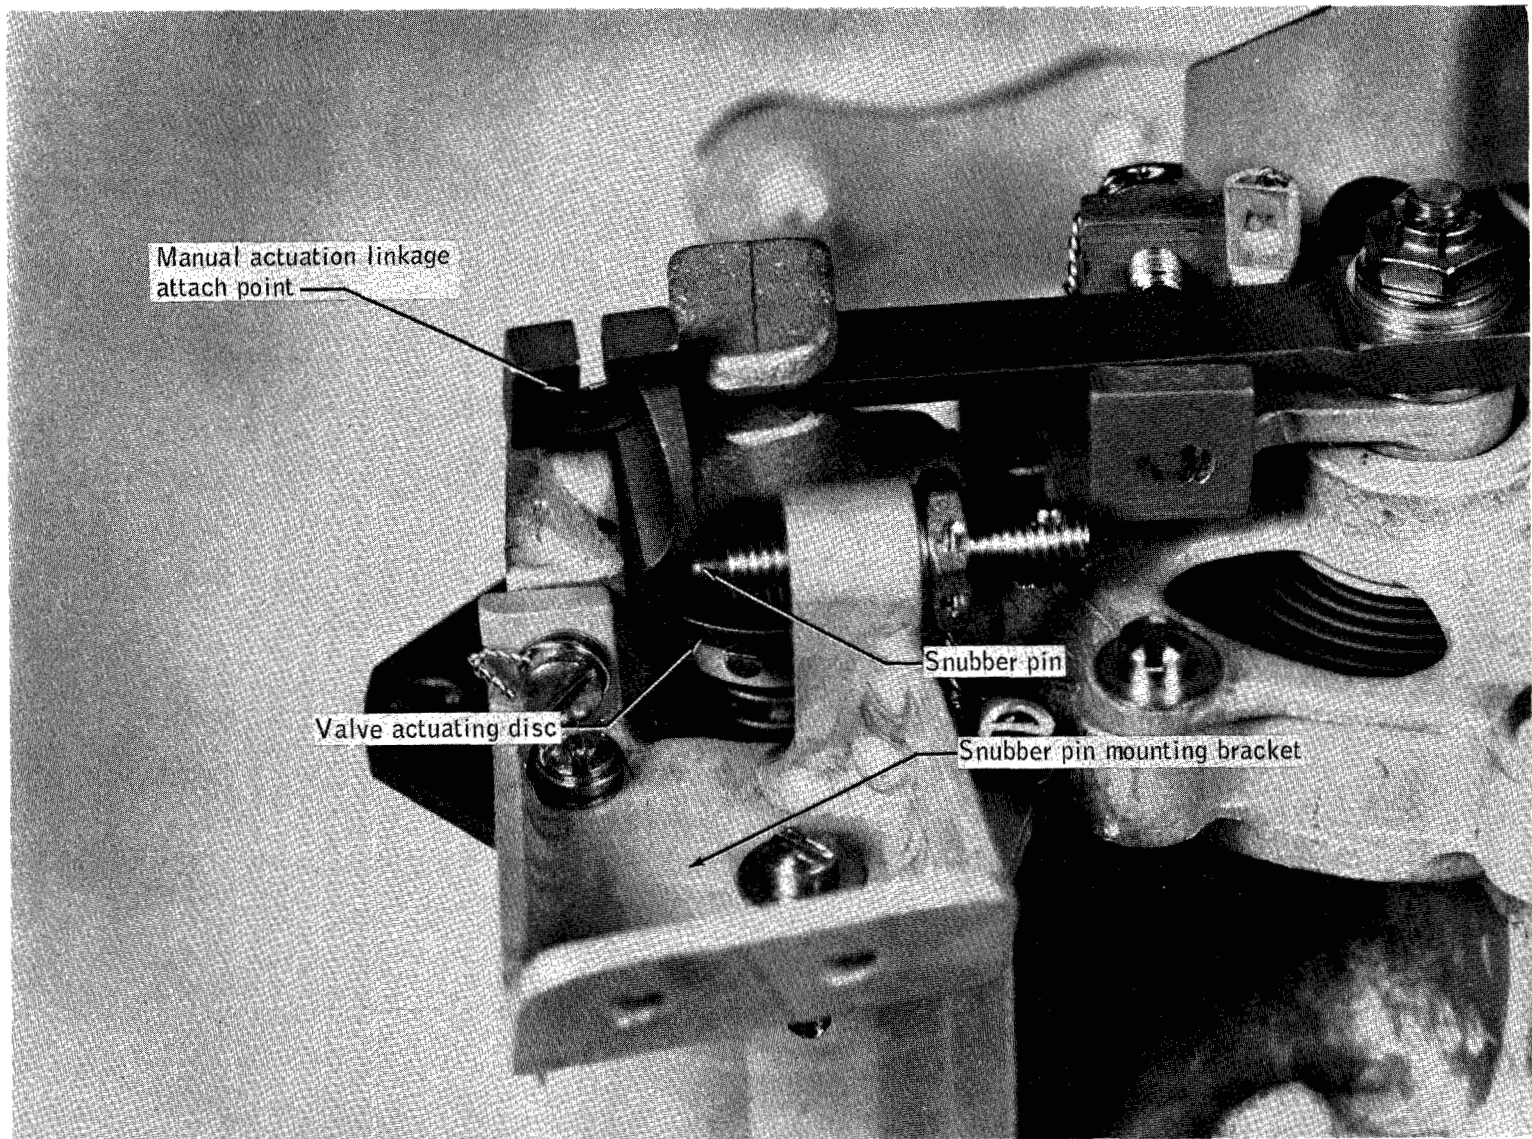
In the MR-2 mission, the cabin pressure decayed to zero during the ballistic flight. Postflight analysis indicated that the ground ventilation inlet valve (MAC P/N 45-83700-721) had vibrated open 57 seconds after lift-off. This malfunction automatically placed the ECS in the postlanding mode, allowing cabin pressure to relieve overboard through the open valve via the negative-pressure relief valve. Postflight inspection of the inlet valve (fig. 2) revealed that a spring-loaded snubber pin and mounting bracket, designed to impose a frictional load on the manual-actuation linkage of the valve, had been removed some time prior to flight because of interference problems with the linkage. The snubber was eliminated from the valve because of the resetting difficulties, and a new latching mechanism was incorporated (fig. 3). This final configuration was identified by MAC P/N 45-83700-785 and subcontractor P/N 122366-3-1. No further difficulties were encountered with this component.

Figure 2. - Ground ventilation inlet valve, MR-2 configuration.

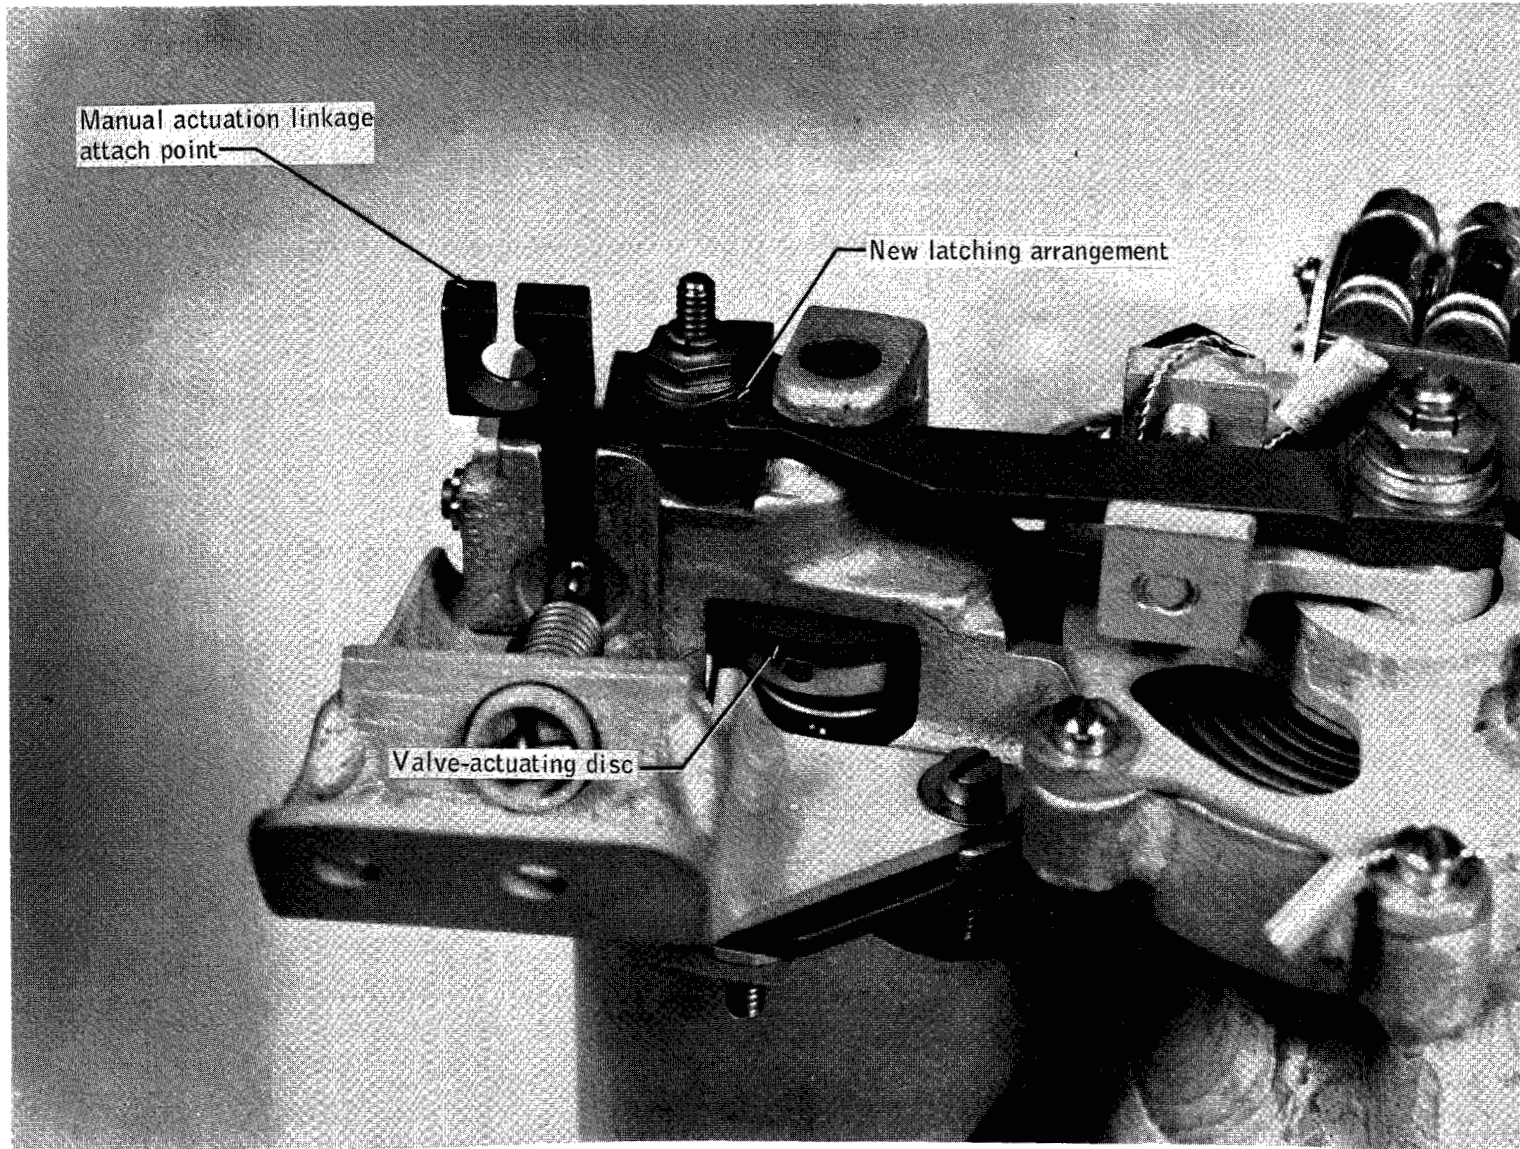
Figure 3. - Ground ventilation inlet valve, modified latching configuration.

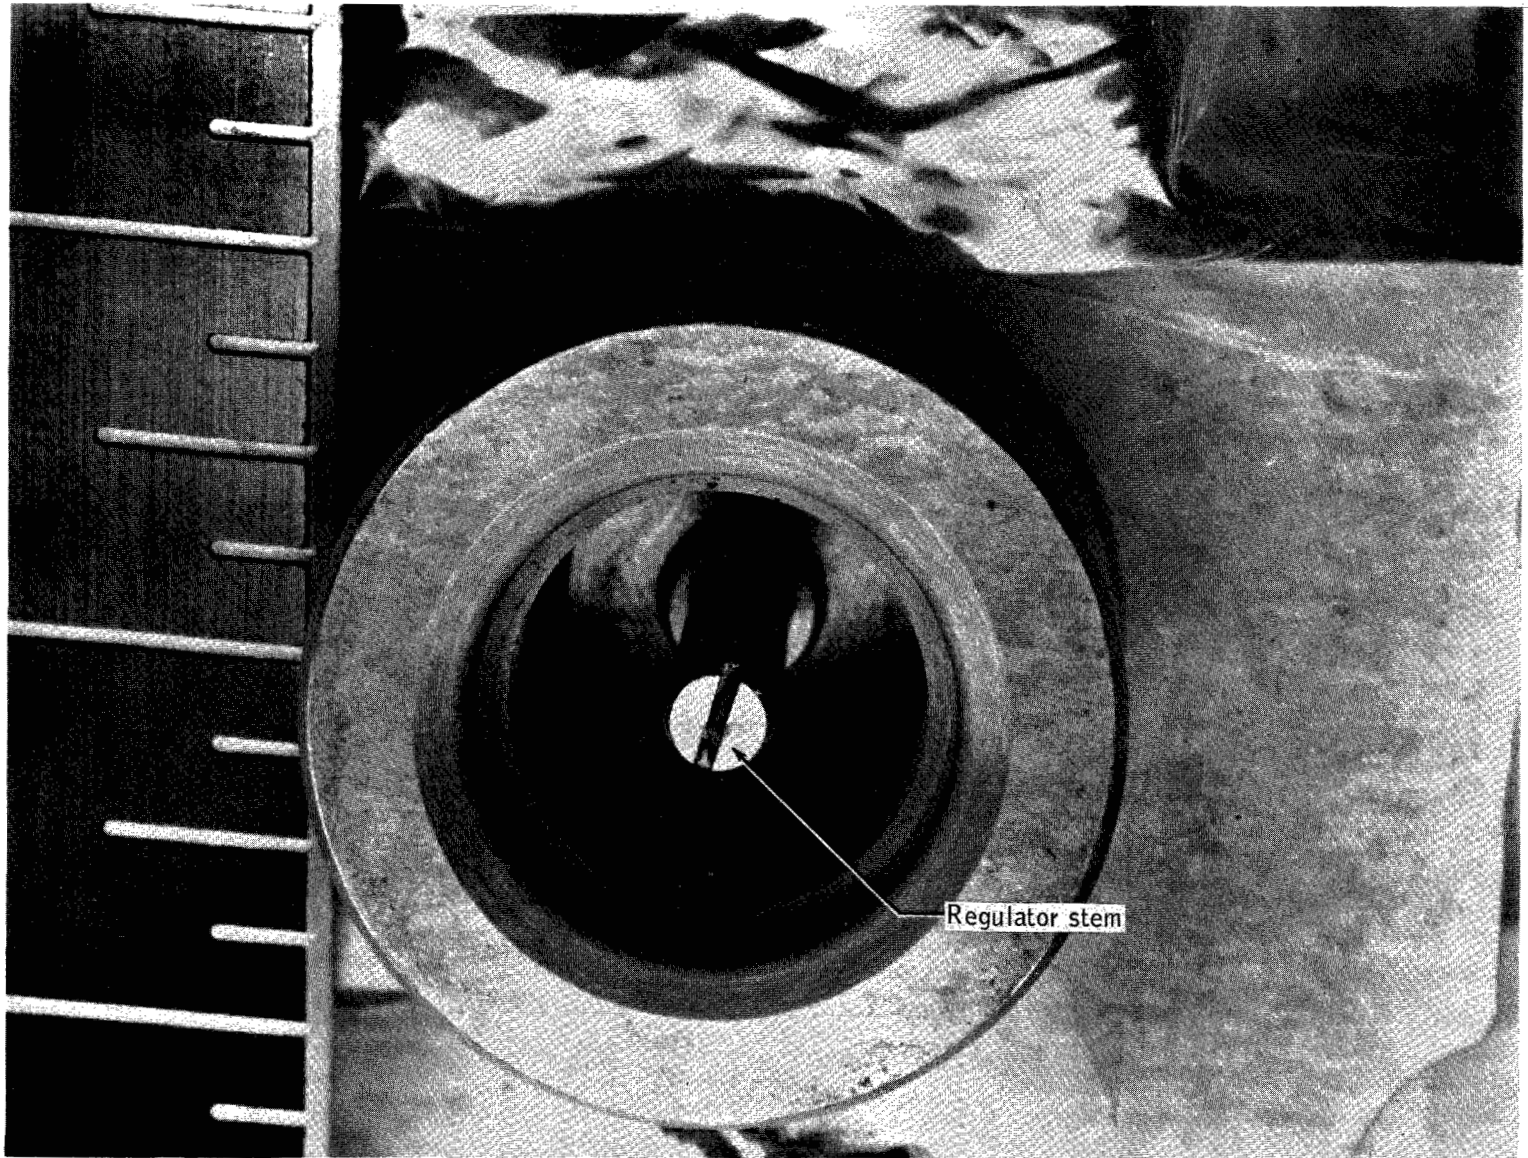
The secondary-oxygen-supply pressure exhibited an unexplained decay during the MA-6 mission. Both oxygen supplies had been serviced to approximately 8000 psig prior to launch; and, since the maximum indication of the supply pressure transducers was 7500 psig, the exact time when the secondary supply began to leak cannot be determined accurately. Postflight testing conducted 9 days after the flight (March 1, 1962) revealed no leakage in the secondary supply. Additional tests conducted on March 8, 1962, confirmed zero leakage in the secondary system. On March 9, 1962, a leak was noticed prior to applying pressure to the outlet of the secondary pressure reducer (MAC P/N 45-83700-29, subcontractor P/N PS 132184-1, vendor P/N 1400-3, and serial number 302). The secondary tank pressure decayed from 4955 psig to 4930 psig in approximately 45 minutes. When the downstream side of the regulator was finally pressurized, the relief valve opened at 160 psig (specification is  $135 \pm 15$  psig). Re-seating of the valve occurred at 146 psig. During this operation, the secondary tank lost 5 psi. Several more checks of the relief valve were made, and values within tolerance were observed. Subsequent to testing the relief valve, the leak from the secondary system was still in evidence, although there was no demand made on the regulator, that is, the downstream side was "dead-ended." The leak continued as long as there was any pressure on the upstream side of the regulator. For example, the secondary tank lost 128 psi in 25 minutes. The leak was audible, and it was observed to be coming

from the ambient sensing port of the secondary pressure reducer. It was speculated at that time that the O-ring on the regulator shaft might be damaged.

1. The cause of the secondary pressure decay during MA-6 was not known.
2. The evidence indicated that the secondary pressure reducer was damaged during postflight testing, and explanations for this failure were unsatisfactory insofar as they were unsupported by experiment and they failed to explain the pressure decay observed during flight. A test program investigating oxygen penetration of elastomers at high pressure was conducted by the subcontractor.

Figure 4. - MA-6 secondary-oxygen-supply high-pressure reducer.

1. The 0.015-inch-thick Teflon backup ring was replaced by a 0.049-inch-thick Kel-F backup ring.
2. Tolerances between the inside diameter of the backup ring and the outside diameter of the poppet stem were controlled to 0.001-inch-maximum diametral gap.

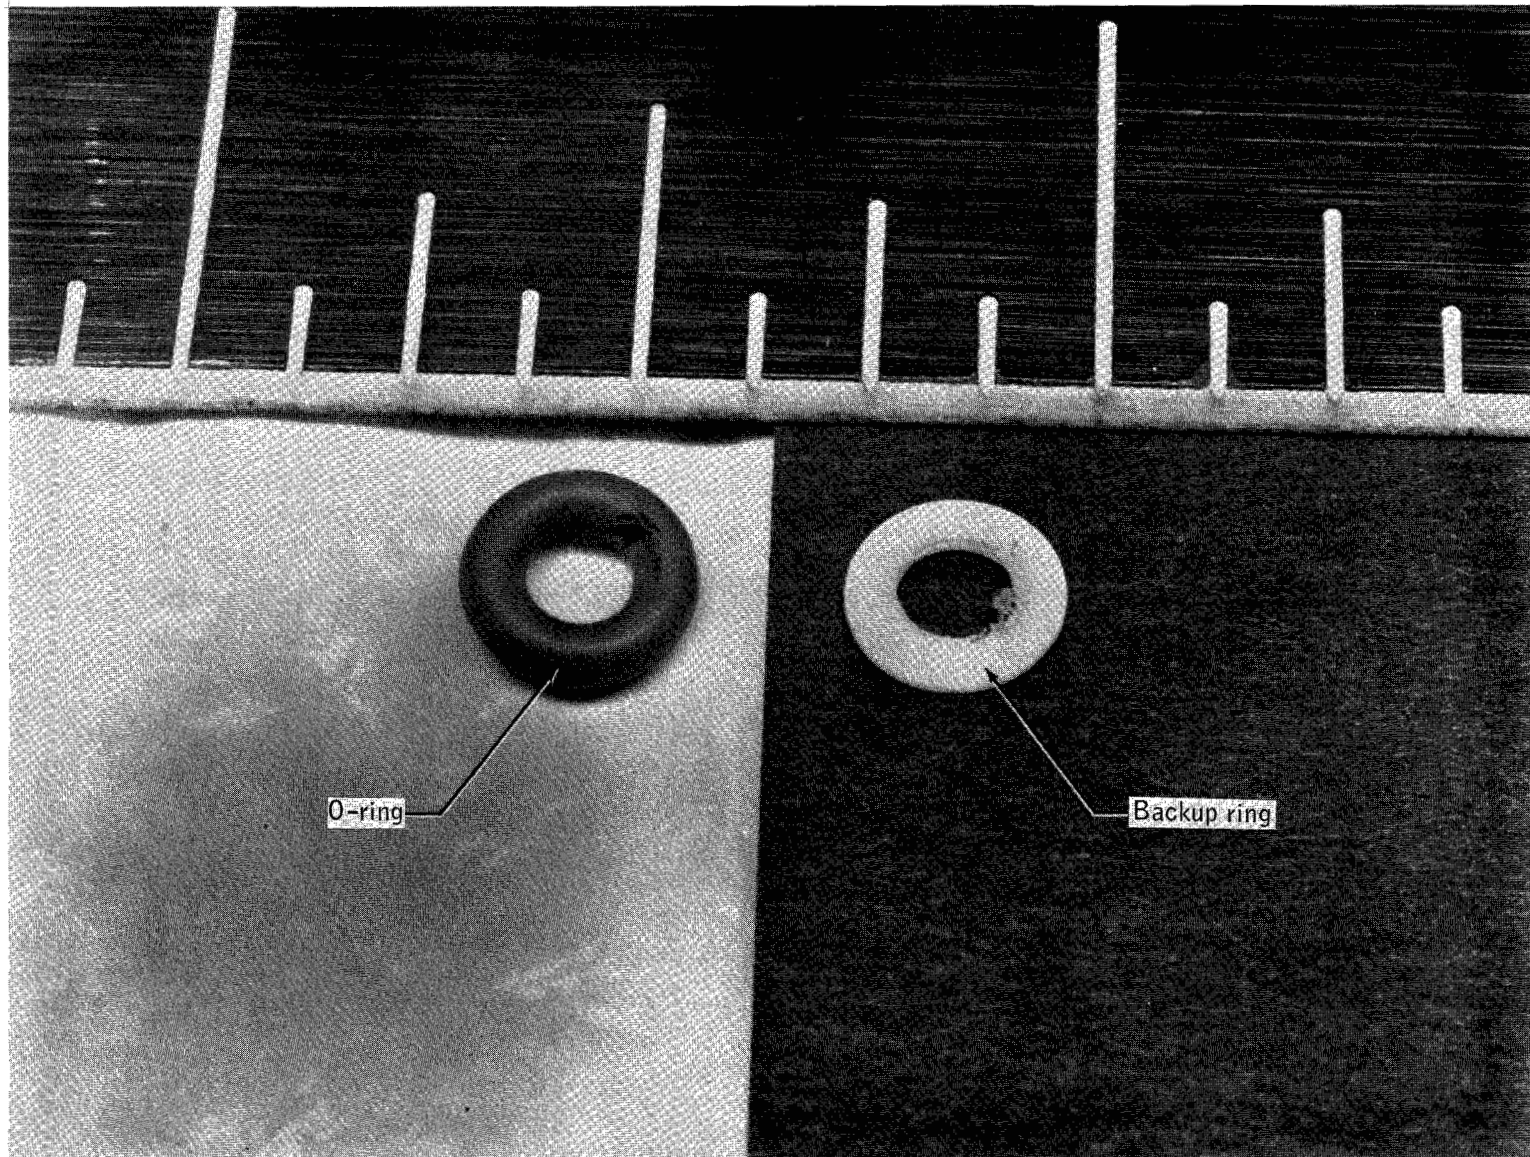
On March 10, 1962, the secondary regulator was removed from the spacecraft. On March 13, 1962, the reducer was disassembled at Cape Kennedy by a subcontractor representative, in the presence of MSC Preflight Operations, MSC Crew Systems Division, and McDonnell personnel. Bits of O-ring material were found in the screwdriver slot of the regulator stem (fig. 4) and were also found impacted against the sintered filter which covered the ambient sensing port. The O-ring itself showed a large gouged-out area, and the flourocarbon backup ring also showed damage (figs. 5 and 6). The damaged surfaces of these parts were on the inner peripheries.

Figure 6. - MA-6 secondary-oxygen-supply high-pressure reducer, inner surfaces of seals.

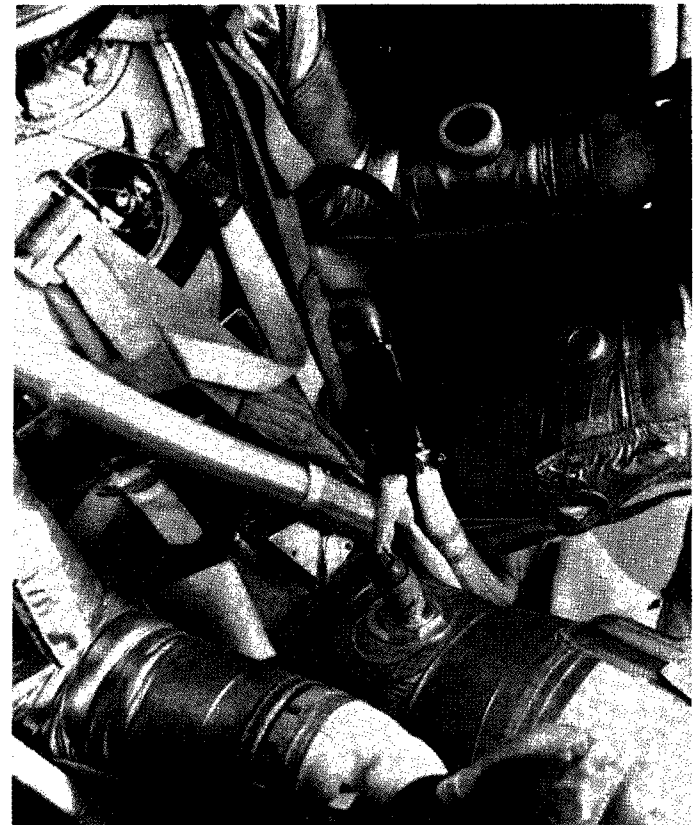
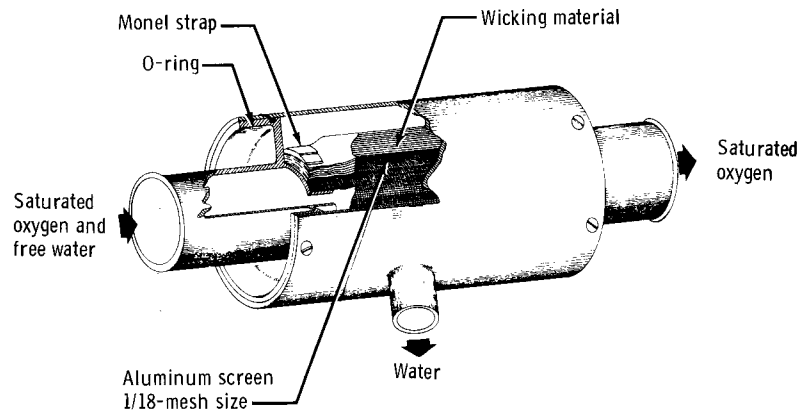
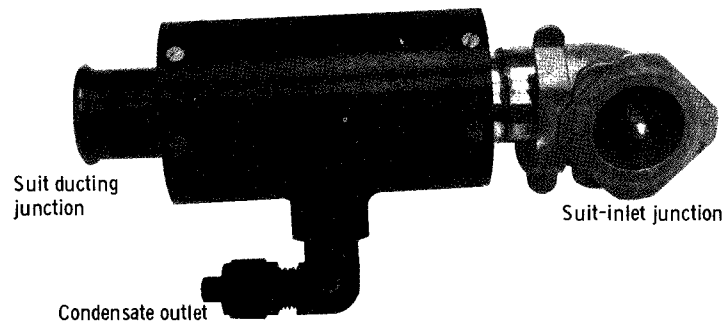
Figure C-11. - MA-9 suit-circuit condensate trap.
