NASA TM X-52336

**CENTAUR SOLID STATE INVERTER FAILURE DURING SIMULATED
FLIGHT IN AN ENVIRONMENTAL SPACE CHAMBER**

by Ralph F. Schmiedlin and B. J. Dastoli

Lewis Research Center
Cleveland, Ohio

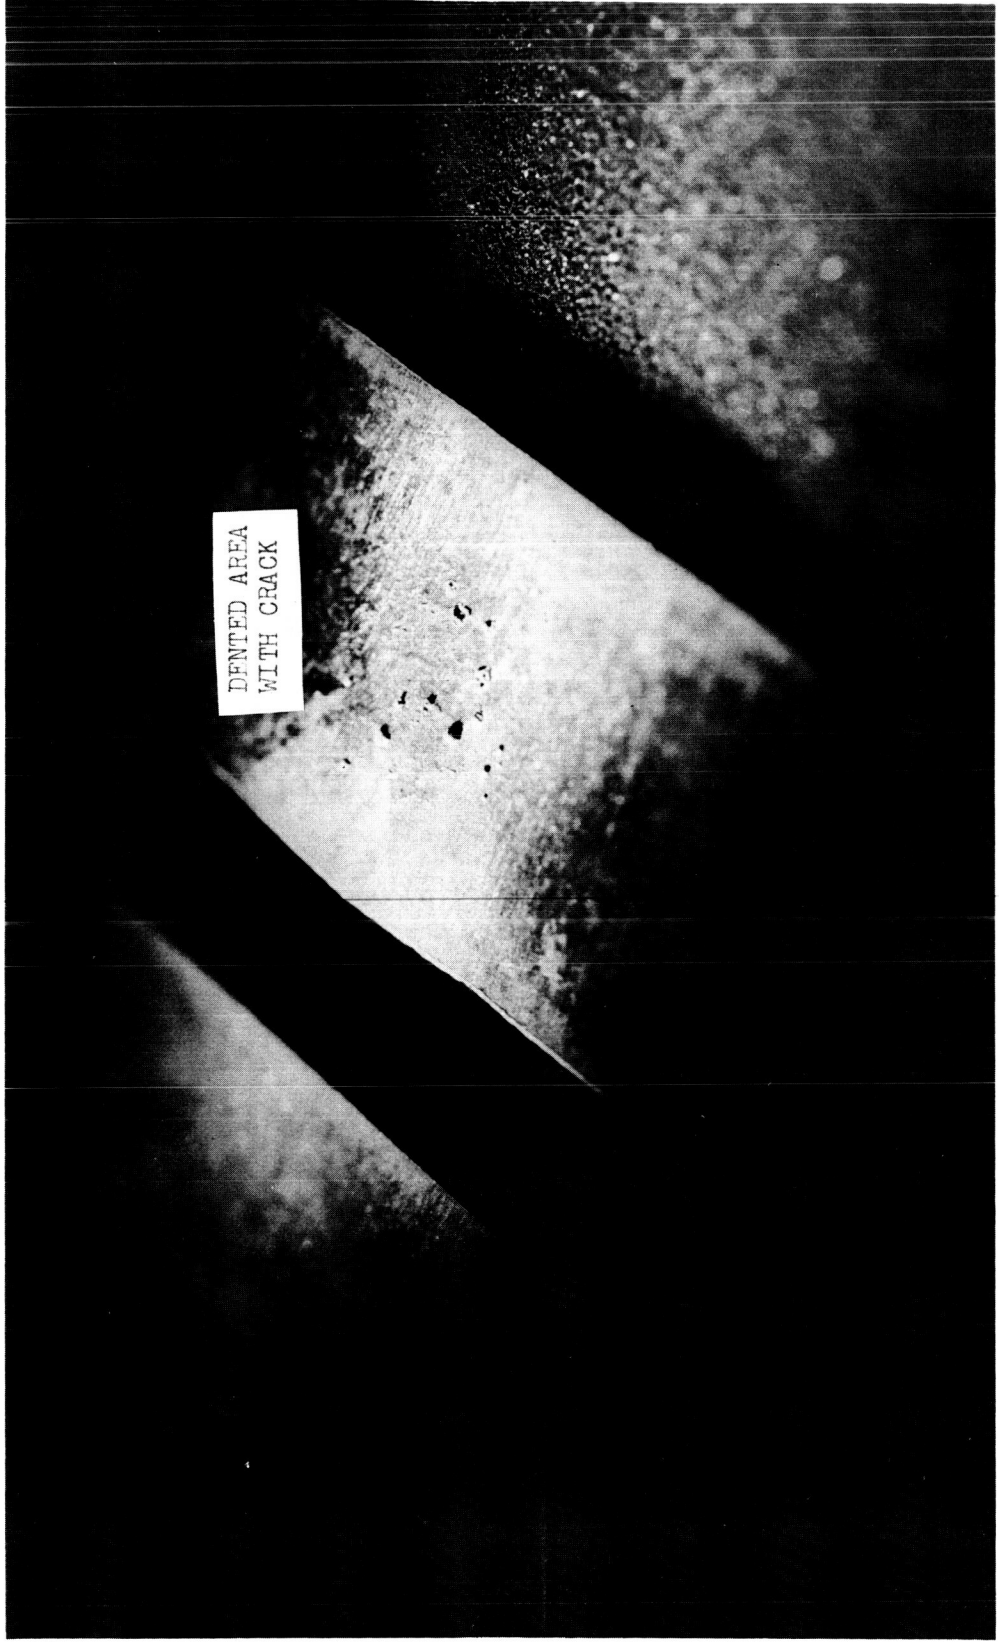
Metal particles detected on another section of the failed shunt but not directly related to the failure are shown in figure 8 (a) and (b). It is quite likely that such a particle may have been located at the failed area. Due to relative motion between the shunt, the mica, and the heat sink, (caused by cyclic heating and cooling of the inverter in various tests), the particle could have finally worn through the mica, causing shorting and arcing to ground. It was also noted during inspection that the lead at the failed end of shunt R53 was relatively rigid and had been flexed for installation which induced stress at the terminal of the shunt. This heavy, long lead also was unsupported, which would allow stress to be induced by vibration, under some conditions.

Shunt.- In the failed inverter (serial number-25), R53 had other defects at time of installation (determined during the failure analysis). A crack was noted next to an area which was dented toward the surface facing the mica in one sector of the shunt (figs. 5 and 8 (a) and (b)). The discoloration on the mating mica surface indicates lack of contact between the mica and the shunt near this dented area (the discoloration is caused by condensation of gases from the charred phenolic shunt cover insulator).

Figure 8(a). - 10X magnification of R53 showing high point imperfections in shunt material and dented area.

Special care must be taken in manufacture and inspection to see that the shunt is free of all burrs, chips, dents, cracks, etc. and that other foreign matter does not get imbedded between the mica insulator and the shunt for the heat sink.
