GEMINI PROGRAM MISSION REPORT

GEMINI IV

JUNE 1965

NATIONAL AERONAUTICS AND SPACE ADMINISTRATION MANNED SPACECRAFT CENTER

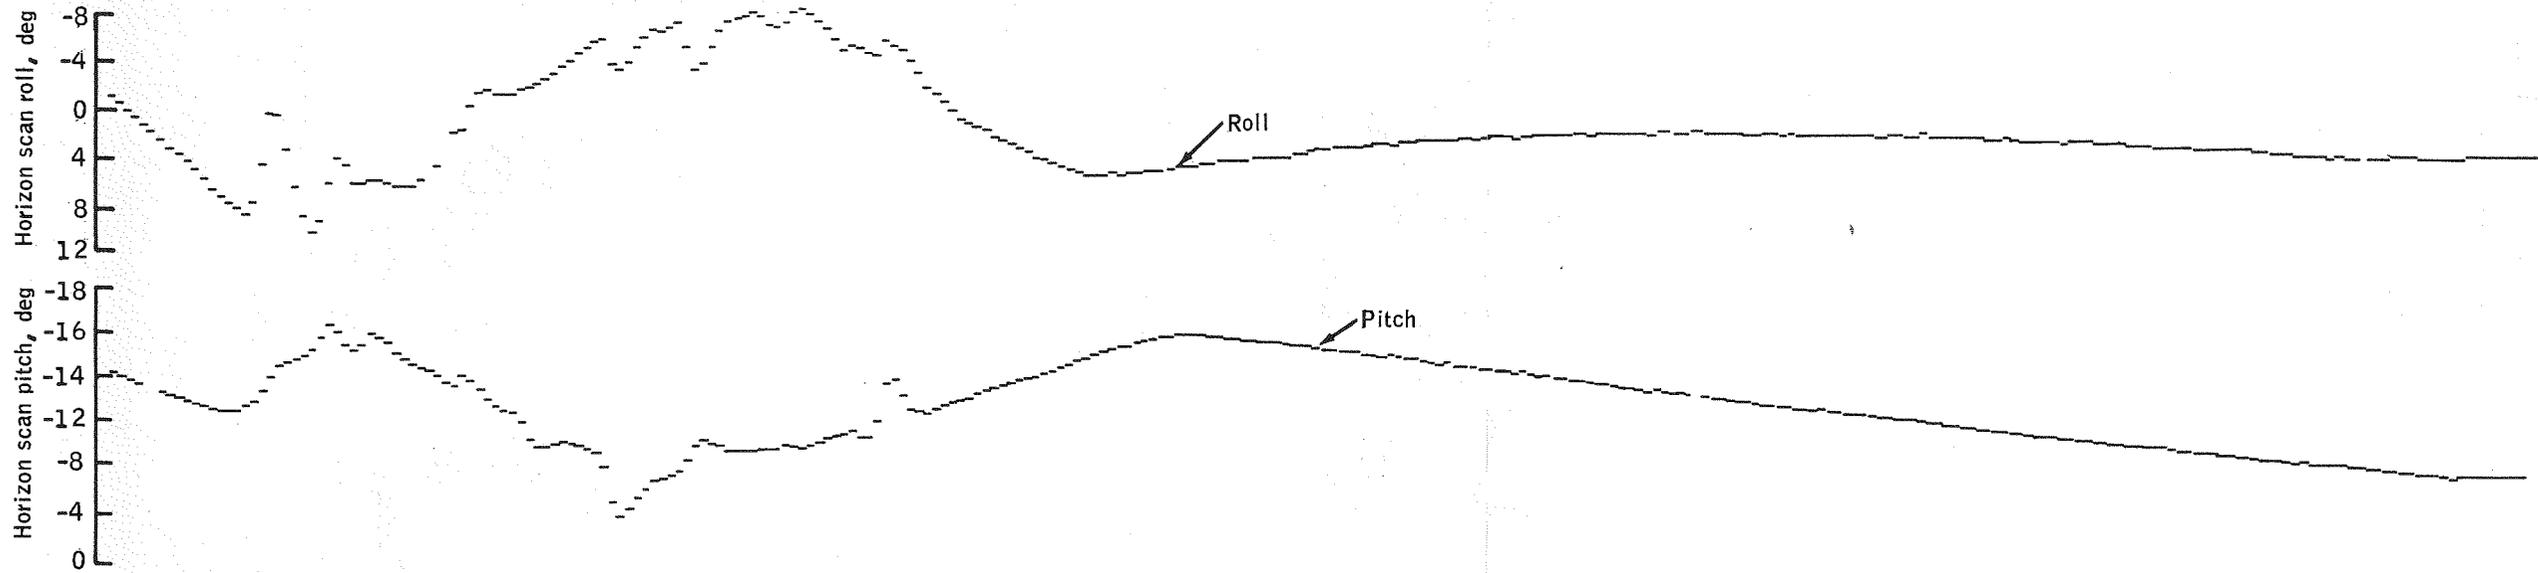
(b) Loss of track of horizon sensor due to sun interference.
Figure 5.1-12. - Continued.

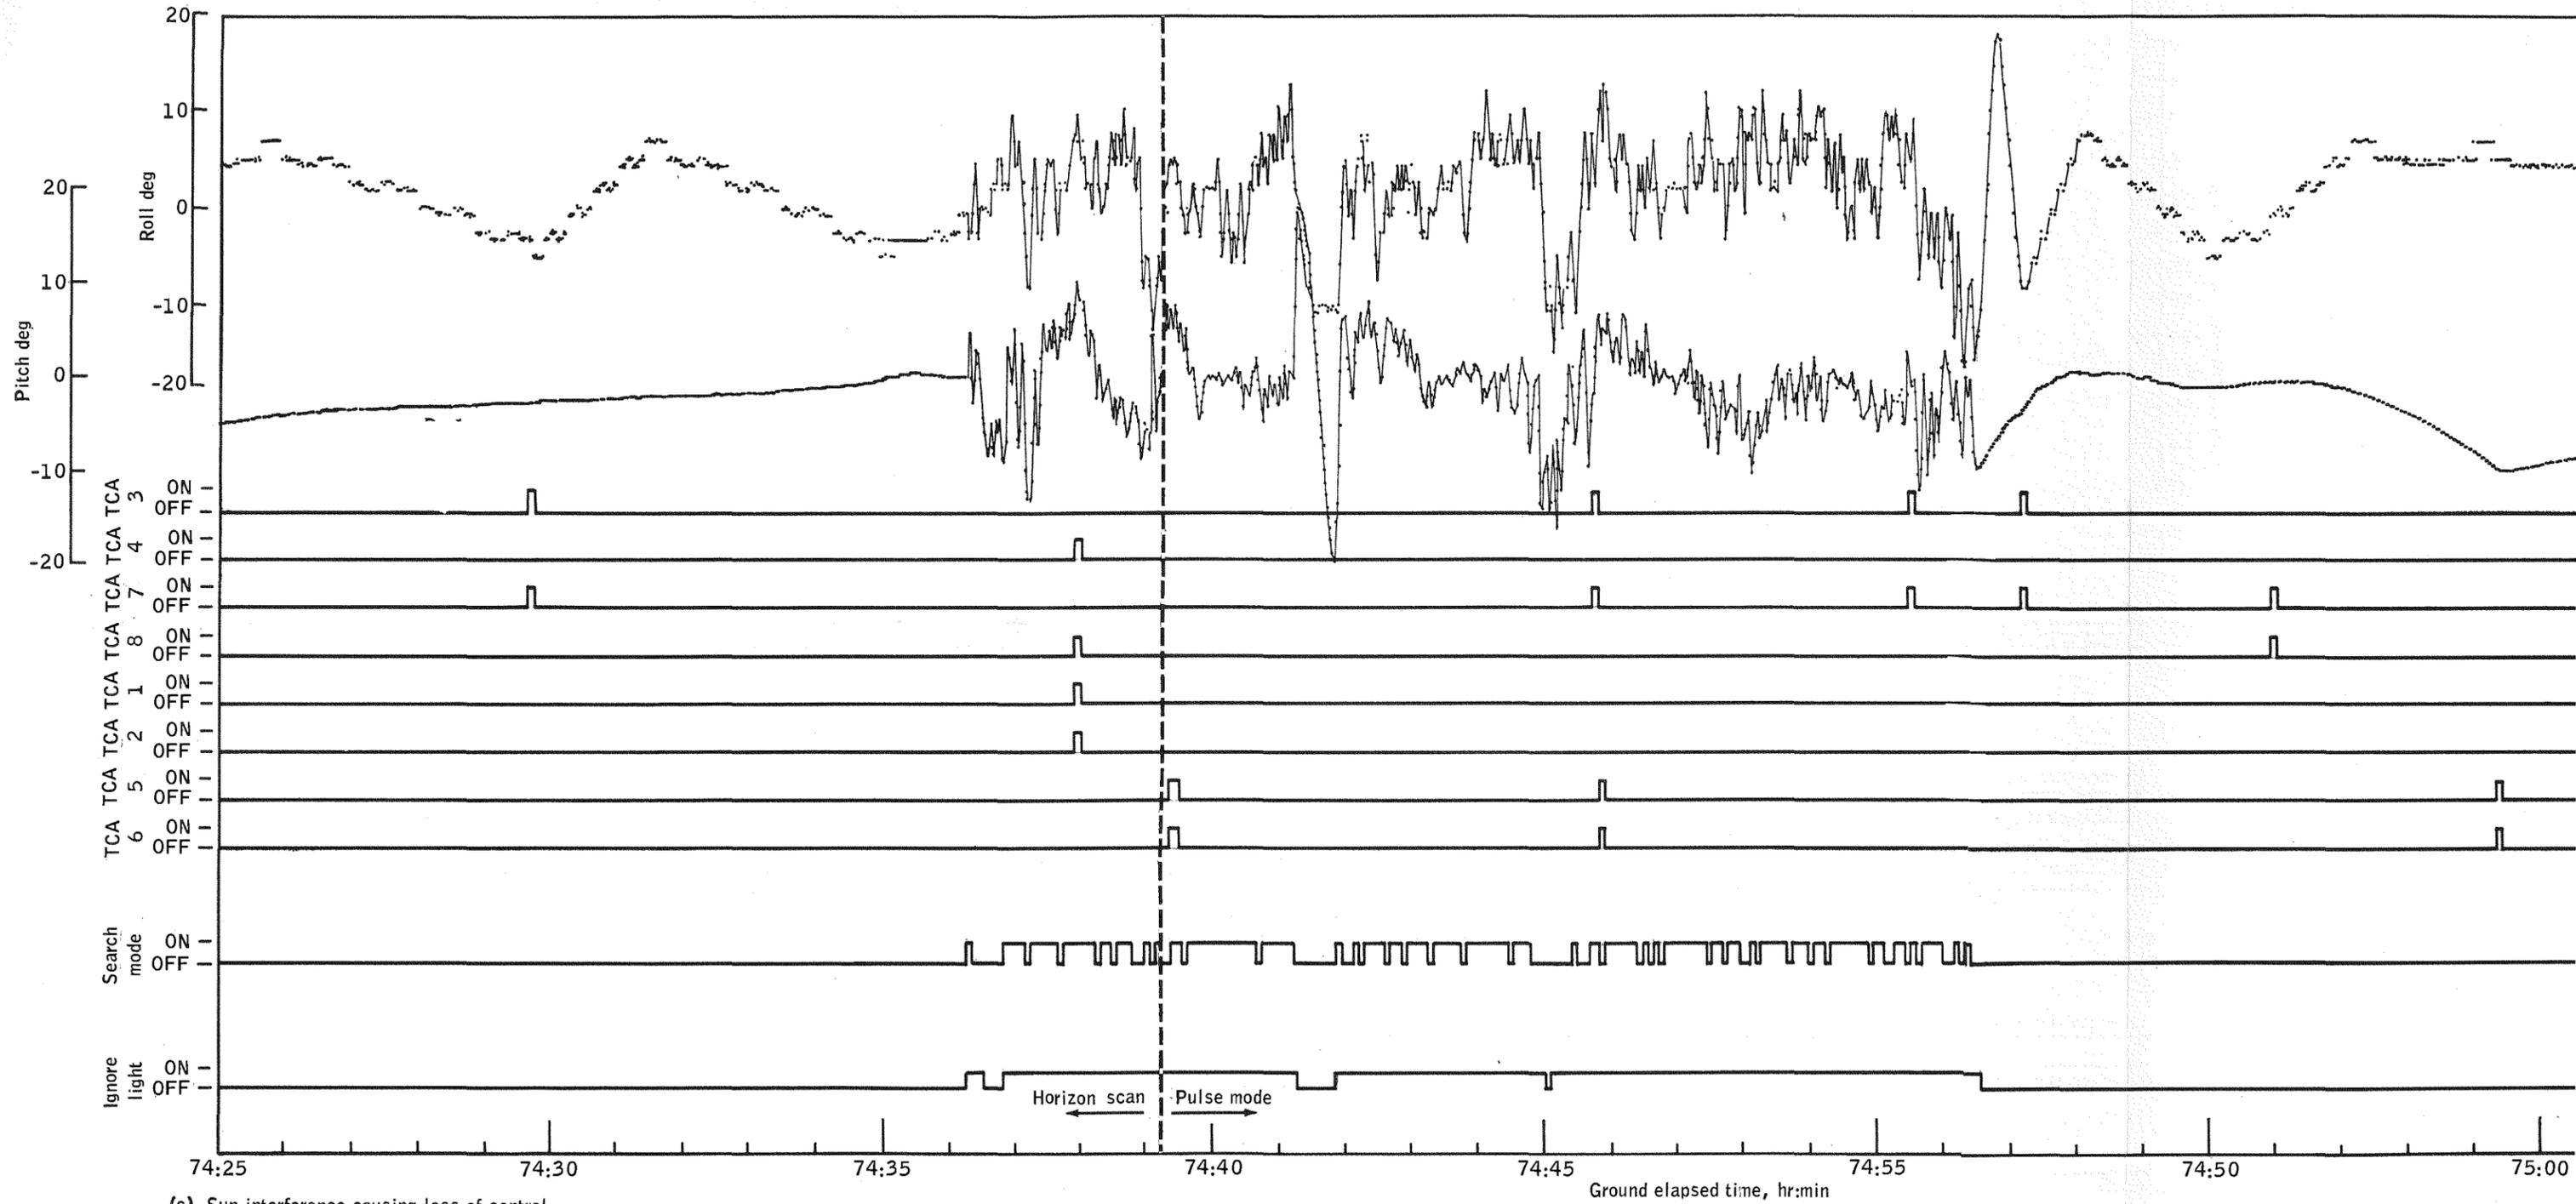
(c) Sun interference causing loss of control
Figure 5.1-12. - Concluded.

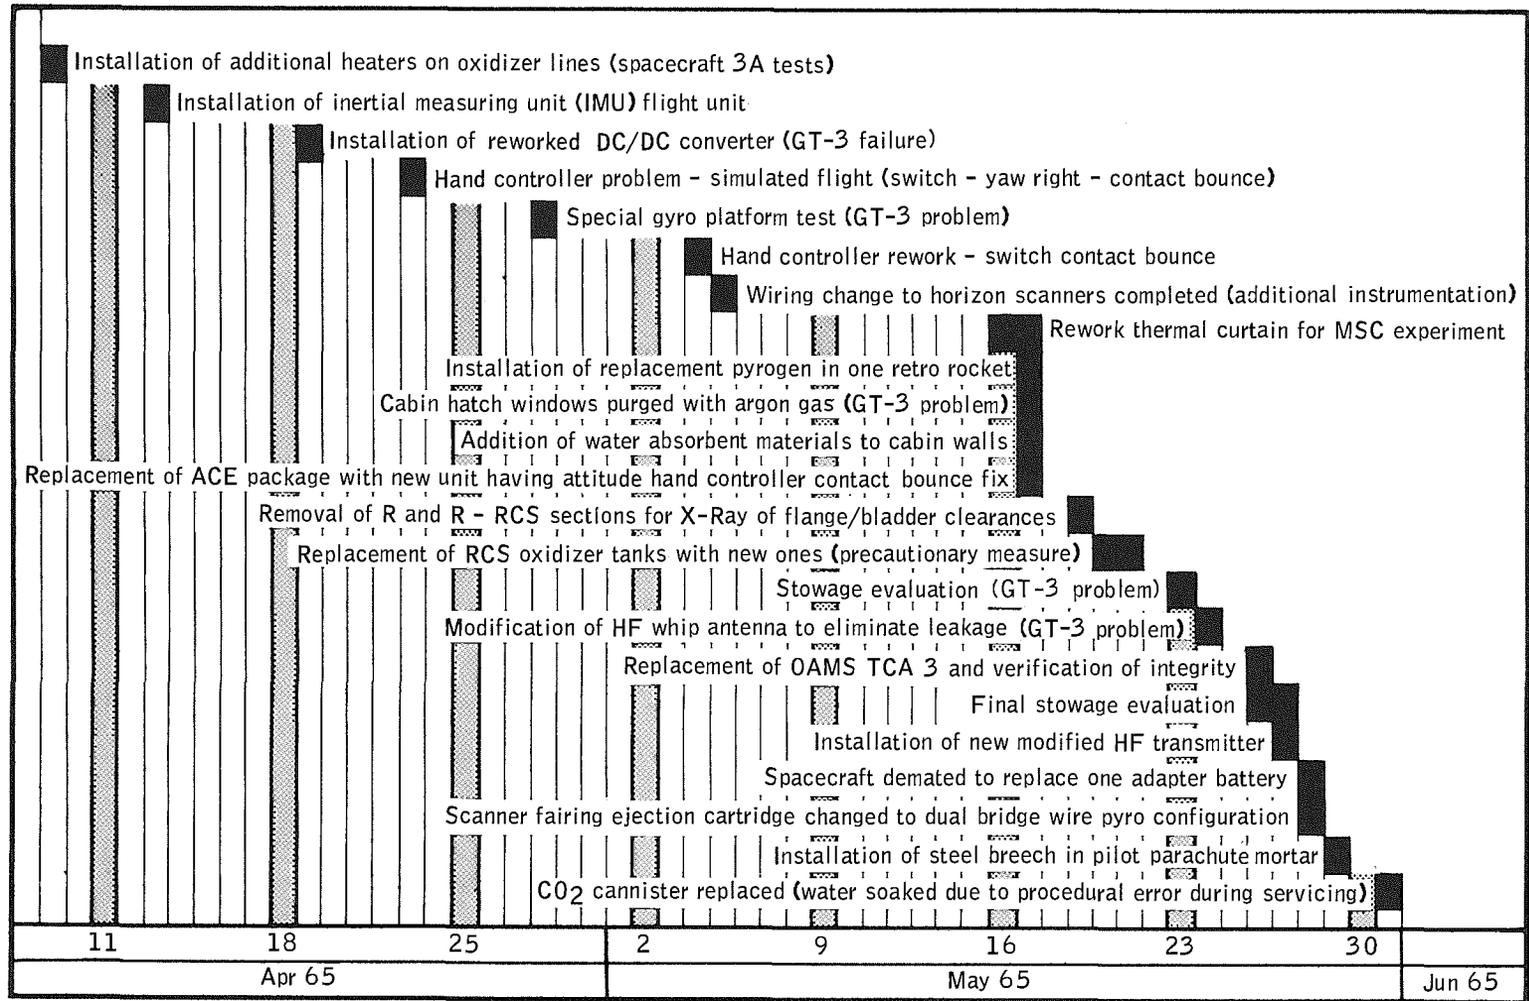
Figure 12-4.- Spacecraft 4 significant problem areas at Cape Kennedy.

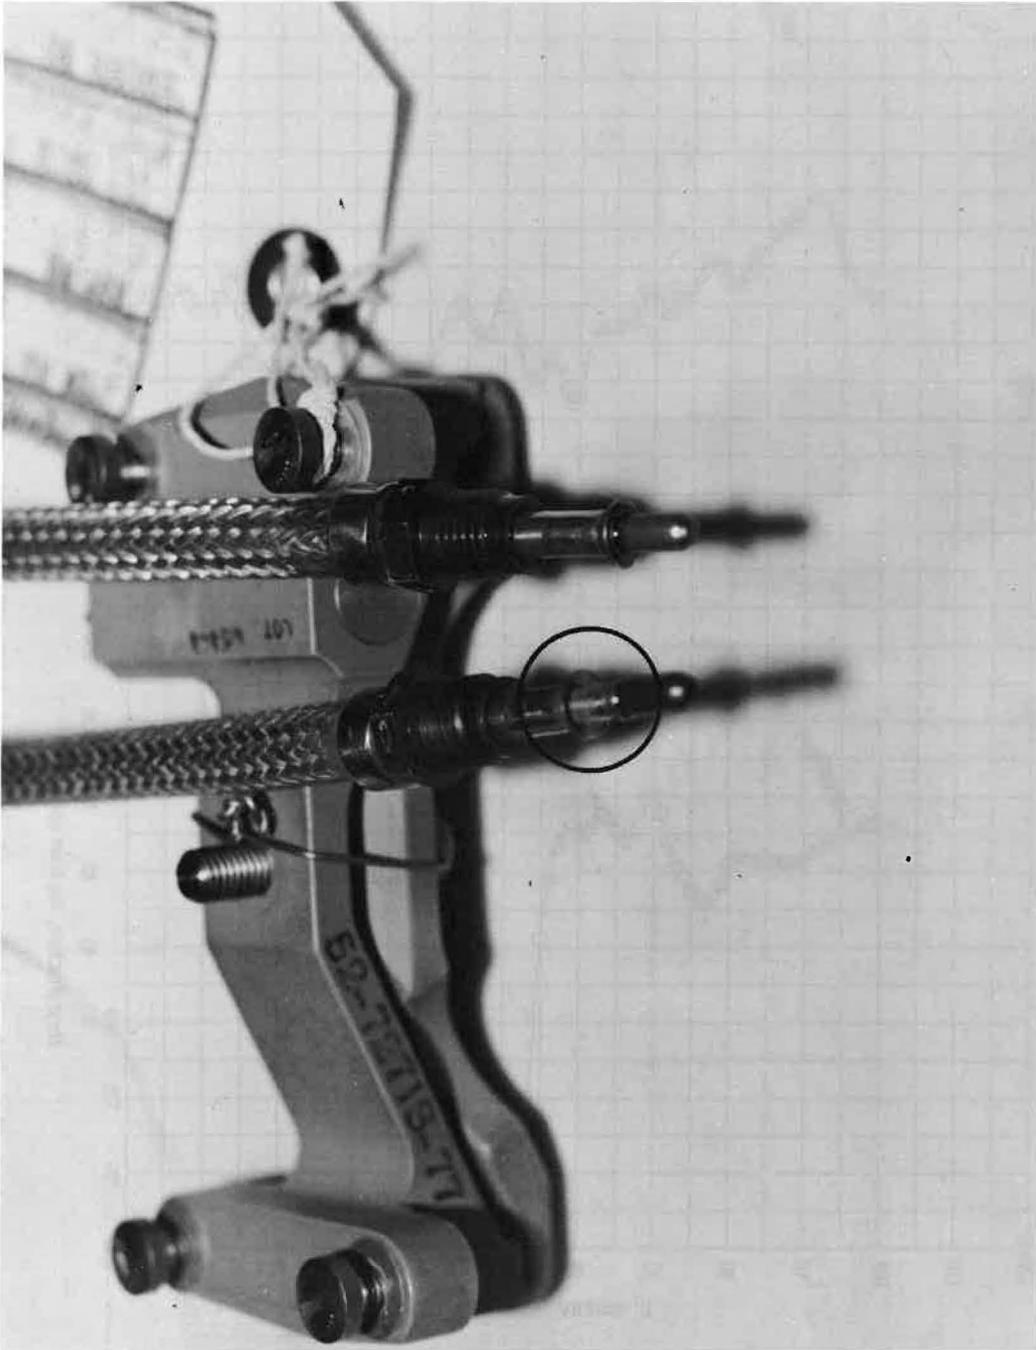
Figure 12-9. - Faulty escape system MDF interconnect.

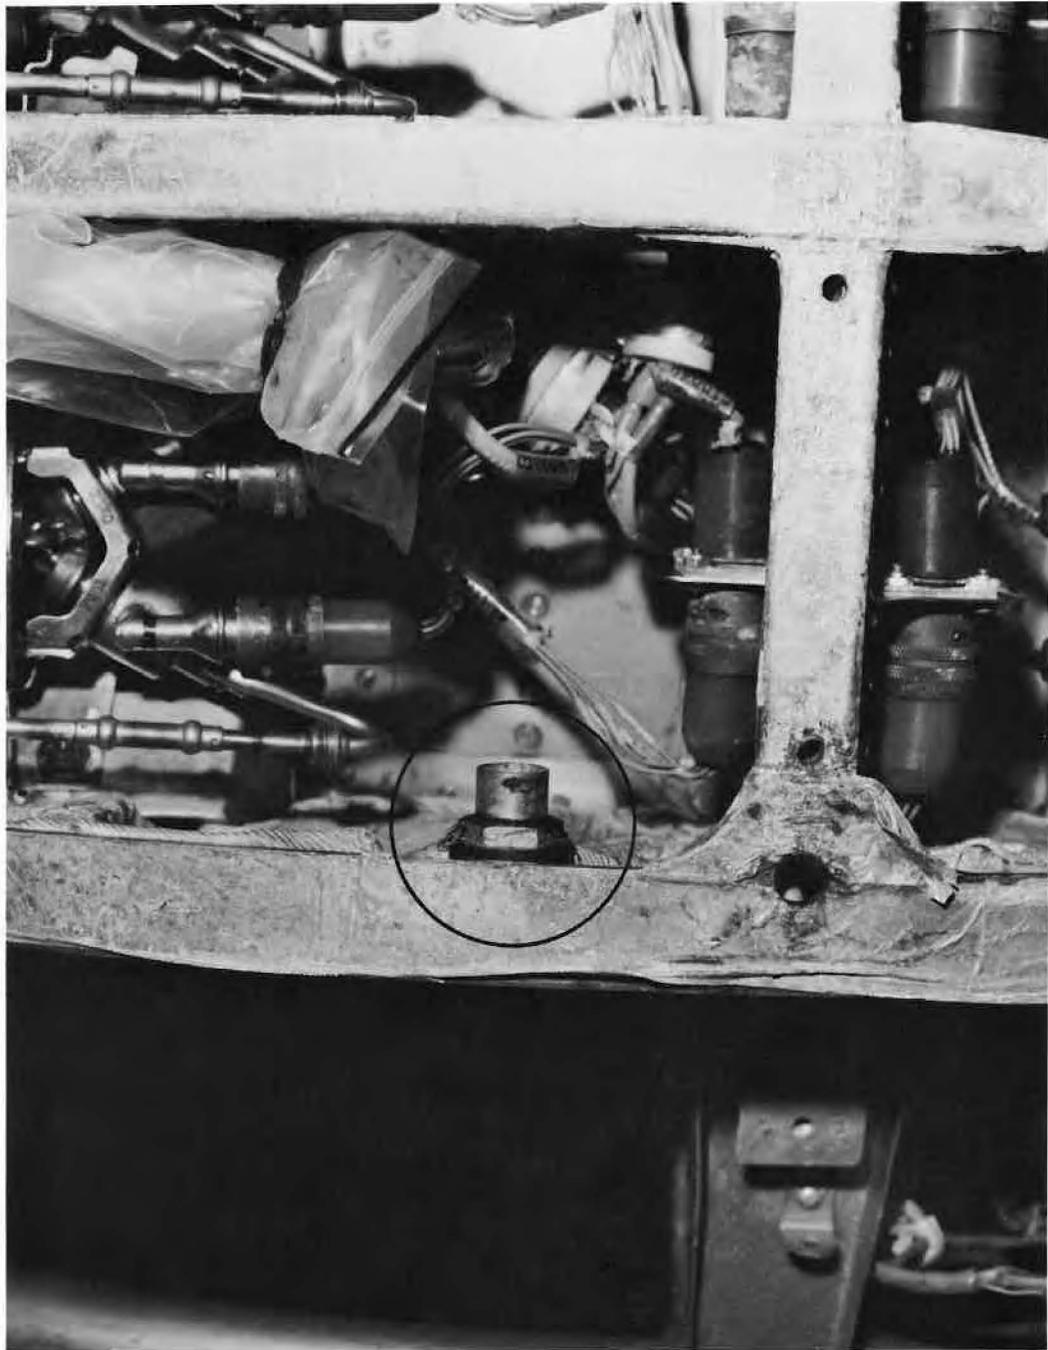
Figure 12-10 - Sheared connector to R and R separation igniter.
