STUDY OF FAILURE AND RELIABILITY IN  
MICROELECTRONIC DEVICES  
8th QUARTERLY SUMMARY REPORT

16 October 1967

CONTRACT NO. NAS 12-72

GENERAL PRECISION SYSTEMS INC.  
Librascope Group  
Systems Division  
808 Western Avenue  
Glendale, Calif. 91201

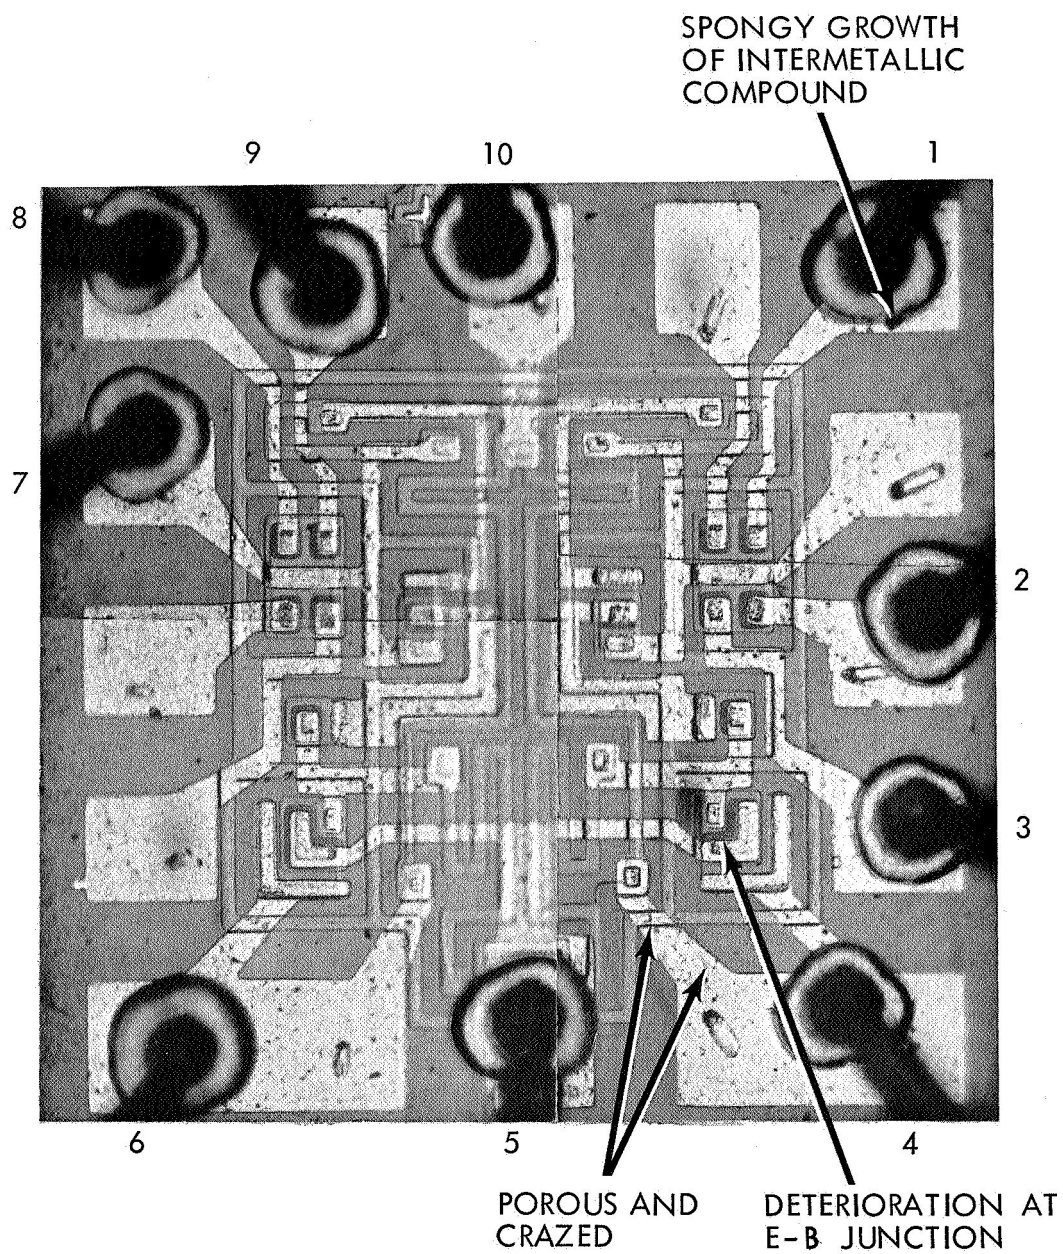
Figure 5. Macrograph Showing Areas Affected by  $V_{(SAT)}$   
Type Failure (Fairchild, No. 42)

In terms of device elemental discrepancies, these failure mode indicators would be conducive to the characterization of the failure cause in the device structure. For instance, referring to the 6th Quarterly Report (February 1967), the specimen No. 19 of Motorola Lot B indicated, during functional tests, that decreases in the breakdown voltages (BV) were incurred by the diodes 8 and 9, (Figure 7). The devices were uncapped and examined metallographically. The examination revealed surface contamination and pinholes in the aluminum metallization of diode 8, and badly misaligned bond and pinholes in excess were present on the cathode metallization of diode 9. In another case, specimen No. 42 of Fairchild device, shown in Figure 5, had failed in  $V_{SAT}$  and BV after 10,000-hour life test.

Metallographic examination of the top view of the device circuit revealed a slight intermetallic growth at the bond interface ( $V_{SAT}$ ), and crazed aluminization and slight deterioration of the emitter-base junction of transistor at pin 4 verified the failure condition BV. These examples can be extended to many other failure modes and their respective metallographic verifications. Consequently, it can be asserted that definite correlation between electrical failure mode indicators and microscopic

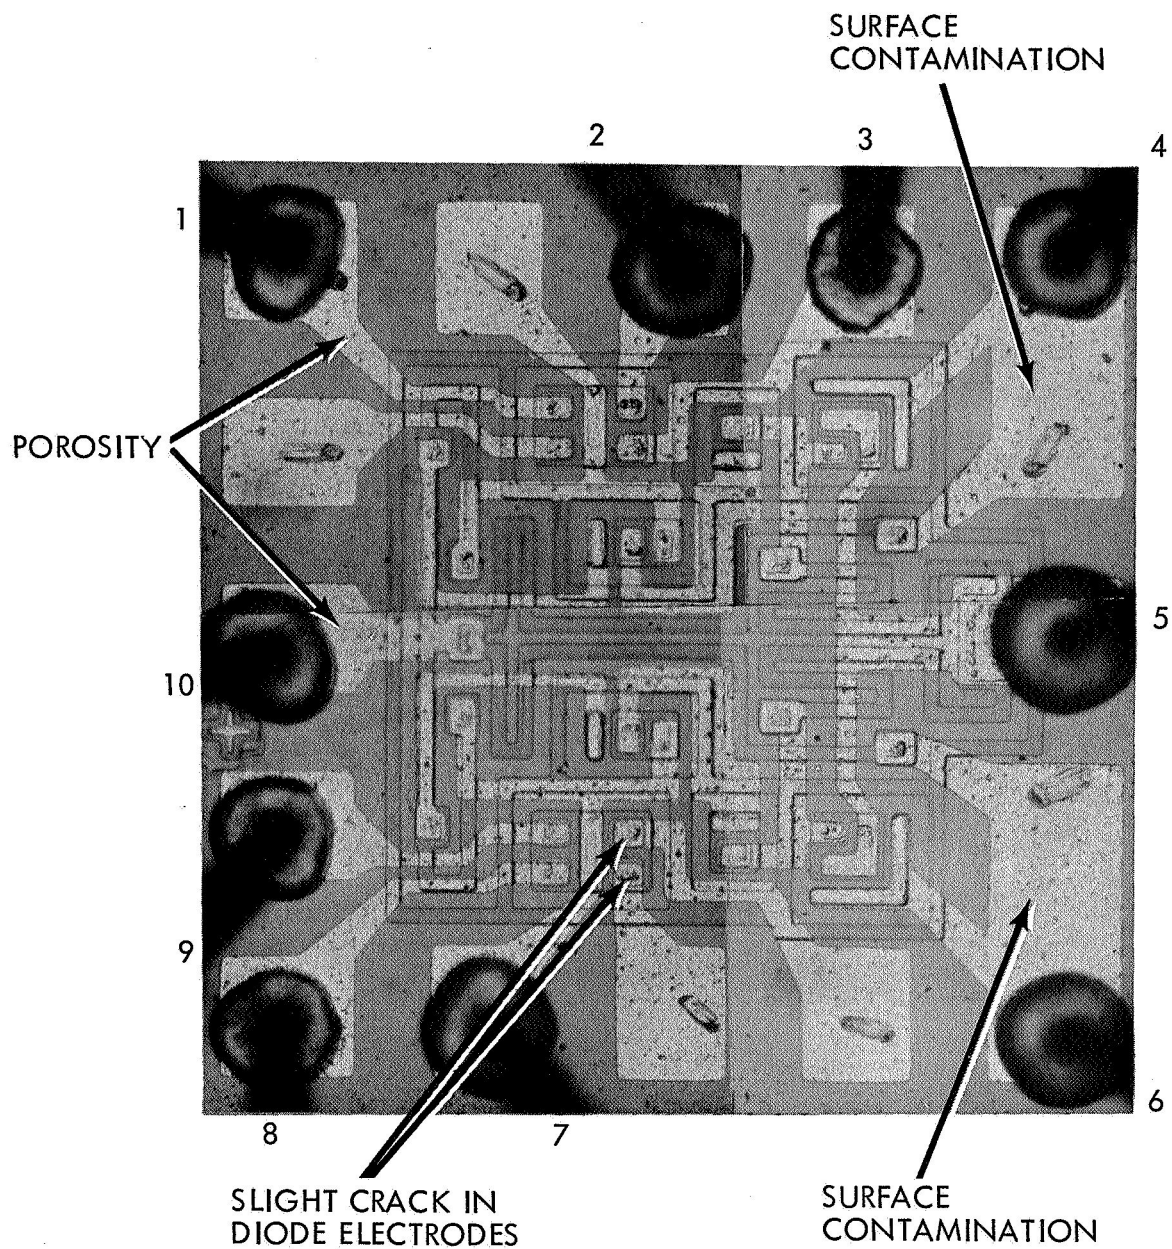
Figure 6. Fairchild Device With BV-Type Failure

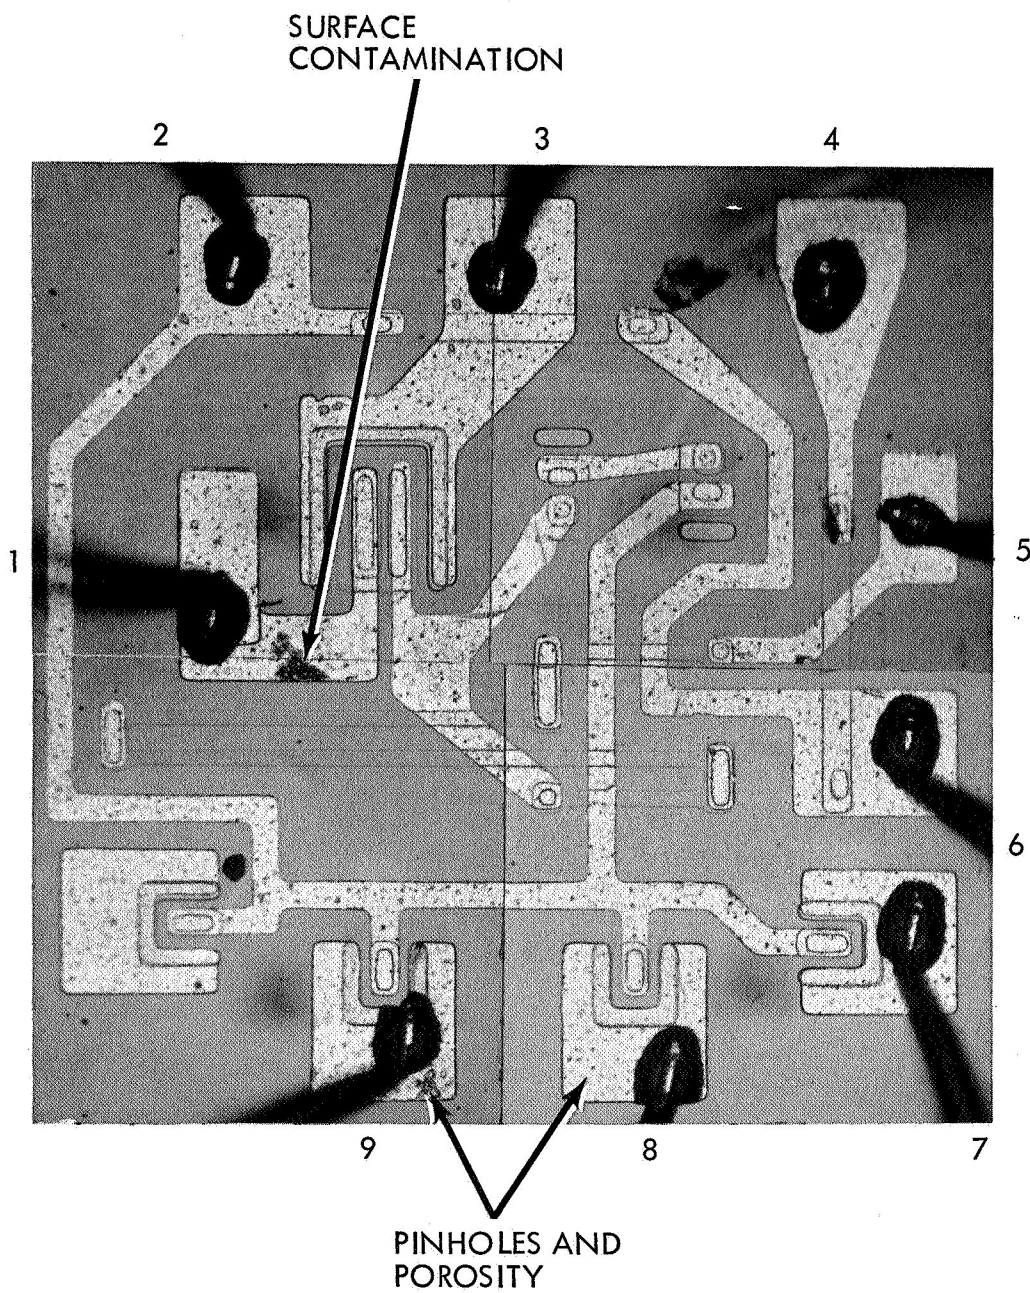
Figure 7. Motorola (Lot B) Device With  $BV_8$  and  $BV_9$  Failures

Subsequent to the 12,000-hour life test, six specimens from Motorola Lot B were subjected to a vibration test described in paragraph 2.1.3. One specimen failed in the vibration test. The failure was due to increased leakage current ( $I_R$ ) and low output transistor breakdown voltage (BV), indicating a short at pin 9. (See representative sample in Figure 7).

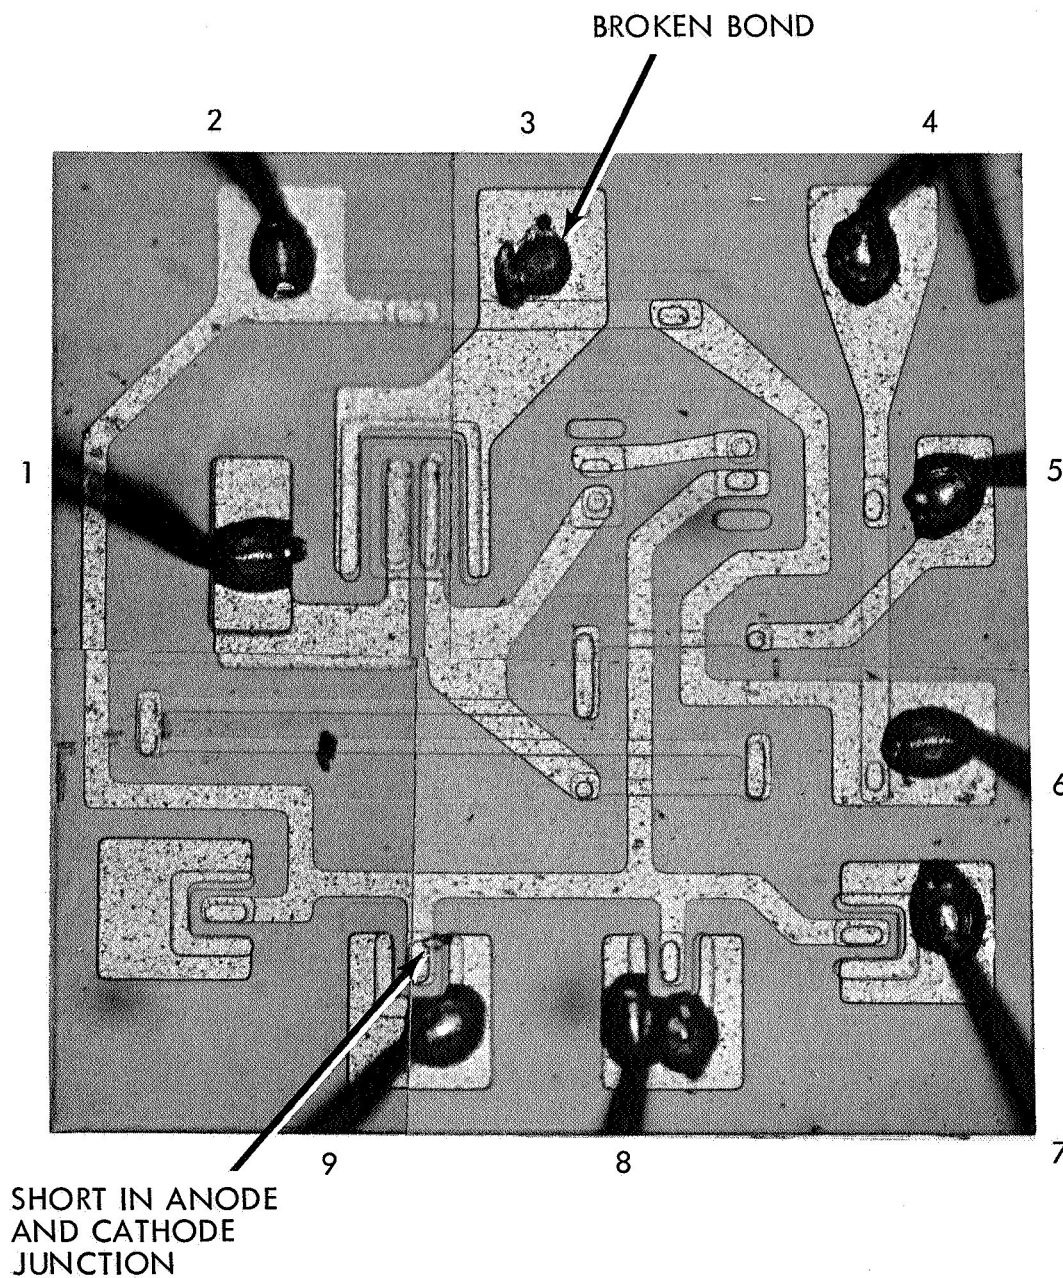
Misalignment of bonds was quite frequent, particularly in Motorola (Lot B), as will be noted from Figure 8. When the bond is so misaligned that it partially extends over the active region of a poorly silicon-dioxide-isolated diode or transistor, the condition may cause a short at the P-N junction either by direct contact of the bond with the P-N regions or by metallic diffusion into the degraded region and bridging the two active regions. Examples of electrical shorts occurring in the latter manner are shown in Figures 9 and 10.

Figure 8. Motorola (Lot B) with BV-Type Failure

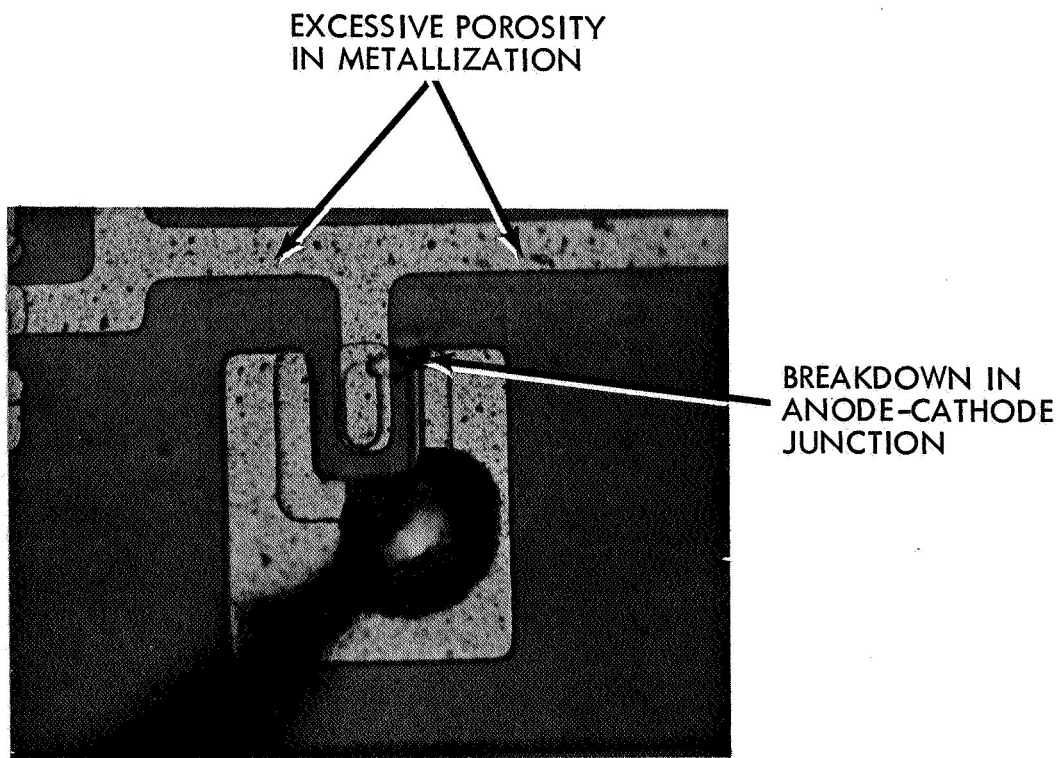
Figure 9. Shorted Diode 9 of Specimen 30

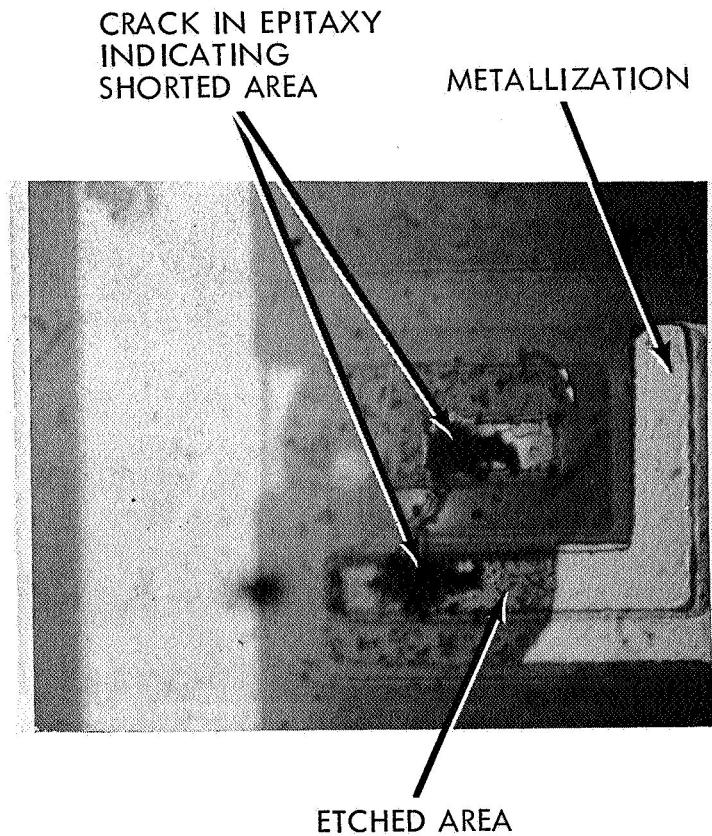
Figure 10. Diode 9 of Specimen 13 Showing the Shorted  
Area Between Anode and Cathode  
(Metallization Partially Removed By  $\text{HNO}_3$ -2HCl Etch)

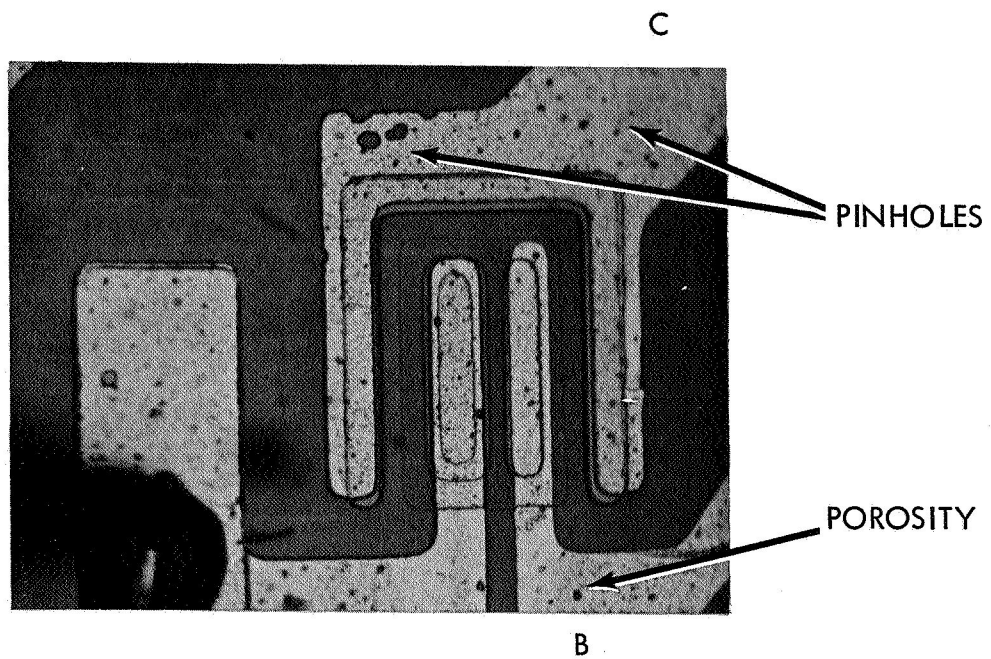
Degradation in the aluminum metallization was infrequently encountered, together with excessive porosity, as shown in Figures 11 and 12. This could have been due to the softening of the metallization during various thermal cycles and step-stress tests. Since in some devices this condition was observed to be associated with a poor passivation film, the aluminum metallization was removed with  $HNO_3$ -2HCl from several representative specimens, after the removal of the passivation film. In Figure 10, a portion of the metallization of diode No. 9 is shown as having been removed. It is evident from the photomicrograph that both the anode and the cathode epitaxies were degraded, forming a narrow path there-between during initial processing. Consequently, the aluminum metallization had partially diffused into the path, bridging the electrode elements

Figure 11. Output Transistor With Excessive Porosity

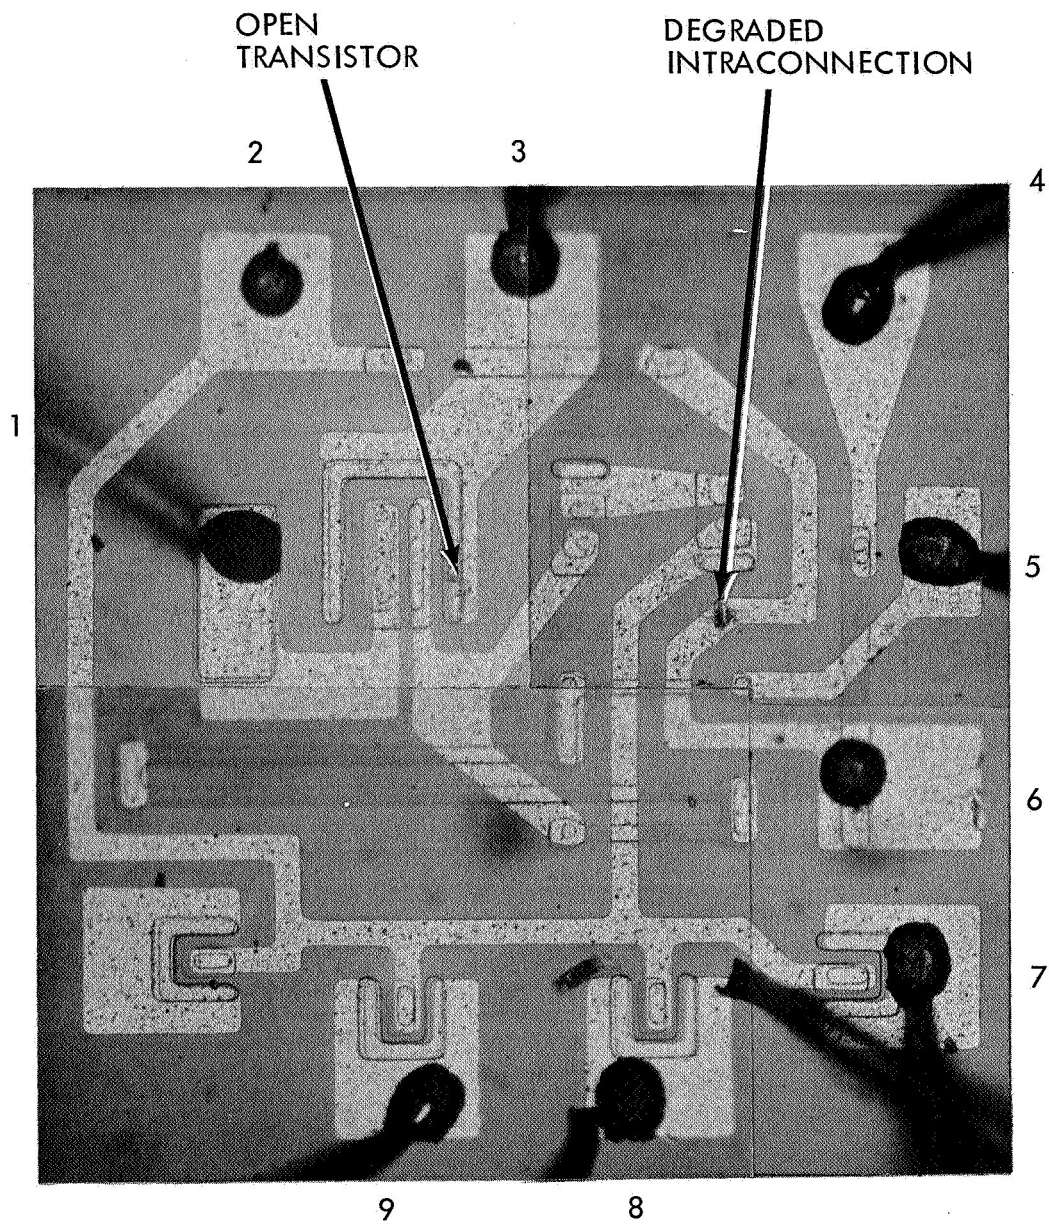
Open diode or transistor was characterized by the top views of the specimen shown in Figures 13 and 14; the Figure 14 is a magnified view of the open transistor with  $V_{(Sat)}$  failure indicator shown in Figure 13. The transistor output voltage had increased from the initial 0.256 to 20.36 volts.

Figure 13. Motorola (Lot B) Device With  $V_{SAT}$  Failure

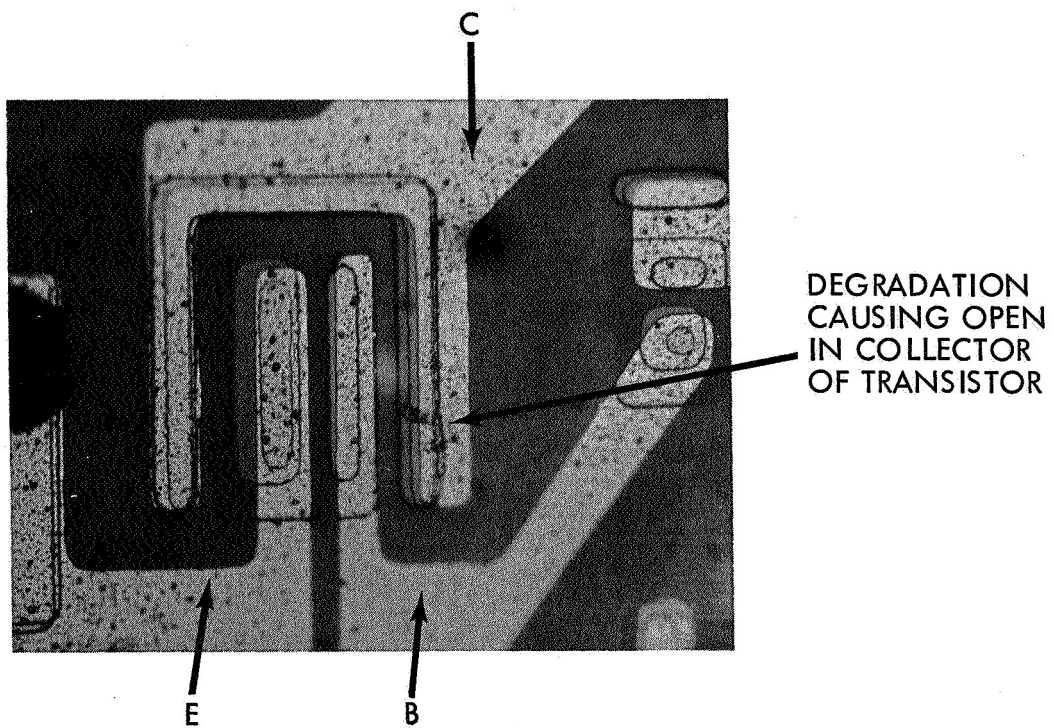
Figure 14. Output Transistor of Specimen 9 (Motorola)

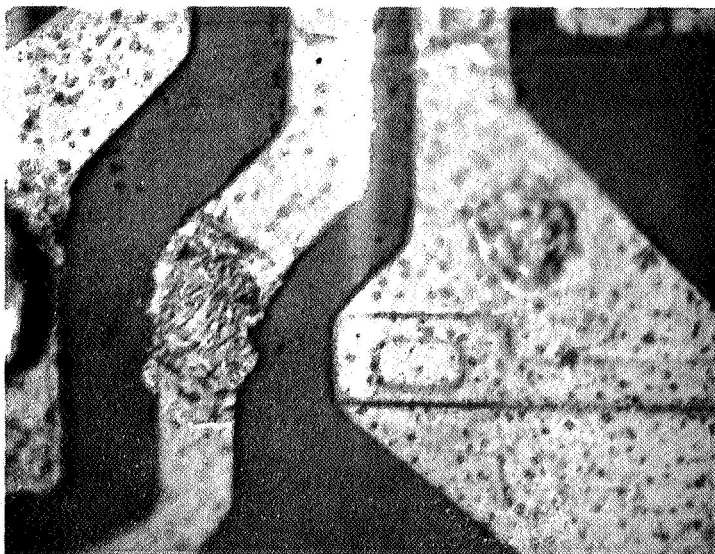
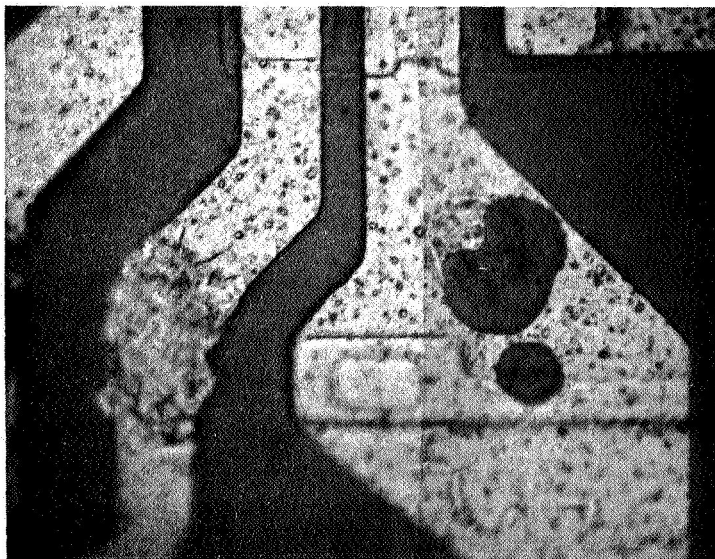
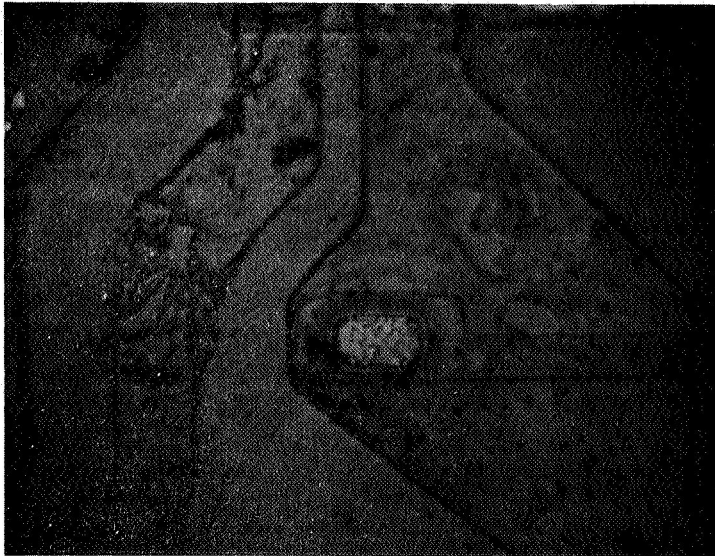
Some of the failed devices were studied by treating them with concentrated HCl for definite intervals of time and finally removing the aluminum metallization completely from the die surface, as shown in Figure 15. This action permitted the observation of any defect in the pyrolytic glass dielectric in the N, N+ and P regions by change of birefringent colors. Subsequent to these observations, the dielectric film was etched in stepwise manner using a 5 percent solution of HF. It was thus possible to study the various active regions at desired depths to determine their physical characteristics as well as certain changes that may have occurred during thermal and electrical test prevailing over the tendency for degradation, inversion, or fouling of the doped regions.

Figure 15. Passivating Film of a Motorola (Lot E) Device  
(Sequence of Dissolution of Aluminum Below the Glass)
