DOCUMENT NO. T5-6539-96

TITLE ANALYSIS OF FAILED CONTACTS FROM METHODE CONNECTOR,

FD-744-3S-SF

MODEL NO. S-IC CONTRACT NO. NAS8-5608

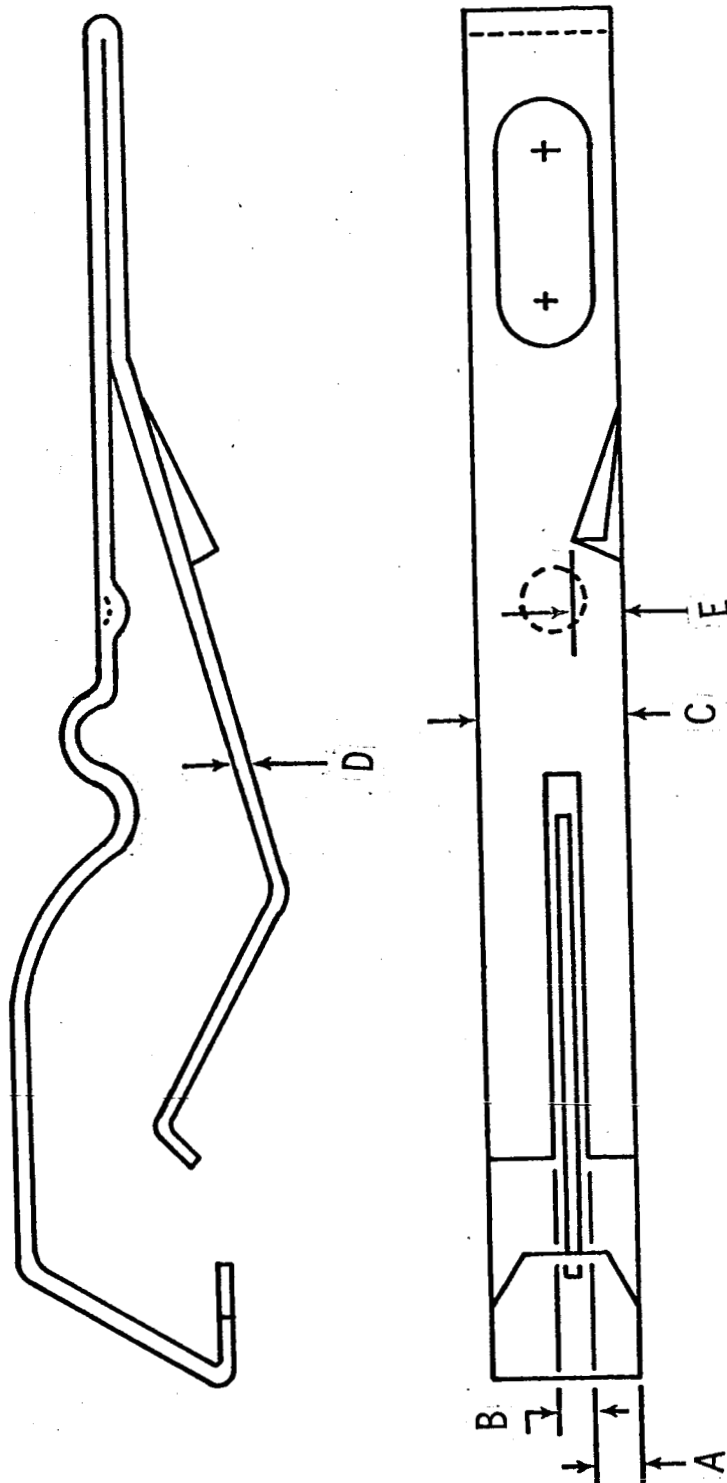
FIGURE 1

Six connectors were measured mechanically for the dimensions shown in Figure 1 and compared with dimensions on Methode drawing 141-1088-00.

- a. Dimensions - The dimensions of all test specimens were within tolerances specified on Methode contact drawing 141-1088-00. Dimensions verified are shown in Figure 1.

CONTACT DIMENSIONS CHECKED
