# SNAP-8 ELECTRICAL GENERATING SYSTEM DEVELOPMENT PROGRAM

PROGRESS REPORT FOR JANUARY - JUNE 1966

NASA CR 72-1-03  
Aerojet Report No. 3233

SEMIANNUAL REPORT

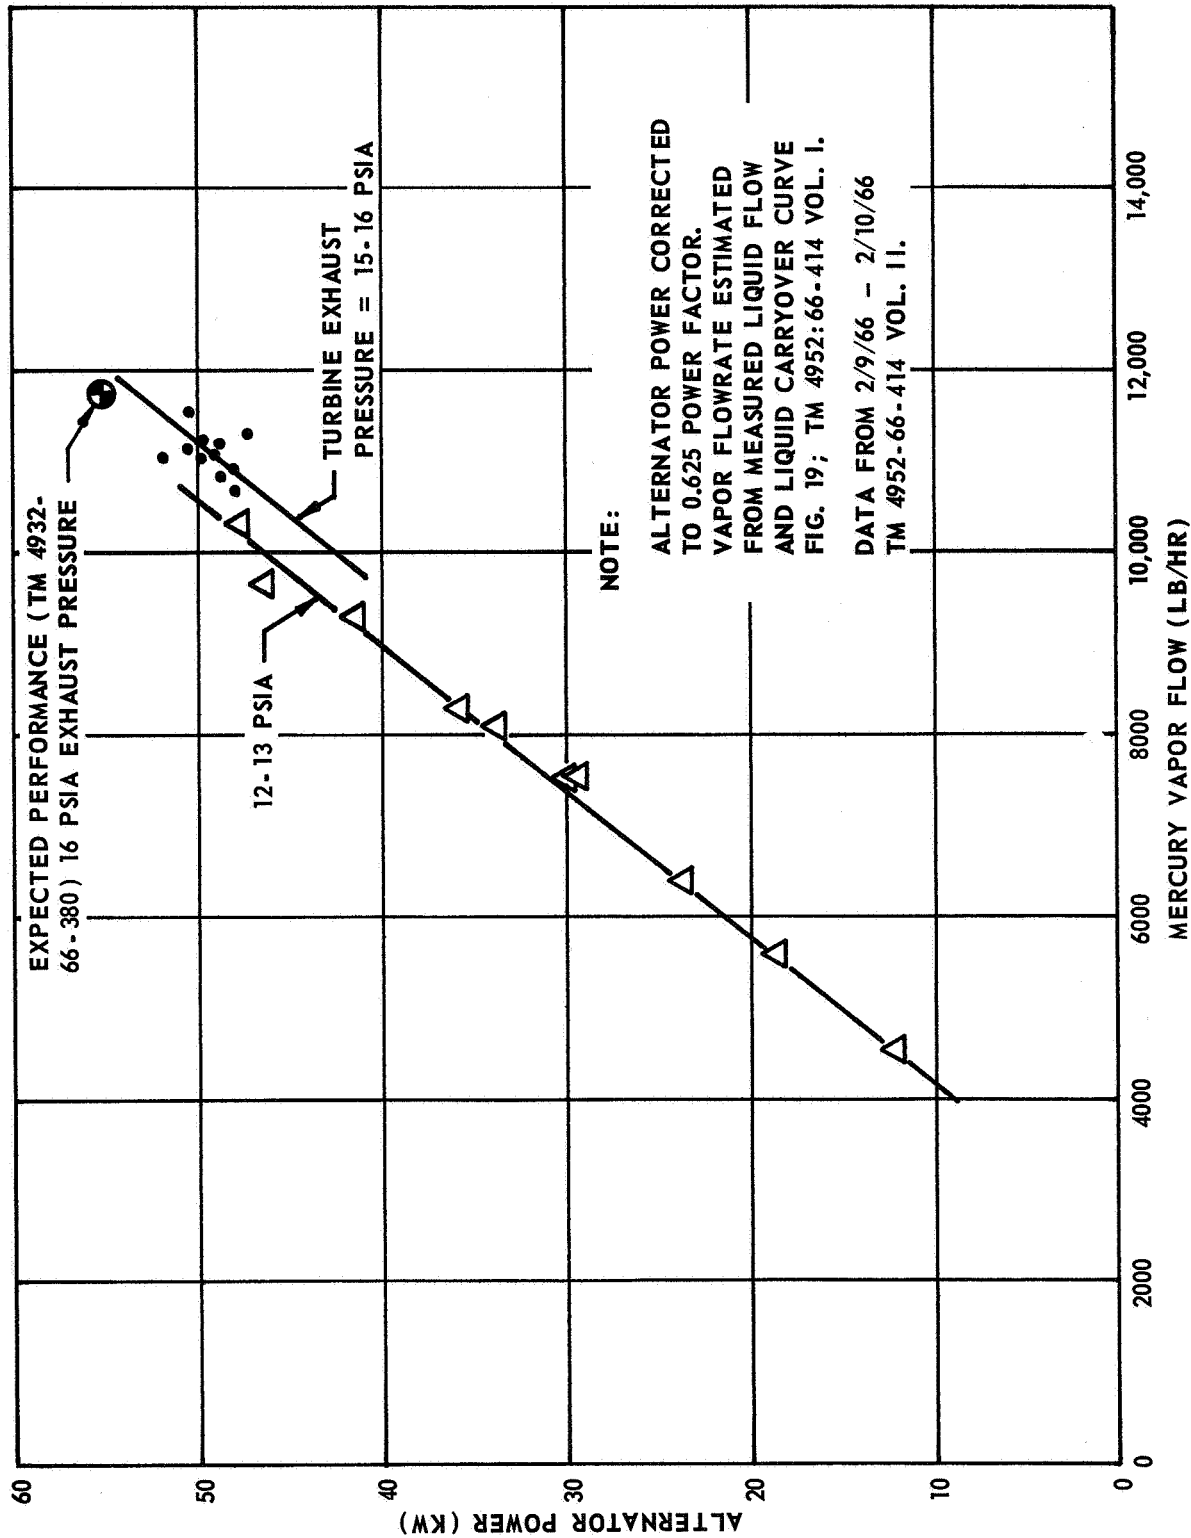
Figure V-2

(1) The S/N A-2 unit 2/3 degraded after about 88 hours of operation.

(2) The 2/3 unit (before degradation) performed the same as, or slightly better than, the 3/2 unit.

TAA (P/N 096800-1, Unit 2/3) Performance Before Degradation: Alternator Power vs Mercury Vapor Flow in PCS-1 Phase IV Step 2

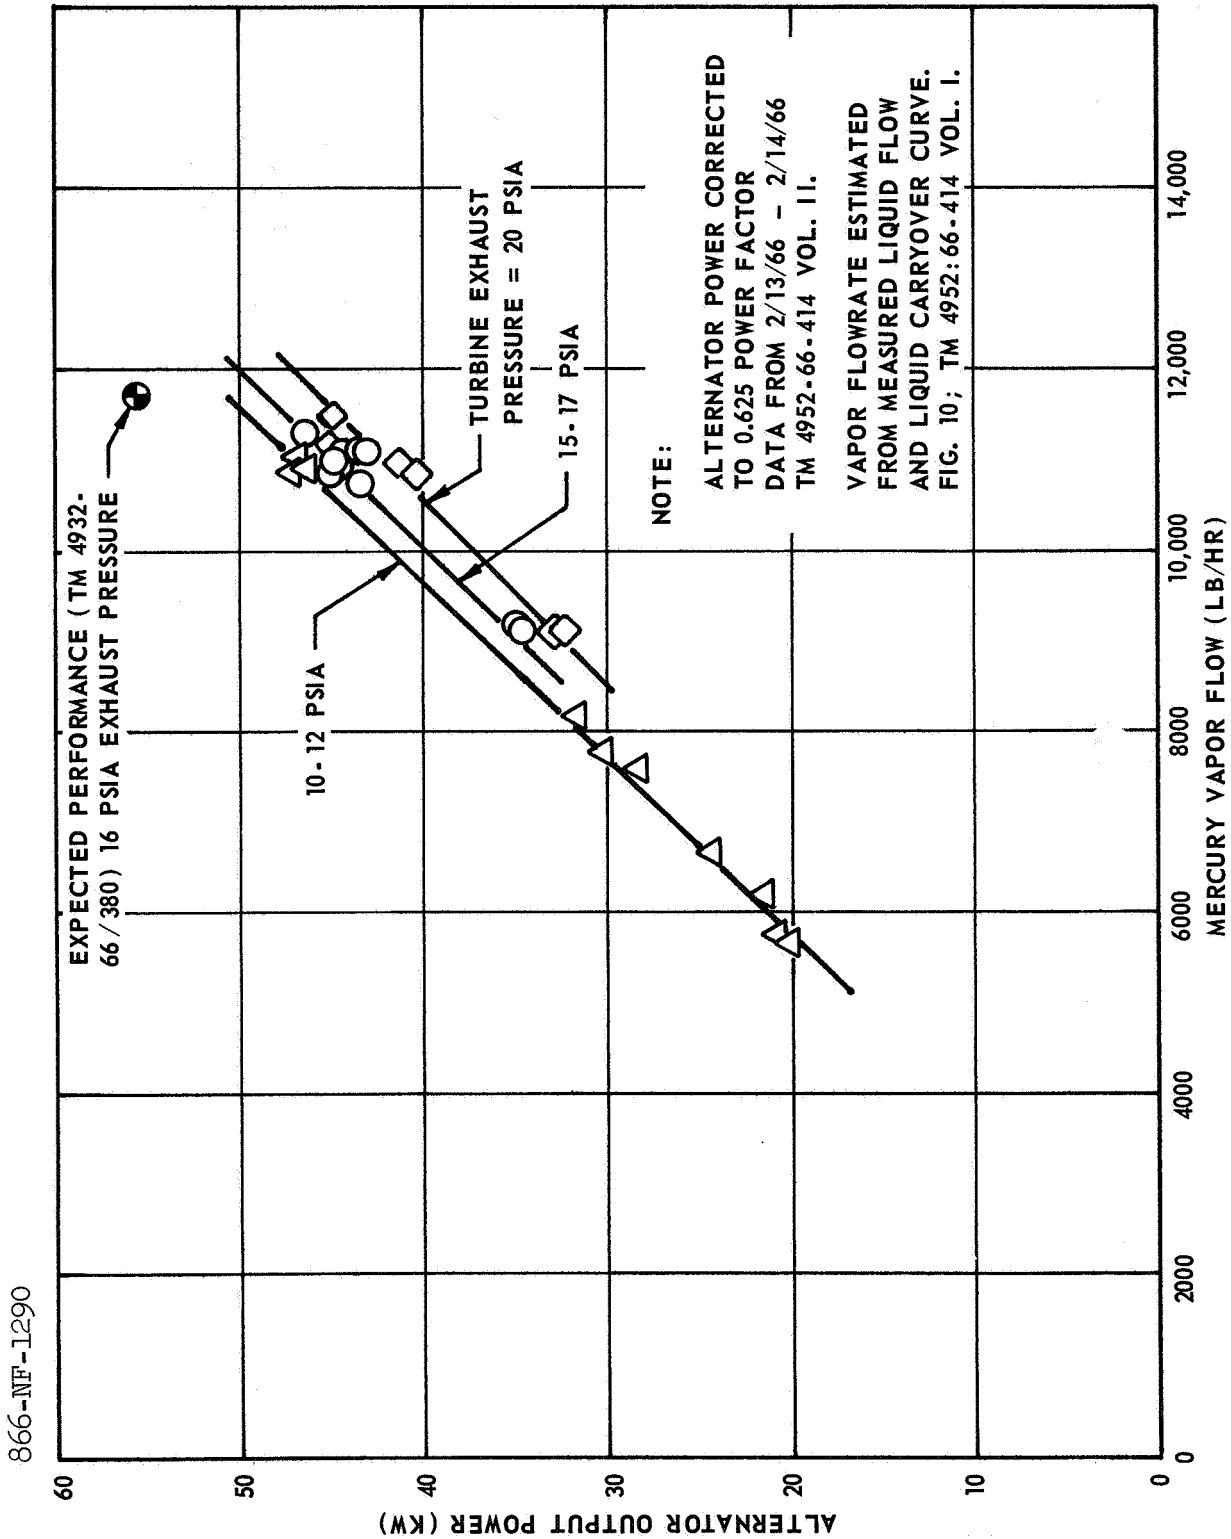
Figure V-3

The TAA performance problem was observed as a decrease in output power. The output power (extrapolated to unity power factor) had degraded from 54 kw, at the reference condition, to 48 kw. An analysis of the data also indicated a general decline of system pressures associated with the TAA performance degradation.

The TAA was removed and analyzed for possible degradation. The investigation revealed a change of approximately 10% in the effected area of the first stage nozzle. This change could account for the loss of power and the decrease of pressure level.

(3) The S/N A-1 unit 5/2 and the S/N A-3 unit 6/1 performed essentially the same as unit 2/3 after degradation.

TAA (P/N 096800-1, Unit 2/3) Performance After Degradation: Alternator Power vs Mercury Vapor Flow in PCS-1 Phase IV Step 2

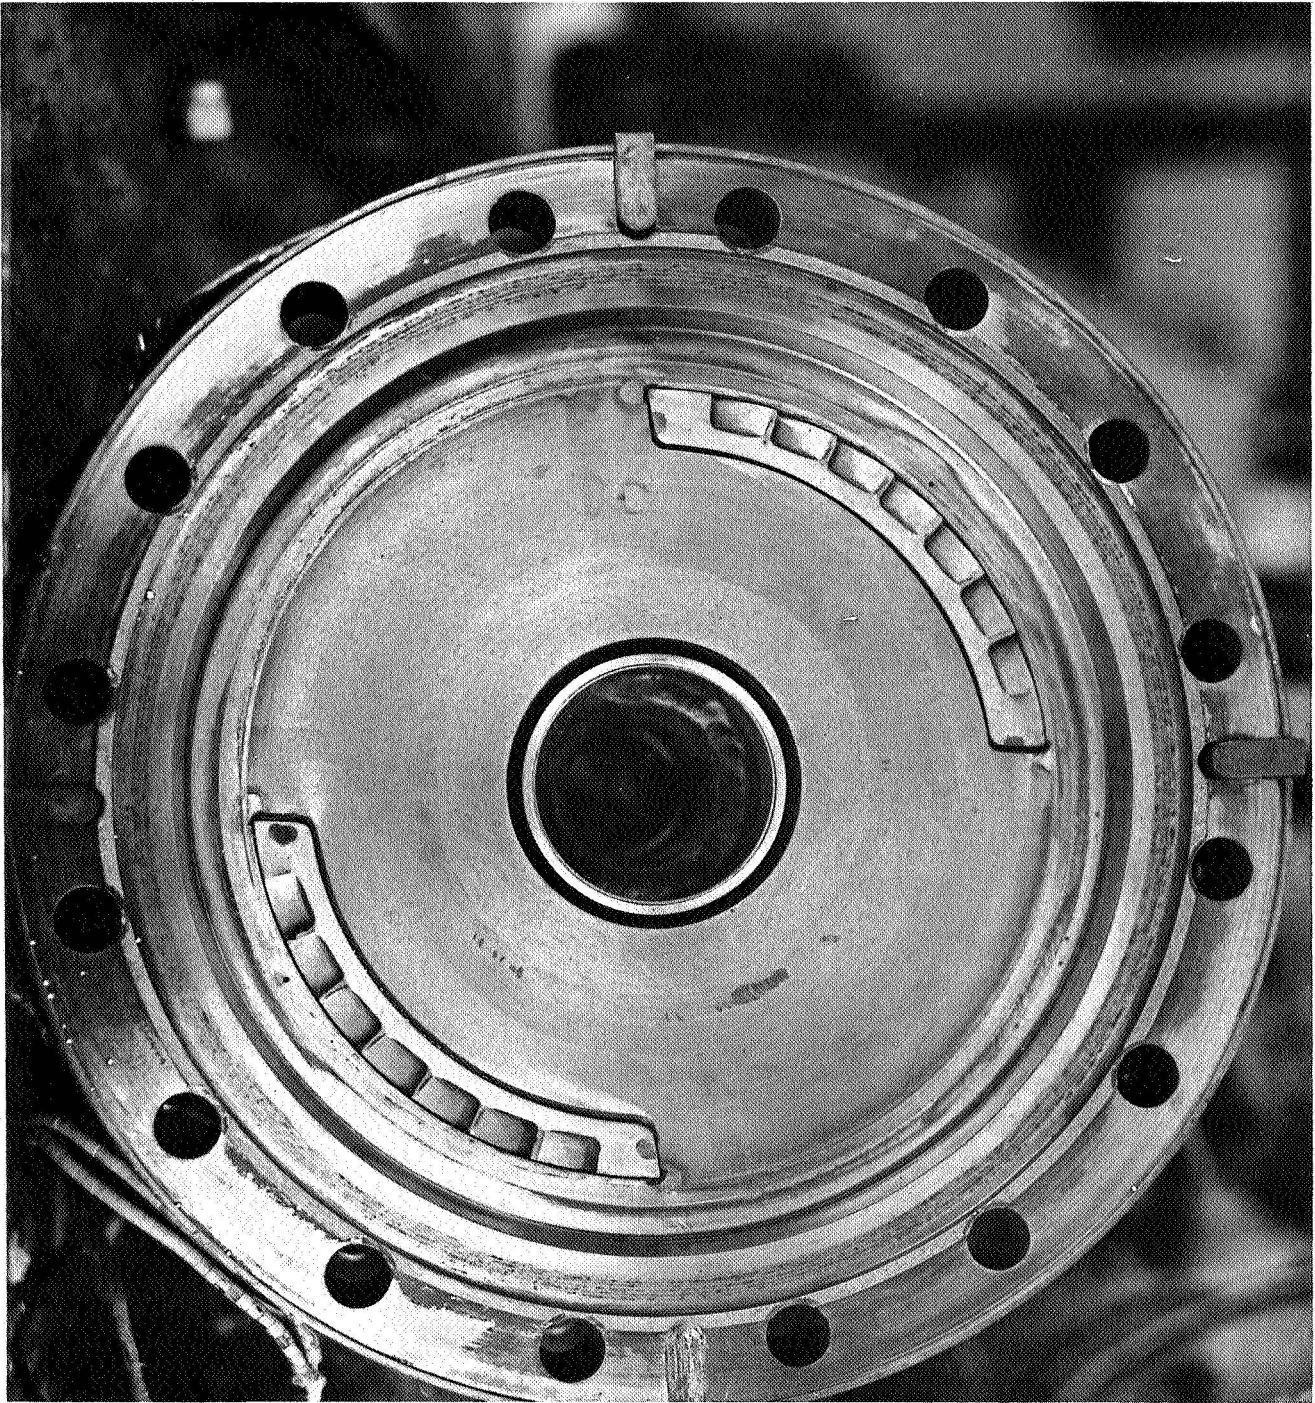
Figure V-10

Turbine-Alternator Assembly (P/N 096800-1, S/N A-2)  
Buildup Removed from PCS-1 Phase 4 Step 2.  
Inlet Housing Showing Nozzle Inserts.

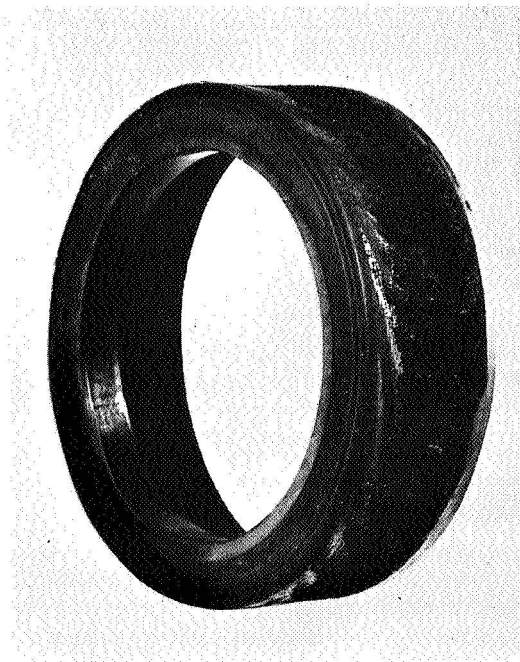
FIGURE A

Greek Ascoloy Mercury Visco Pump runner  
after 820 hours operation. Note cavitation  
erosion damage on outside diameter.

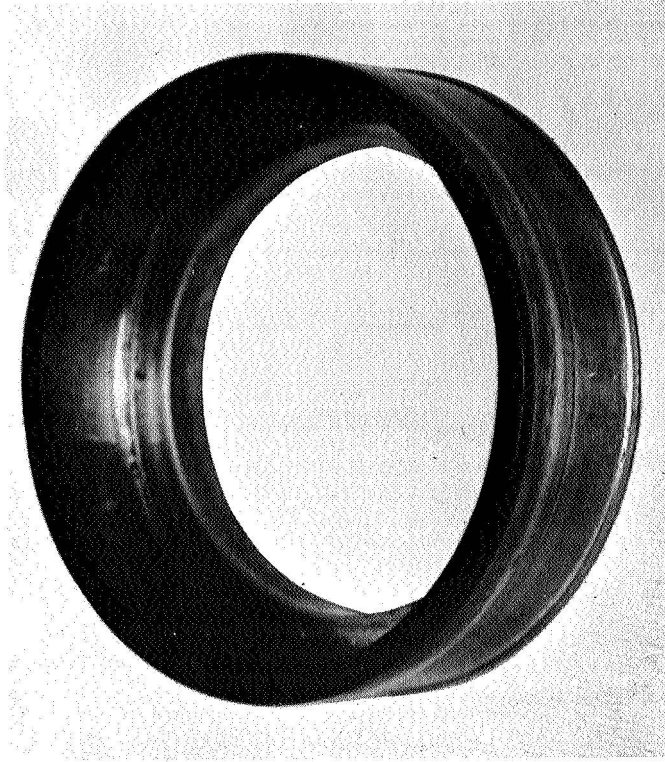
FIGURE B

Stellite 68 Mercury Visco Pump runner after  
140 hours operation. Note absence of cavitation  
erosion damage on outside diameter.

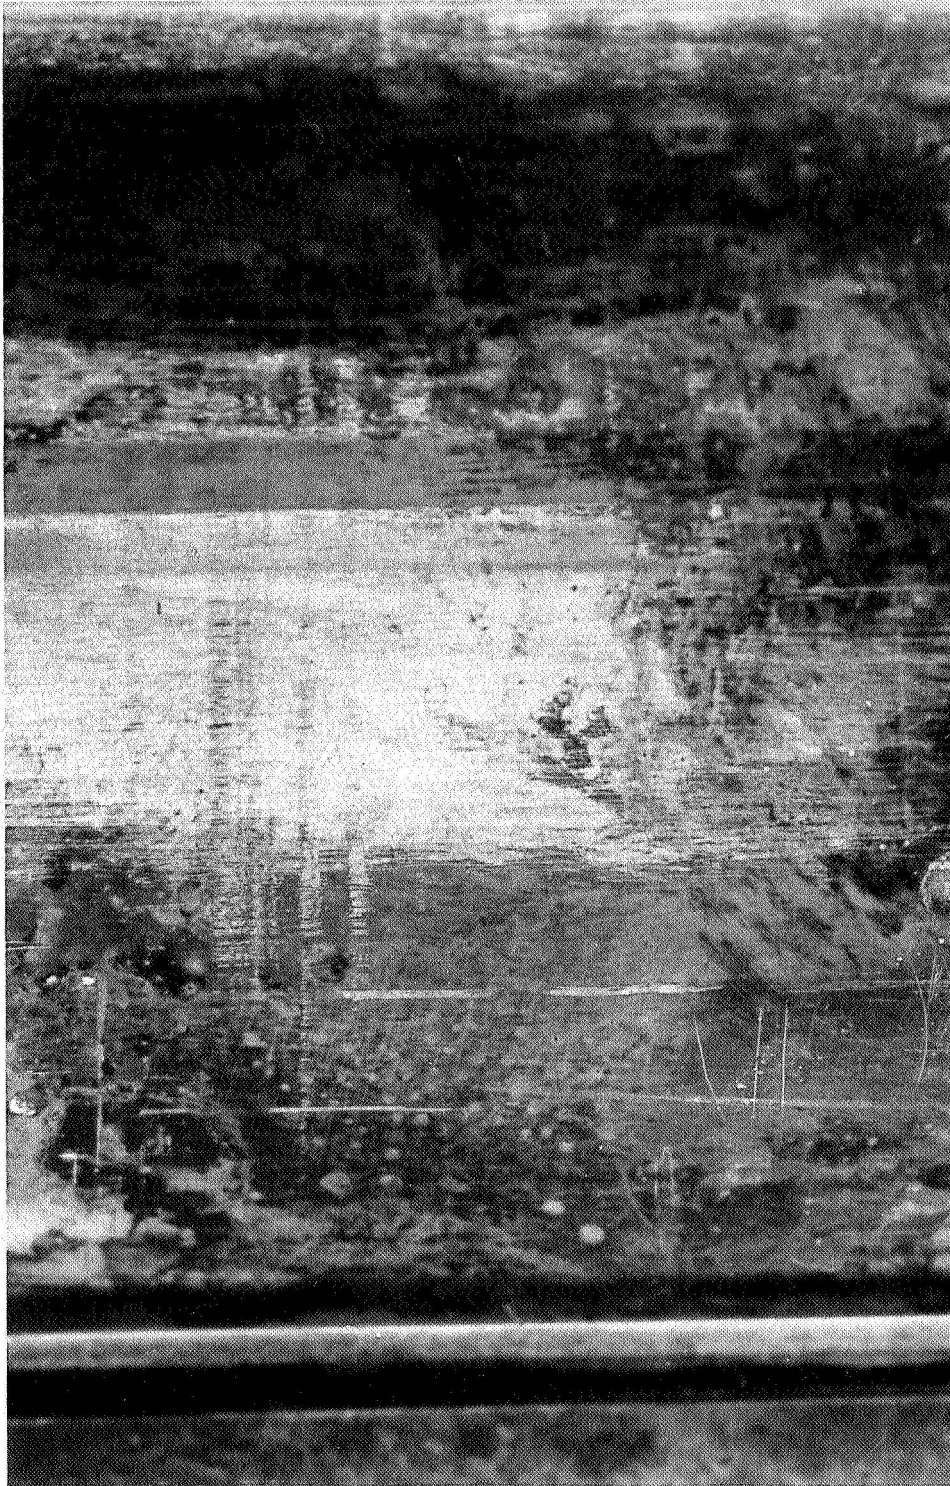
Figure V-35

Motor-End Radial Bearing Pad (S-415), Showing Center Burnishment with Marks Assumed Made During Disassembly From NAK PMA S/N A-6

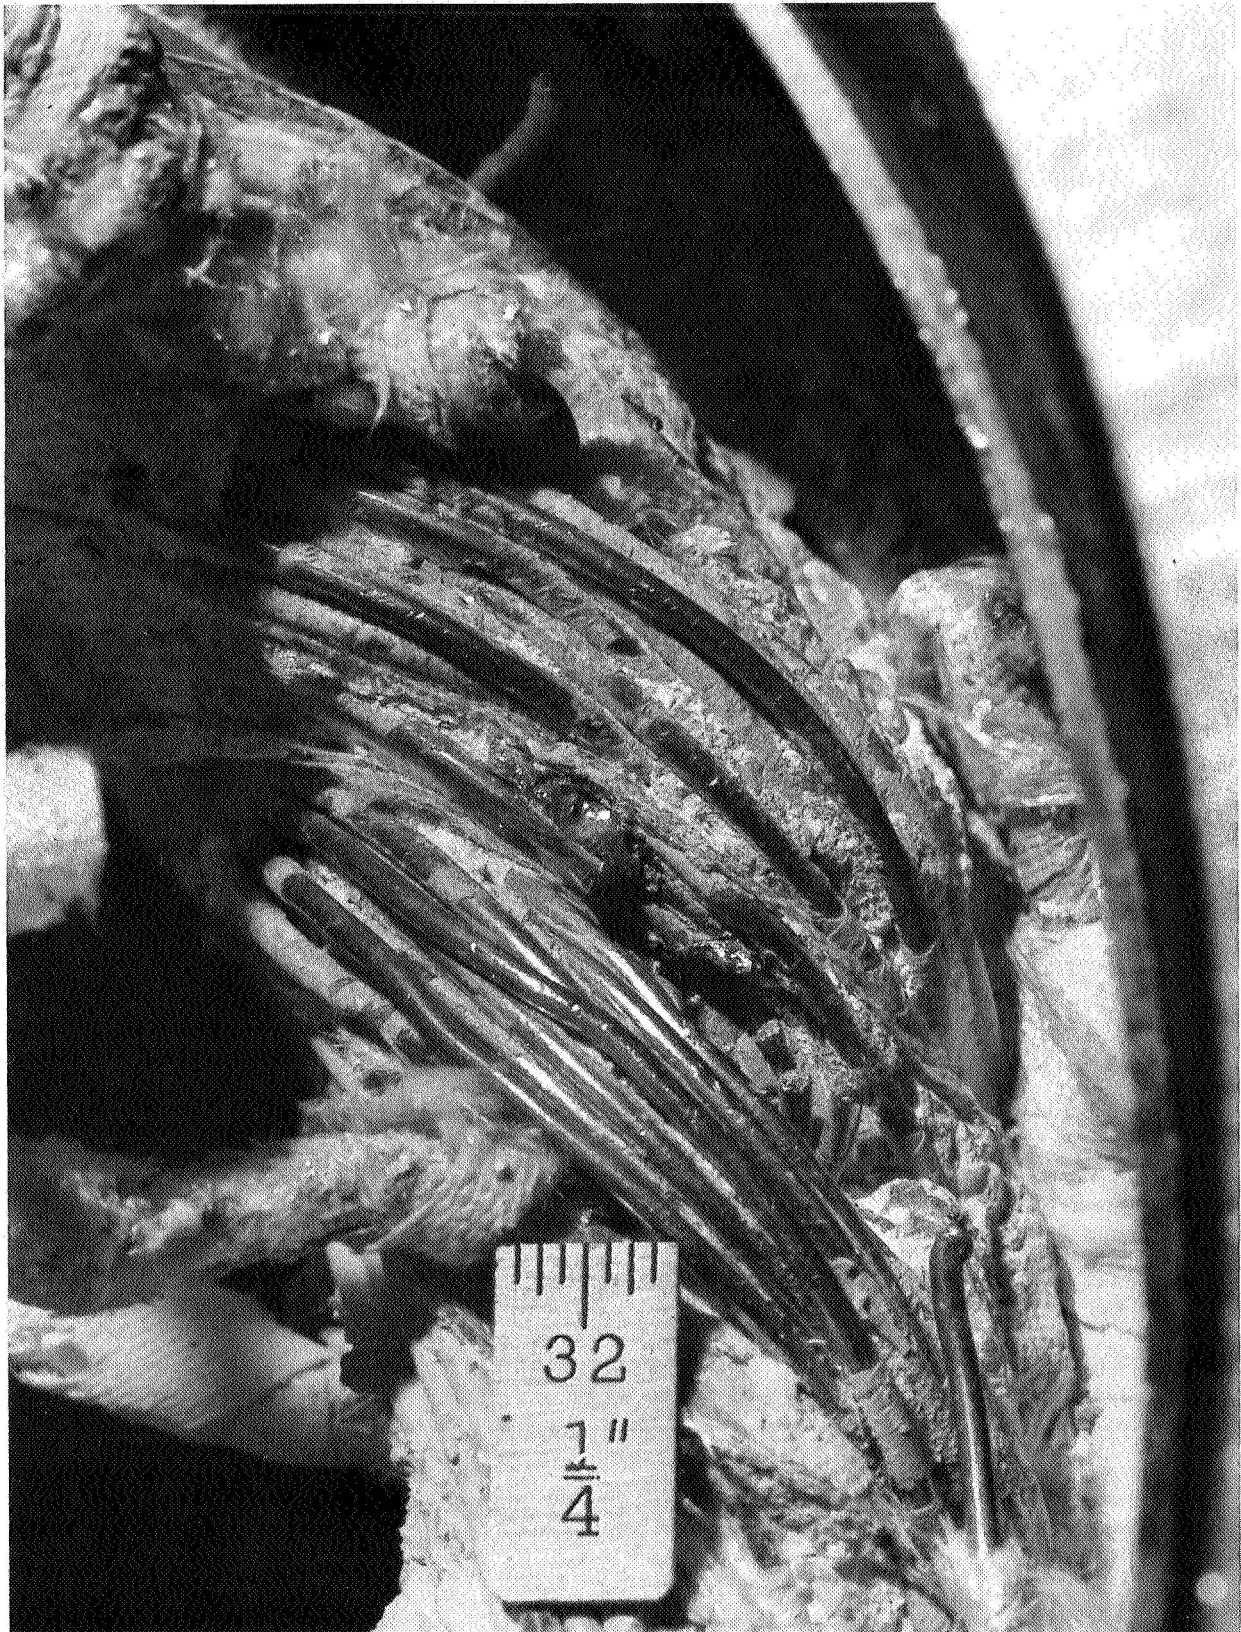
Figure V-39

Winding Failure of NaK Pump-Motor Assembly S/N A-2

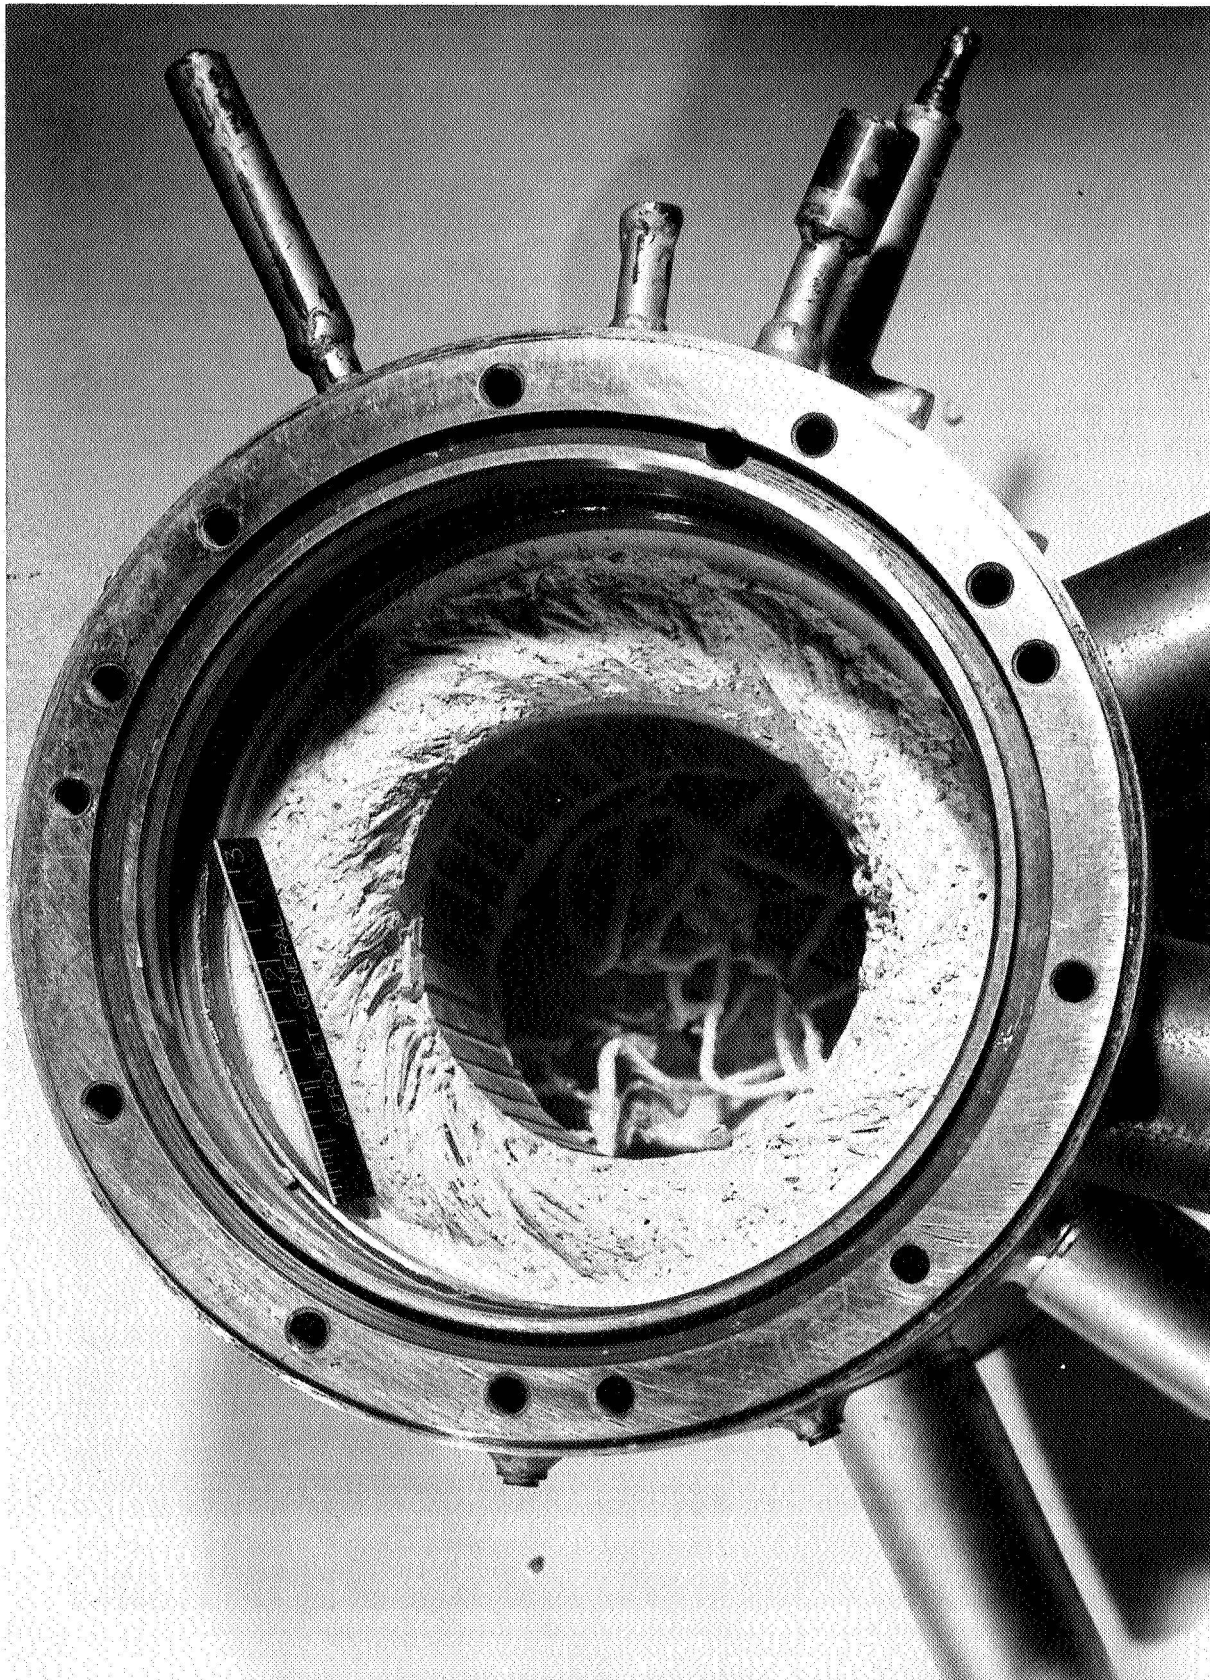
Figure V-40

Potting Compound Used for NaK PMA Motors  
Shown Partially Removed During Failure  
Investigation of NaK PMA S/N A-2

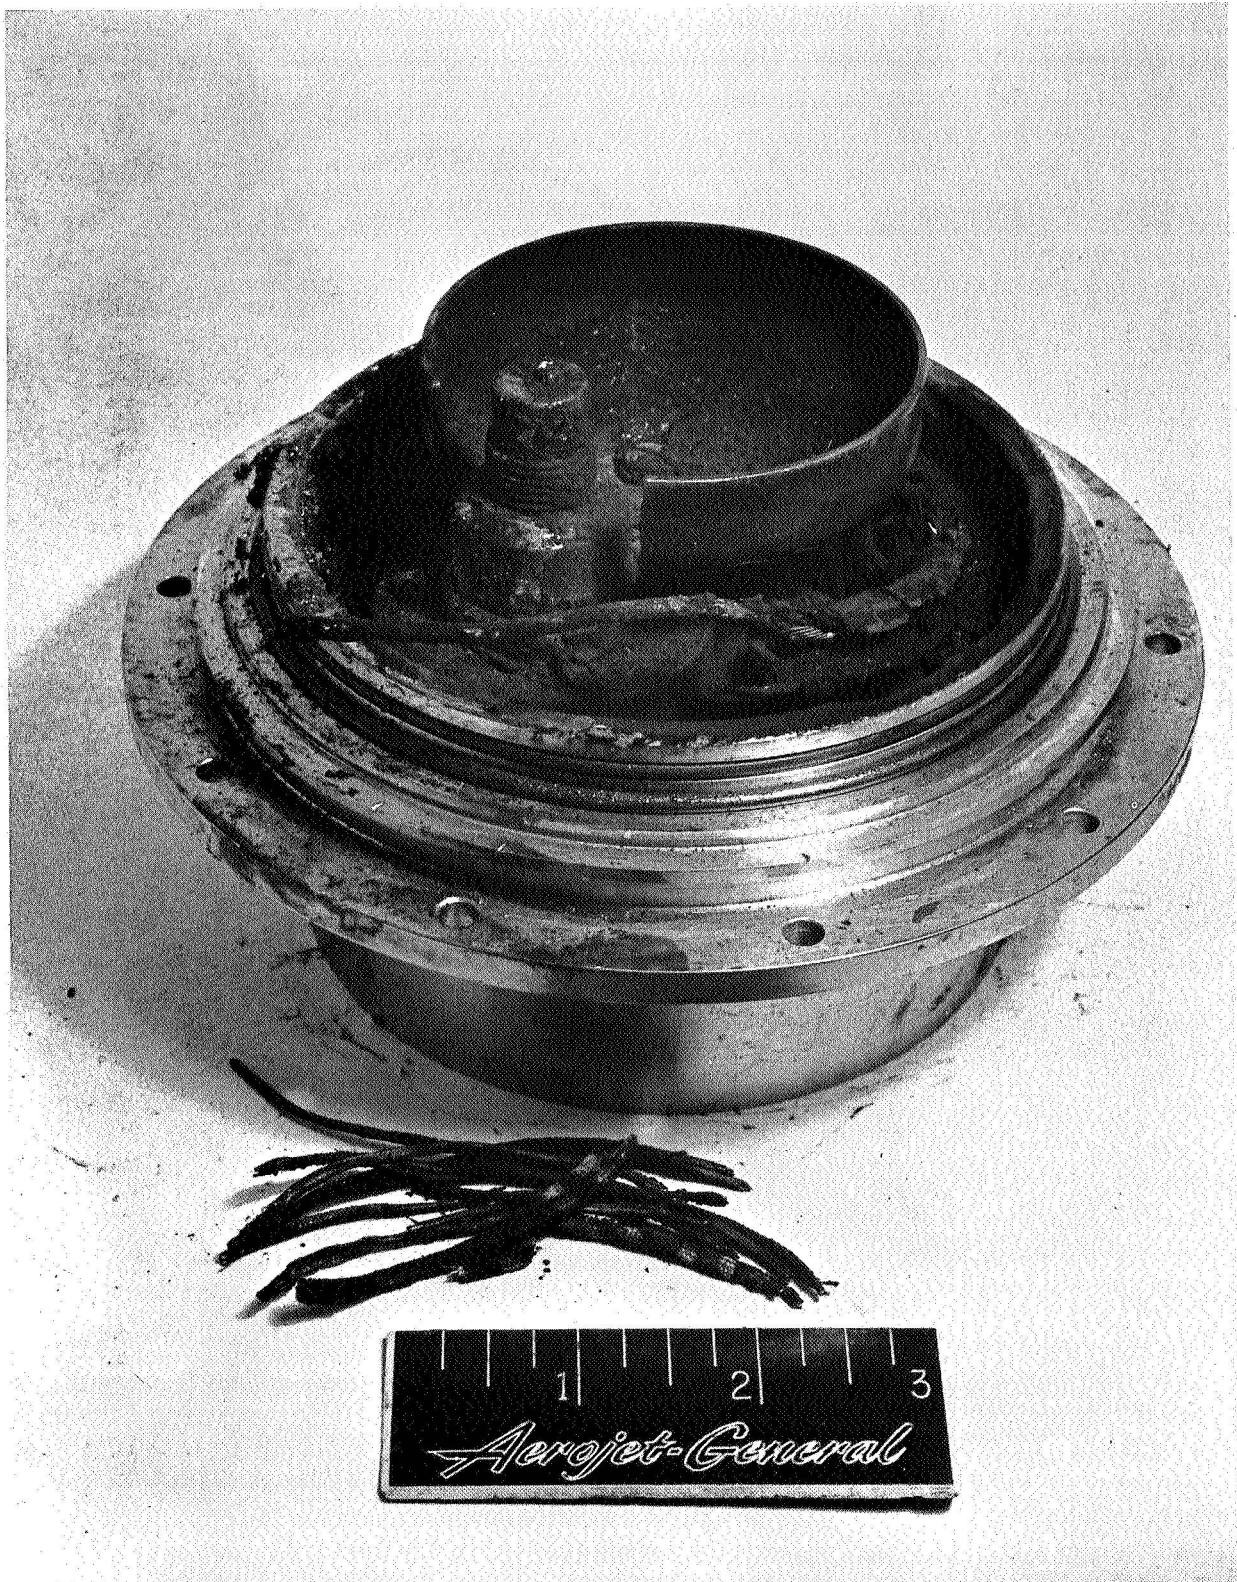
- The PMA failed at the end of Start 8 after 264 hours due to a failed stator can and electrical short.

Motor From Mercury PMA, Showing Damage Due to Mercury Contact After 938 Hours of Operation (View 1)

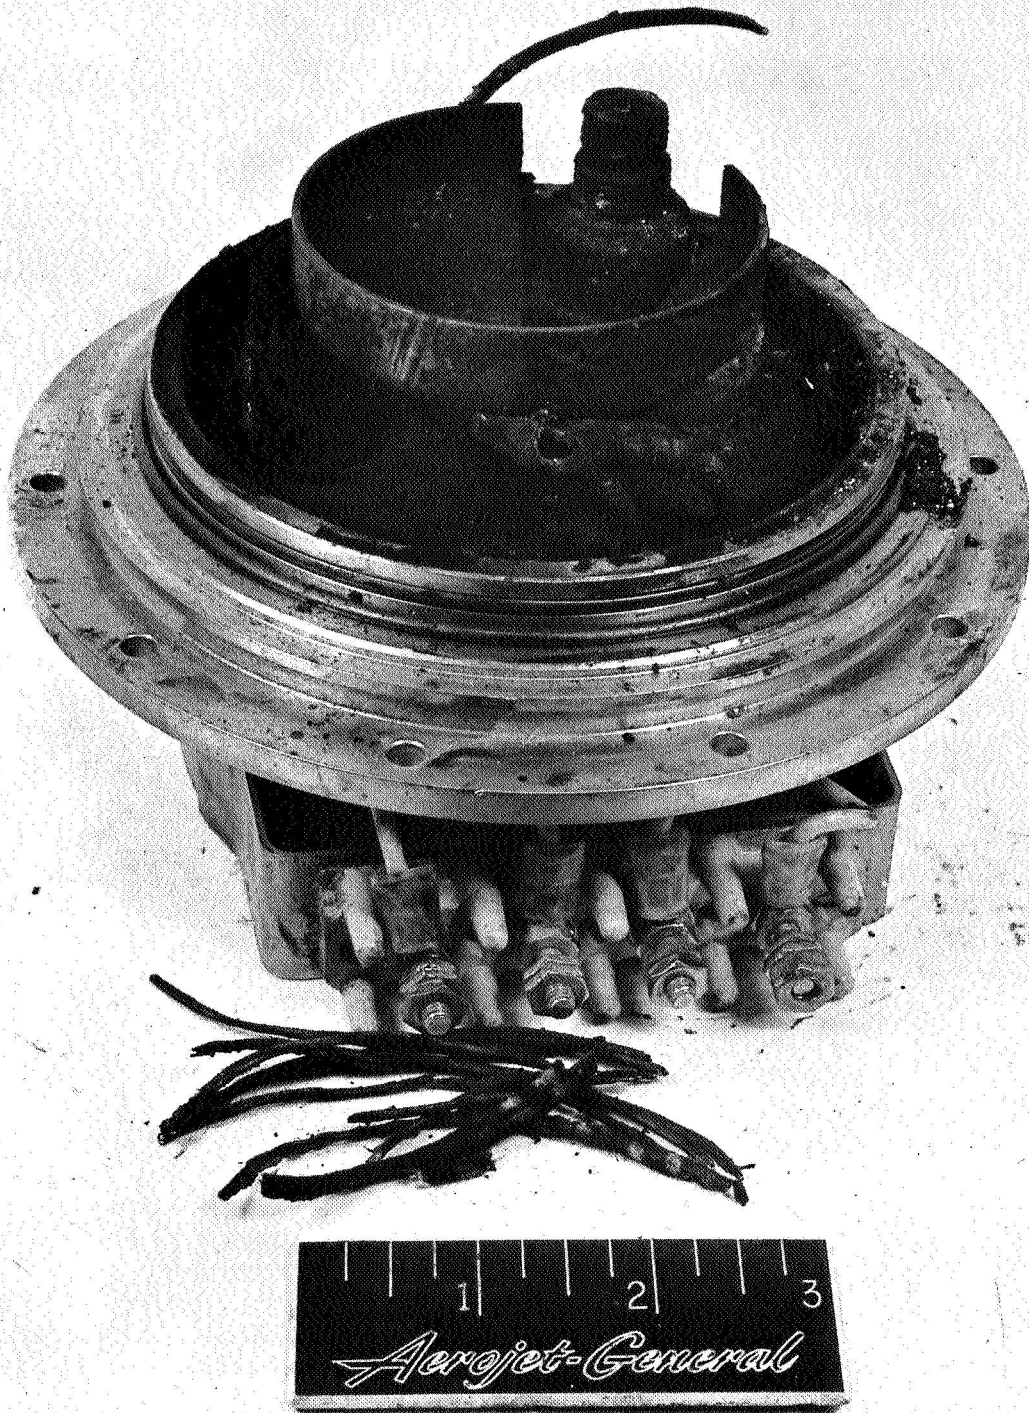
Motor From Mercury PMA, Showing Damage Due to Mercury Contact After 938 Hours of Operation (View 2)

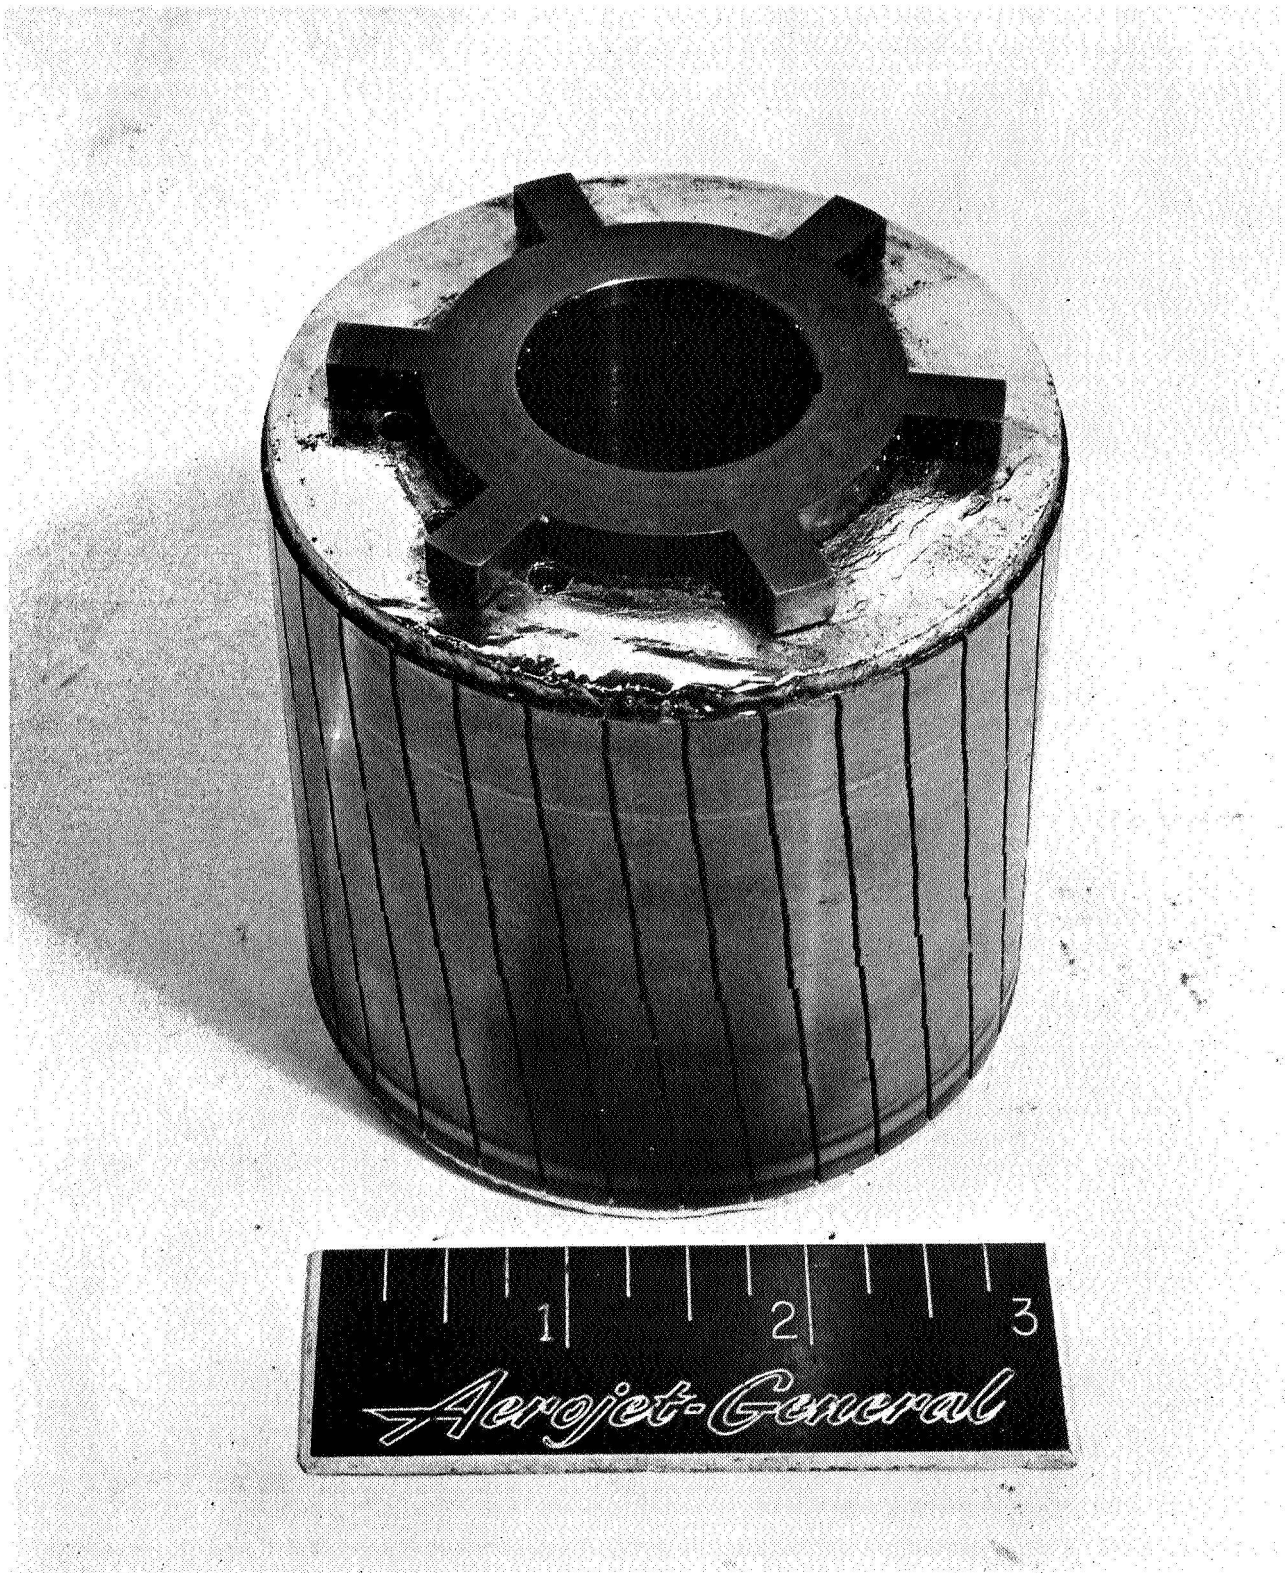
Figure V-63

Motor From Mercury PMA, Showing Damage Due to Mercury Contact After 938 Hours of Operation (View 3)

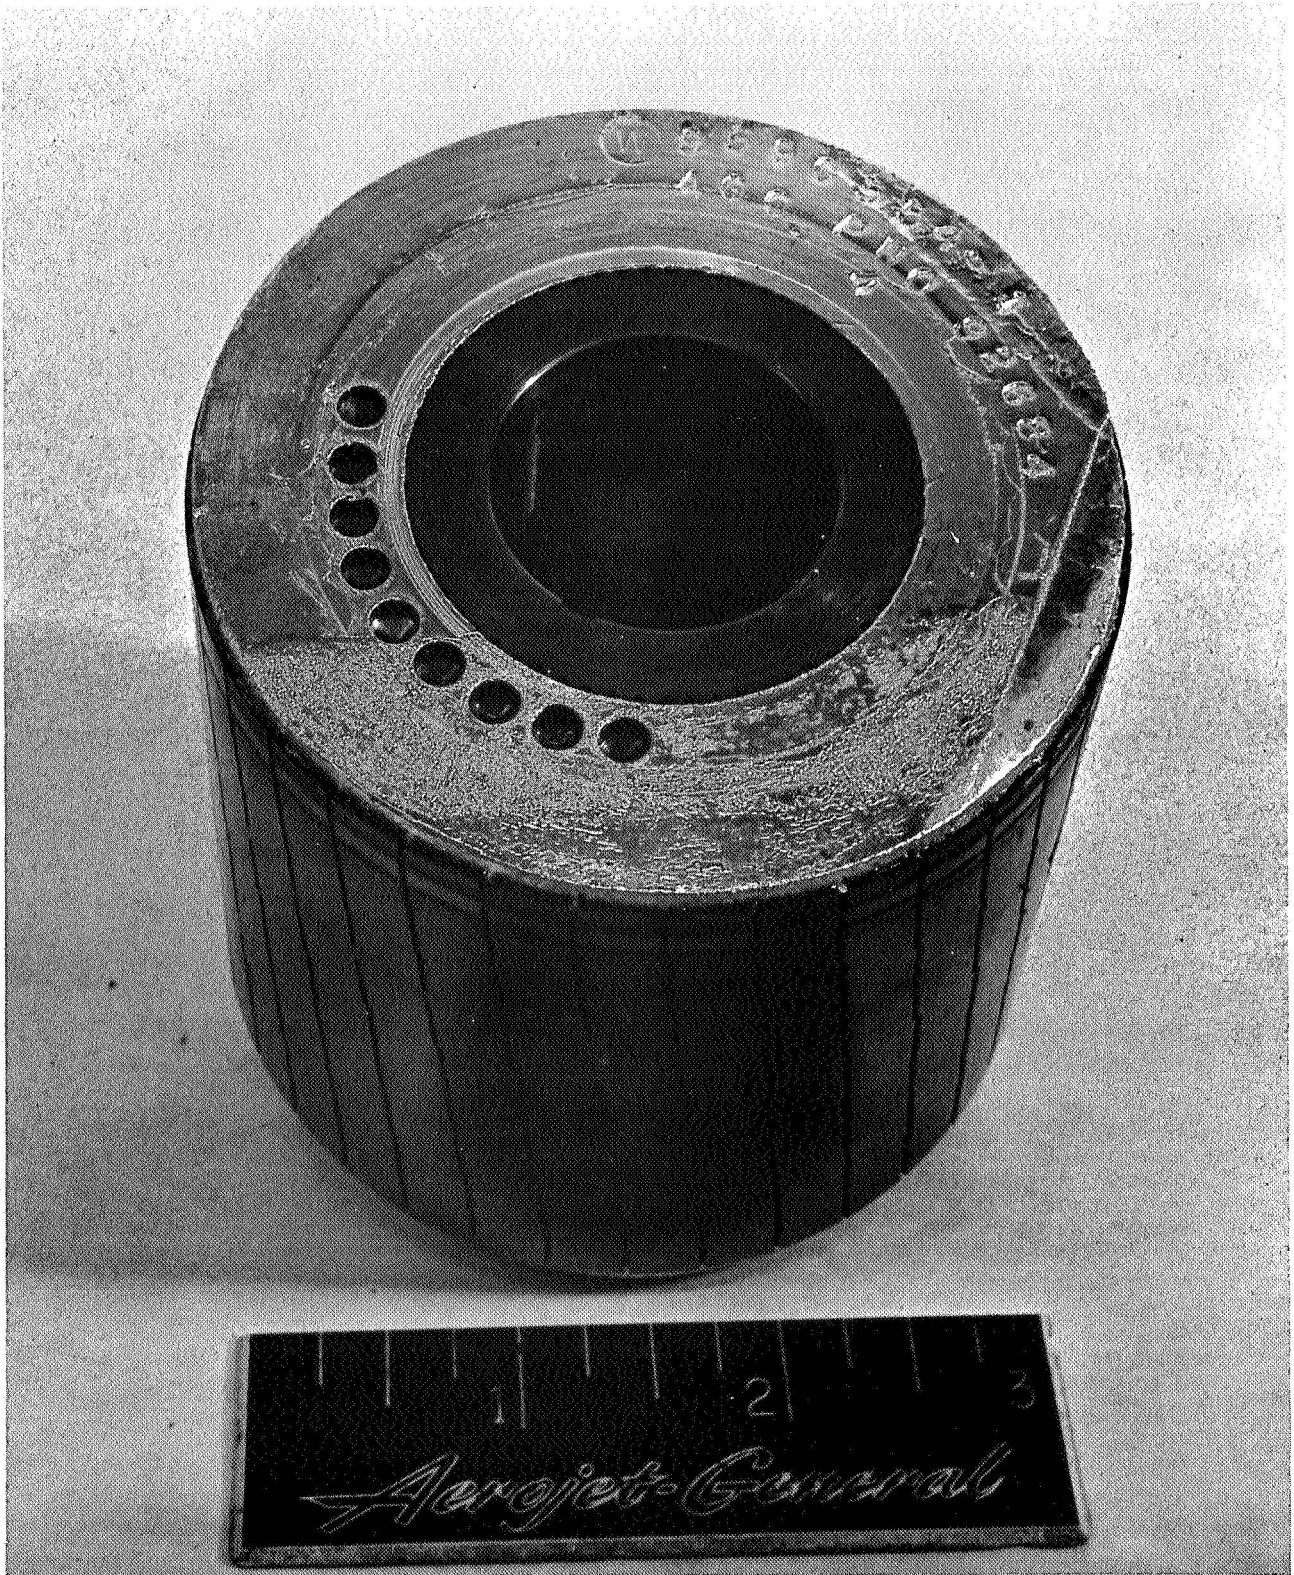
Figure V-64

Motor From Mercury PMA, Showing Damage Due to Mercury Contact After 938 Hours of Operation (View 4)

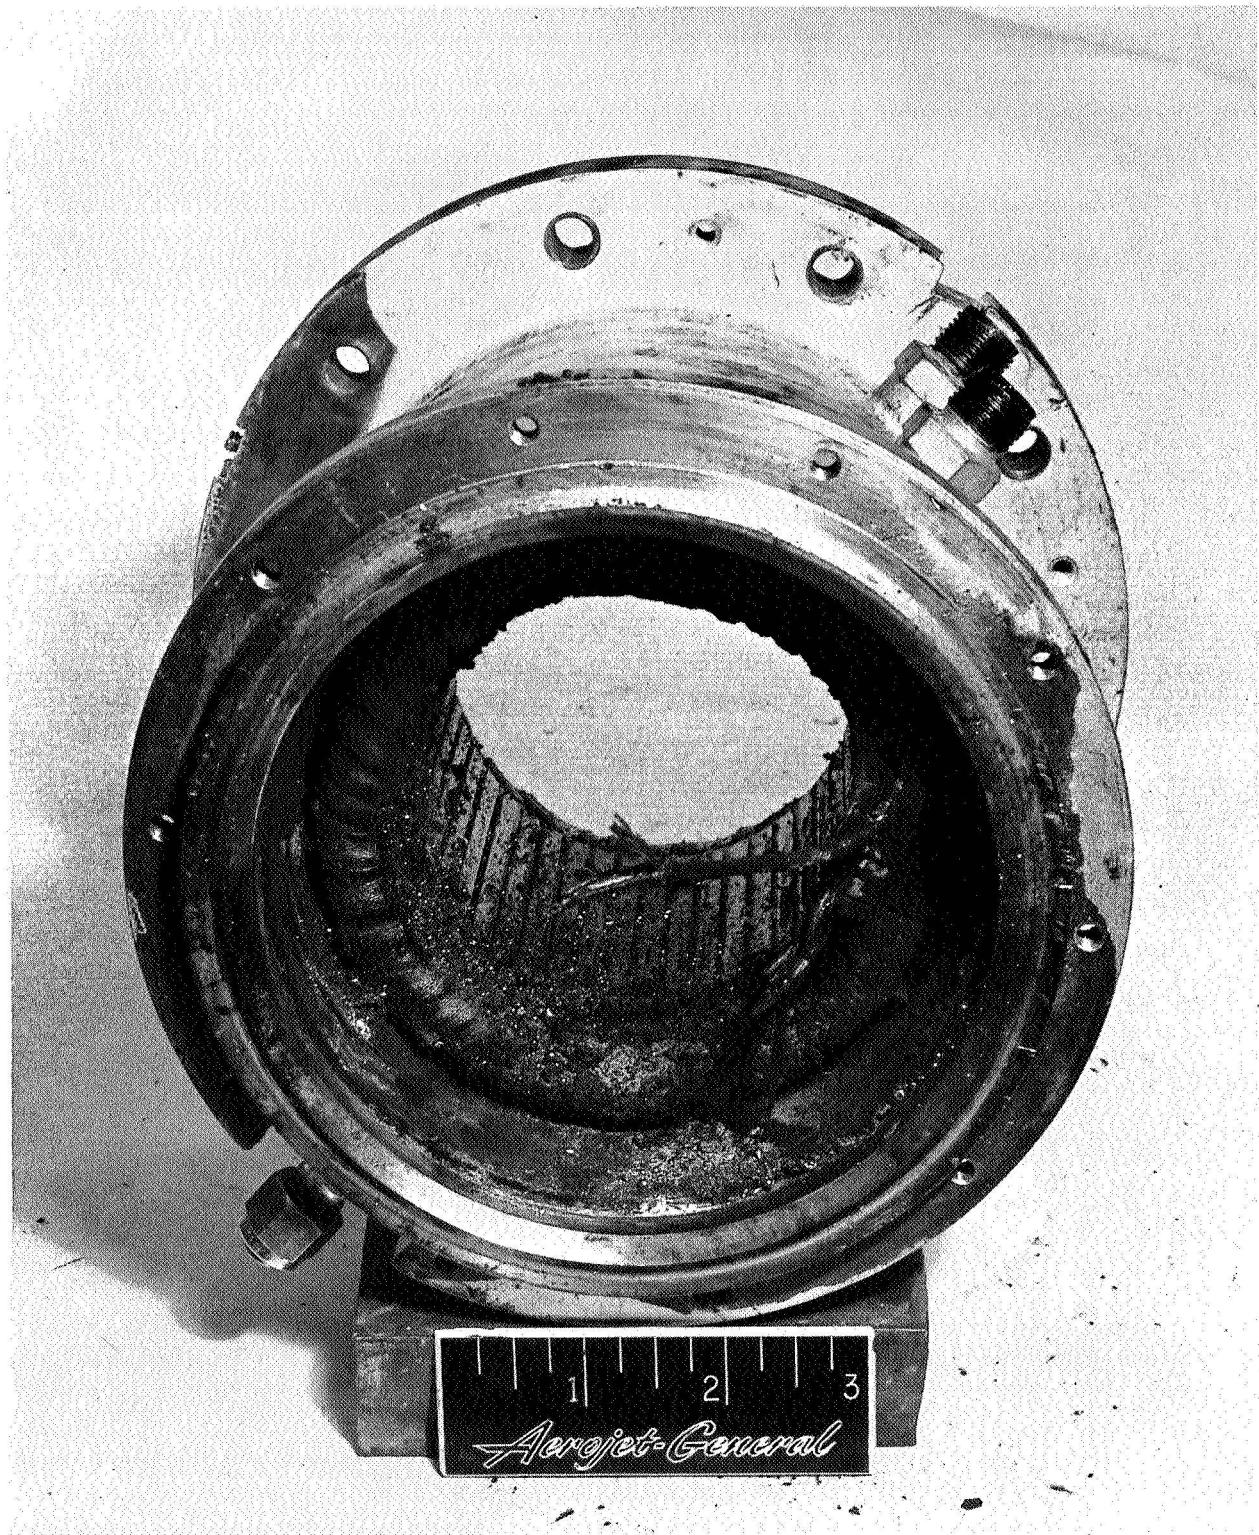
Motor From Mercury PMA, Showing Damage Due to Mercury Contact After 938 Hours of Operation (View 5)

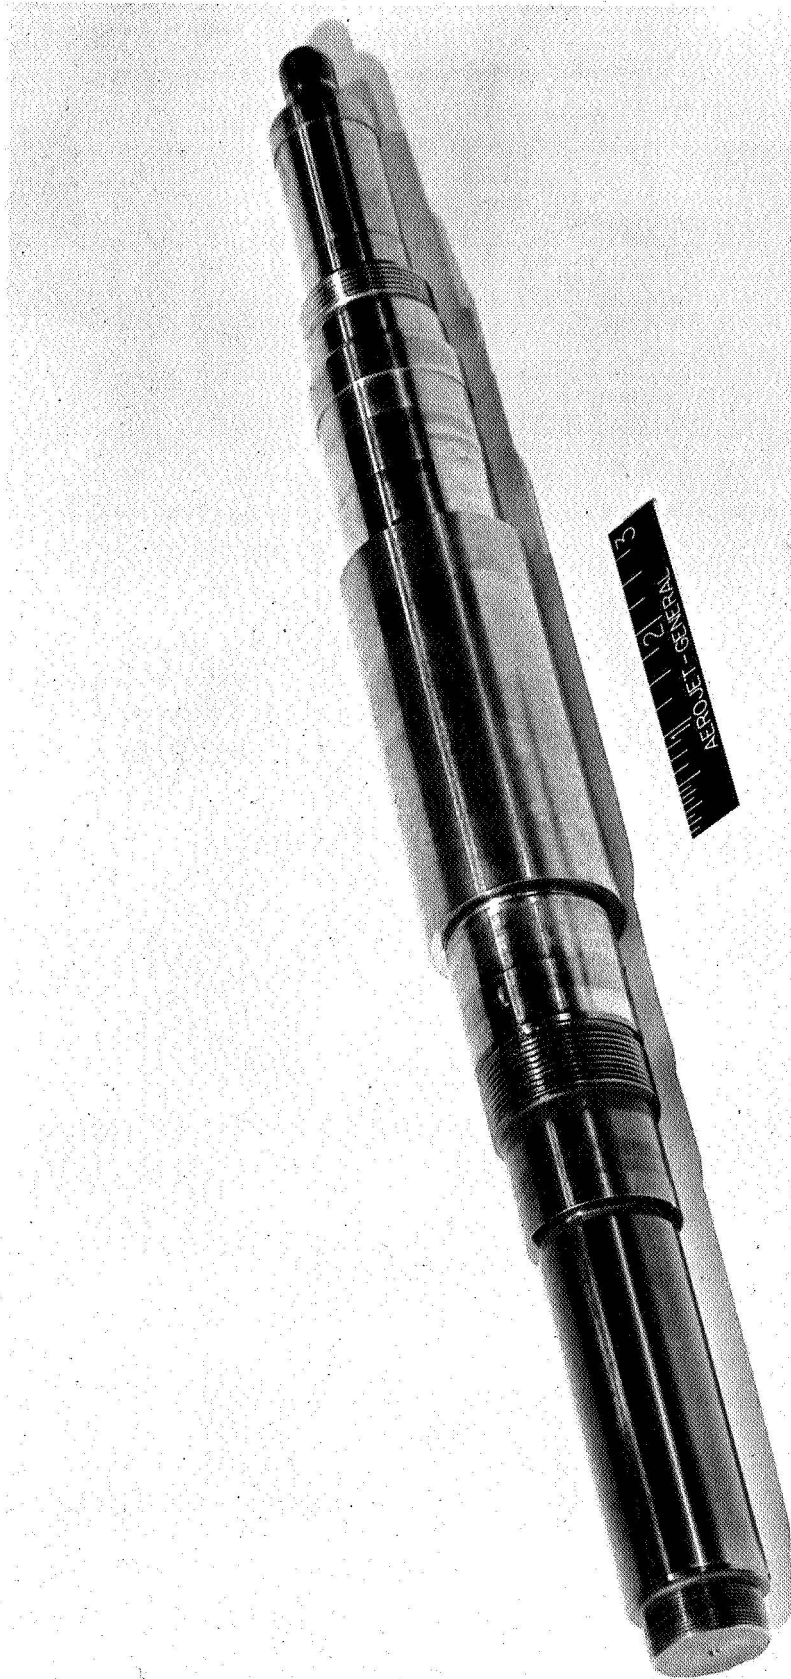
Figure V-66

Shaft From Mercury PMA After 756 Hours operation in SL-1,  
Showing Heat Discoloration on Motor-End of Shaft
