# SNAP-8 ELECTRICAL GENERATING SYSTEM DEVELOPMENT PROGRAM

PROGRESS REPORT FOR JANUARY - JUNE 1966

NASA CR 72-1-03  
Aerojet Report No. 3233

SEMIANNUAL REPORT

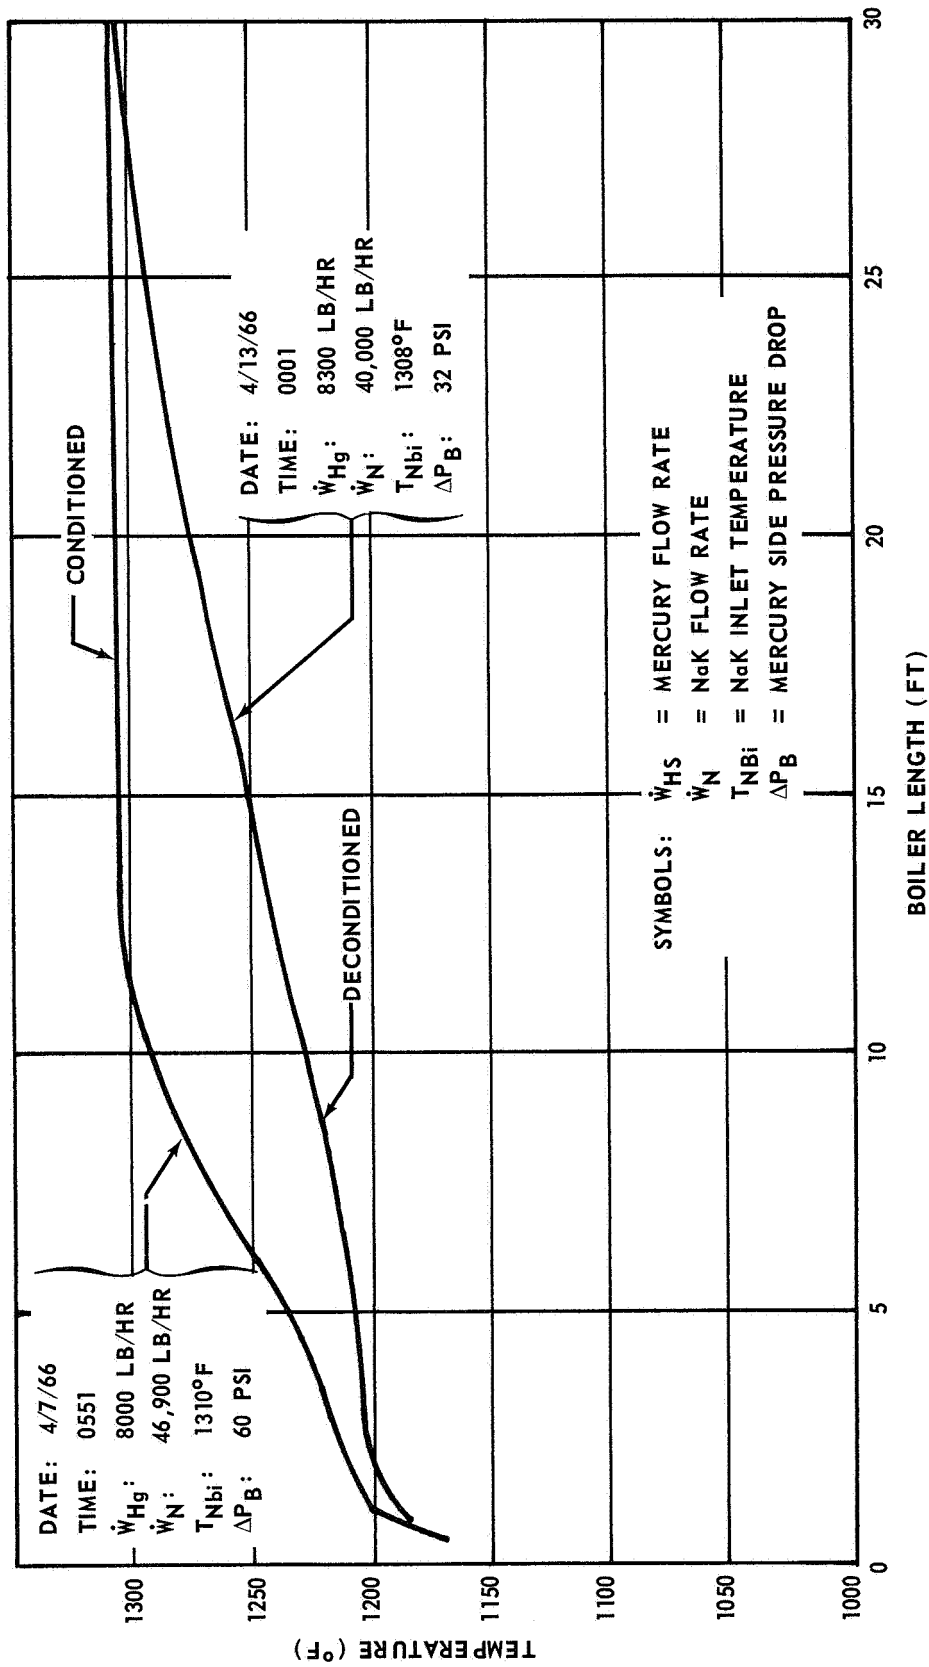
Figure V-73

The performance of the boiler during Step 2 was very good. From the beginning of testing, the boiler was conditioned. The only limitation on boiler performance was that it did not appear to be as completely conditioned as during previous testing in Step 1. No problems were experienced with the boiler during Step 2 until startup 9 on 12 April 1966. At the time of this startup, the boiler was deconditioned as a result of oil contamination during the preceeding shutdown.

Tube-in-Tube Boiler (P/N 097444-7, S/N A-2) Temperature Profiles During PCS-1 Phase IV Step 2 Testing  
Variation in Conditioning
