R-7450-2

J-2 ENGINE AS-502 (APOLLO 6)

FLIGHT REPORT

VOLUME 2: S-II STAGE FAILURE ANALYSIS

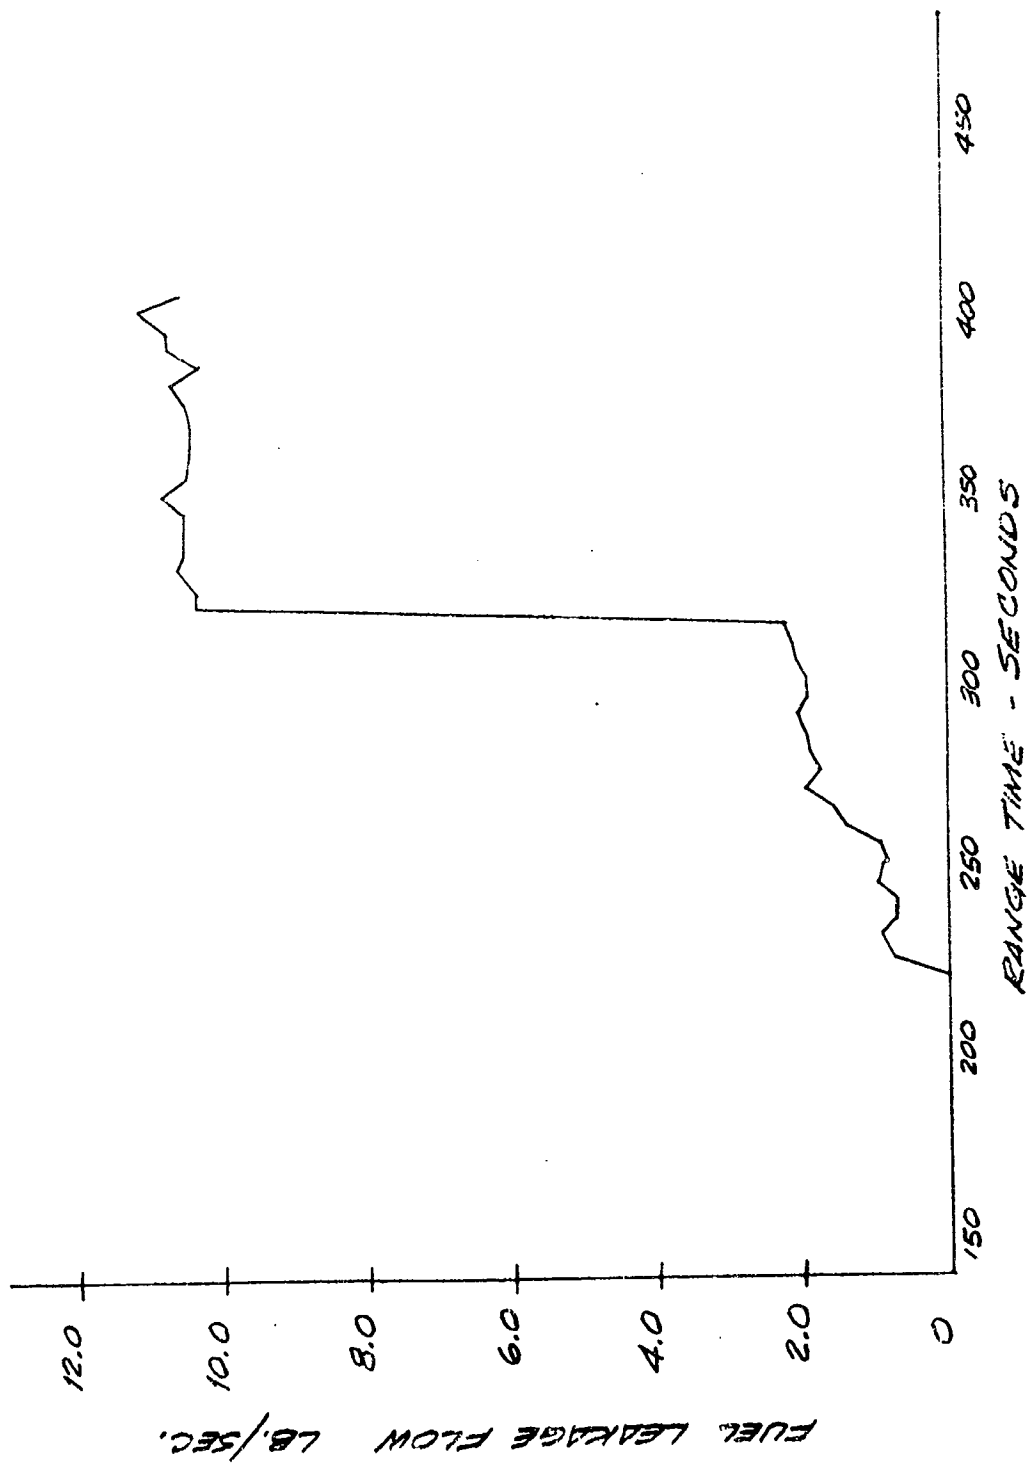
Figure 49. AS-502 Engine 202 (J2044) Fuel Leakage vs Time

From 270 seconds on, the ASI chamber was subjected to high mixture ratio operation, which resulted in erosion damage to the main injector assembly. There were no ASI flight flow measurements to determine what the ASI mixture ratio was that caused this damage. Mixture ratio was first estimated at 8.0, based on passing 0.1 lb/sec fuel to the ASI injector.

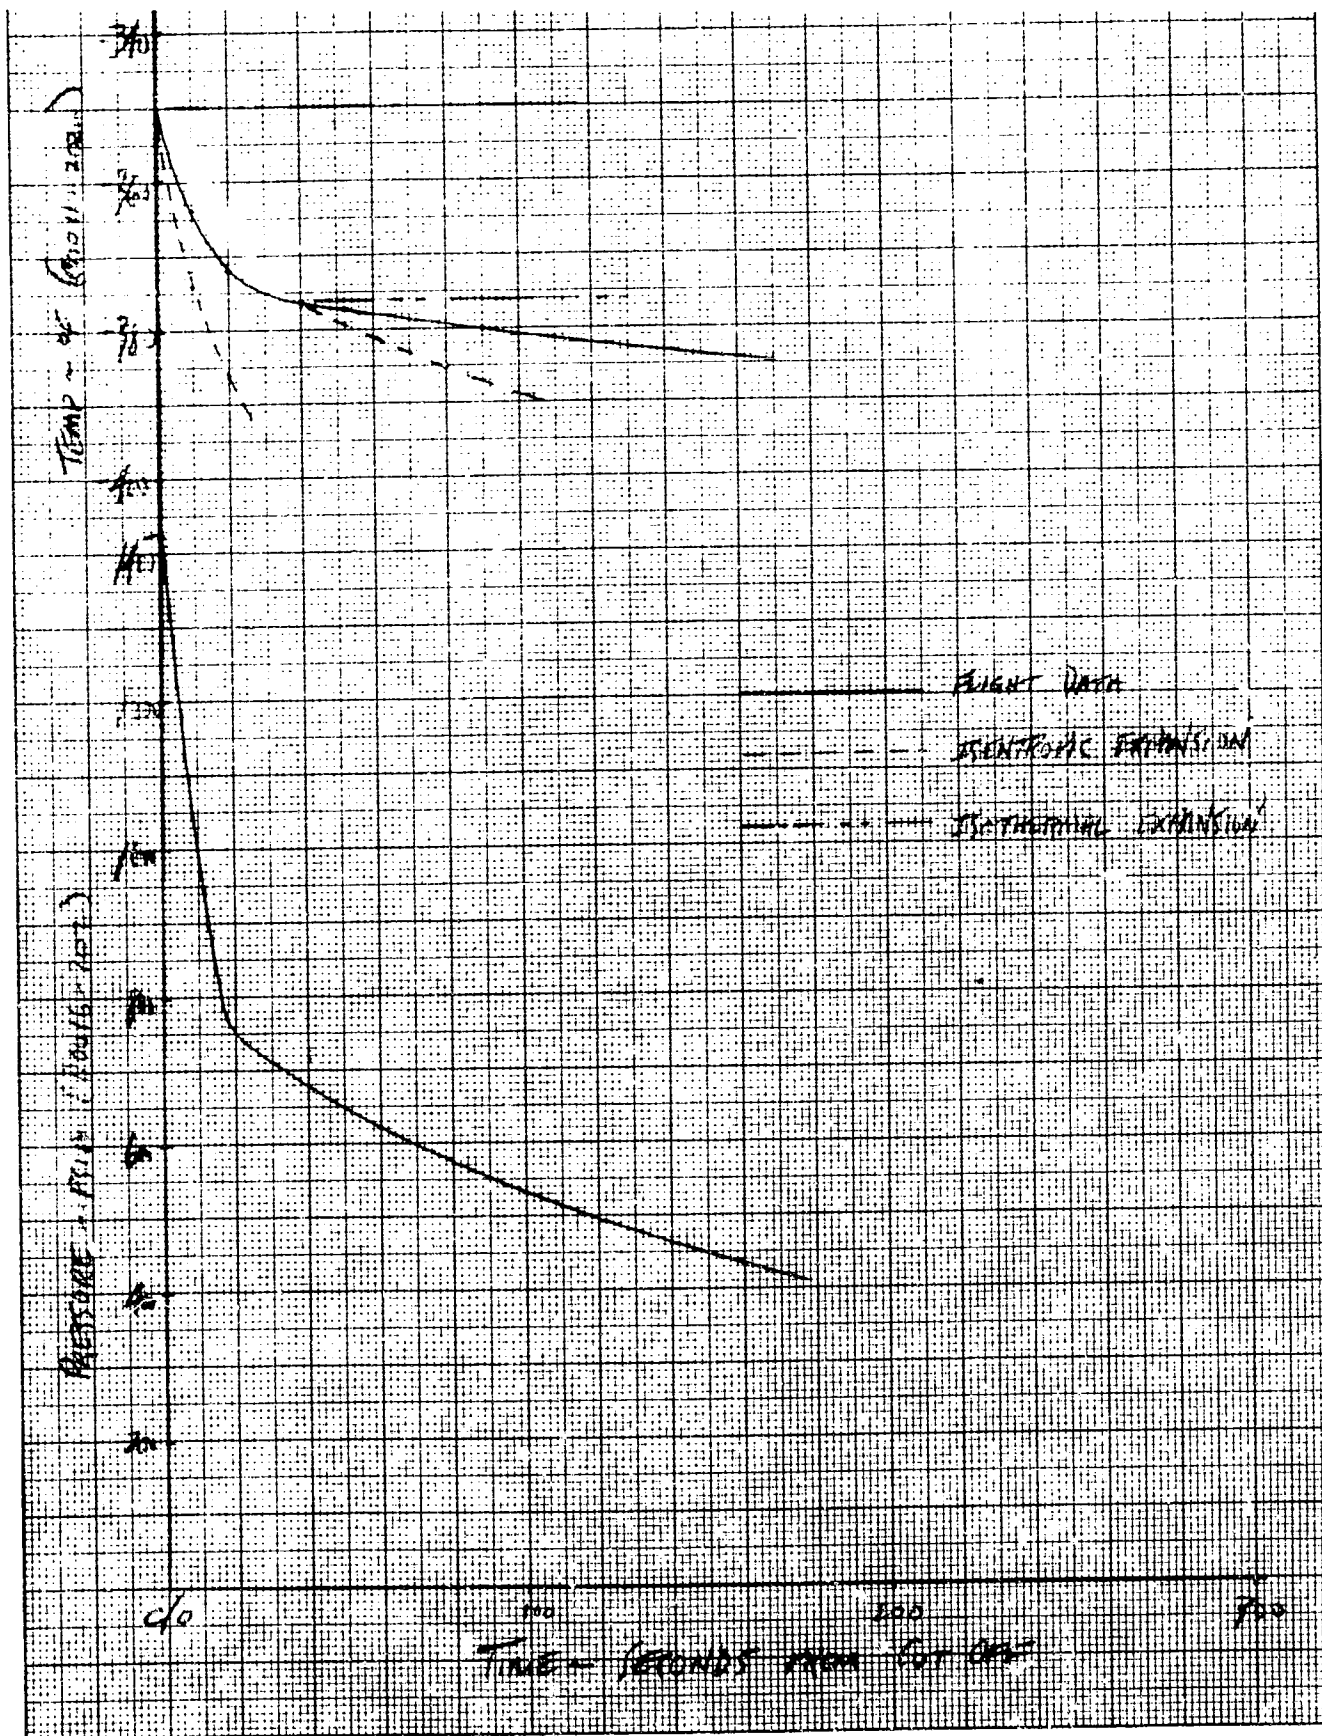
Figure 77. AS-502 Start Tank Blowdown Anomaly, Engine 202

The following calculations corroborate the polytropic process and flow area change mechanism:

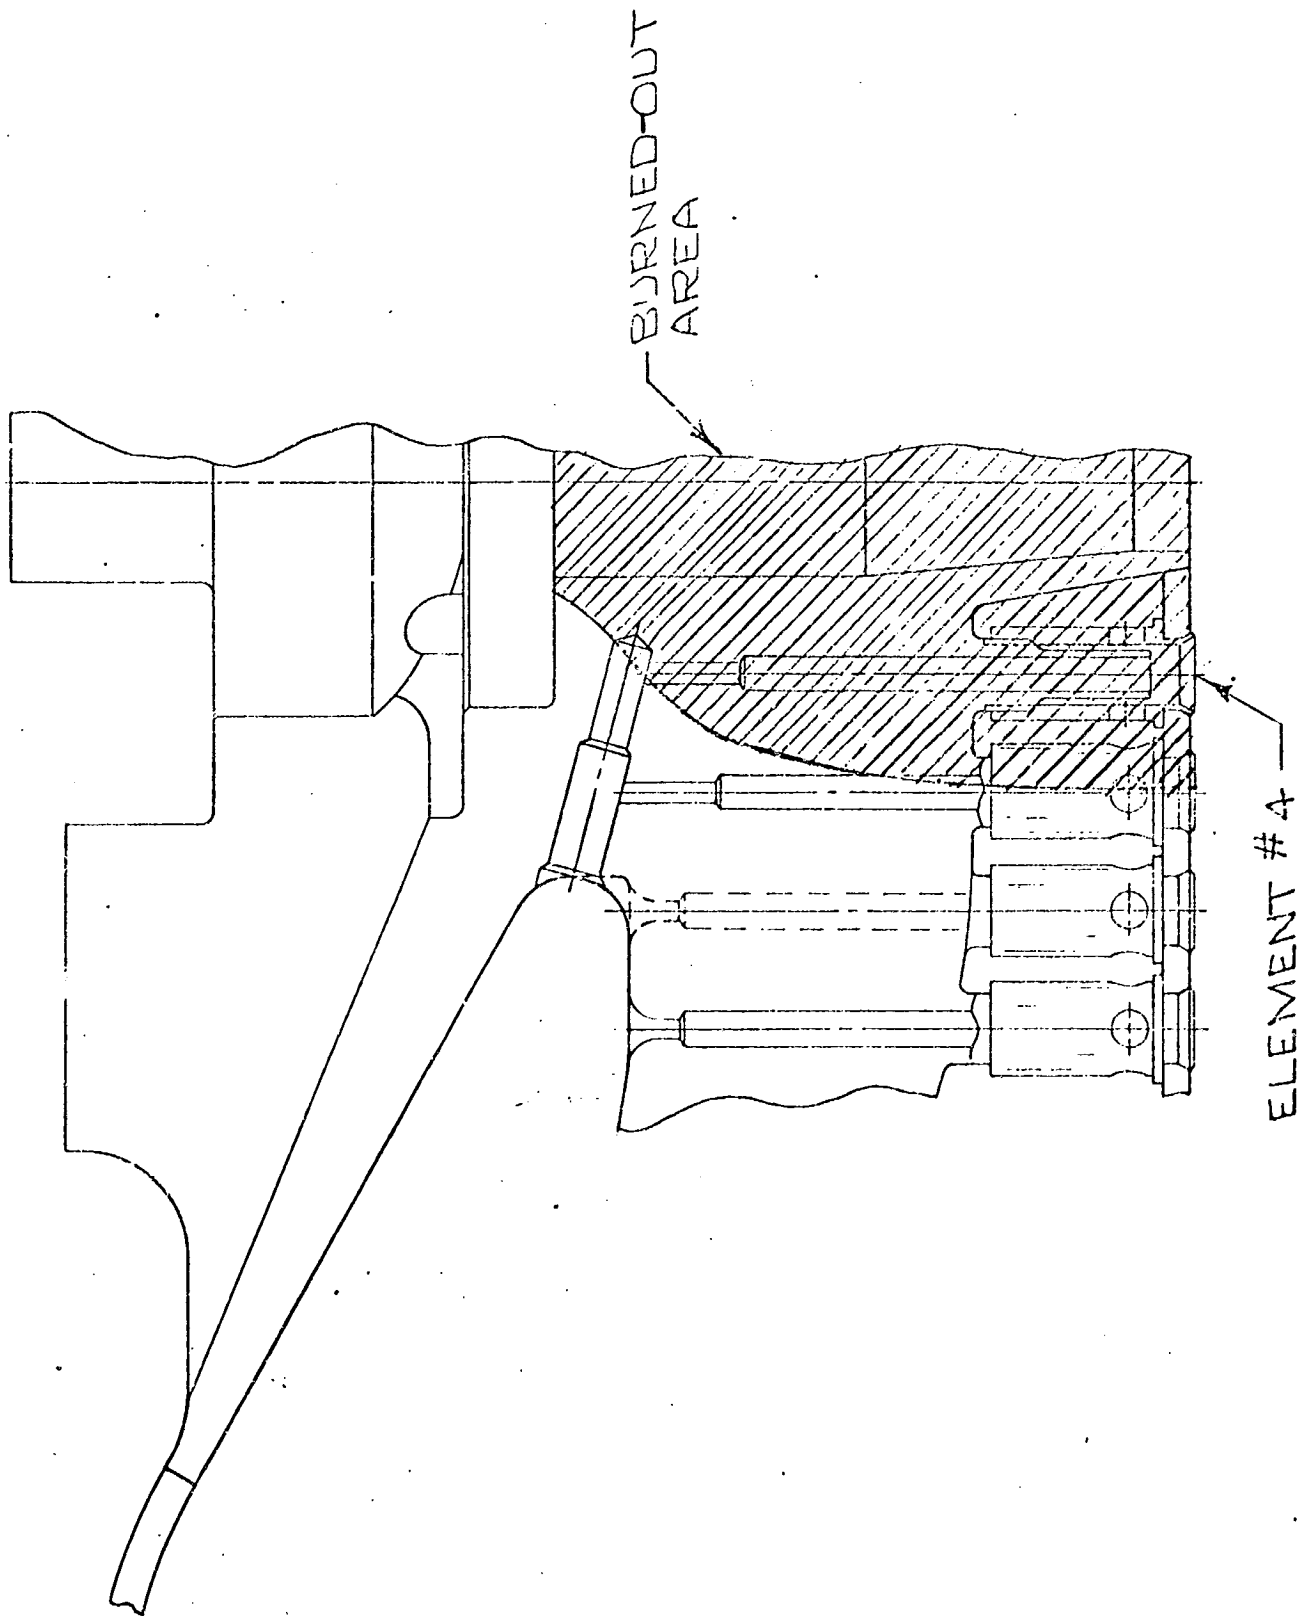
Figure A-8. Posttest Injector Condition, MSFC ASI Fuel Line Failure Simulation (Area of Greatest Damage)

Significant main injector, main chamber, and ASI seal damage was incurred during test 217-4. A total of 15 oxidizer passages (including two oxidizer "doghouses") were violated by erosion. Very intense continuous main injector burning and erosion began immediately after the No. 1 ASI fuel valve (Fig. A-4) was ramped closed; the burning continued until approximately 3 seconds prior to cutoff at which time the burning appeared to diminish slightly. Two thrust chamber tubes in the lower nozzle were ruptured during test 217-4; analysis of test data and instrumentation motion pictures and appearance of the ruptured tubes indicate that the damage was caused by ejected injector material striking the nozzle interior

wall. These ruptures resulted in (1) 8 to 9 lb/sec of main fuel being dumped into the lower nozzle, and (2) application of significant side loads to the thrust chamber.

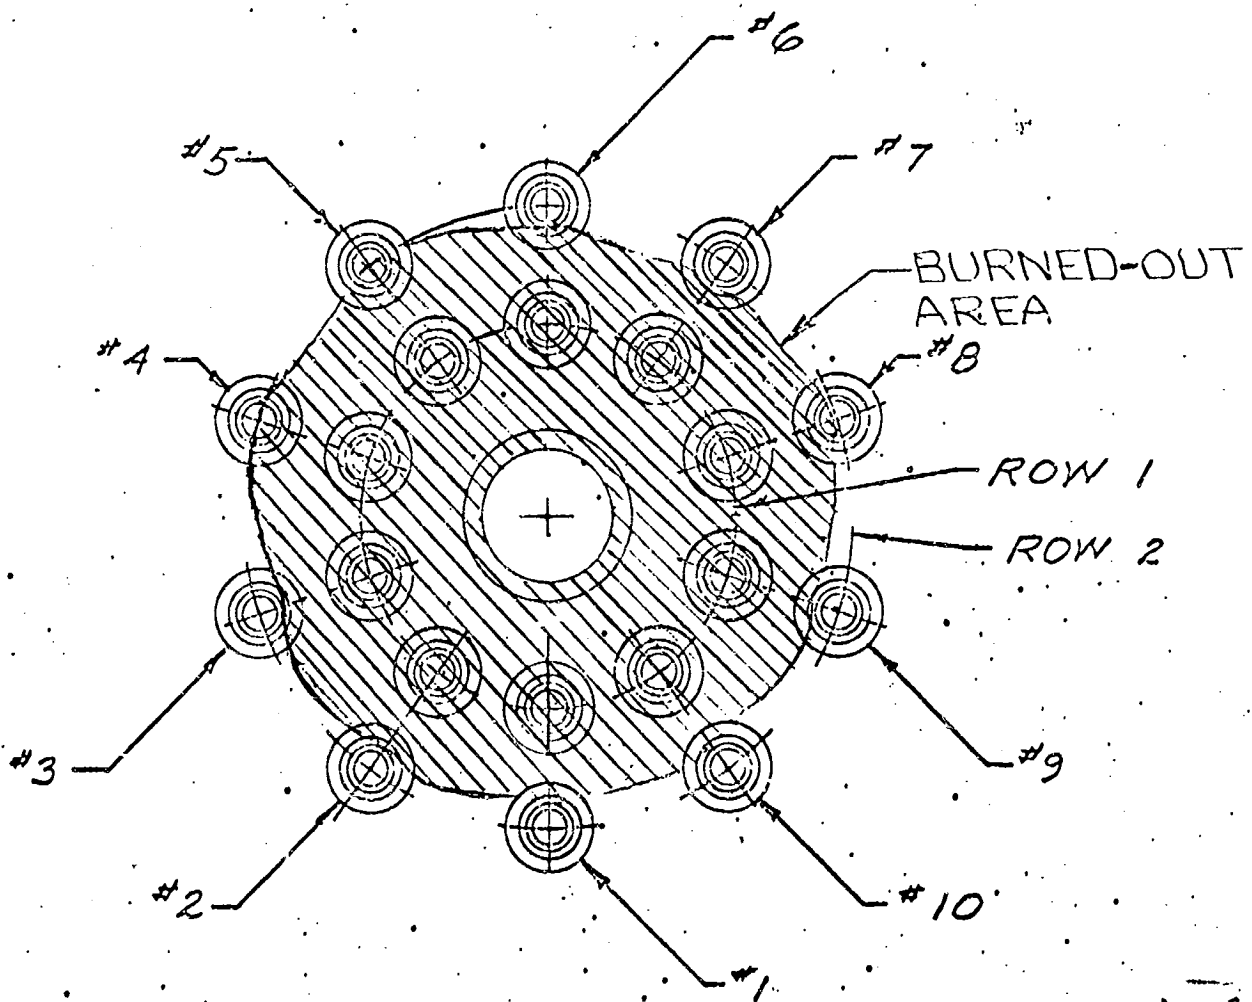
Figure Posttest Injector Condition, MSFC ASI Fuel Line Failure Simulation (View of Face)

2. Thrust chamber P_c and c^* efficiency were unaffected by erosion and penetration of the main injector fuel manifold, oxidizer manifold, and oxidizer elements in the vicinity of the ASI nozzle.
3. The c^* efficiency is reduced by opening to atmosphere any portion of the ASI injector or main injector.
4. Erosion of the ASI nozzle can occur with an ASI oxidizer/fuel mixture ratio as low as 2.5.
5. Damage to the thrust chamber nozzle resulted from ejected injector fragments.
6. Side forces, i.e., moment loading at the gimbal bearing, can result from failure of thrust chamber tubes with attendant fuel leakage flow to the interior of the thrust chamber nozzle.
