J-2 ENGINE AS-502 (APOLLO 6)

FLIGHT REPORT

VOLUME 3: S-IVB STAGE FAILURE ANALYSIS

DATE 17 June 1968

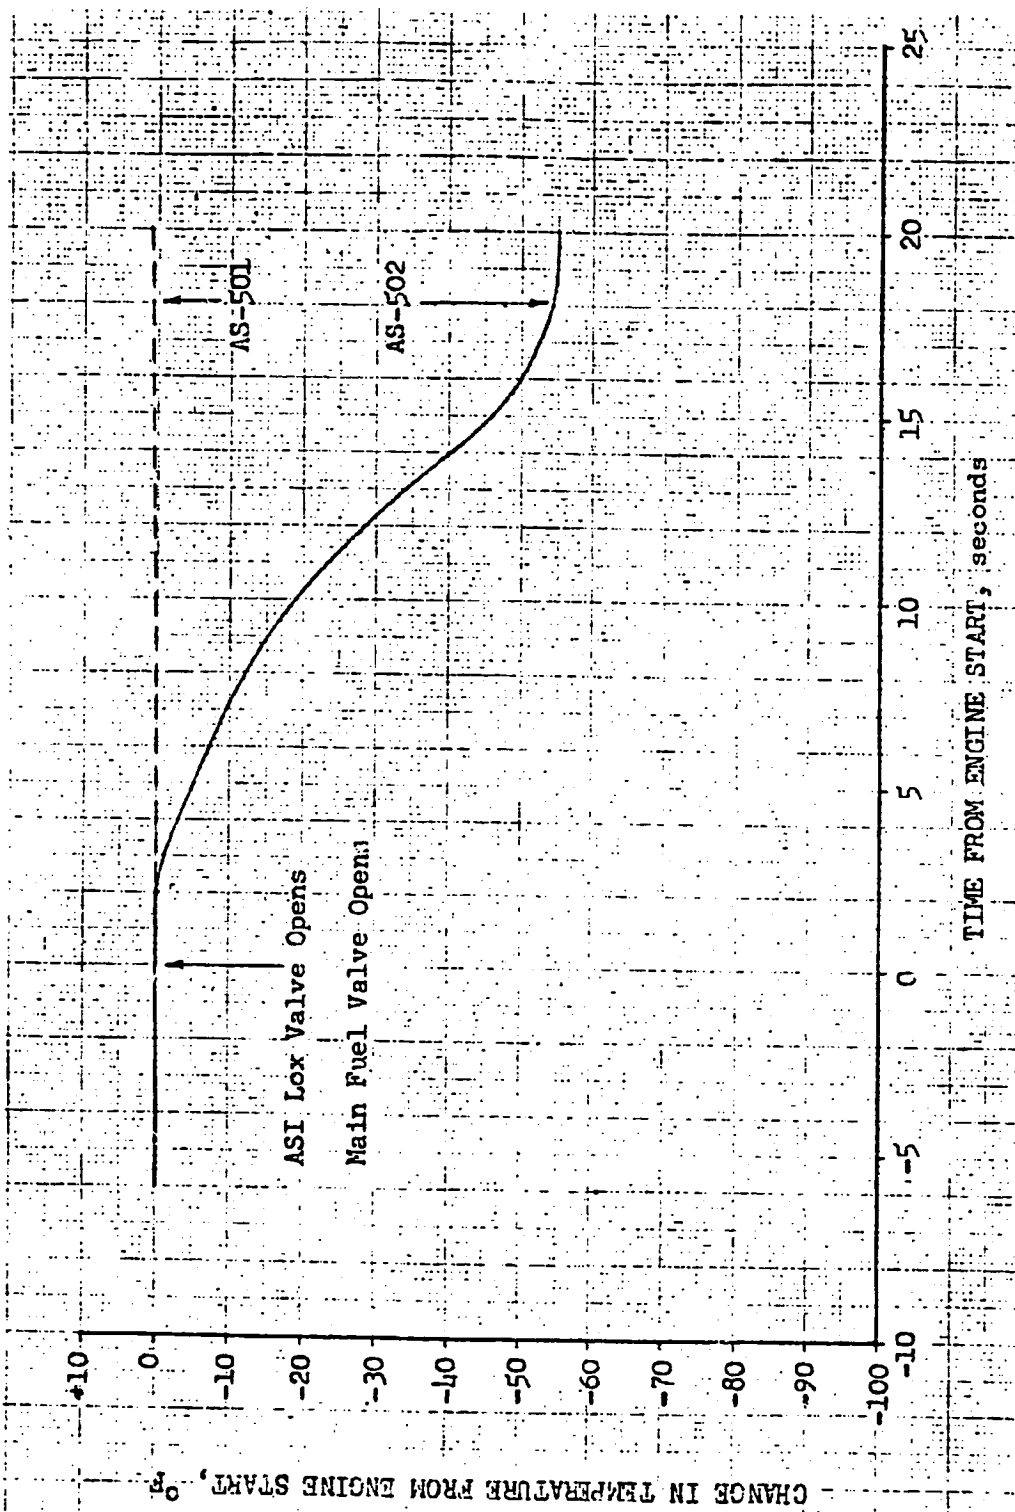
Figure 23. S-IVB Engine J2042 Second-Burn MOV Closing Line Temperature Comparison

Figure 23 shows the MOV line temperature measurement is not chilled until after engine start command. Because propellants are down to all engine valves prior to engine start, it must be concluded that the source of leakage is in the areas shown in Fig. 24. either downstream of the MFV, including the ASI fuel line, or downstream of the ASI oxidizer valve. Other engine parameters showed chilling after mainstage signal when the pumps have developed sufficient pressure to produce the flows required to chill these parameters. No parameters showed heating, thus eliminating the gas generator and exhaust system as the source of hot gas. These data support the earlier hypothesis of failure of the ASI fuel line.

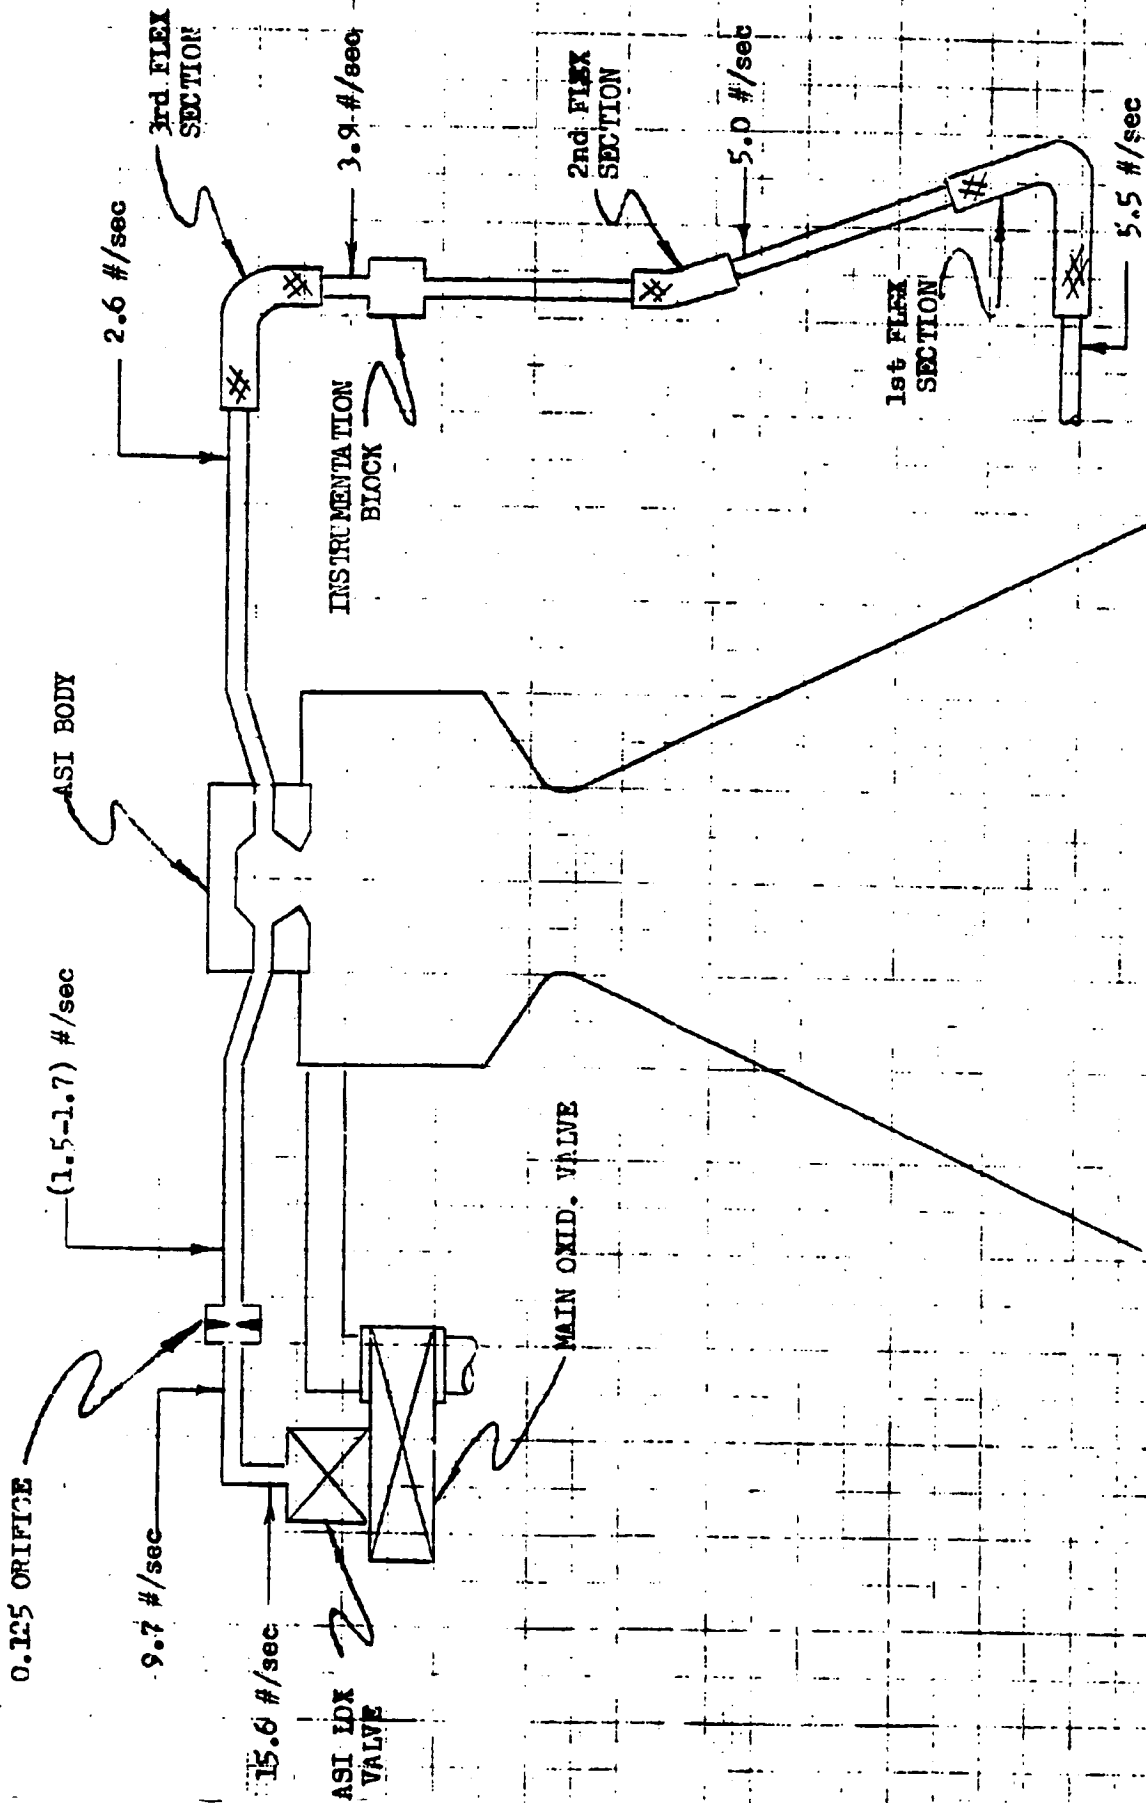
Figure 41. Expected Leakage Flow for Various Break Points in the ASI Propellant Feed System

Fuel Leak Located Near Dome Area Section of the ASI Fuel Line. Analysis of engine area temperature data (Thermal Environment section) conclusively supports hydrogen leakage (i.e., chilling to cryogenic hydrogen temperature) localized to the engine dome area on the fuel pump side of the engine or the general area of the ASI fuel line between the instrumentation block and the ASI fuel inlet. Figure 41, summarizing the ASI system flows based on best estimates of nominal line resistance for various break points in either line, indicates the total ASI fuel feed system leakage between the instrumentation block and the ASI inlet is between 2.6 and 3.9 lb/sec with the line totally failed. Such overboard leakage is sufficient to explain a significant portion of the observed performance shift.

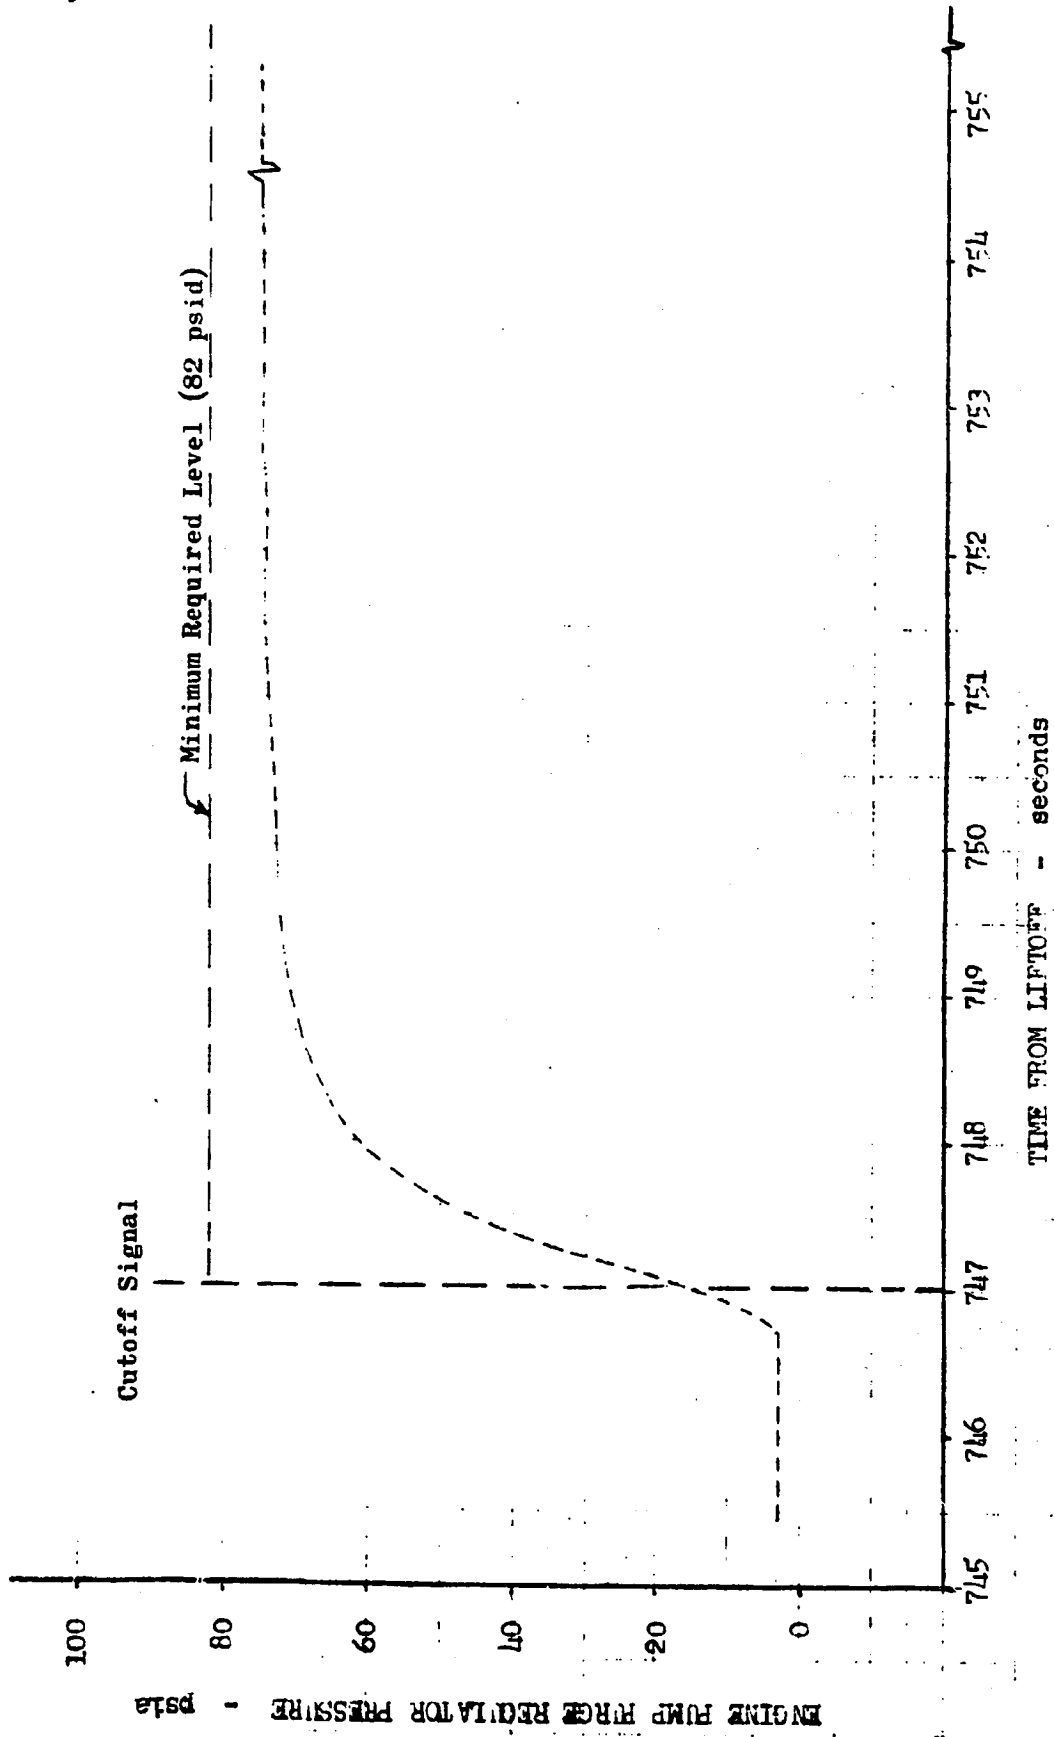
Figure 47. AS-502 S-IVB First Burn, Engine Pump Purge Regulator Pressure vs Time

Figure 47 depicts the engine pump purge regulator pressure buildup at cutoff. The data revealed that the highest pressure level attained during the purge was below the minimum required limit (6 psi low). This has been brought to the attention of the S-IVB stage contractor (Huntington Beach Facility).

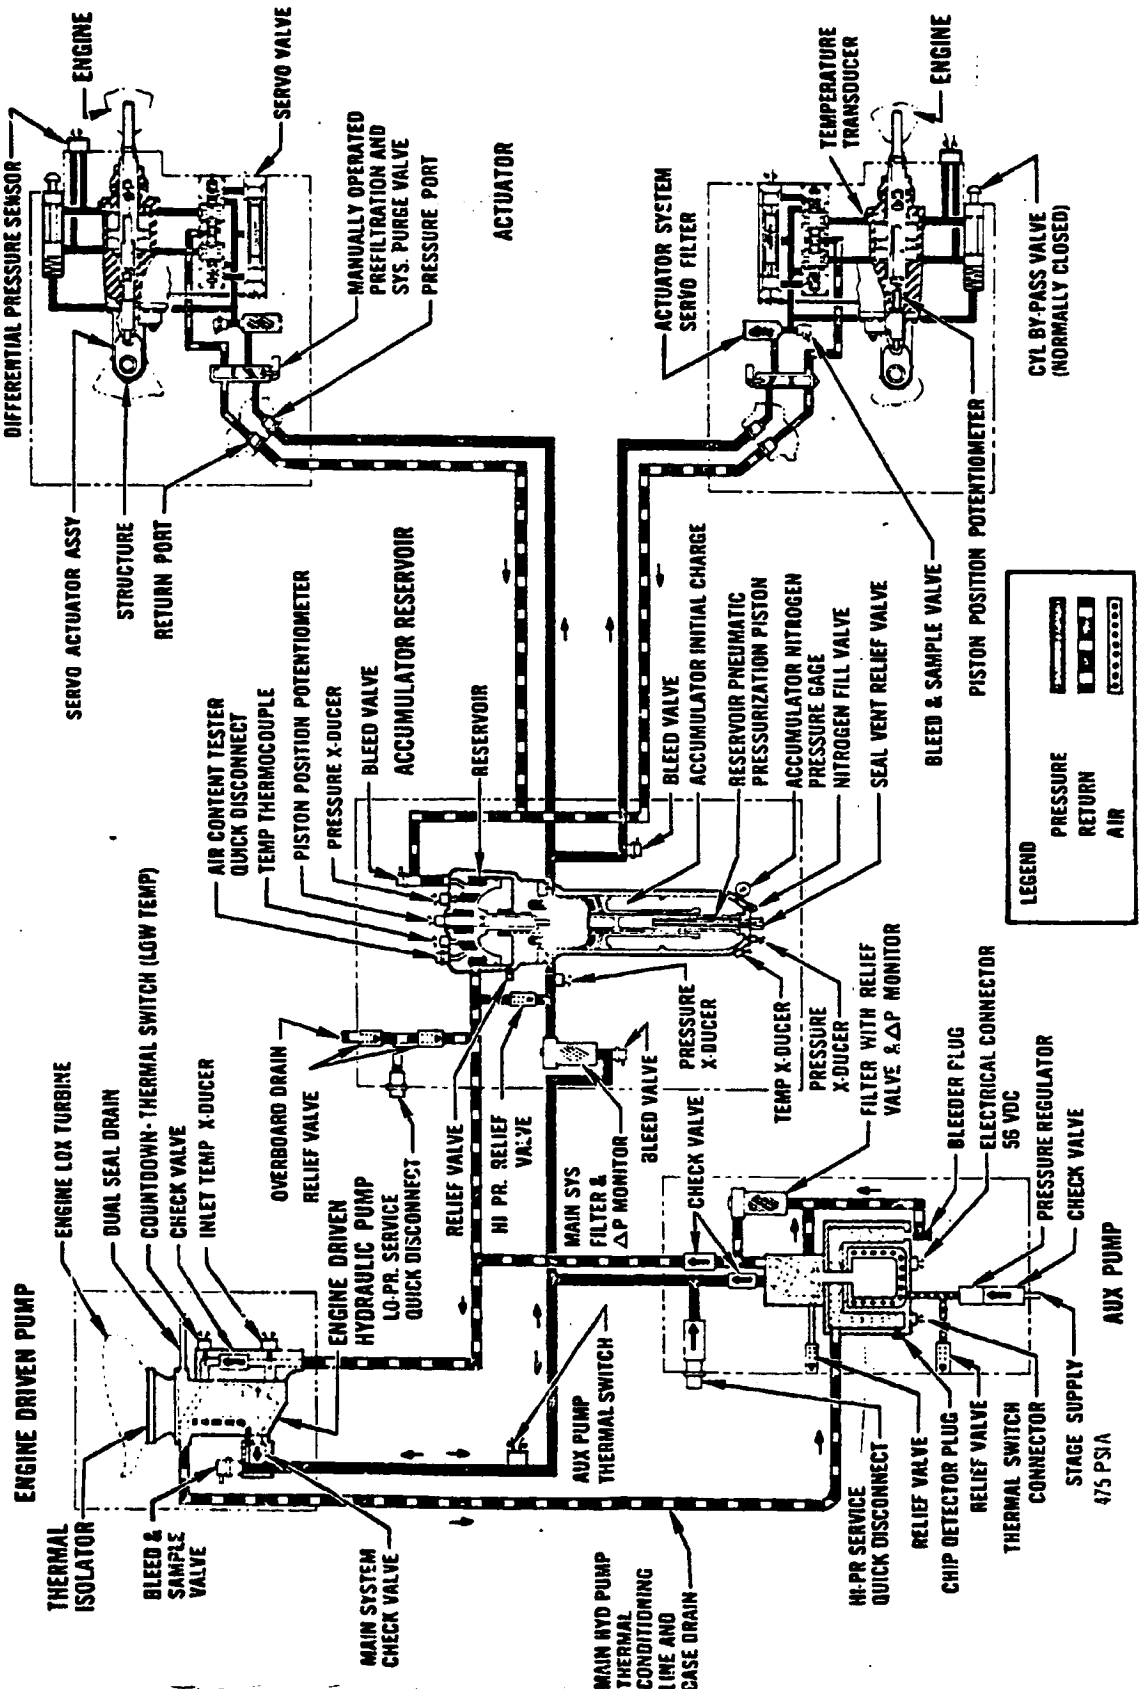
Figure 54. S-IVB Hydraulic System Schematic

In view of the low-temperature environment that occurred during the first burn of the J-2 engines as a result of cryogenic leakage, the most logical cause of the hydraulic pump failure appears to be freezing of hydraulic fluid because of impingement of cryogenics on hydraulic system lines and/or hoses. Laboratory test data support this hypothesis, and the flight anomaly was reproduced by the S-IVB stage contractor, McDonnell-Douglas Corporation, during their special test program. The hydraulic pump anomaly was a result rather than a cause, of the J-2 engine anomalies.

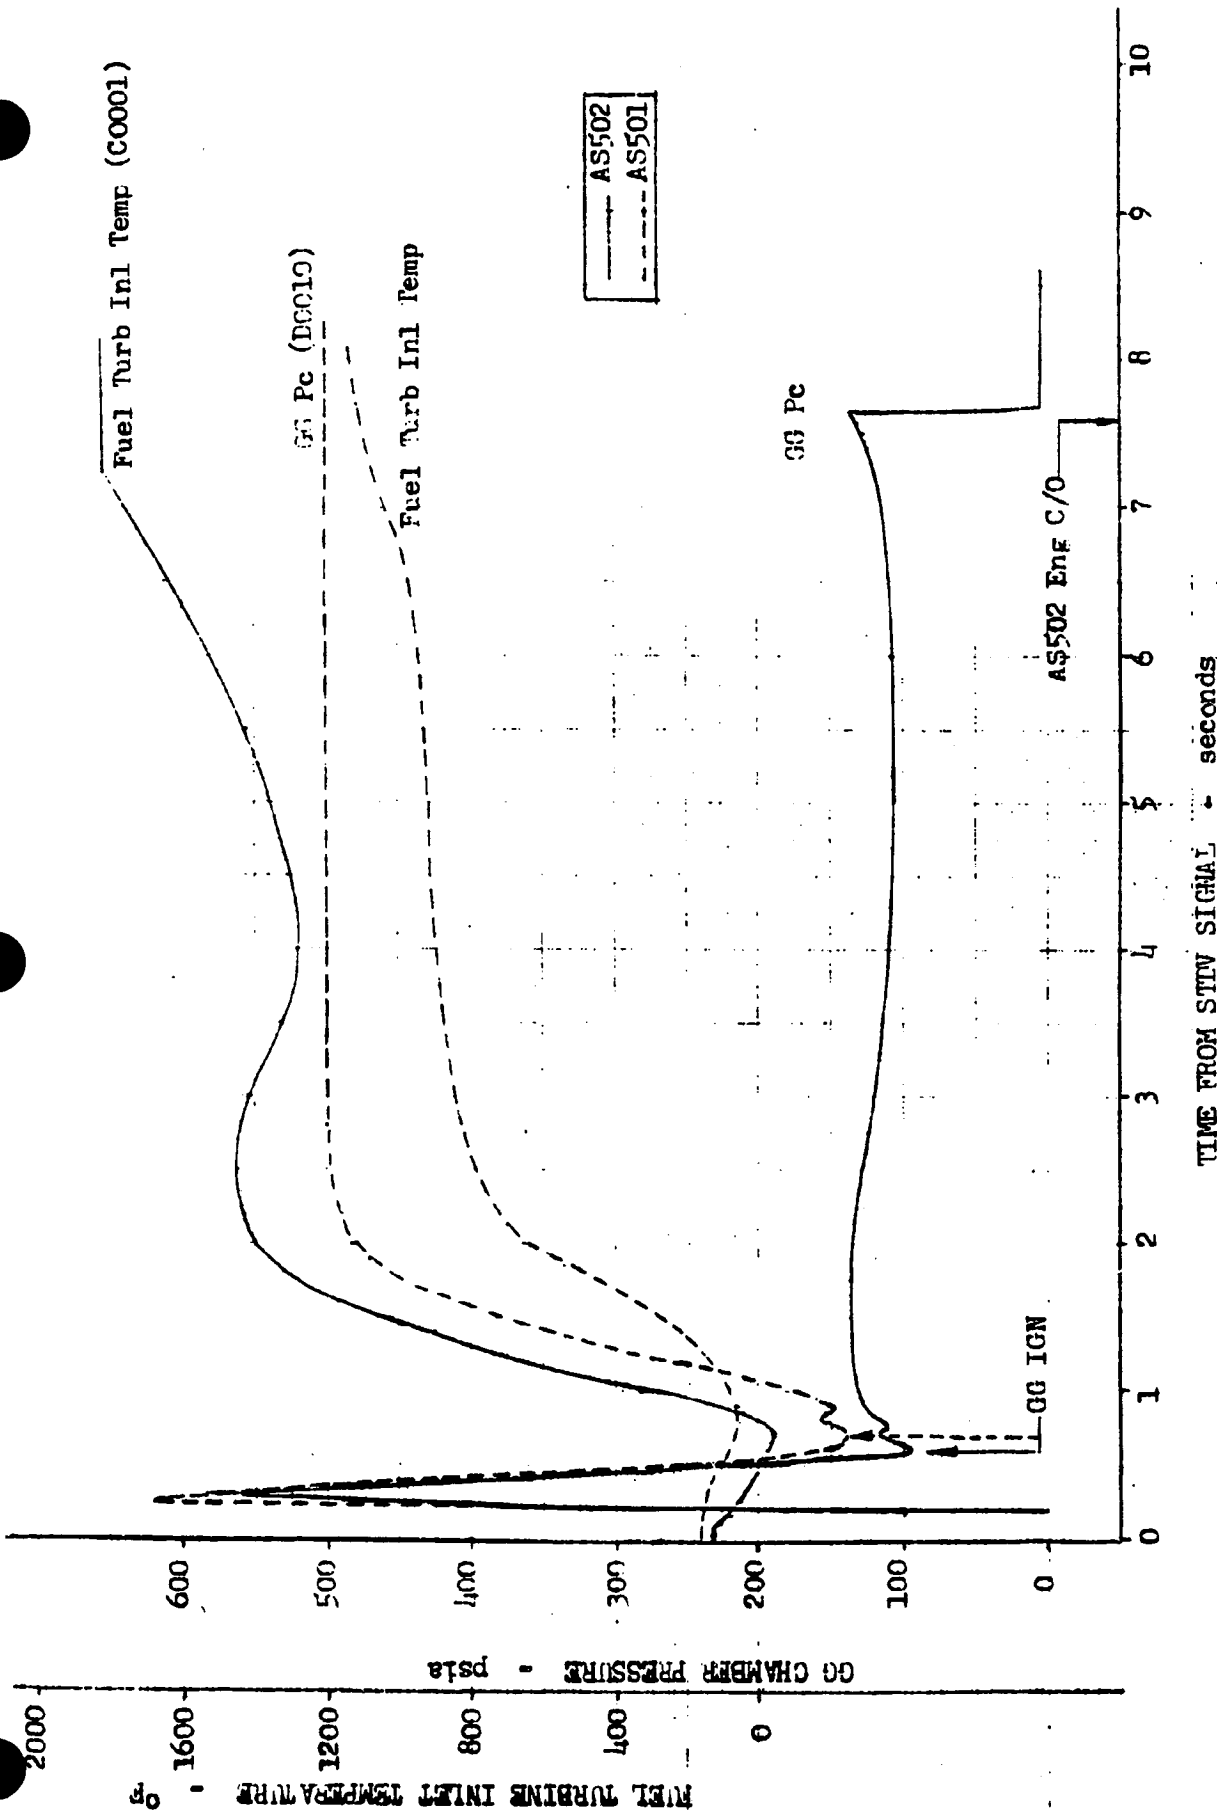
Figure 57. Comparison of AS-501 and AS-502 S-IVB Second Burn, Gas Generator Chamber Pressure and Fuel Turbine Inlet Temperature vs Time

Fuel turbine inlet temperature normally approaches 1050 F at nominal PU and 1200 F at maximum thrust (full-closed PU valve), as it does for AS-501 in Fig. 57. On AS-502, the fuel turbine inlet temperature initially rose to 1460 F quite rapidly, showing quicker response than this resistance bulb normally does. This may have been caused by the excessive gas generator temperature that resulted from the abnormal start. Fuel turbine inlet temperature remained excessive for the duration of the second burn, pegging upscale at 1800 F 300 milliseconds prior to cutoff. Comparing Fig. 55 and 56, it can be seen that fuel turbine inlet temperature follows the same trend as the differential between oxidizer pump discharge pressure and fuel pump discharge pressure.

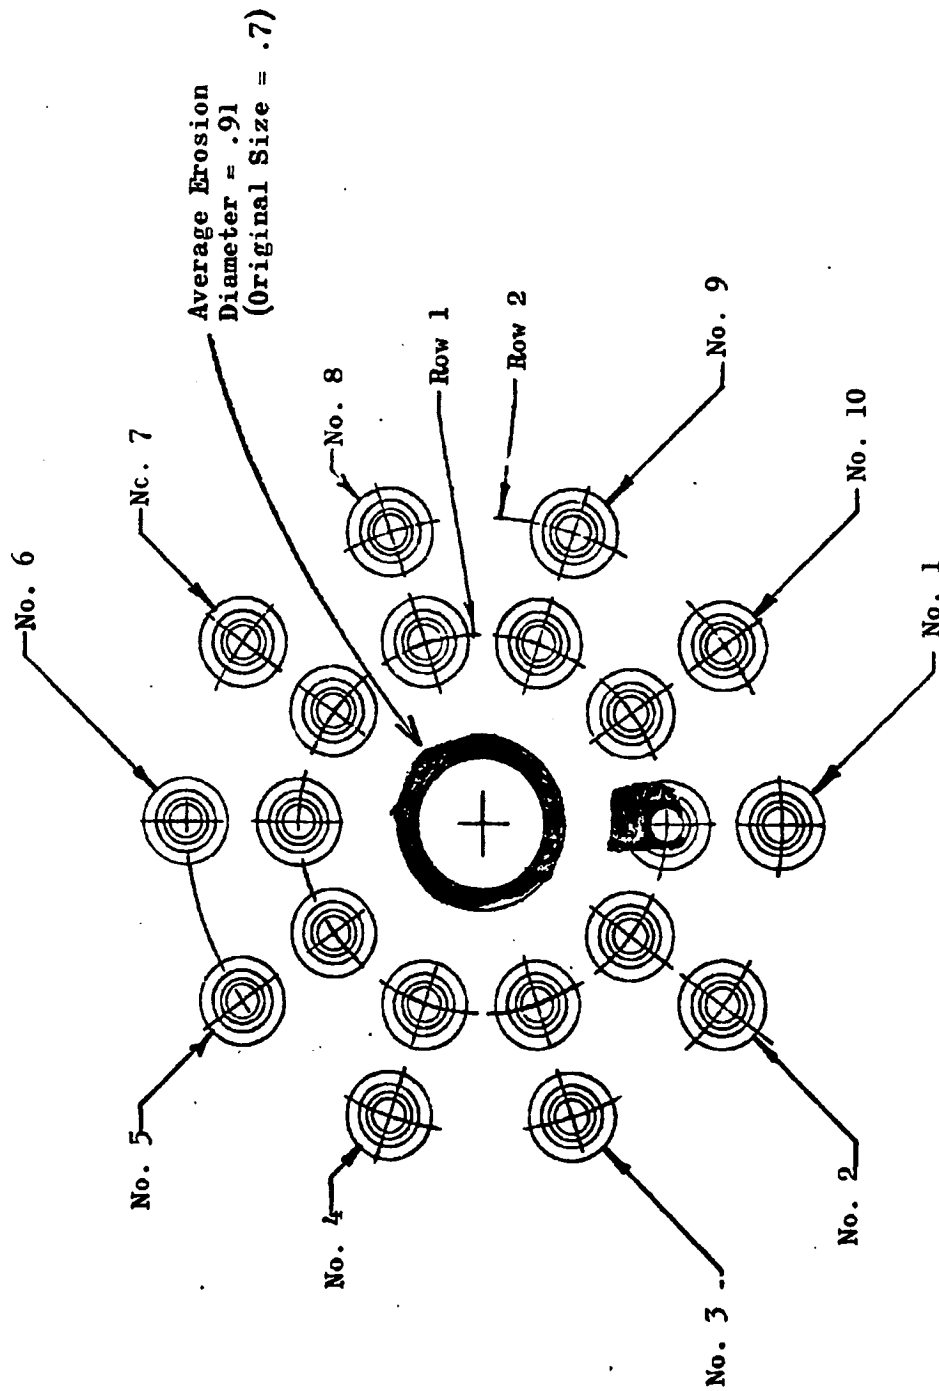
Figure 79. ASI Nozzle (Main Injector) Showing Erosion, Engine J016-4, Test J13-041, Posttest Injector Condition

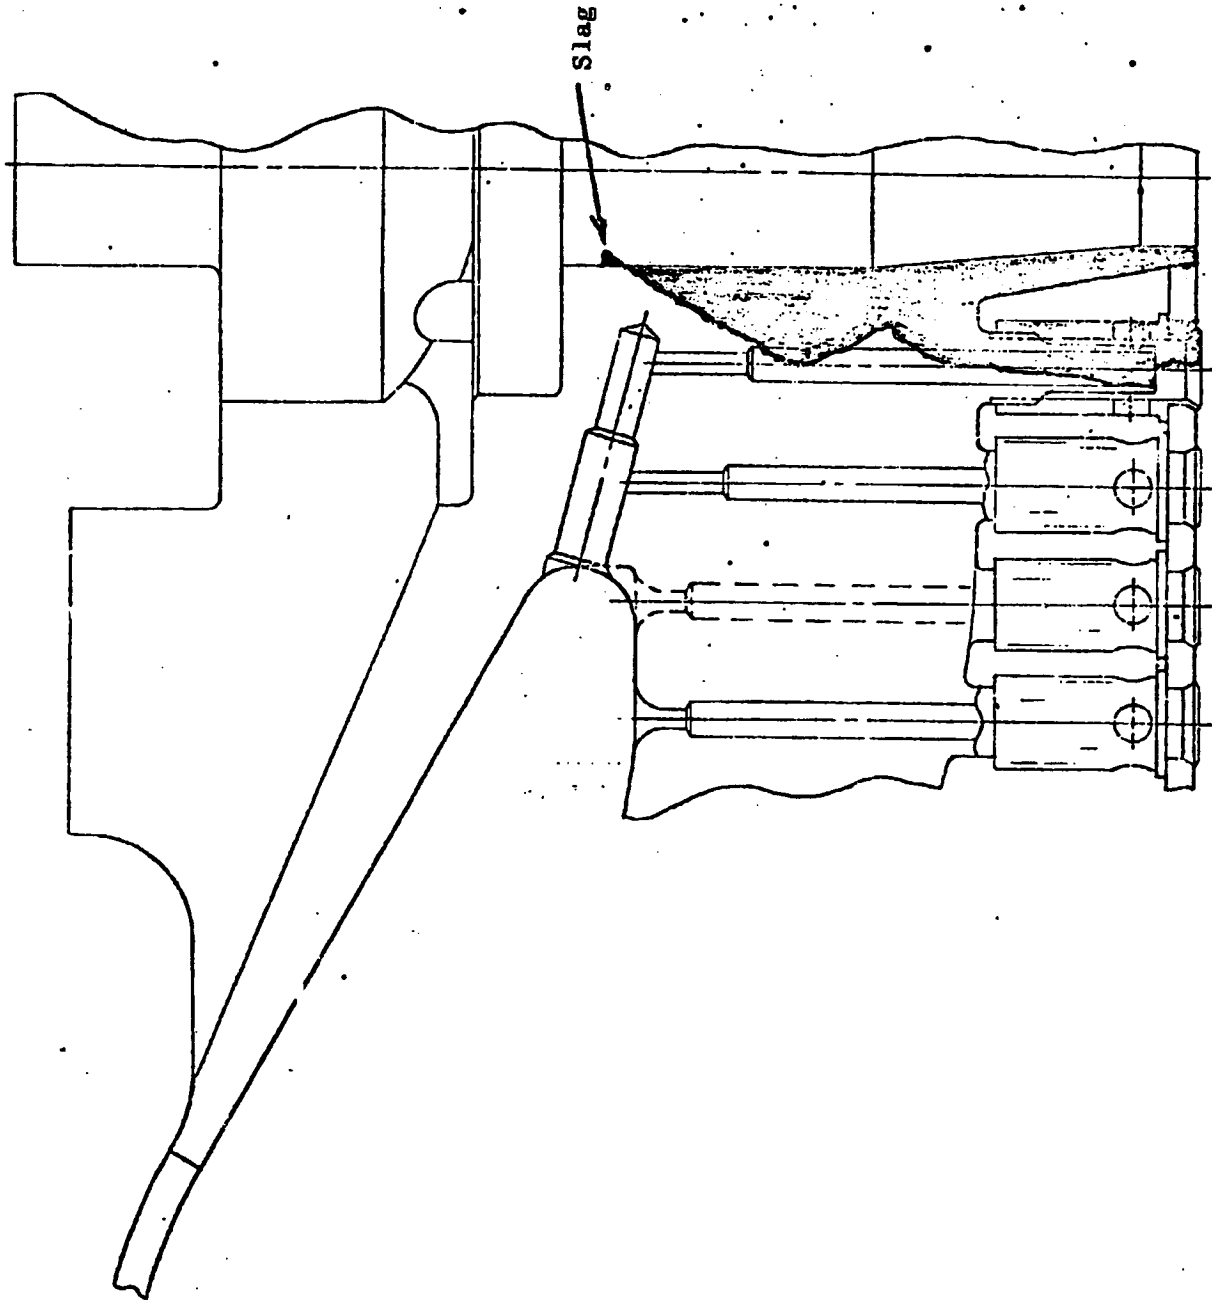
Figure 80. Engine J016-1, Test 313-041, Posttest Injector Condition
(Section at Element 1)

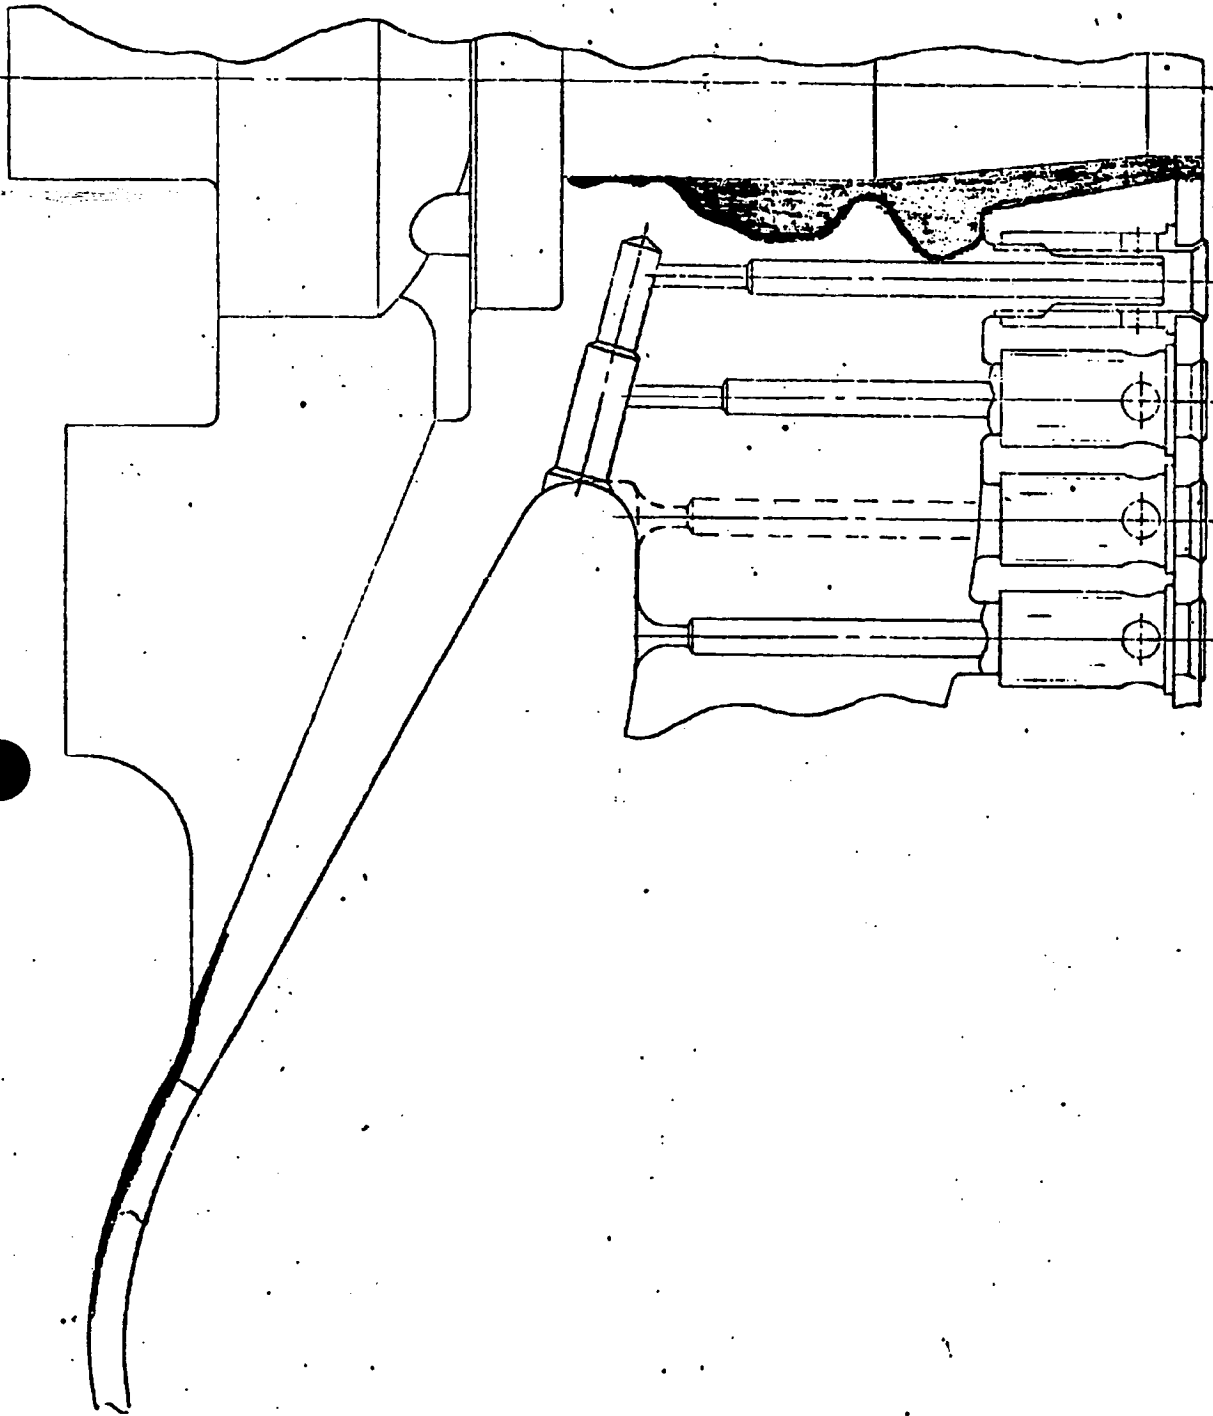
Figure 81. Engine J016-4, Test 313-041, Posttest Injector Condition
(Section at Element 2)

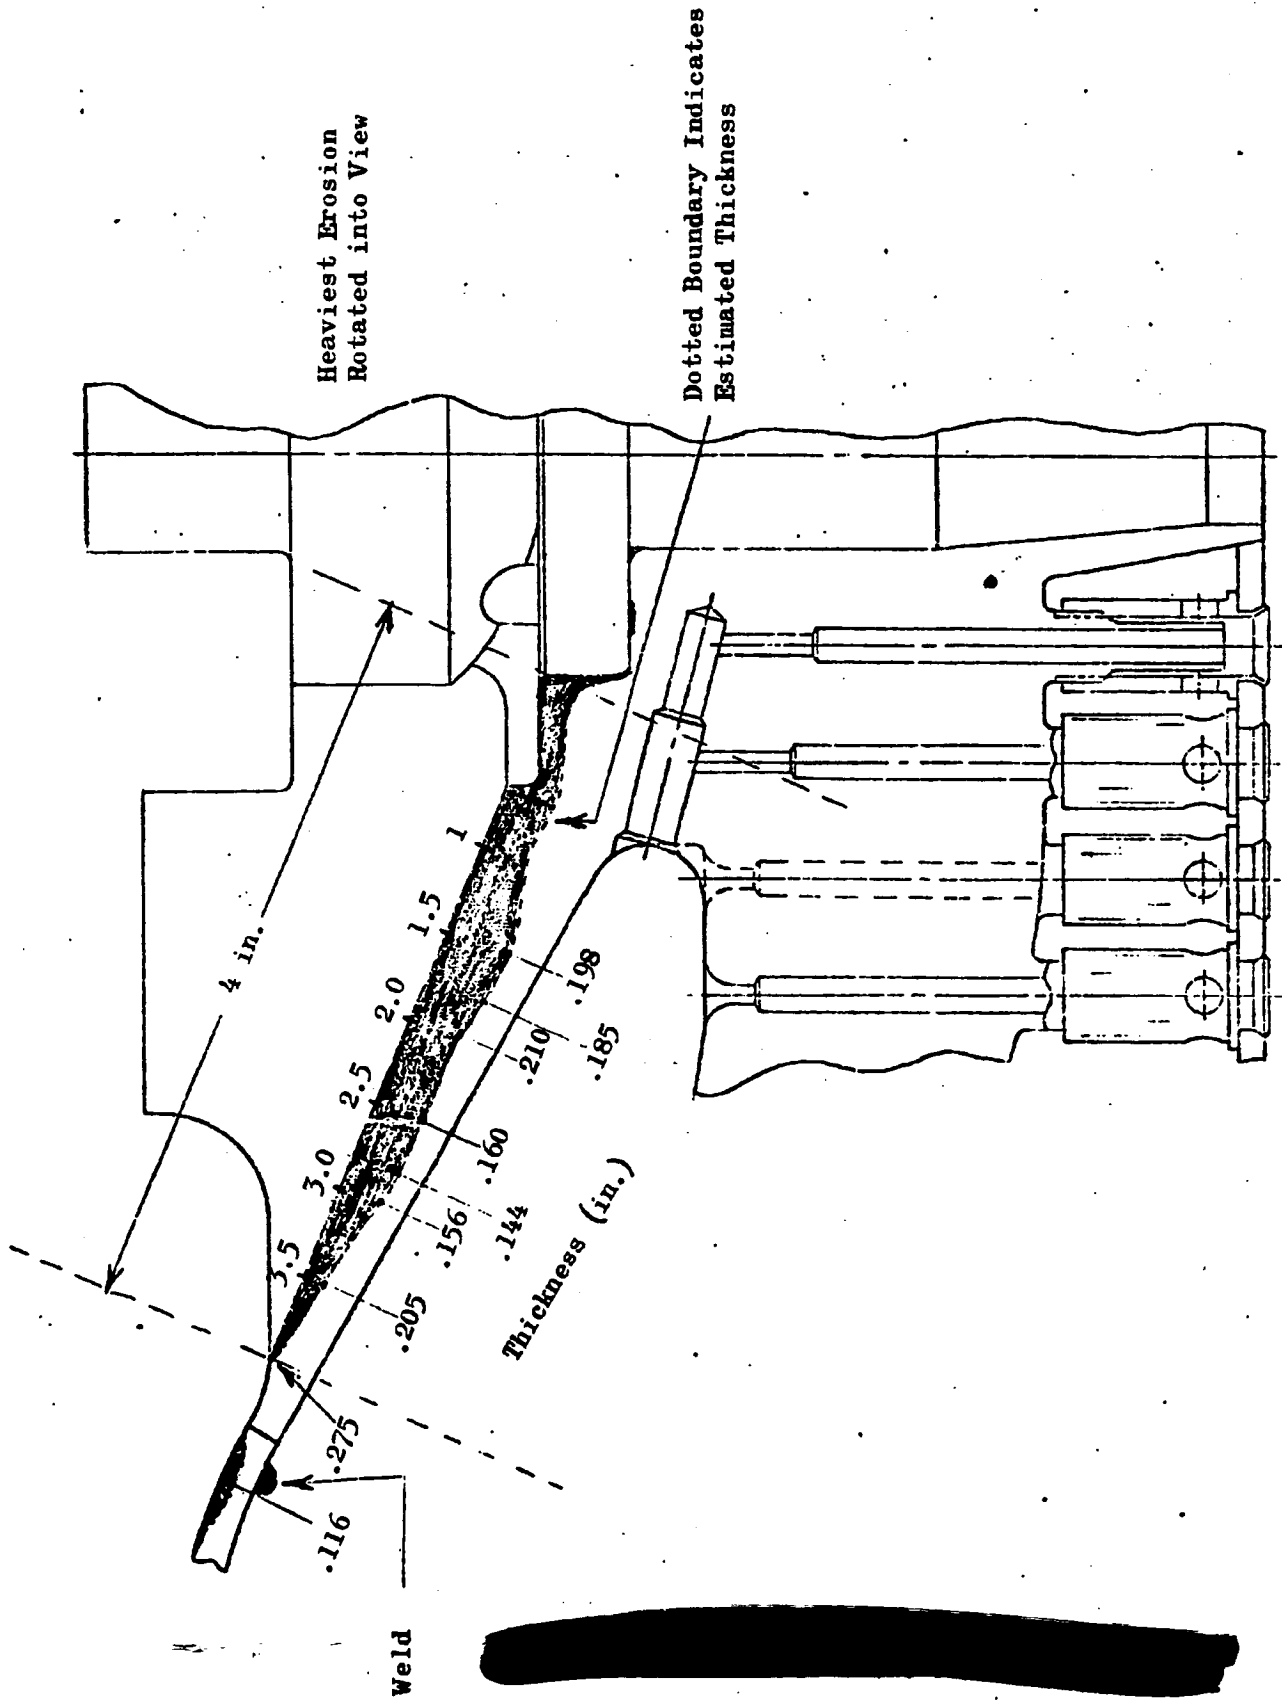
Figure 82. Engine J016-4, Test 313-041, Posttest Injector Condition

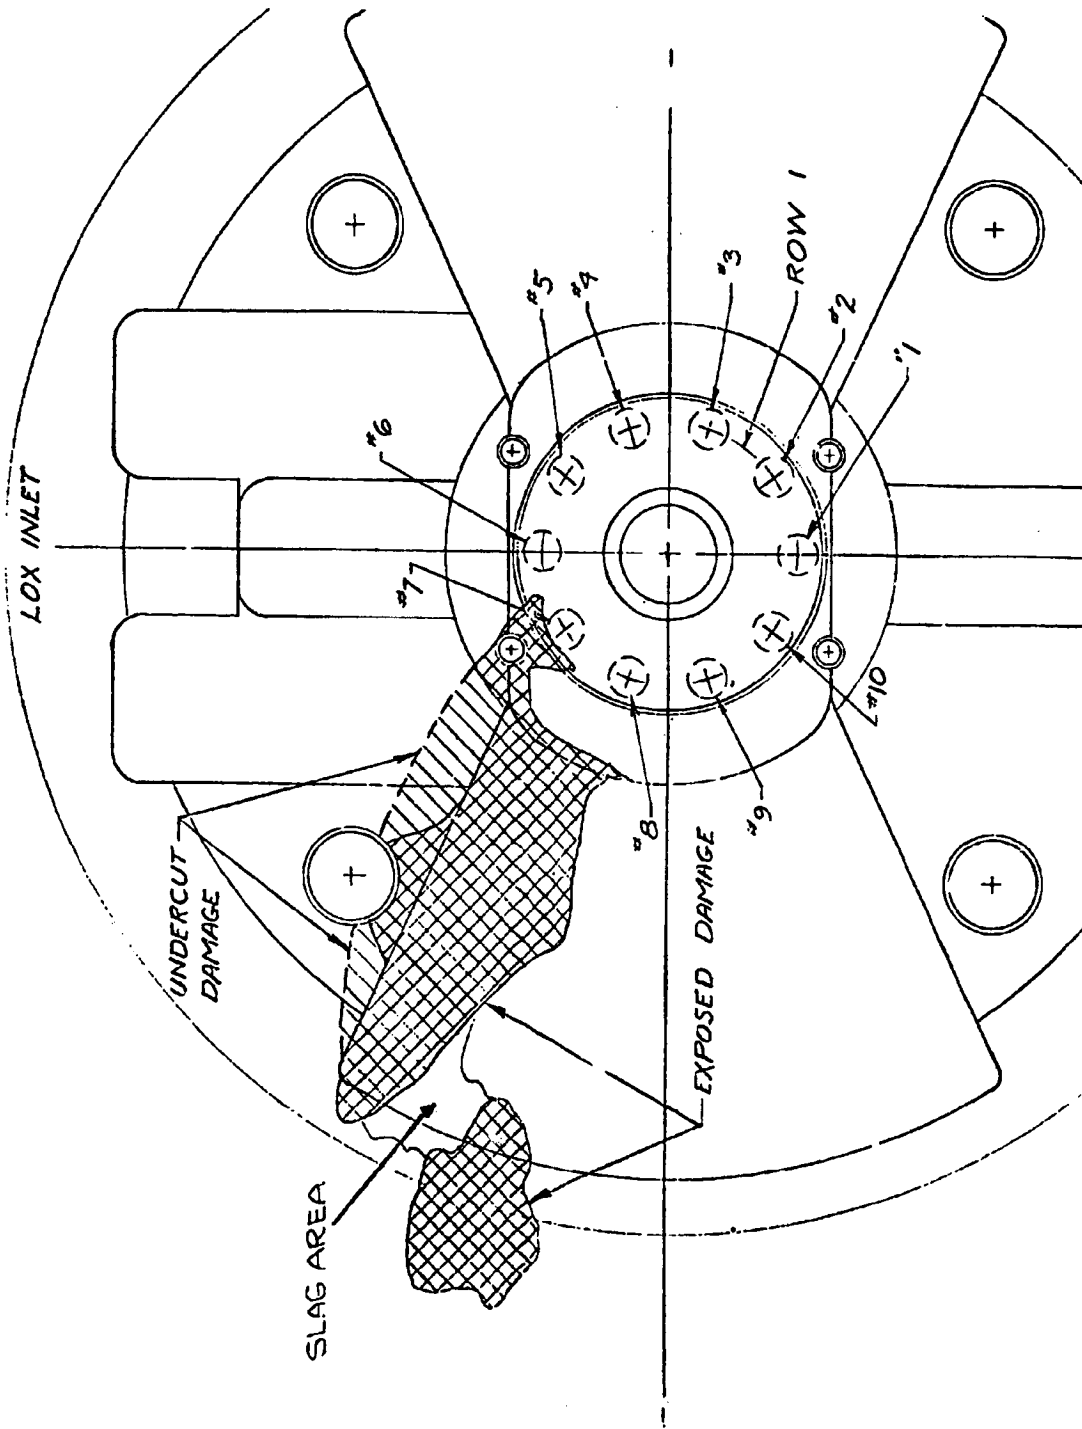
Figure 85. Engine J016-4, Test 313-041, Posttest Injector Condition Showing Oxidizer Dome Damage
