REPORT NO. R-4035-46-1

SEPTEMBER 1968

# A PERFORMANCE EVALUATION OF GEOS - II

**PREPARED BY**  
communications & systems, incorporated

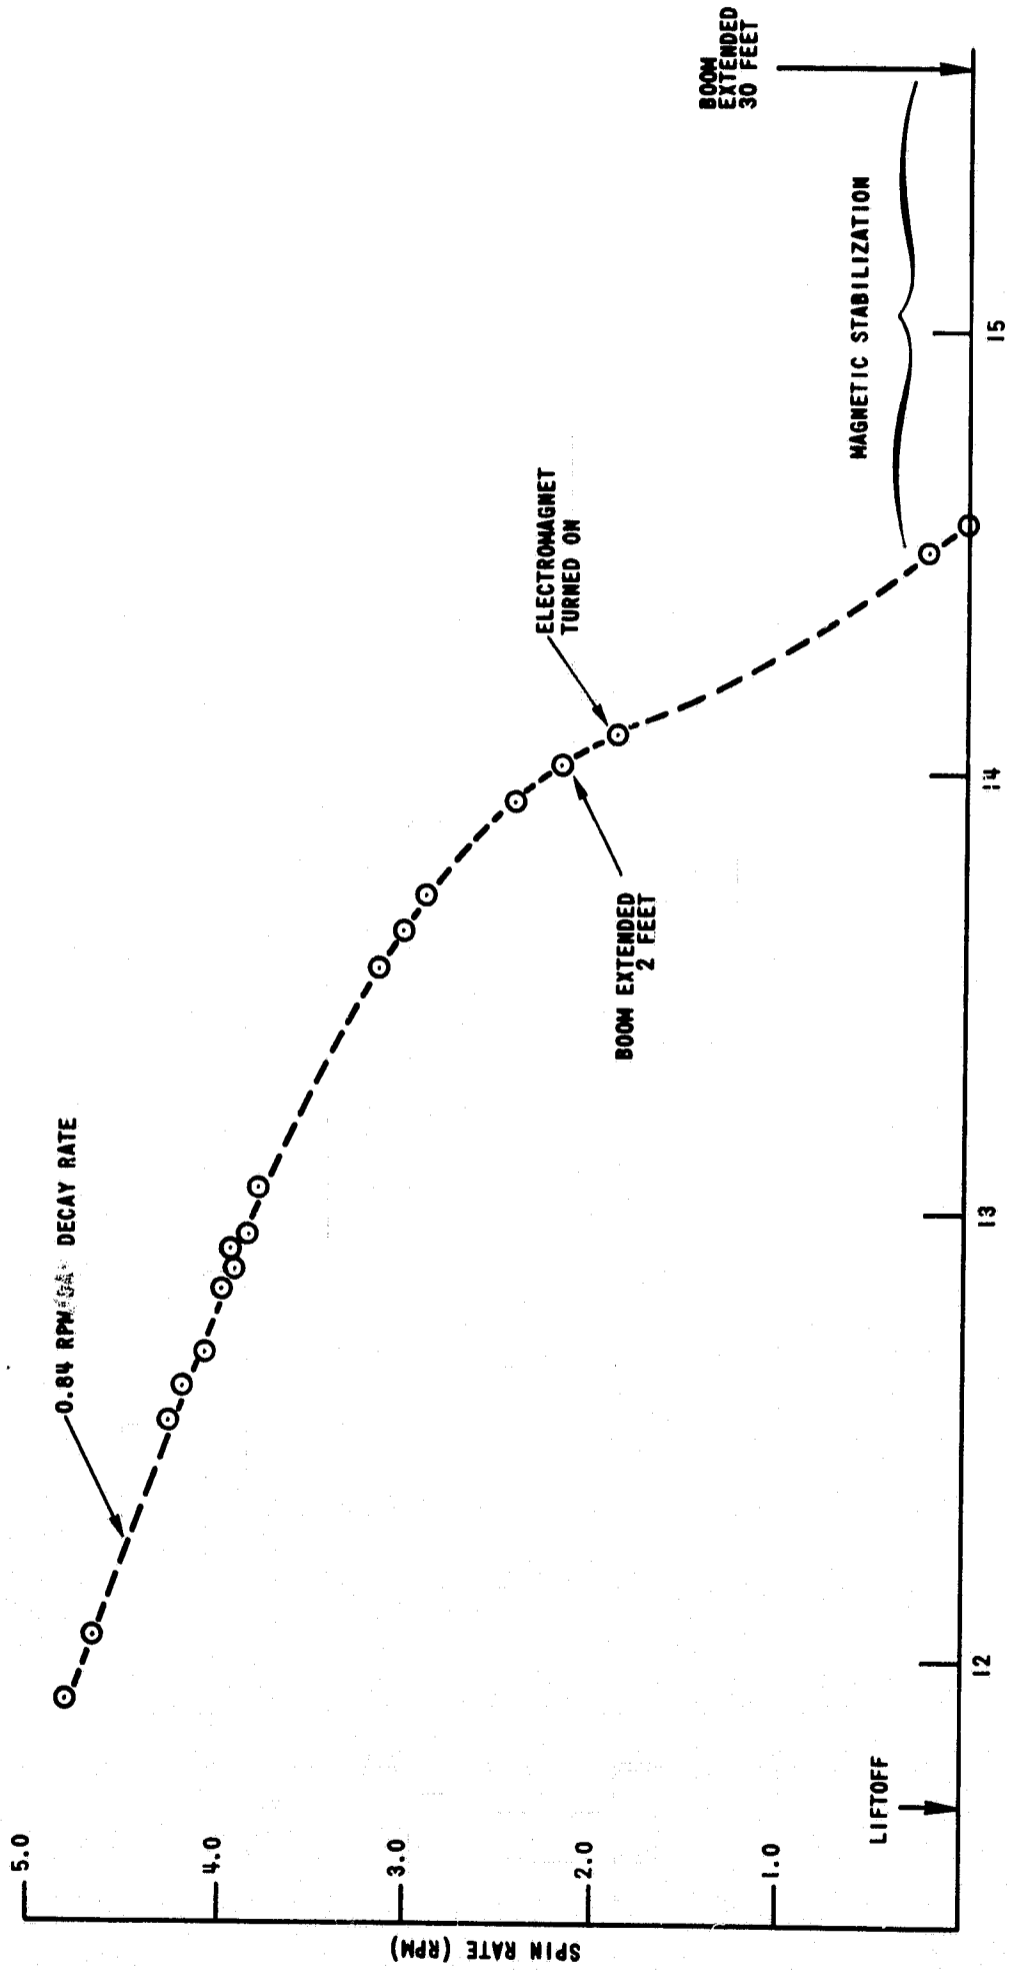
Figure 3-1 GEOS-II Spin Rate Versus Time

Telemetry data taken on 12 and 13 January showed a steady increase in the three spacecraft battery temperatures. This was attributed to an undesirable satellite/sun attitude (with the spacecraft in 100% sunlight). The main battery temperature increased to 125°F and the transponder and optical batteries to about 112°F by 1120Z on 13 January. All manual and automatic power dumps and main systems were commanded on in an attempt to lower the battery temperatures, however, the temperatures remained too high. APL decided that extending the gravity gradient boom would change the attitude significantly and reduce the temperatures to safer levels. Therefore, at 2350Z on 13 January, commands were sent from the Howard County station to uncage the end mass and extend the boom about three feet. The spin rate at that time was approximately 2.1 rpm. This maneuver resulted in the temperatures rapidly decreasing to a level within the nominal limits (all below 100°F).

With the eddy current damper released from the magnetic influences of the spacecraft, it functioned to rapidly reduce the remaining spin. At 0140Z, 14 January, the electromagnet was turned on by APL to allow alignment of the spacecraft spin axis with the earth's magnetic field. By 1400Z on 14 January, the spin rate had decreased to virtually zero and magnetic stabilization was established. At 1350Z, 15 January, the boom was extended, by command from the Howard County station, to 29 feet 11 inches and gravity gradient stabilization was established in the right side up mode. A graphic illustration of the spin rate versus time is shown in Figure 3-1 with the significant events as discussed above annotated.

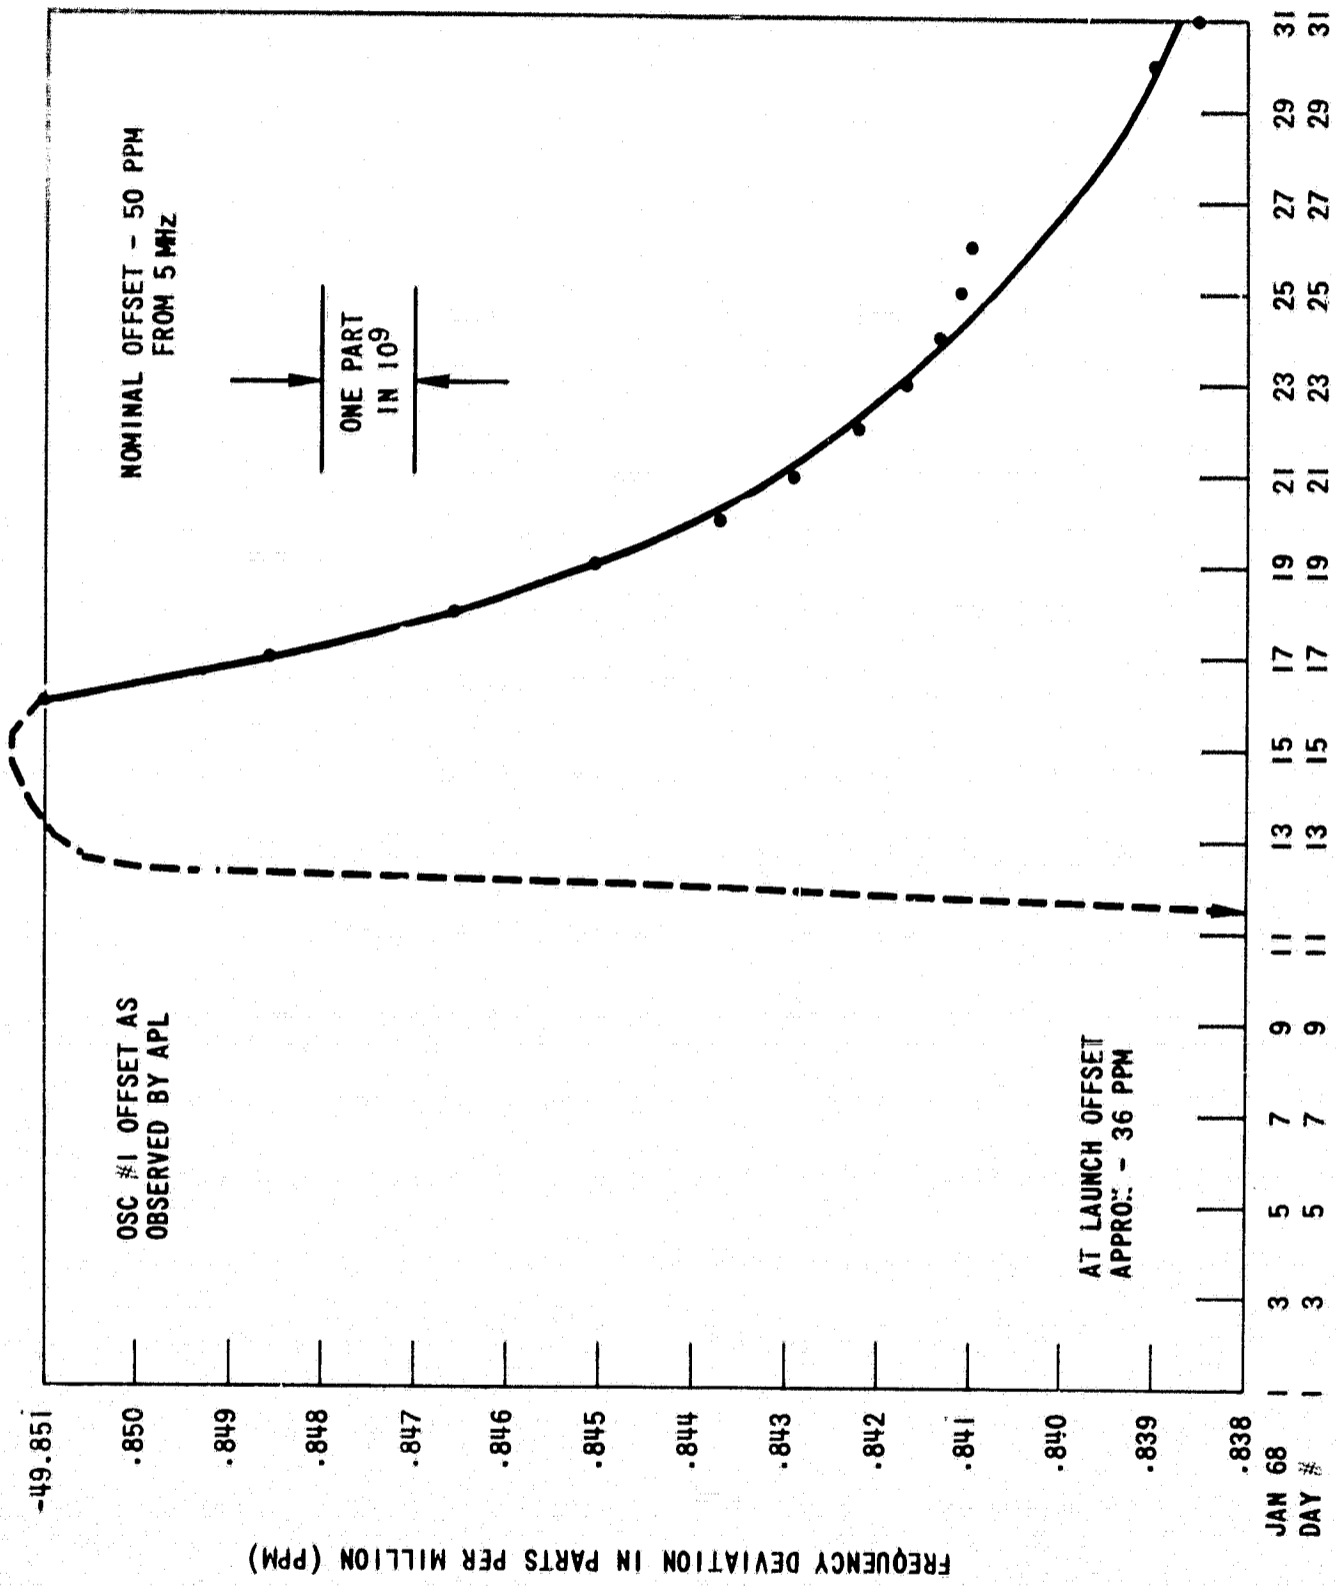
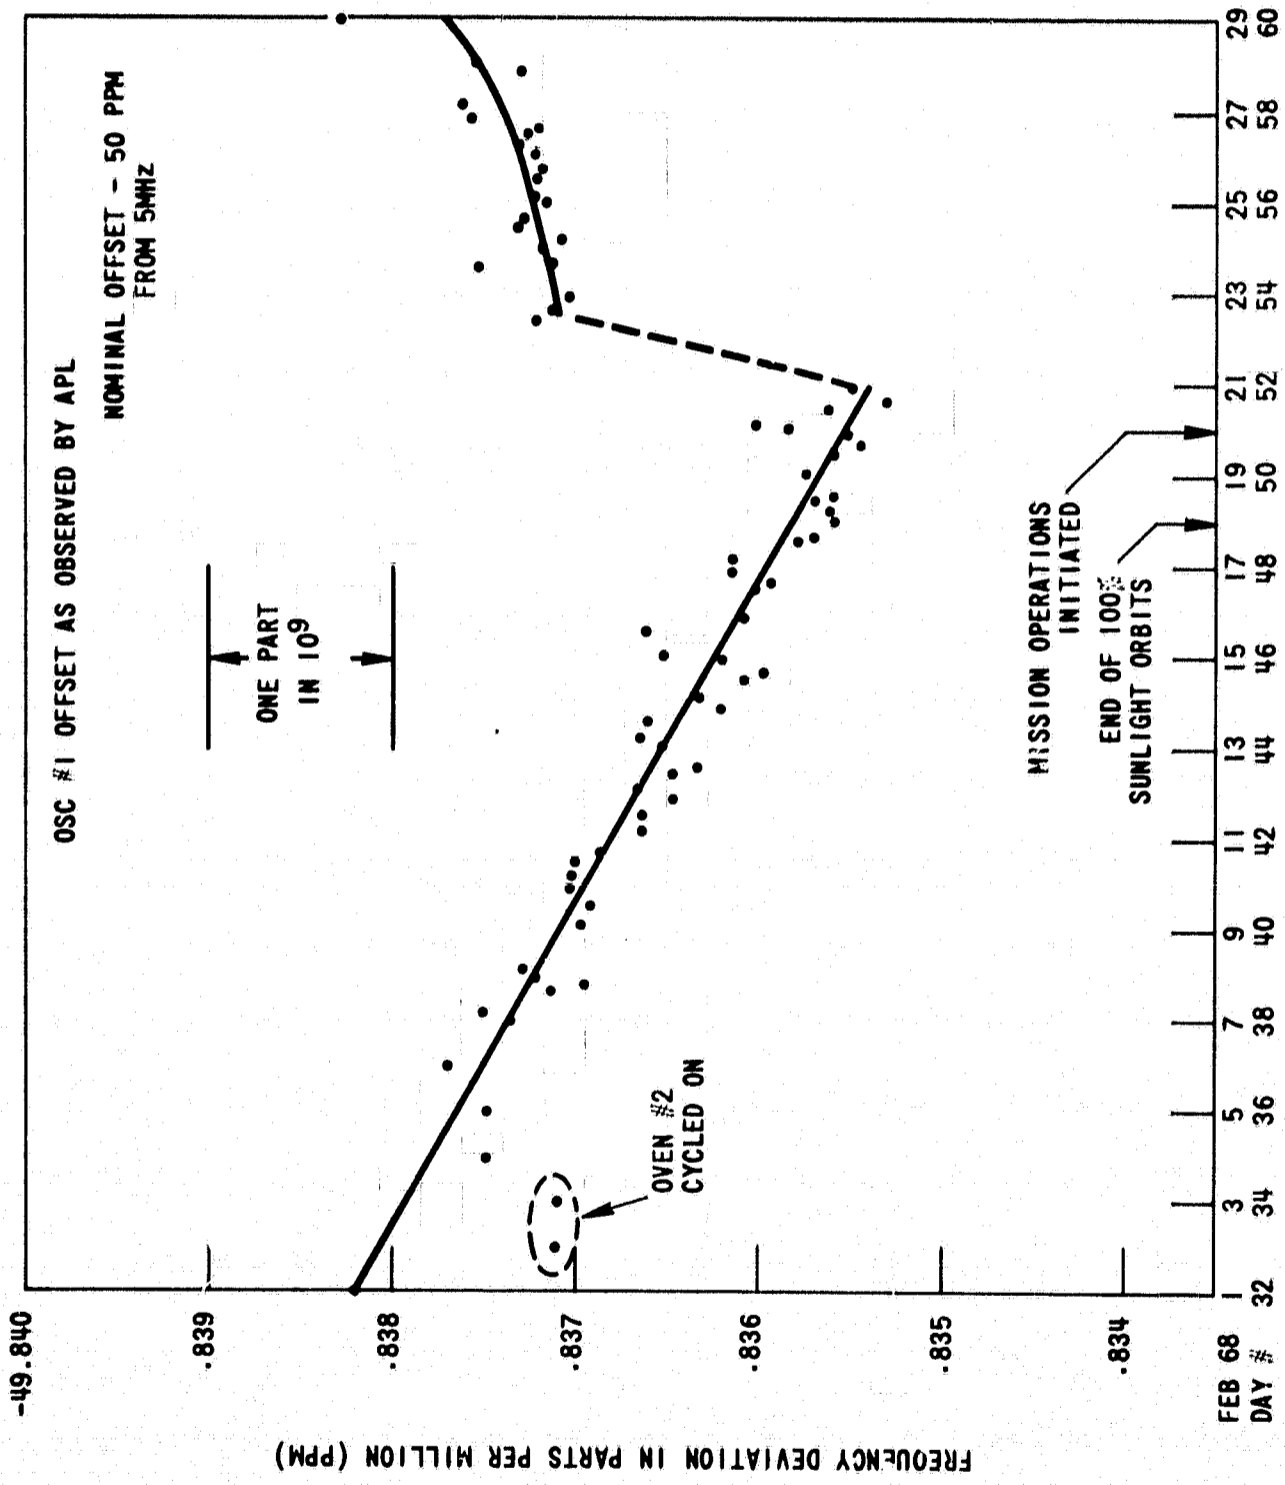
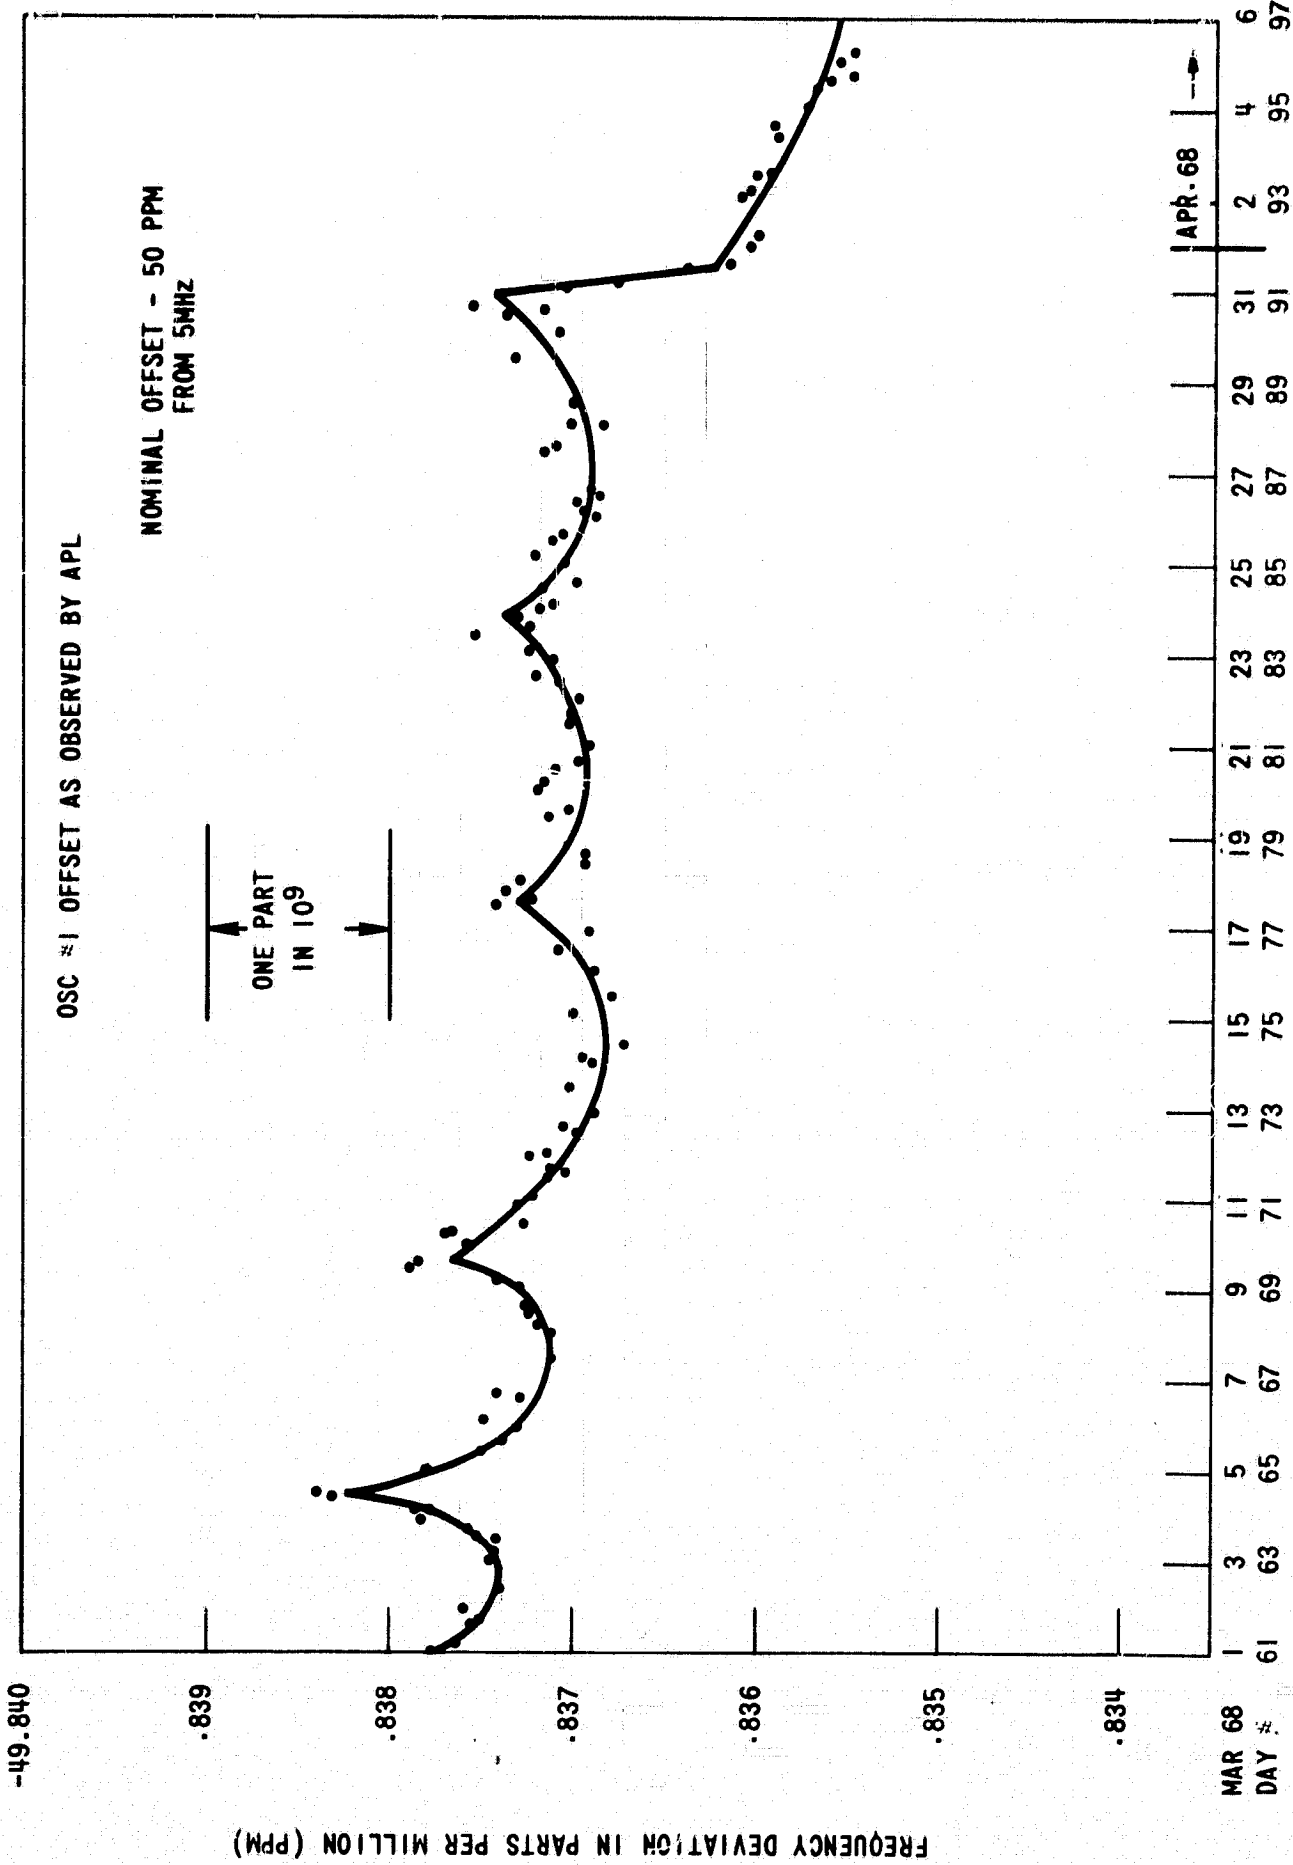
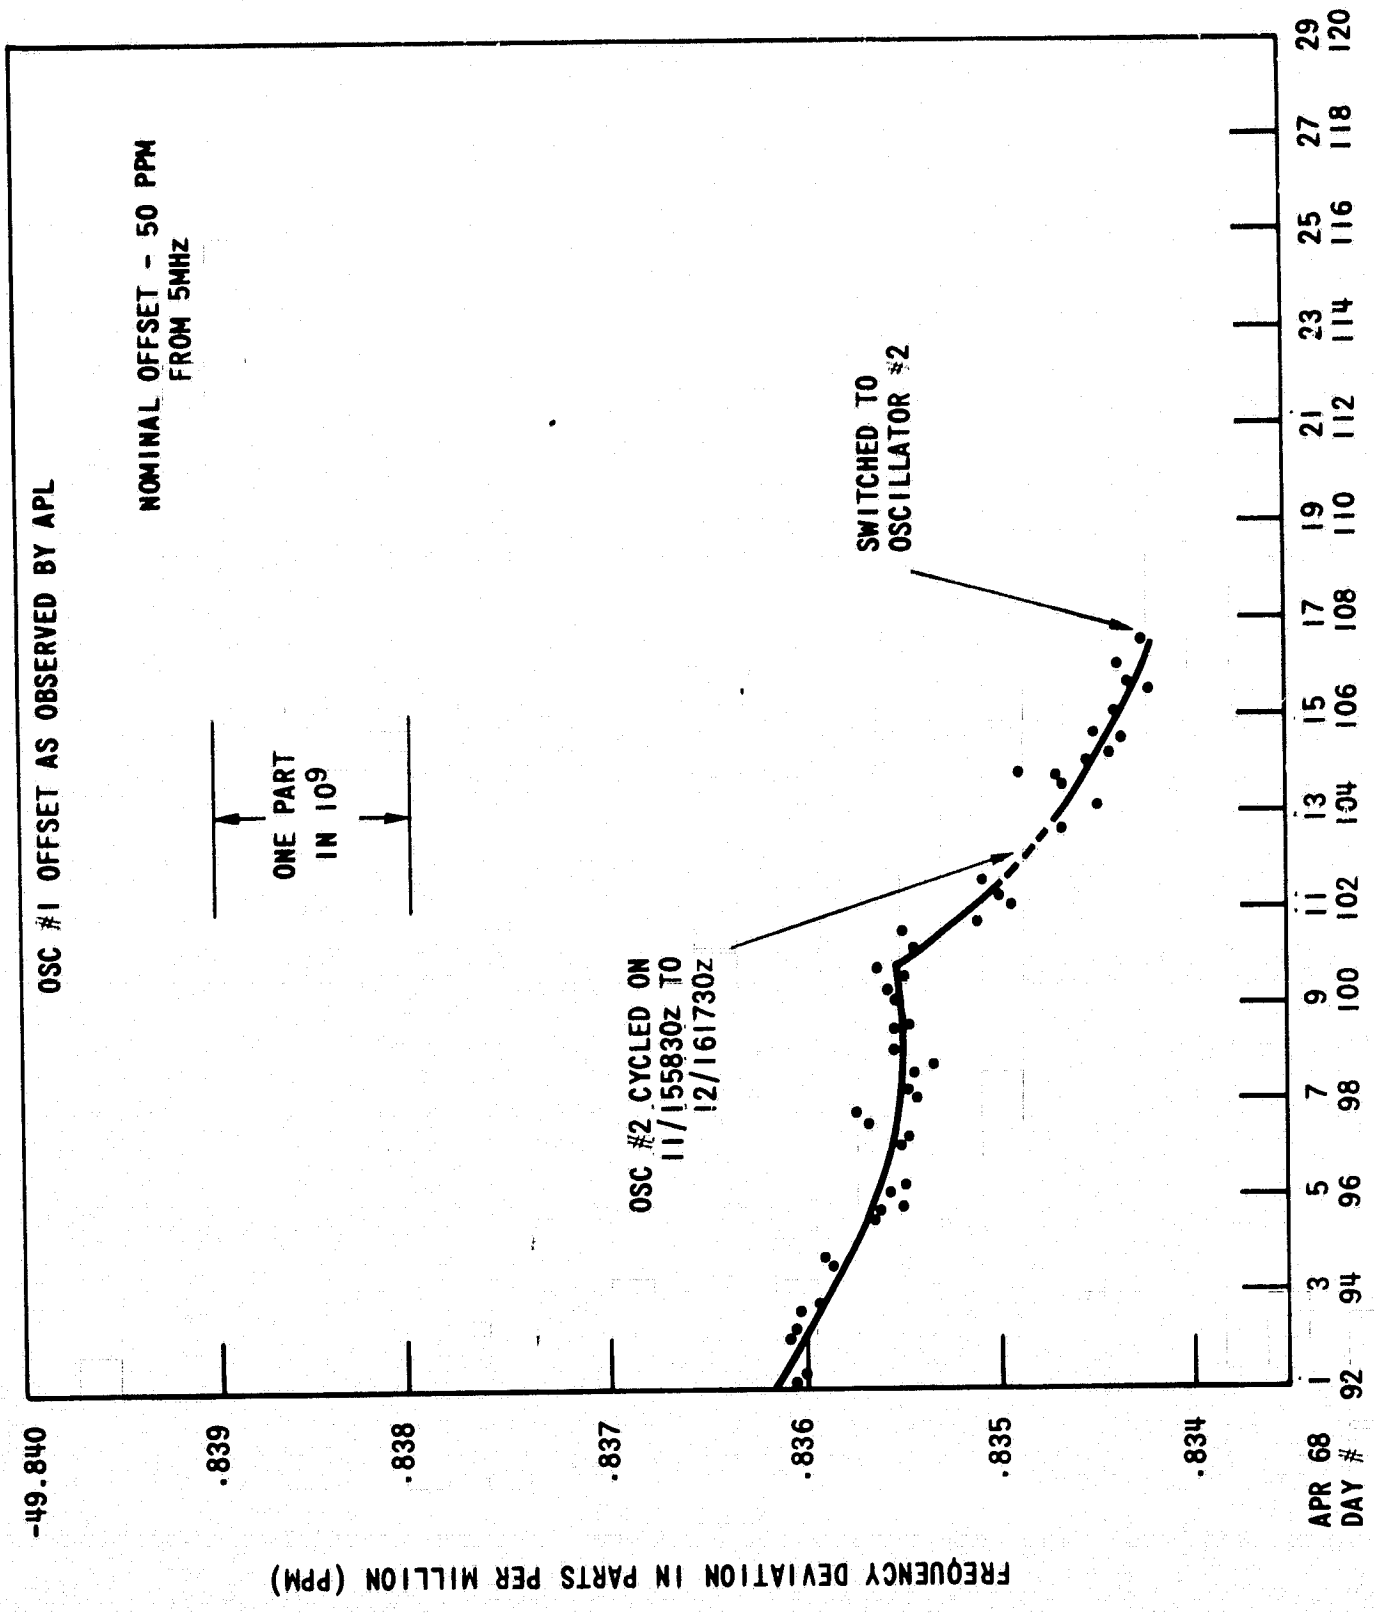
Figures 3-4 through 3-7 are plots of the 5-MHz oscillator number one frequency deviation from launch through 16 April 1968, the day this oscillator was switched out of operation. The data were obtained from reports submitted to the GOCC by APL and are derived from Navy Doppler tracking data.

By 20 February 1968, the day mission operations were initiated, oscillator number one had stabilized to a drift rate of about 1.5 parts in  $10^{10}$  per day. If reasonably predictable, this drift rate would have been completely satisfactory to sustain operations. However, on 21 February 1968, the frequency changed, either instantaneously or at a very rapid rate, by approximately sixteen parts in  $10^{10}$ . As can be seen in Figures 3-4 through 3-7, its drift then became erratic and difficult to

predict. On 31 March, another frequency shift appeared with magnitude of approximately twelve parts in  $10^{10}$  within one day. On 10 April, on advice from the Technical Advisory Group it was decided to switch to oscillator number two, and on 16 April 1968, the switch was accomplished.

The cause of the frequency shifts and erratic drift of oscillator number one is unknown. The erratic behavior began about two days after the orbit of the spacecraft entered partial darkness suggesting that oscillator number one is extremely temperature sensitive, that is, sensitive to the allowable fluctuations of the oven. It is apparent that the oven was not at fault, as the same oven (number one) is being used with oscillator number two and similar behavior has not been noted.
