14. NASA STUDIES ON EFFECT OF GROOVED RUNWAY OPERATIONS ON AIRCRAFT VIBRATIONS AND TIRE WEAR

By Thomas J. Yager

NASA Langley Research Center

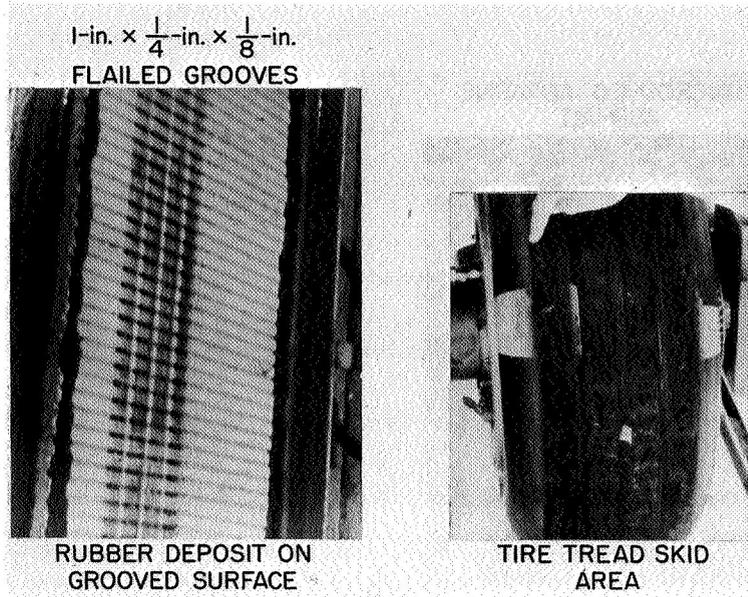
In an attempt to determine the effect of transverse pavement grooves on aircraft tire tread wear and cutting, tests with various types of aircraft tires were made at the landing-loads track. Figure 1 shows the results obtained with a 3-groove fabric-reinforced 30 × 11.5-14.5, type VIII, aircraft tire during a low-speed (4 knots) braking test run on the 1- × 1/4- × 1/8-inch transversely grooved test surface for a dry surface condition. The test tire was inflated to 210 lb/in² and the test was conducted at 0° yaw. As shown in the photographs of figure 1, tread rubber was deposited on the test surface but the tire tread did not receive any cuts or damage during this run from a free-rolling condition to a locked-wheel condition. Some tread wear, however, did occur at relatively high slip-ratio values. In contrast to the normal trend observed on smooth surface runways where the rubber deposits adhered to the surface, the tread rubber deposited in the dry surface grooves during locked-wheel braking was powdery or granular in form and could be easily brushed away.

Figure 1.- Condition of grooved surface and tire after braking test. 3-groove fabric-reinforced $30 \times 11.5-14.5$, type VIII, tire; inflation pressure, 210 lb/in^2 ; dry surface; ground speed, 4 knots; 0° yaw.

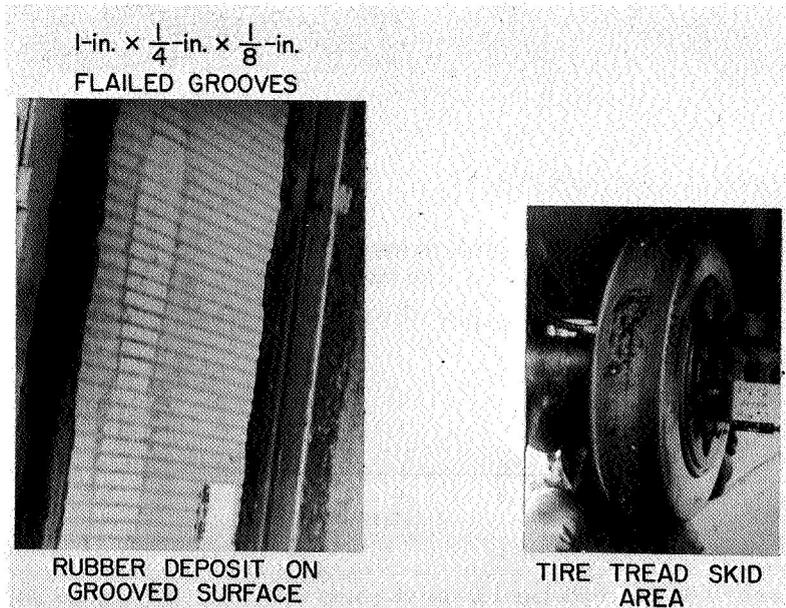
As indicated by the photographs of the tire skid area, some tire wear occurred for locked-wheel conditions on the 1- × 1/4- × 1/8-inch grooved surface, but on the ungrooved abrasive asphalt surface for the same test conditions, substantial damage to the tire tread occurred. Some of the tread cuts resulting from the braking run on the ungrooved surface were as deep as the tire cord. Considerable side force was developed by this test tire at 4° yaw during the run prior to the locked-wheel condition but no other tread wear or cutting occurred except for that shown in figures 2 and 3.

Figure 2.- Condition of grooved surface and tire after braking test. Fabric-reinforced rubber tread tire; inflation pressure, 400 lb/in^2 ; damp surface; ground speed, 4 knots; 40° yaw.

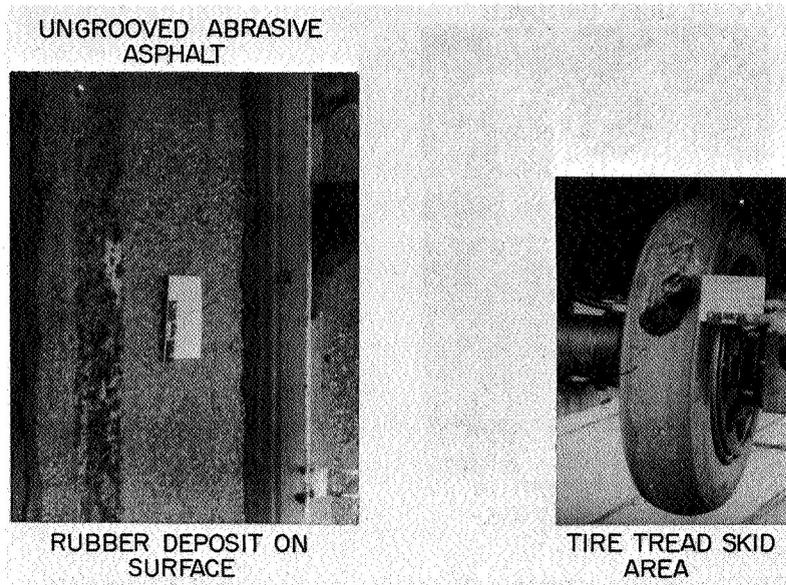
Figure 3.- Condition of ungrooved surface and tire after braking test. Fabric-reinforced rubber tread tire; inflation pressure, 400 lb/in²; damp surface; ground speed, 4 knots; 4° yaw.

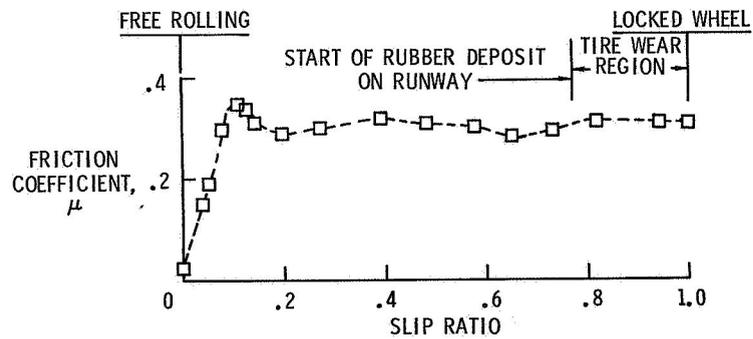
By using a new $30 \times 11.5-14.5$, type VIII, aircraft tire, a braking test run at 102 knots was made at the landing-loads track to evaluate further the effect of pavement grooves on tire tread wear. The test tire had a 3-groove fabric-reinforced rubber tread, and the variation in friction developed between the tire and the grooved pavement during braking is shown as a function of slip ratio in figure 4. The damp test surface was grooved $1 \times 3/8 \times 1/4$ inch. Figure 5 shows the 5-foot-long rubber deposit from the tread on this grooved surface and the tire tread damage area resulting from the braking run. By measuring the length of the tread damage area and by calculating the rolling circumference and angular velocity of the tire, it was determined that the surface rubber deposit was initiated at a slip ratio of about 0.8. Prior to this point in the braking cycle, no significant tread wear occurred. The tire tread wear and the chevron-type cuts shown in figure 5 occurred between slip ratios of 0.8 and 1.0. Therefore, the results of this test indicate that to minimize tire tread wear and cutting, high slip-ratio values should be avoided during aircraft ground operations.

Figure 4.- F-4D aircraft tire during braking on grooved surface. 30 × 11.5-14.5, type VIII, tire; damp concrete; ground speed, 102 knots.

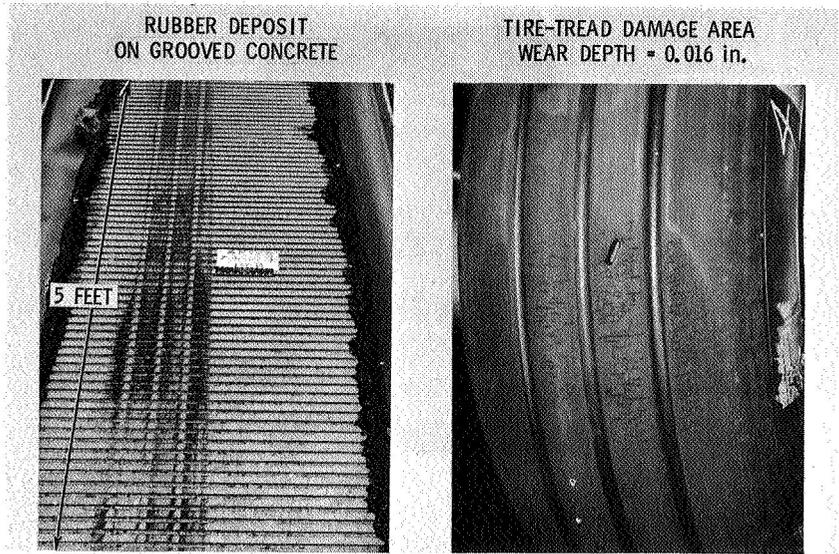
Figure 5.- Condition of test surface and tire after braking.

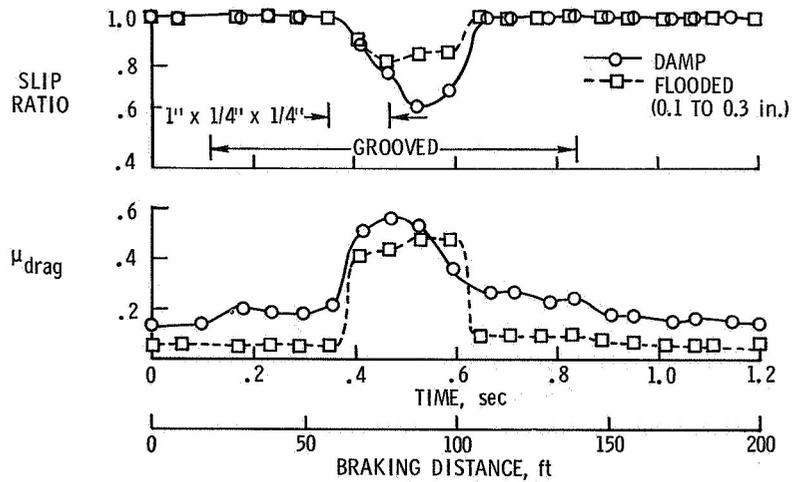
The time histories of the variation of slip ratio and drag friction coefficient μ_{drag} shown in figure 6 were obtained at a speed of 100 knots on 10 different grooved and ungrooved surfaces for damp and flooded conditions. The high friction that developed between the tire and the $1- \times 1/4- \times 1/4$ -inch grooved surface (fig. 6) exceeded the torque limitations of the brake system used on the test carriage and resulted in partial wheel spin-up as indicated by the variation in slip ratio. The other ungrooved and grooved test surfaces, which were flaired-type grooves of $1/8$ -inch depth, did not develop sufficient friction to overcome the brake torque limitation. The slip-ratio value of 1.0 indicates that the wheel remained locked on the other test surfaces for damp and flooded conditions.

Figure 6.- Comparison of locked-wheel braking on various test surfaces. Smooth 49 x 17, type VII, tire; inflation pressure, 170 lb/in²; ground speed, 100 knots; yaw angle, 4°.

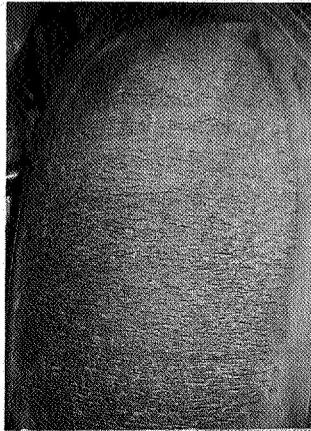
The condition of the tire tread as a result of the locked-wheel runs is shown in figure 7. The numerous, small chevron-type cuts in the all rubber tread of the smooth 49×17 , type VII, test tire did not exceed 0.06 inch in depth. In subsequent test runs with this tire, the results indicated that these chevron-type cuts did not significantly impair the tire tread life.

Figure 7.- Condition of tire tread after locked-wheel runs.

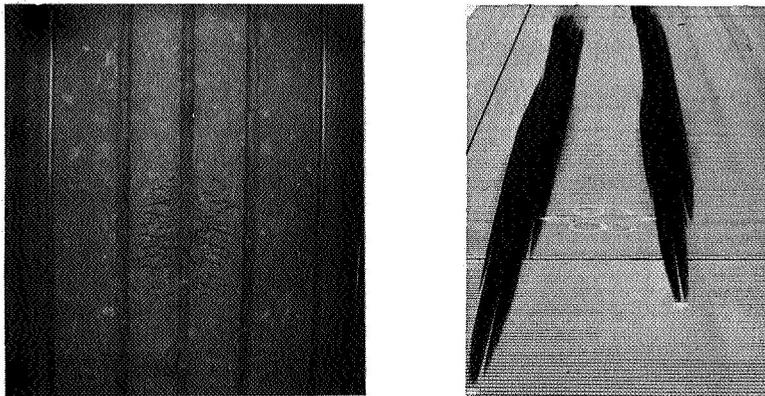
These chevron-type cuts in the tire tread were also observed during the tests of the 990 aircraft on the landing research runway. Figure 8 shows the condition of the tire and surface after a firm touchdown of the 990 aircraft on dry grooved concrete. The aircraft was equipped with new 5-groove all rubber tread main tires. Although only the right

main gear touchdown area is shown here, the left main gear touchdown area showed similar rubber deposits and all eight main gear tires had similar tread cut areas. In analyzing these results, the width of the rubber deposit on the runway at the point of initial touchdown equaled the width of the tread cut area on the main tires. Since the tires did not have any other cutting around the tread and the rubber deposit on the runway is shown to increase in width, it would indicate that the chevron-type cuts shown in figure 8 occurred only at initial touchdown when the tire was stationary. As soon as wheel spin-up started, the tire tread had no further cutting.

Figure 8.- Condition of grooved surface and tire tread after firm touchdown of 990 aircraft.
Dry concrete; inflation pressure, 160 lb/in².

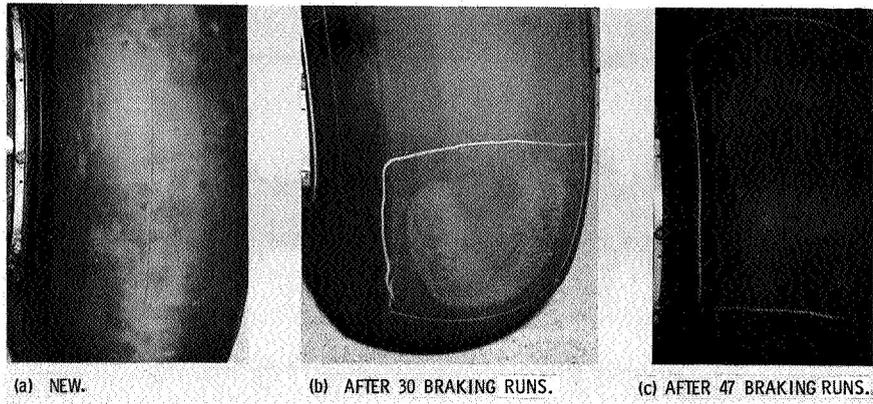
During the maximum antiskid braking tests of the F-4D aircraft, some tire tread wear was experienced but no chevron-type cutting was observed. However, no prolonged wheel lockups occurred during the braking tests of the F-4D, and the main tires of the F-4D had a 3-groove fabric-reinforced rubber tread. During the maximum braking tests of the 990 aircraft on wet and flooded surfaces, prolonged wheel lockups occurred on the ungrooved surfaces particularly with the smooth all rubber tread main tires. Because of the normal test run procedure of applying maximum antiskid braking through adjacent ungrooved and grooved tests surfaces, chevron-type cuts developed on the tire tread when the tire encountered the grooved surface at locked-wheel conditions. Some of the smooth tire tread cuts are shown in figure 9. No further cutting occurred during maximum braking test runs from a grooved to an adjacent ungrooved surface. Approximately 50 maximum antiskid braking test runs were made with the chevron cuts in the tire tread. Again the maximum measured depth of these cuts did not exceed 0.06 inch. As a result of further braking tests, these cuts increased in number but did not increase in depth.

Figure 9.- Effect of braking tests on smooth main tire tread of 990 aircraft. 41 × 15.0-18, type VIII, main tires; inflation pressure, 160 lb/in².

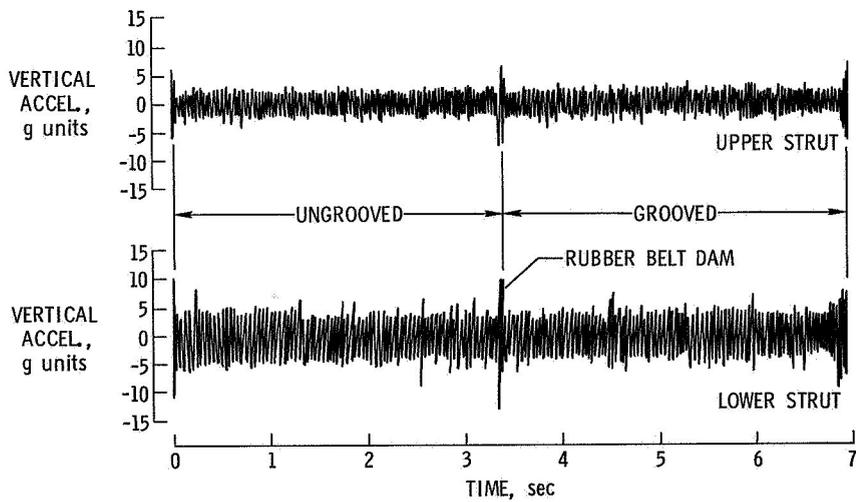
The upper and lower strut accelerometer traces shown in figure 10 were obtained for free-rolling conditions on dry ungrooved and grooved concrete. These data show that the magnitude of the lower strut vibration is greater than that measured at the upper strut on both test surfaces. As the aircraft ground speed increased from 61.5 to 96.0 knots (fig. 11), the amplitude of the strut vibrations also increased. No change in amplitude could be observed when results obtained on grooved and ungrooved surfaces at the same speed were compared. When the time scales of figures 10 and 11 were expanded, no significant difference was measured in the frequency of the lower strut vibration on the dry grooved surface as compared with the dry ungrooved surface at both test speeds.

Figure 10.- Free-rolling vibrations from main strut of F-4D aircraft. Dry concrete; ground speed, 61.5 knots.

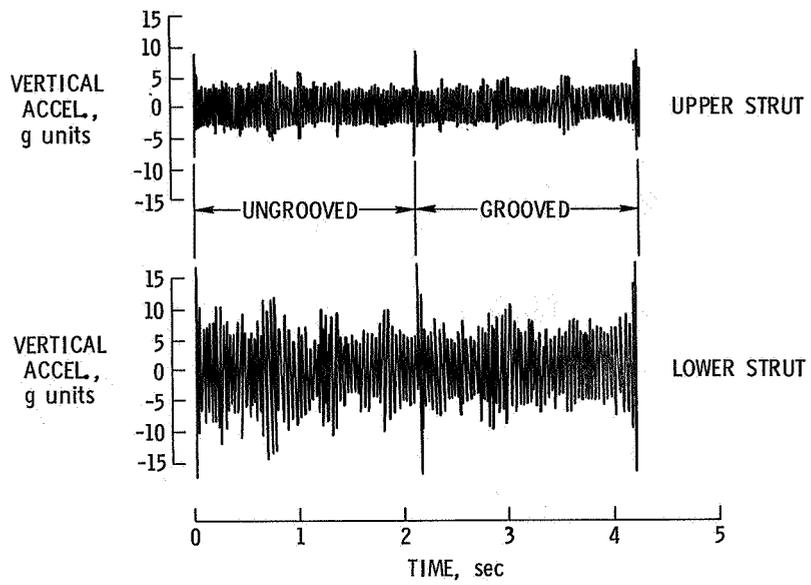
Figure 11.- Free-rolling vibrations from main strut of F-4D aircraft. Dry concrete; ground speed, 96.0 knots.

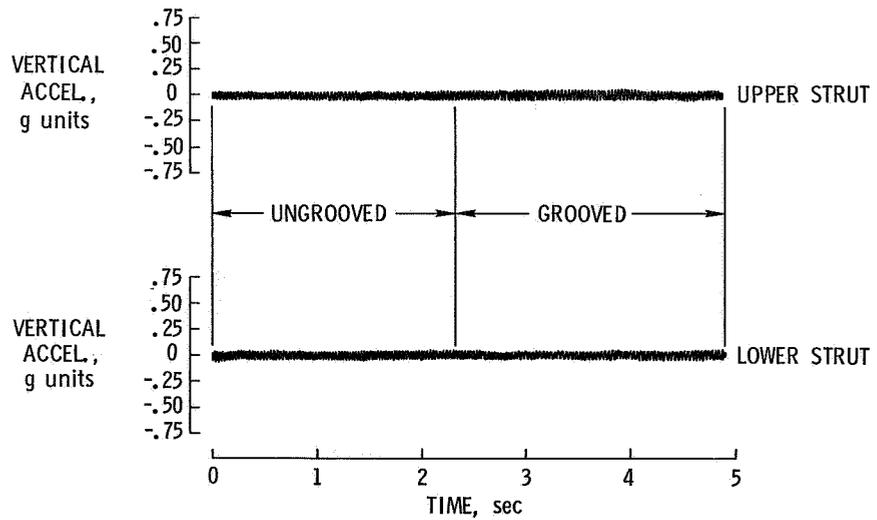
Strut accelerometer data similar to the data for the F-4D aircraft were obtained at speeds of 83 knots and 123 knots during the tests of the 990 aircraft on grooved and ungrooved surfaces as shown by the examples in figures 12 and 13. The magnitude of the strut vibrations for the 990 aircraft on dry grooved and ungrooved asphalt at both test speeds is less than that shown for the F-4D aircraft in figures 10 and 11. As in the case of the vibration data of the F-4D aircraft, no significant difference was measured in the frequency or amplitude of the lower strut vibration of the 990 aircraft on the dry grooved surface as compared with the dry ungrooved surface at both test speeds. On the basis of these test results, it is believed that grooved runways do not significantly alter aircraft vibration.

Figure 12.- Free-rolling vibrations from main strut of 990 aircraft. Dry asphalt; ground speed, 83 knots.

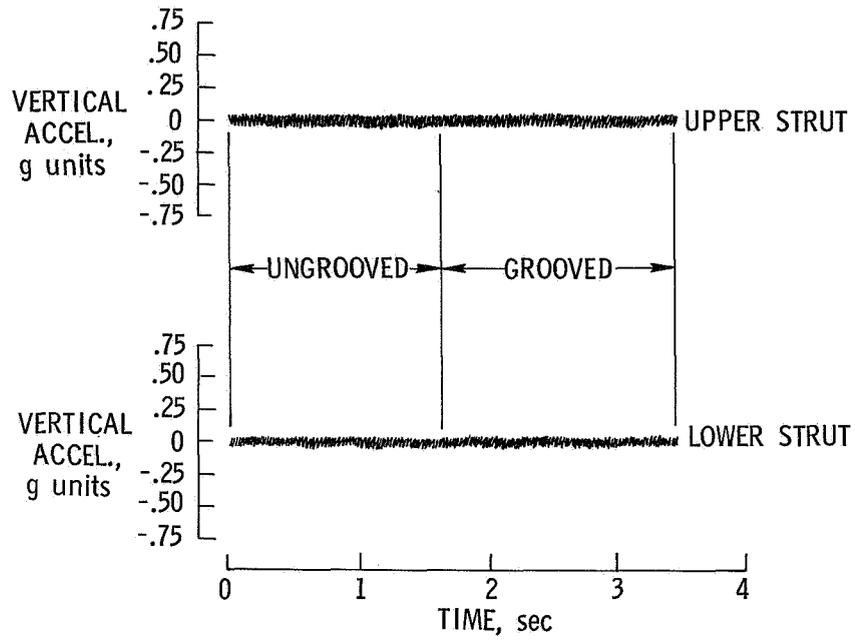
Figure 13.- Free-rolling vibrations from main strut of 990 aircraft. Dry asphalt; ground speed, 123 knots.
