15. A SURVEY OF THE EFFECT OF GROOVED RUNWAY OPERATIONS ON THE WEAR OF COMMERCIAL AIRLINE TIRES

By James M. Petersen

Thompson Aircraft Tire Corporation

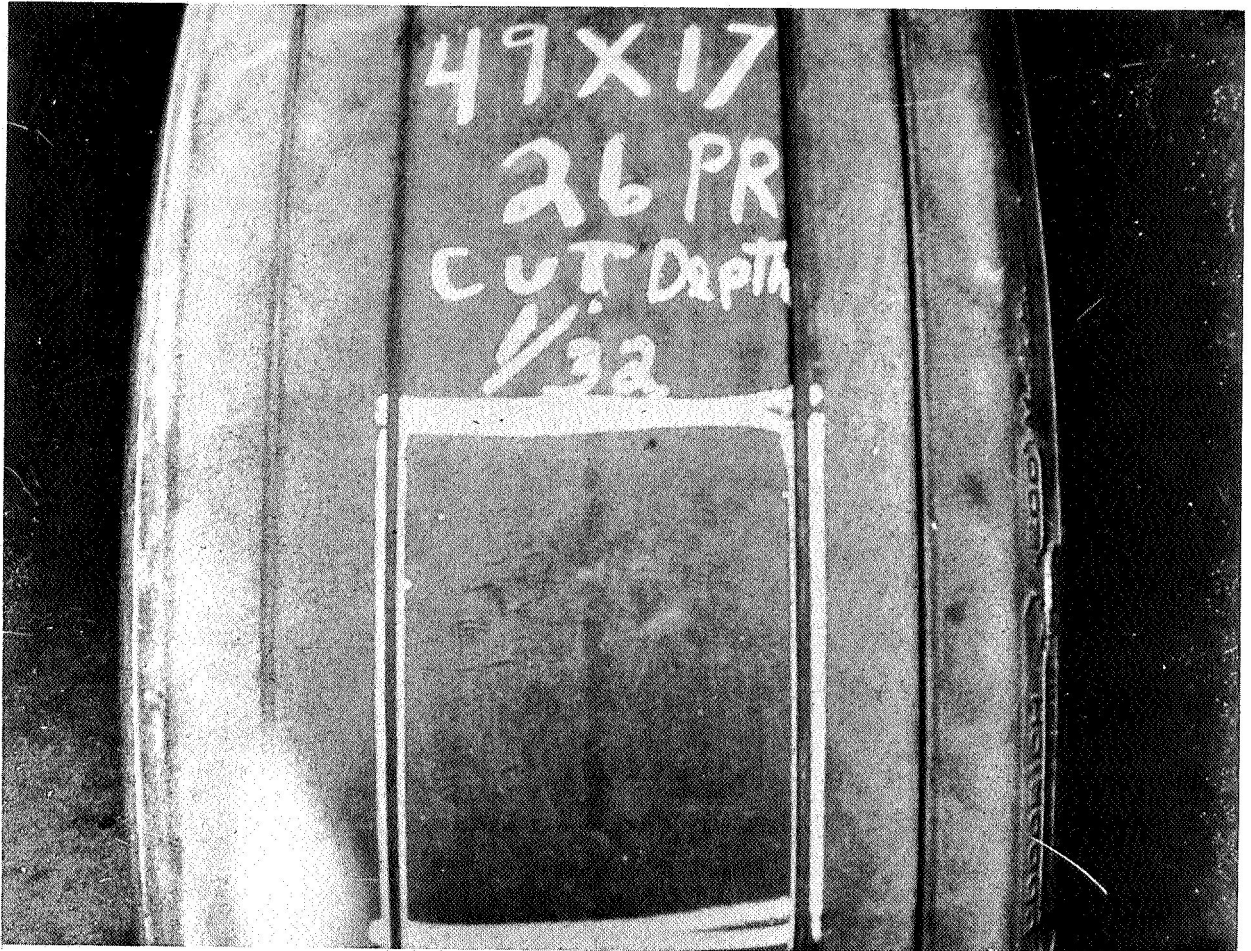
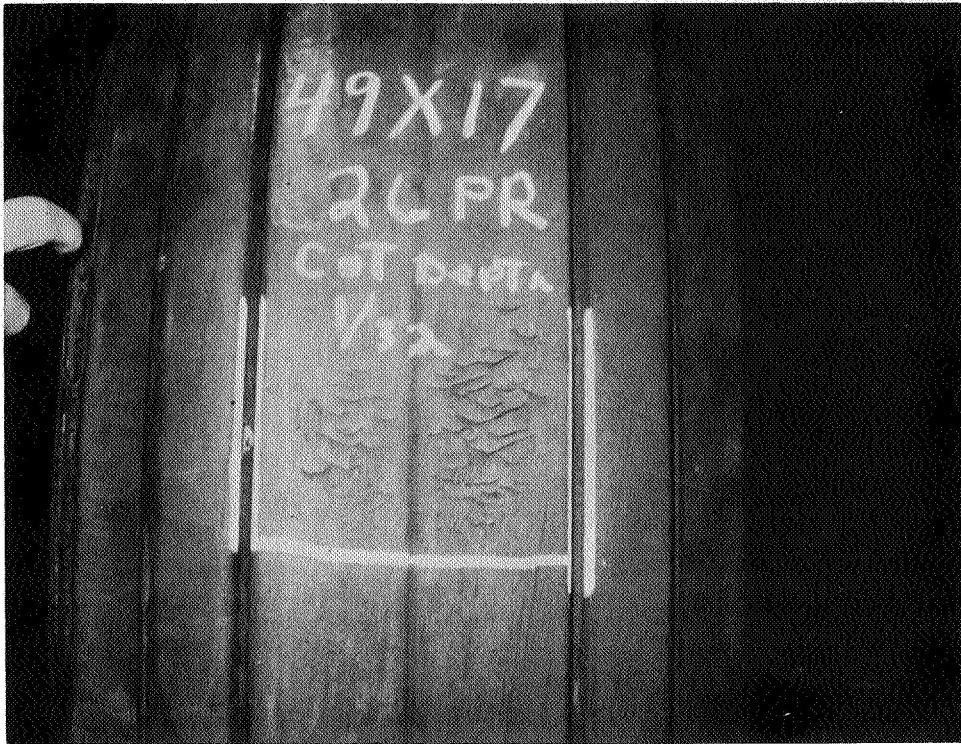
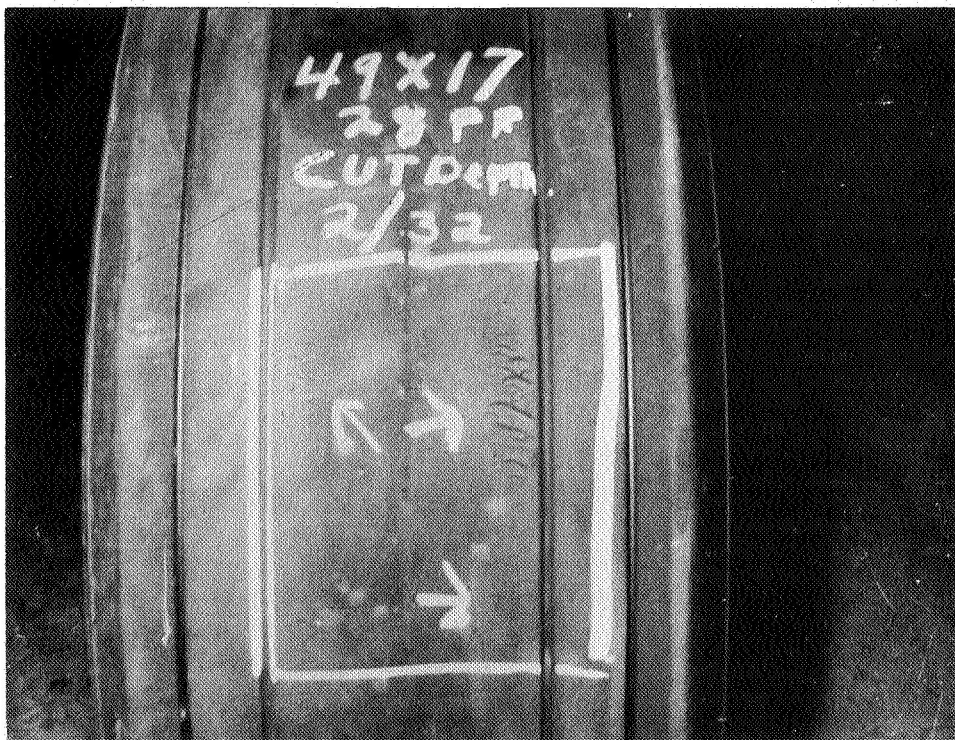
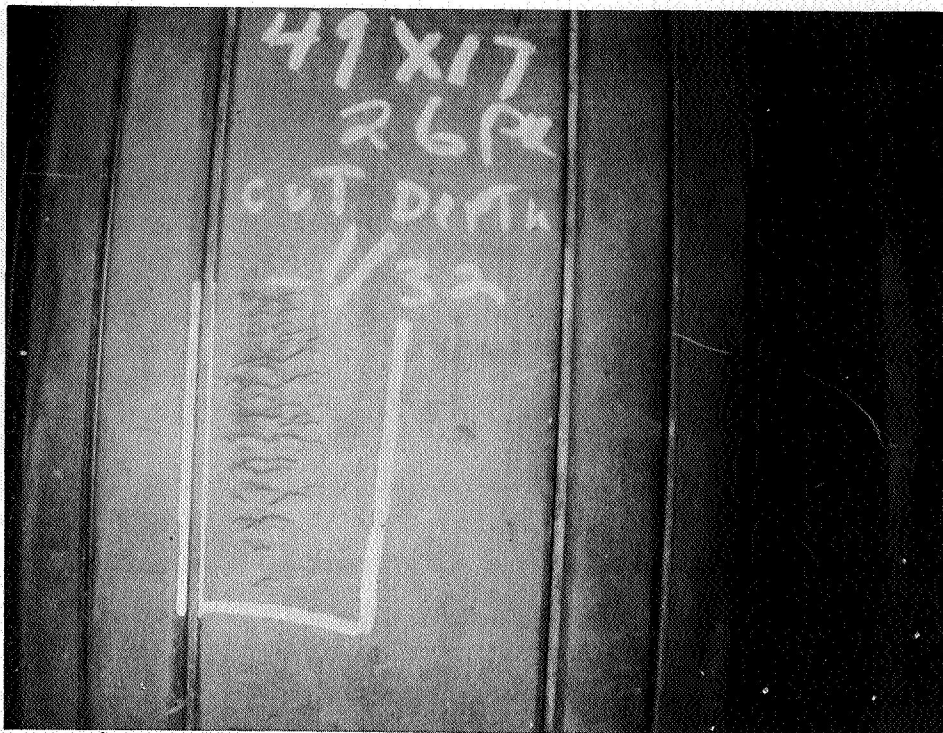
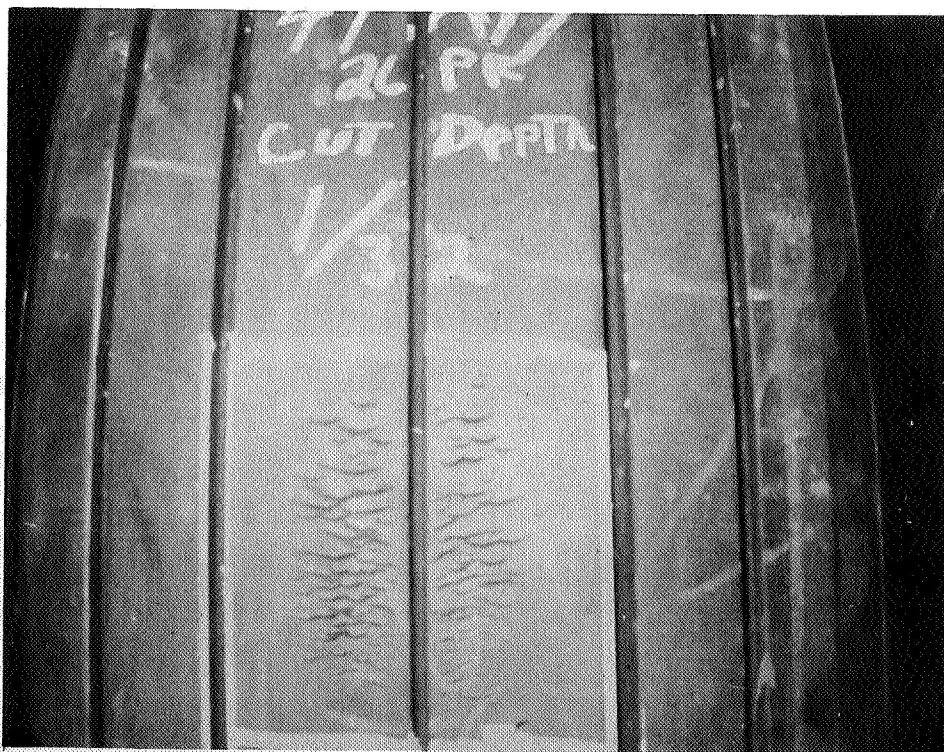
Figure 1.- 49 × 17/26 ply rating tire.

Photographs of 49 × 17 commercial aircraft tires showing examples of chevron cutting are presented as figure 1. This type of cutting is rather superficial and was not the cause of tire removal. Since the tires have been observed for indication of grooved runway effects other than the chevron cuts, no other common wear characteristic has been noted. As can be seen in the photographs, the chevron cuts in some tires appear to have been worn away by normal operations. From the observations the commercial
