## 18. PAVEMENT GROOVING AT JOHN F. KENNEDY INTERNATIONAL AIRPORT

By I. J. Dornfeld and James P. Muldoon

Port of New York Authority

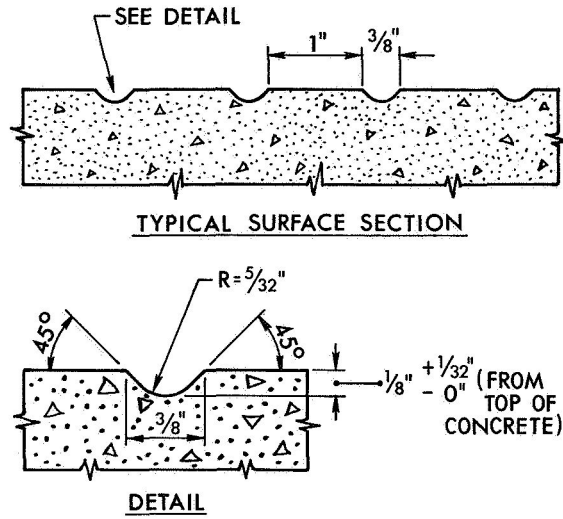
rectangular groove in withstanding spalling caused by the freezing of entrapped water, since its shape would permit the expanding ice to move up and out of the groove rather than bear against the sides. The tests, while not extensive, did confirm the superiority of the V-groove in this respect. It was also believed that the V-groove would offer greater resistance to spalling or raveling during construction, as well as in an operating environment, by virtue of its lack of right-angled edges. The V- or sinusoidal-shaped groove illustrated in figure 3 was therefore chosen.

Figure 3.- Cross section of runway grooves.
