19. REPORT ON GROOVED RUNWAY EXPERIENCE AT
WASHINGTON NATIONAL AIRPORT

By R. C. McGuire

Federal Aviation Administration

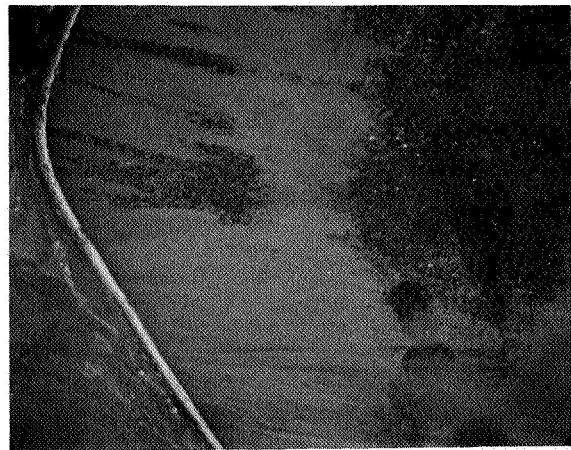
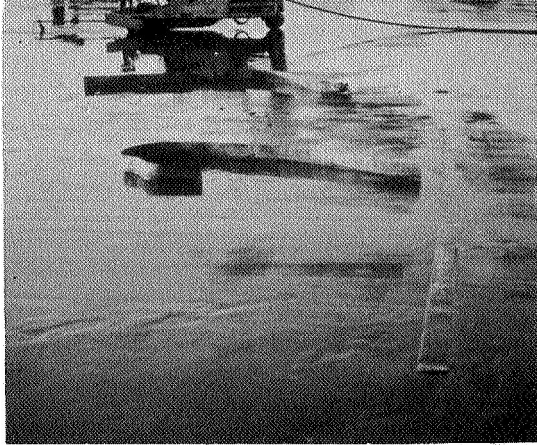
The postgrooving "dust" problem was first detected on this job as a "visibility" problem by landing aircraft. The need for daily thorough removal of postgrooving slurry of pavement grit and water (figs. 8 and 9) thus became apparent and was made known to other airport managers who were considering grooving.

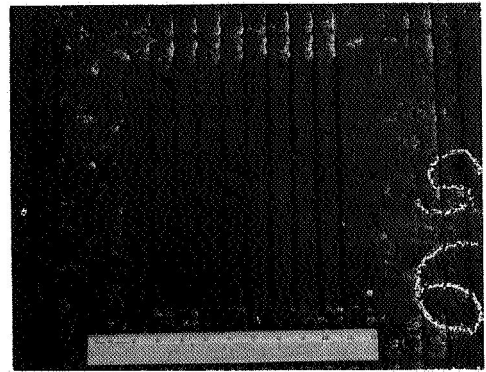
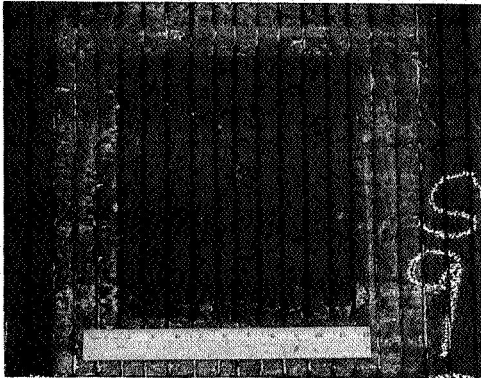
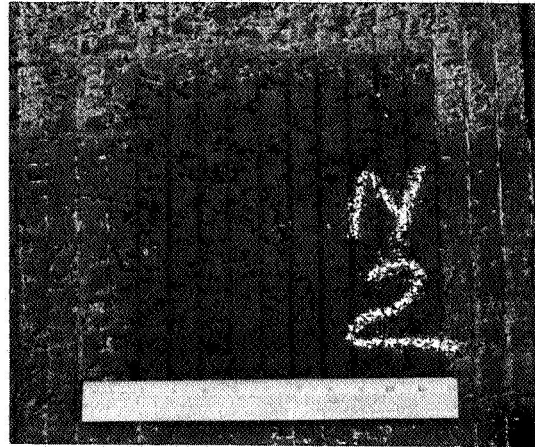
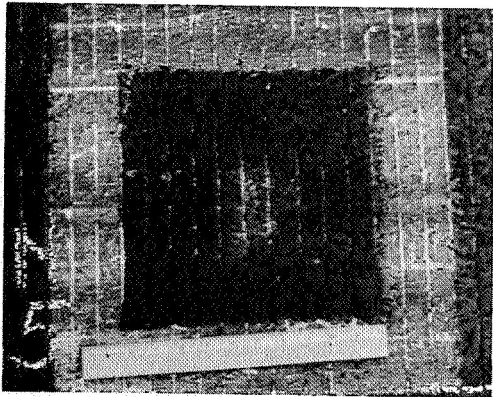
To evaluate the endurance of the grooves, engineering "control" points were established in the touchdown areas to assess wear and tear. (See figs. 10 and 11.) These control points were photographed when the runway was grooved, and were again photographed recently after more than 400 000 operations. Several of these photographs are shown as figures 12 to 15.

No serious deterioration of the grooves was noted after 18 months of use, nor had the grooves collapsed due to summer heat or become filled with touchdown rubber. They were not damaged by snowplows, nor had they packed with antiskid sand. The surface was scarred by airport maintenance equipment on occasion (figs. 16 and 17) and experienced some "pop-outs" (fig. 18). However, the most noticeable recent change has been a

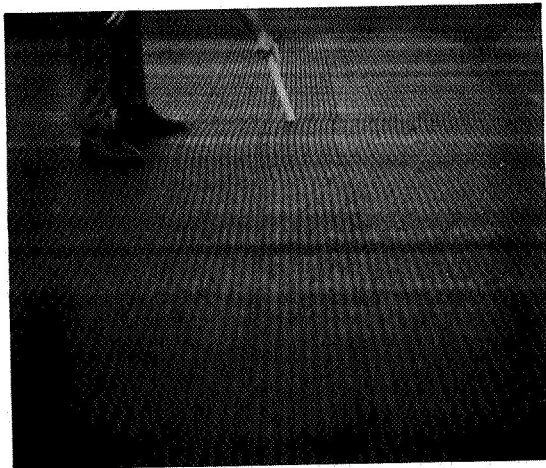
Figure 19

shift of a portion of the surface in the touchdown area of runway 36 (fig. 19). This shift seems to be related to the pavement construction and further study is planned.

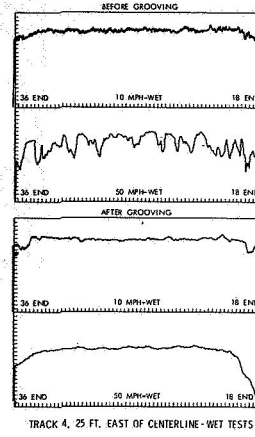
Figure 22

The resulting data showed that the grooves removed the great variation in the wet traction of the ungrooved runway. In essence, it equalized the wet friction characteristics of the entire runway by removing the "spikes" in the data (fig. 22). These spikes are the effect of rubber deposits, smoothly worn surfaces, and contaminants on the wet friction characteristics of an ungrooved runway.

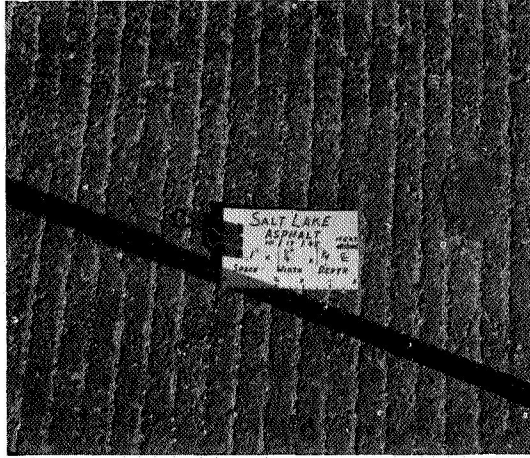
Figure 25

All test beds have experienced at least four seasons. The groove patterns in the concrete taxiways have stood up well. Those in the asphalt taxiways have not been as successful, particularly those in Las Vegas, Salt Lake City, and Miami, because of the effect of high ambient temperature and of traffic on plastic flow and displacement of the stone chips in the wheel track areas. Although the individual reports on each test site have not yet been summarized, the following specific comment by the engineering observers of the Salt Lake City and Las Vegas tests are of interest (fig. 25):

In all cases, 1/4" deep grooves (in asphalt) are structurally poorer than 1/8" deep grooves. At Salt Lake the 1/8" deep grooves were cut into the stone chips . . . the 1/4" deep grooves penetrated the bituminous course which is more plastic . . . From these observations, the 1/4" x 1/4" x 1" grooves (seem to) have less structural stability than the same pattern only 1/8" deep. 3/8" grooves would remain open longer . . . Grooves spaced 2" apart, 3/8" wide, 1/8" deep had the least deformation . . . All grooves 1/8" deep withstood deformation better than any 1/4" deep.

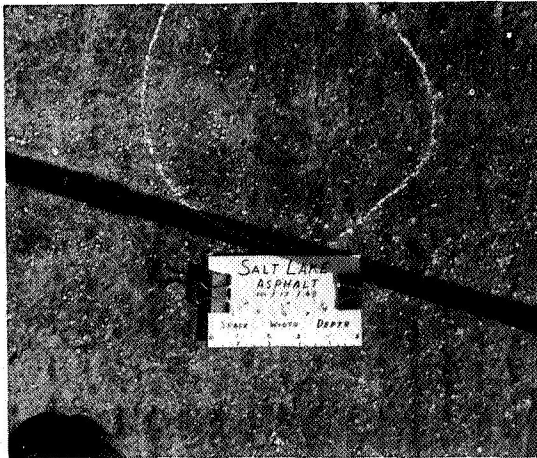
Figure 26

Another problem experienced to date is that the application of a seal coat to a grooved surface will fill up the grooves, as shown in figure 26.

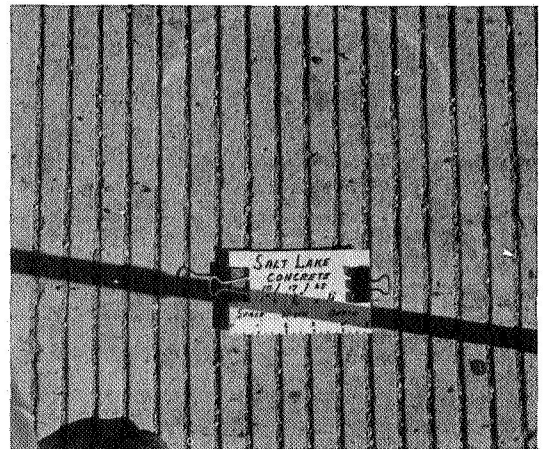
Figure 27

3. The surface structure of an asphalt runway should be considered when evaluating the potential effect of grooves on pavement endurance.
4. Grooves in portland cement runways appear to have greater endurance and resistance to environmental effects than those in asphaltic concrete runways.
5. Wider (3/8") grooves tend to accumulate debris – as shown in figure 27.
