25. PAVEMENT GROOVING ON HIGHWAYS

By Eugene E. Farnsworth

California Division of Highways

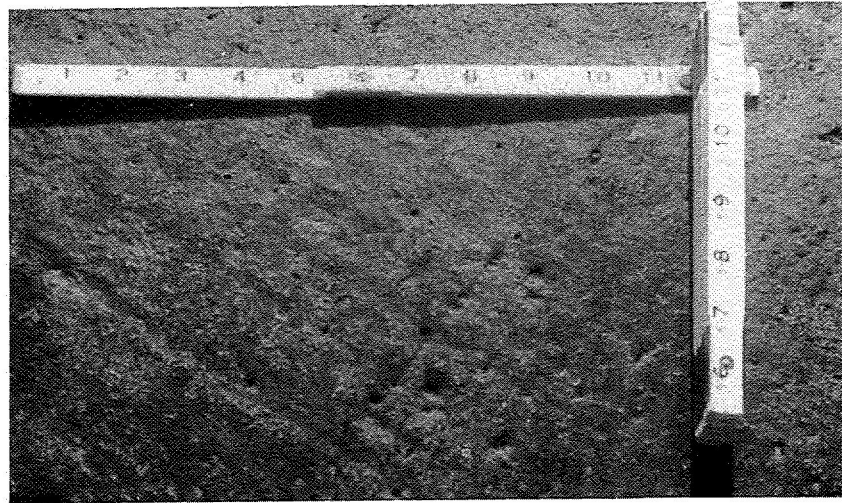
Portland cement concrete before grooving, 1959

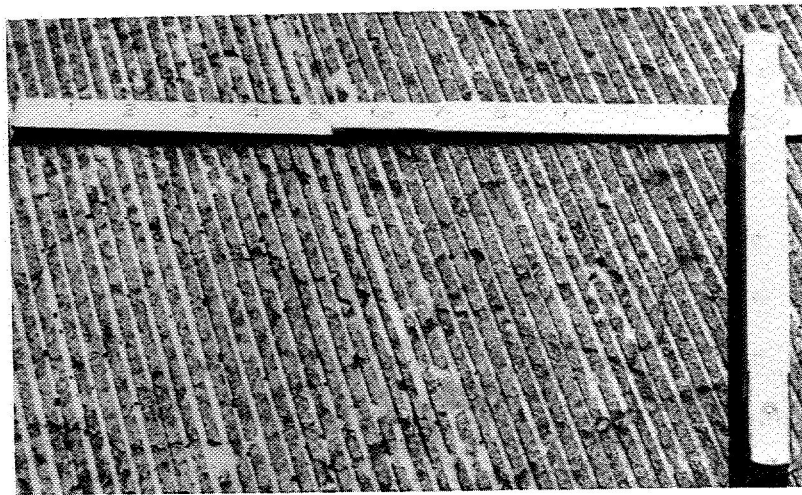
After grooving, 1960

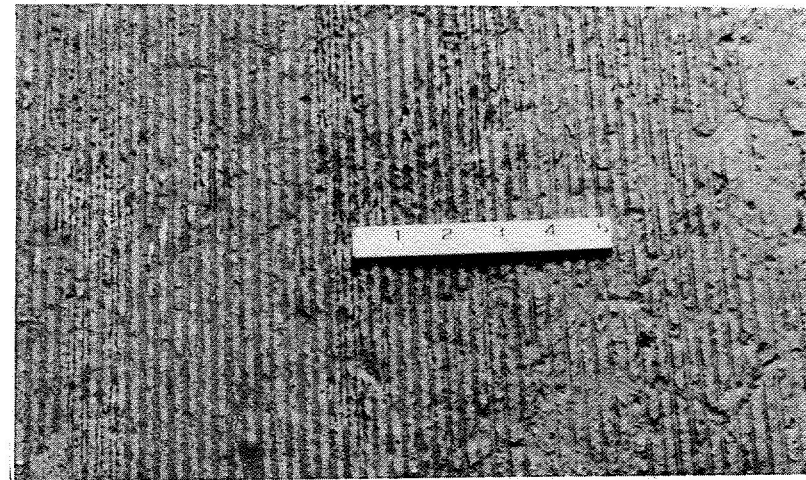
Figure 1.- Grooving Project A, U.S. 99 at Turlock O.H., 1/8-inch by 1/8-inch grooves on 3/8-inch centers.

The oldest grooving in California (project A) was placed in 1960. The pattern was 1/8 inch by 1/8 inch on 3/8-inch centers. After 8 years of heavy traffic wear there is very little deterioration of the grooves (fig. 1). Figure 2 illustrates the change in friction values of portland cement concrete (PCC) pavement after grooving of various projects in California. At project A the coefficient of friction is increasing with age. The friction values shown are for the California tester, 0.25 being the critical value for remedial action.

After grooving, 1968

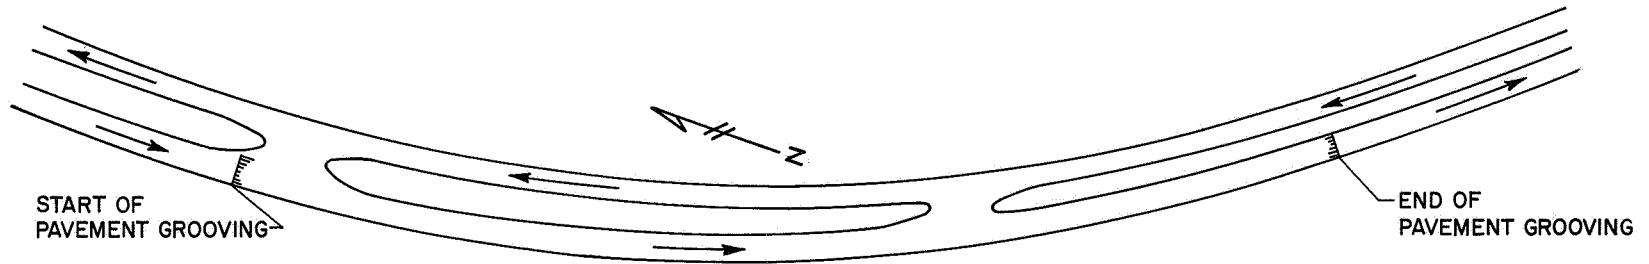
Figure 3.- Highway I-5, 50 miles north of Los Angeles.

Figure 3 shows the results of grooving on I-5, 50 miles north of Los Angeles. This grooving, 1/8 inch by 1/8 inch on 1/2-inch centers, was completed in 1963. ADT in this area is 17 000. Cost of the work was \$2,500. There were nine wet-pavement accidents during the 2 years before the grooving and none during the 5 years after the grooving.

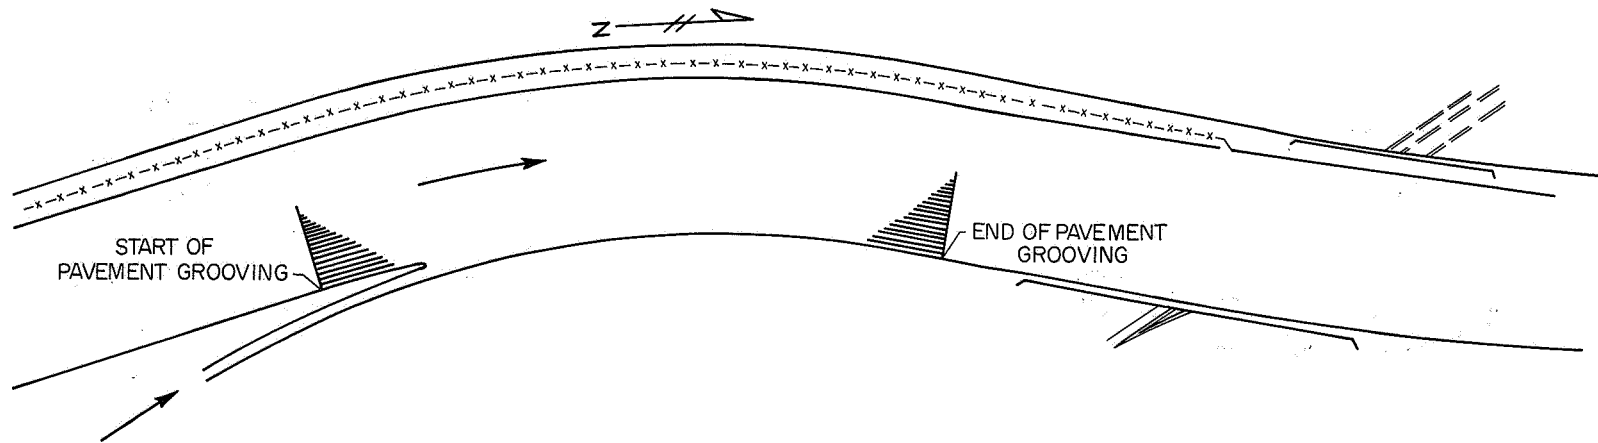
Figure 4.- Highway I-5, near El Toro Marine Base.

Figure 4 shows the results of grooving on I-5 at Laguna Canyon Road just off the west end of the El Toro Marine Base runway. The grooving was completed in 1966, using a pattern of 1/8 inch by 1/8 inch on 1/2-inch centers. The ADT in this area is 45 000. The radius of curvature is 2000 feet. Before grooving, friction tests averaged 0.25 with a low of 0.17; after grooving, friction tests averaged 0.30 with a low of 0.27. Accident data at this location are as follows:

1963	No wet accidents
1964	8 wet accidents
1965	47 wet accidents
1966	1 wet accident
1967	1 wet accident

This study illustrates how rapidly the wet-pavement accident problem can develop.

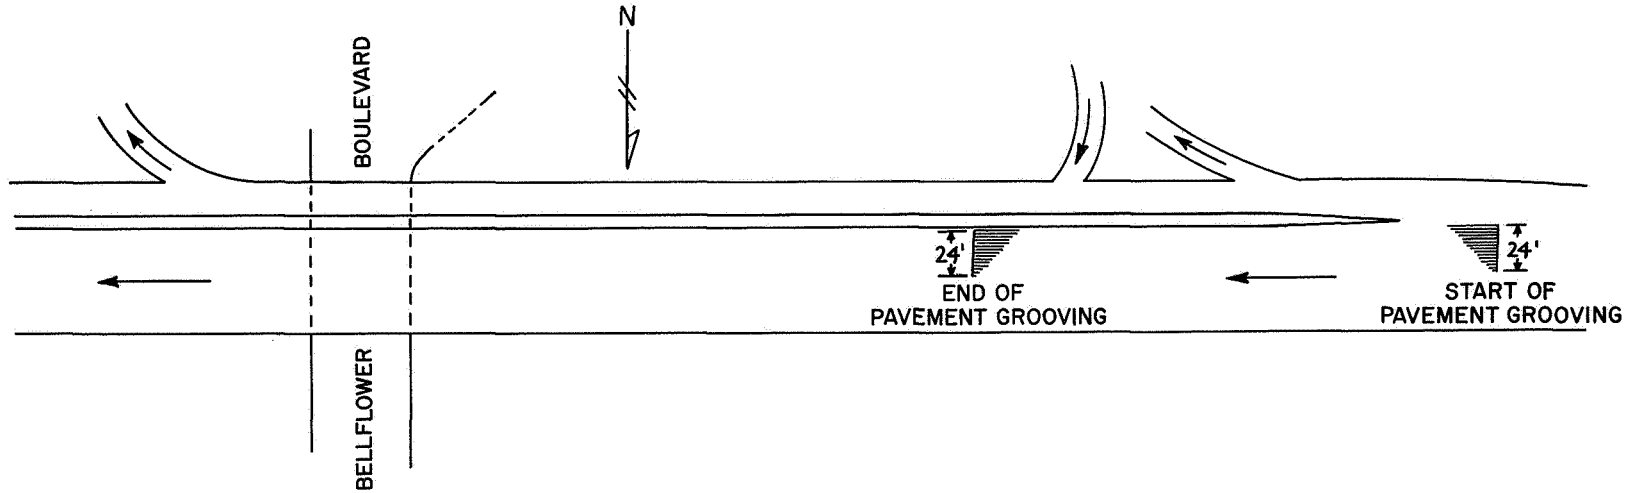
Figure 5.- Highway I-405 (San Diego Freeway), Long Beach at Bellflower Boulevard.

Figure 5 shows the before-and-after accident diagram for grooving of 1/8 inch by 1/8 inch on 1-inch centers on I-405 near Bellflower Boulevard in the City of Long Beach. The grooving was done in 1966 and the ADT here is 131 000. Before grooving, friction tests averaged 0.20 with a low of 0.14; after grooving, friction tests averaged 0.24 with a low of 0.17. One and one-half years after, friction tests averaged 0.20 with a low of 0.14. There were 20 wet-pavement accidents during the year before grooving and none for the next 2 years from the grooved section. This is a tangent section of roadway and the skidding started at the sag point where the vehicles started to accelerate as they approached the Bellflower Boulevard overcrossing.

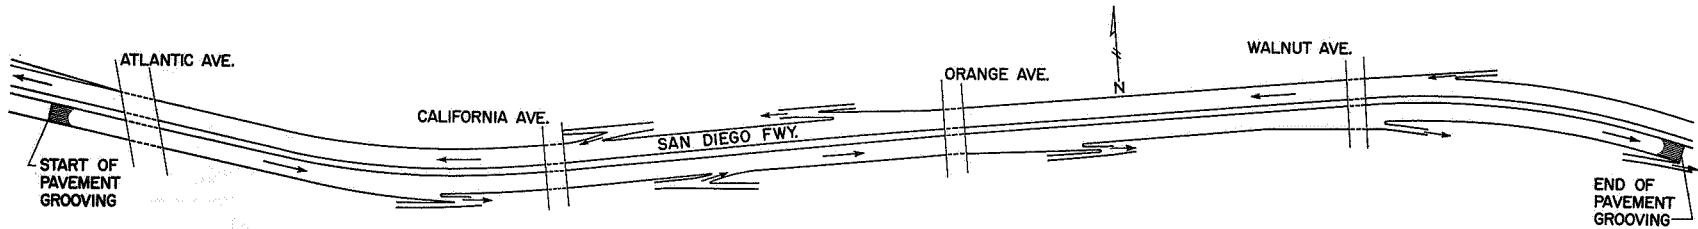
Figure 6.- Highway I-405, Long Beach.

A broader approach to pavement grooving is shown in figure 6, where 1 mile of the southbound I-405, also in Long Beach, was grooved. There were two curves in the mile, one with a radius of 2800 feet and 4 percent superelevation and the other with a radius of 2500 feet and 6 percent superelevation. The ADT at this location is 148 000. The grooving, 1/8 inch by 1/8 inch on 3/4-inch centers, was done in 1966 at a cost of \$25 000 for four lanes of freeway. Before grooving, friction tests varied from 0.12 in the right lane to 0.38 in the median lane; after grooving, friction tests varied from 0.26 to 0.44, respectively. There were 61 wet-pavement accidents during the year before grooving (60 percent occurring in the two median lanes) and three in the year following the grooving. A comparative study of accidents was made on the northbound freeway lanes, where there were seven wet-pavement accidents in the year before and five the year after grooving. There was no significant change in the number of dry-weather accidents.

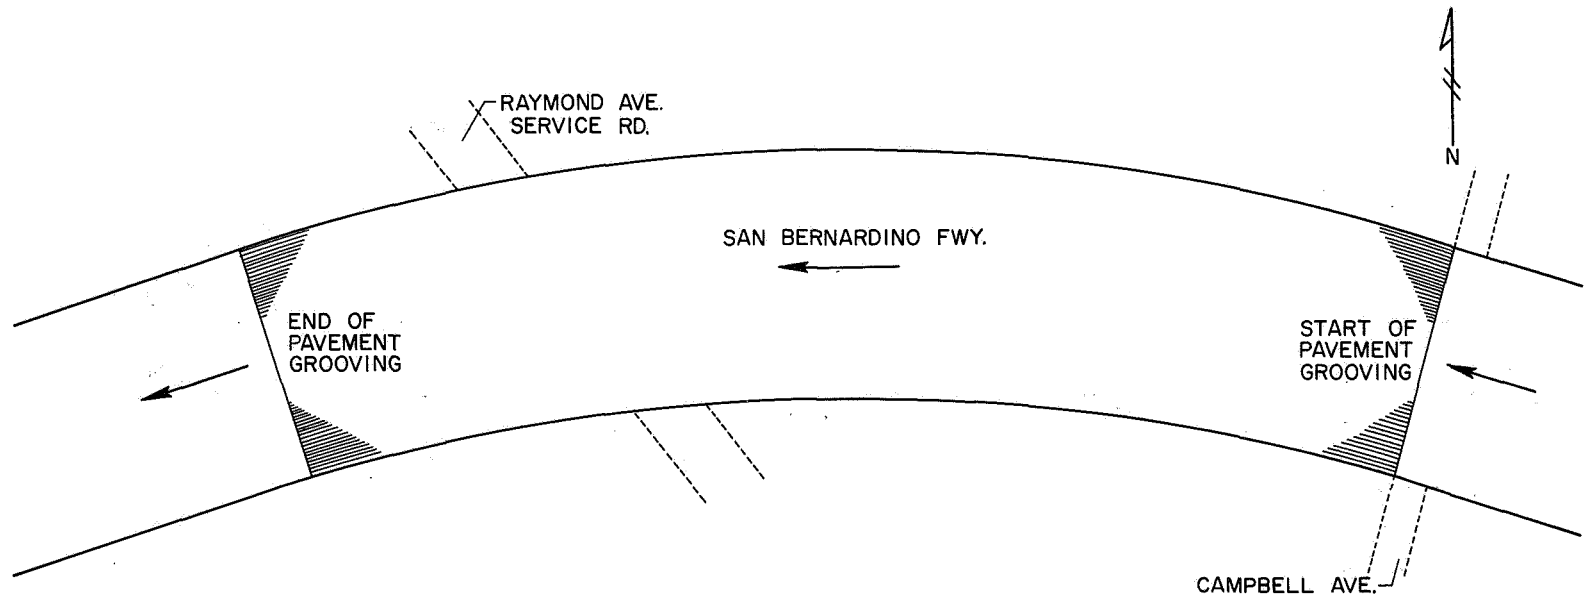
Figure 7.- Highway I-10, about 5 miles east of Los Angeles.

Figure 7 presents a study on a 1000-foot-radius curve on I-10 about 5 miles east of Los Angeles. This curve is on the westbound roadway. It has a superelevation of 5 percent and an ADT of 164 000. The grooving pattern used here was 1/8 inch by 1/8 inch on 3/4-inch centers. Before grooving, friction tests averaged 0.27 with a low of 0.17; no tests were made after grooving. There were 26 wet-pavement accidents the year before grooving and two in each of the next 2 years after. The after-grooving accidents were occurring at the beginning of the curve before reaching the grooved area, which begins at the BC of the curve. On curves to the left, where the crossfall of the roadway is reversed by the superelevation, it is necessary to begin the grooving on the tangent in the supertransition area. There is a concentration of water flow in this area during periods of rainfall which may cause tire hydroplaning to occur.

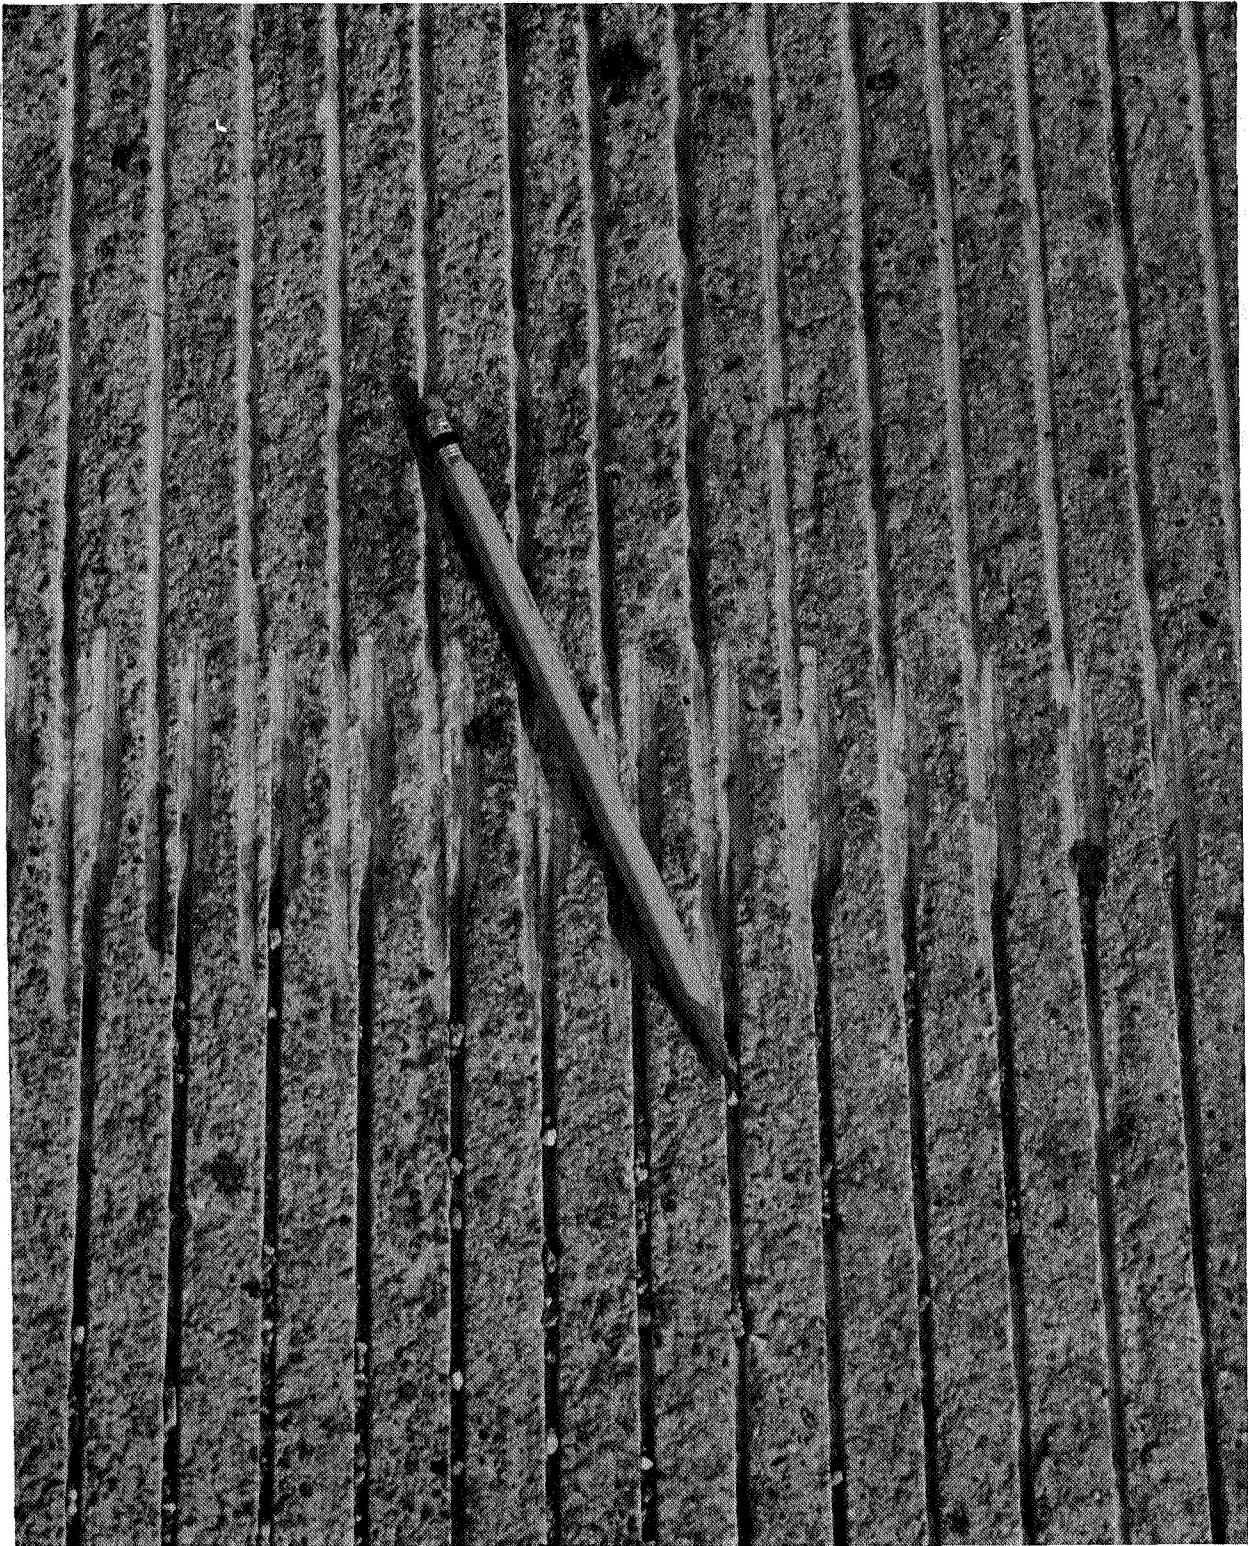
The width of the groove is critical. After grooving of 1/4 inch by 1/4 inch on 1-inch centers was placed in one location, several complaints were received from drivers of light cars and motorcycles. The complaints were that the vehicle tended to "track" and appeared to be caught in a manner resembling being caught in streetcar tracks. The 1/8-inch grooving has been acceptable in almost every location. To further reduce this tracking effect, grooves were made with a 0.095-inch-wide blade. Tests made on this grooving pattern (0.095 inch by 1/8 inch on 3/4-inch centers) indicate that it will be as effective as the 1/8-inch groove and more desirable from a tracking standpoint. Figure 8 is a photographic comparison of the 1/8-inch grooves and the 0.095-inch grooves.

Figure 8.- Pavement with 1/8-inch-wide grooves at top and 0.095-inch-wide grooves at bottom.

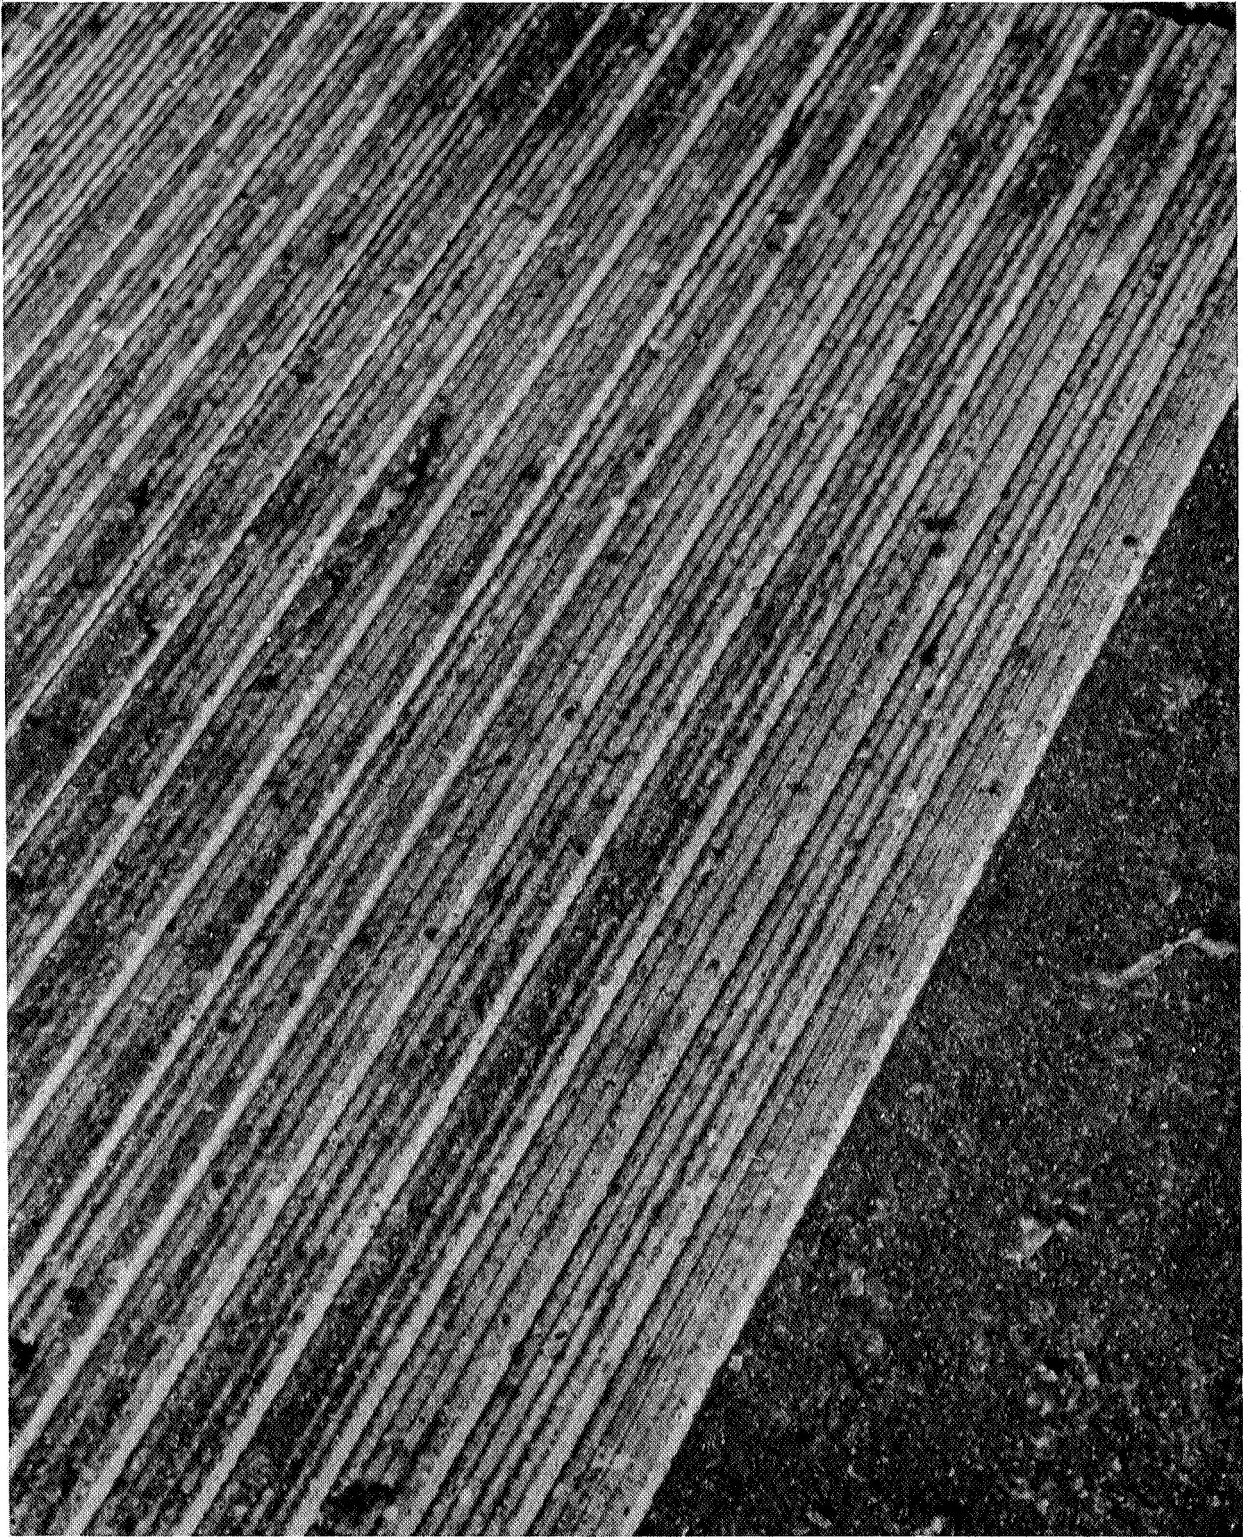
Another pattern, which resembles bump cutting with grooves, has been placed experimentally at several locations. This pattern can be produced by the diamond-studded cylinder type of cutter or by diamond saw blades. This pattern is a series of grooves 0.095 inch wide by 1/8 inch deep on 3/4-inch centers with four grooves 0.095 inch wide by 1/32 inch deep spaced evenly between each pair of the 1/8-inch-deep grooves. Figure 9 shows this pattern as placed on PCC pavement. Use of this pattern is recommended for pavement that is very smooth, where grooving alone will not produce the desired coefficient of friction. This pattern has not been in place long enough to determine its wear characteristics. The coefficients of friction for PCC pavement were 0.22 before and 0.37 after this pattern was placed. On the same pavement, the coefficient of friction was 0.31 for grooves of 1/8 inch by 1/8 inch on 3/4-inch centers.

Figure 9.- Combination bump-cutting and grooving pattern.
