27. RESULTS FROM STUDIES OF HIGHWAY GROOVING AND TEXTURING
 BY SEVERAL STATE HIGHWAY DEPARTMENTS

By Larry G. Mosher

Clipper Manufacturing Company

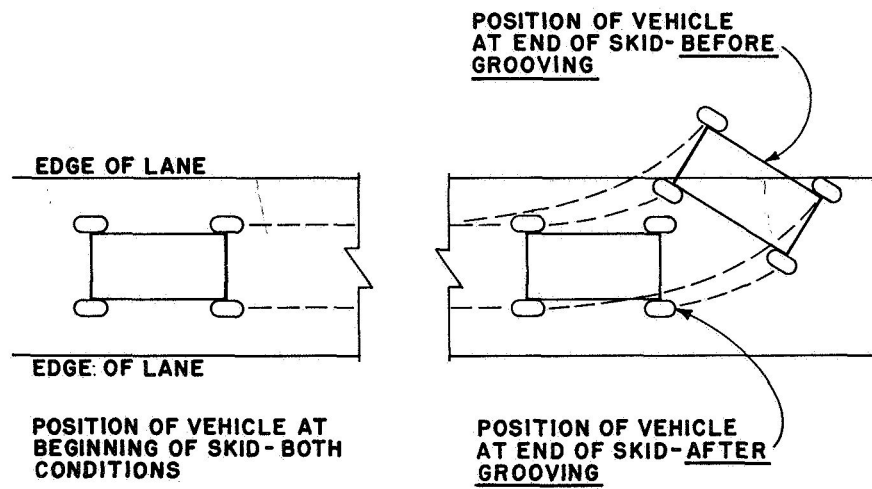
Grooves placed in the longitudinal direction or parallel with the roadway have proven most effective in increasing directional control of the vehicle. The rubber tire on the automobile penetrates into the grooves forming a mechanical interlock that helps hold the vehicle in alignment with the roadway, much the same as tiny streetcar tracks. (See fig. 3 and ref. 3.) Longitudinal grooving is particularly effective in preventing hydroplaning accidents on curved sections of roadways, bridges, and tangent sections of roadways subject to high cross winds. During an emergency stop, the longitudinal grooves also help hold the vehicle within its own traffic lane, a factor which is extremely important on multiple-lane roadways. (See fig. 4 and ref. 2.)

Figure 4.- Skid pattern before and after grooving.

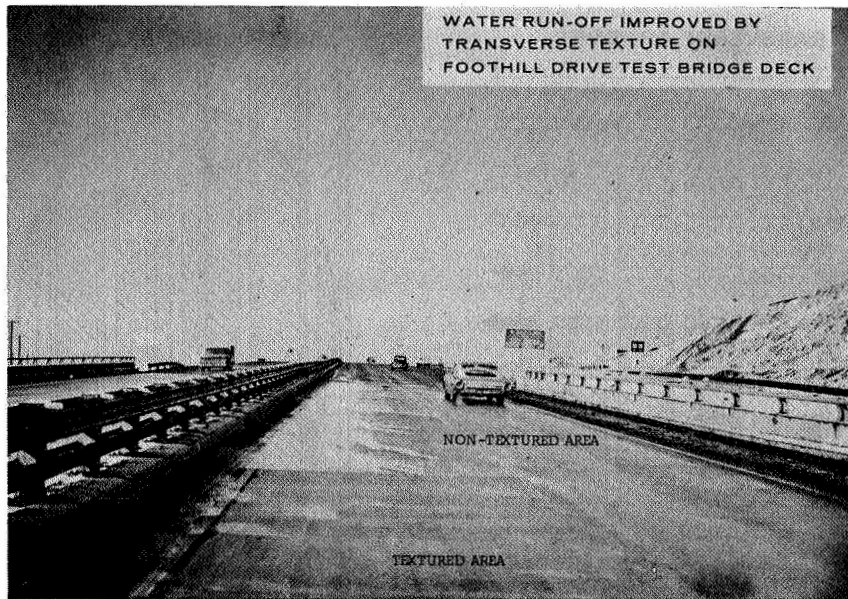
Coefficient-of-friction measurements made with skid trailers may help identify dangerous pavements of the type described above, but do not necessarily indicate whether the grooves solve the problem. Pavements sometimes show a high value of coefficient of friction at speeds of 30 to 40 mph due to a good microtexture, but this effect may fall off rapidly with increased speed (ref. 4). Also, worn tires on vehicles may react differently than the tires used on the skid testing vehicle. If the skid trailer is equipped with its own watering device near the tire footprint, it may fail to indicate the improved drainage of the pavement that grooving normally provides. (See fig. 5.)

Figure 5.- Pavement drainage.

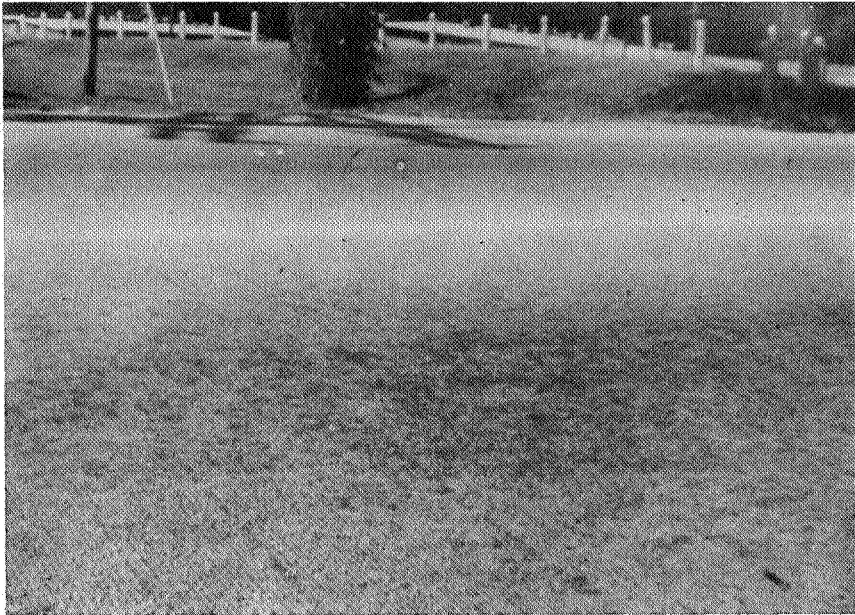
Much concern has been expressed about grooves in asphalt pavement losing their effectiveness by the flowing back together of this flexible material, particularly during hot weather. This result has been observed under certain conditions when a fairly new asphalt pavement or a pavement with a low aggregate content has been grooved. This condition seems predominant at locations subjected to power steering of the vehicle while it is stopped. Older asphalt pavement with high aggregate content seems to hold up very well. The pavement in St. Louis, Missouri, has been subjected to two summers and one winter of intersection traffic and looks almost as good as it did when the grooves were placed there 18 months ago. (See fig. 9.)

Figure 9.- Grooved pavement in St. Louis, Missouri.

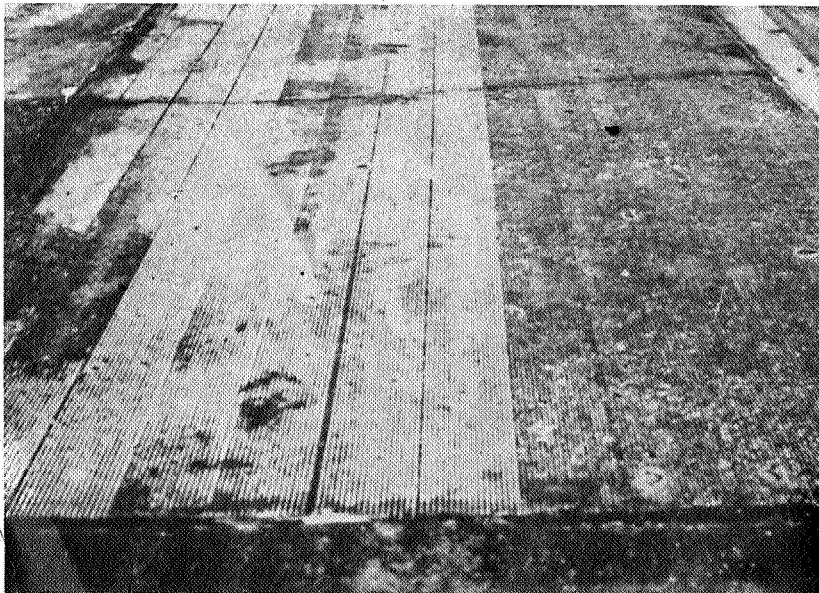
There have been some complaints that longitudinal grooving affects the steering of certain automobiles and motorcycles, but no severe problems have been encountered. However, when grooving pavement longitudinally, care should be taken to prevent any irregularities or "wiggles" in the pavement grooving pattern. Upon observing some early attempts of pavement grooving, it is noted that frequent variations in alinement can be found in the longitudinal grooves. (See fig. 10.) These variations may be attributed to

manual steering of the grooving equipment and the tendency for the equipment to slip downhill when working on a superelevation. Recent improvements in grooving equipment assure an alined grooving pattern parallel to the roadway. (See fig. 11.)

Figure 10.- Irregularities in longitudinal grooves.

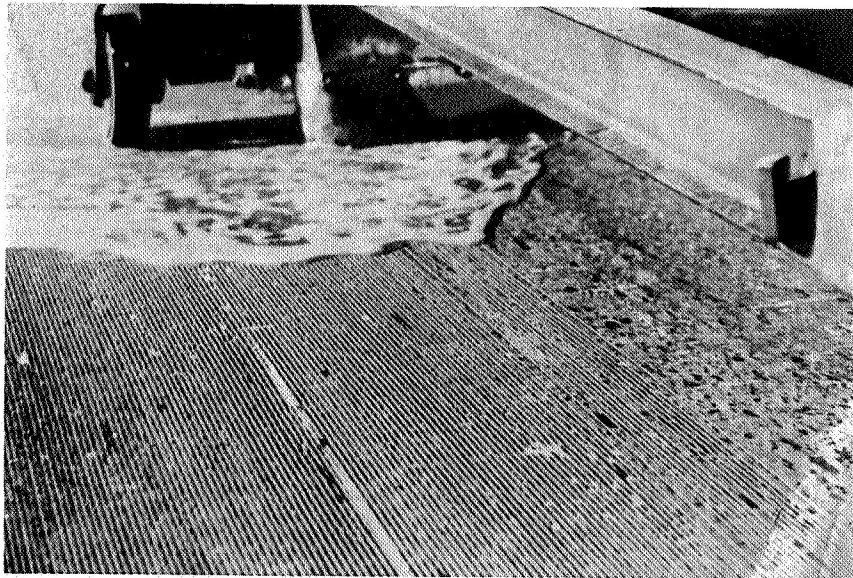
Another problem that has been noted, particularly during grooving operations, is the disposal of the water and the fine material cut from the grooves. Approximately 1 gallon of water per square foot of grooving is required to cool the cutting head. The resulting slurry can make the adjacent pavement very slippery, particularly if grooving begins on the high side of a multiple-lane roadway. (See fig. 12.) To avoid this situation and to facilitate cleaning up of the grooved area, a recent improvement in grooving equipment is a slurry pickup device. When a device of this type is used, the pavement is left free of dust or slipperiness and washed clean. (See fig. 13.)

Figure 12.- Slurry.

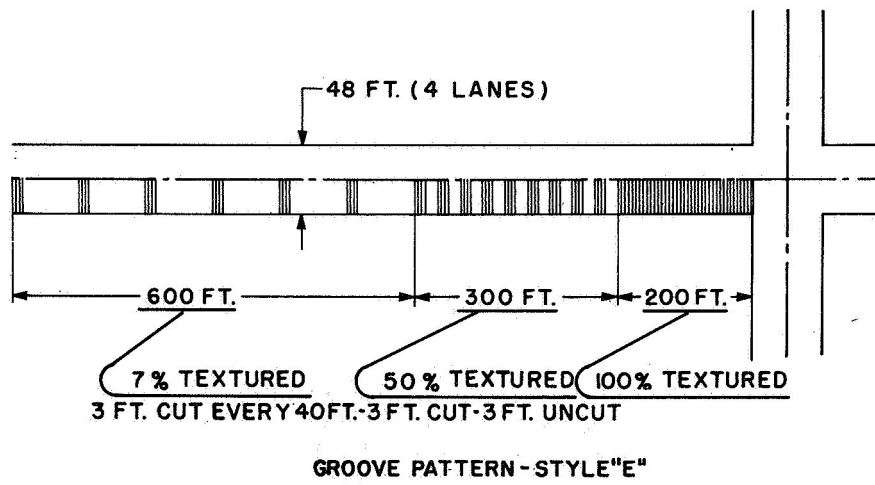
COMMENTS: The 7-percent textured area consists of a 3-foot textured area every 40 feet. The 50-percent textured area consists of a 3-foot textured area alternating with a 3-foot untreated area. No accident data are available. This pattern was not effective in increasing tire noise as a warning. (See fig. 14.)

Figure 14.- King Street intersection in St. Augustine, Florida.
