# NAVAL AIR PROPULSION TEST CENTER

NAPTC-AED-1869

ROTOR BURST PROTECTION PROGRAM  
INITIAL TEST RESULTS

PHASE IV - FINAL REPORT  
PROBLEM ASSIGNMENT NASA DPR R-105

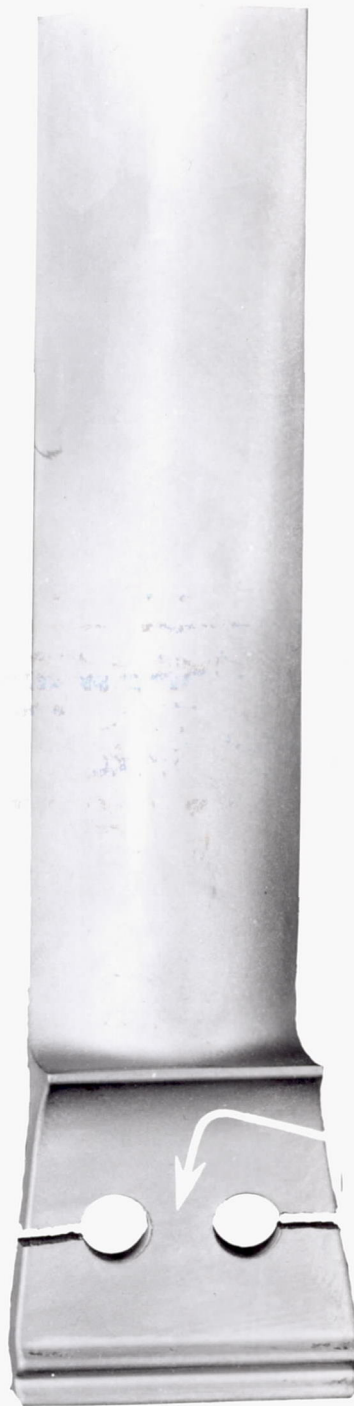
**MODIFIED TURBINE BLADE**

42. Blade failures at predicted speeds were induced by modifying the blade as shown in plate 8. This consisted of reducing the area normally required to support the centripetal load generated during rotation. A straight-forward centripetal force analysis was used  $\sigma_u A = (W/g) \bar{r} \omega^2$  to determine the burst speed. We found that the simplest and most accurate way to get the values of W (the weight) and  $\bar{r}$  (the centroid) for a particular blade was to determine them experimentally.

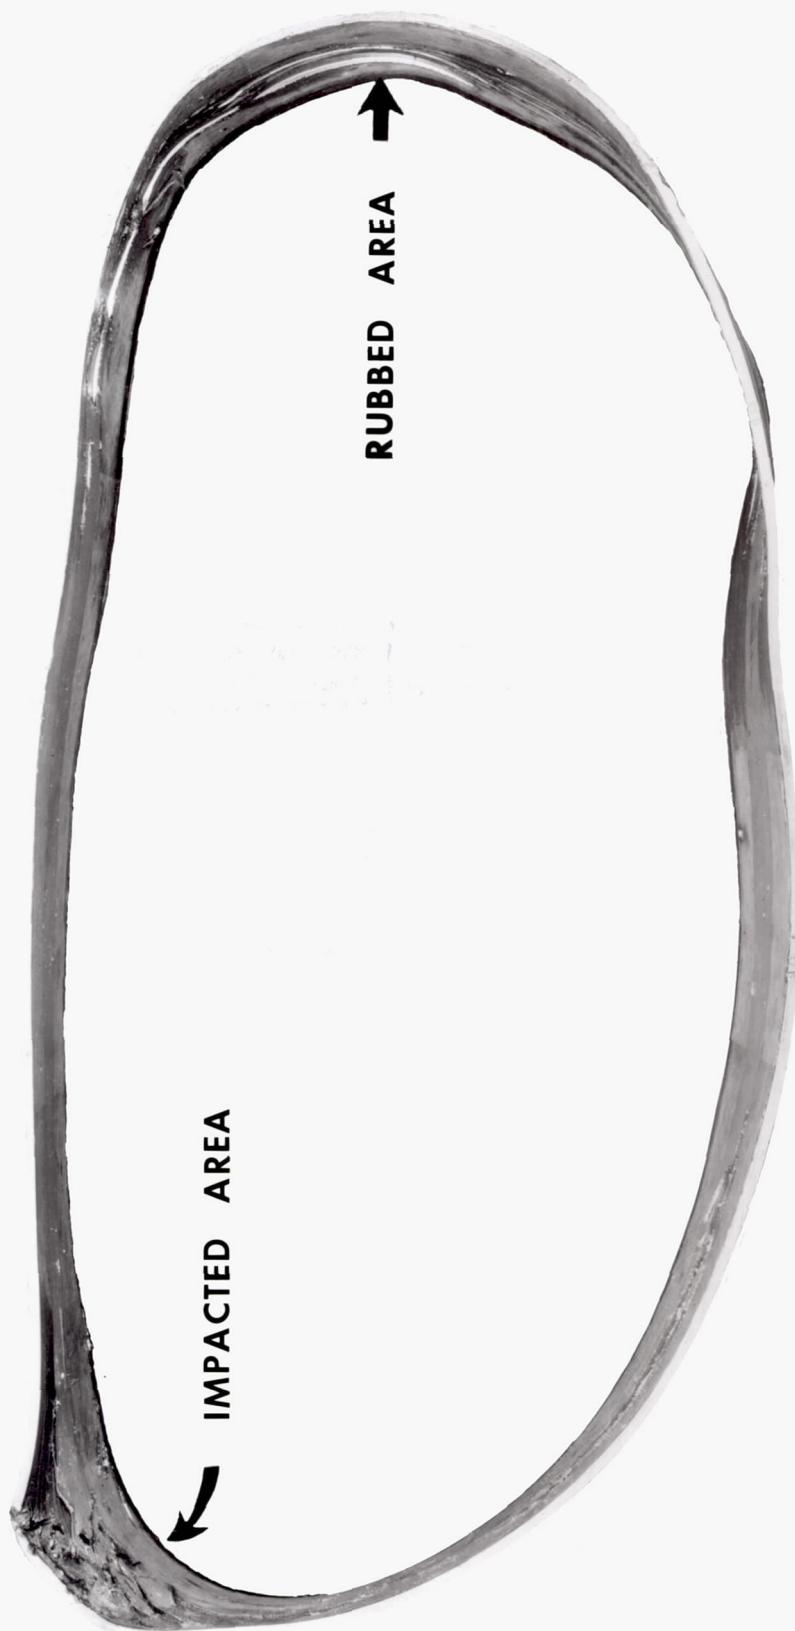
59. The post-test photograph of the containment ring of test No. 10 is shown in plate 19. The ring area that experienced the blade rubbing is shown on the right of the photo; the impacted area is on the left side. Plates 20 and 21 show, in detail, the total damage to the rubbed area and impacted area, respectively, of the ring.

POST-TEST NO. 10  
CONTAINMENT RING

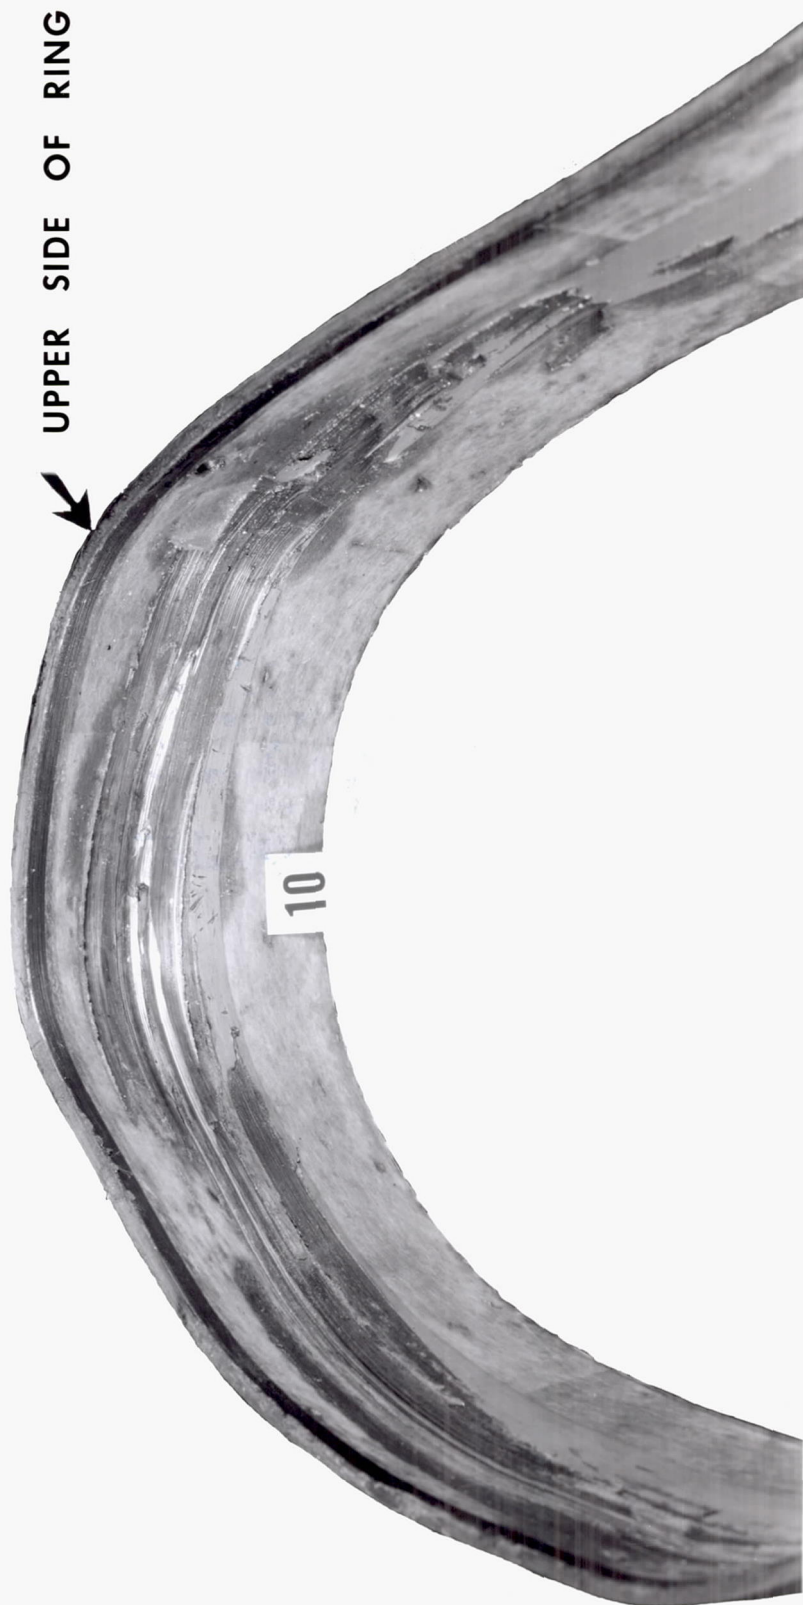
POST-TEST NO. 10  
CONTAINMENT RING-RUBBED AREA DETAIL

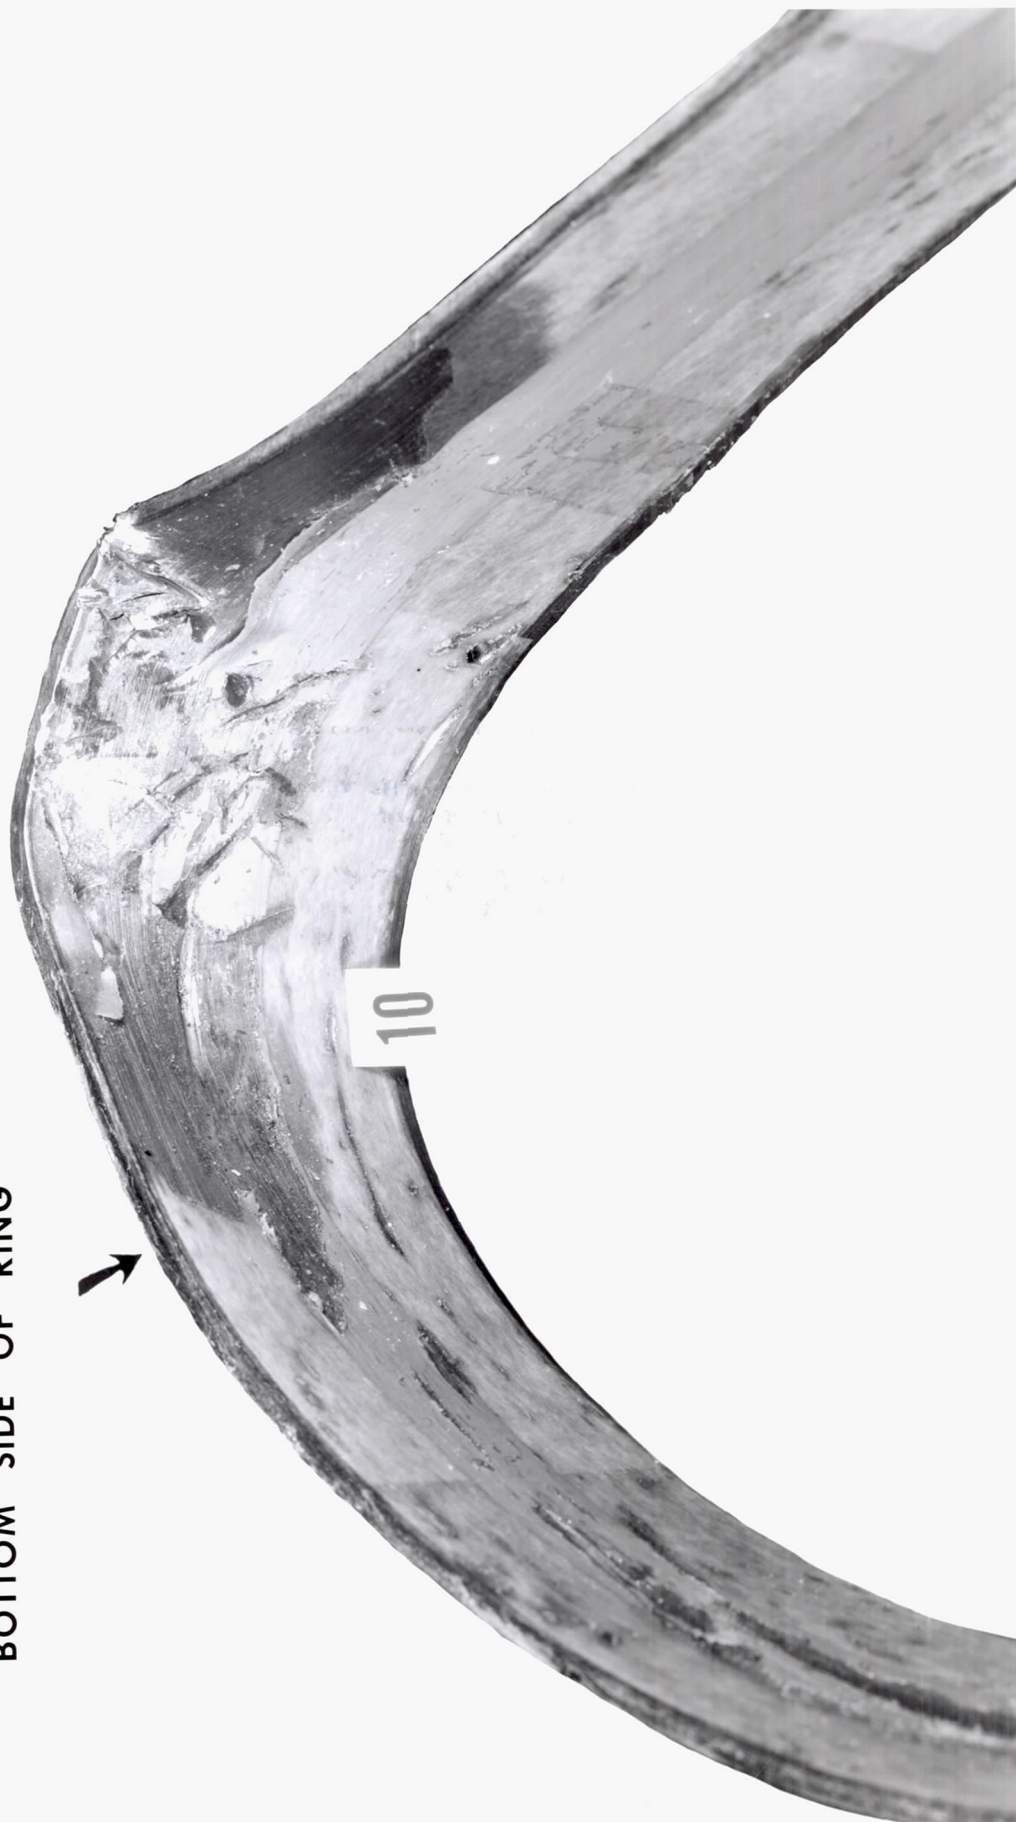
POST-TEST NO. 10  
CONTAINMENT RING-IMPACT AREA DETAIL

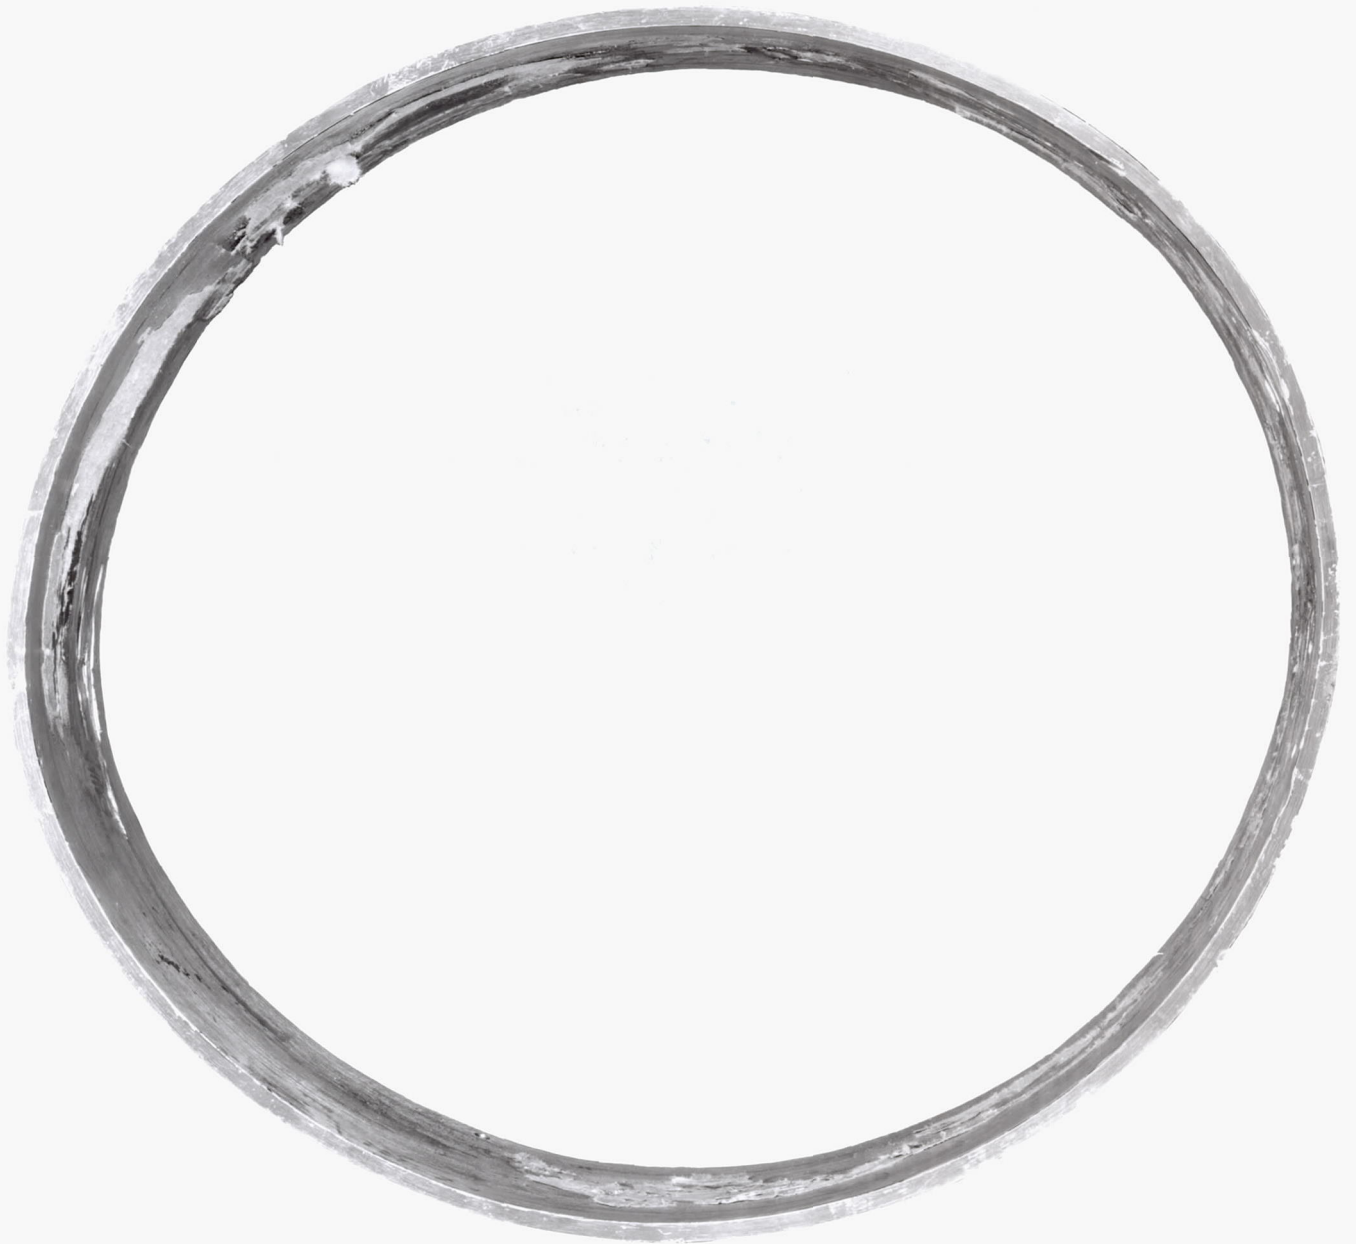
60. A four-single blade burst, similar to test No. 10 was performed within a steel ring during test No. 7. High speed photographs were not obtained from test No. 7 and therefore it can only be assumed that the No. 7 blade failure was similar to No. 10. Plate 22 indicates the amount of total distortion experienced by the No. 7 containment ring. Comparing this post-test photograph with plate 19, a large difference in ring distortion can be seen. Two major parameters contributing to this difference are probably ring thickness and radial blade clearance. The ring from test No. 7 was twice as thick (0.250 inches vs. 0.125 inches) as the No. 10 ring; and the No. 7 test had a smaller radial clearance (0.475 inches vs. 0.6875 inches) than the No. 10 test.

POST-TEST NO. 7  
CONTAINMENT RING

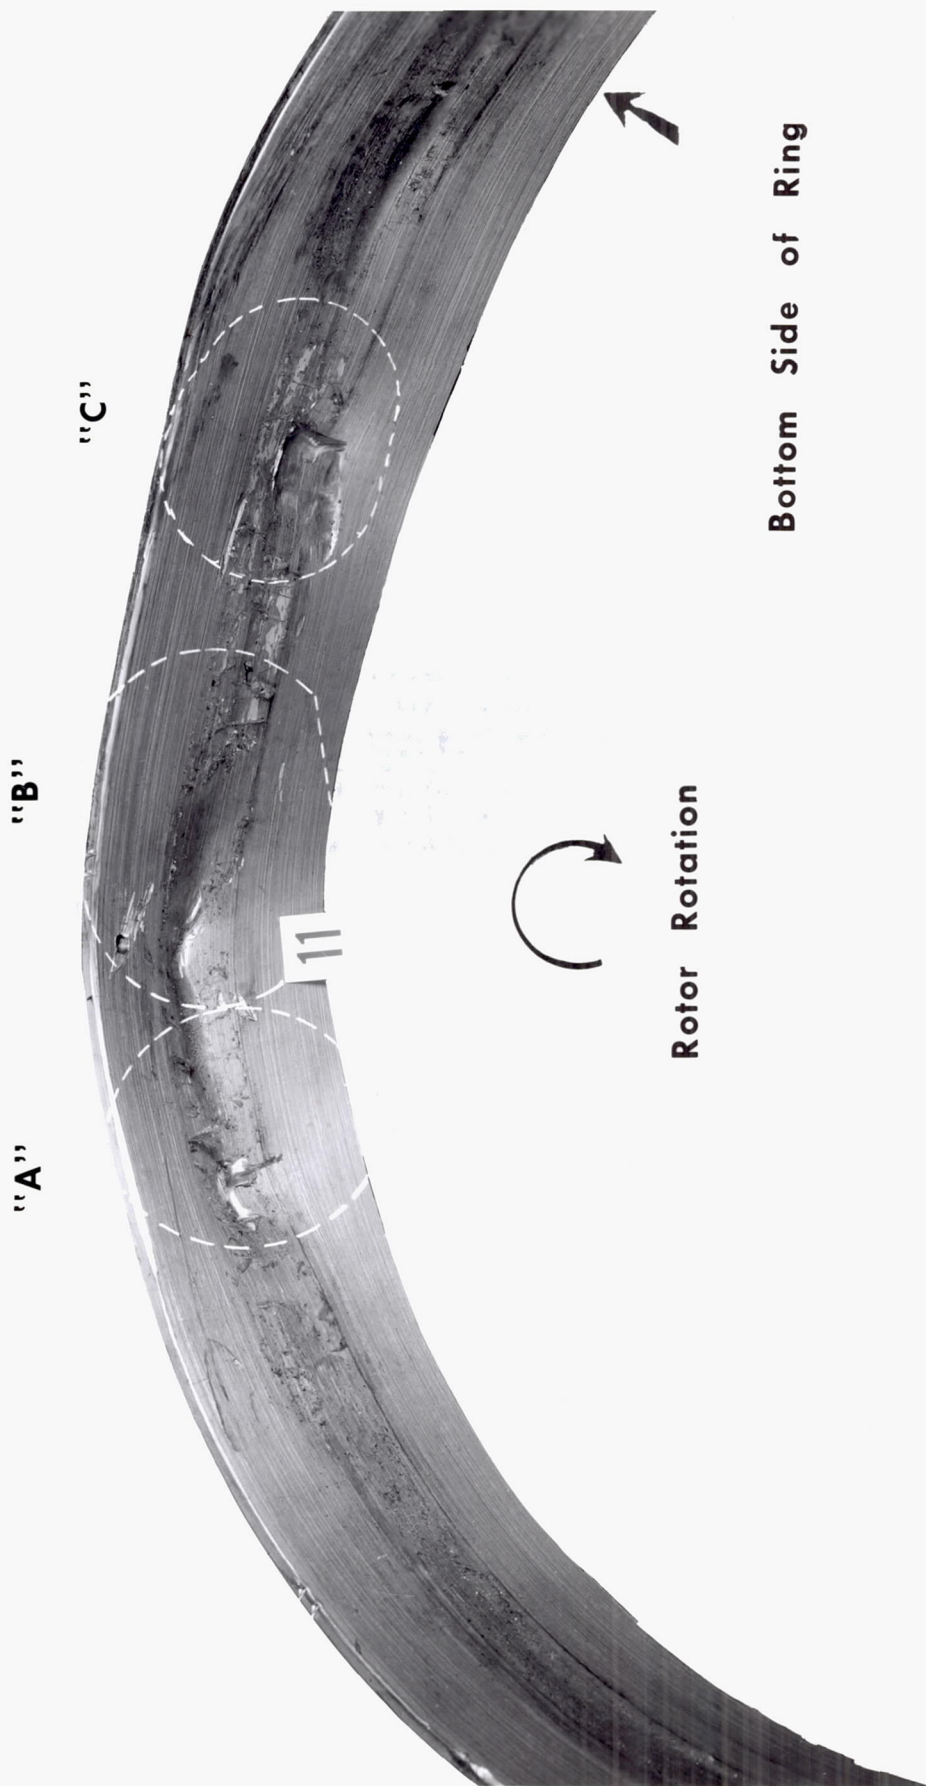
POST-TEST NO. 11  
CONTAINMENT RING-DETAIL OF IMPACTED AREA

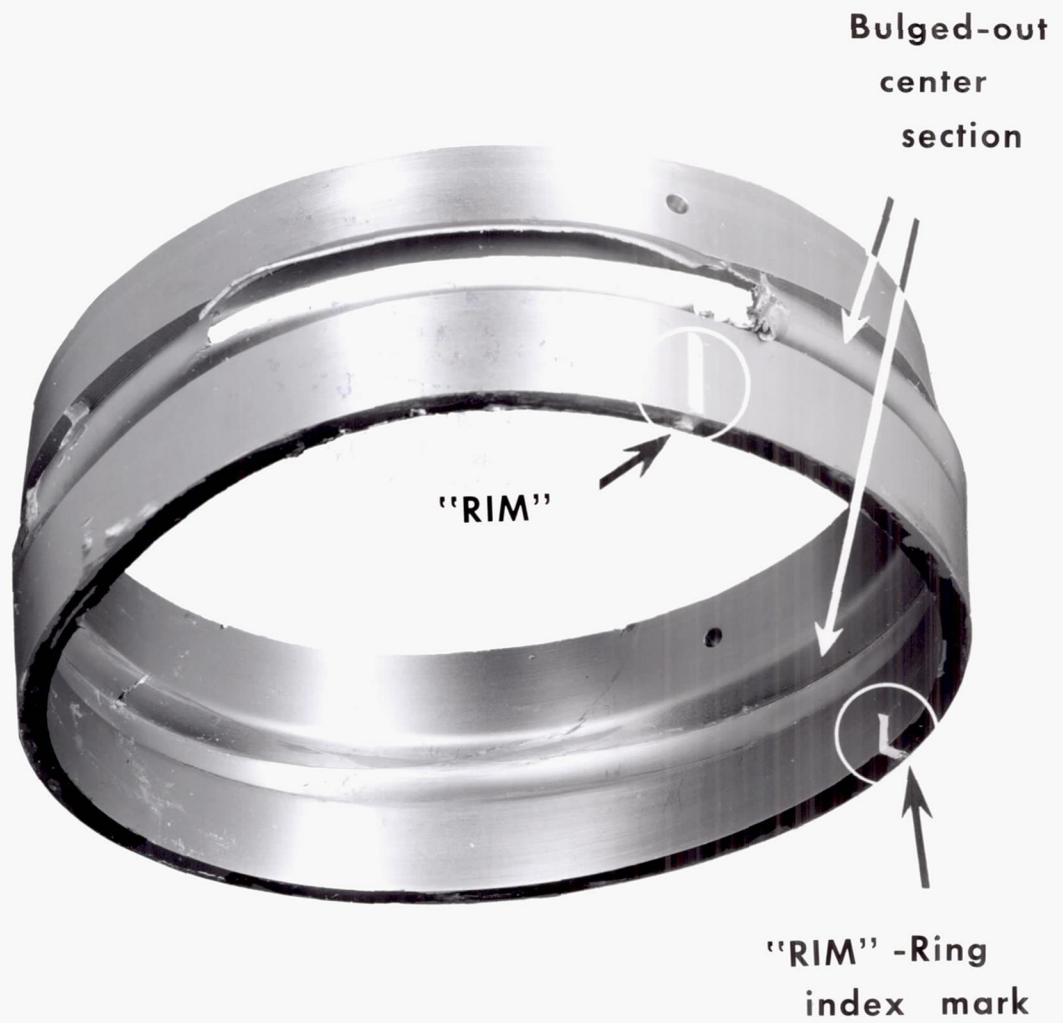
POST-TEST NO. 12  
CONTAINMENT RING-FRAGMENT A PERFORATED AREA

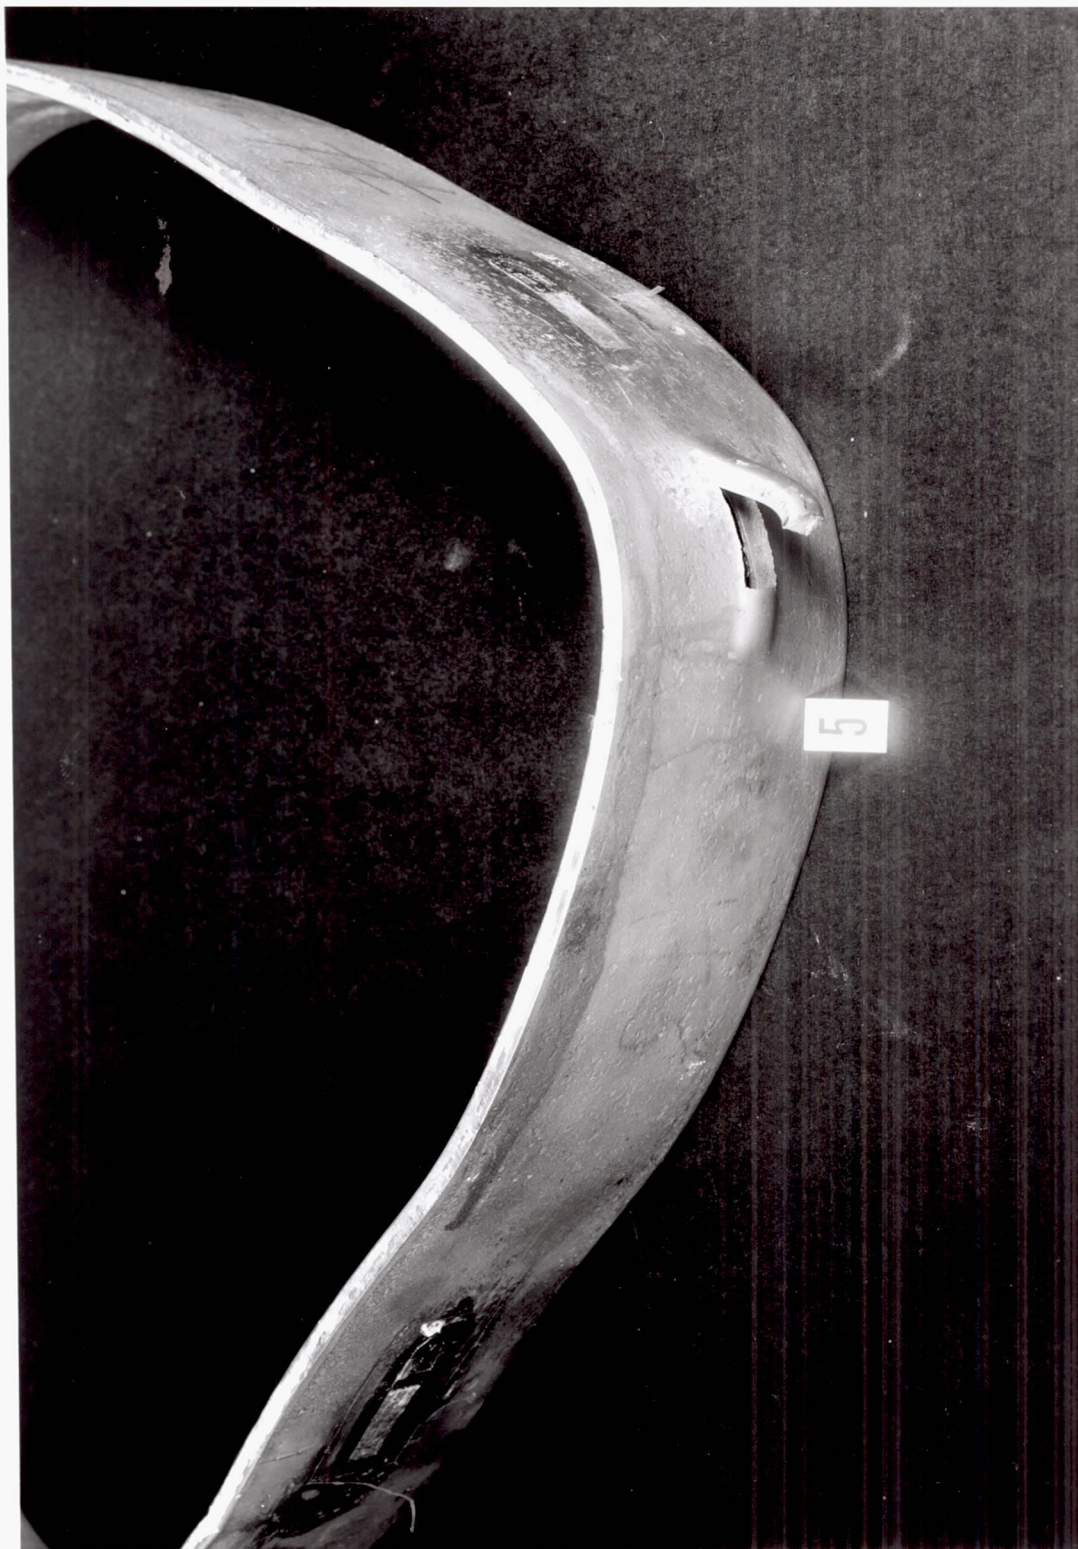
POST-TEST NO.5 CONTAINMENT RING  
PERFORATED AREA

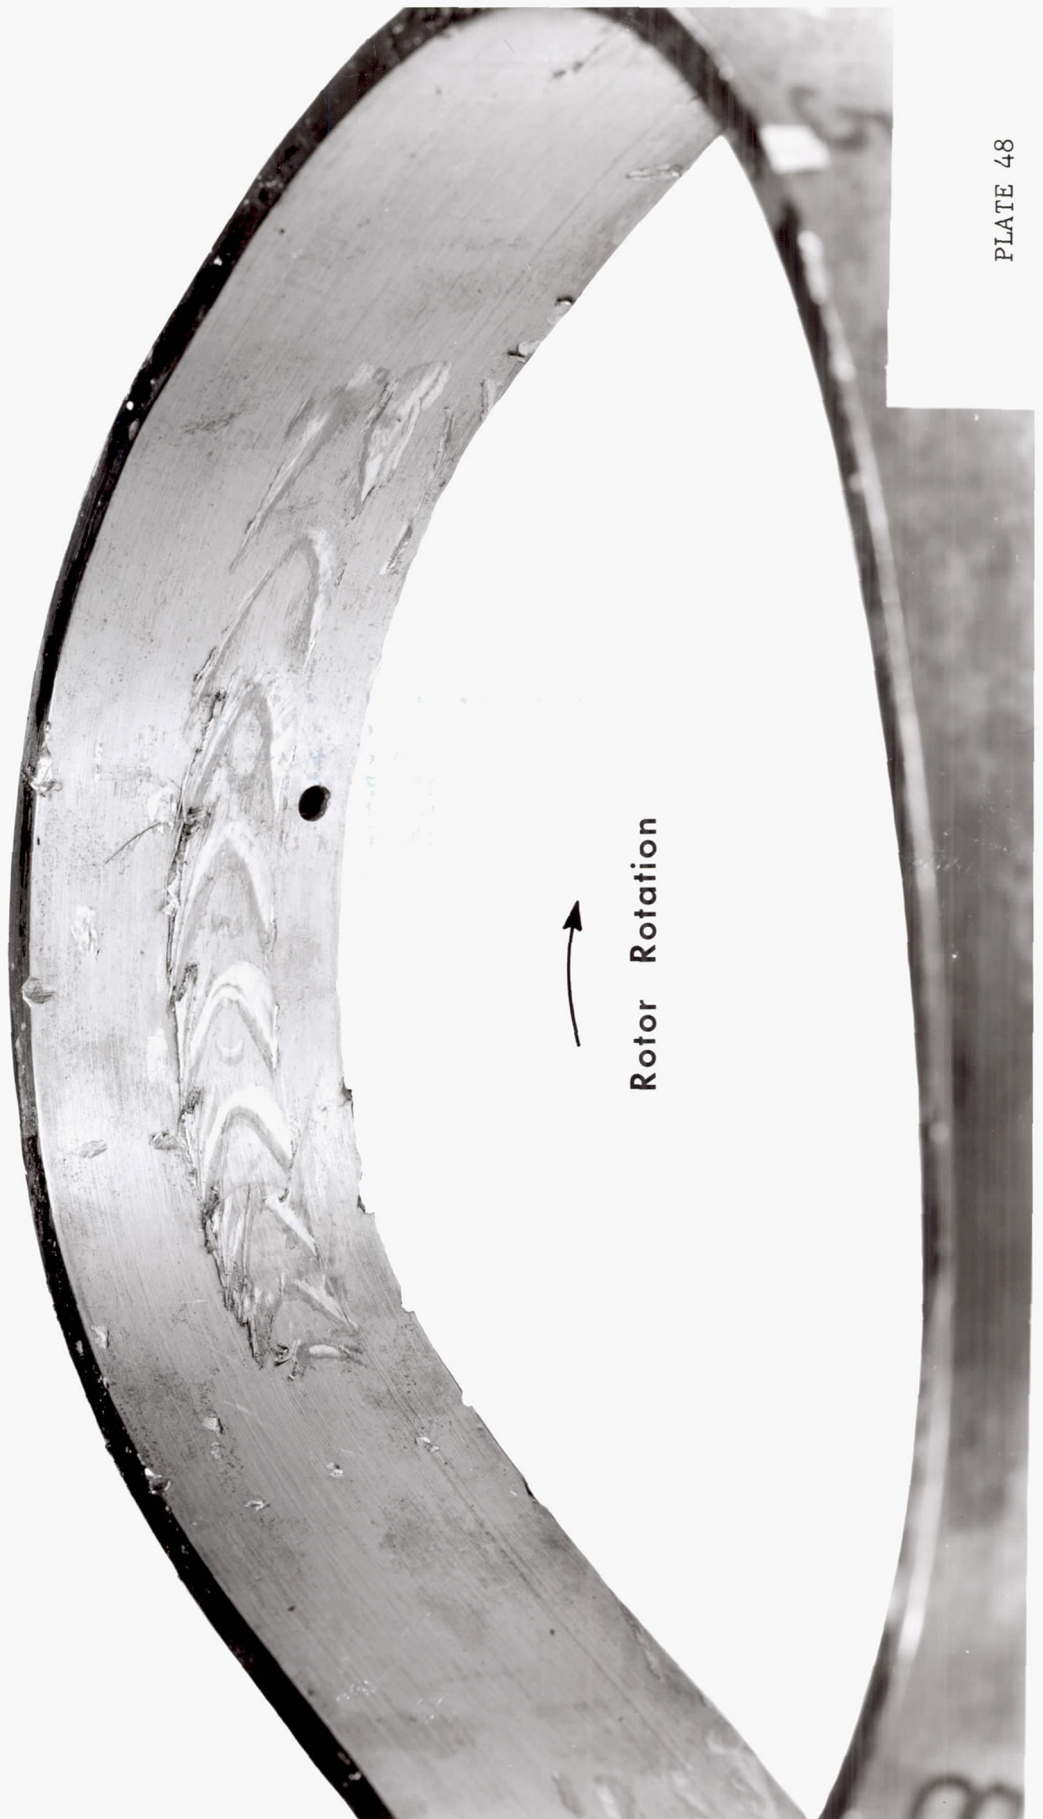
POST-TEST NO. 20  
FRAGMENT INDENTATION OF INSIDE  
SURFACE OF CONTAINMENT RING

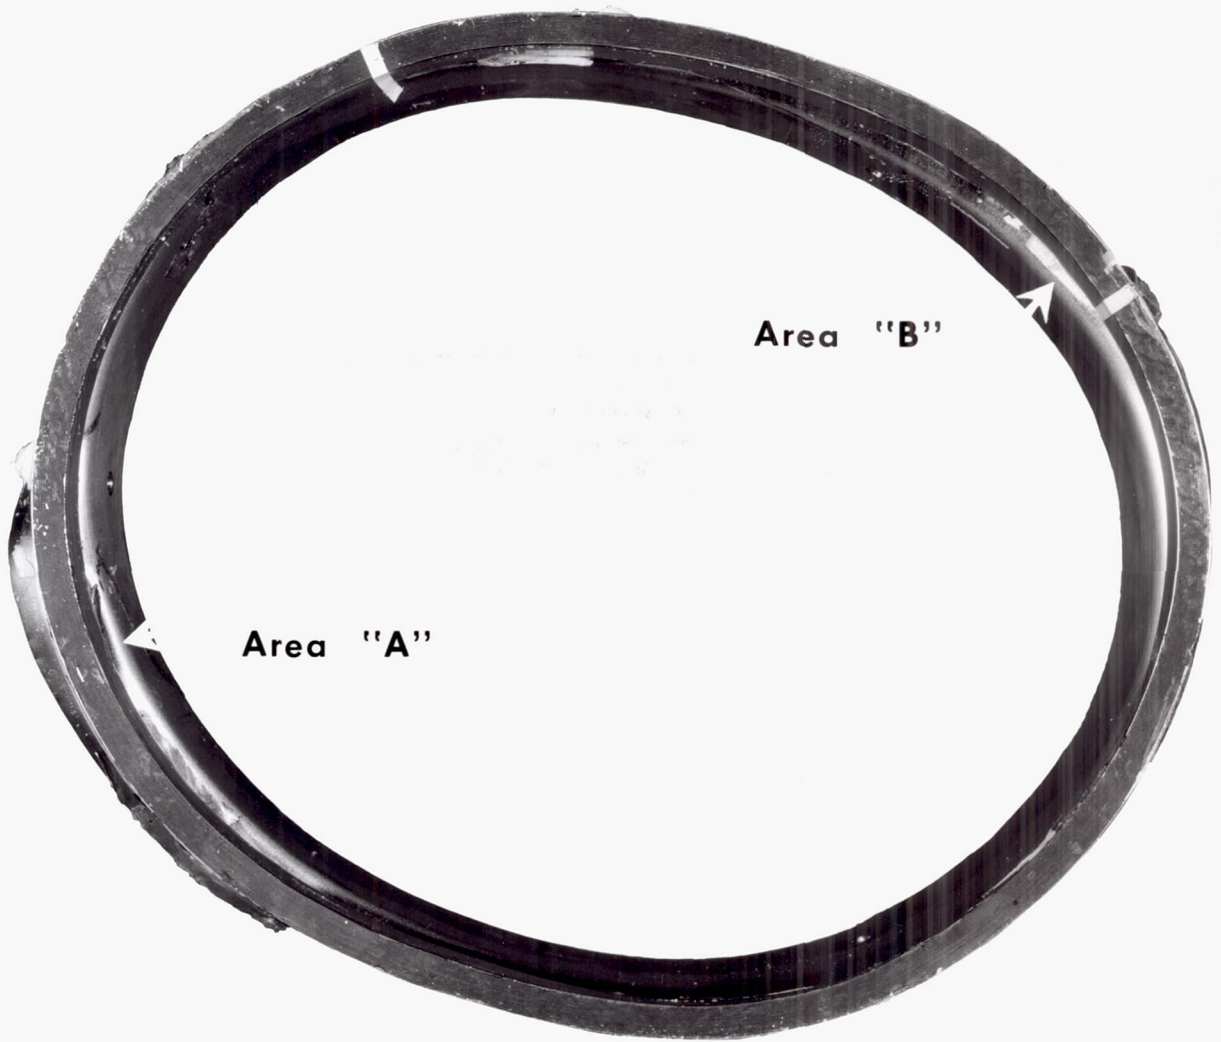
POST-TEST NO. 20  
CONTAINMENT RING DISTORTION

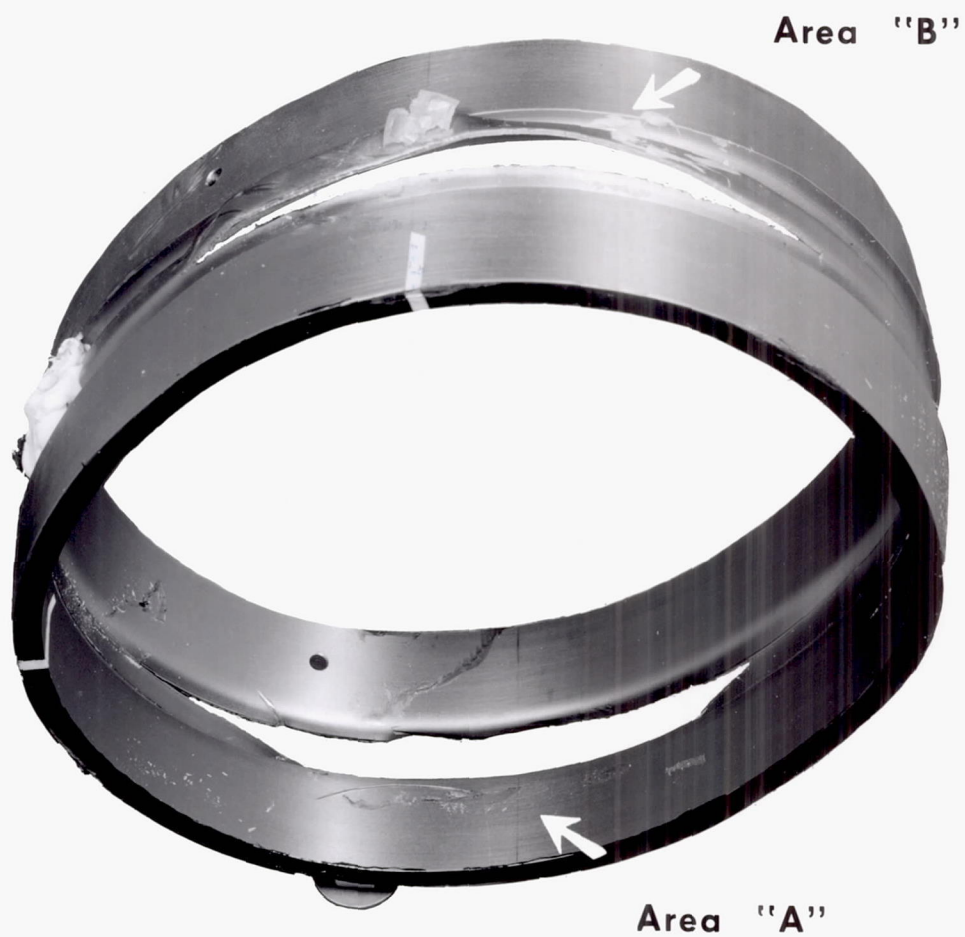
POST-TEST NO. 13  
CONTAINMENT RING DETAIL OF OPENINGS

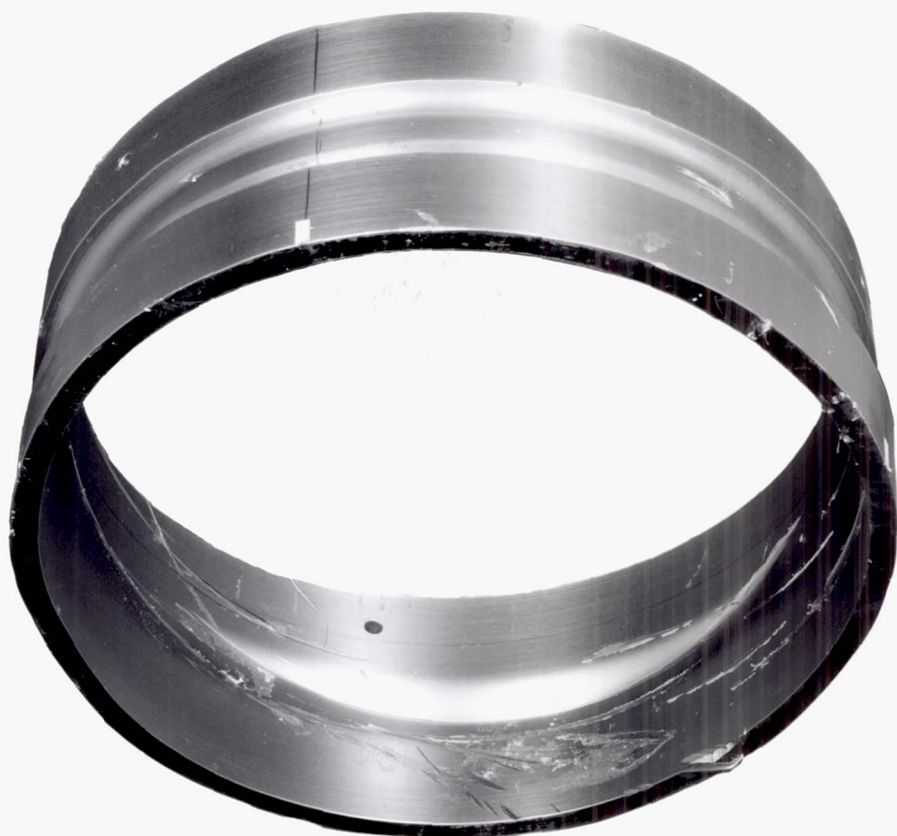
POST-TEST NO. 15  
CONTAINMENT RING INDENTATION DETAILS
