## ADVANCED REFRACTORY ALLOY CORROSION LOOP PROGRAM

### QUARTERLY PROGRESS REPORT NO. 13

For Quarter Ending July 15, 1968

prepared by  
R. W. Harrison

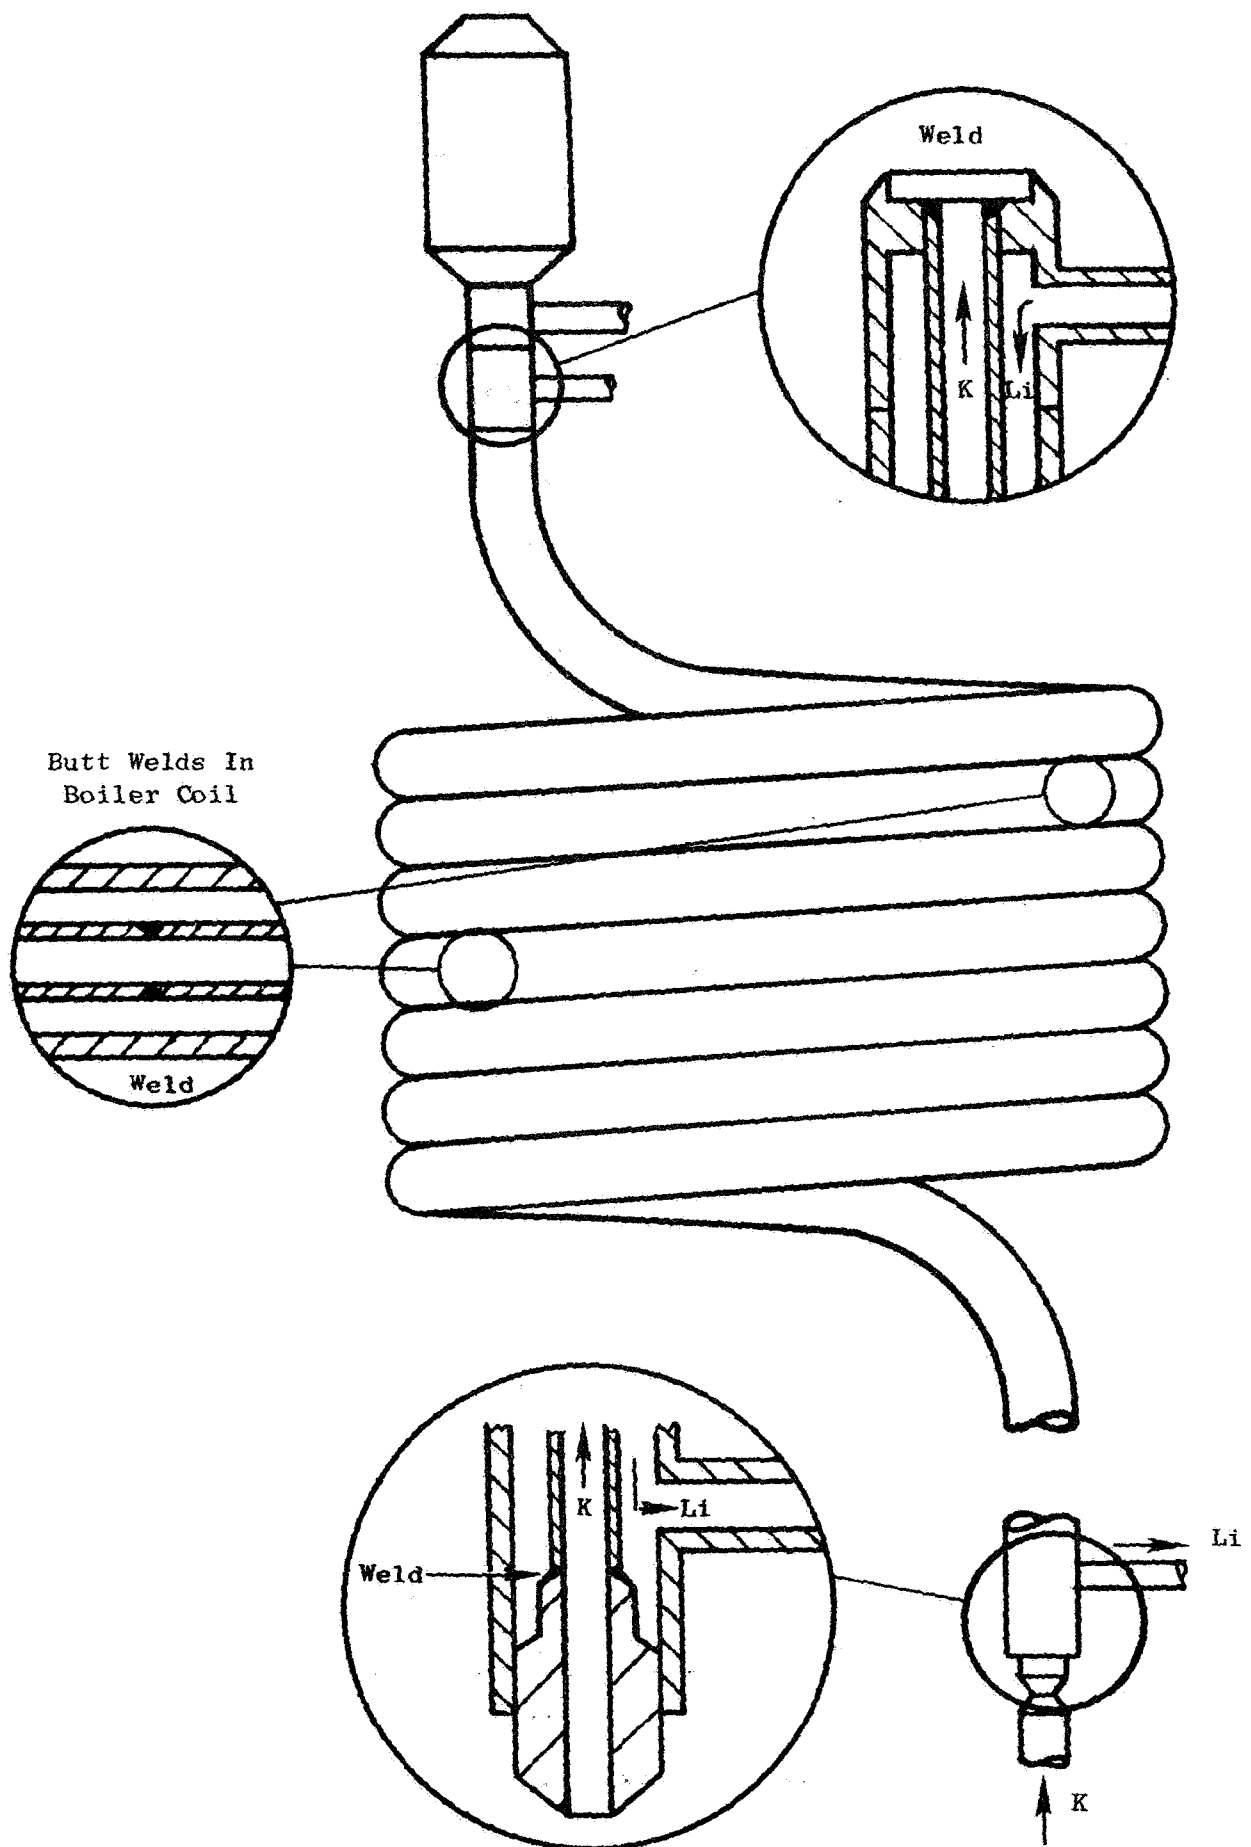
The methods to be employed in repairing the boiler, if possible, are contingent upon the location of the leak between the potassium and lithium circuits. There are four welds in the potassium circuit of the boiler, as shown in Figure 2, which could be the source of the leak. If the leak is found to be either at the top or bottom weld areas of the boiler, appropriate repair plans can be devised. If the leak is within the boiler coils, repair may not be possible and a new boiler may be required.

Figure 2. Welds in 0.375-Inch OD T-111 Alloy Tubing in T-111 Rankine System Corrosion Test Loop Which Separate the Potassium and Lithium Circuits.

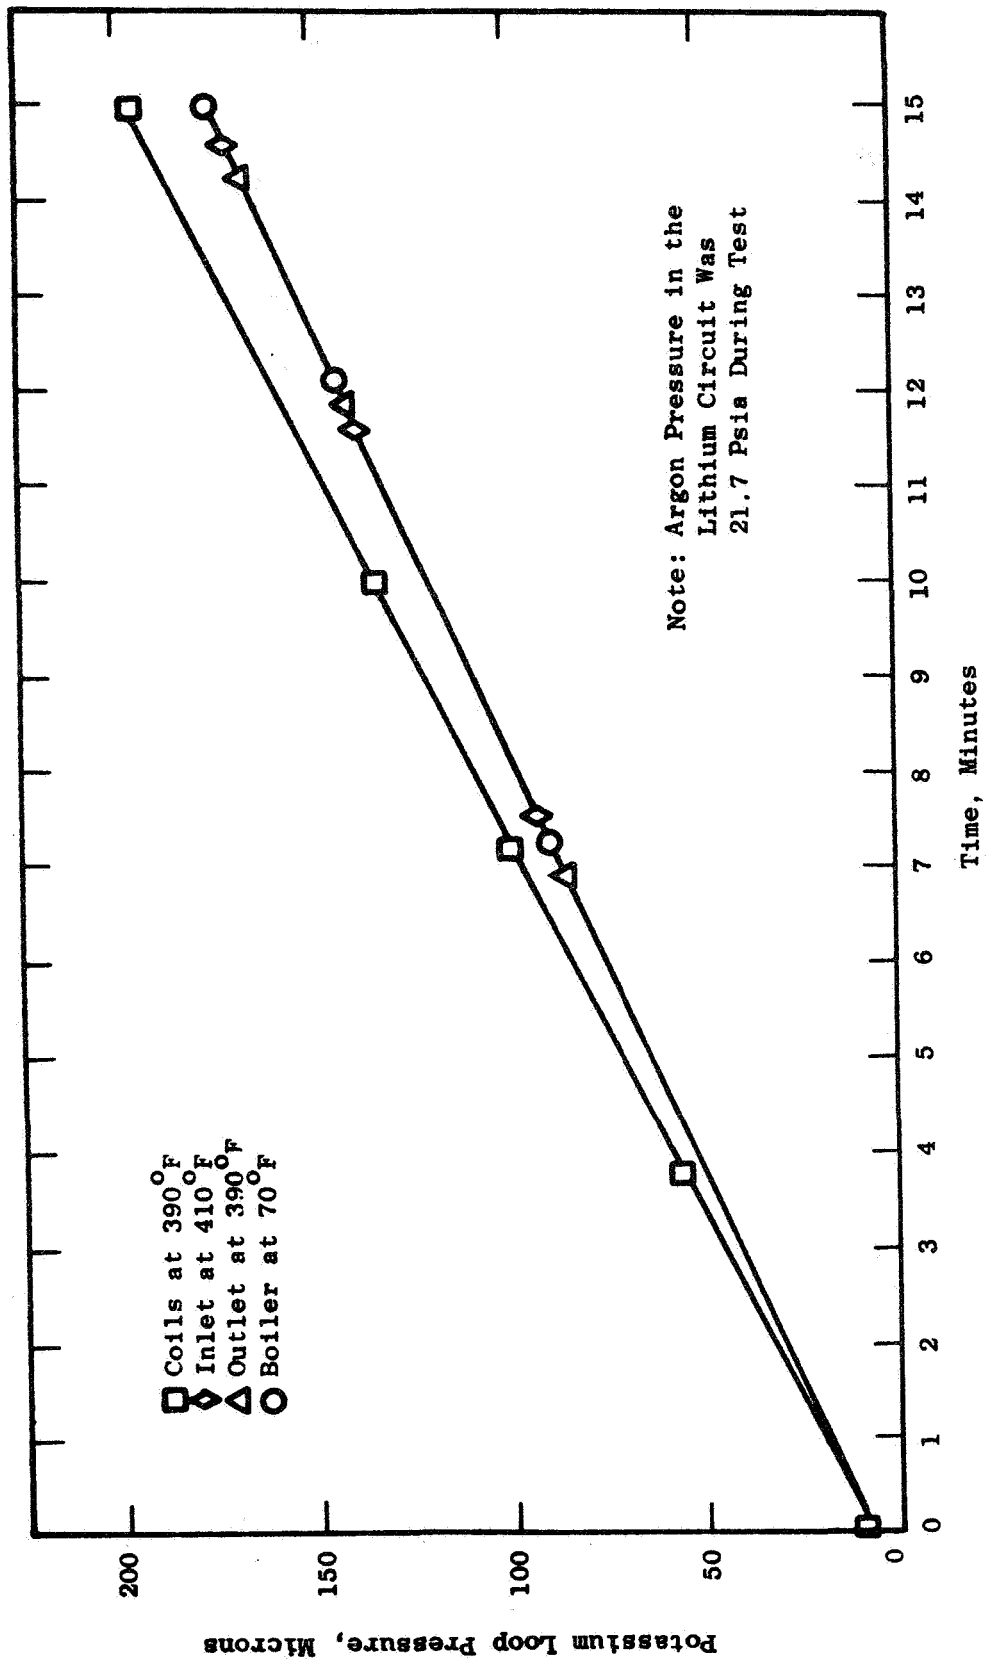
Figure 3. Pressure Rise in Potassium Circuit of T-111 Corrosion Loop  
as a Function of Boiler Temperature.

Following these measurements, the entire boiler was heated, and the pressure rise rate was measured and compared to the room temperature pressure rise rate as shown in Figure 4. Again, the hot boiler had a significantly higher pressure rise rate than the room temperature measurement. A pressure rise rate was also measured with the lithium loop pressure at 0.2 psia and the entire boiler at 400°F. The slight increase in the pressure after 15 minutes of testing indicated that the change in the pressure rise rate was primarily due to the leak and not to outgassing.

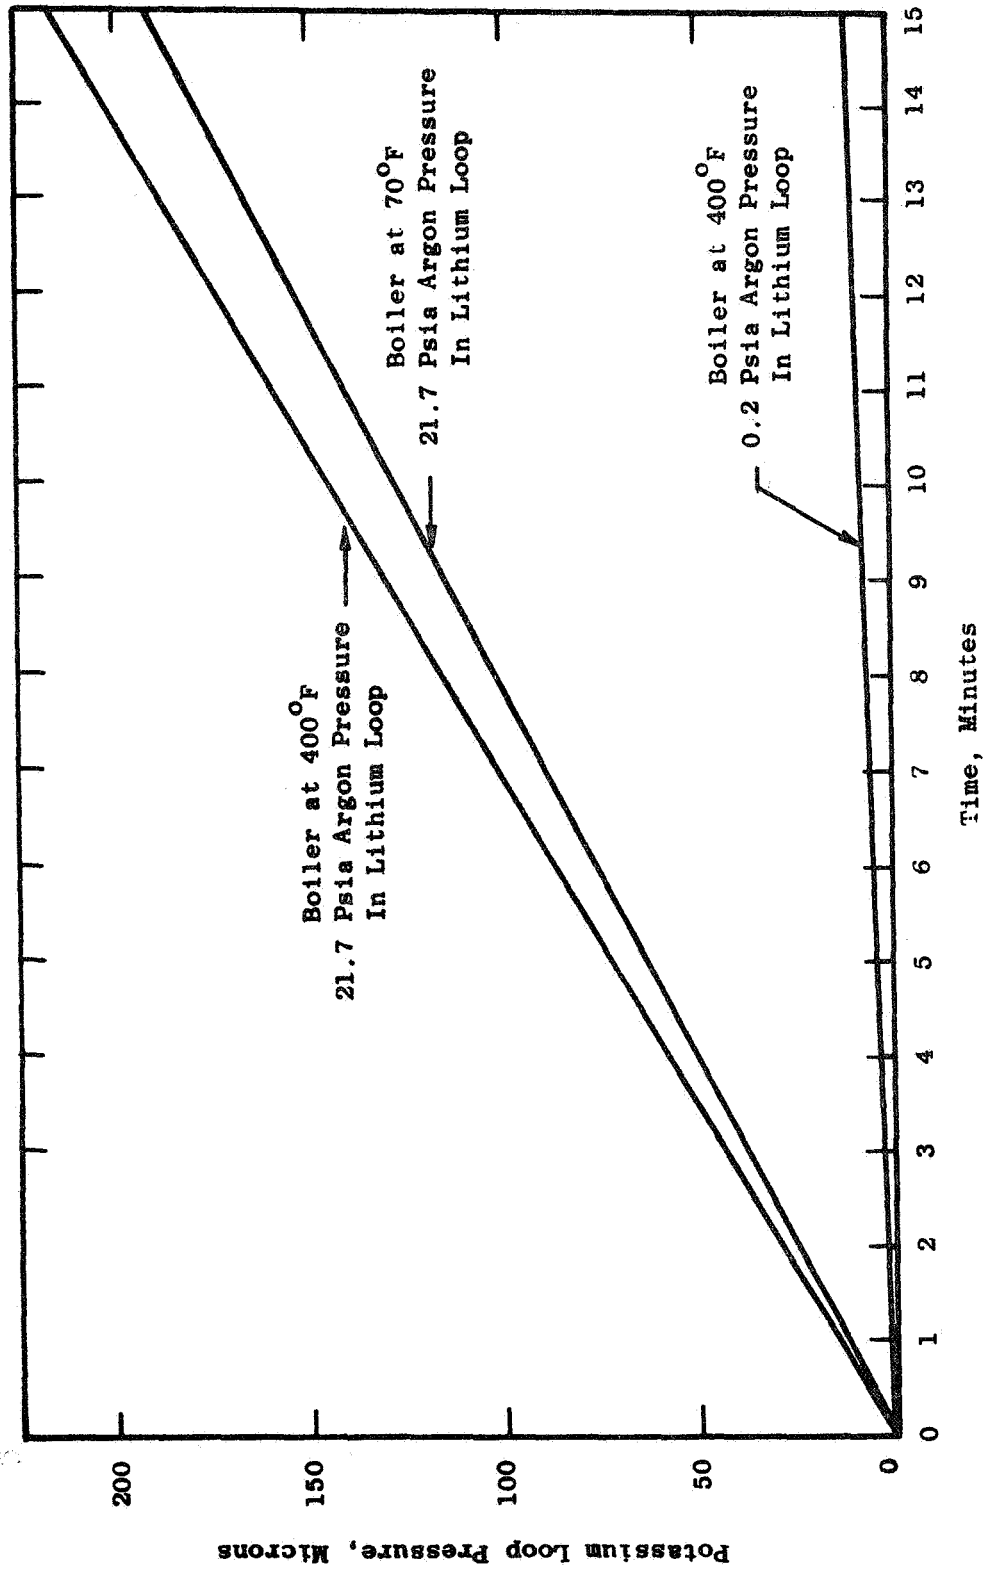
Figure 4. Pressure Rise in Potassium Circuit of T-111 Corrosion Loop as a Function of Boiler Temperature and Lithium Circuit Helium Pressure.

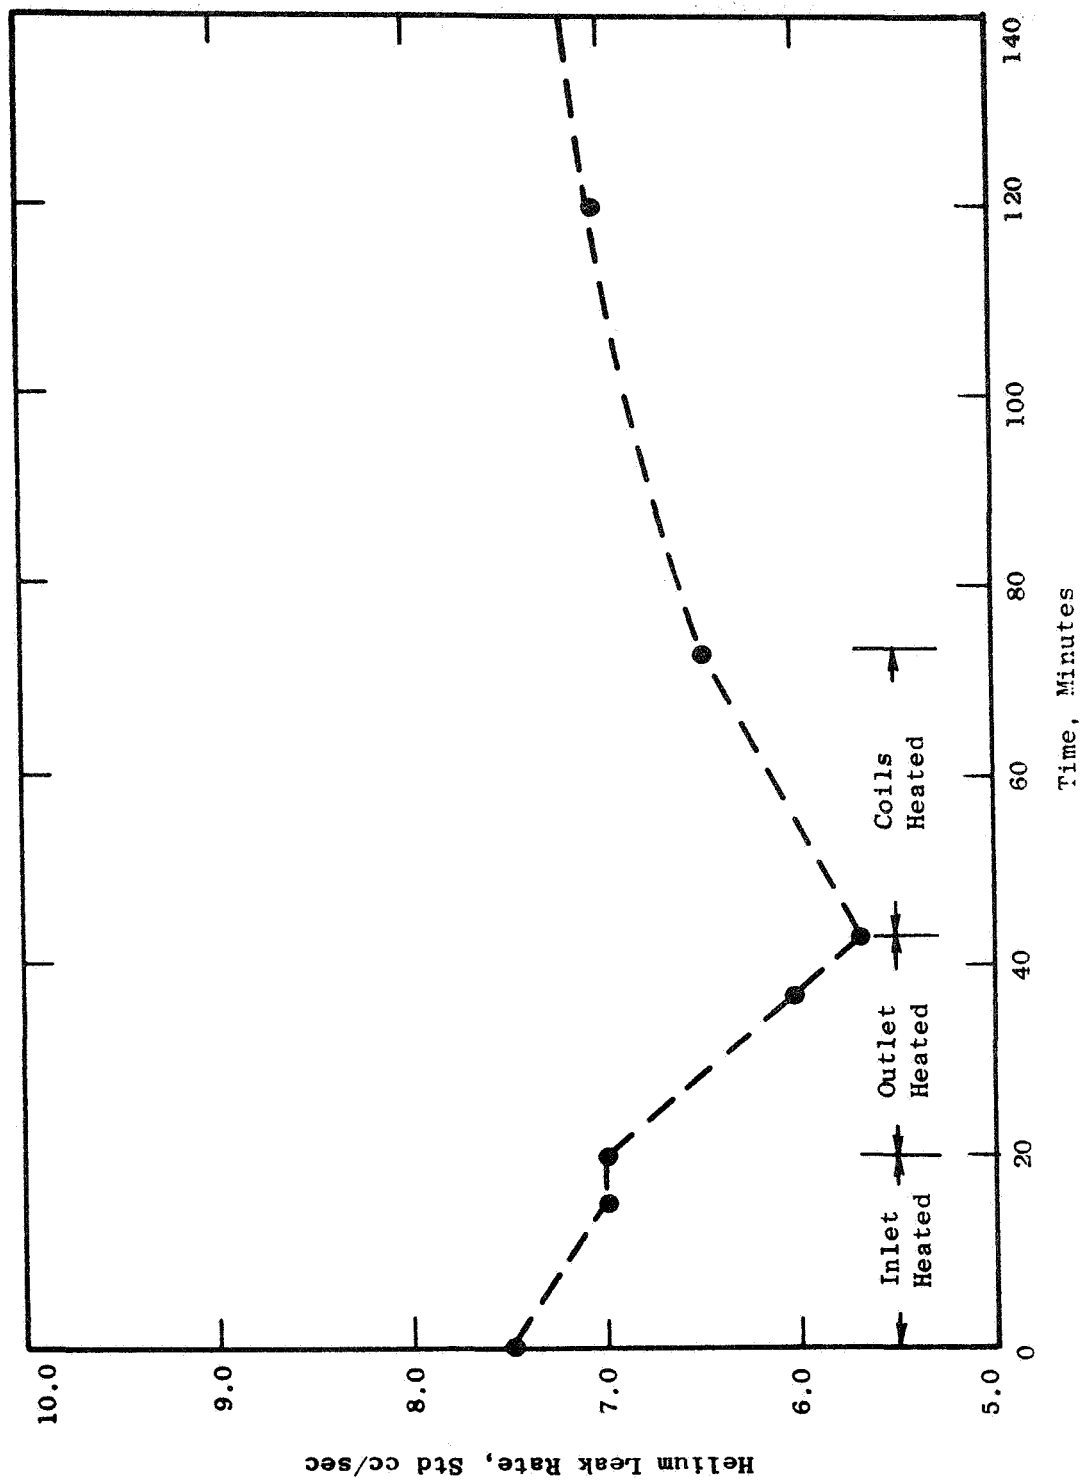
inlet to the boiler was then heated to 380°F for approximately 20 minutes with a slight decrease in the helium level as shown in Figure 5. The heater power to the boiler inlet was turned off, and the boiler outlet was heated to 400°F. Again, the helium level decreased at the same rate as observed when the inlet was heated. When the center section of the boiler which consists of seven 10-inch diameter coils was heated, the helium level increased indicating a higher leak rate. The leak rate continued to increase even after the power was turned off. Subsequently, with the boiler at room temperature, the lithium circuit was pressurized with argon to 35 psig while the potassium circuit was evacuated. The boiler remained at these conditions for three days without indicating a leak as evidenced by the lack of a drop in pressure in the lithium circuit.

The results of these tests indicated that the leak might be in the center section of the boiler, and that the leak was only apparent when the boiler was heated above the melting point of lithium (367°F).

Figure 5. Effect of Heating Localized Sections of T-111 Corrosion Loop Boiler on Helium Level in Evacuated Potassium Circuit Measured with a General Electric M-60 Helium Leak Detector.

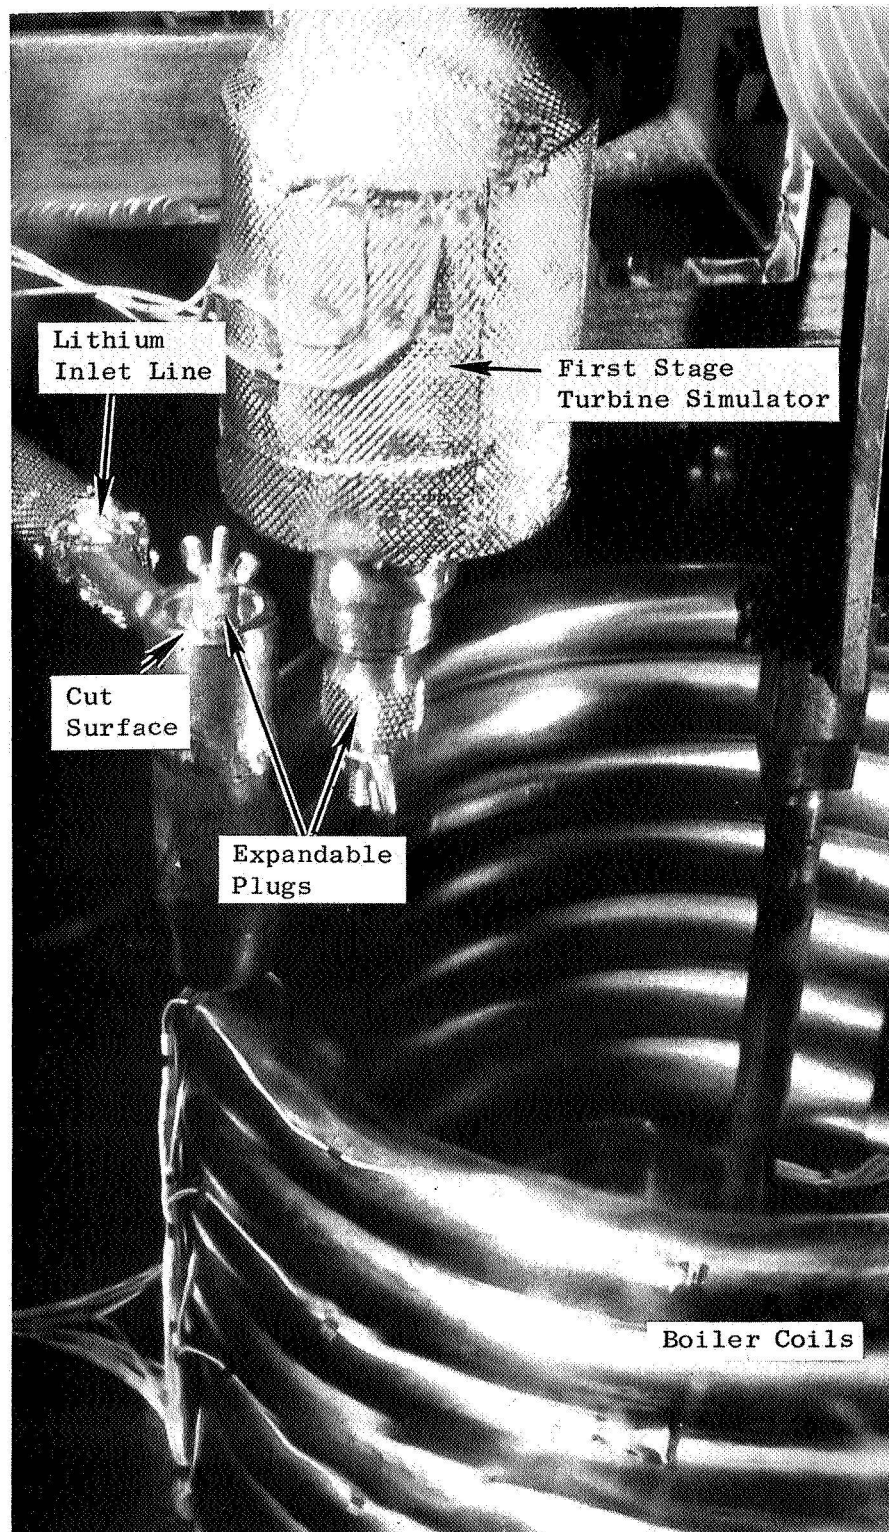
Inspection and helium mass spectrometer leak checking of the weld did not reveal a leak at this location. Subsequent room temperature leak checking of the boiler coils and the bottom of boiler also did not reveal a leak. The vinyl chamber was removed.

Figure 8. T-111 Corrosion Test Loop Boiler Following Initial Cut.. The Potassium Circuit was Sealed from Atmosphere with Expandable Plugs. (C68062845)

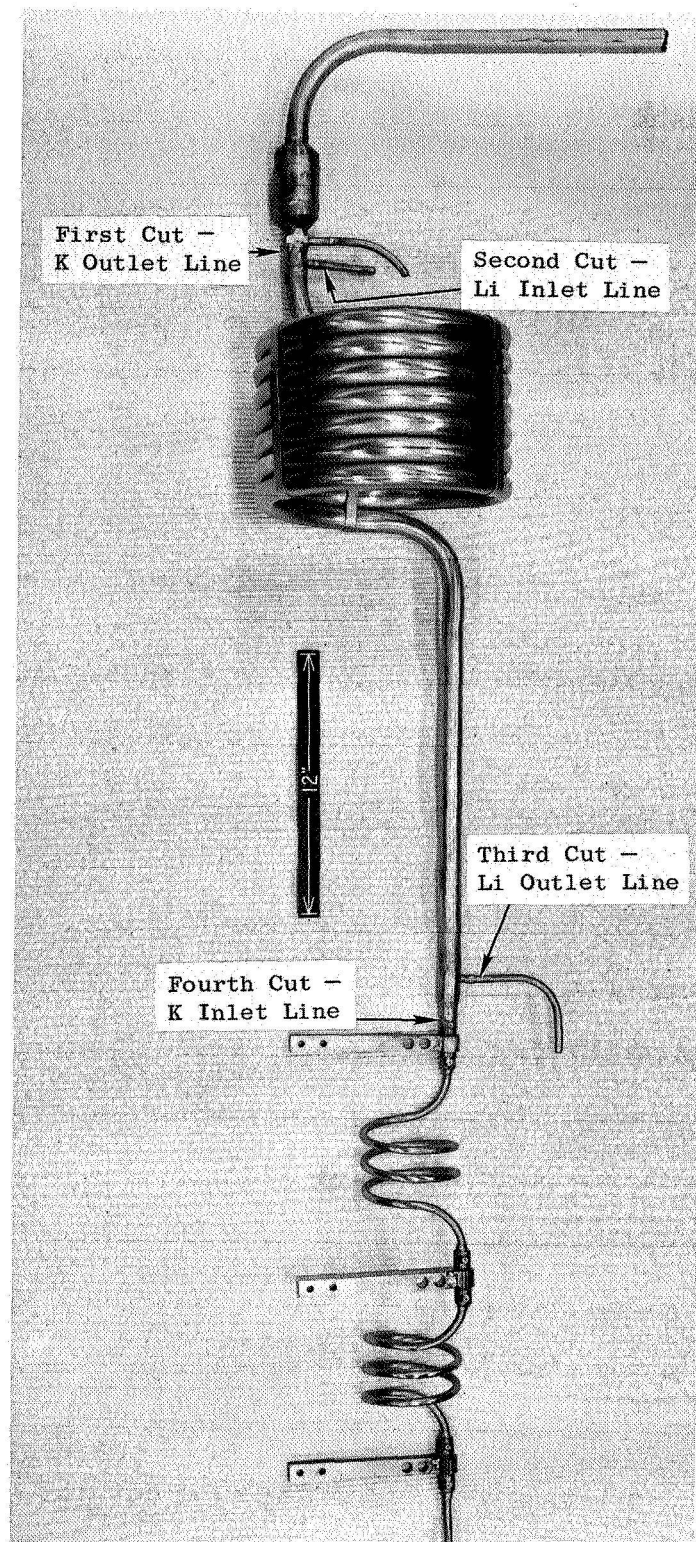
Since it could definitely be determined that the leak was not at the top weld and this was the only weld that could be repaired in place preparations were made to cut the boiler from the loop. Three additional cuts were required to remove the boiler: the lithium inlet line, the lithium exit line and the potassium inlet just above the top electrode as shown in Figure 10. The vinyl chamber was re-installed and the lithium inlet and outlet lines were cut and sealed. Similar techniques were employed as previously described with the exception of the seals on the boiler which were made with Swagelok fittings as shown in Figure 12. The Swagelok caps were substituted for the expandable plugs to facilitate subsequent attachment of the boiler to the cleaning apparatus for the removal of residual alkali metal. The final cut to remove the boiler was made at the potassium inlet. Tube wall thickness in this area, 0.250-inches, was too large for cutting with the tubing cutter. The wall thickness was therefore reduced by hand filing to 0.125 inches over a 0.750-inch length and V-grooved in the area to be cut to 0.050-inches prior to final cutting with the tubing cutter within the vinyl chamber. The boiler was removed from the loop on July 10, 1968.

Figure 10. Location of Tubing Cuts Made to Remove Boiler from Loop as Indicated on Boiler Assembly of T-111 Rankine System Corrosion Test Loop Before Final Assembly. (C67100412)

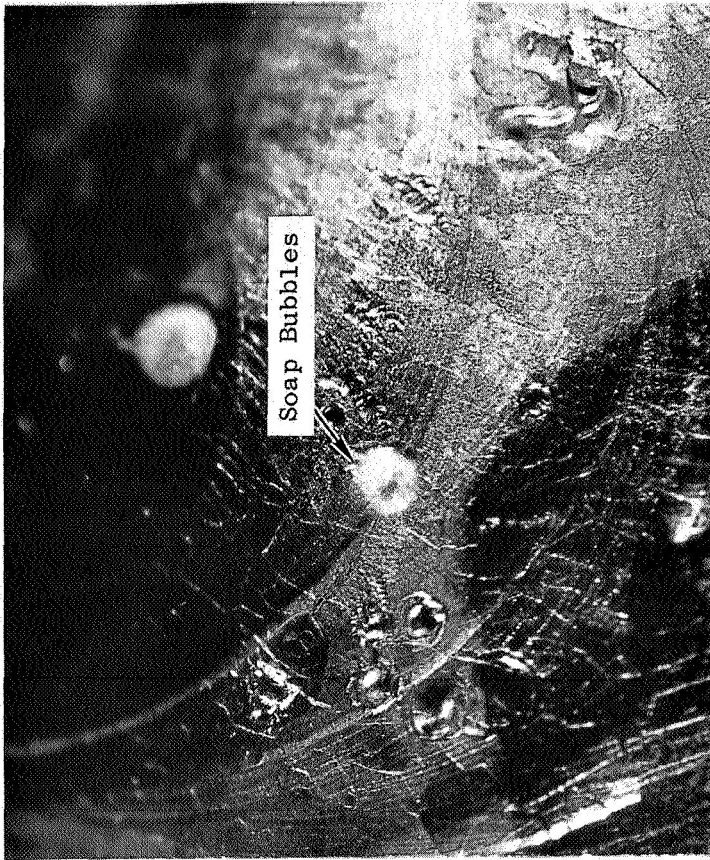
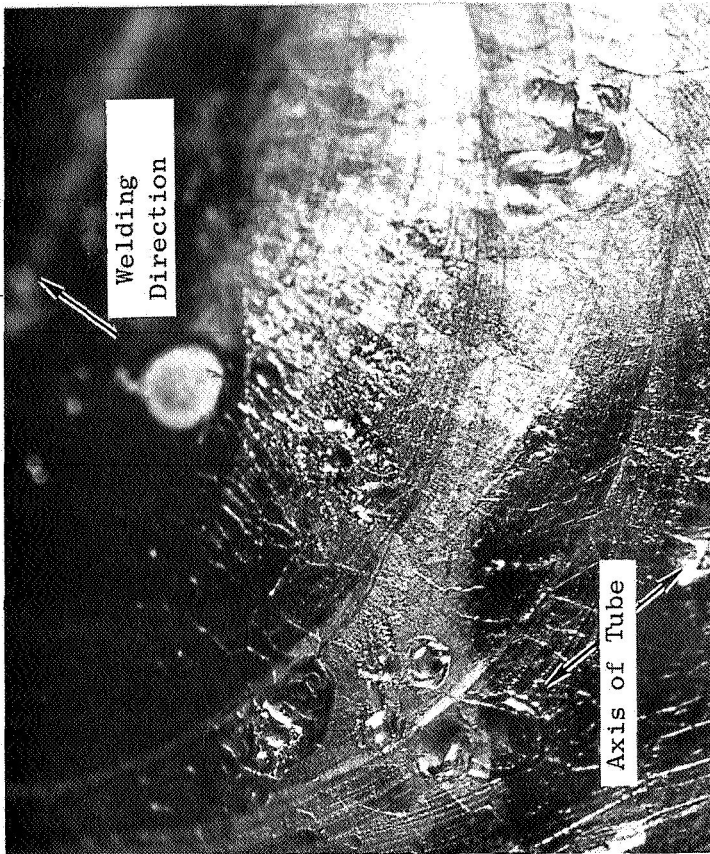
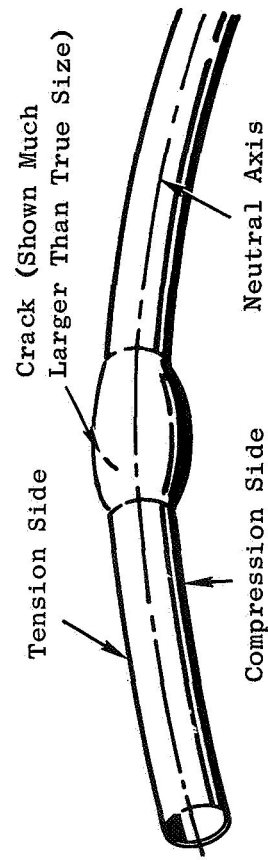
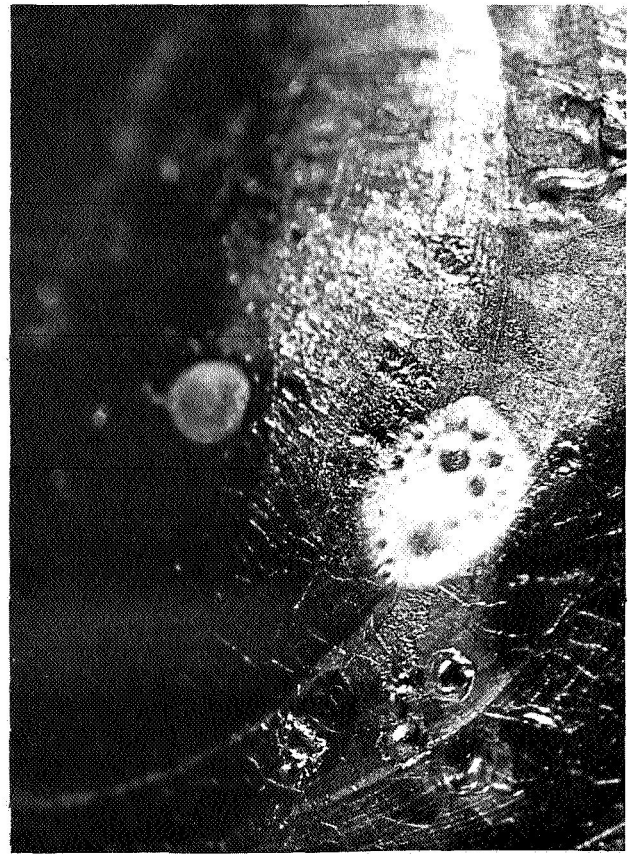
Examination at 30X magnification indicated the leak to be a minute intergranular crack in the weld nugget.

The tube was pressurized with air and the suspected leak area was coated with a soap film and observed at 30x magnification. Bubbles were observed at the leak as shown in Figure 13, and appeared to come from a hole; however, closer examination indicated a grain boundary crack as the source of the leak which is shown in Figure 14. Subsequently the weld nugget section was removed from the tube and ground longitudinally up to the crack area in preparation for metallographic examination. At this time a similar but much shorter crack was observed at 30x magnification on the ID of the tube.

Figure 13. Location of Leak in Weld Nugget of 0.375-Inch Diameter T-111 Tube Removed from Boiler. The Bubbles were Produced by Air Pressurization of Tube with a Soap Film Coating on OD. (C68081422, C68081423, C680814250 Mag.: 10X

- A. Complete the examination of the crack in the boiler tube to ascertain the failure mechanism.
- B. The location of the leak in the boiler was such that the boiler could be repaired by removal of one coil. The details of this approach will be recommended to the NASA Program Manager for approval.
- C. Metallographic examination and chemical analysis of T-111 samples removed from the boiler will be performed to qualify the boiler for possible reuse.
- D. Testing of the lithium thermal convection capsules will be initiated.

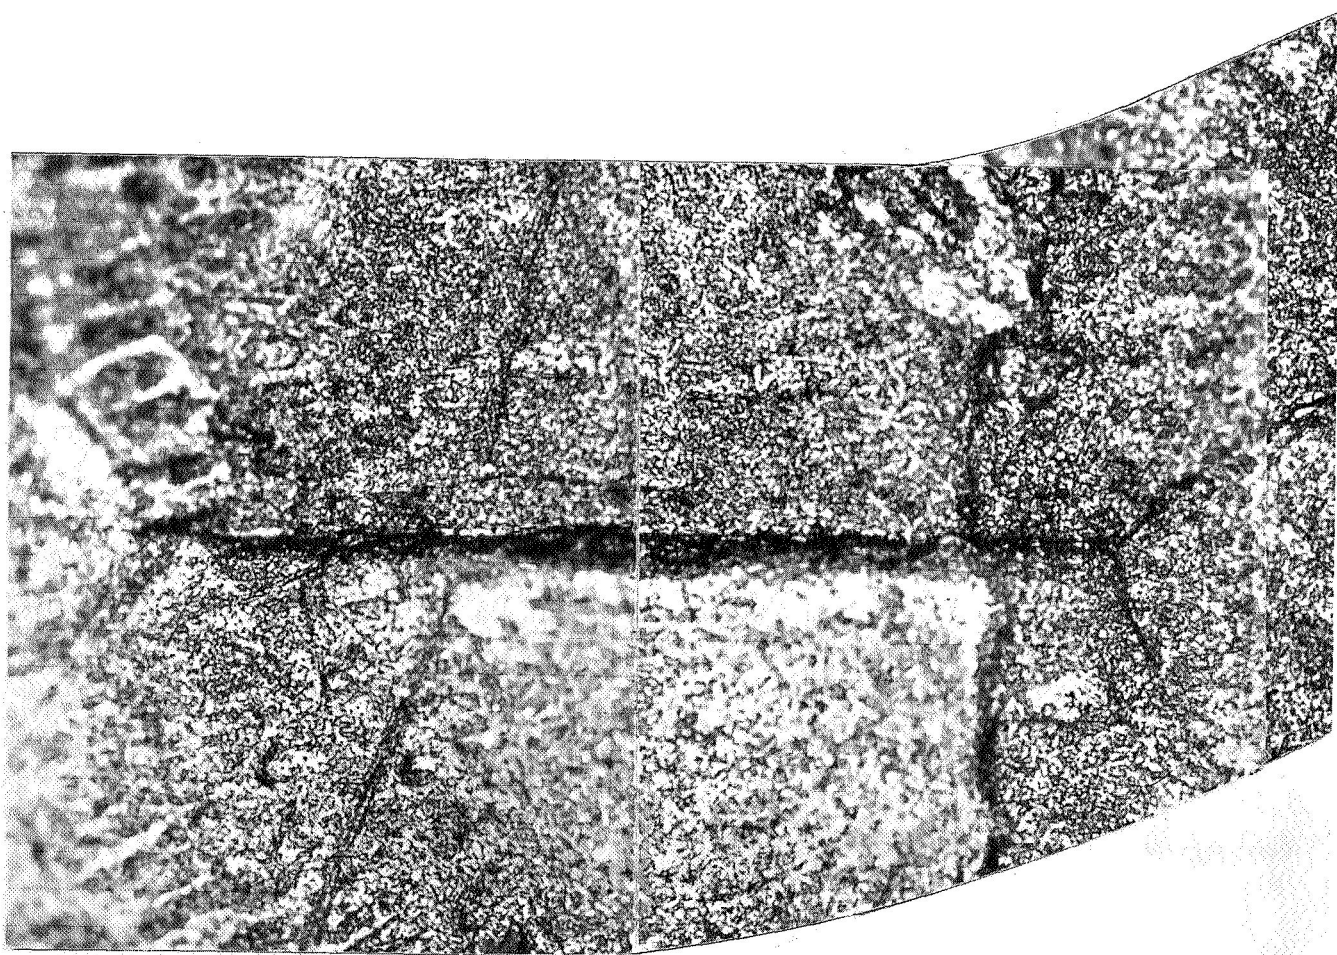
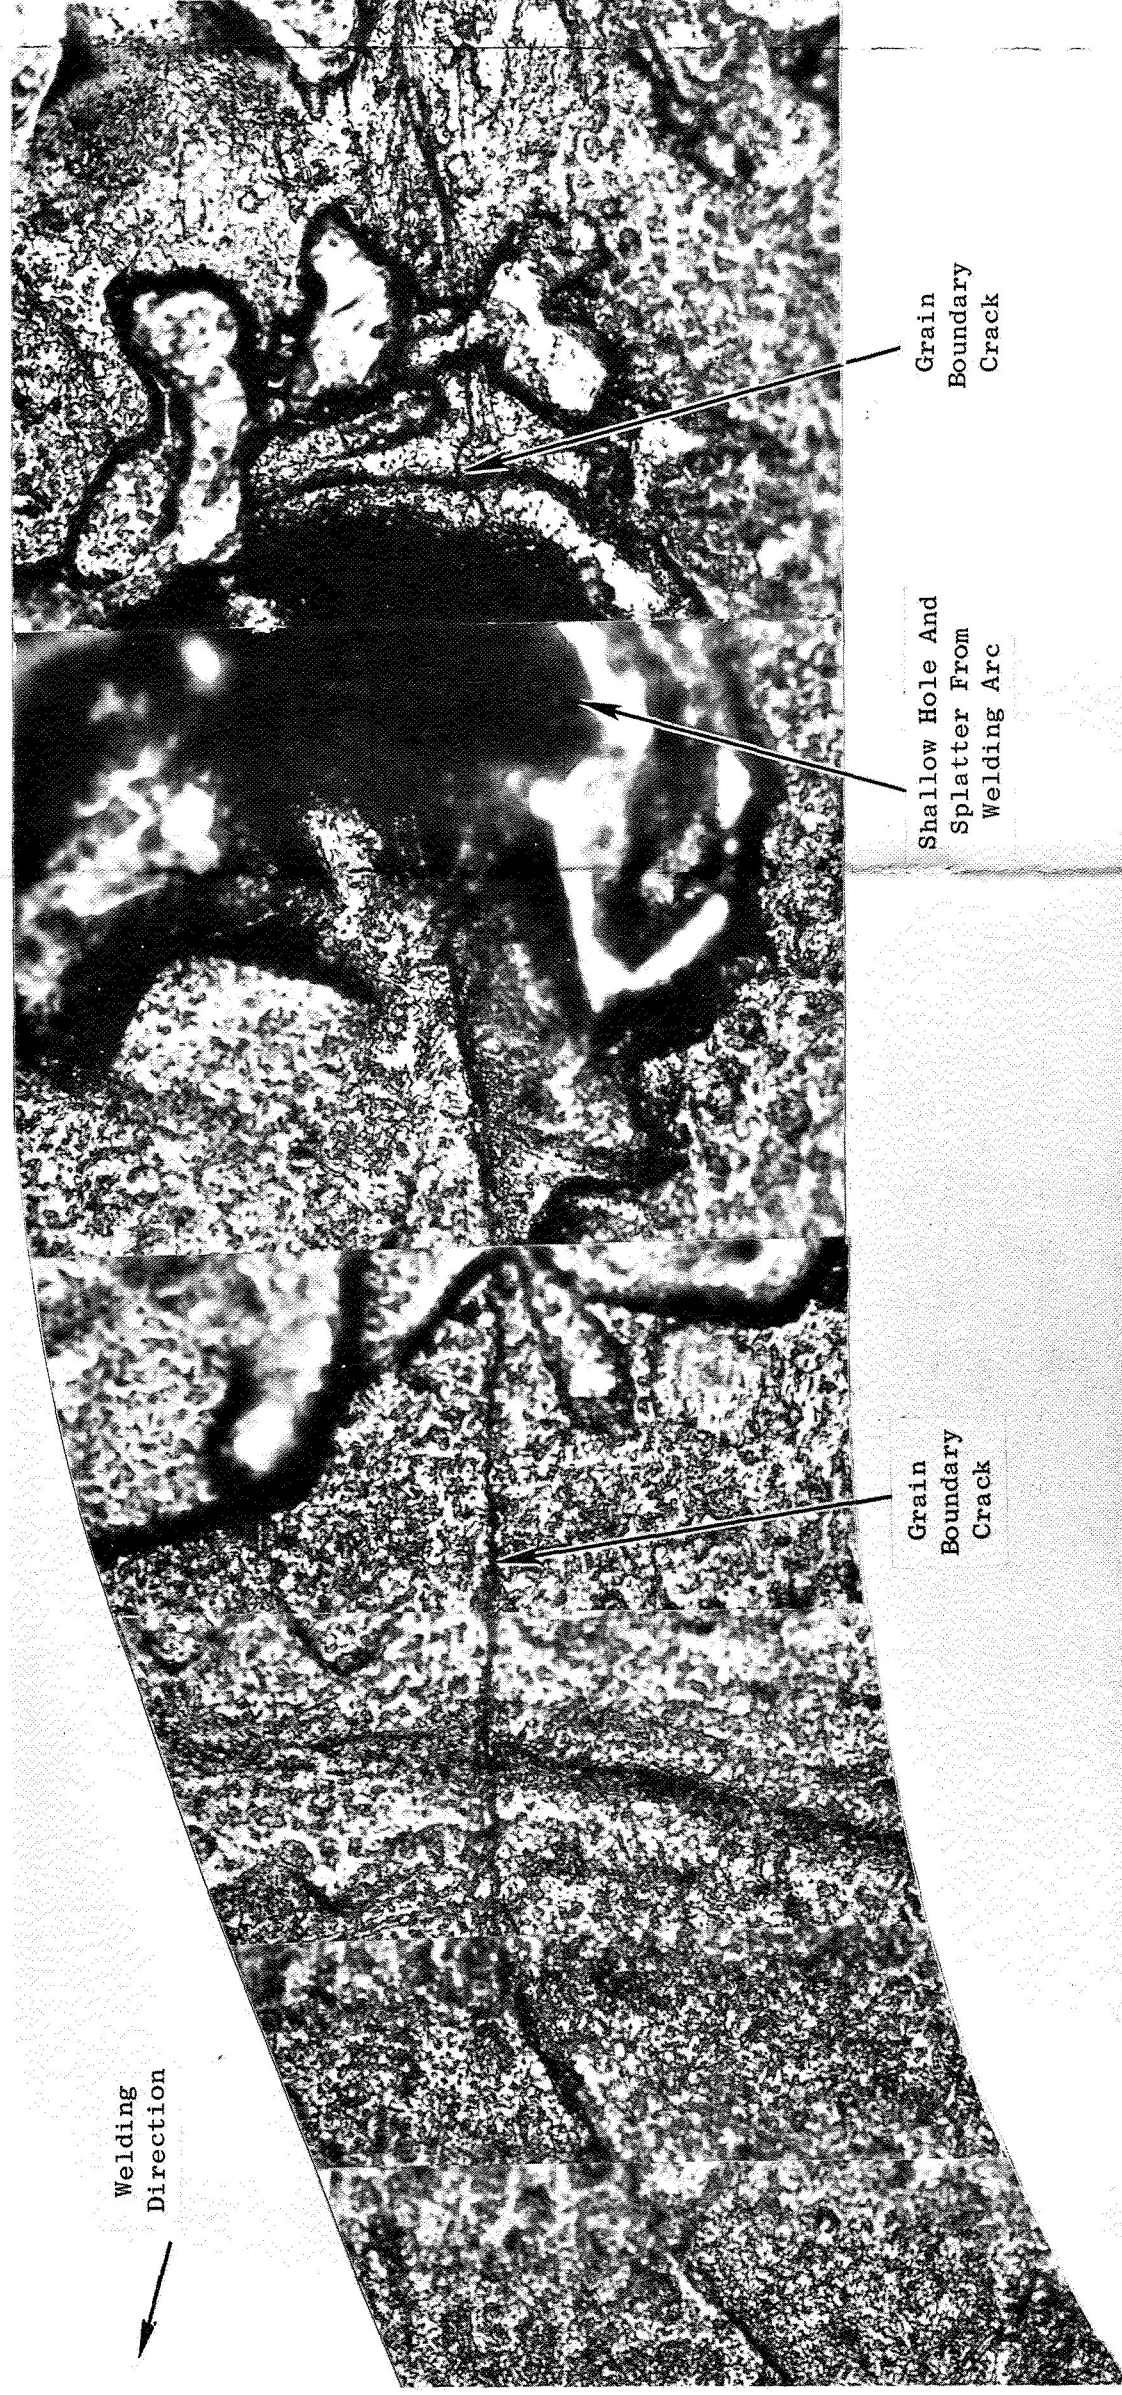
Figure 14. Grain Boundary Crack in Weld Nugget of 0.375-Inch Diameter Tube Responsible for Leak in the Boiler of T-111 Rankine System Corrosion Test Loop. (F92011-92018) Mag.: 500X
