HYDRAZINE ELECTROLYSIS CELL

SAFETY LIMITS TESTS

SUMMARY REPORT  
TASKS VII AND VIII  
JPL CONTRACT No. 951720  
3 JUNE 1969

HUGHES AIRCRAFT COMPANY  
SPACE SYSTEMS DIVISION  
EL SEGUNDO, CALIFORNIA

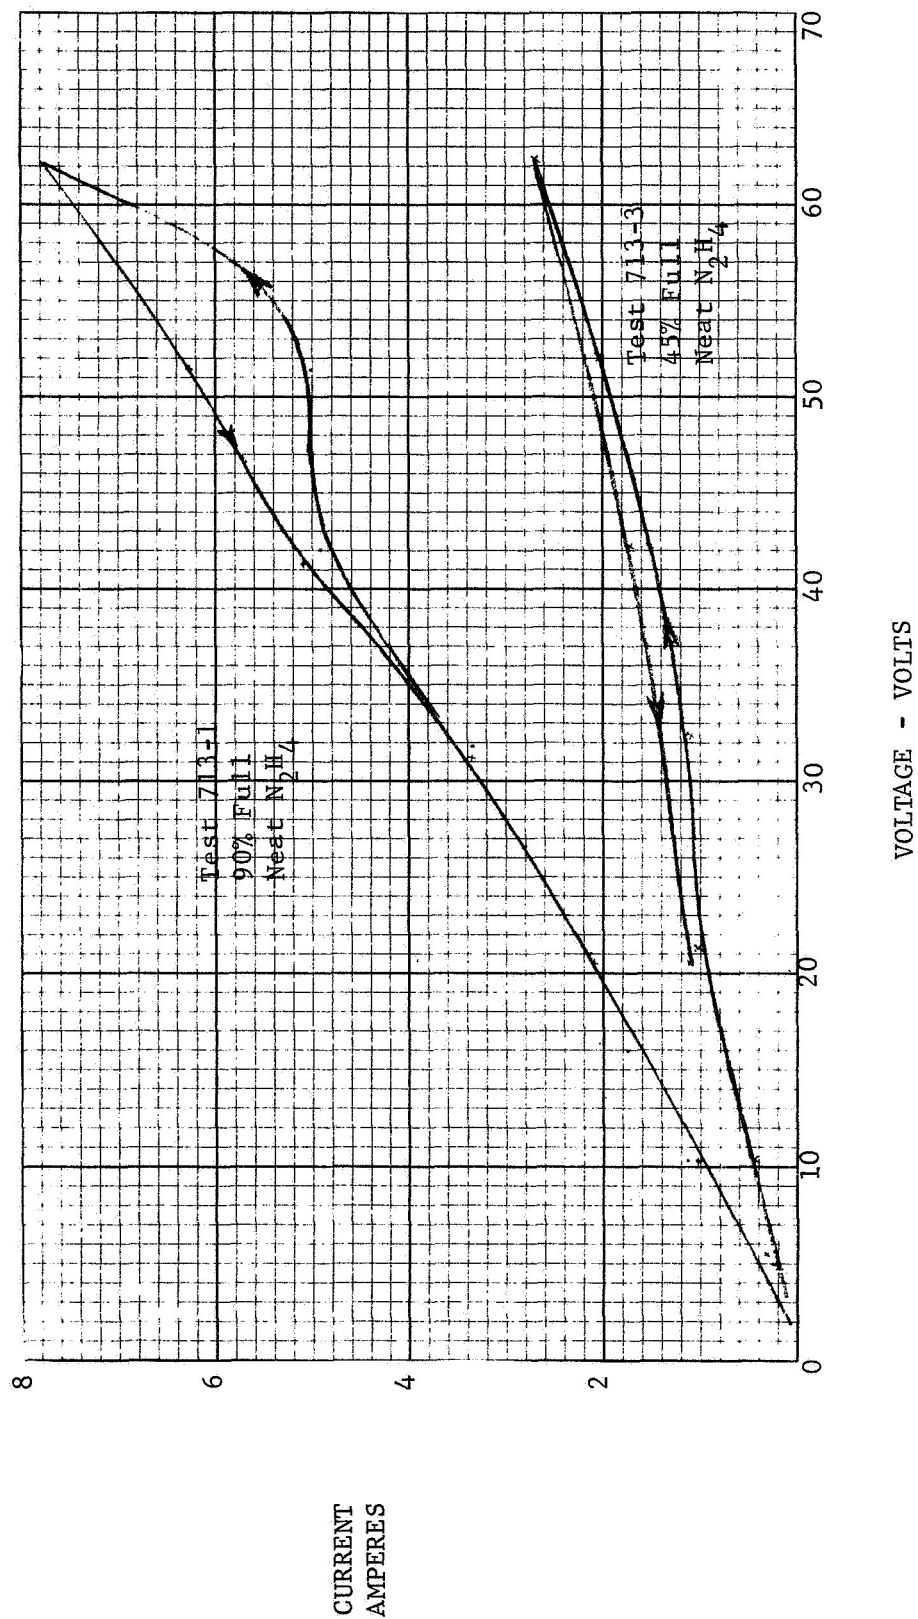
FIGURE 6

The low resistance value is attributed to a local area of the cathode screen being in a near short condition with the anode. This is based on the fact that the distance between cathode and anode is the largest resistance in the unit and is the only variable large enough to explain such a low reading.

After completion of propellant off-loading and leak testing, the voltage-current survey was started. Voltage was increased in steps up to 60V. Cell operation appeared normal and satisfactory. Data from this test are included in Appendix B, and the current-voltage data are plotted in the lower curve of Figure 6.

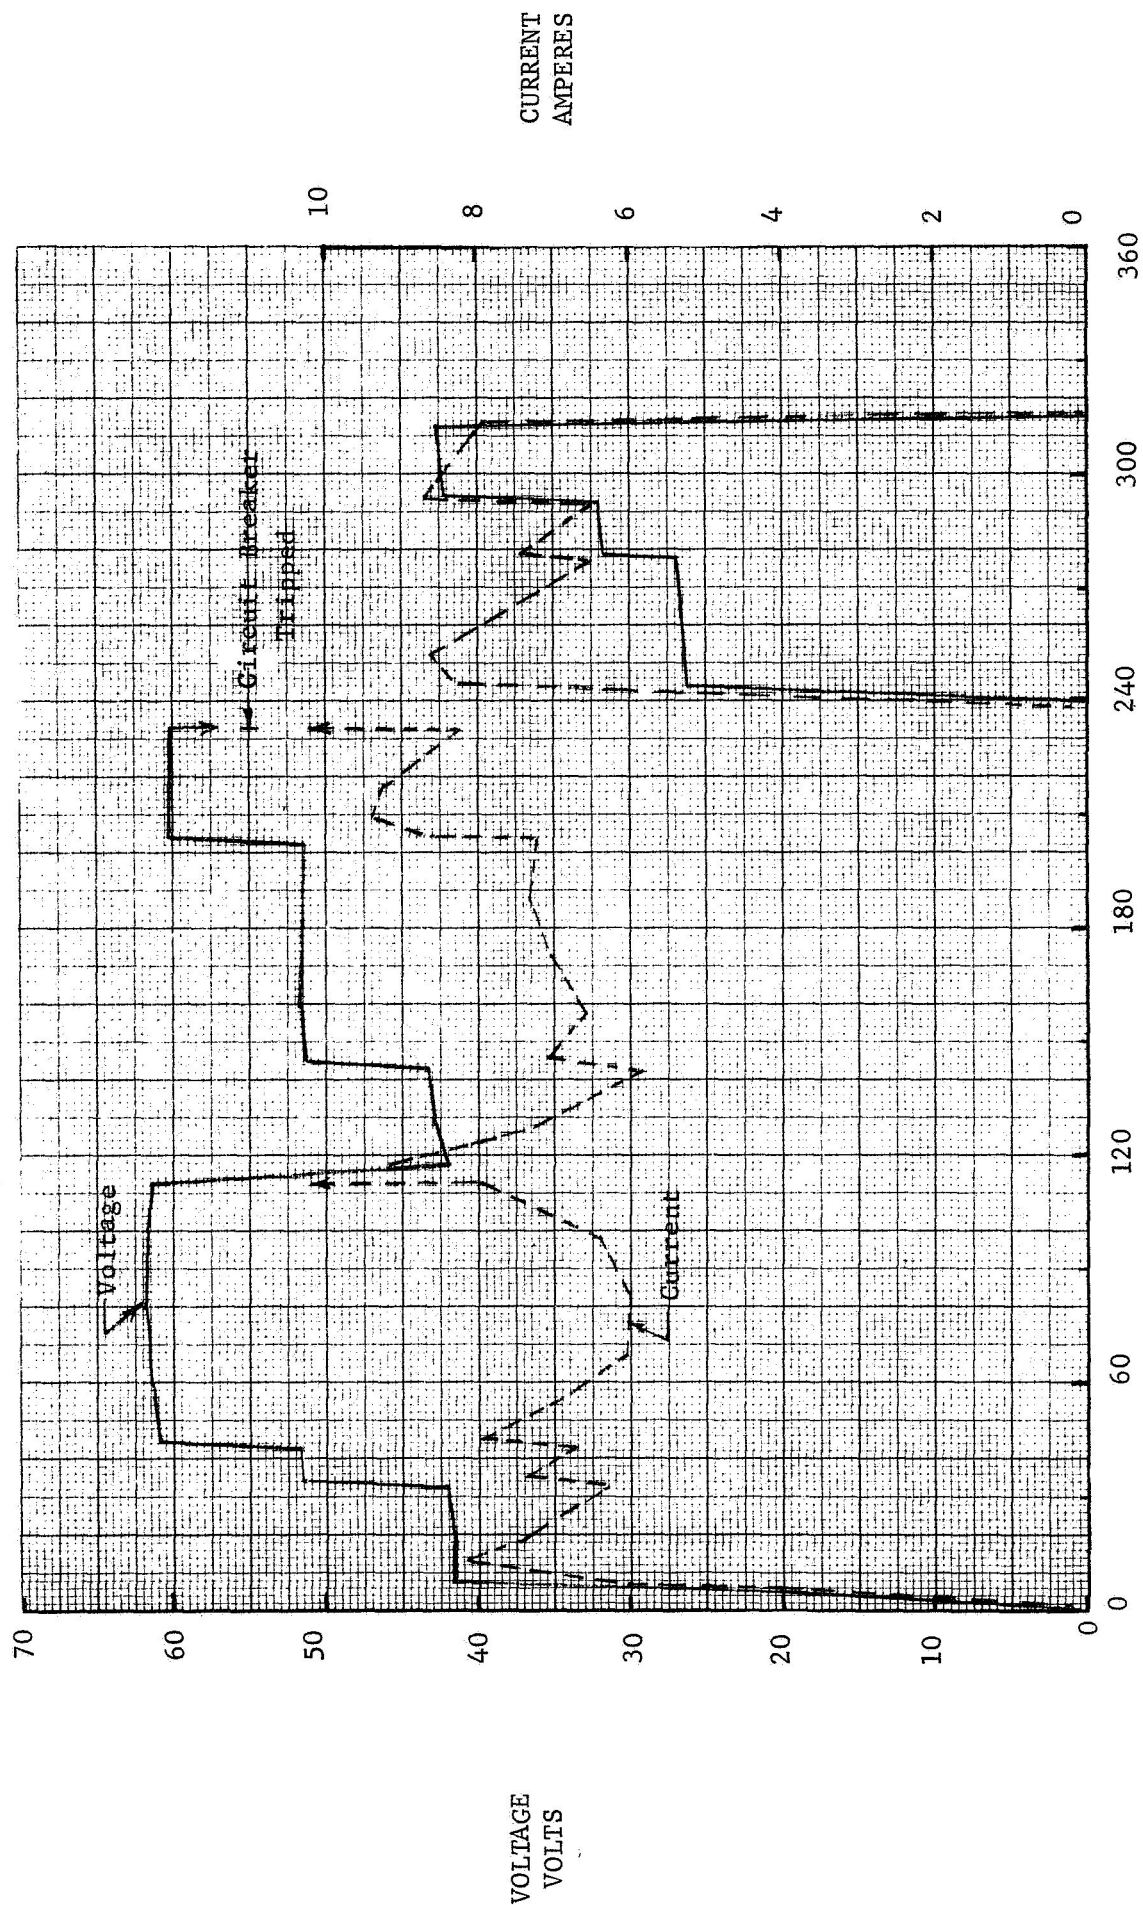
FIGURE 7

During this test an unexpected current increase occurred on two occasions. After 118 minutes of operation it was noted that the current was increasing and exceeded 10 amperes. This necessitated a reduction of voltage to keep the current below that value. Later in the test, the current suddenly increased and tripped the 15 ampere circuit breaker on the power supply. This current surge was coincident with the first vent cycle of the system relief valve.

These current surges were probable due to the near-short area of the cathode contacting the anode. It could have been caused by higher pressure, deformation of the screen at much higher temperatures, or the action of gas bubbles when the relief valve opened.

VOLTAGE-CURRENT HISTORY - TEST NO. 713-2

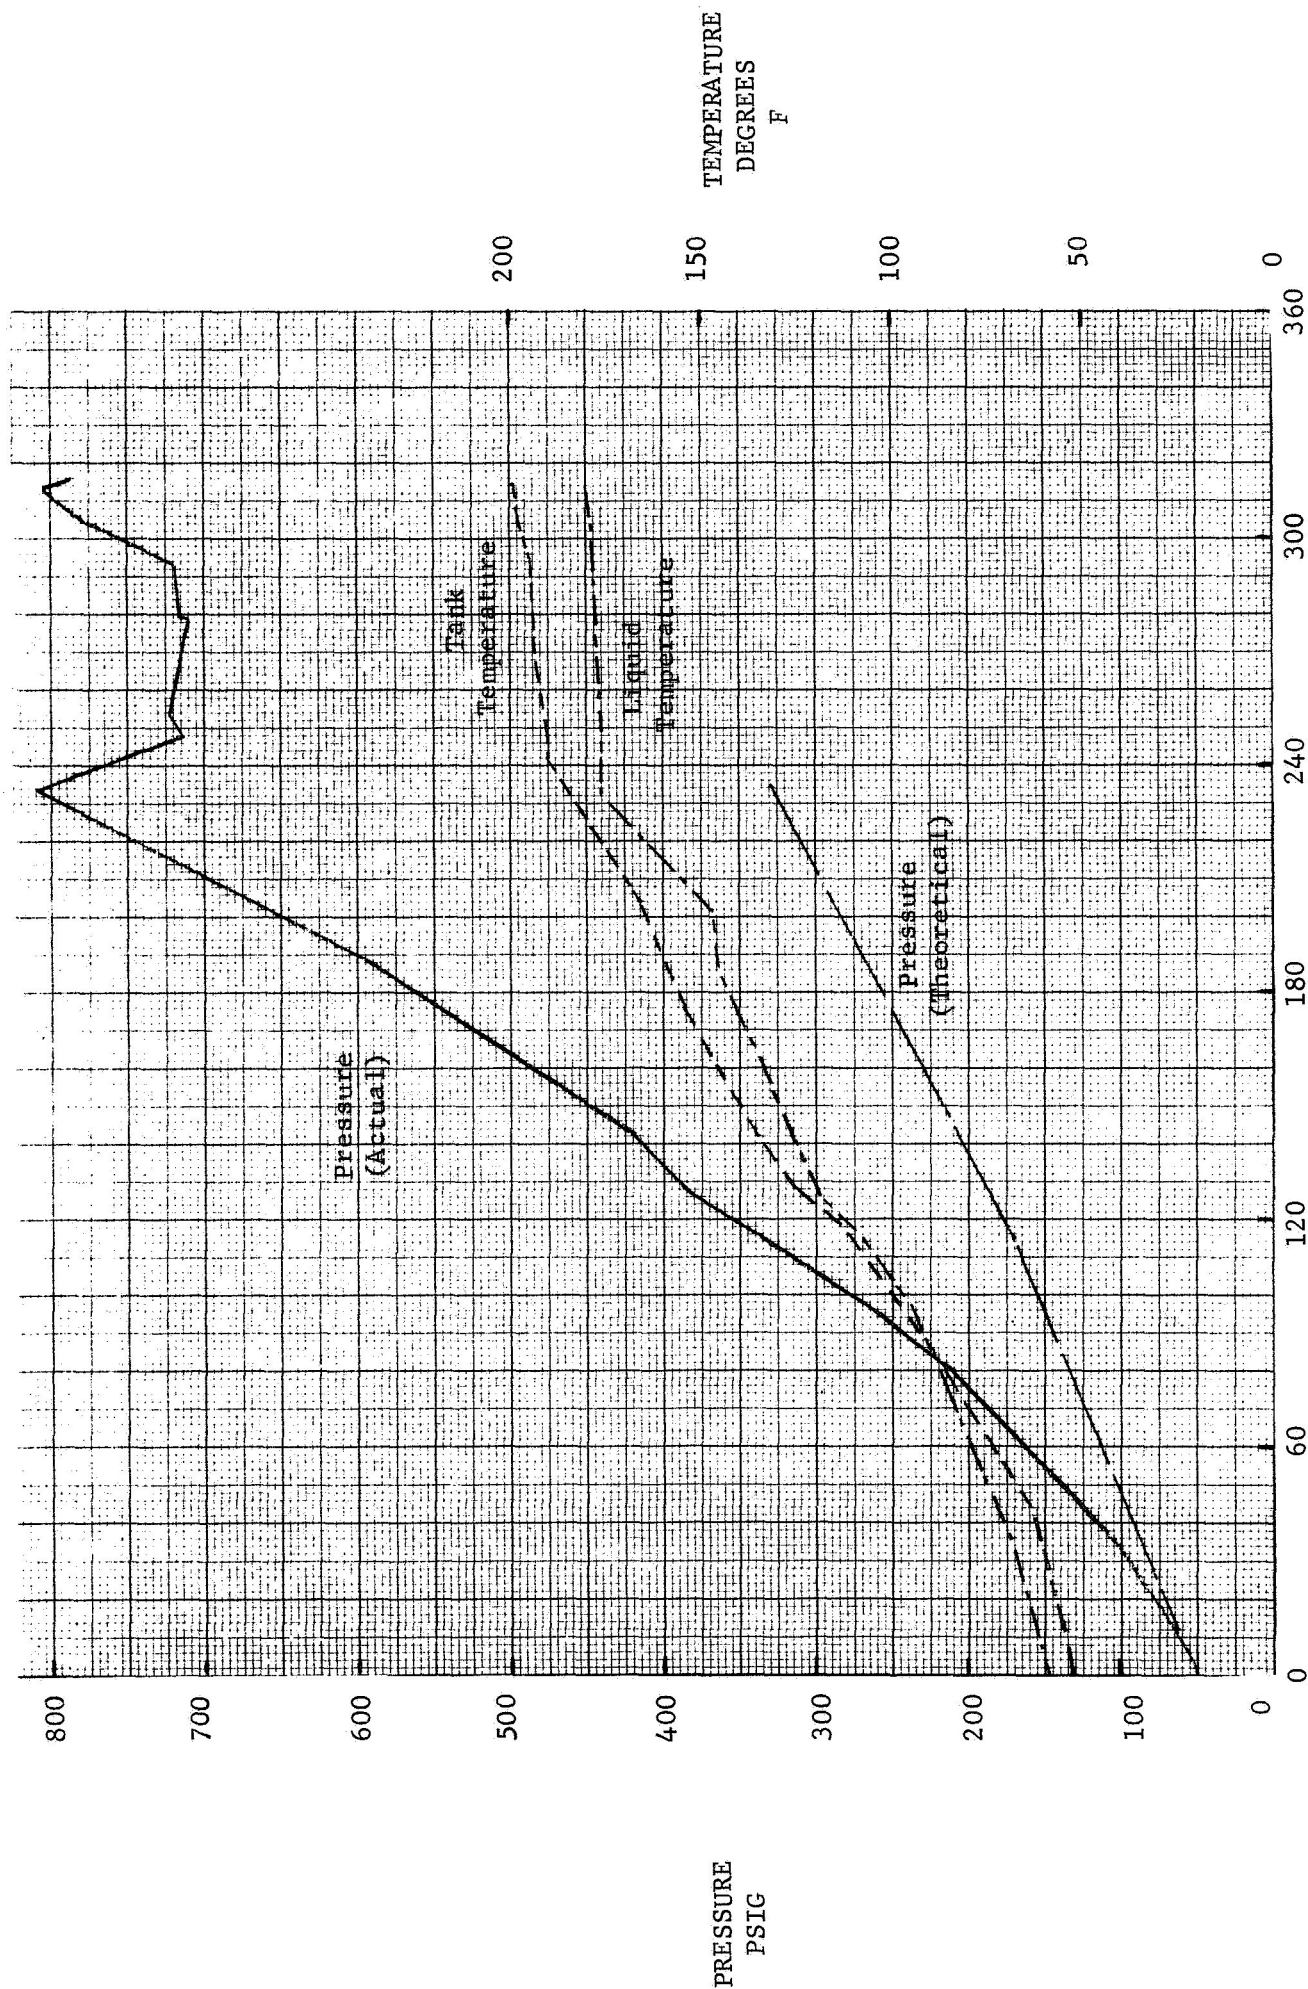
FIGURE 8

# PRESSURE TEMPERATURE HISTORY - TEST NO. 713-2

Aside from these events the operations of the cell appeared to be normal throughout this test. However, later analysis of the data showed that the actual pressure rise during the first 238 minutes of this test (i.e., up to the time the relief valve first vented) was much greater than could be accounted for by temperature rise and electrolytic gas generation. For reference purposes the pressure increase due to these two factors is plotted in Figure 8. For further discussion of this abnormal pressure rise and current surges see paragraph on "Failure Investigation".

During the test of the day preceding the cell failure, erroneous pressure data had been acquired because of a decimal error in reading pressure on the digital voltmeter used for displaying all the parameters from this test. This error occurred because a single digital voltmeter was used to display each of the five parameters (voltage, current, tank temperature, liquid temperature, and pressure) by selecting the desired parameter with a selector switch. When switching from one parameter to another it was necessary to mentally relocate the decimal point because of differing sensitivity of signal conditioning equipment in the various channels. This led to confusion and resulted in an error when initially pressurizing the tank prior to Test 713-2. This error was carried through the rest of that test and was not detected until the following day when pressurizing the tank to perform a leak test. These erroneous pressure data were identified and corrected prior to test 713-3 and hence have no direct bearing on the failure other than the tank's being exposed to higher pressures than had been planned on the day before failure occurred. However, these overpressure conditions still did not exceed the stress-temperature conditions of the proof test.

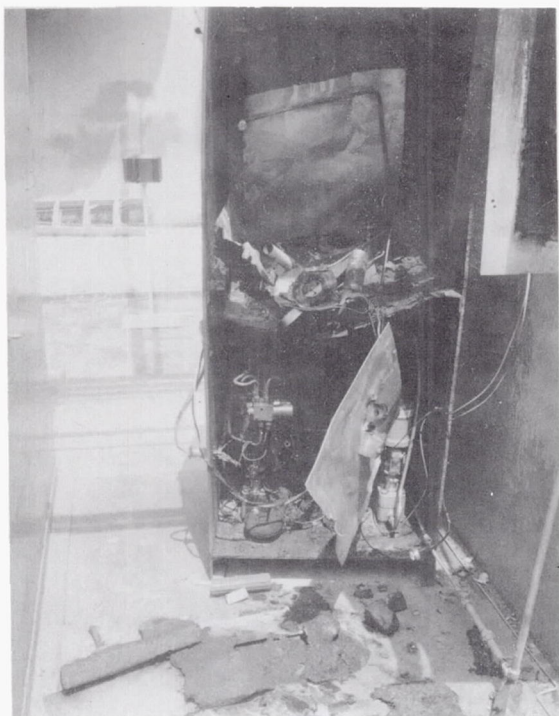
FIGURE 9

After recording the data on 60V, the voltage was lowered to 40V, data was recorded there then lowered to 20V. While recording data at 20V, it was observed that the temperatures were rising very rapidly (see notes on data sheet in Appendix B). Before the pressure data channel could be selected to obtain a reading of pressure, the tank ruptured. The electrolysis cell and test chamber were severely damaged by the force of the explosion and the subsequent fire, which was fed largely by the thermal insulation of the test chamber.

TEST CHAMBER  
AFTER FAILURE

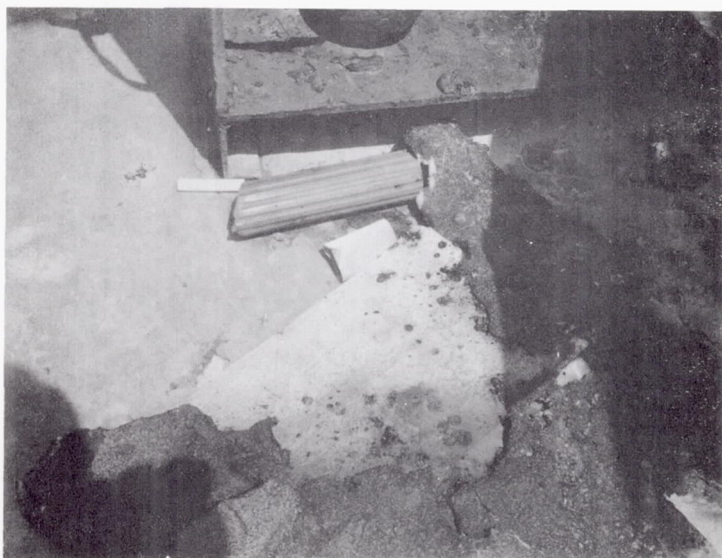
FIGURE 10

ANODE AND OTHER PARTS  
AT BASE OF TEST  
CHAMBER

2. Anode - Found on ground just below chamber with lower 1 to 2 inches missing. Fragments of anode were found scattered on hillside up to approximately 20 feet from chamber.

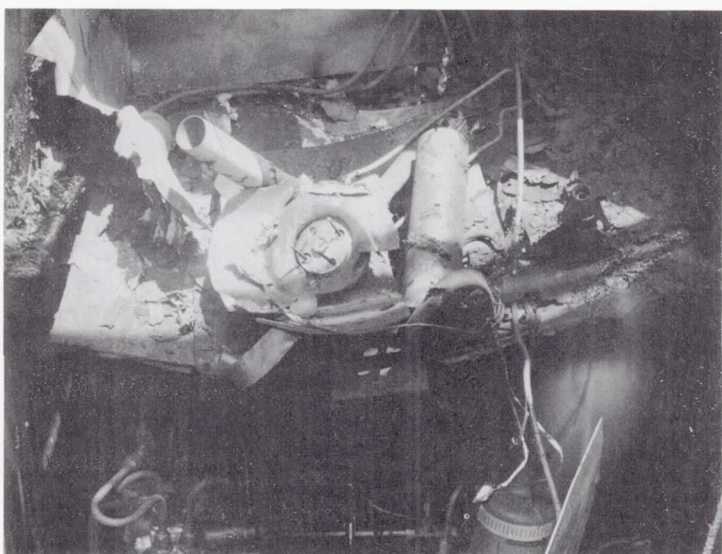
FIGURE 11

TANK FLANGE,  
INNER AND OUTER  
ELECTRODE ENCLOSURES

- a. The outer enclosure of the electrode module was bulged out locally at its lower edge from a high internal pressure. This was a very local condition. The remainder of the part was still round and relatively undamaged except for the top edge being torn out at the attachment screw hole.
- b. The inner enclosure of the electrode module was collapsed inwardly at its lower end from an external force. Some metal was missing from along one side of the lower edge.
- c. The lower 1 to 2 inches of the anode were shattered into many small fragments, but the remainder of the part was still intact.
- d. Many pieces of the cell were found scattered on the hillside up to 20 feet away. Some of these showed damage from heat, while others did not.

The available evidence indicates that a reaction sufficiently violent to damage the aluminum inner and outer enclosures and shatter the lower end of the anode occurred between the inner and outer enclosures. Based on the orientation of the parts, the location of the reaction was established near to the bottom of the cell and also near the surface of the main body of liquid in line with the cathode connector.

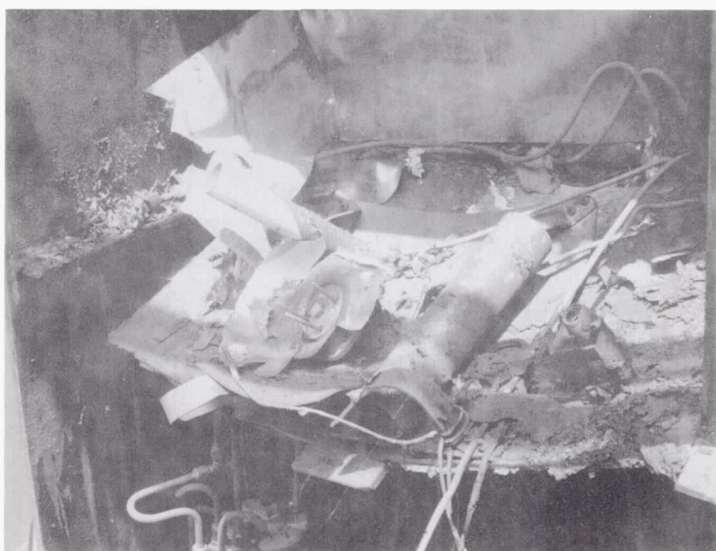
FIGURE 12

PARTS OF ELECTROLYSIS  
CELL REMAINING  
IN TEST CHAMBER

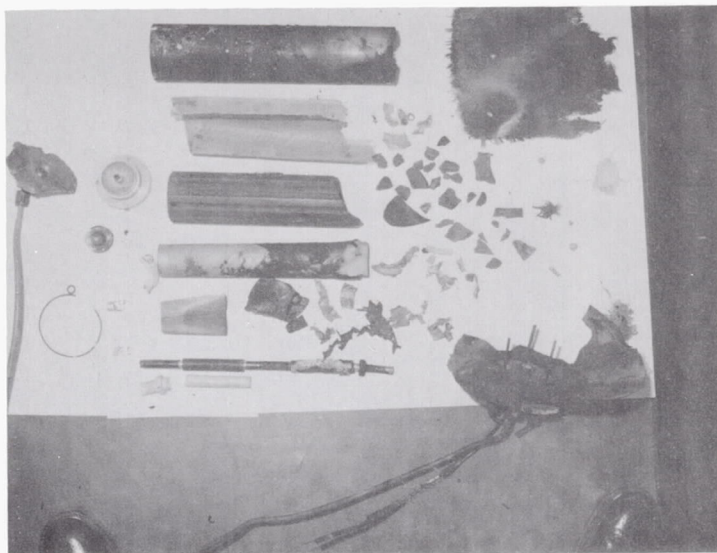
FIGURE 13  
ELECTROLYSIS CELL PARTS  
AND FRAGMENTS

A cathode screen hot-spot is the only mechanism that fits all the evidence. It accounts for low resistance in a near-short condition; it explains the additional gas generation above prediction and why it increases with higher power; it explains the two current surges as shorts; and it explains the failure occurring during the second day rather than the first day, since the area in question is above the assumed propellant level in the electrolysis cell as evidenced by the failed hardware description.

The most probable cause of the near-short condition is the loose edge wires on the screen digging into or between the loose weave of the wick. This condition has occurred at least once before when a low resistance (5 ohms) was recorded. At normal cell power levels it would not be a serious problem. Most of the power dissipation would occur at this point. When the liquid level was above this point, as in Test 713-2, it apparently kept the temperature under control, but the temperature was still high enough to decompose hydrazine. When the liquid level was dropped for Test 713-3 this area quickly heated out of control. (5 minutes above 40 volts) The wick retained liquid to allow current flow.
