EIGHTH QUARTERLY REPORT  
EVALUATION TESTING OF PROTECTIVE  
COATINGS ON REFRACTORY METALS

September 1969

CONTRACT NAS 7-460

TRW SYSTEMS GROUP

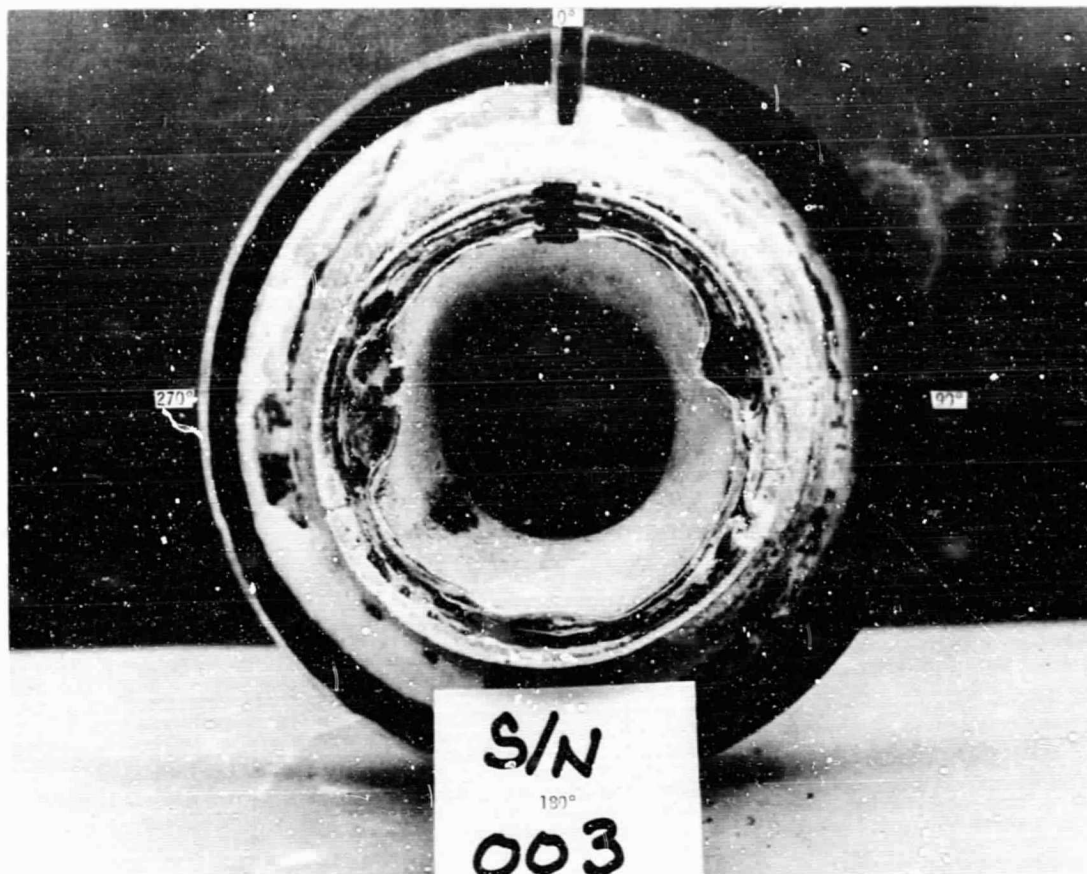
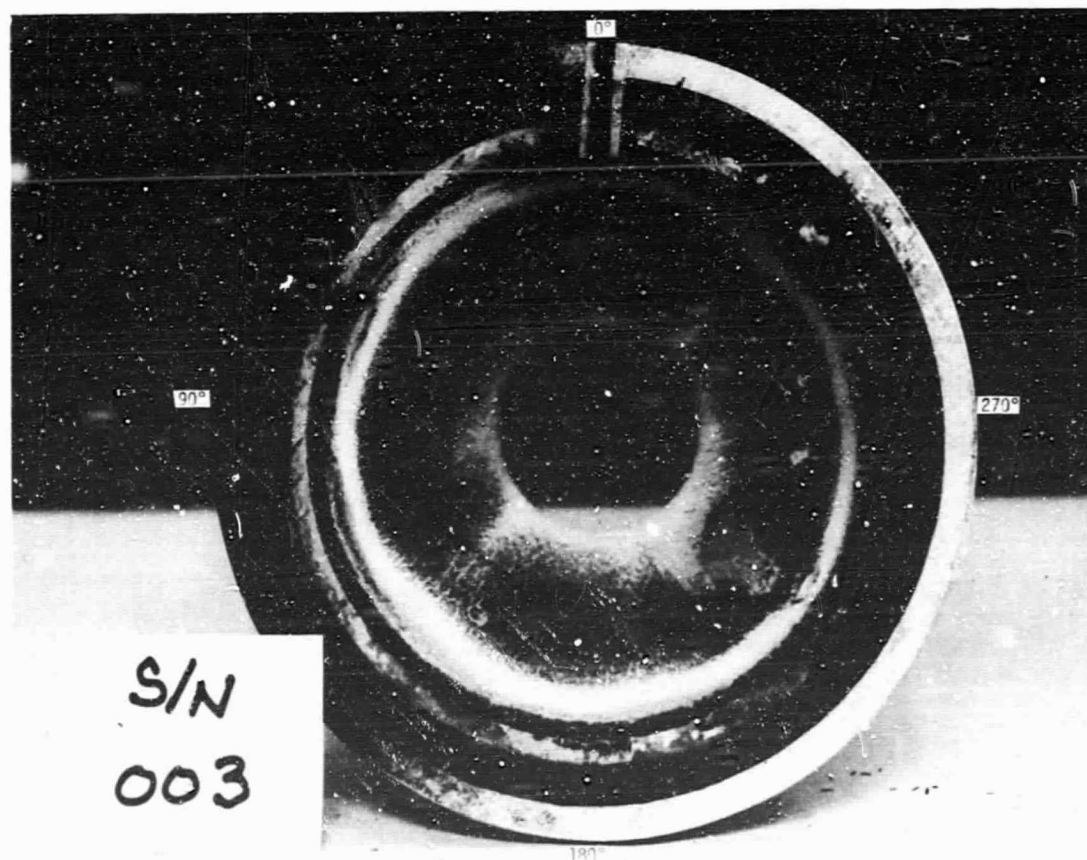
Figure 1. Post-Test Condition of S/N 003 - 1000 sec at 4500°F

| TEST DESCRIPTION | | | | | | |
|---|---|---|---|---|---|---|
| S/N003 | HF-20Ta Clad, Ta Barrier | .854 | 145 | 1.20 | 144 | Nozzle in servicable condition after 1000 sec. duration at 4500°F. Gross clad separation at exit. Craters are starting to develop on convergent section inside & outside. |

| Test Specimen S/N | Coating | Target Combustion Temperature | Firing Time sec. | No. of Starts | Comments |
|---|---|---|---|---|---|
| 003 | Hf-20Ta Clad, Ta Barrier | 4500°F | 10 | 1 | Nozzle in serviceable condition. Gross clad separation at exit. Craters are developing on convergent section inside and outside |

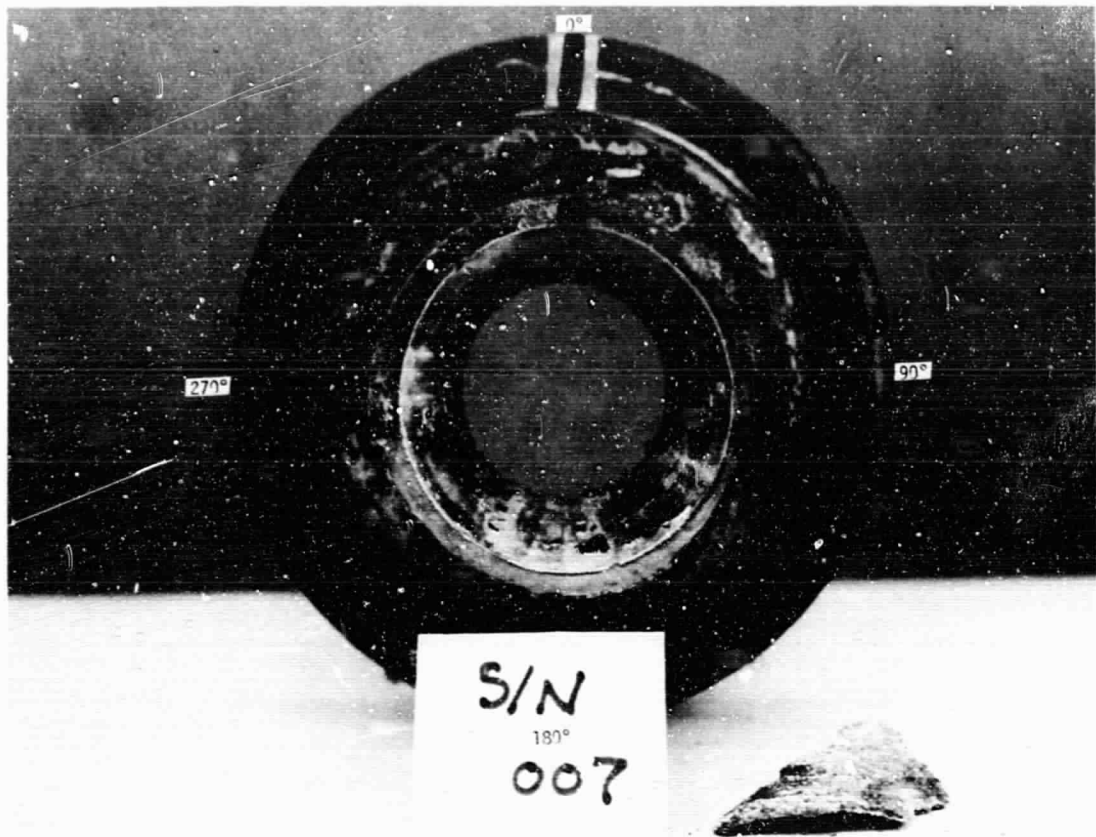
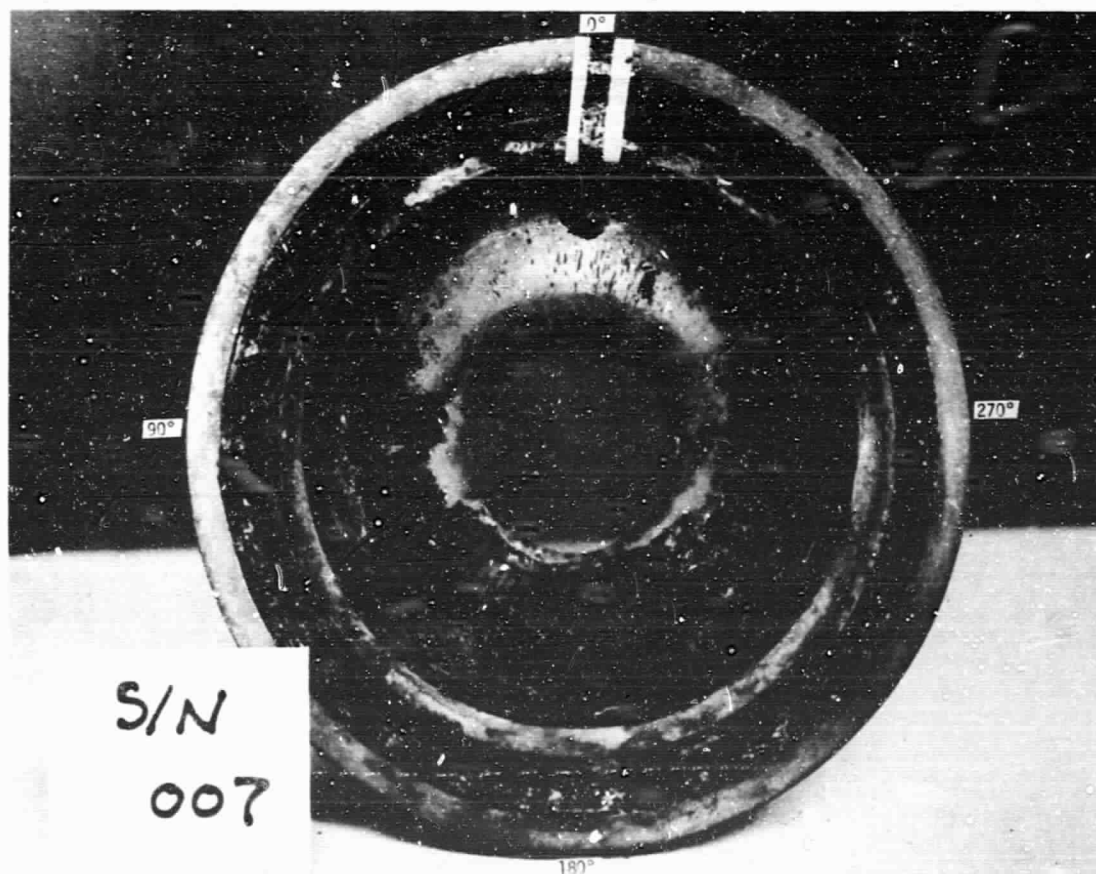
Figure 2. Post-Test Condition of S/N 007 - 63 sec at 4500°F

| TASK | MATERIAL TYPE OR<br>PURPOSE OF TESTS | Target Combustion<br>Temperature of 4000°F | | Target Combustion<br>Temperature of 4500°F | | SPECIMEN FAILURE COMMENTS |
|---|---|---|---|---|---|---|
| S/N 007 | Ir | .886 | 144 | 1.20 | 145 | Nozzle burnout at throat at 120° orientation after 63 sec. duration at 4500°F. Extensive substrate oxidation on inside and outside. Much of exterior coating has spalled off and remaining coating is badly cracked and blistered. |

| Test Specimen S/N | Coating | Target Combustion Temperature | Firing Time sec. | No. of Starts | Comments |
|---|---|---|---|---|---|
| 007 | Ir | 4500°F | 10 | 1 | Nozzle burnout at throat at 120° orientation. Extensive substrate oxidation on inside and outside. Much of exterior coating has spalled off and remaining coating is badly cracked and blistered. |

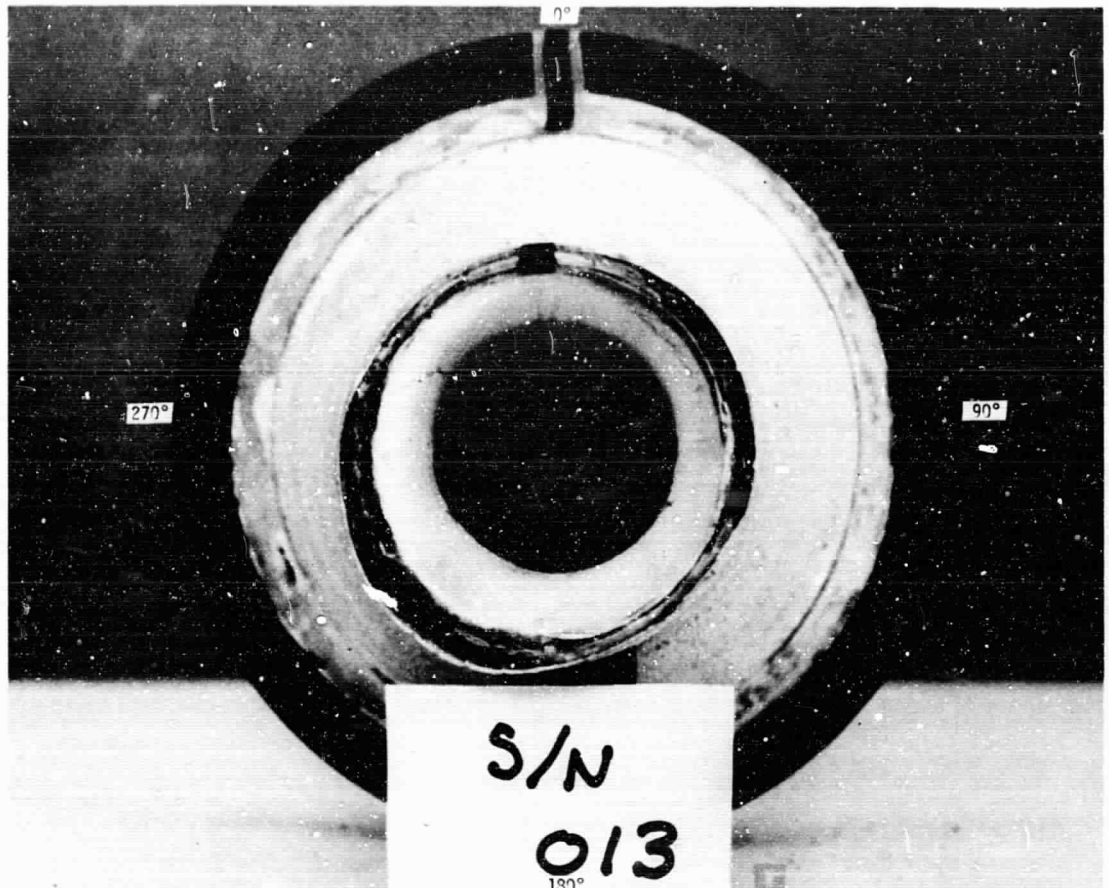
Figure 3. Post-Test Condition of S/N 013 - 1000 sec at 4500°F

| TASK | MATERIAL TYPE OR<br>PURPOSE OF TESTS | Target Combustion<br>Temperature of 4000°F | | Target Combustion<br>Temperature of 4500°F | | SPECIMEN FAILURE COMMENTS |
|---|---|---|---|---|---|---|
| S/N 013 | Hf-20Ta-clad, Cb barrier | 1.55 | 135 | 1.19 | 144 | Nozzle in good condition after 1000 sec. duration at 4500°F. Some clad separation at exit but otherwise cladding is intact. |

| Test Specimen S/N | Coating | Target Combustion Temperature | Firing Time sec. | No. of Starts | Comments |
|---|---|---|---|---|---|
| 013 | Hf-20Ta Clad, Ta Barrier | 4500°F | 5 | 1 | Nozzle in good condition. Some clad separation at exit but otherwise cladding is intact. |

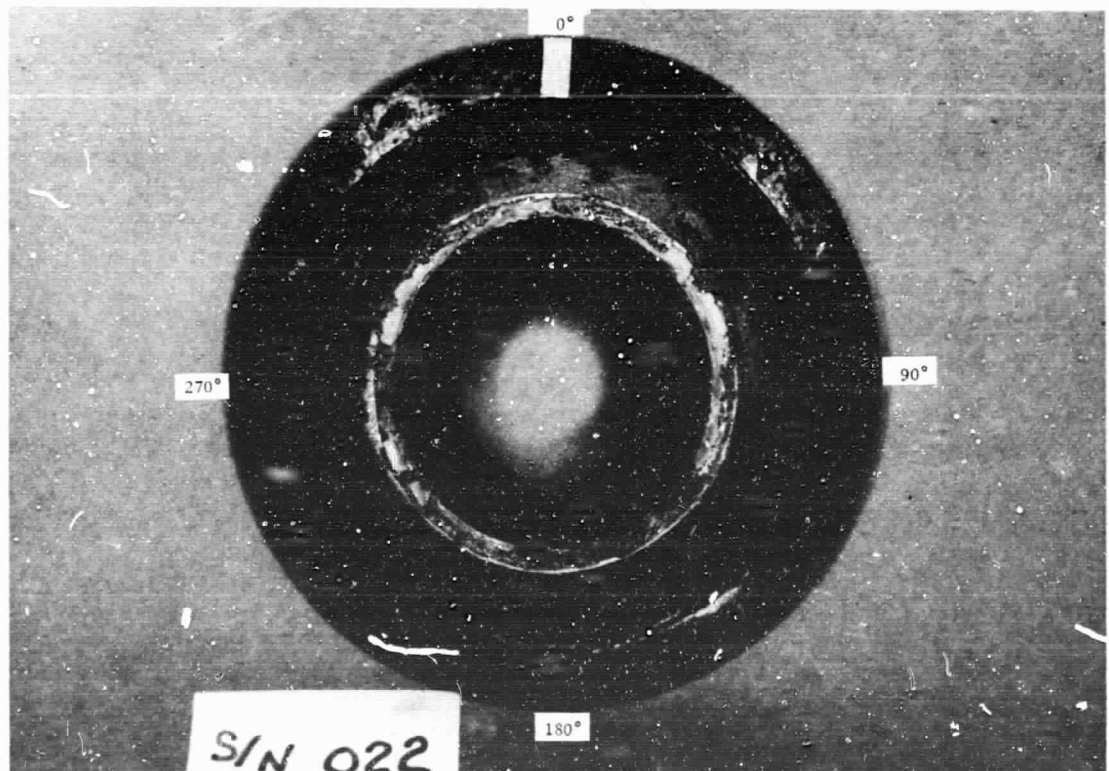
Figure 4. Post-Test Condition of S/N 022 - 480 sec at 4000°F

| TASK | MATERIAL TYPE OR<br>PURPOSE OF TESTS | Target Combustion<br>Temperature of 4000°F | | Target Combustion<br>Temperature of 4500°F | | SPECIMEN FAILURE COMMENTS |
|---|---|---|---|---|---|---|
| S/N 022 | Ir/Re | .85 | 144 | DNA | DNA | Extensive spalling of coating on exterior and subsequent oxidation of substrate after 480 sec. duration at 4000°F. Internal spalling of coating at throat. |

| Test Specimen S/N | Coating | Target Combustion Temperature | Firing Time sec. | No. of Starts | Comments |
|---|---|---|---|---|---|
| 022 | Ir/Re | 4000°F | 10 | 1 | Extensive spalling of coating on exterior and subsequent oxidation of the substrate. Internal spalling of coating at throat region from 170° to 260°. |

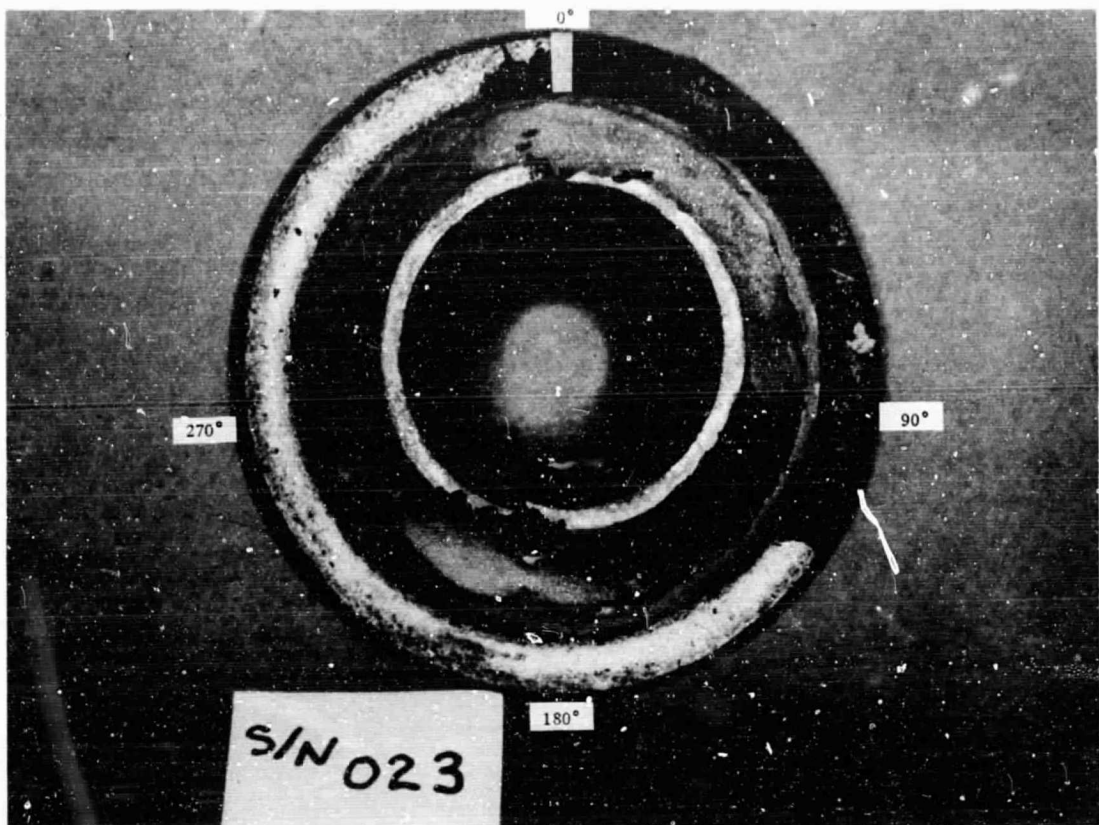
Figure 5. Post-Test Condition of S/N 023 - 670 sec at 4000°F

| TASK | MATERIAL TYPE OR<br>PURPOSE OF TESTS | Target Combustion<br>Temperature of 4000°F | | Target Combustion<br>Temperature of 4500°F | | SPECIMEN FAILURE COMMENTS |
|---|---|---|---|---|---|---|
| S/N 023 | Ir/Re | .89 | 151 | DNA | DNA | Nozzle burnout at throat at 200° orientation after 670 sec. duration at 4000°F. Gross coating spalling and oxidation of substrate on exterior. |

| Test Specimen S/N | Coating | Target Combustion Temperature | Firing Time sec. | No. of Starts | Comments |
|---|---|---|---|---|---|
| 023 | Ir/Re | 4000°F | 10 | 1 | Burnout downstream of throat at 200°. Gross coating spalling and oxidation of substrate on exterior. Internal coating surfaces are in good condition. |

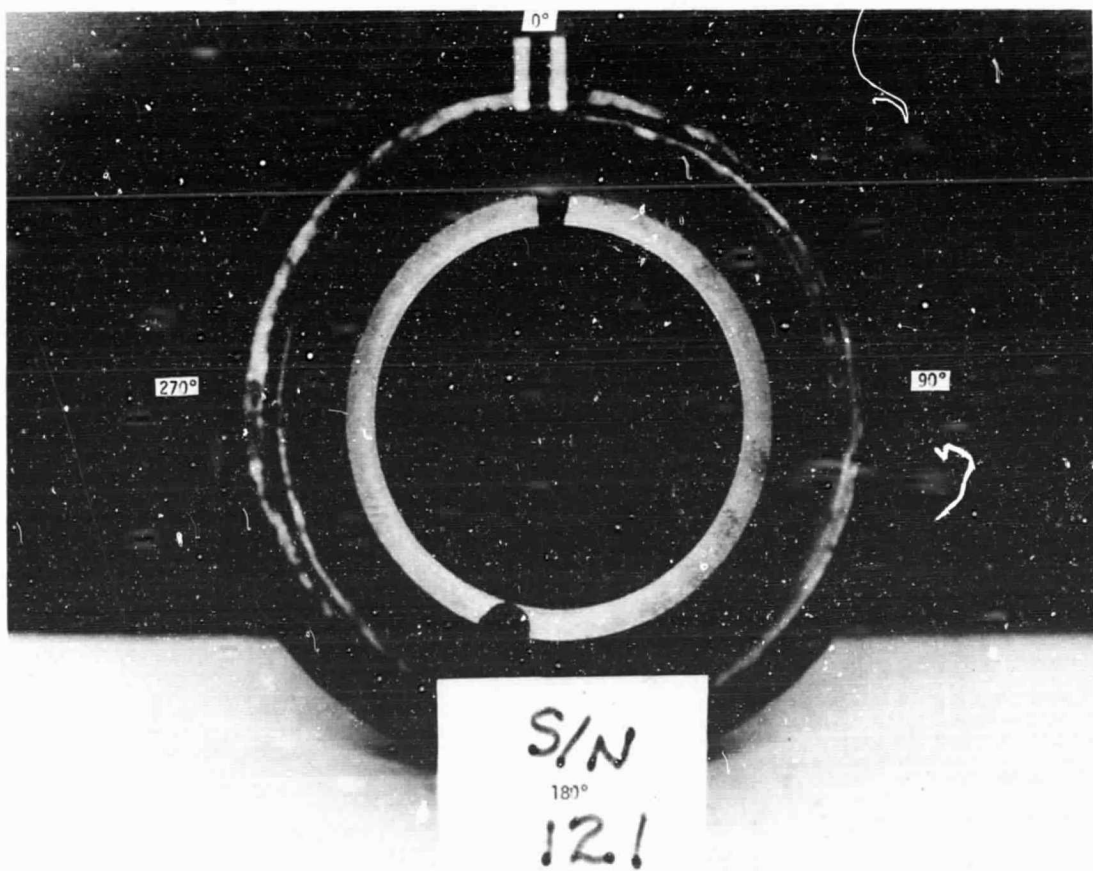
Figure 6. Post-Test Condition of S/N 121 - 1000 sec at 4500°F

temperature of 4500°F. These consisted of two Hf-20Ta clad nozzles (S/N 003 and 013) and one molybdenum disilicide (S/N 121) coated nozzle. The survival of the molybdenum disilicide coated nozzle at the combustion temperature of 4500°F was somewhat of a surprise due to the previous failures of identical nozzles S/N 122 and 120 at 4000°F and 4500°F combustion temperatures, respectively. Perhaps the post-test metallurgical analysis will shed some light on this inconsistent behavior of the molybdenum disilicide specimens. For the present it is concluded the survival of S/N 121 at a combustion temperature of 4500°F is indicative of a specimen wall temperature which is borderline in being equal to 3200°F; the approximate melting point of molybdenum disilicide.

| TASK | MATERIAL TYPE OR<br>PURPOSE OF TESTS | Target Combustion<br>Temperature of 4000°F | | Target Combustion<br>Temperature of 4500°F | | SPECIMEN FAILURE COMMENTS |
|---|---|---|---|---|---|---|
| S/N 121 | Molybdenum Disilicide | .85 | 143 | 1.20 | 145 | Nozzle in excellent condition after 1000 sec. duration at 4500°F. A nick in the coating at 225° orientation on the exit rim has been enlarged due to substrate oxidation. |

| Test Specimen S/N | Coating | Target Combustion Temperature | Firing Time sec. | No. of Starts | Comments |
|---|---|---|---|---|---|
| 121 | Molybdenum Disilicide | 4000°F | 10 | 1 | Nozzle in excellent condition. A nick in the coating at 225° orientation on the exit rim has been enlarged due to substrate oxidation. |

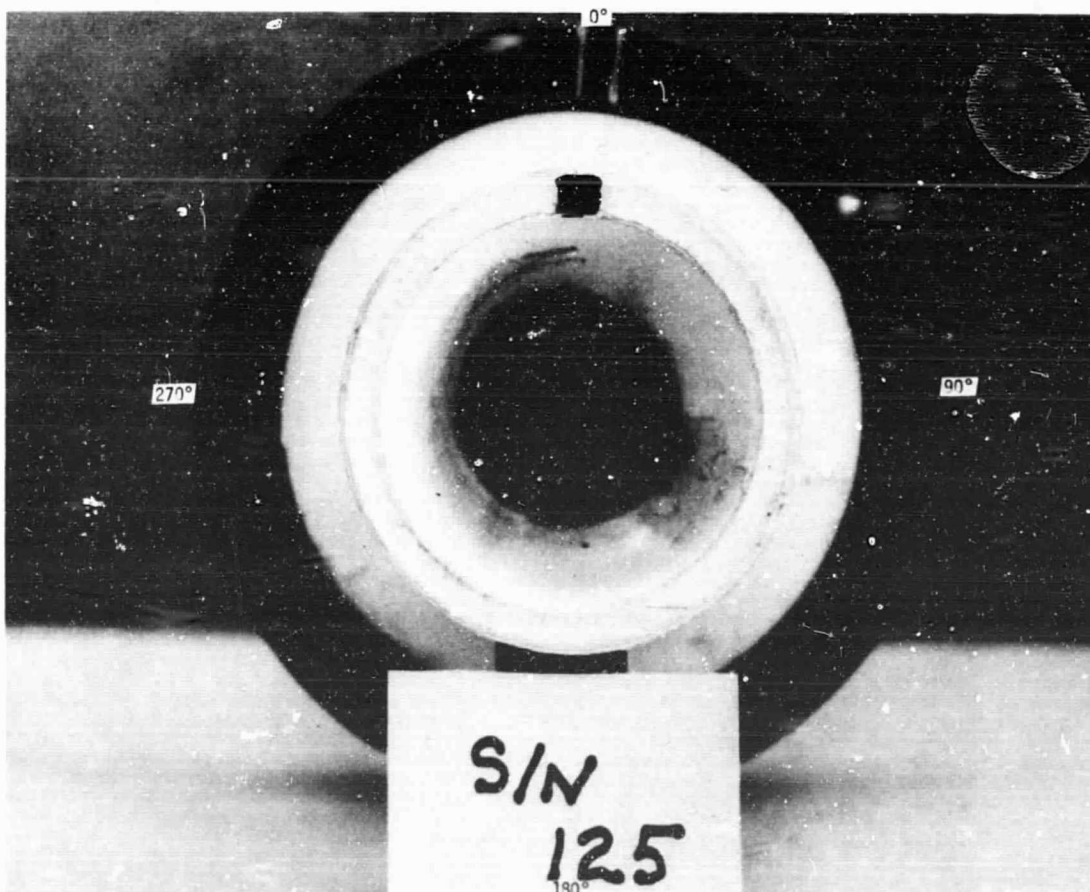
Figure 8. Post-Test Condition of S/N 125 - 845 sec at 4500°F

| EXPERIMENTAL SUMMARY - TASK III AND IV (CONTINUED) | | | | | | |
|---|---|---|---|---|---|---|
| S/N 125 | Hf-20Ta-0.25 Si | .85 | 145 | 1.21 | 149 | Substrate oxidation initiated at 105° orientation at throat after 845 sec. duration at 4500°F. Flow of yellowish material from the oxidized area. Remaining coating has some surface spalling and cracks. |

| Test Specimen S/N | Coating | Target Combustion Temperature | Firing Time sec. | No. of Starts | Comments |
|---|---|---|---|---|---|
| 125 | Hf-20Ta-0.25 Si | 4000°F | 5 | 1 | Substrate oxidation initiated at 105° orientation at throat. Flow of yellowish material from the oxidized area. Remaining coating has some surface spalling and cracks. |

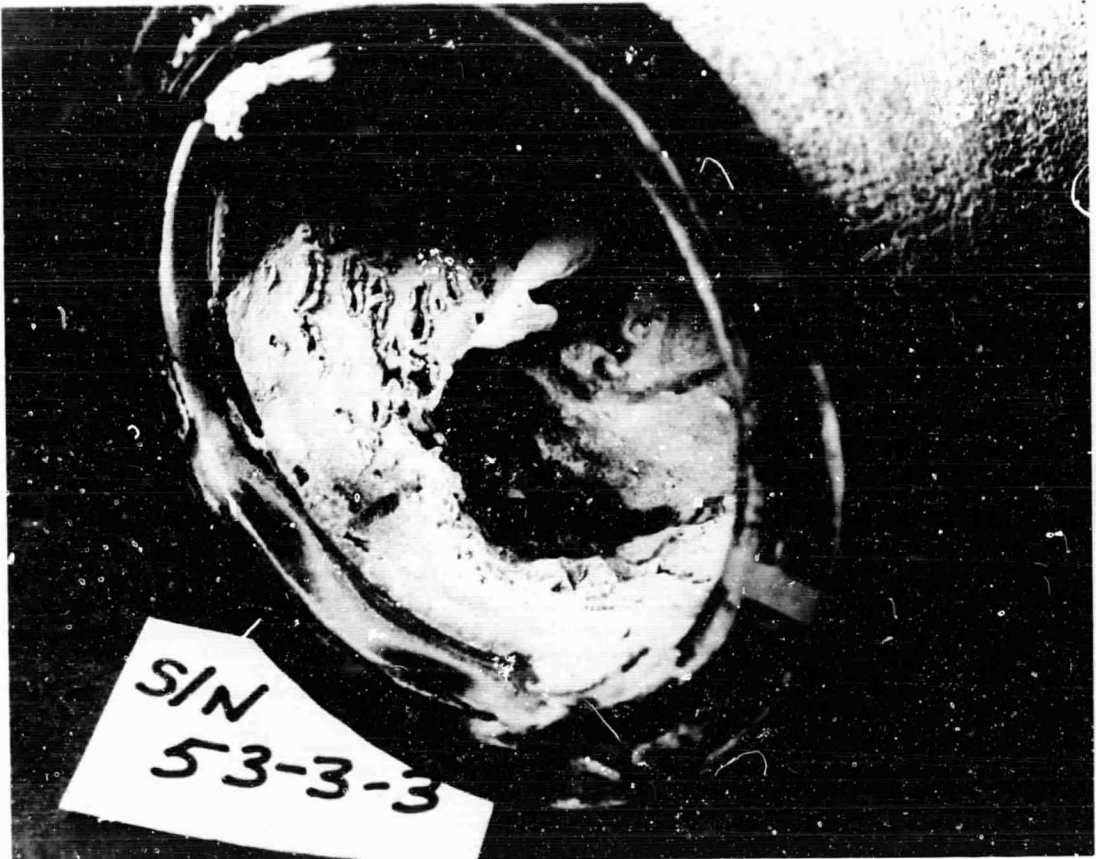
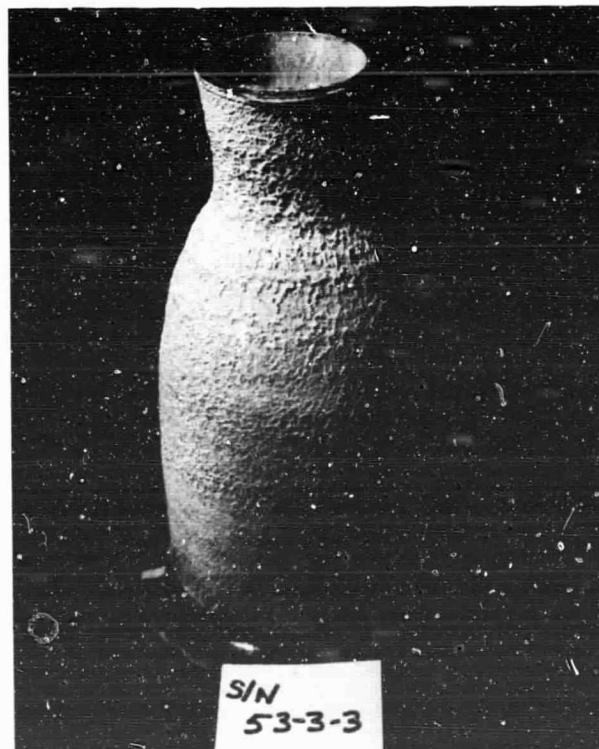
Figure 9. Post-Test Condition of S/N 53-3-3 - 478 sec at 4000°F

| EXPERIMENTAL SUMMARY - TASK III AND IV (CONTINUED) | | | | | | |
|---|---|---|---|---|---|---|
| S/N 53-3-3 | Hf-20Ta Clad | .86 | 147 | DNA | DNA | Chamber burnout in barrel section at 245° orientation after 478 sec. duration at 4000°F. Heavily cratered and oxidized on interior for first 1.5 inch into the chamber barrel. |

| Test Specimen S/n | Coating | Target Combustion Temperature | Firing Time sec. | No. of Starts | Comments |
|---|---|---|---|---|---|
| 53-3-3 | Hf-20Ta Clad | 4000°F | 5 | 1 | Chamber burnout in barrel at 24° orientation. Heavily cratered and oxidized on barrel for 7.5 inch into the chamber barrel. |

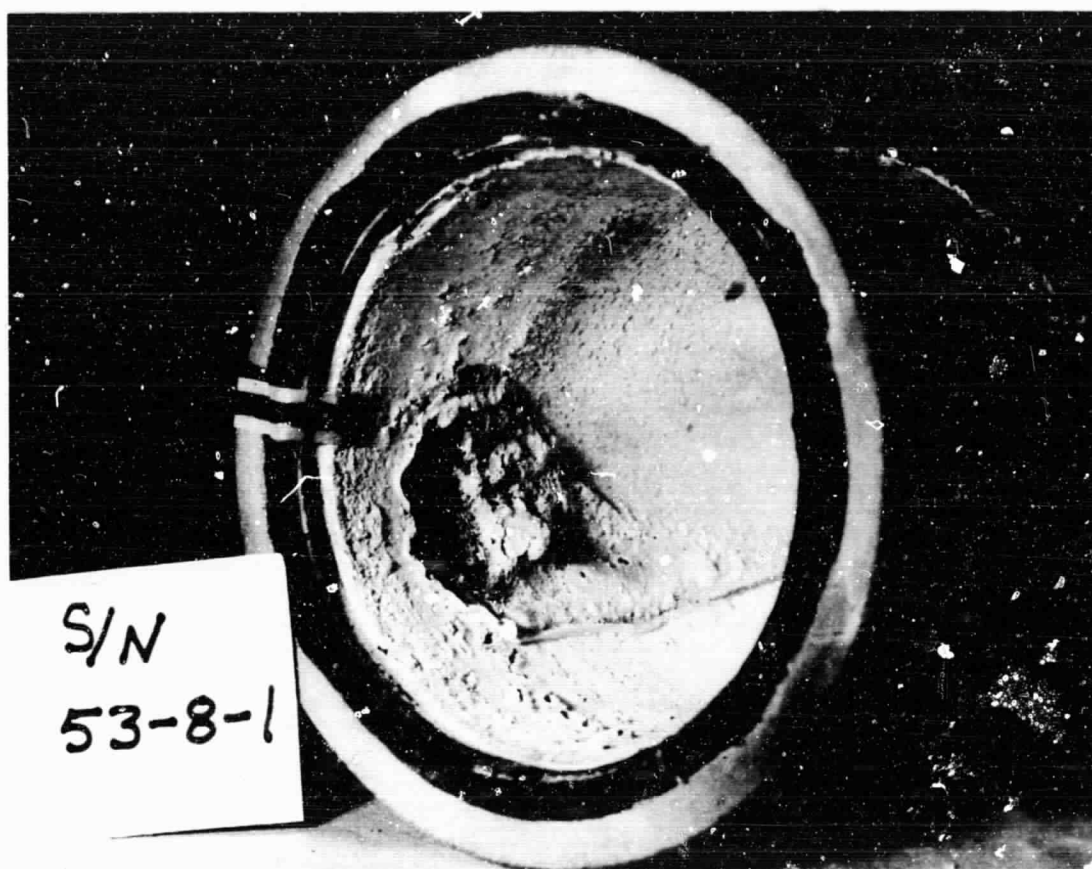
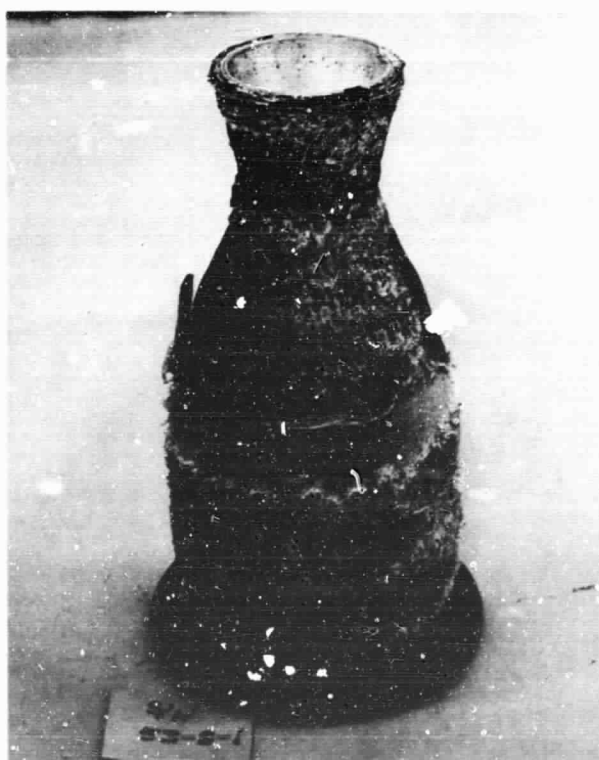
Figure 10. Post-Test Condition of S/N 53-8-1 - 88 sec at 4500°F

| EXPERIMENTAL SUMMARY - TASK III AND IV (CONTINUED) | | | | | | |
|---|---|---|---|---|---|---|
| S/N 53-8-1 | Hf-20Ta Clad | .85 | 147 | 1.21 | 145 | Chamber burnout in barrel sections at 30° orientation after 88 sec. duration at 4500°F. Cratering on interior for first 1.5 inch into chamber barrel. Extensive spalling of exterior coating during cooldown after the test. |

| Test Specimen S/n | Coating | Target Combustion Temperature | Firing Time sec. | No. of Starts | Comments |
|---|---|---|---|---|---|
| 53-8-1 | Hf-20Ta Clad | 4000°F | 10 | 1 | Chamber burnout in barrel at 30° orientation. Cratering on interior for 7.5 inch into chamber barrel. Extensive spalling of coating during cool down after the test. |

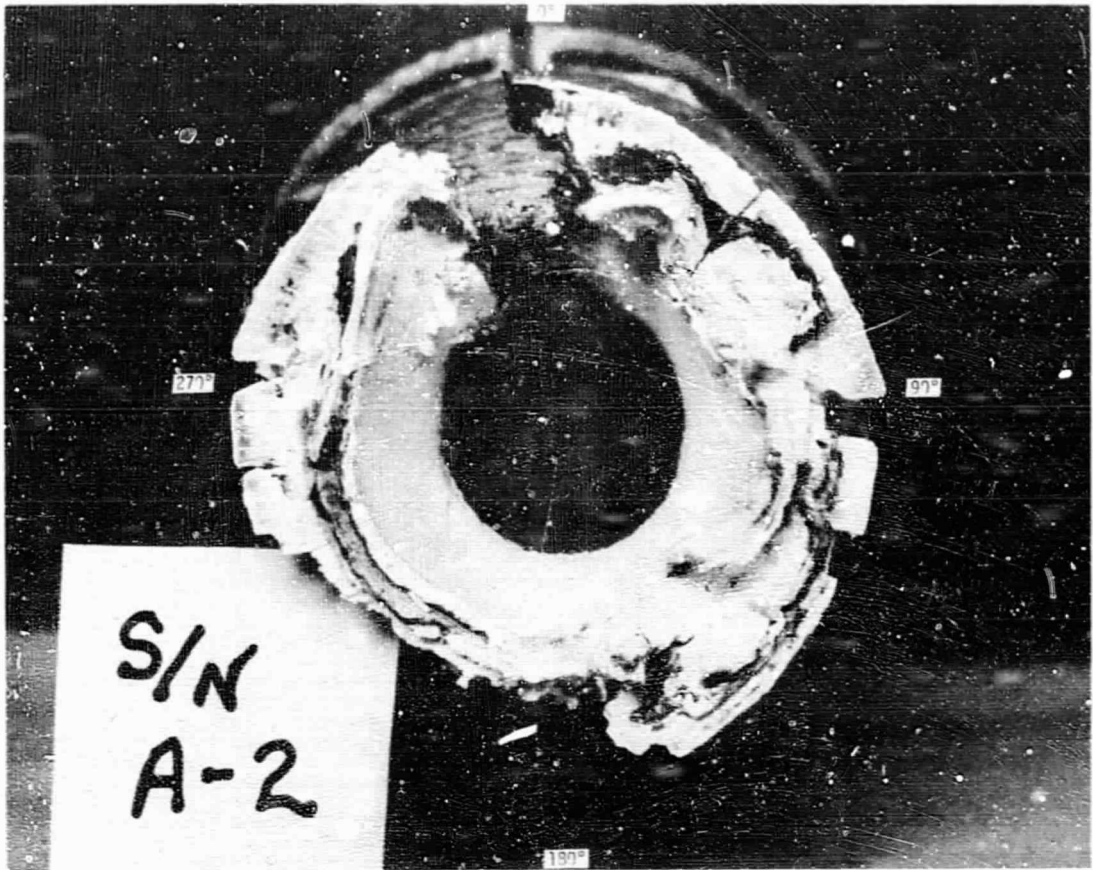
Figure 11. Post-Test Condition of S/N A-2 - 3937 sec at 4500°F

During the life firing tests of six selected chambers from Task IV, one of the Ha-20Ta clad chambers had notable success. Specimen S/N A-2 accumulated a total of 3937 seconds firing time at the maximum chamber temperature of 4500°F before failure. Included in this time was four engine start-ups from ambient temperature; the multiple engine starts being required for propellant re-tanking. The significance of this firing together with the success of the two Hf-20Ta clad nozzles from Task III is that it has demonstrated the practicality of fabricating a reliable Ha-20Ta clad specimen capable of providing long specimen life at elevated temperatures. The approximate specimen wall temperature during these firings was 3200°F. Although this temperature level may not be regarded as a severe test of the coating system when compared to its theoretical temperature limitation, it is reasonable to believe the Ha-20Ta clad system would also demonstrate long life at even higher wall temperatures. The premise for this conclusion is that prior experience during this program has indicated the fabrication techniques and/or controls used to achieve a uniform, defect-free coating is more crucial to the coatings success than the operating temperature.

| EXPERIMENTAL SUMMARY - TASK III AND IV (CONTINUED) | | | | | | |
|---|---|---|---|---|---|---|
| S/N A-2 | Hf-Ta-Clad | DNA | DNA | 1.19 | 144 | Burn through at throat and tearing to the nozzle exit at 350° orientation after 3937 sec duration at 4500°F. Extensive clad separation and loss of substrate at exit. Crater formations on interior and exterior. Internal chamber barrel in reasonably good condition. |

| Test Specimen S/n | Coating | Target Combustion Temperature | Firing Time sec. | No. of Starts | Comments |
|---|---|---|---|---|---|
| A-2 | Hf-Ta Clad | 4500°F | 10 | 1 | Burn through at throat and tearing to the nozzle exit at 350° orientation. Extensive clad separation and loss of substrate at exit. Crater formations on interior and exterior. Internal chamber barrel in reasonably good condition. |

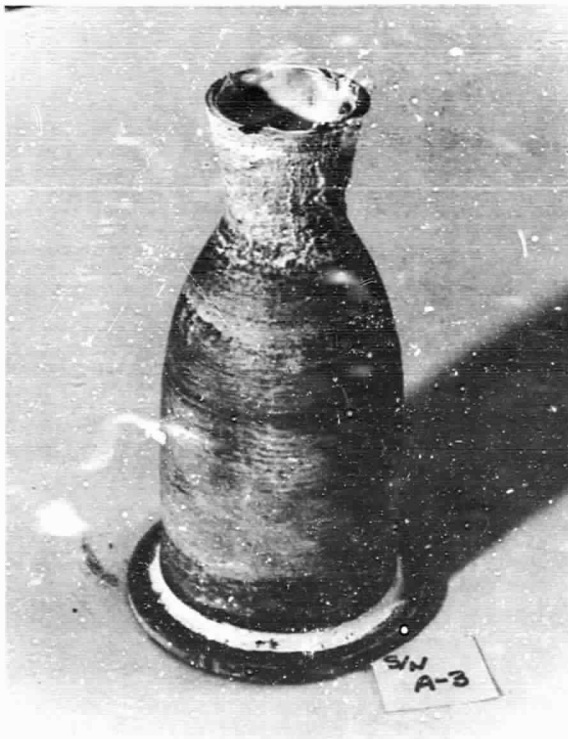
Figure 12. Post-Test Condition of S/N A-3 - 587 sec at 4500°F

| TEST DESCRIPTION | | | | | | |
|---|---|---|---|---|---|---|
| S/N A-3 | Hf-Ta-Clad | DNA | DNA | 1.19 | 148 | Burn through at throat at 300° orientation after 587 sec. duration at 4500°F. Clad separation at exit. Some crater formation developing on outside and inside at throat. Internal chamber barrel in good condition. |

| Test Specimen S/n | Coating | Target Combustion Temperature | Firing Time sec. | No. of Starts | Comments |
|---|---|---|---|---|---|
| A-3 | Hf-Ta Clad | 4500°F | 10 | 1 | Burn through at throat at 300° orientation. Clad separation at exit. Some crater formation developing on outside and inside at throat. Internal chamber barrel in good condition. |

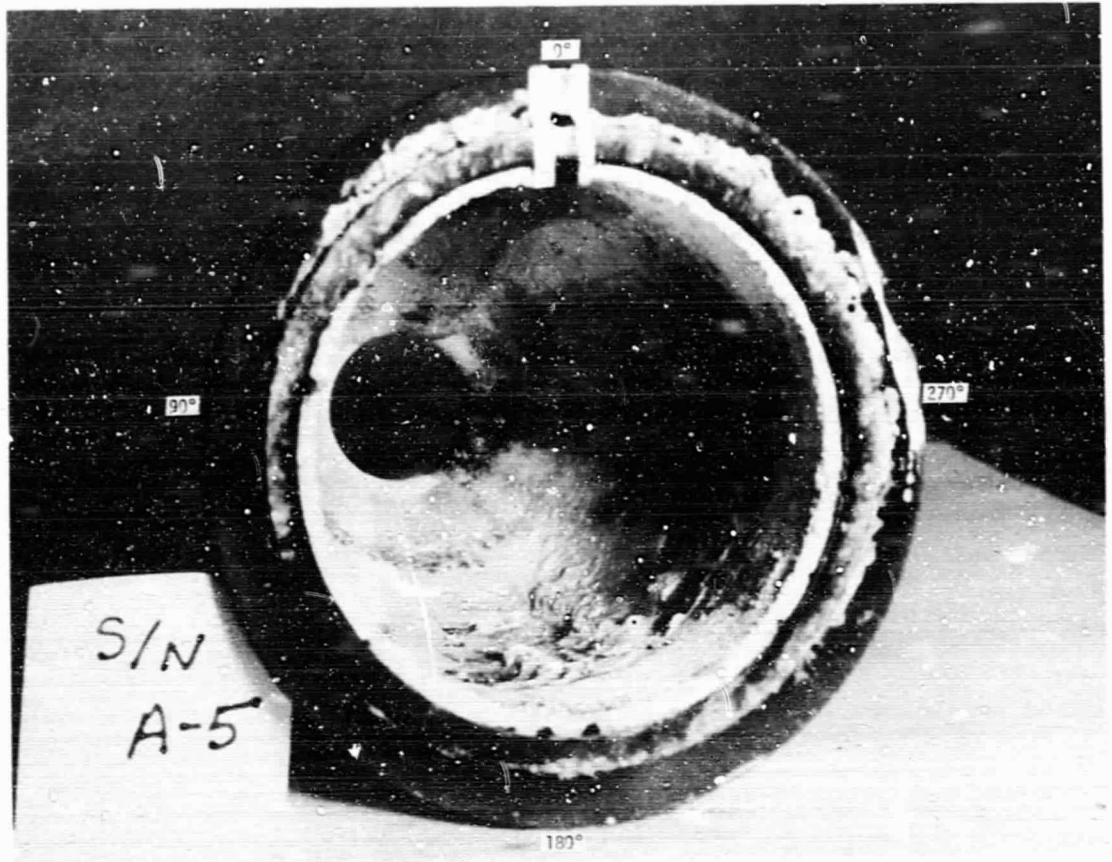
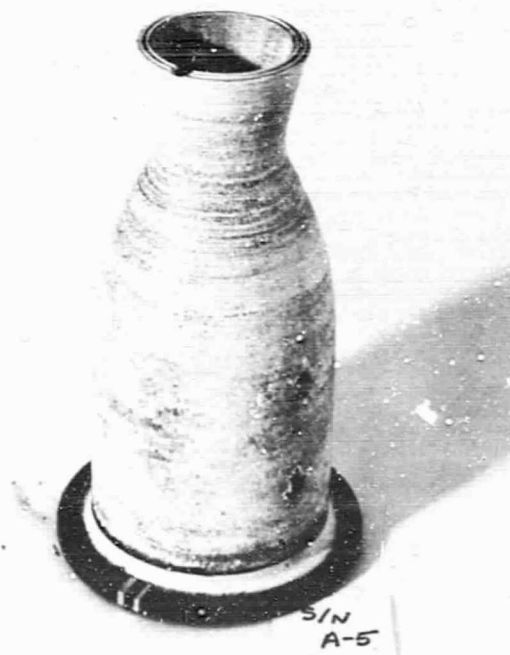
Figure 13. Post-Test Condition of S/N A-5 - 50 sec at 4500°F

| TEST DESCRIPTION | | | | | | |
|---|---|---|---|---|---|---|
| S/N A-5 | Hf-Ta-W Clad | DNA | DNA | 1.20 | 145 | Chamber burnout in barrel at 280° orientation after 50sec. duration at 4500°F. Extensive cratering exposing oxidized substrate on interior of chamber barrel. Considerable flow of yellow/brown material from oxidized regions. Nozzle section and exterior in good condition. |

| Test Specimen S/n | Coating | Target Combustion Temperature | Firing Time sec. | No. of Starts | Comments |
|---|---|---|---|---|---|
| A-5 | Hf-Ta-W Clad | 4500°F | 10 | 1 | Chamber burnout in barrel at 280° orientation. Extensive cratering exposing oxidized substrate on interior of chamber barrel. Considerable flow of yellow/brown material from oxidized regions. Nozzle section and exterior in good condition. |

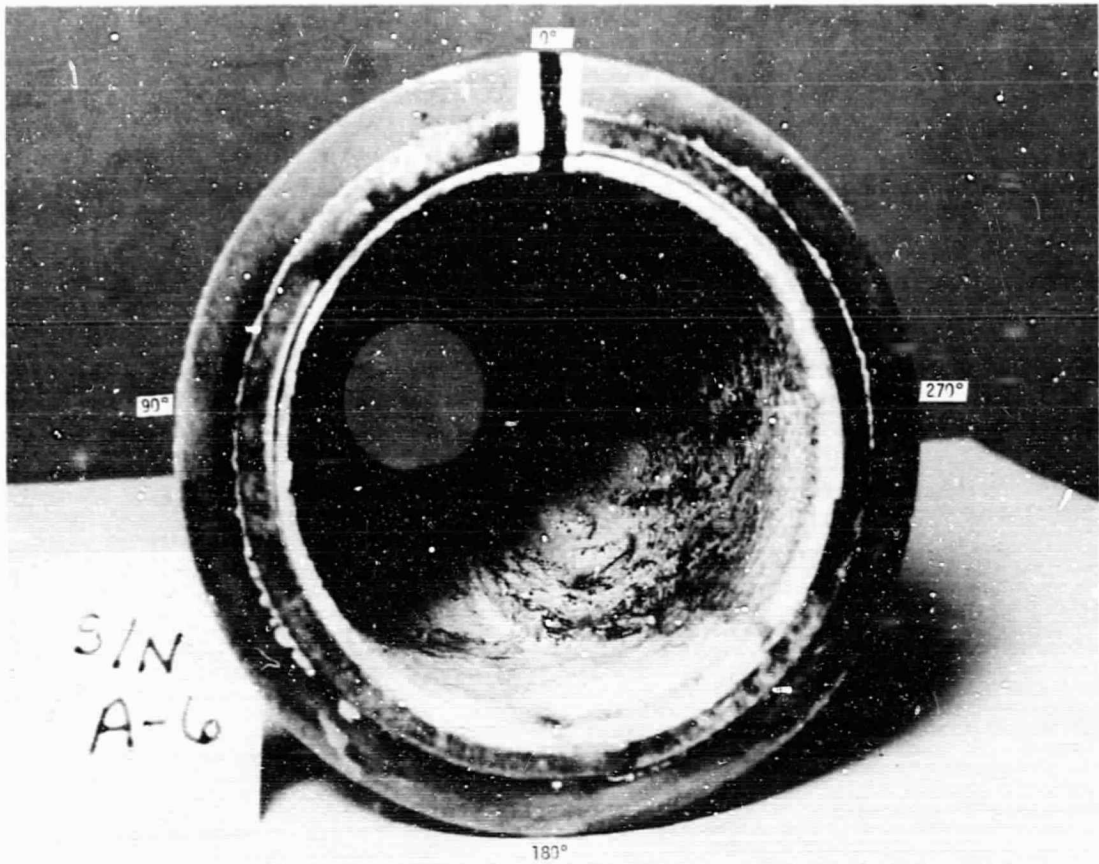
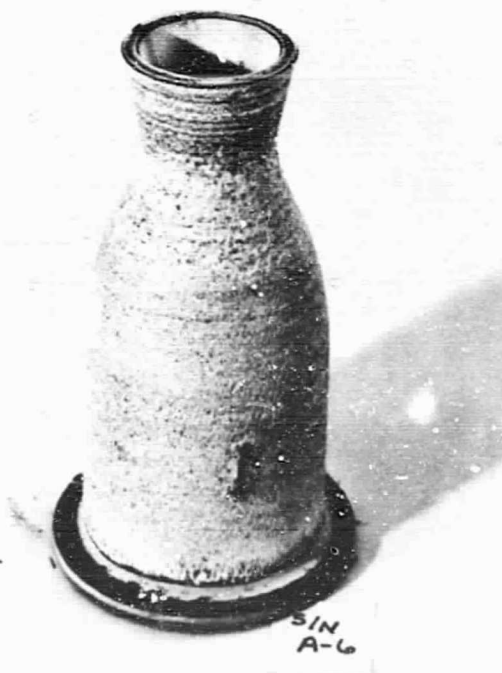
Figure 14. Post-Test Condition of S/N A-6 - 63 sec at 4500°F

| TEST DESCRIPTION | | | | | | |
|---|---|---|---|---|---|---|
| S/N A-6 | Hf-Ta-Mo Clad | DNA | DNA | 1.20 | 145 | Chamber burnout in barrel at 230° orientation after 63 sec duration at 4500°F. Extensive substrate oxidation on interior of chamber barrel. Considerable flow of gray material from oxidized regions. Nozzle section and exterior in good condition. |

| Test Specimen S/n | Coating | Target Combustion Temperature | Firing Time sec. | No. of Starts | Comments |
|---|---|---|---|---|---|
| A-6 | Hf-Ta-Mo Clad | 4500°F | 10 | 1 | Chamber burnout in barrel at 230° orientation. Extensive substrate oxidation on interior of chamber barrel. Considerable flow of gray material from oxidized regions. Nozzle section and exterior in good condition. |

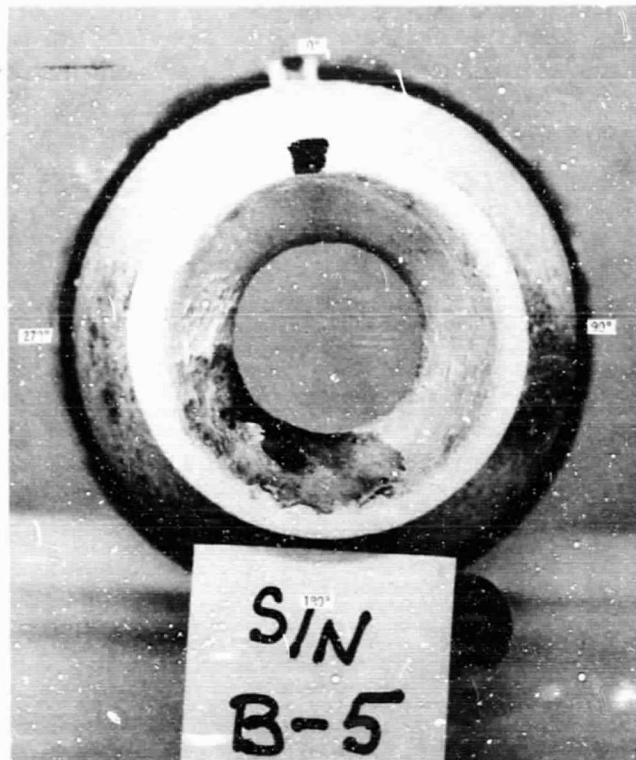
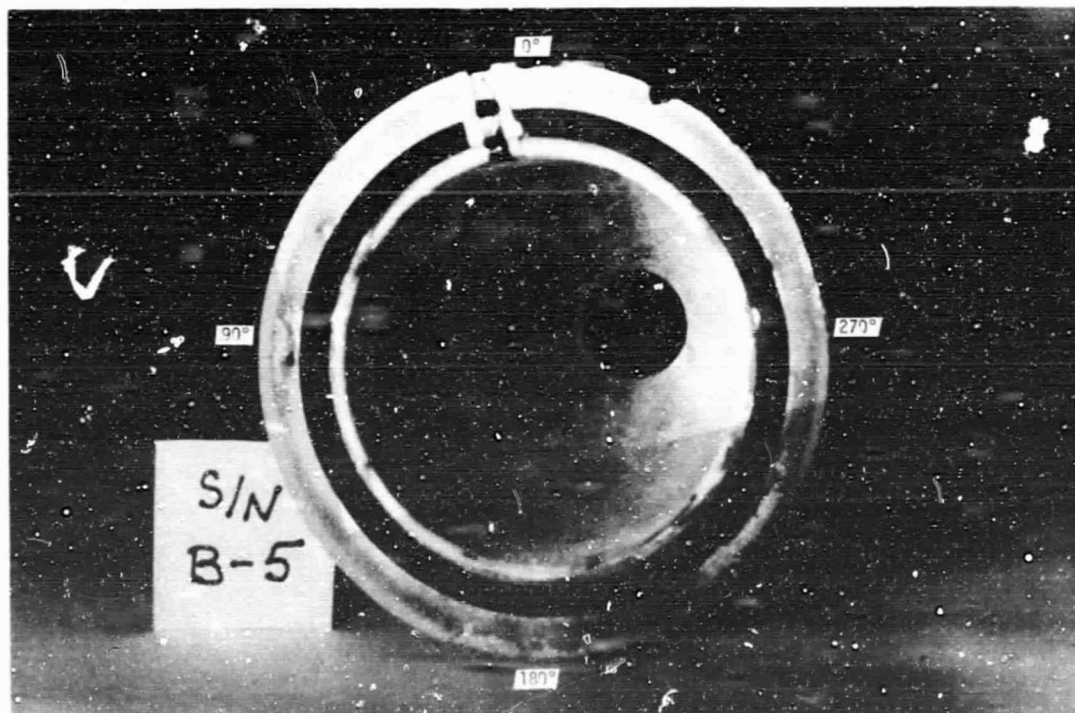
Figure 15. Post-Test Condition of S/N B-5 - 634 sec at 4500°F

| TEST DESCRIPTION | | | | | | |
|---|---|---|---|---|---|---|
| S/N B-5 | Hf-Ta-Slurry | DNA | DNA | 1.21 | 150 | Substrate oxidation in throat region at 220° orientation after 634 sec. duration at 4500°F. Large blister formation downstream of throat on outside at 230°. Remaining coating in good condition. |

| Test Specimen S/n | Coating | Target Combustion Temperature | Firing Time sec. | No. of Starts | Comments |
|---|---|---|---|---|---|
| B-5 | Hf-Ta Slurry | 4500°F | 10 | 1 | Substrate oxidation in throat region at 220° orientation. Large blister formation downstream of throat on outside at 230°. Remaining coating in good condition. |

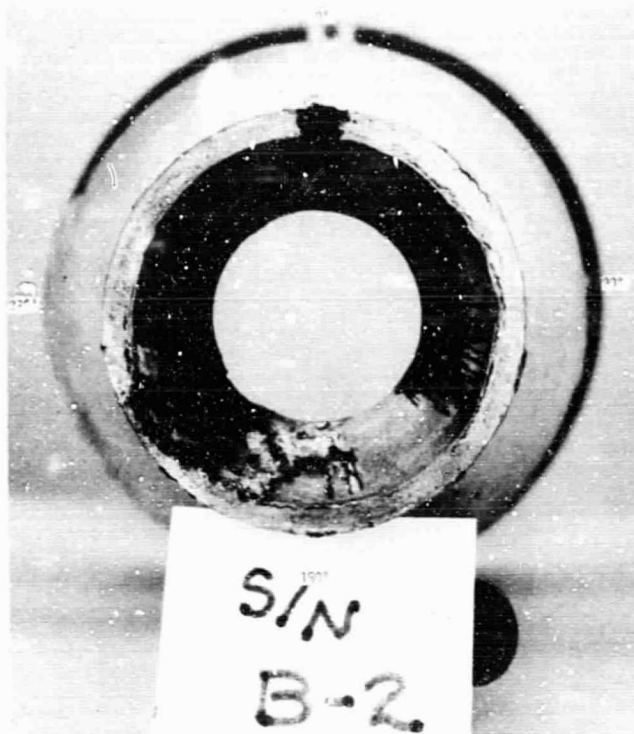
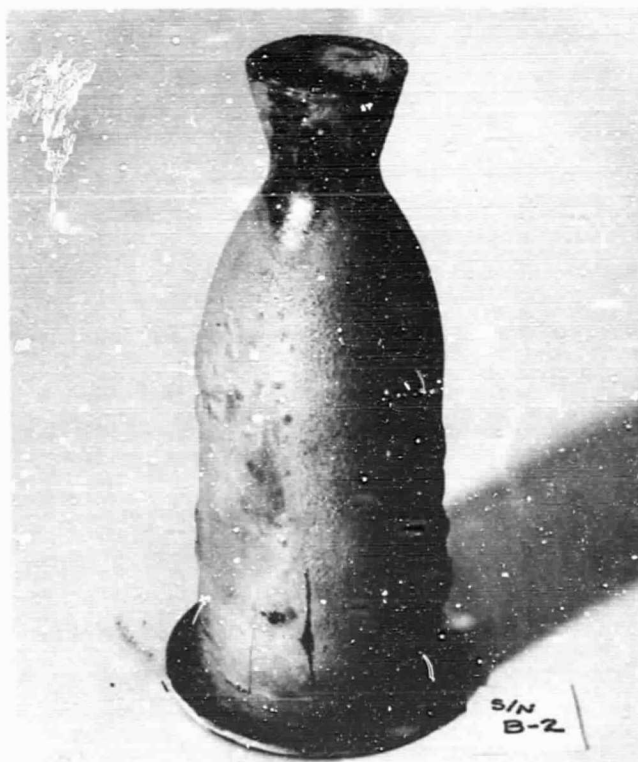
Figure 16. Post-Test Condition of S/N B-2 - 57 sec at 4500°F

barrel section. This leakage was detected during the pressure check made prior to the firing. Similar but more extensive leakage was detected on the unfired identical specimen (S/N B-4). The leakage in these two chambers may have been through cracks in the substrate which were not detectable during the pre-test metallurgical examination. The differences noted in the firing durations for the various Hf-Ta clad specimens again points out the importance of having proper fabrication techniques and/or controls in providing a reproducible, uniform, and defect free coating; and consequently, long specimen life.

| TEST DESCRIPTION | | | | | | |
|---|---|---|---|---|---|---|
| S/N B-2 | Ir-Re-90Ta-10W | DNA | DNA | 1.20 | 145 | Burn through at throat at 220° orientation after 57 sec duration at 4500°F. Many deep longitudinal cracks in chamber barrel. Some cracks completely through the specimen. Prior to the test the specimen had gas leakage through the chamber walls. Heavy blister formations on exterior barrel section. |

| Test Specimen S/n | Coating | Target Combustion Temperature | Firing Time sec. | No. of Starts | Comments |
|---|---|---|---|---|---|
| B-2 | Ir-Re | 4500°F | 10 | 1 | Burn through at throat at 220° orientation. Many deep longitudinal cracks in chamber barrel. Some cracks completely through the specimen. Prior to the test, the specimen had gas leakage through the chamber walls. Heavy blister formations on exterior barrel section. |

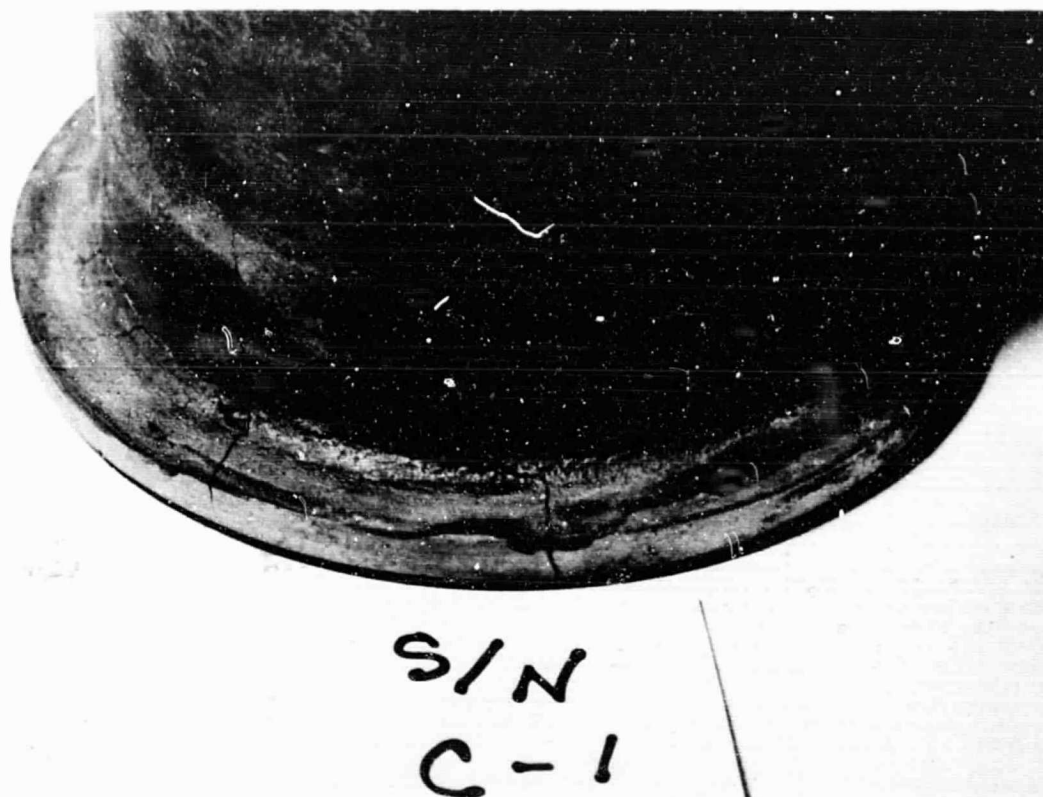
Figure 17. Cracked Flange Area on S/N C-1

During the Task IV chamber tests an attempt was made to test one of the Ir-Re coated tungsten chambers (S/N C-1 and C-11); however, both chambers cracked at the junction of the flange to the chamber barrel as they were being installed. Cracking occurred at a bolt torque value of approximately 25 in.-lb. Photographs of the cracked areas are shown in Figures 17 and 18.

| TEST DESCRIPTION | | | | | | |
|---|---|---|---|---|---|---|
| S/N C-1 | Re-Ir-W | DNA | DNA | DNA | DNA | Specimen could not be tested due to cracks developing at the flange during installation. |
