EIGHTH QUARTERLY REPORT  
EVALUATION TESTING OF PROTECTIVE  
COATINGS ON REFRACTORY METALS

September 1969

CONTRACT NAS 7-460

TRW SYSTEMS GROUP

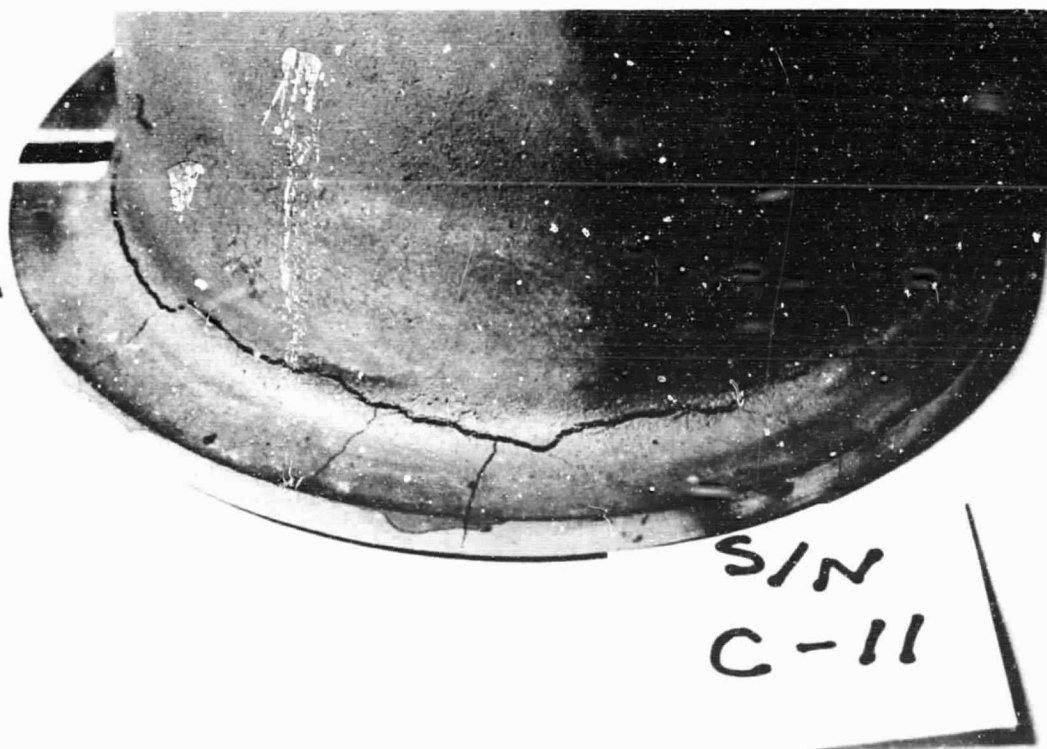
Figure 18. Cracked Flange Area on S/N C-11

During the Task IV chamber tests an attempt was made to test one of the Ir-Re coated tungsten chambers (S/N C-1 and C-11); however, both chambers cracked at the junction of the flange to the chamber barrel as they were being installed. Cracking occurred at a bolt torque value of approximately 25 in.-lb. Photographs of the cracked areas are shown in Figures 17 and 18.

| TEST DESCRIPTION | | | | | | |
|---|---|---|---|---|---|---|
| S/N C-11 | Re-Ir-W | DNA | DNA | DNA | DNA | Specimen could not be tested due to cracks developing at the flange during installation. |
