METALLOGRAPHIC EXAMINATION OF SOLDERING OF MULTILAYER  
BOARDS FOR AIRLOCKReport 061-015-76 Model Airlock

METALLOGRAPHIC EXAMINATION OF SOLDERING OF MULTILAYER  
BOARDS FOR AIRLOCK

The object of this test was to evaluate the solder connections of components on multilayer boards. This test became necessary when Electro-Mechanical Research (EMR) Co. requested a deviation from MDC. P.S. 22800 in soldering components on multilayer boards. EMR indicated that incomplete solder flow into the plated holes occurs because of the heat sink created by eleven copper layers, ground planes, and shields.

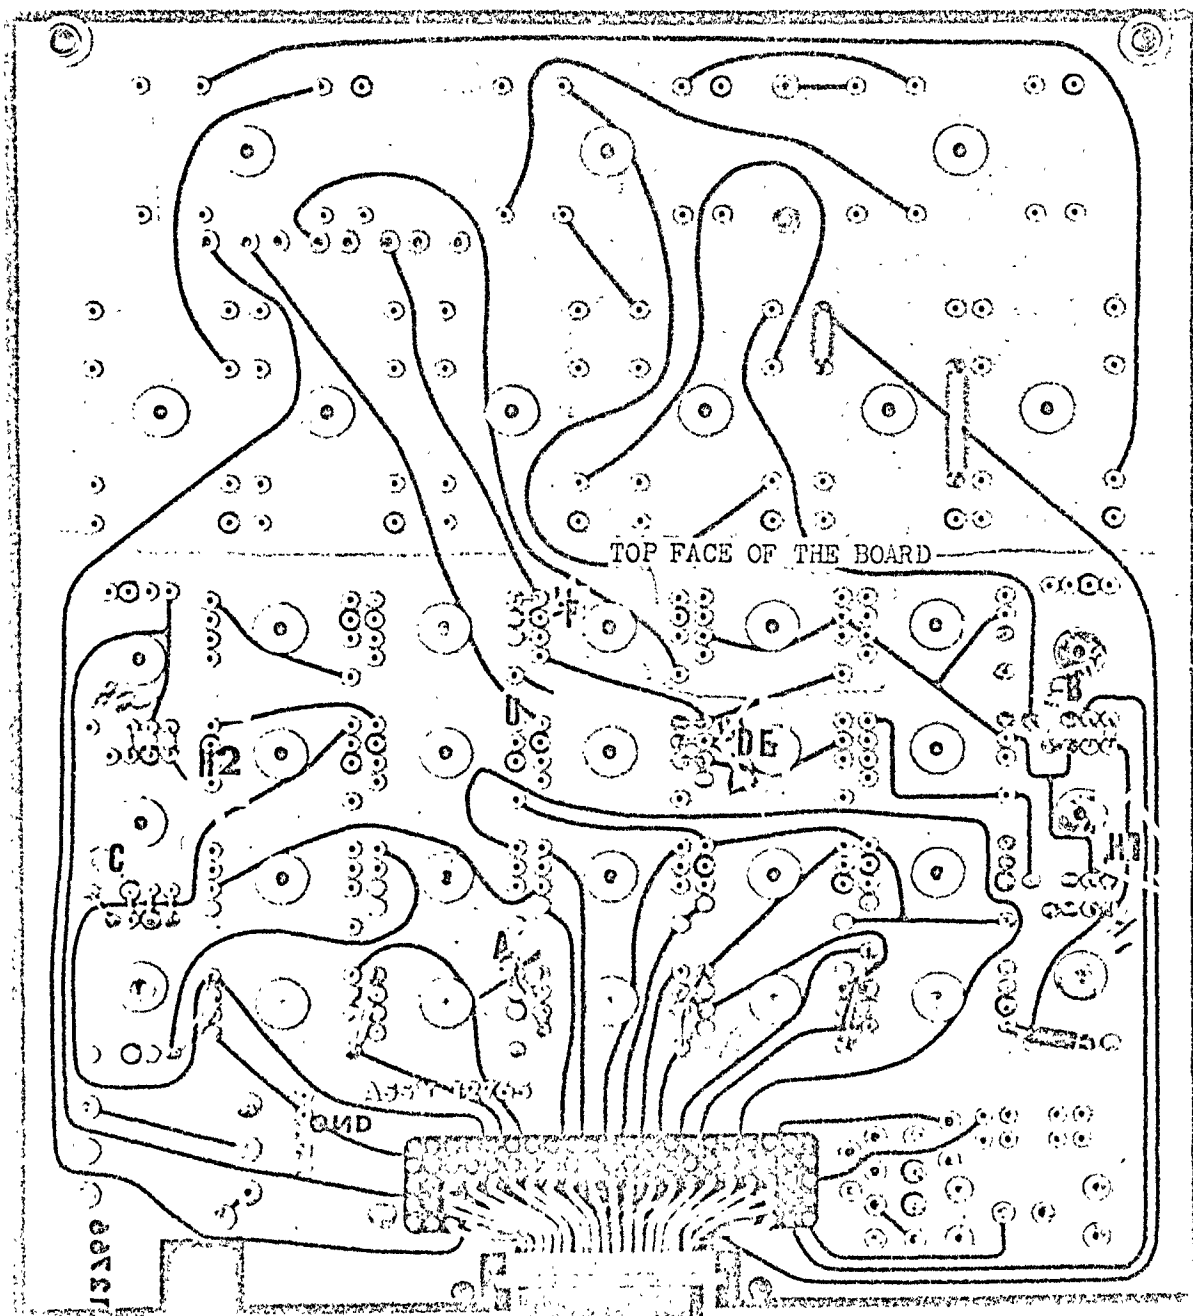
FIGURE 1

AS-RECEIVED CIRCUIT BOARD (THE CONNECTIONS TO BE SECTIONED ARE MARKED WITH ARROWS)

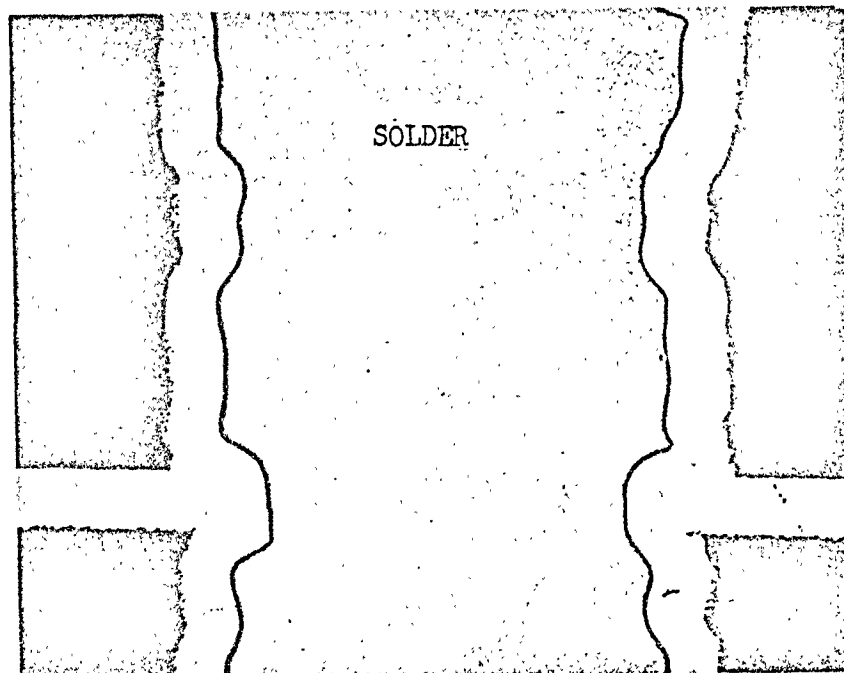
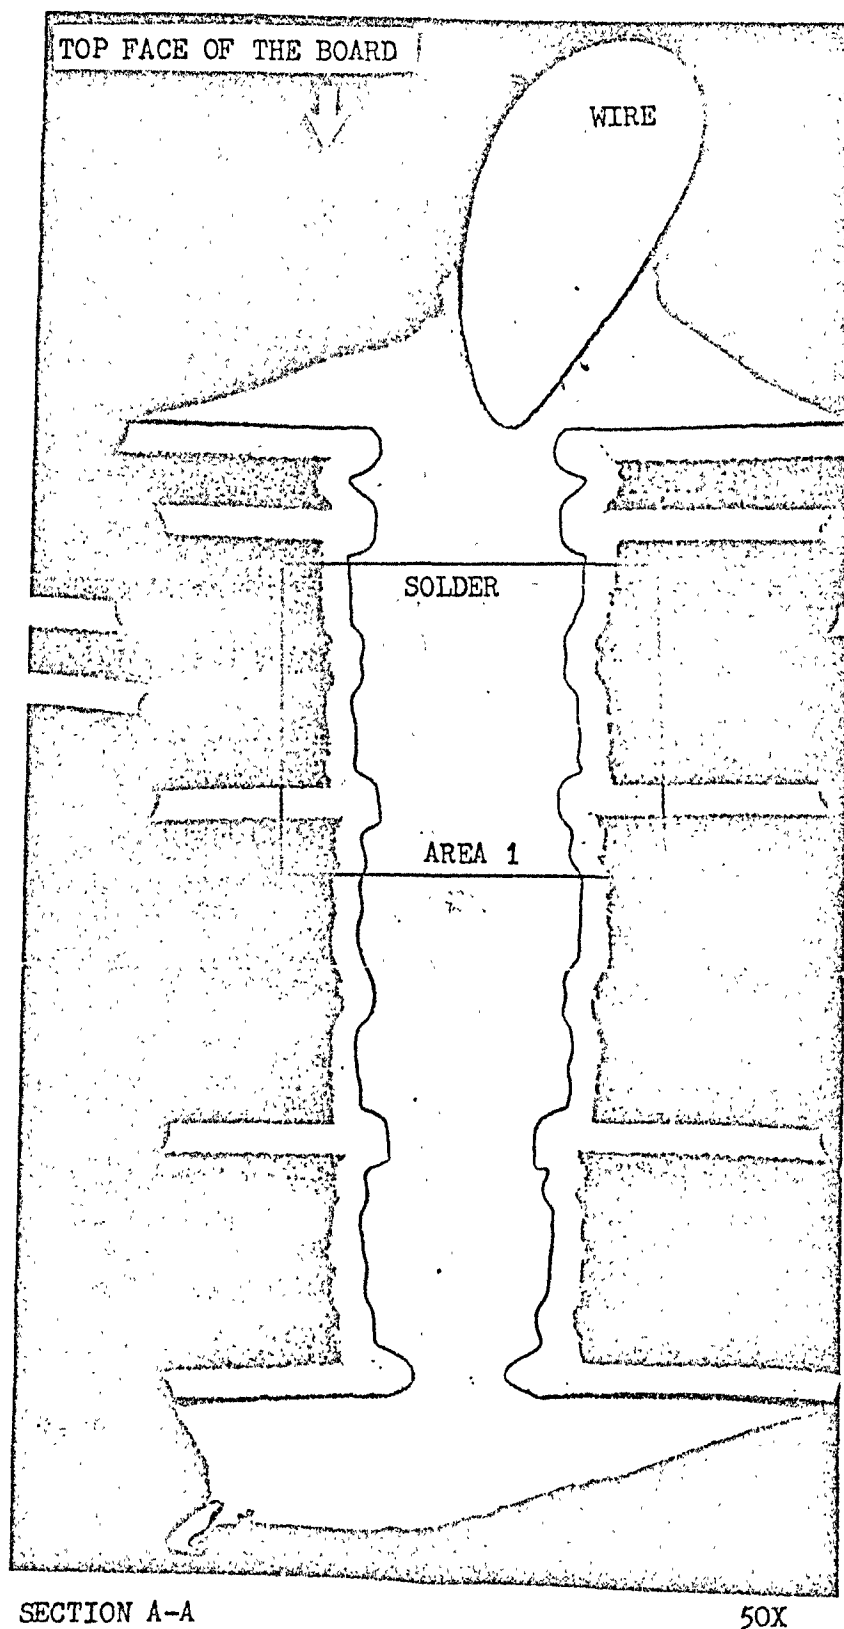
FIGURE 2

CONNECTION A SHOW

COMPLETE SOLDER FLOW

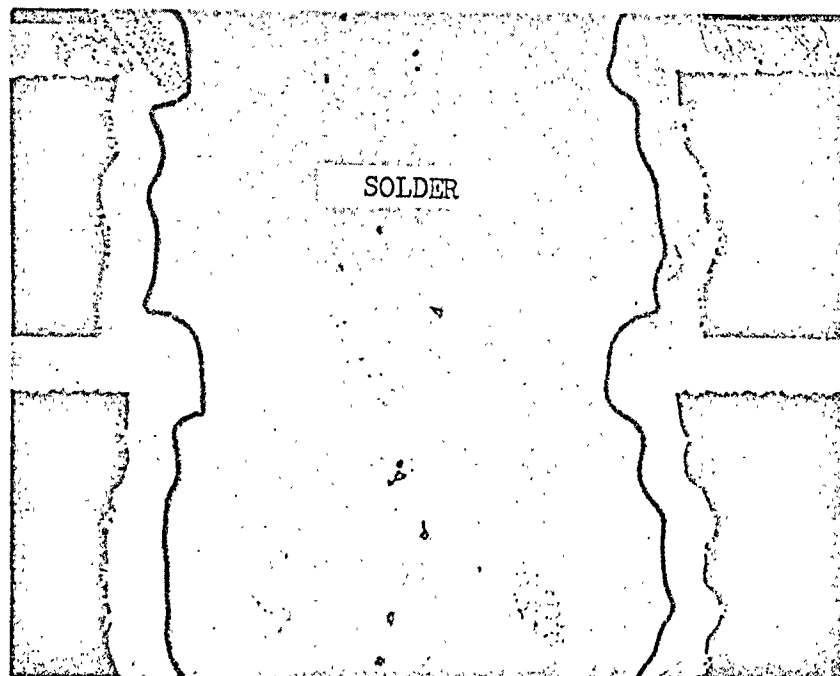
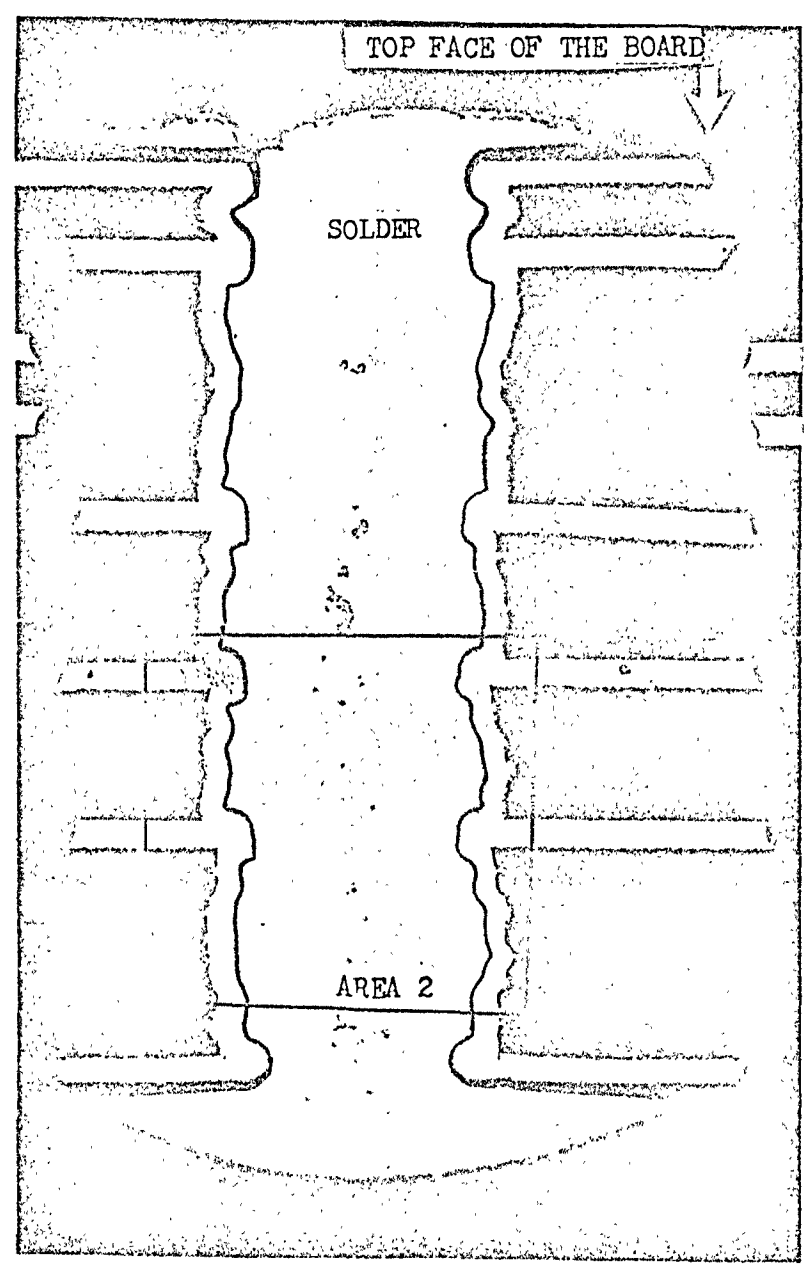
FIGURE 3

CONNECTION B SHOW

ING COMPLETE SOLDER FLOW

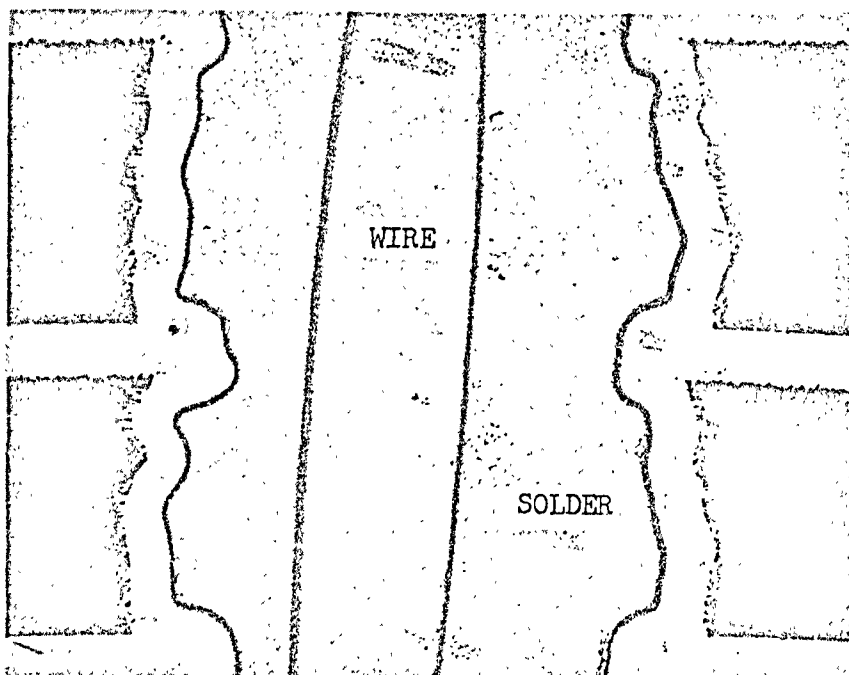
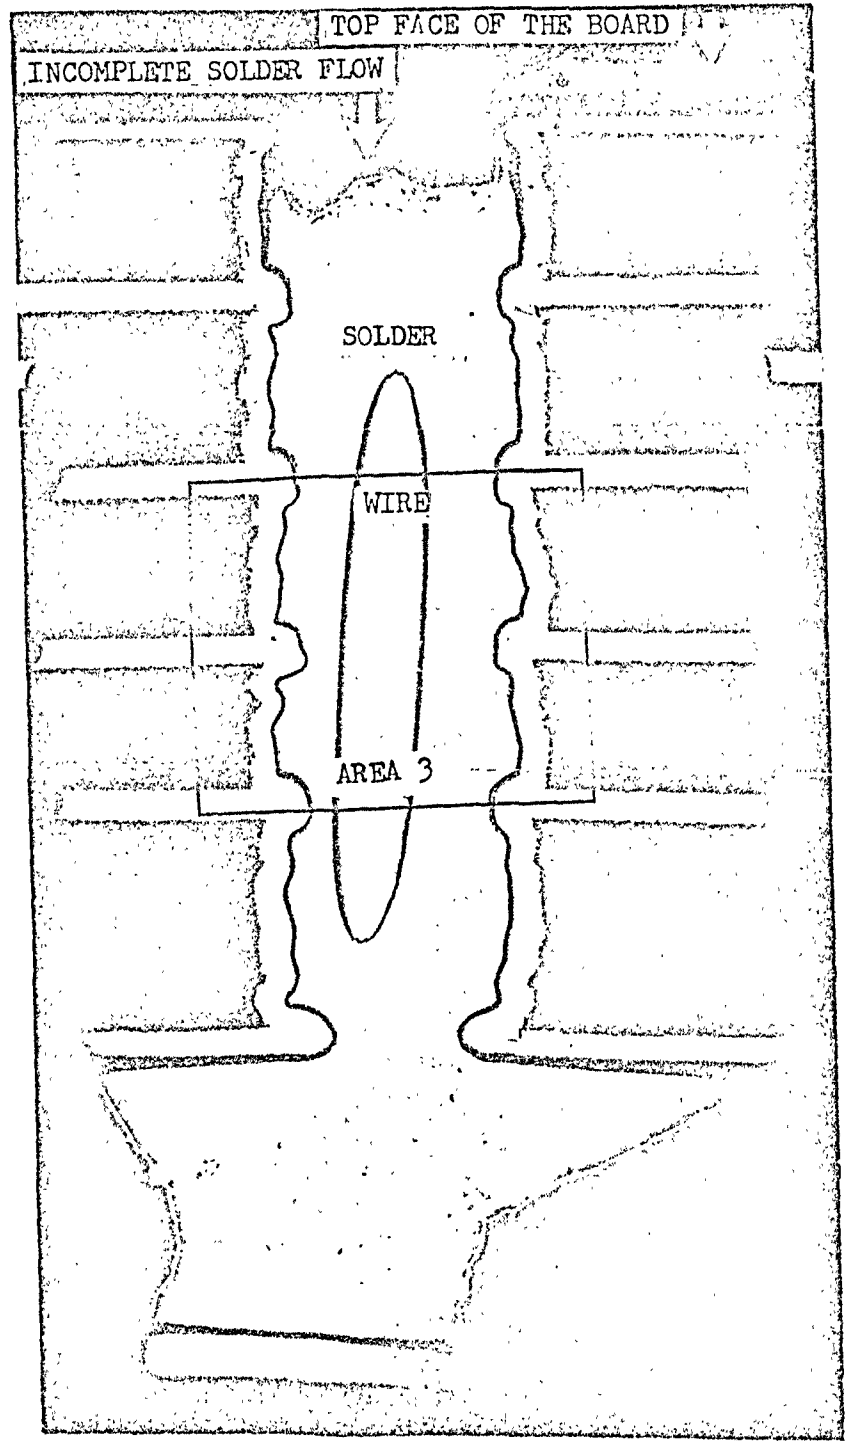
FIGURE 4

1. Connections C, DE, and F showed incomplete solder flow as shown in Figures 4, 5, and 6, respectively.
2. Hole "U" (designated as the unsoldered hole), which had been copper-tin-lead plated but which did not have a solder connection, showed evidence of a void in the solder plate and a crack in the copper plate. This condition is shown in Figure 10 on page 13. Repolishing of the specimen confirmed that the copper plate was fractured 0.07 inch below the top face of the board, (Figure 11 on page 13).

CONNECTION C SHOWING

INCOMPLETE SOLDER FLOW

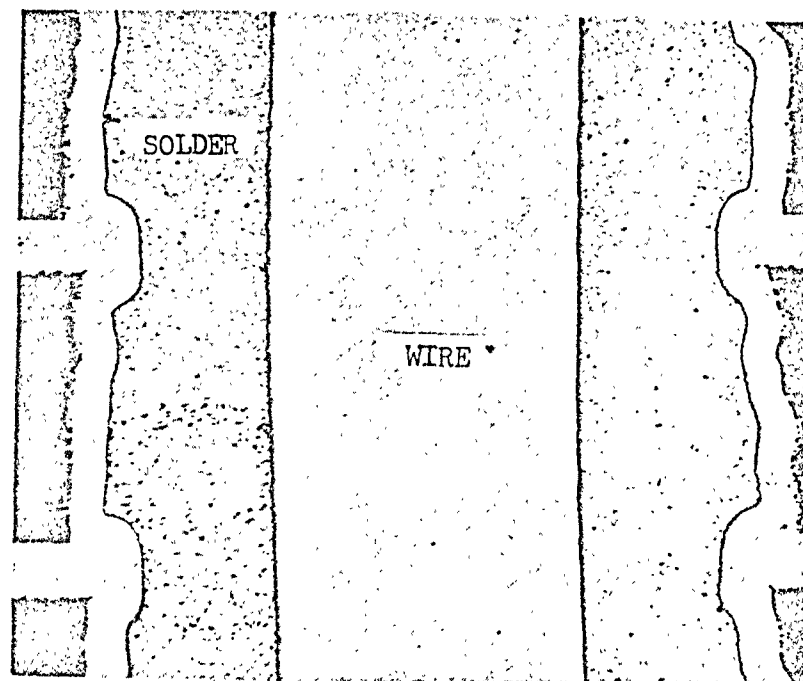
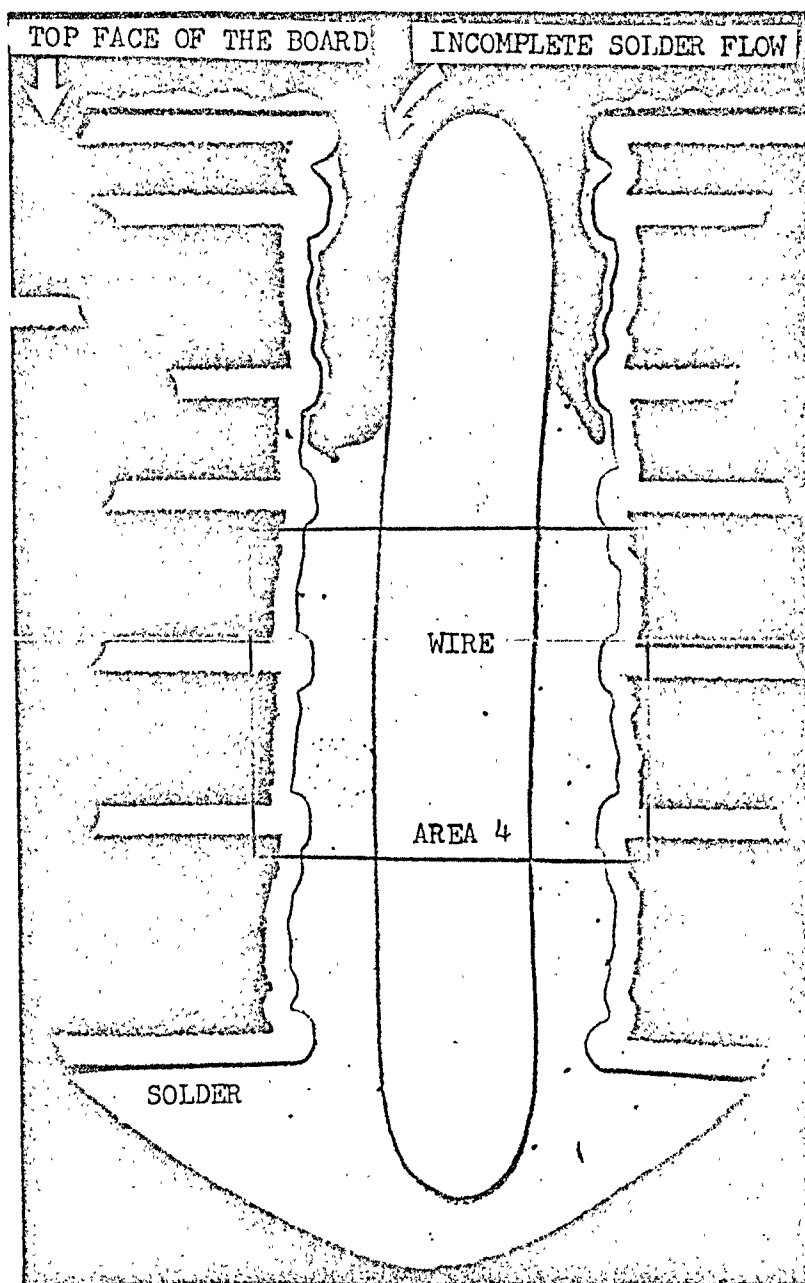
FIGURE 5

CONNECTION DE SHOWING

INCOMPLETE SOLDER FLOW

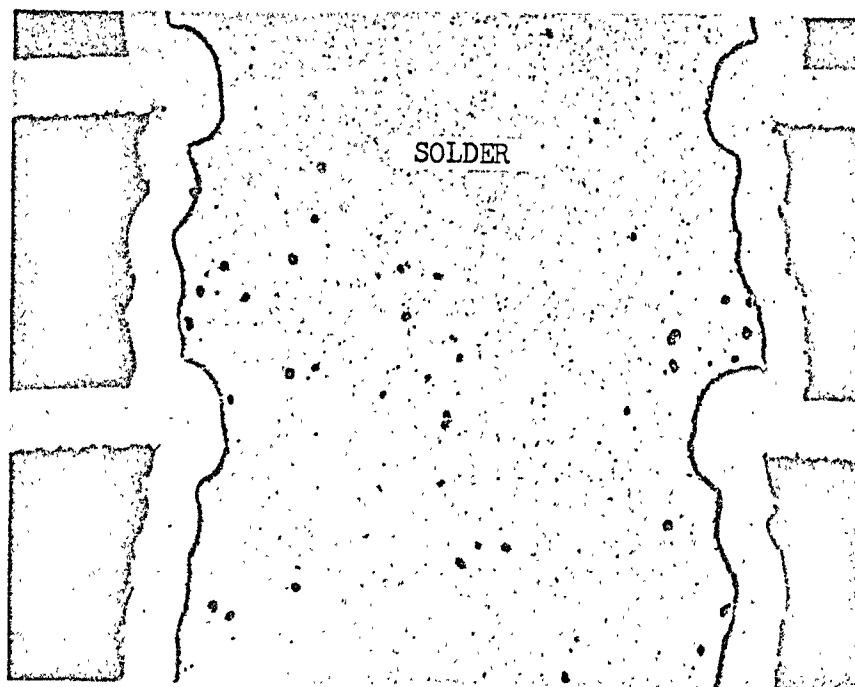
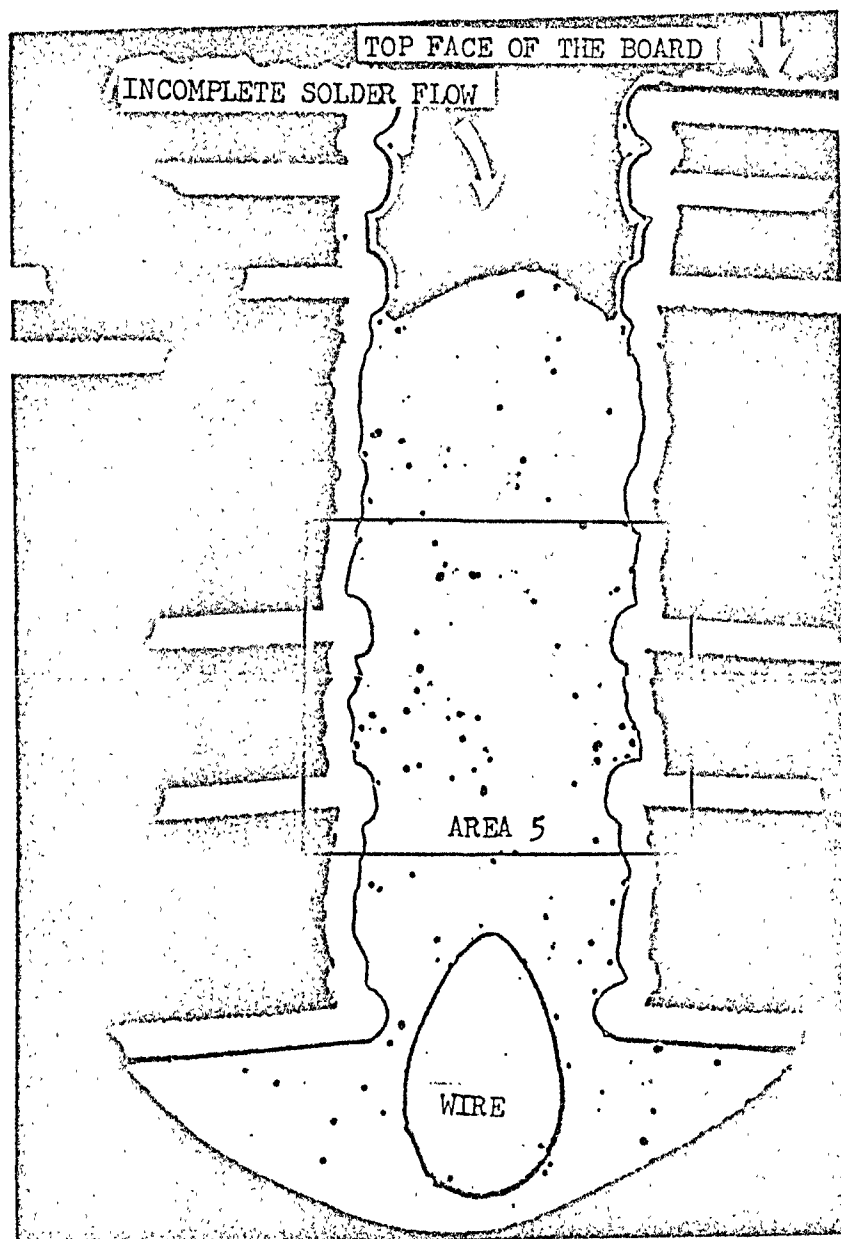
FIGURE 6

CONNECTION F SHOWING

INCOMPLETE SOLDER FLOW

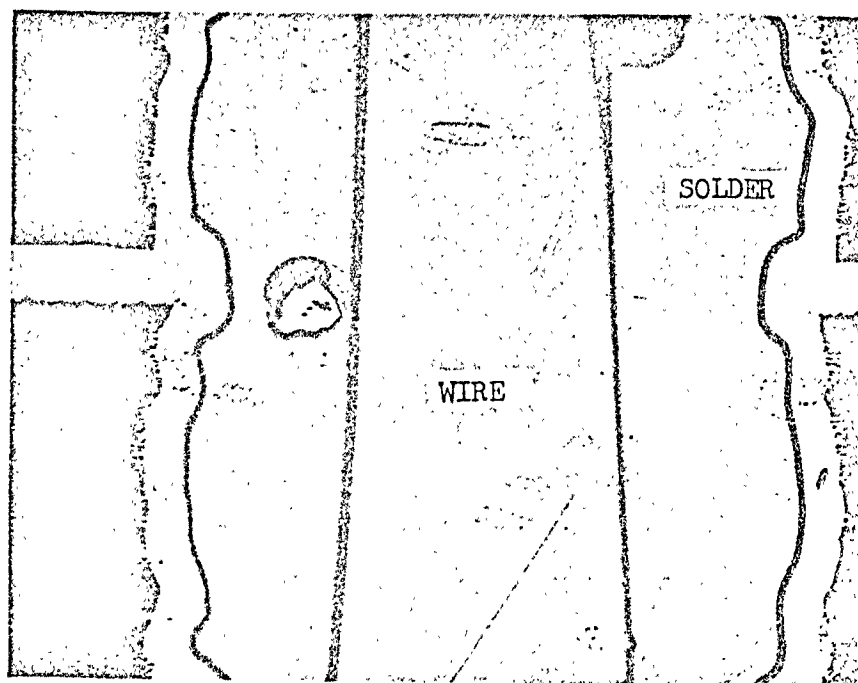
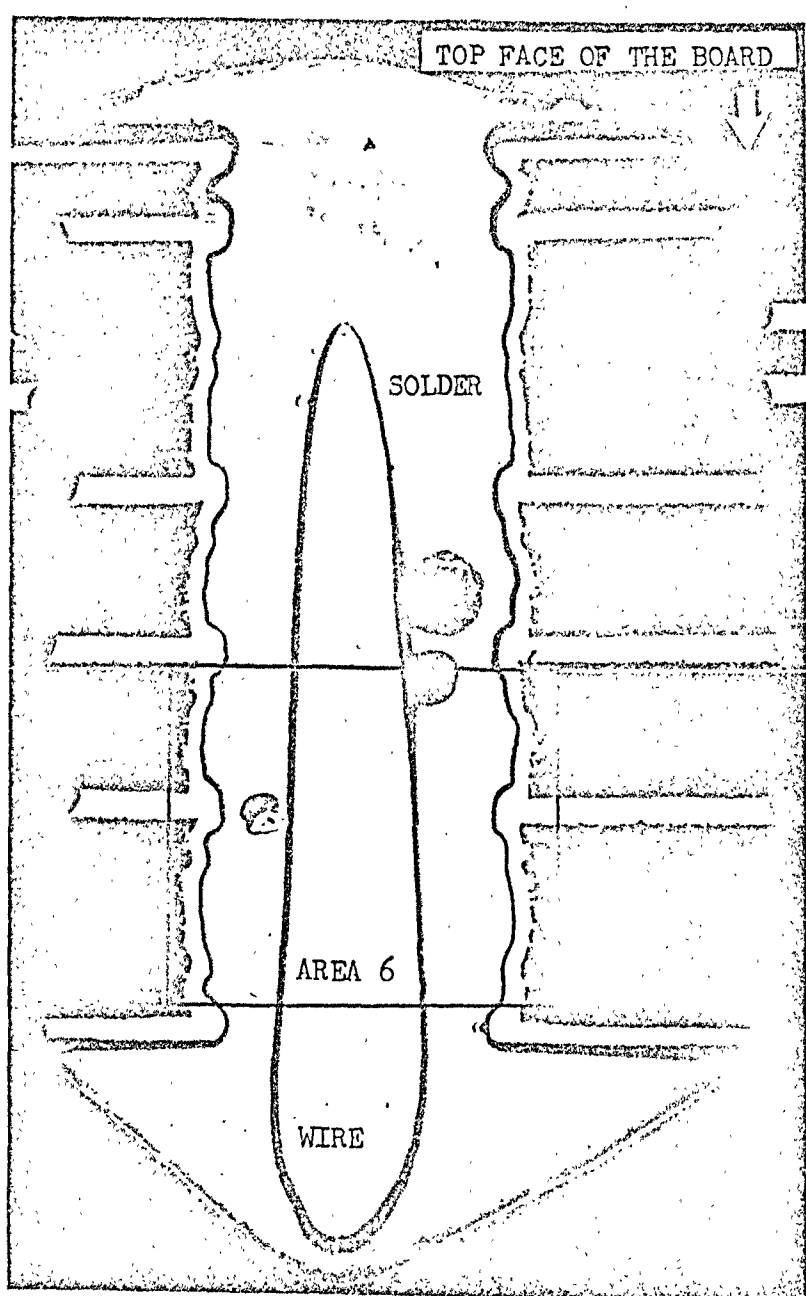
FIGURE 7

CONNECTION H1 SHOWS  
EXCEPT FOR

COMPLETE SOLDER FLOW  
IDS ALONG WIRE

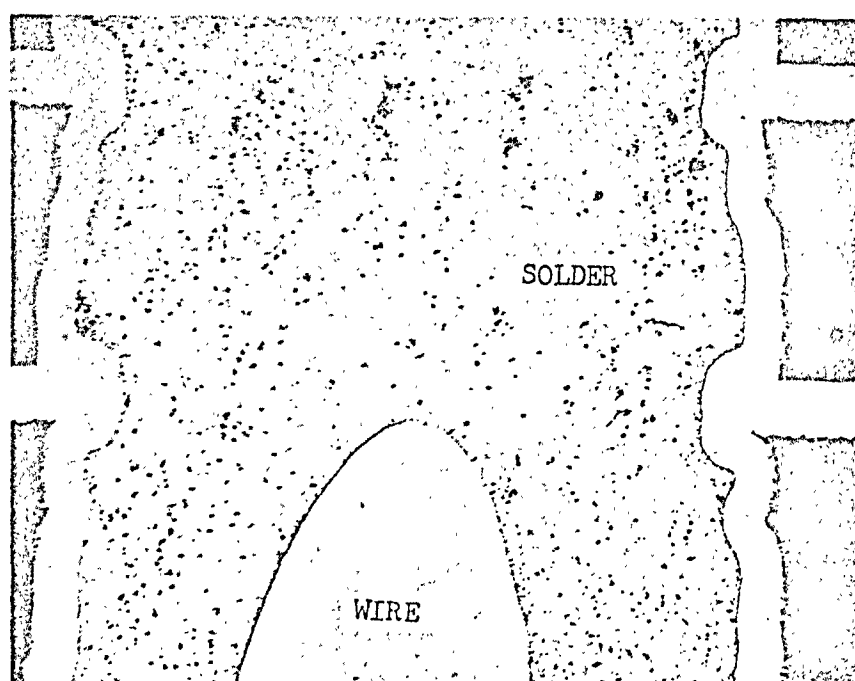
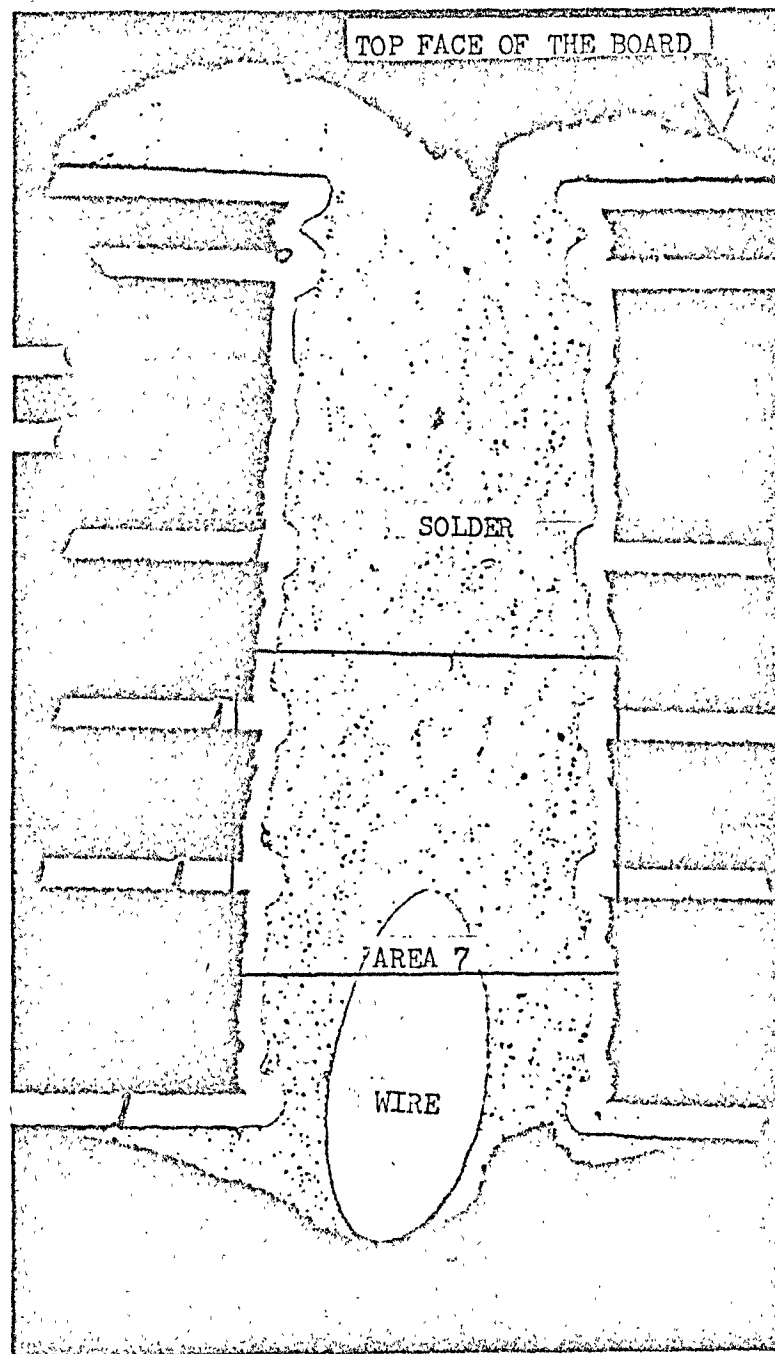
FIGURE 8

CONNECTION H2 SH

NG COMPLETE SOLDER FLOW

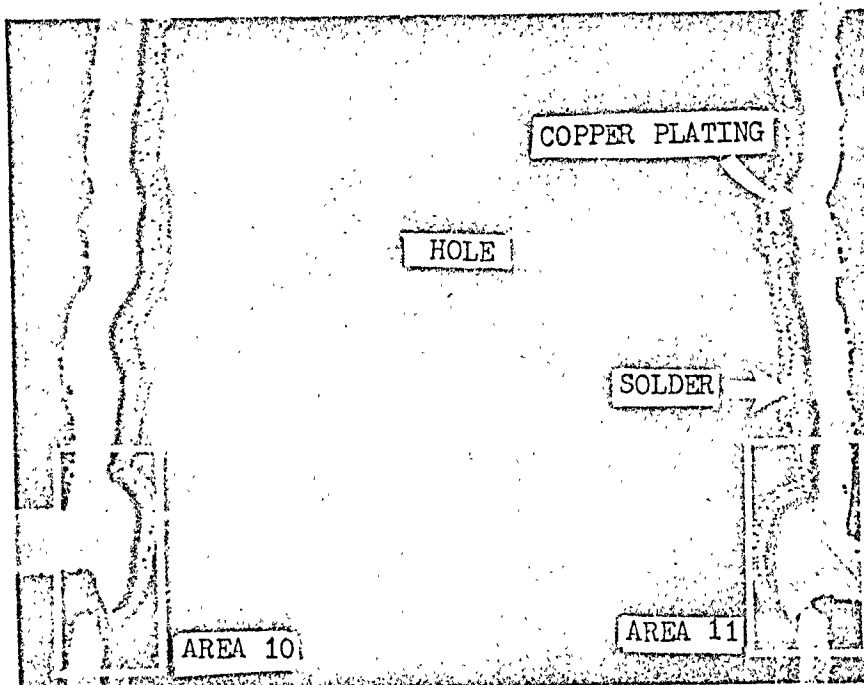
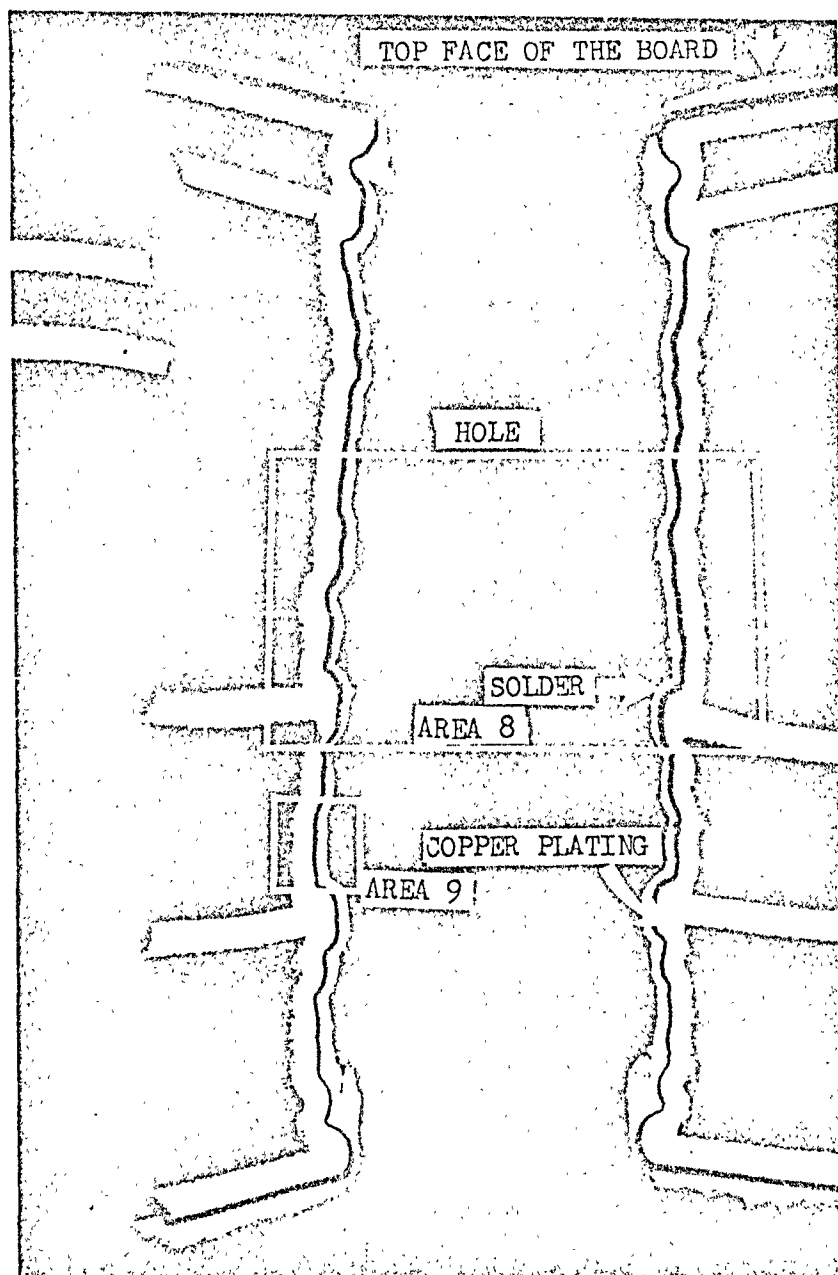
FIGURE 9

UNSO

RED HOLE

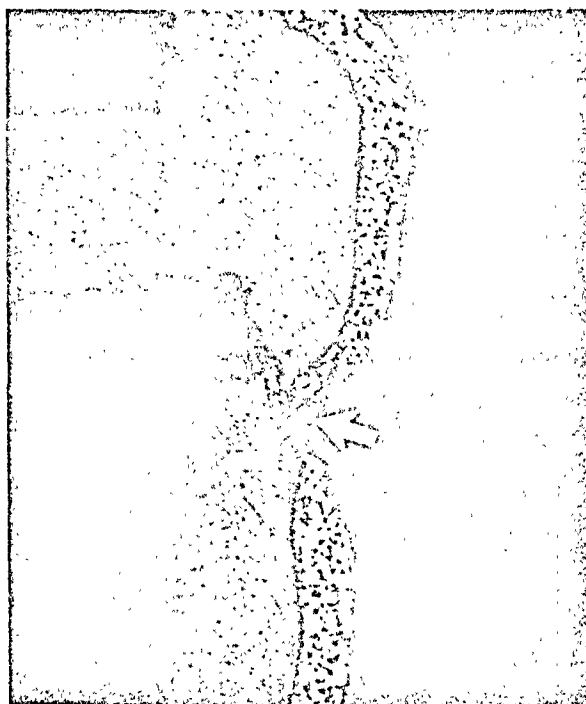
FIGURE 10.-AREAS 10 AND 11 OF SECTION U-U

Area 10, Break in  
Copper Plate (arrow)

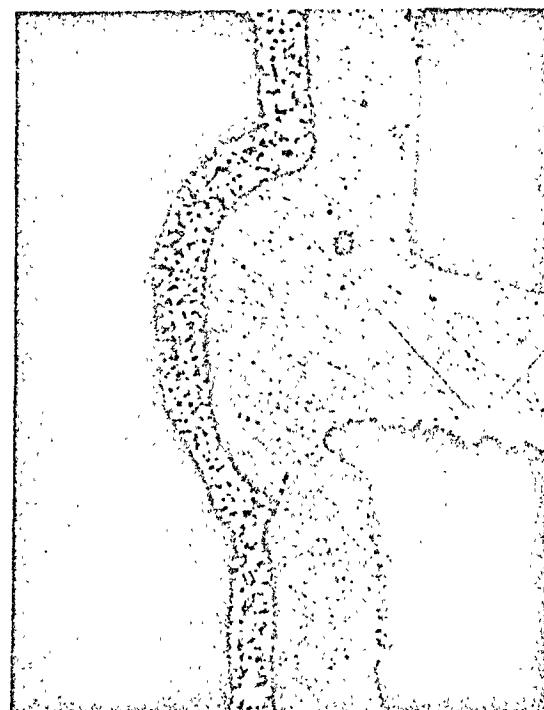
Area 11, Crack in  
Copper Plate (arrow)

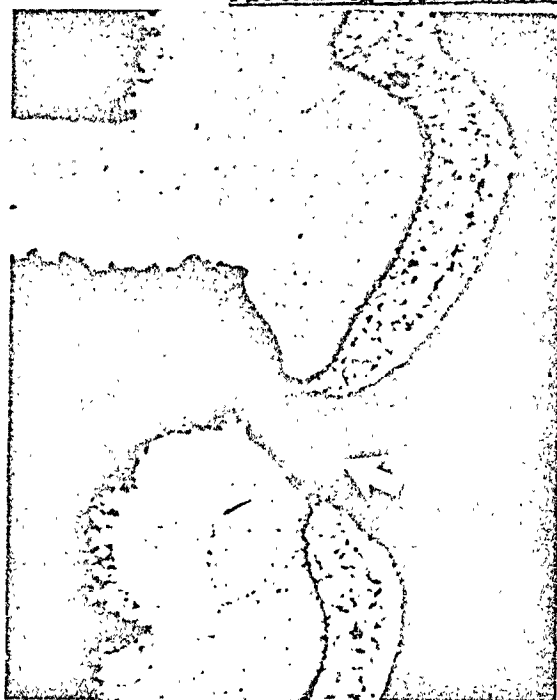
FIGURE 11 SAME AREAS AS FIGURE 10 AFTER REPOLISHING

Area 10, Break in  
Copper Plate (arrow)

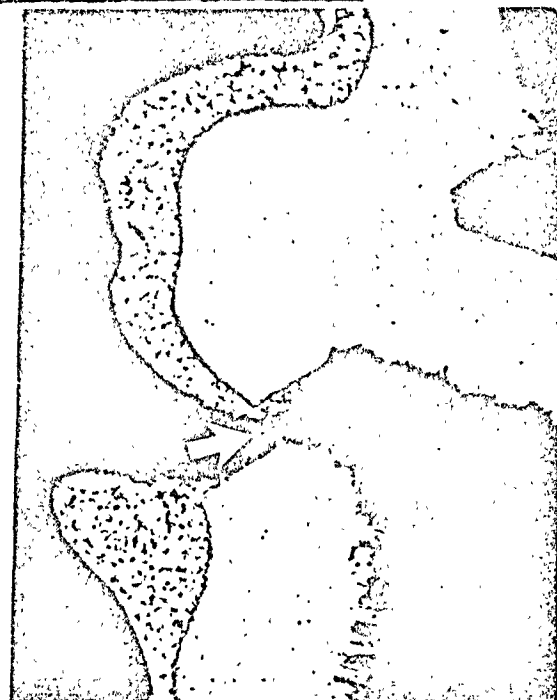
Area 11, Break  
In Copper Plate (arrow)

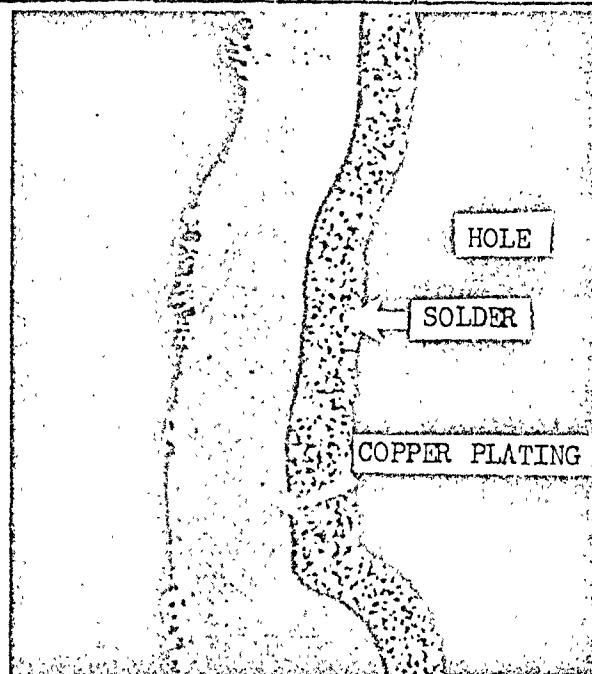
Area 9

3. Thickness measurements of the solder layer and the copper plate were made on the unsoldered hole from the photomicrograph in Figure 13 on page 13. The thicknesses were as follows: average copper plate-0.0024 inch, solder layer-0.0013 inch.

FIGURE 12-AREA OF SECTION U-U FROM  
WHICH THICKNESS MEASUREMENTS WERE TAKEN
