## SOLAR SATELLITE PROJECT

INSTRUMENTATION AND FLIGHT  
PERFORMANCE OF HCO HIGH  
RESOLUTION WAVELENGTH  
SPECTROMETER

NASA AEROBEE 4.185 US  
NASA CONTRACT NSR-22-007-067

May 1969

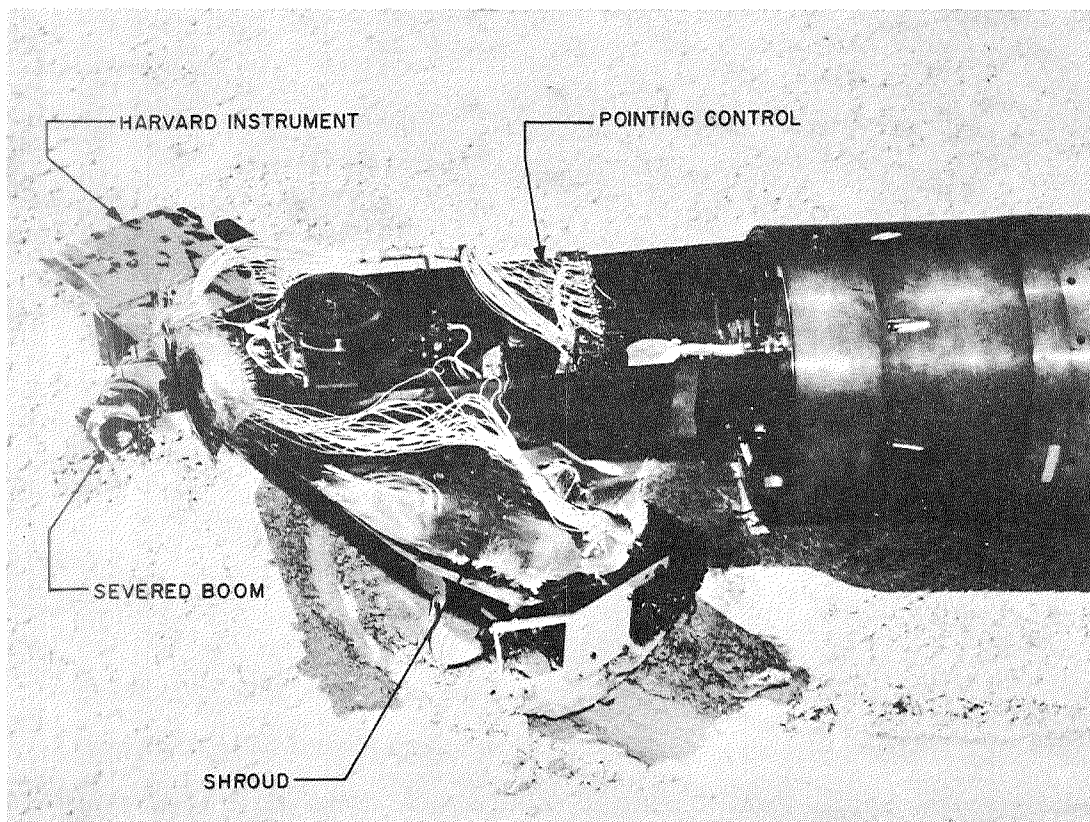
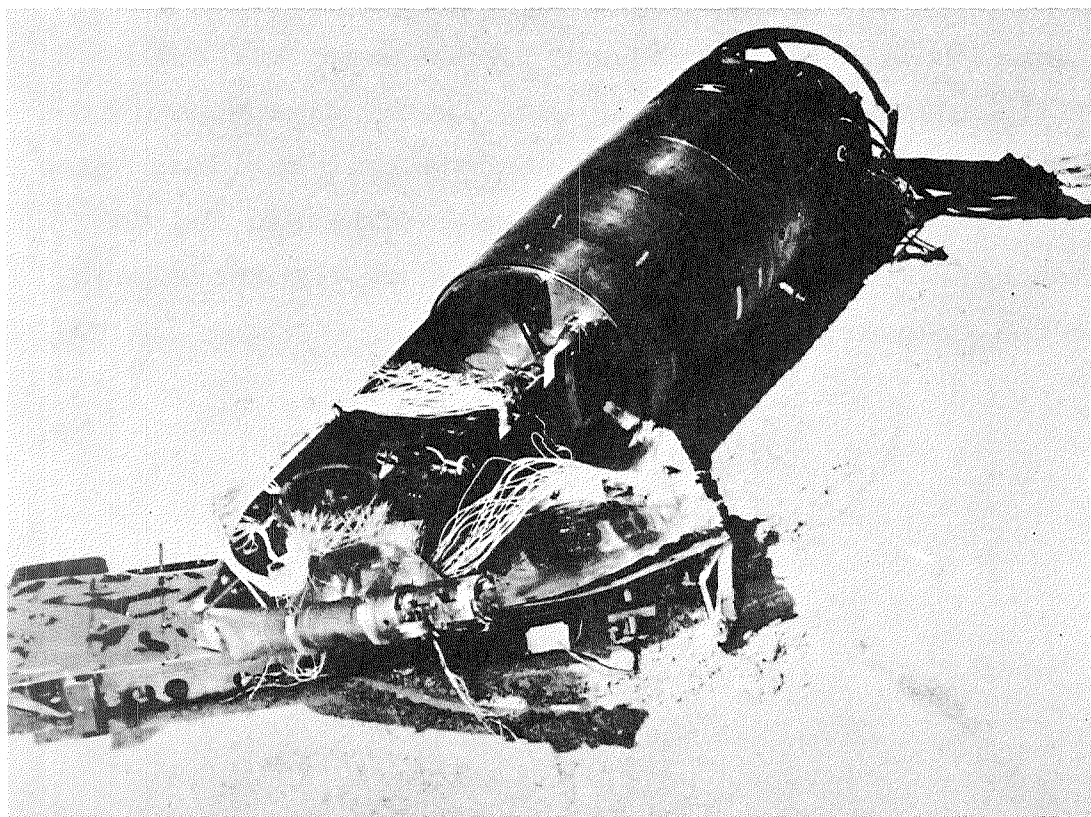
FIGURE 1 -INSTRUMENT AT RECOVERY

The instrument had broken out of the stowed position during reentry, probably on parachute deployment. Because of this, and because the nose cone did not come down, the instrument was subjected to surface heating, buffeting, and desert contamination. The fiberglass thermal shield was burned and ripped away, but the rest of the instrument exhibited very little damage when it was brought back to the Navy Headquarters building after the shot. The instrument will be refurbished and relaunched. (Figure 1 shows two views of the instrument at the recovery site.)

- A. The nose cone had not restowed and was separated from the pointing control prior to impact.
- B. The heat shield on the instrument was missing.
- C. The nose cone lift motor was missing
- D. The lift support tube had been bent at its base about 70 degrees during reentry or on impact.
- E. The instrument had broken out of the stowed position, probably on parachute deployment.
- F. There was enough heating during reentry to melt some vinyl tubing, cable clamps, spot ties and soldered electrical connections.
- G. There was no evidence of electrical arcing in the pointing control or instrument.

Examination of the nose cone assembly was made with two items very apparent. The first was that the joint between the lift tube and the upper nose cone casting was loose and the retaining roll pins had worked loose. This joint is assembled as a ring fit and the roll pins maintain position both laterally and longitudinally in the joint. The next point of examination was in the area of the upper casting on the lift support tube. This casting is a shrink fit to the support tube and is held in place with four steel dowel pins. The lift motor with its gear box and pinion gear is attached to this casting. The examination showed that this casting was loose on the support tube and two dowel pins were missing. One of the remaining dowel pins had moved far enough in toward the center of the casting to prevent passage of the nose cone tube when it attempted to drive down.

The nature of the damage and especially the loosening of the nose cone joint and the upper support tube joint showed that the nose cone must have been whipping violently while in the raised position. A correlating factor to this whipping motion was found in the flight data. It was determined during preflight ground tests that maximum nose cone motion, or its point of resonance, occurred with a rocket spin rate of 2.4 to 2.5 rps. From the flight data it was found that the rocket roll rate after the pointing control had acquired the sun was 2.48 rps. Hence, it could be expected that the nose cone motion due to vehicle roll rate was at the maximum.

5) To prevent yoke pins from loosening, the yoke has been redesigned.

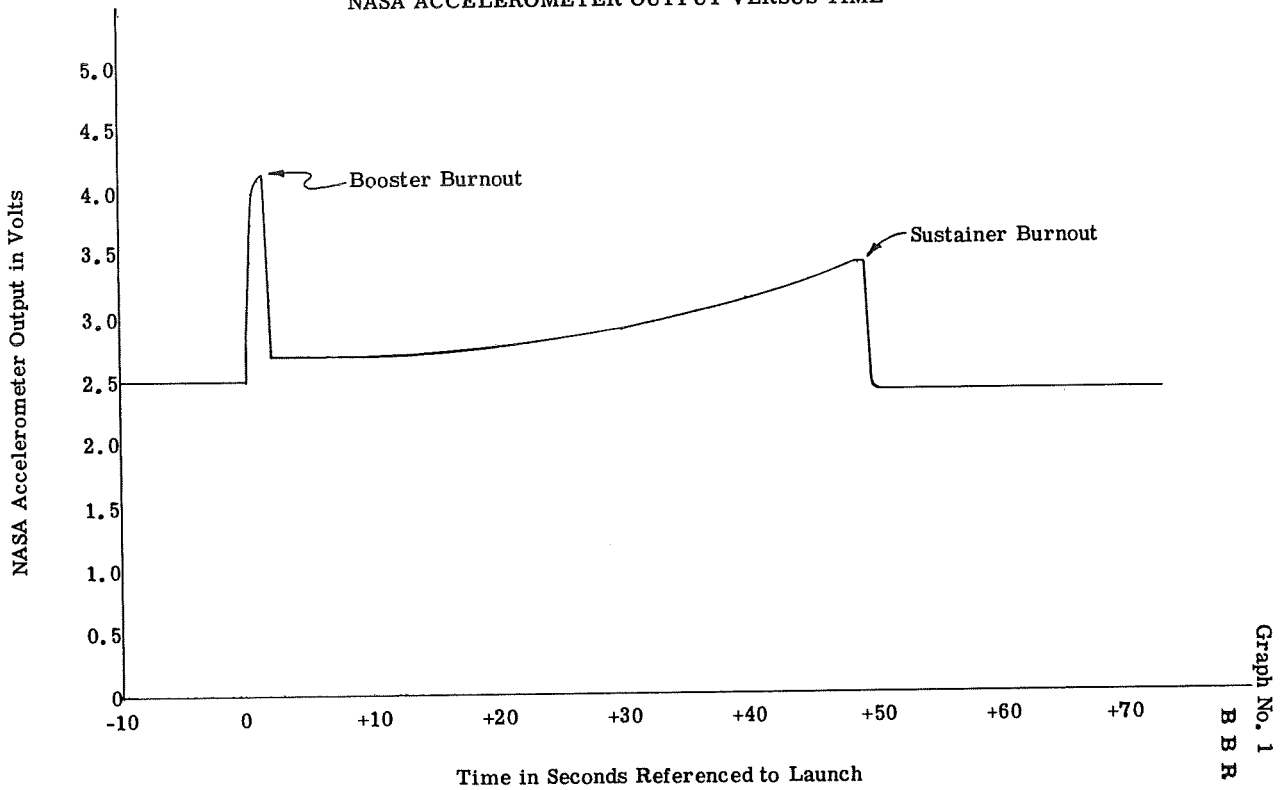
NASA 4,185 US/SPC 324 D/B  
NASA ACCELEROMETER OUTPUT VERSUS TIME

Graph No. 1 is a plot of the NASA accelerator output versus time from lift-off to  $T + 73$  seconds. The data was on a shared telemetry channel which was switched at  $T + 73$  seconds. The output is plotted as telemetered voltage since the transducer calibration was not available at BBRC. It should be also noted that the vehicle sustainer chamber pressure transducer did not operate properly during this flight and therefore no data are available.

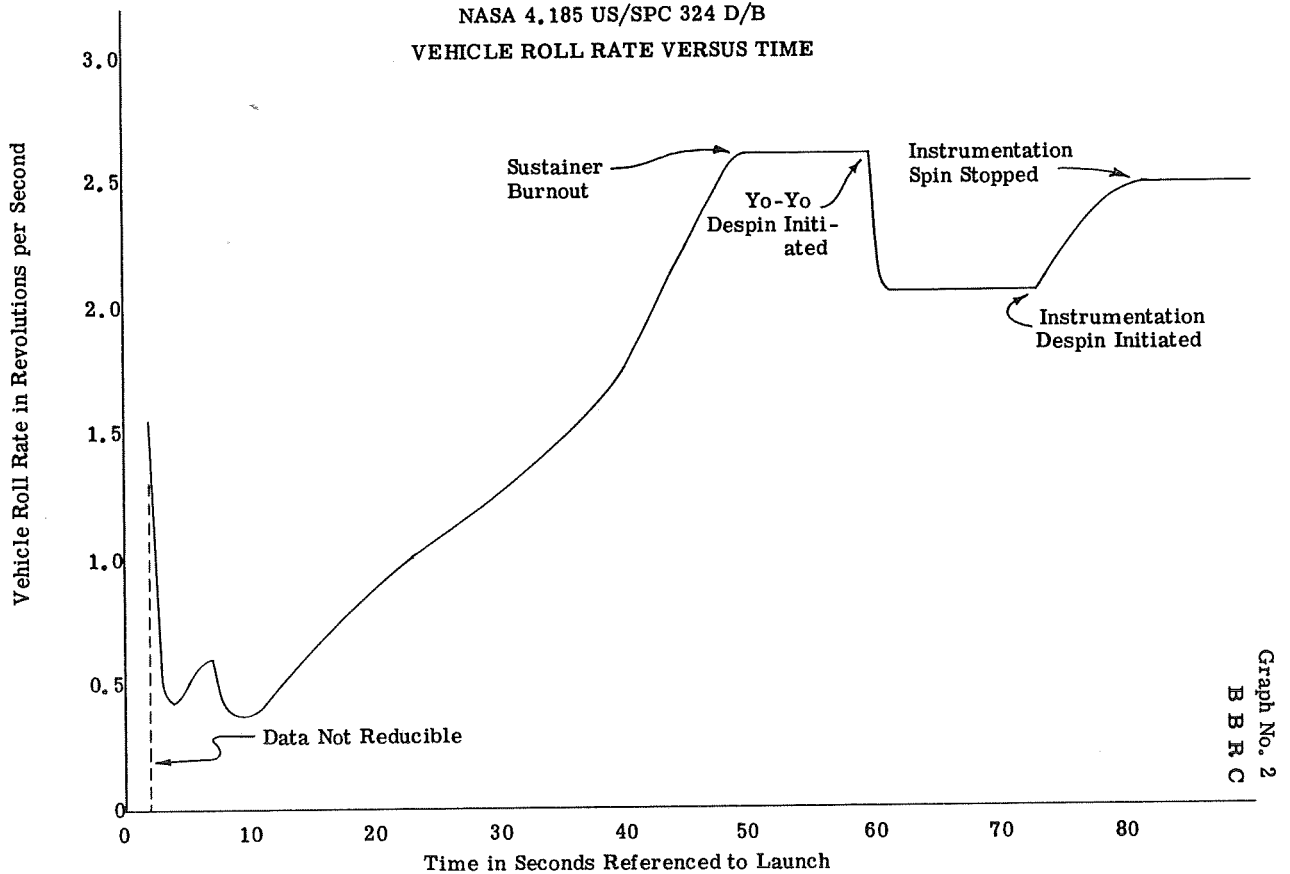
NASA 4,185 US/SPC 324 D/B  
VEHICLE ROLL RATE VERSUS TIME

Graph No. 2 is a plot of the vehicle roll rate versus time from  $T + 2.0$  seconds to  $T + 90$  seconds. The roll rate of the vehicle at sustainer burnout was 2.60 rps, which was maintained until Yo-Yo despin initiation occurred at  $T + 59.7$  seconds, despinning the vehicle to 2.05 rps. The despin of the upper payload section then increased the vehicle roll rate to the final figure of 2.48 rps.

4) Excessive vibration caused by rocket spin rate proved a problem during the last flight. Therefore, a different yo-yo despin system will be used on the

next rocket in order to control the spin rate and the vibration. The 30% yo-yo system used on the last flight will be replaced by a 50% yo-yo system.
