SUMMARY REPORT  
TASKS VII AND VIII  
JPL CONTRACT No. 951720  
3 JUNE 1969

HYDRAZINE ELECTROLYSIS CELL  
SAFETY LIMITS TESTS

PREPARED BY  
N. E. MORGAN

HUGHES AIRCRAFT COMPANY  
SPACE SYSTEMS DIVISION  
EL SEGUNDO, CALIFORNIA

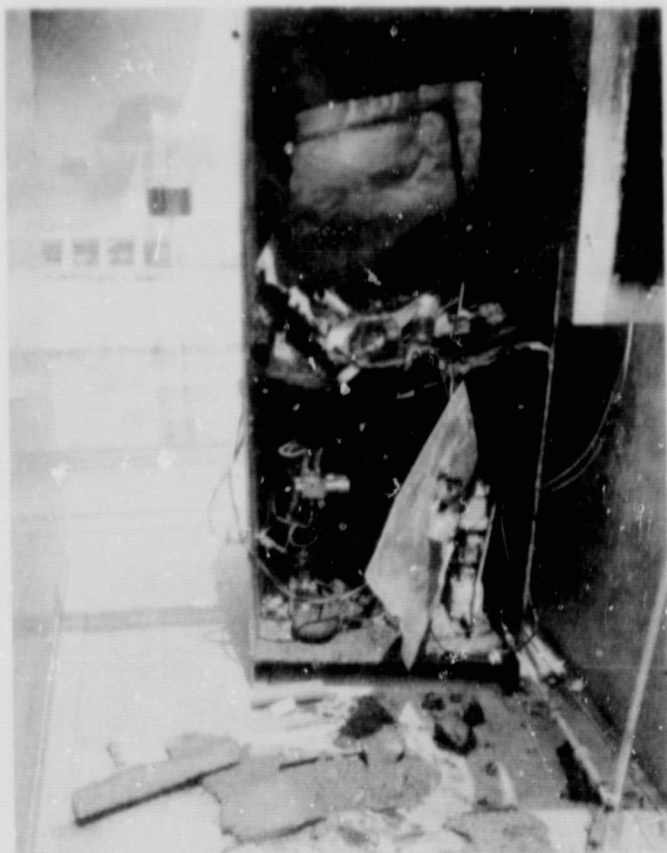
FIGURE 9

TEST CHAMBER  
AFTER FAILURE

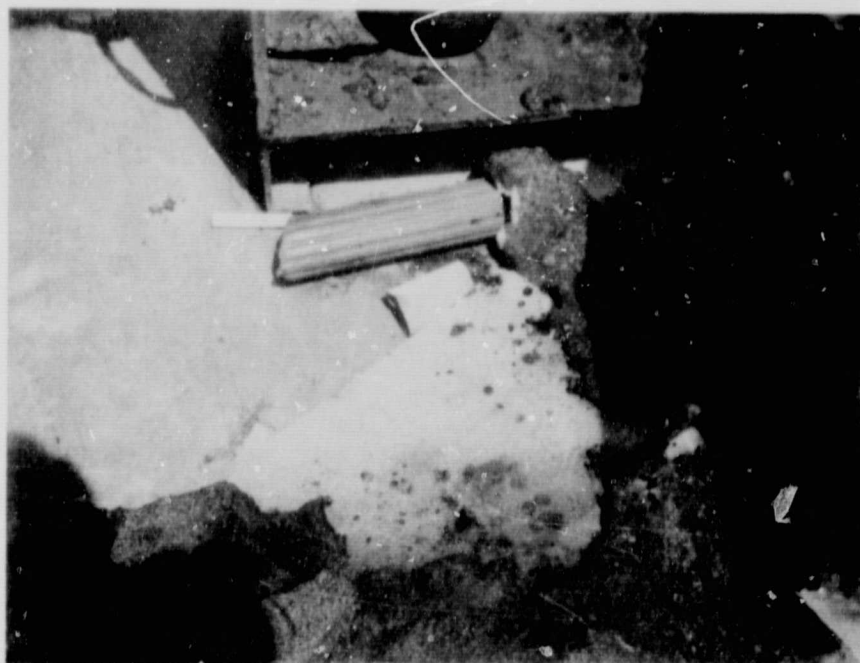
FIGURE 10

ANODE AND OTHER PARTS  
AT BASE OF TEST  
CHAMBER

2. Anode - Found on ground just below chamber with lower 1 to 2 inches missing. Fragments of anode were found scattered on hillside up to approximately 20 feet from chamber.

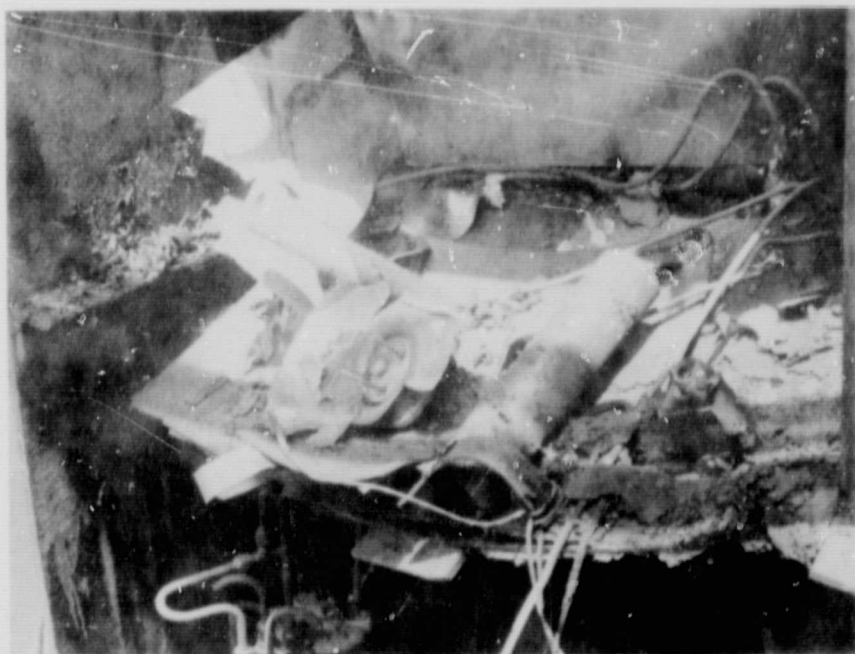
FIGURE 12

PARTS OF ELECTROLYSIS  
CELL REMAINING  
IN TEST CHAMBER

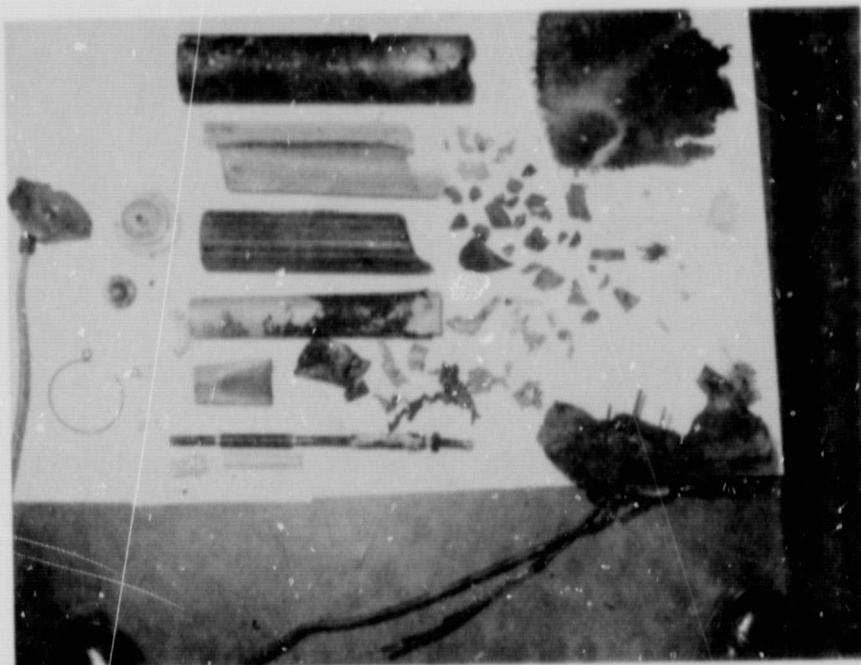
FIGURE 13  
ELECTROLYSIS CELL PARTS  
AND FRAGMENTS

The available evidence indicates that a reaction sufficiently violent to damage the aluminum inner and outer enclosures and shatter the lower end of the anode occurred between the inner and outer enclosures. Based on the orientation of the parts, the location of the reaction was established near to the bottom of the cell and also near the surface of the main body of liquid in line with the cathode connector.
