EVALUATION OF TANTALUM FOR MERCURY
CONTAINMENT IN THE SNAP-8 BOILER

TOPICAL REPORT

AEROJET-GENERAL CORPORATION

November 1969

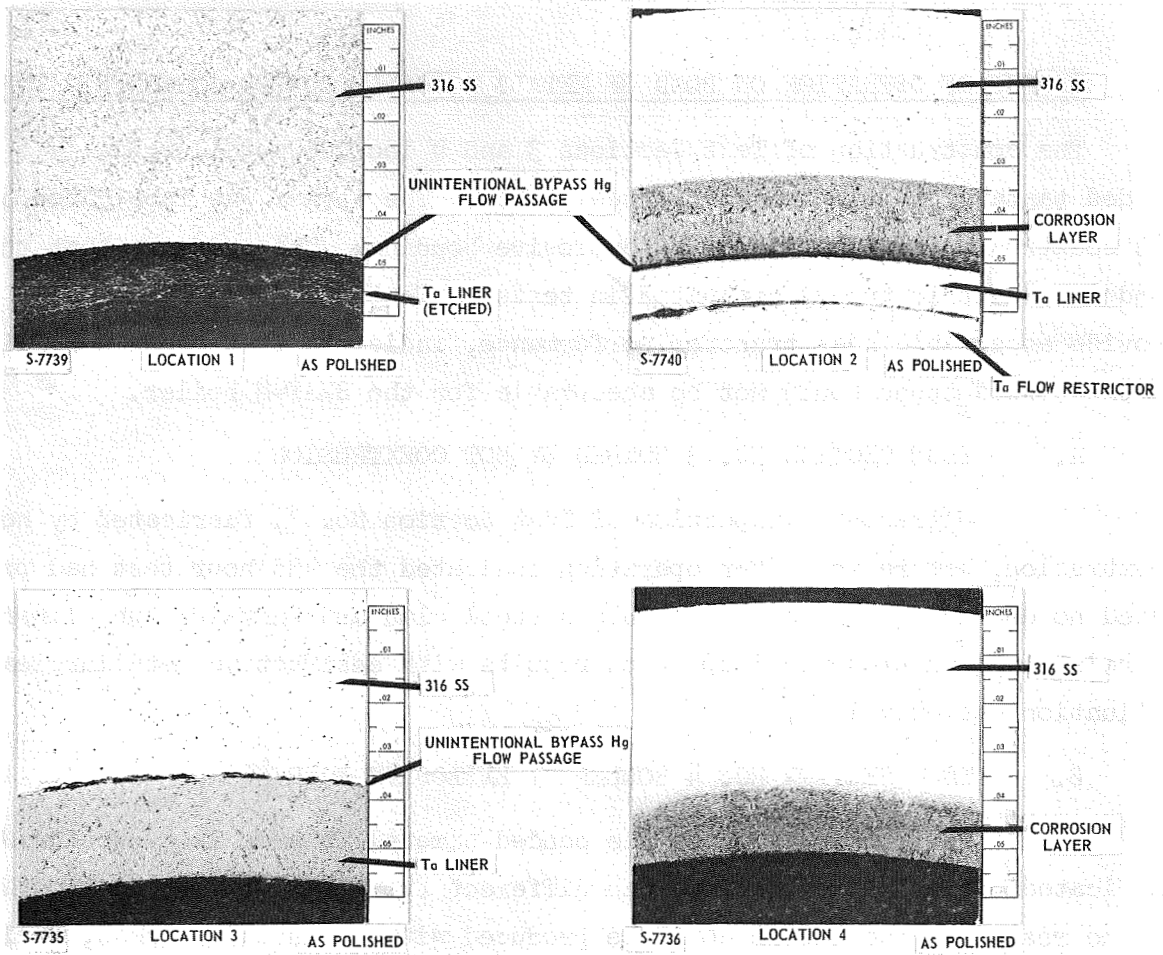
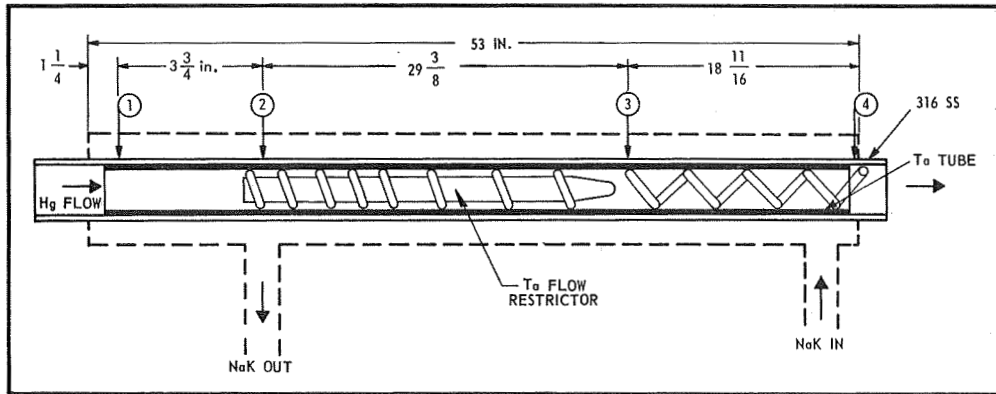
Figure 11. Hg Corrosion Attack of 316 Stainless Steel in Test Section No. 1 After 2858 Hours of Operation

Test Section No. 1 actually transferred the heat efficiently, however, post-test metallurgical evaluation indicated that the acceptable heat transfer resulted because the annular space between the unbonded tantalum and 316 stainless steel tubes was filled with flowing mercury. In effect, a double concentric mercury flow passage existed. This flow pattern defeated the prime purpose of incorporating tantalum for mercury containment, since the by-pass flow contacted the 316 stainless steel tube inner surface. Proof of by-pass flow, as an unacceptable condition, was provided by the mercury corrosion attack of the 316 stainless steel tube found in the metallographic specimens examined from Test Section No. 1 (see Figure 11).

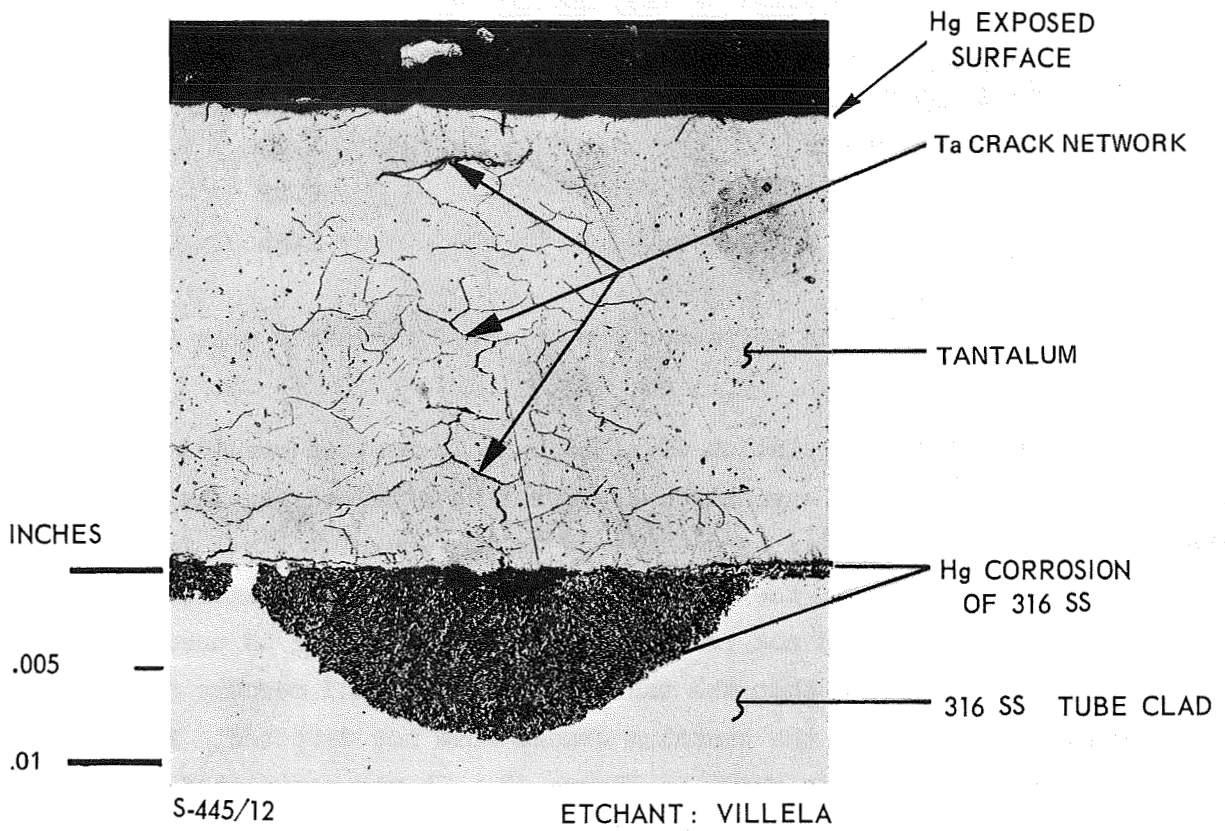
Figure 12. Tantalum Cracks and Mercury Attack of 316 Stainless Steel Bimetal Tube Clad in Test Section No. 4

Complete correlation of ultrasonic inspection results with destructive metallurgical evaluation could not be attained because during the air injection tests, cracking occurred in the tantalum liner from the mercury exposed surface to the tantalum-316 stainless steel interface. The inspection technique could not reliably evaluate the degree of unbond in these areas. It was also found that the tantalum cracking, and mercury corrosion of the 316 stainless steel under the tantalum cracks were not detected. A typical area containing these defects is shown in Figure 12. It was postulated that the incorporation of an additional scan using the ultrasonic shear wave technique could correct this deficiency in the inspection procedure; however, development work in this area had not been accomplished at the time this section was inspected. It would appear that regardless of the capability of the ultrasonic inspection technique for detecting these areas, this gross air contamination of the tantalum liner, in an operating SNAP-8 boiler would not be acceptable and must be avoided through reliable boiler and system design, and improved system operating procedures during ground testing.

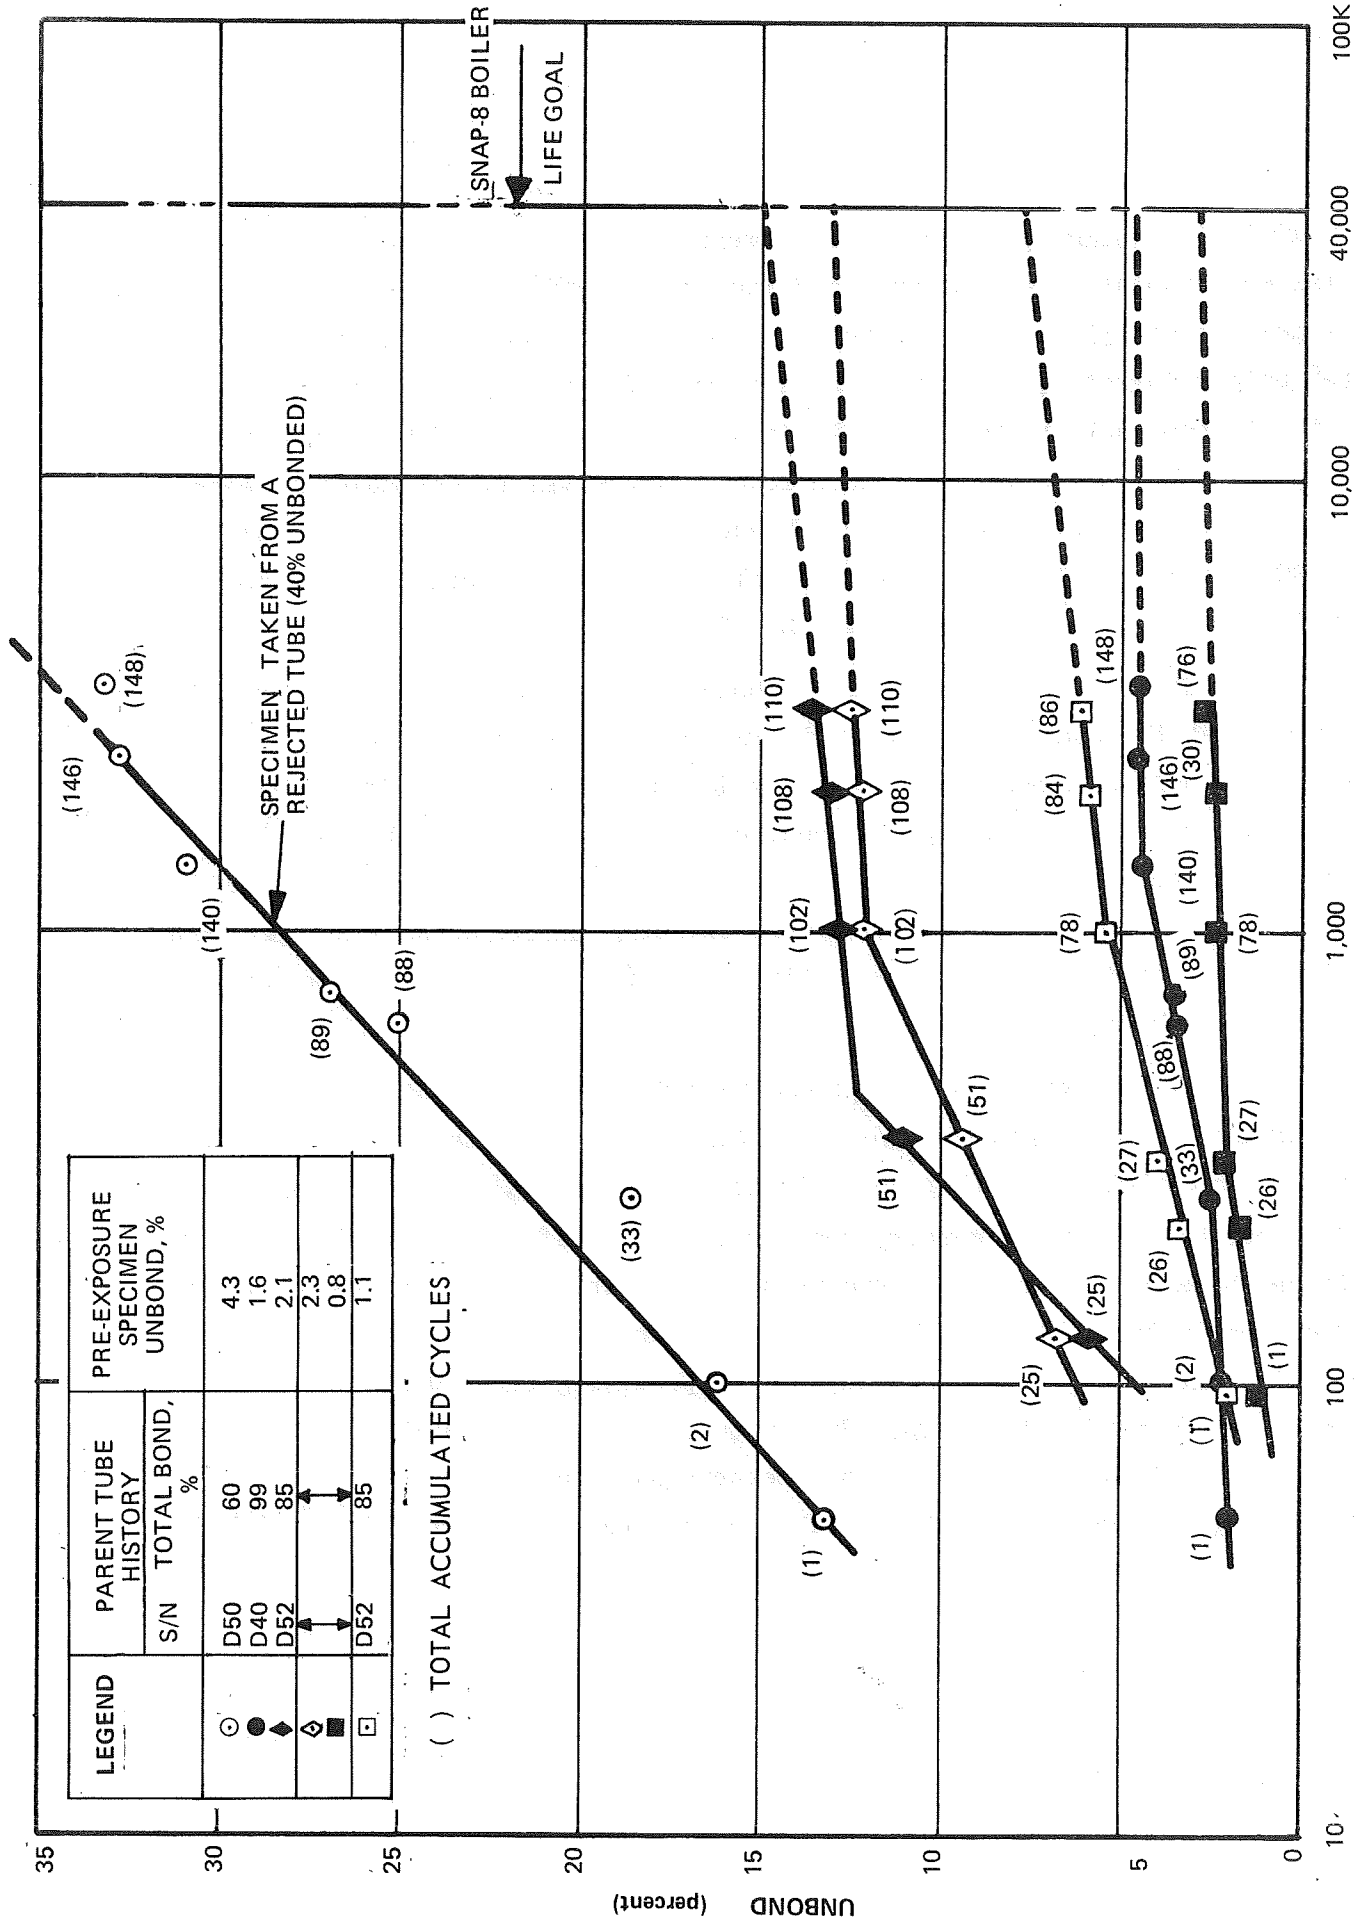
Figure 13. Debonding at 1300°F of Short Specimens Removed from 8-Foot-Long Explosively Bonded Tubes

The results of explosively bonded tube specimens (see Figure 13) indicated that the quality of the bond, and the debonding potential of pre-existing unbond areas, was related to the amount of unbond in the as-fabricated tube. For example, the specimen cut from a tube containing 40% unbond, which on a comparative basis is considered poorly bonded, exhibited a much greater tendency for growth of pre-existing unbond areas than specimens cut from tubes containing higher quantity bonds (the entire tube containing 15%, or less unbond).

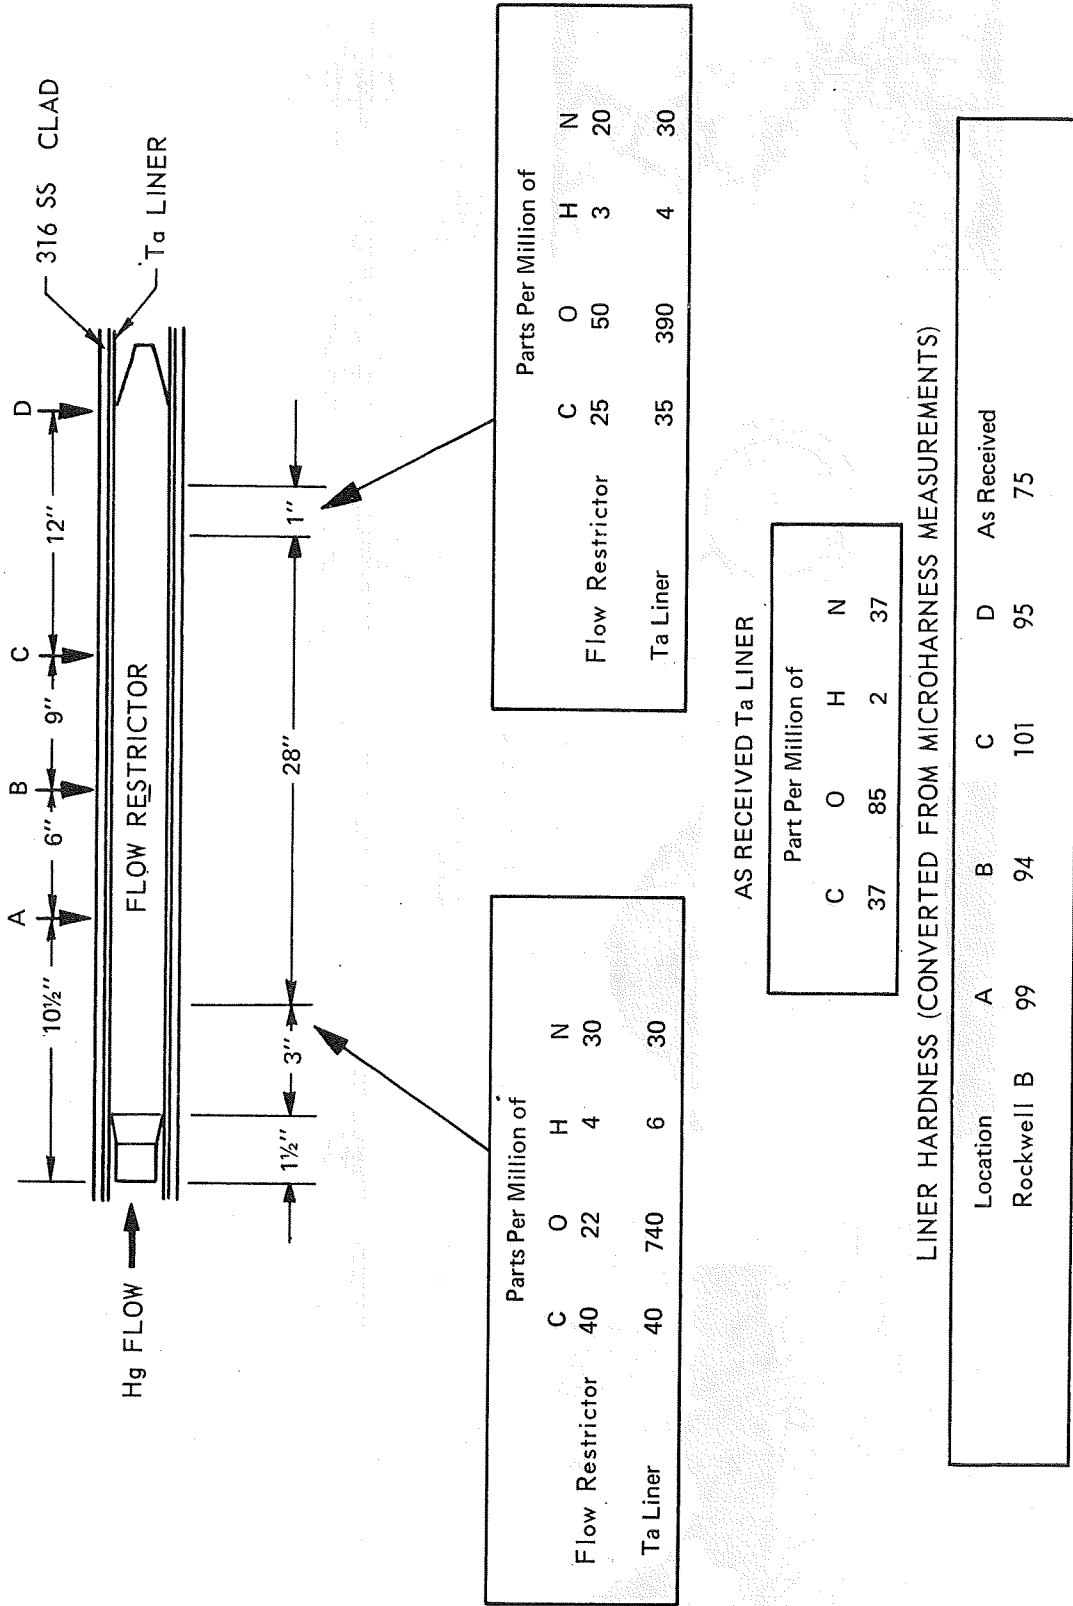
Figure 14. Interstitial Analysis of Tantalum Liner and Mercury Flow Resistor and Liner Hardness Test Section No. 4

A minor air-tantalum interaction was evident in tantalum samples from the plug insert region, and was characterized by: an increase in the oxygen from a pretest value of 85 ppm to 740 ppm in the tantalum liner, the development of a subsurface oxide, approximately one mil deep in the tantalum liner and tantalum plug, and by an increase in the tantalum ID microhardness and plug OD microhardness (see Figure 14). A major tantalum-air interaction was evident in the area immediately downstream of the plug insert region and was characterized by an extensive cracking in the tantalum liner (see Figure 15), and reduction of the wall thickness of the tantalum liner.

Cracks were evident in the liner ID, OD, and center, and several extended from the tantalum liner ID to the OD. Microhardness measurements taken adjacent to the cracks were approximately equivalent to microhardness measurements taken in the uncracked area. When tantalum-air interaction occurred, the microhardness increased and when the diffused oxygen concentration exceeded the saturation solubility limit for the exposure temperature, tantalum oxide precipitation occurred in the grain boundaries and on certain crystallographic planes. One explanation for the cracking would be that it was caused by the combined effect of thermal cycling stresses and reduced ductility of the tantalum due to the air-tantalum interaction.

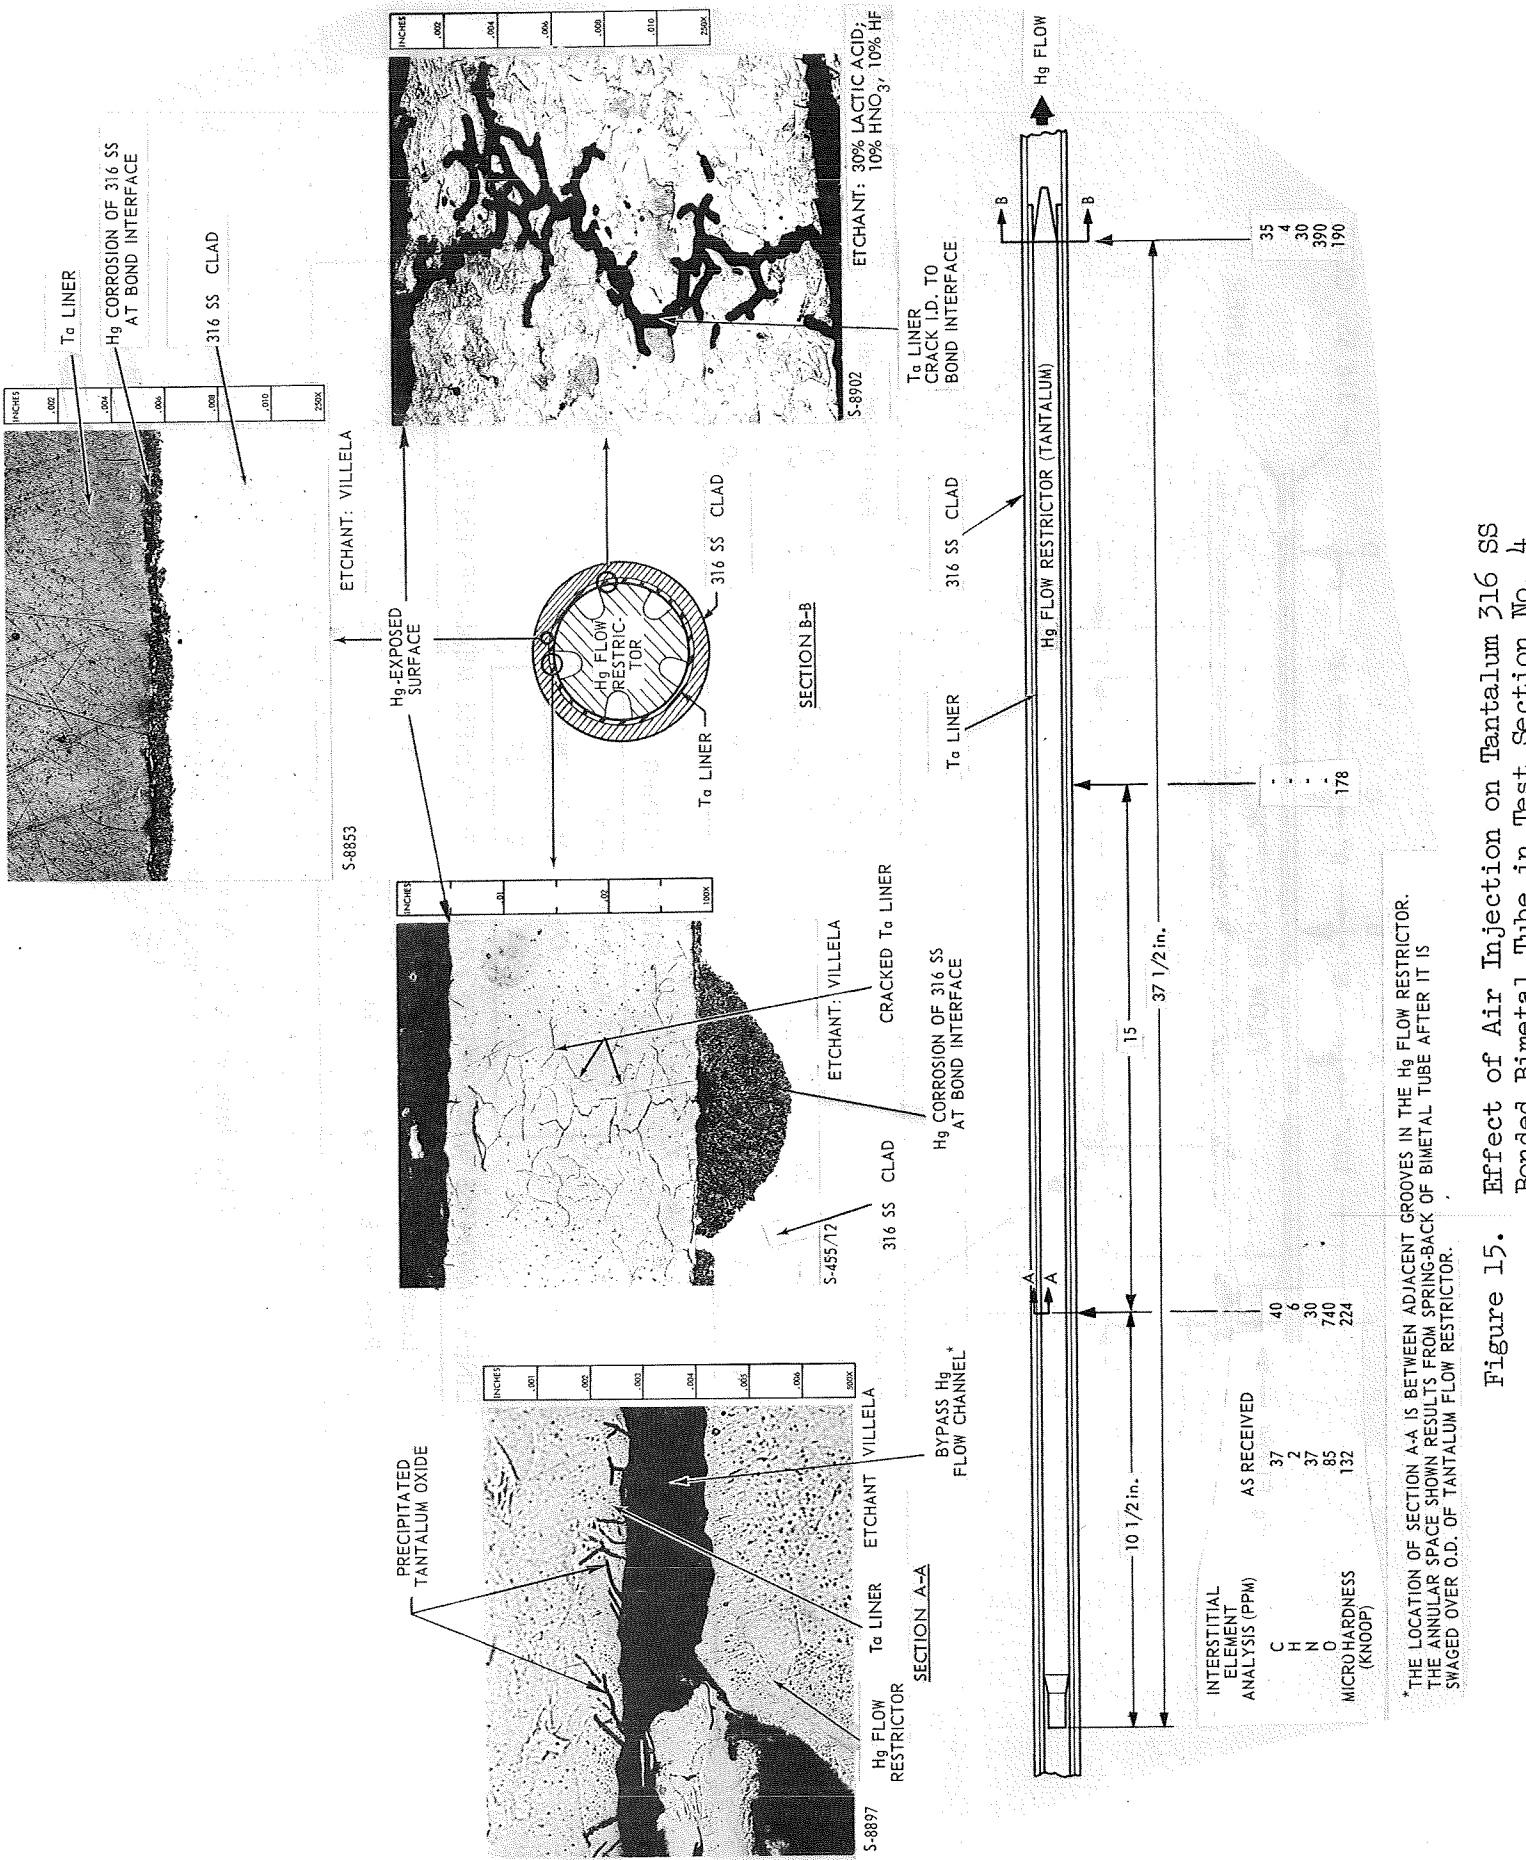
Figure 15. Effect of Air Injection on Tantalum 316 SS Bonded Bimetal Tube in Test Section No. 4

Stainless steel leaching was evident in the plug exit region. The mercury attacked the stainless steel internal diameter surface and leached out certain areas (see Figure 15). The attack occurred in areas adjacent to

cracks that formed at the tantalum to stainless steel interface. Apparently the mercury diffused through the network of cracks in the tantalum liner ultimately contacting the 316 stainless steel clad at the tantalum/316 stainless steel interface. Subsequent leaching-type corrosion, typical of mercury attack of 316 stainless steel, occurred. Based on this corrosion mechanism, and the anticipated rate of attack established by other studies, the Type 316 stainless steel tube was estimated to be under attack for 610 hours.

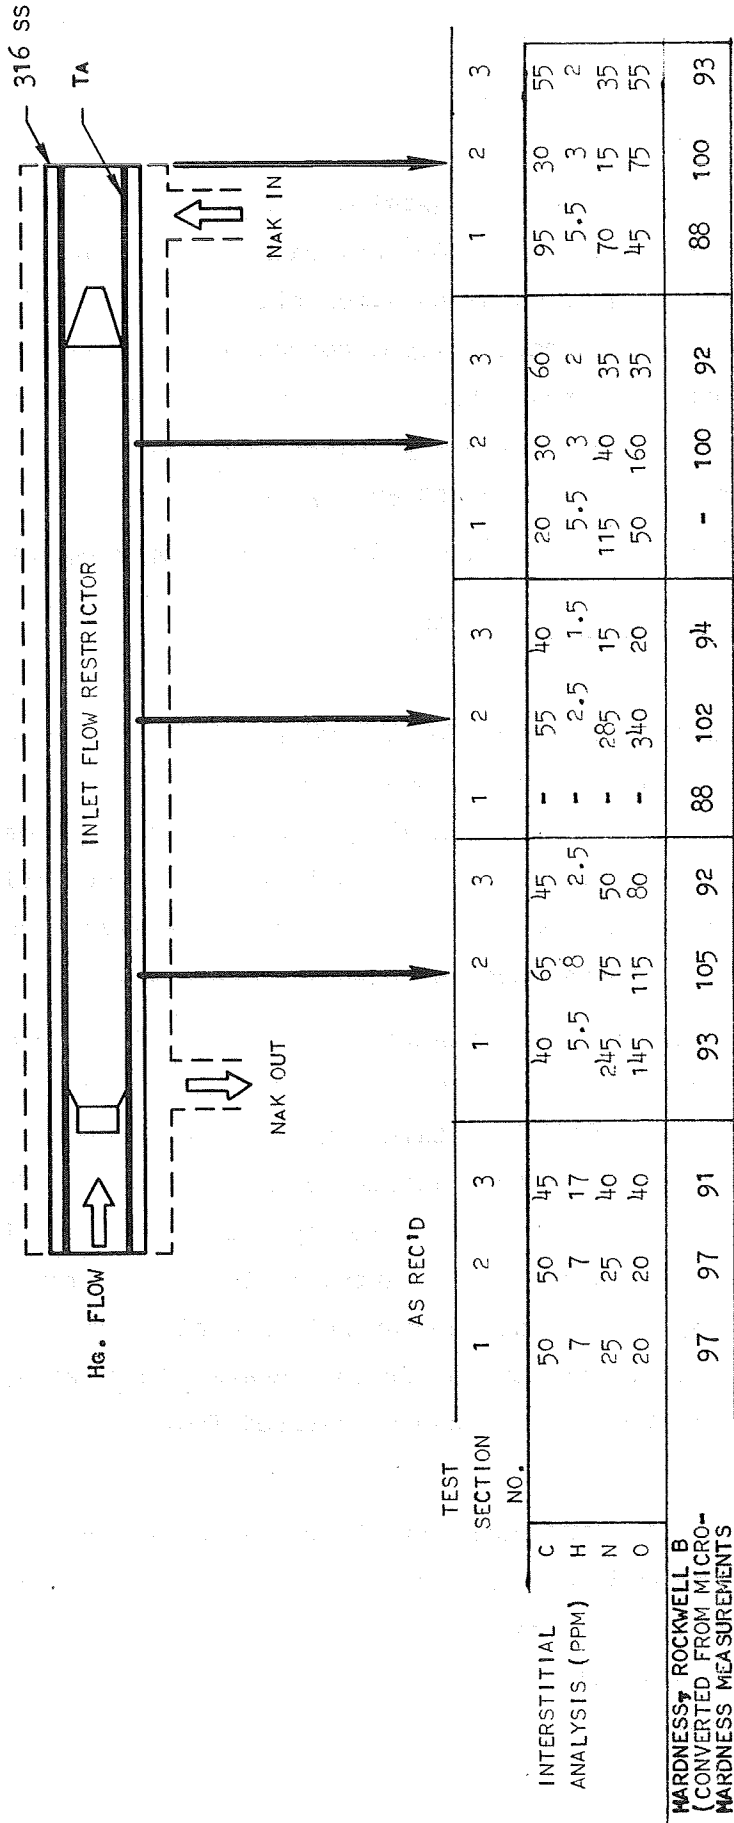
Figure 16. Interstitial Analysis and Hardness of Tantalum Tube in Sections 1, 2 and 3

Air was not intentionally injected into these sections and there was no obvious system failure which could have resulted in air contamination. However, interstitial analysis of the tantalum indicated that an undetected source of air had contaminated the tantalum tubes in each of these test sections. An increase in hardness as a result of section operation, determined by microhardness measurements, confirmed the chemical analysis results. The pre- and post-test comparative data were as shown in Figure 16.

The interstitial analysis and microhardness checks indicated that the tantalum in each section picked up oxygen and nitrogen, especially near the mercury inlet end of the tantalum liner. Some increase in strength and a reduction of ductility of the tantalum could be expected from the increase in oxygen and nitrogen content but it is likely this would not significantly affect the corrosion resistance of the tantalum liner. The most likely sources of the nitrogen and oxygen were air contamination during the mercury loop out-gassing procedure performed at startup or in-leakage of air when, during mercury loop shut-down, a subatmospheric pressure resulted from mercury vapor condensation.

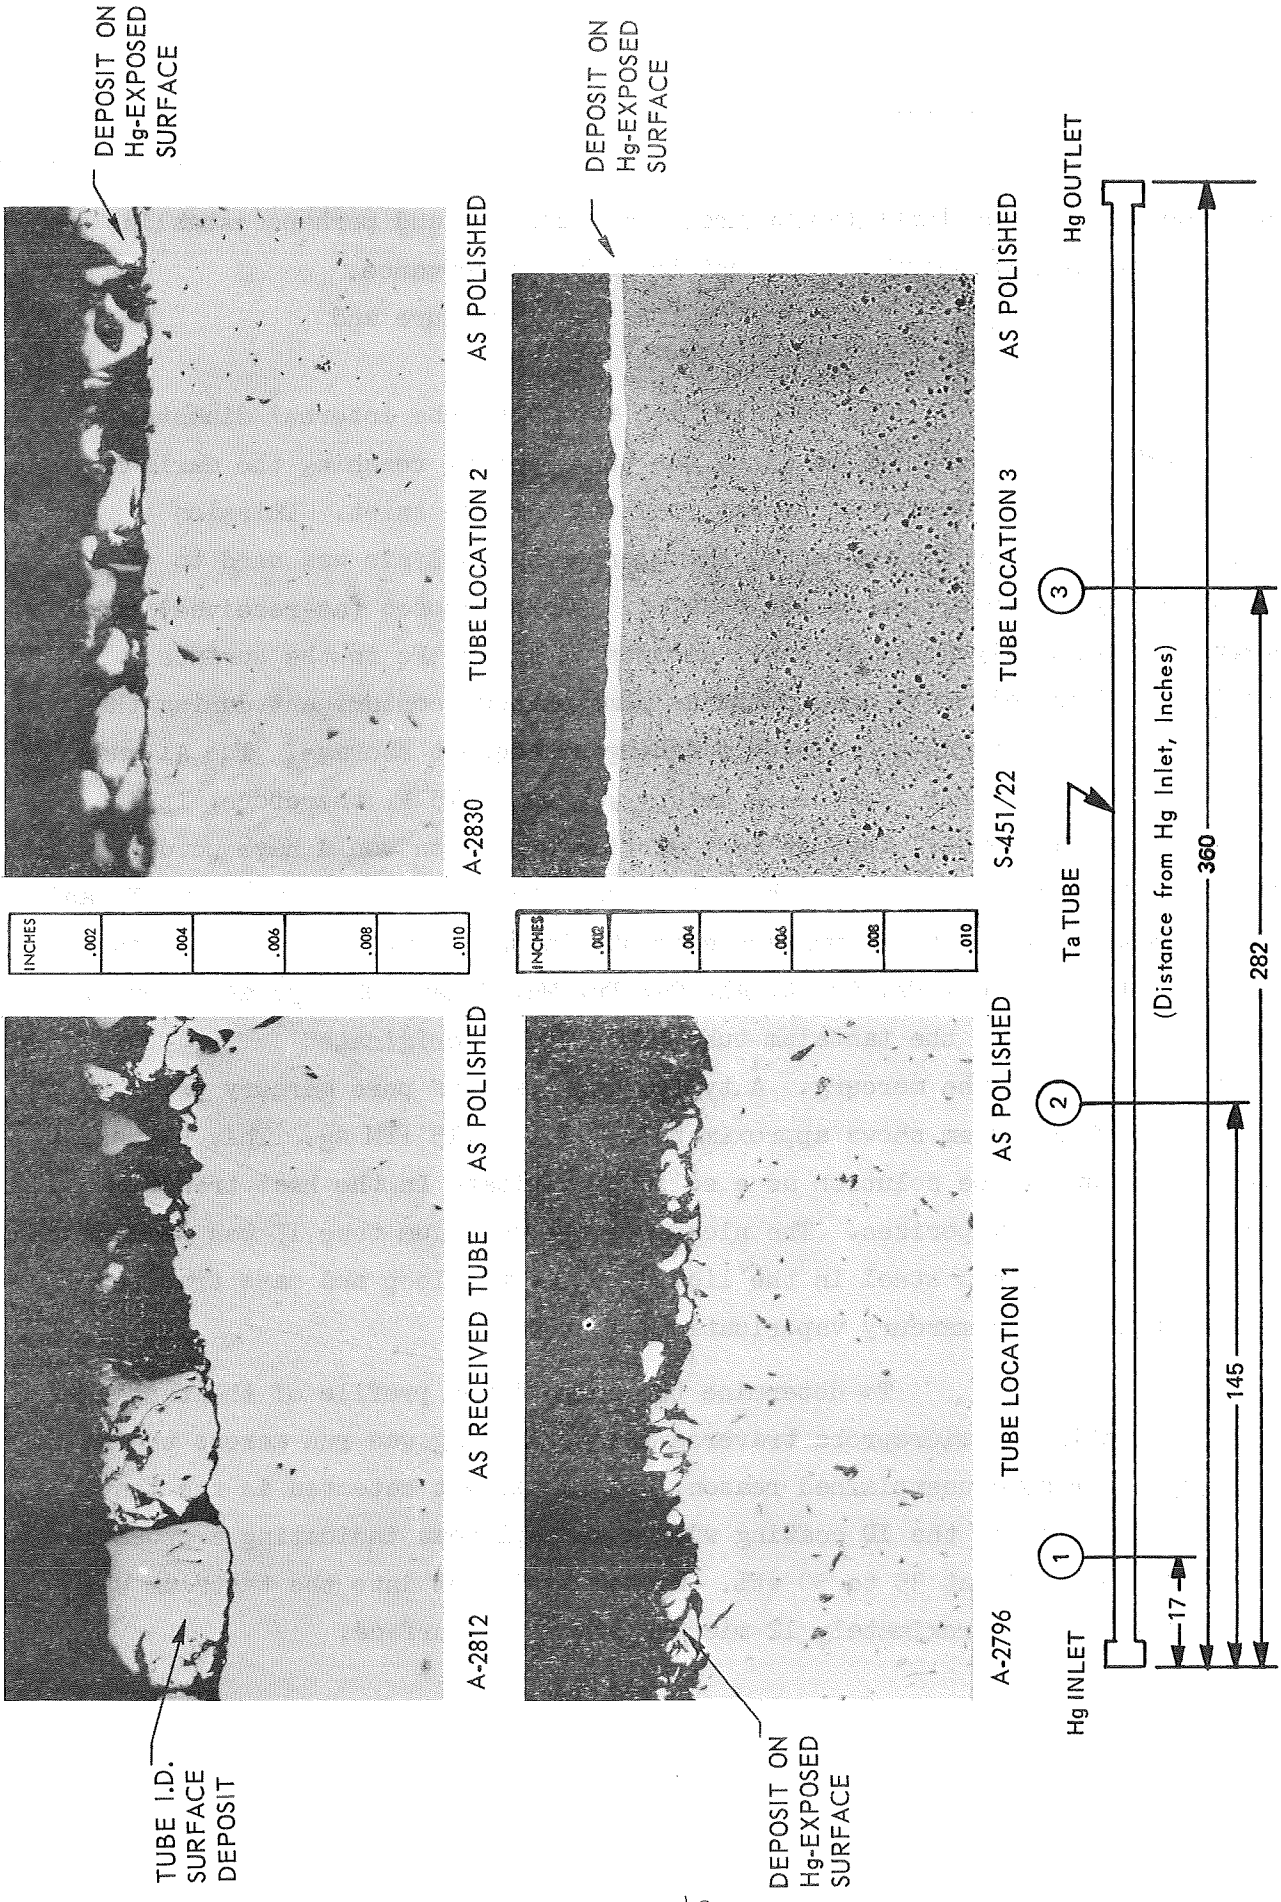
Figure 17. Coating on Hg Exposed Surfaces of Ta Tube in Test Section No. 5

A surface coating was noticed on the mercury exposed surface of all tantalum components in the test section. These included the inside wall of the tantalum tube, the outside surface of the tantalum mercury flow restrictor, at the mercury inlet, and at the outside surface of the tantalum alloy (Ta-10%W) turbulator wire downstream of the flow restrictor. The coating appeared as a mixture of microstructural constituents when viewed at high magnification. Of particular significance was the presence of a similar coating on the as-received tantalum tube (see Figure 17). An investigation

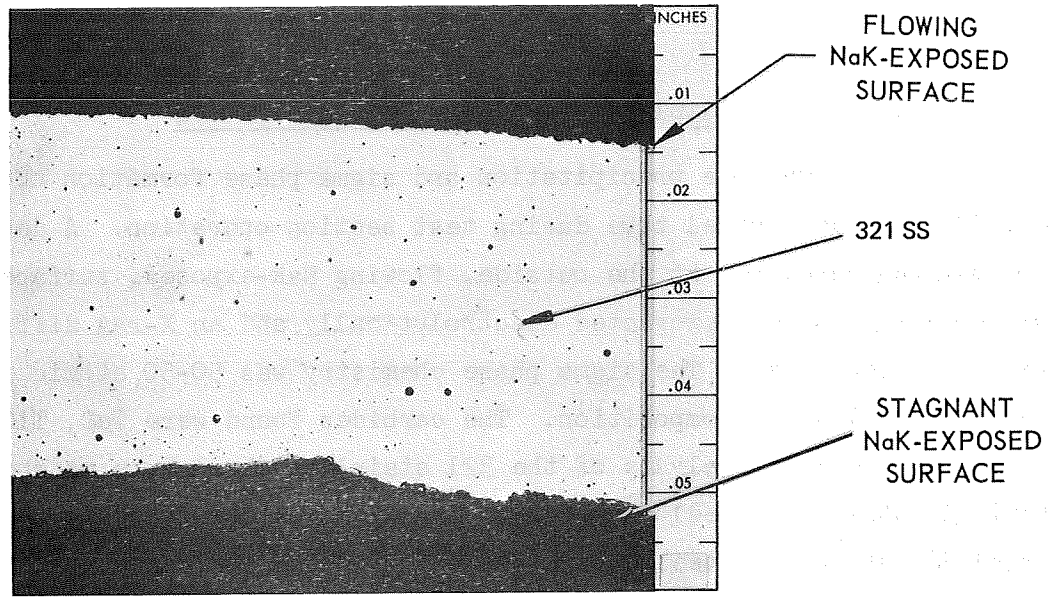
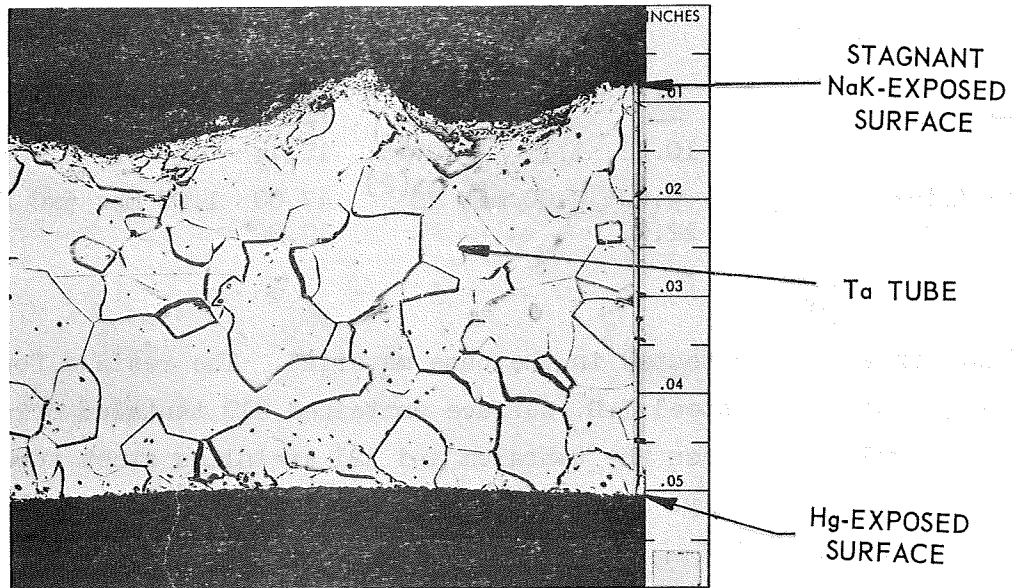
Figure 19. Galled Opposing Ta and 321 Stainless Steel Surfaces in Test Section No. 5

Metallographic evaluation of the tube surfaces indicating areas of metal removal confirmed this theory of mechanical transference of tantalum. A typical location was as shown in Figure 19 where both the tantalum tube O.D. and corresponding location on the 321 stainless steel I.D. were affected. The cold worked distorted grains associated with the defect on the tantalum tube surface were presumed to have resulted by galling between the tube surfaces during test section assembly. Typical indications of 321 stainless steel tube galling were also visually observed without the benefit of magnification.

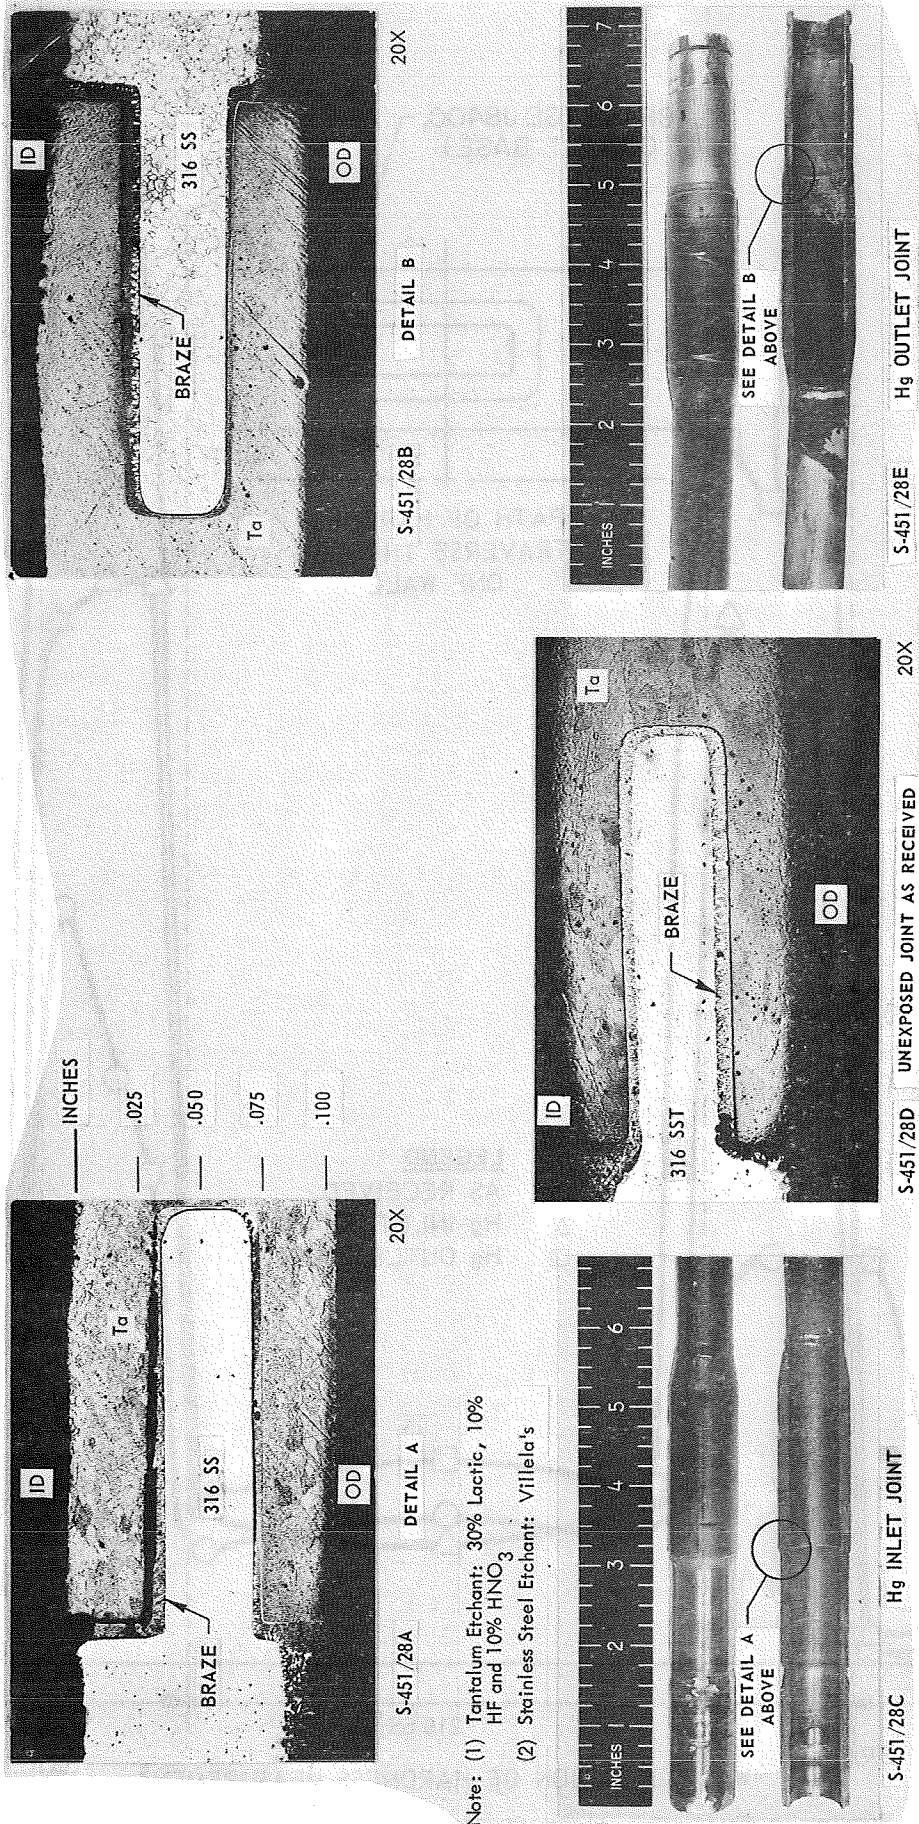
Figure 20. Inlet and Outlet Transition Joints of Test Section No. 5

The braze area (J-4800 cobalt base alloy, General Electric Co.) of both inlet and outlet transition joints were found defective after the test. However, comparison with an unexposed, as-fabricated, joint specimen, indicated that the deficiency probably existed prior to the test, based on the presence of similar defects. A separation existed at the braze-tantalum interface on the I.D. side of the tantalum groove (see Figure 20) and braze alloy removal was noted at the mercury exposed faces of the joint. A question remains relative to the separation. It may not have resulted from test section operation. At various times during laboratory testing the brittleness of the braze alloy (even in the as-brazed condition) has resulted in braze layer cracking during specimen preparation. One consequence of exposure during testing, based on comparison of microhardness measurements, indicated that the 2858 hours operation had caused significant hardening and consequential reduced ductility of the braze at the braze/tantalum interface (see Figure 21).

The evaluation results indicate that the braze transition joint requires extensive additional testing before it would be recommended for use in a full size boiler requiring 40,000 hr. life and 100 restart cycles. The low braze ductility in the as-fabricated condition plus the apparently lowered ductility of the braze area during elevated temperature, 1300°F exposure makes the joint susceptible to failure as a result of any operating transient which mechanically shocks the structure.
