General Disclaimer

One or more of the Following Statements may affect this Document

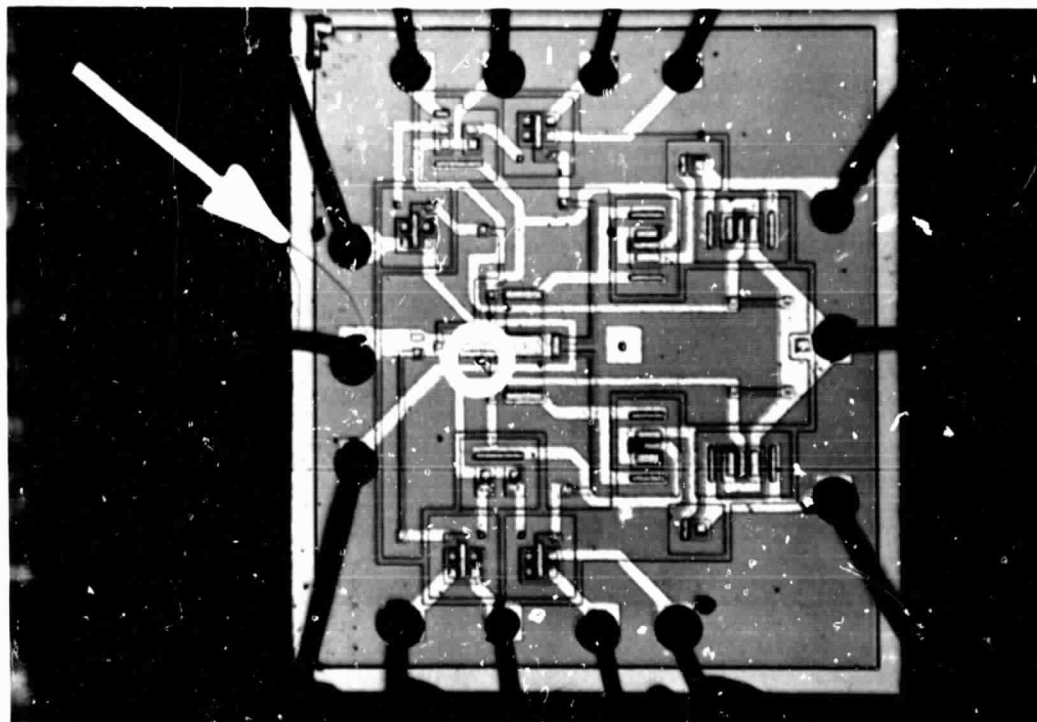
55X 1-1
FIGURE 1. TYPE SN5451 MICROCIRCUIT, SPECIMEN 12, SHOWING
CRACKS IN SILICON DIE (ARROW) AND GOLD PARTICLES
BRIDGING METAL STRIPES (CIRCLE)

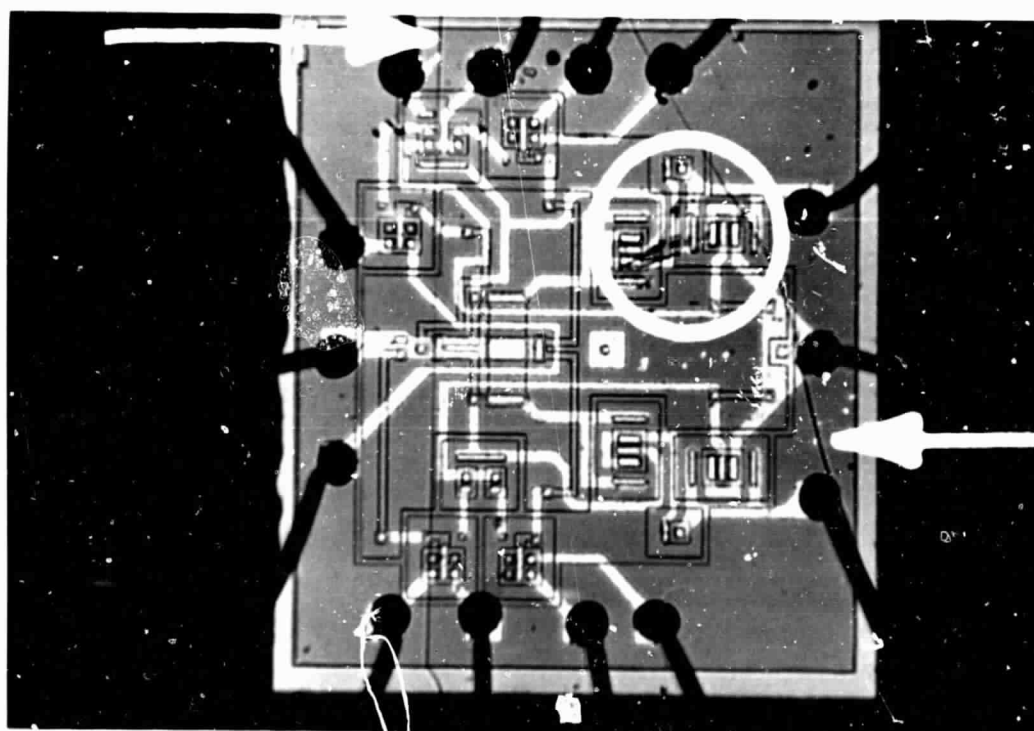
55X 1-2
FIGURE 2. TYPE SN5451 MICROCIRCUIT, SPECIMEN 13, SHOWING
TWO CRACKS IN SILICON DIE (ARROWS) AND SMEAR IN
METALLIZATION (CIRCLE)

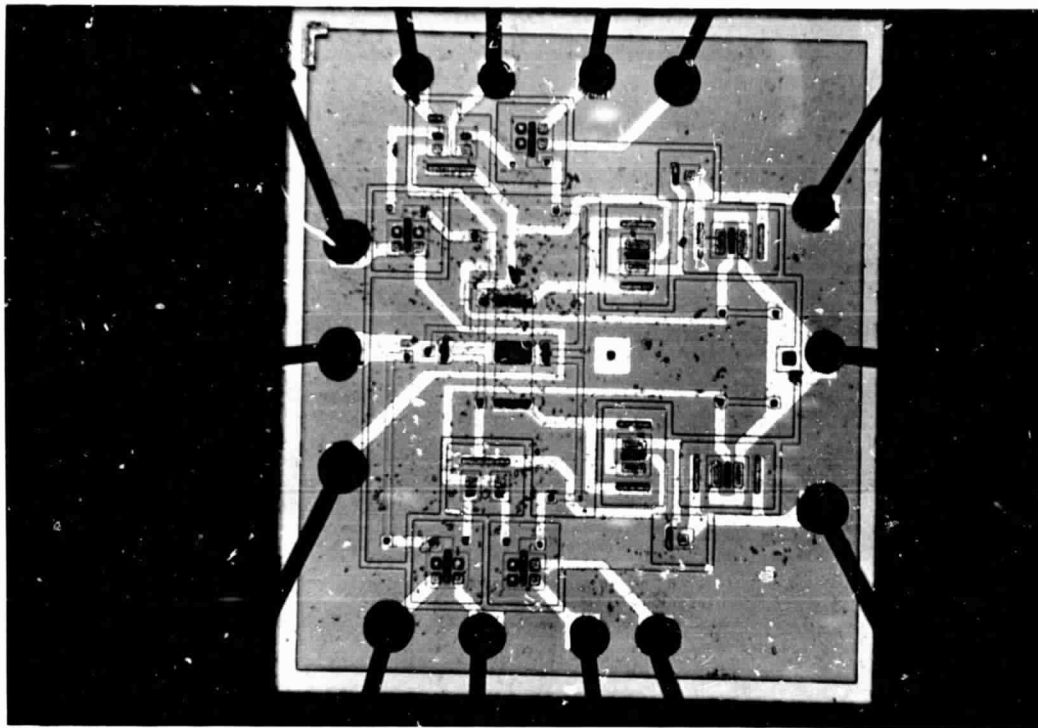
55X 1-0
FIGURE 3. TYPE SN5451 MICROCIRCUIT, SPECIMEN 11, SHOWING
EXTENT OF OXIDE DEFECTS

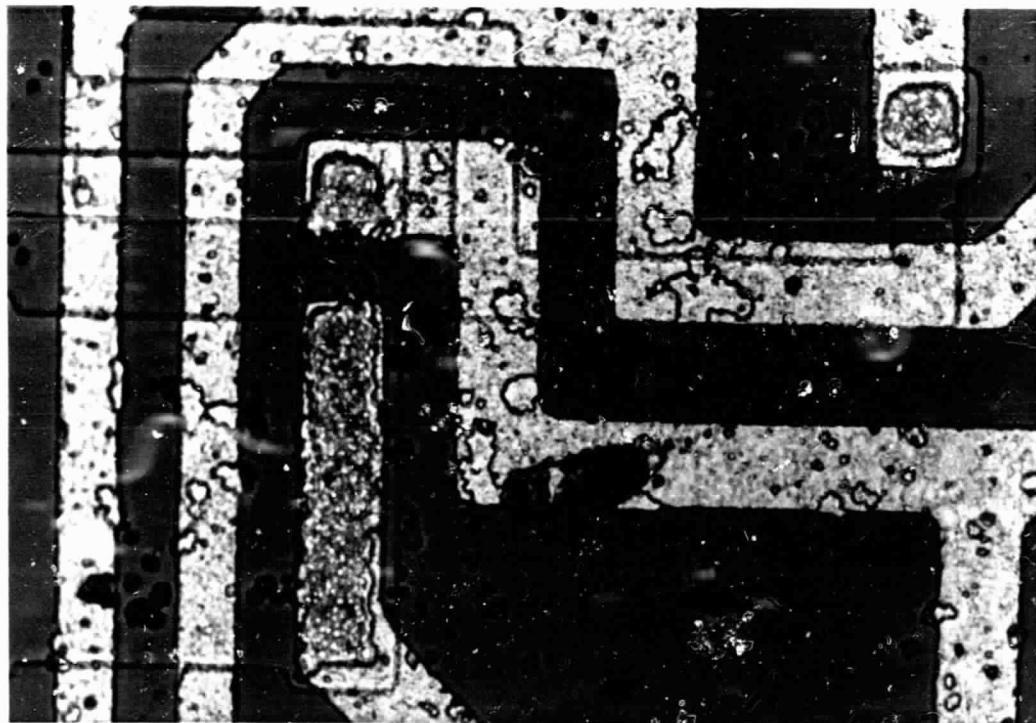
500X 2-20
FIGURE 4. TYPE SN5451 MICROCIRCUIT, SPECIMEN 11, SHOWING
DETAILED VIEW OF OXIDE DEFECTS AND WINDOWS
HAVING RAGGED OUTLINES IN SECTIONS F3, F4, G3
AND G4

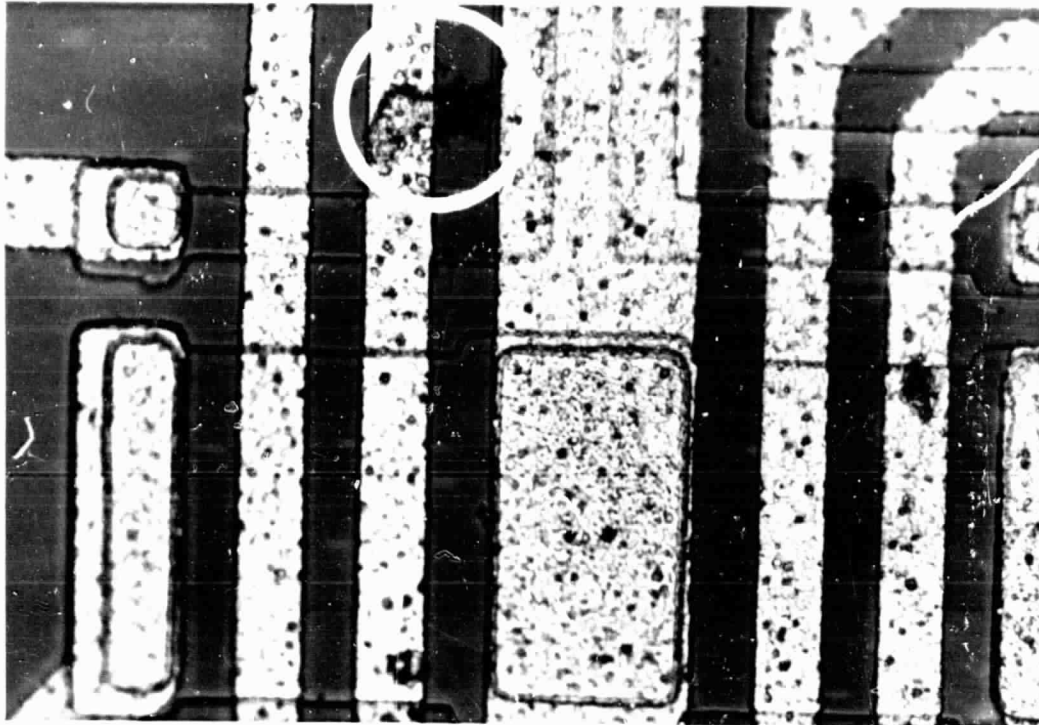
500X 3-6
FIGURE 5. TYPE SN5451 MICROCIRCUIT, SPECIMEN 12, SHOWING FOREIGN PARTICLES BETWEEN METAL STRIPES IN SECTIONS E4 AND F4

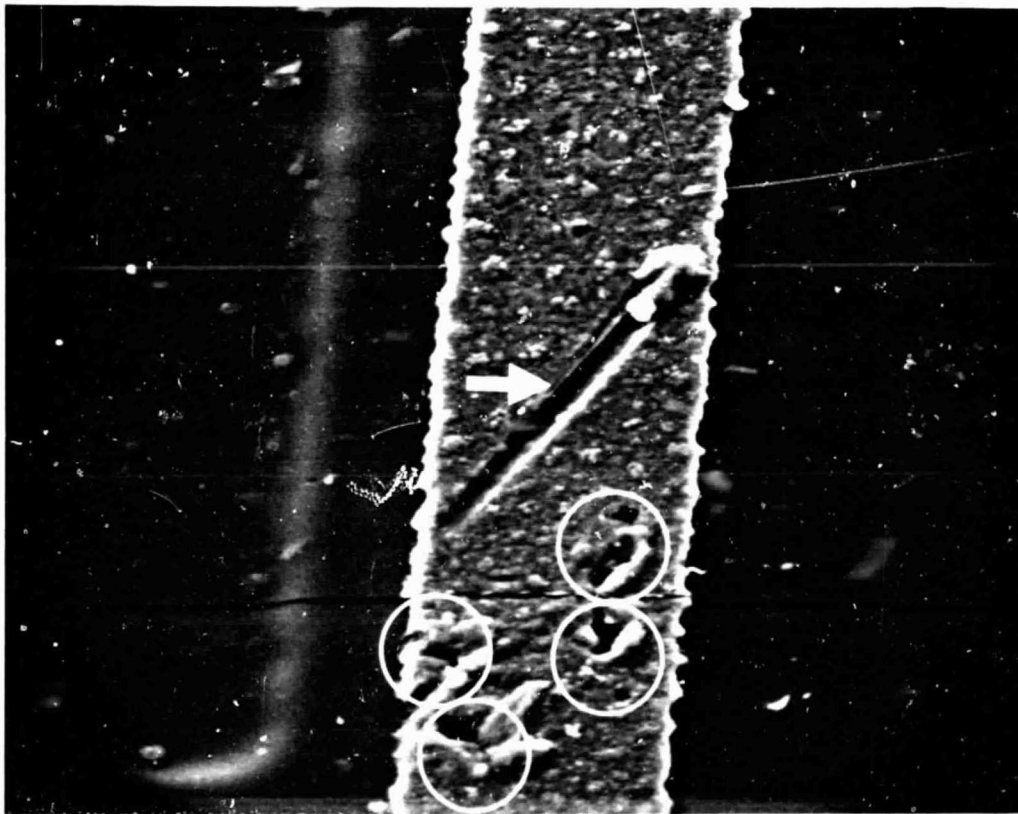
2000X S1086
 FIGURE 8. TYPE SN5451 MICROCIRCUIT, SPECIMEN 14, SHOWING
 SCRATCH CAUSED BY GOLD PARTICLE (ARROW) AND
 POKKS IN METALLIZATION (CIRCLES) IN SECTION
 E7 (SE)

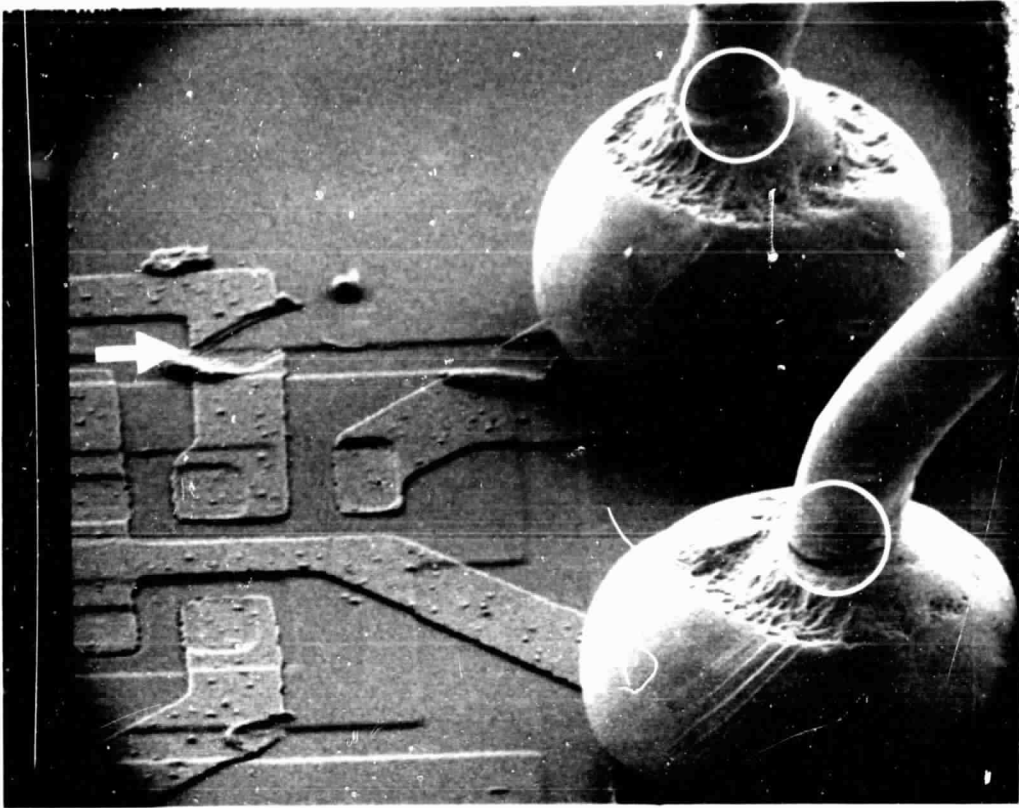
500X S1053
 FIGURE 9. TYPE SN5451 MICROCIRCUIT, SPECIMEN 13, SHOWING
 CRACKS IN LEAD WIRES (CIRCLES) AND DAMAGED
 METALLIZATION (ARROW) IN SECTIONS I2, J2, AND
 J4 (SE)

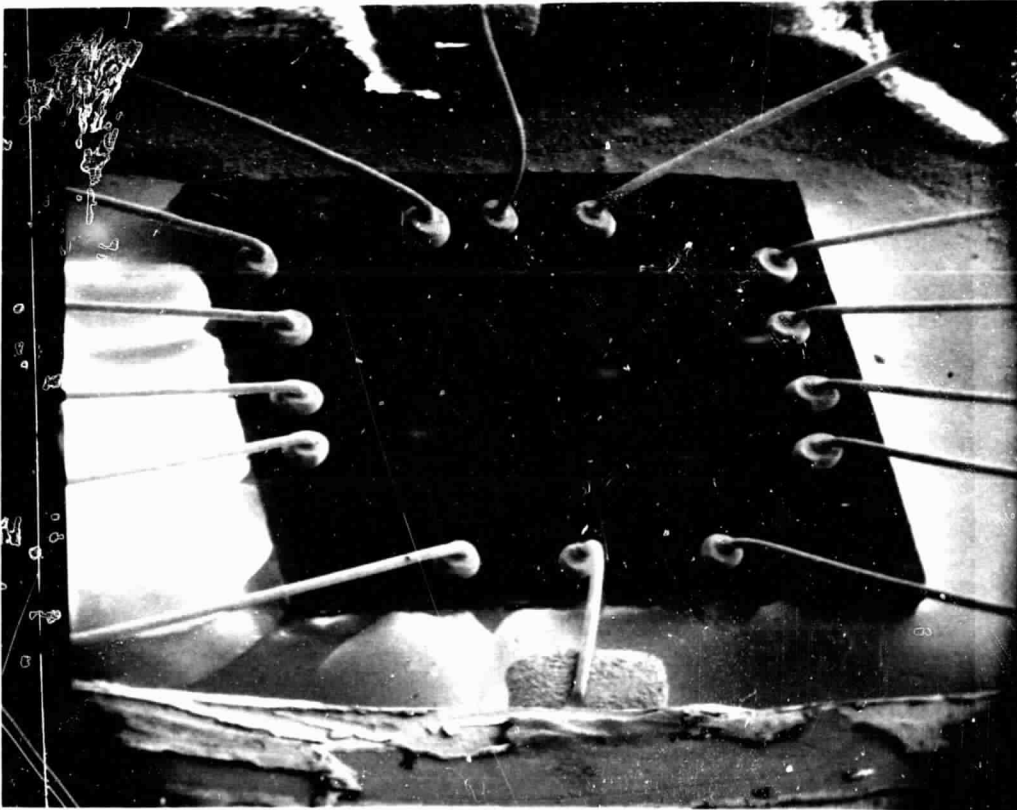
50X S1106
 FIGURE 10. TYPE SN5451 MICROCIRCUIT, SPECIMEN 15, SHOWING
 VARIATIONS IN BALL-BOND SIZE AND STRETCHED
 INTERNAL LEAD WIRES (SE)

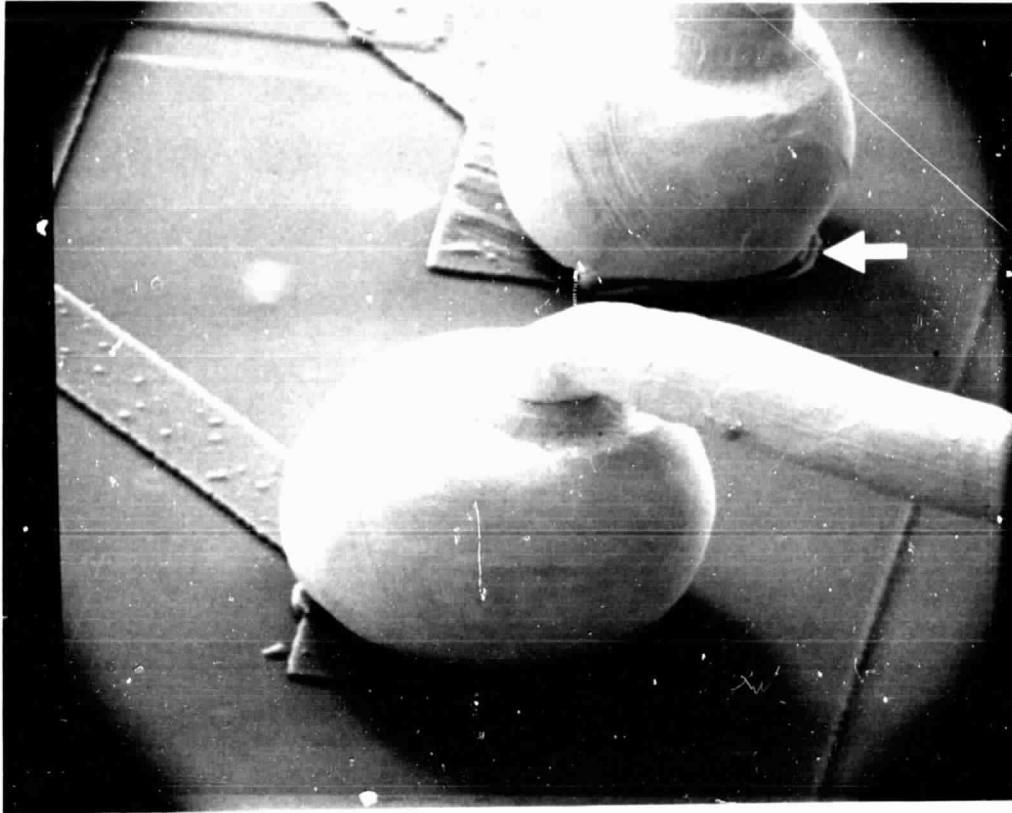
500X S1039
 FIGURE 11. TYPE SN5451 MICROCIRCUIT, SPECIMEN 11, SHOWING
 NECKING IN LEAD WIRE ABOVE BALL BOND AND
 METALLIZATION DAMAGE ON BONDING PAD (ARROWS)
 IN SECTIONS J5, J6, AND J7 (SE)

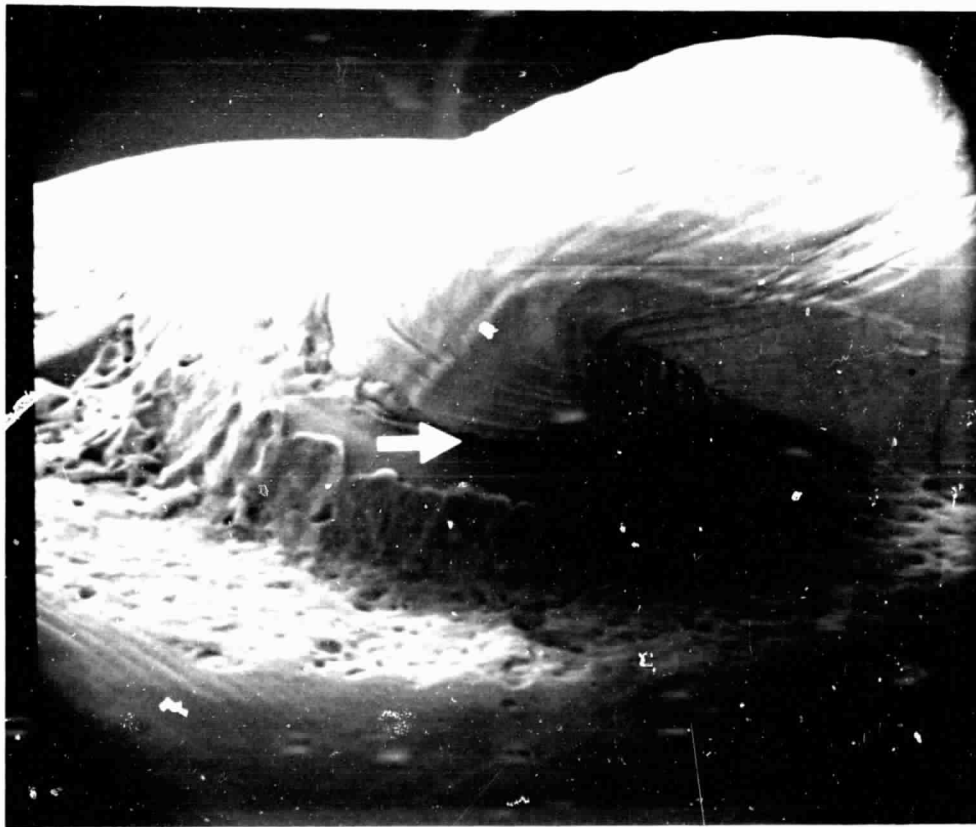
2000X S1038
 FIGURE 12. DETAILED VIEW OF THE BALL BOND FROM FIGURE 11
 SHOWING NECKED WIRE AND CRACK AT TOP OF BALL
 BOND (ARROW) (SE)

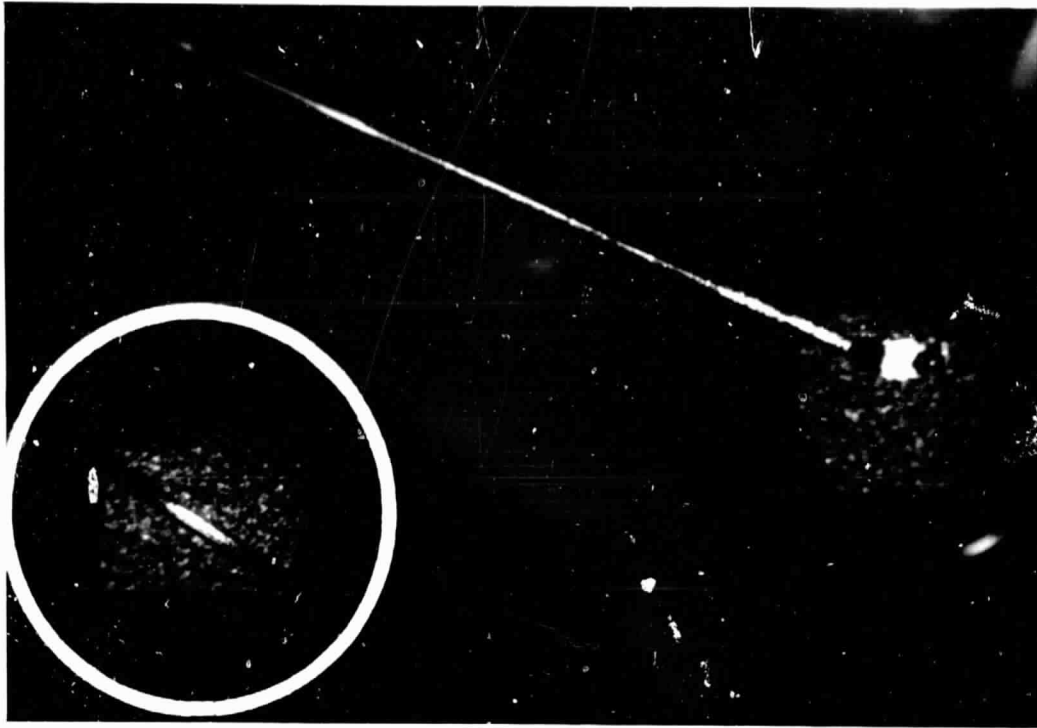
91X 2-19
FIGURE 13. TYPE SN5451 MICROCIRCUIT, SPECIMEN 11, SHOWING DEFECTIVE LEAD WIRE BOND ON POST 12

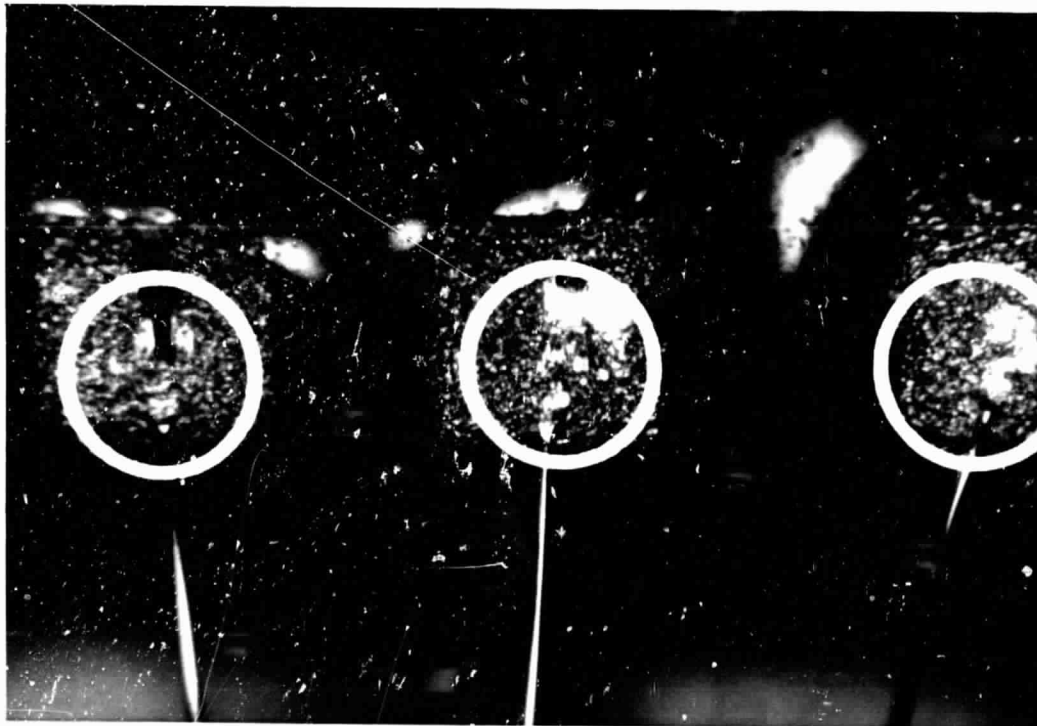
91X 3-9
FIGURE 14. TYPE SN5451 MICROCIRCUIT, SPECIMEN 13, SHOWING OVERBONDED LEAD WIRES ON POSTS 6, 7, and 8

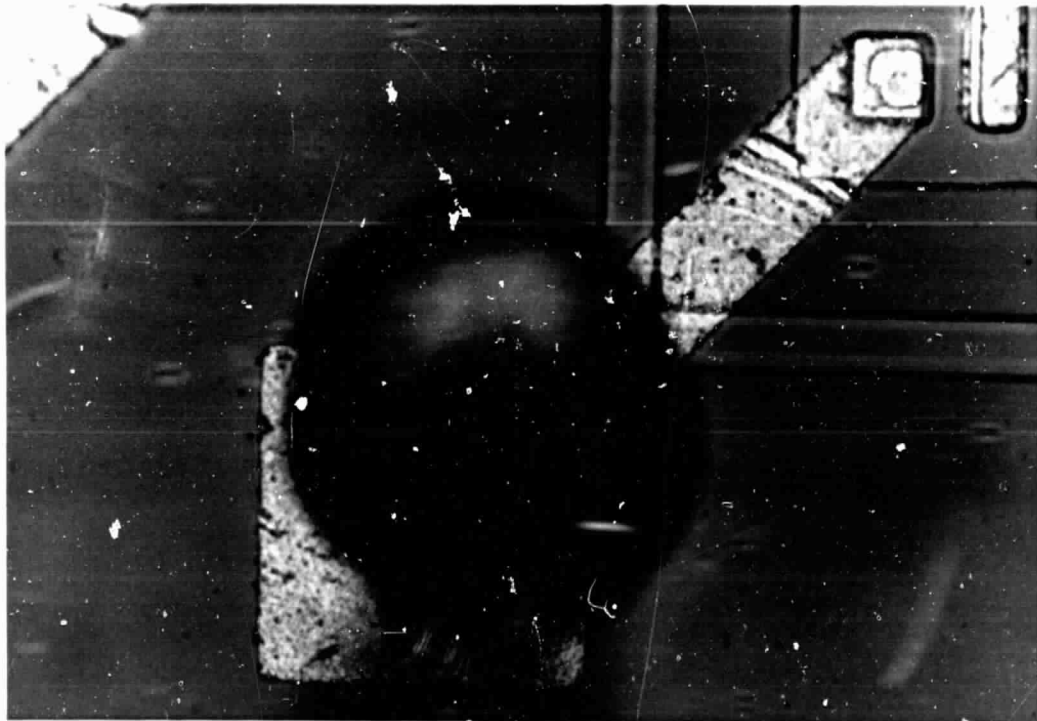
500X 3-16
FIGURE 16. TYPE SN5451 MICROCIRCUIT, SPECIMEN 14, SHOWING OFF-CENTER BALL-BOND COVERING FILLET BETWEEN BONDING PAD AND STRIPE IN SECTION J5

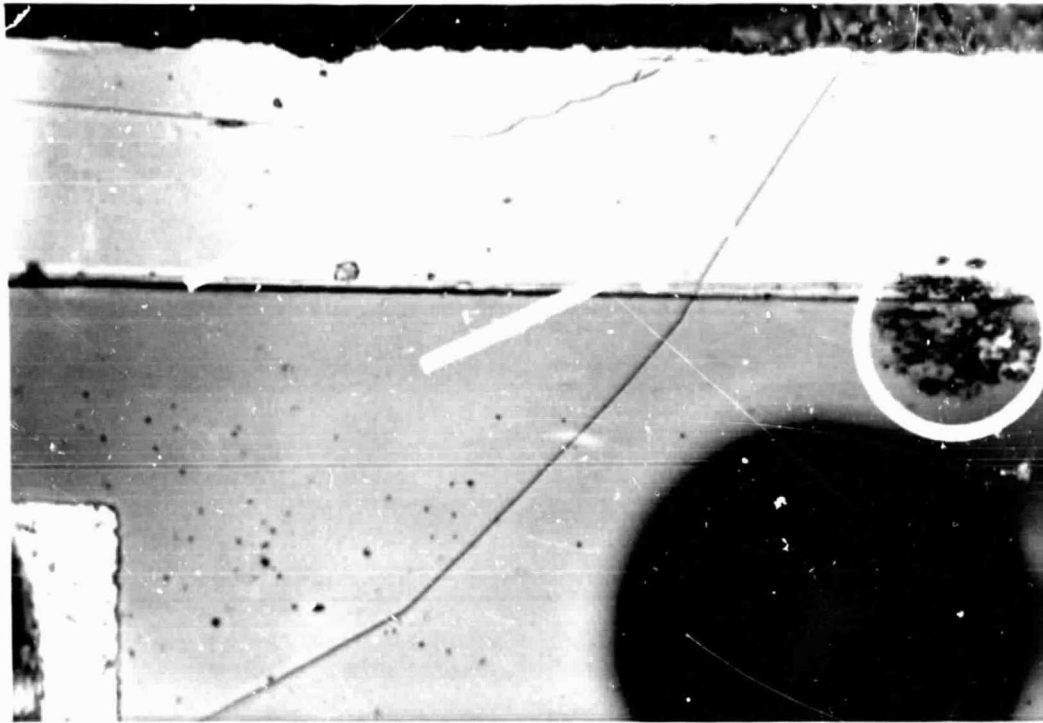
500X 3-7
FIGURE 17. TYPE SN5451 MICROCIRCUIT, SPECIMEN 12, SHOWING
CRACKS IN SILICON DIE (ARROWS) AND EVIDENCE OF
A FALSE BALL-BOND STRIKE (CIRCLE) IN SECTIONS
F1 AND G1

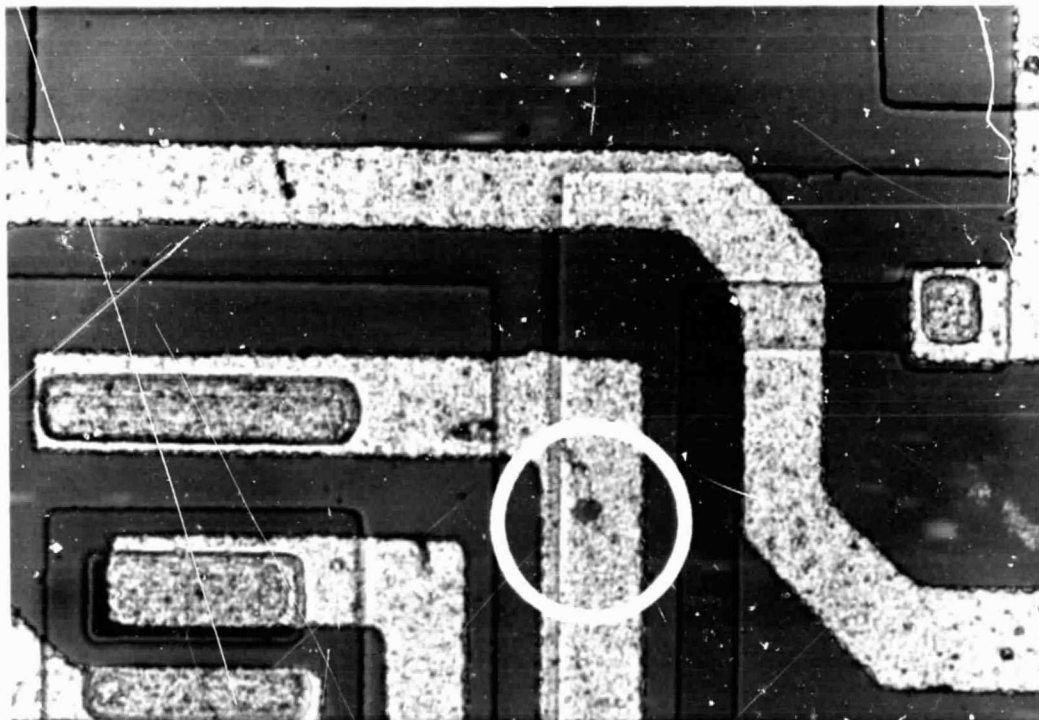
500X 4-9
FIGURE 18. TYPE SN5451 MICROCIRCUIT, SPECIMEN 15, SHOWING
PHOTOLITHOGRAPHIC VOID IN METAL STRIPE IN
SECTION D6

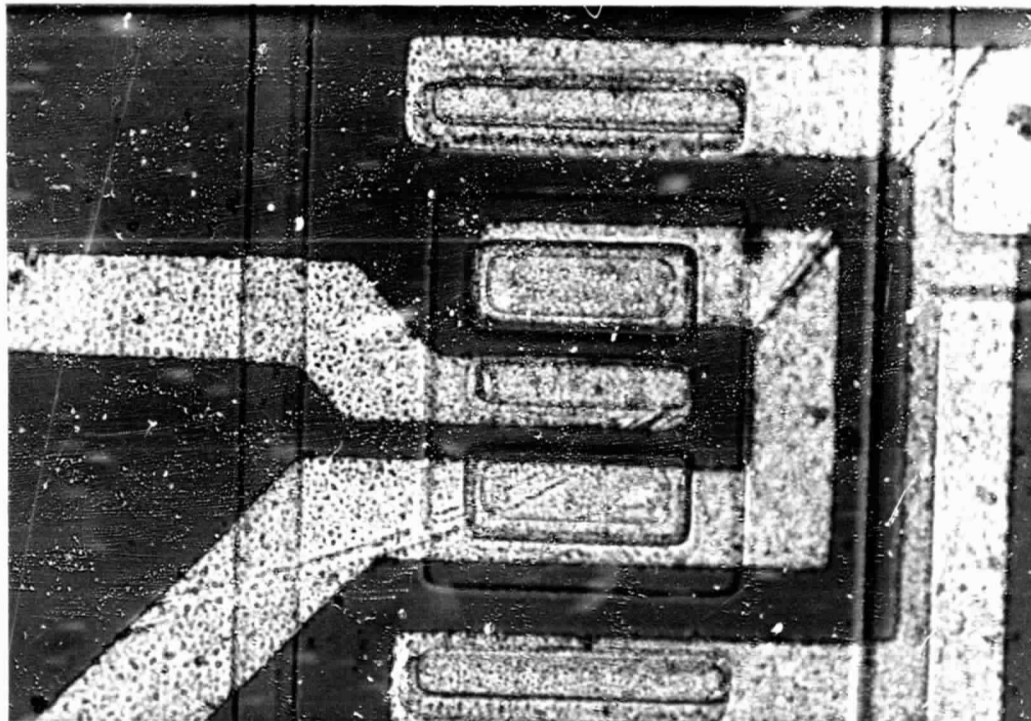
500X 8-13
 FIGURE 22. TYPE SN5451 MICROCIRCUIT, SPECIMEN 14, SHOWING
 LONG SWEEPING SCRATCH ACROSS METALLIZATION IN
 SECTION G8, G9, H8, AND H9

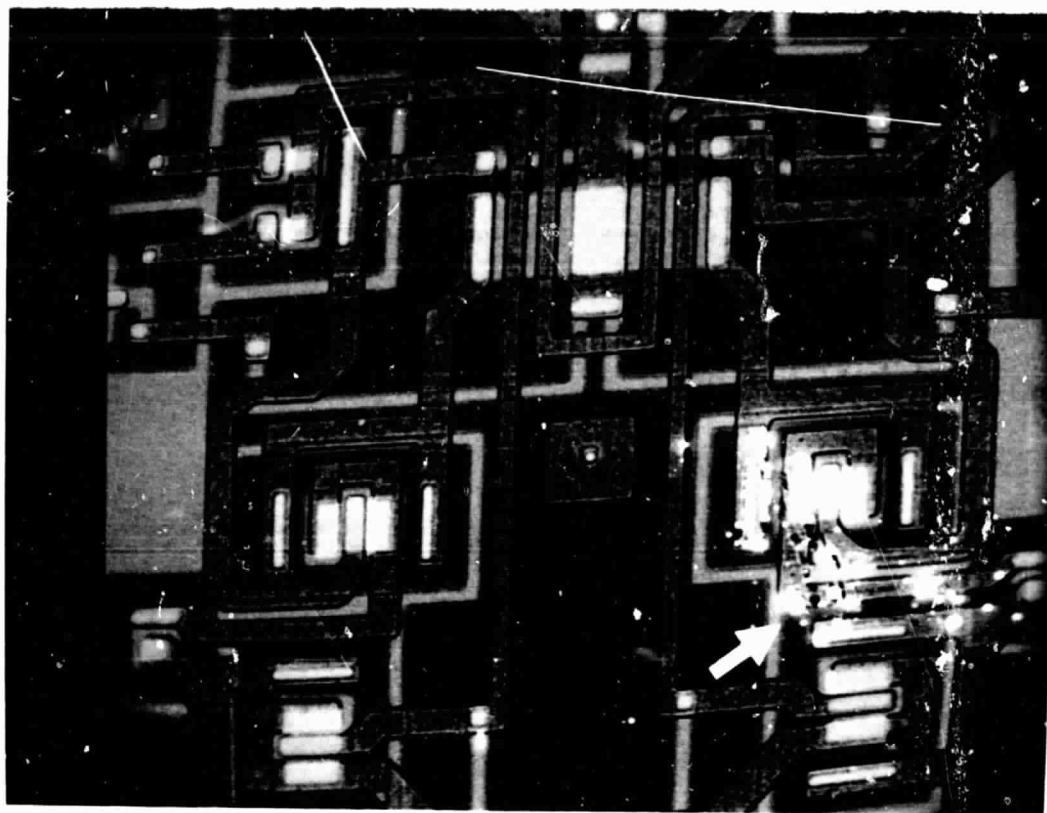
130X S1050
 FIGURE 23. TYPE SN5451 MICROCIRCUIT, SPECIMEN 13, SHOWING
 GOLD PARTICLES IN DAMAGED REGION OF METALLIZATION,
 SECTIONS G6, G7, AND H7 (BSE)

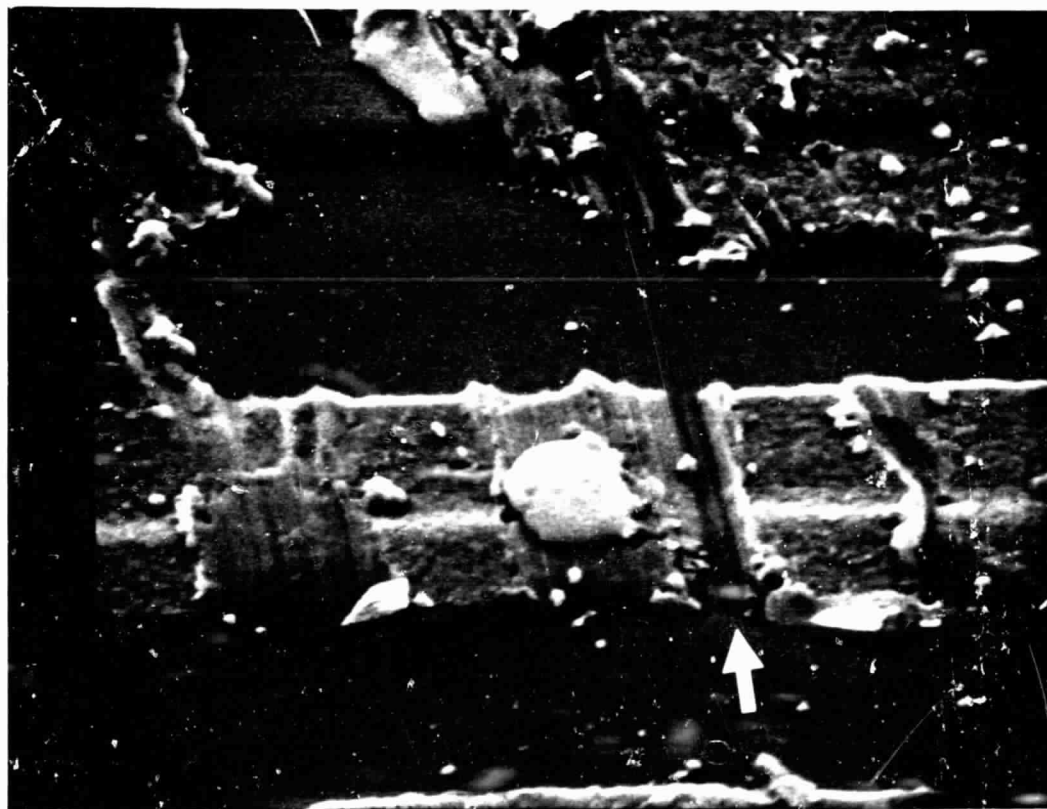
2000X S1055
 FIGURE 24. DETAILED VIEW OF FIGURE 23 SHOWING SEVERED
 CONDUCTOR, SMEARS, AND GOLD PARTICLES IN
 SECTION G7 (SE)

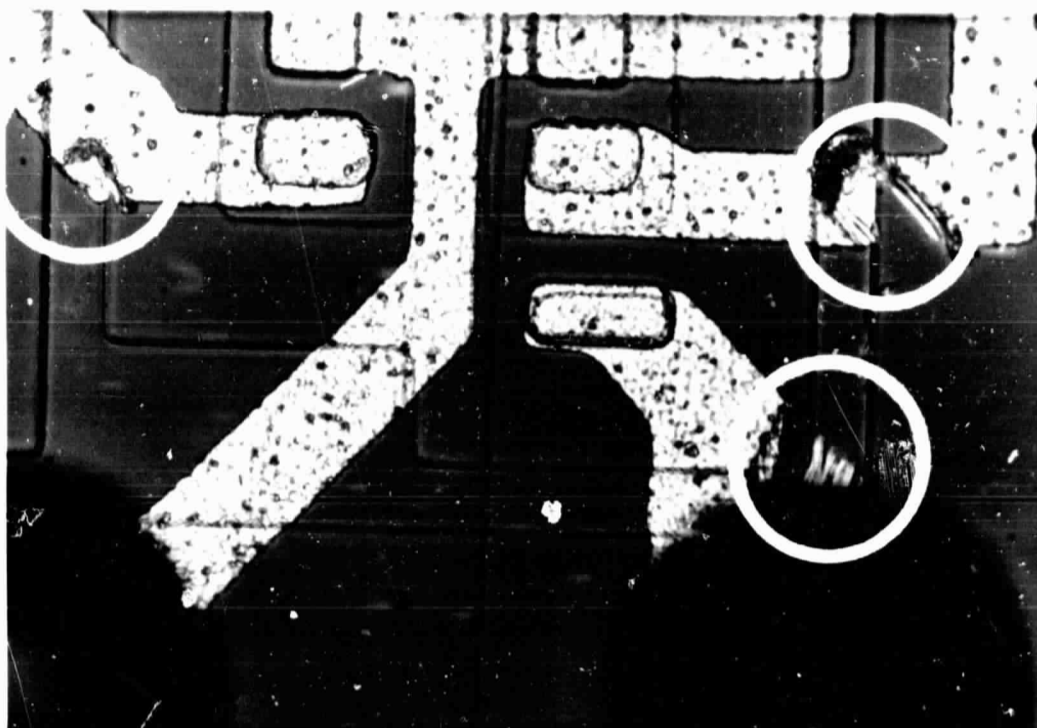
500X 3-12
FIGURE 25. TYPE SN5451 MICROCIRCUIT, SPECIMEN 13, SHOWING
SMEARS IN METALLIZATION CAUSED BY ELECTRICAL
PROBES, SECTIONS I2, I3 AND I4

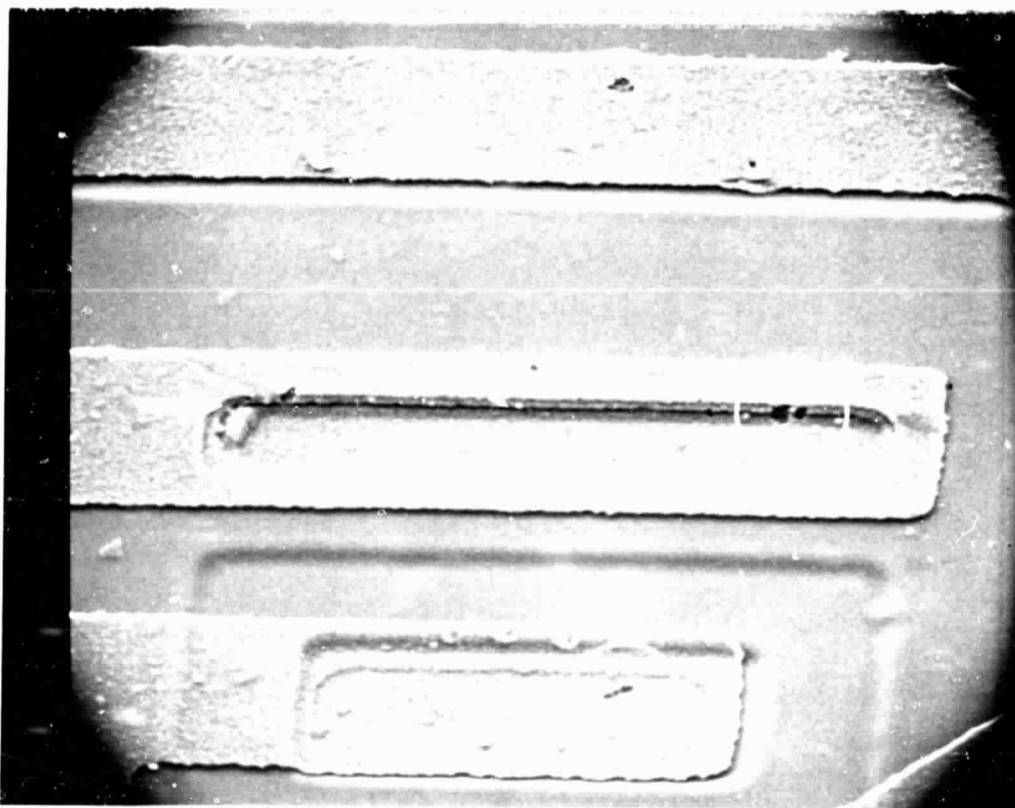
1000X S1085
FIGURE 26. TYPE SN5451 MICROCIRCUIT, SPECIMEN 14, SHOWING
CRACK IN METALLIZATION AT OXIDE-STEP IN WINDOW
CUT (ARROW) AND POCK MARKS (CIRCLES) IN SECTIONS
G6, G7, H6, AND H7 (SE)

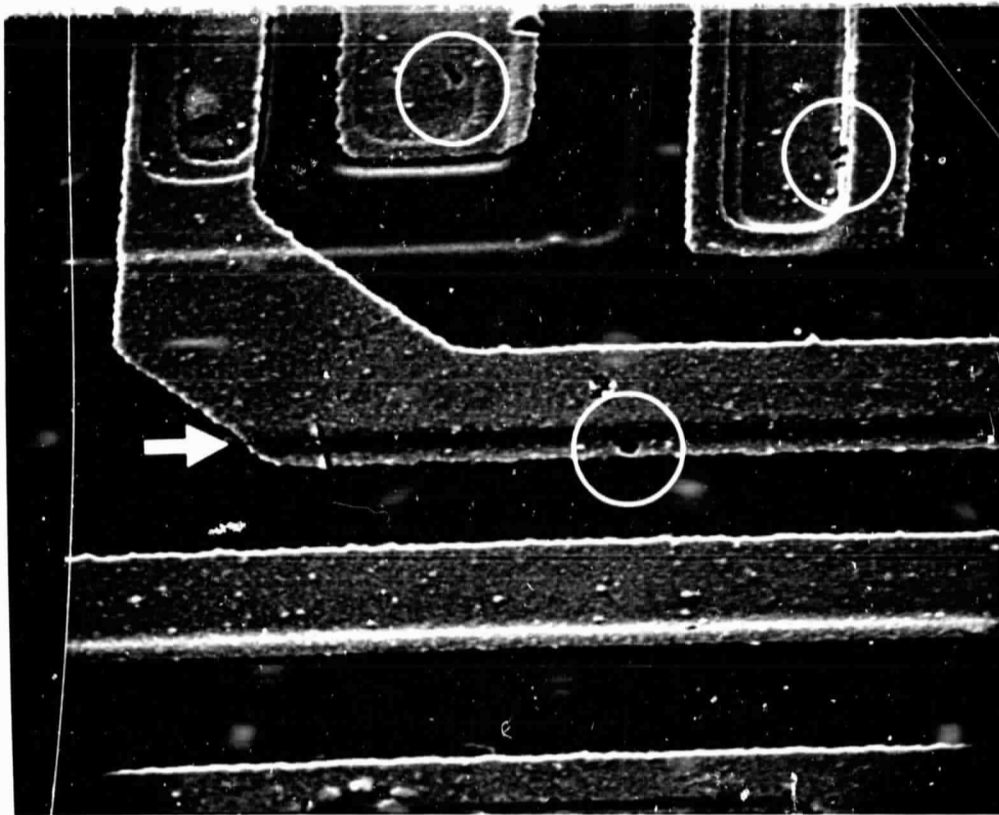
1000X S1080
 FIGURE 27. TYPE SN5451 MICROCIRCUIT, SPECIMEN 14, SHOWING
 CRACK IN METALLIZATION AT OXIDE STEP NOT IN
 WINDOW CUT (ARROW) AND POCKS (CIRCLES) IN
 SECTIONS G7 AND H7 (SE)

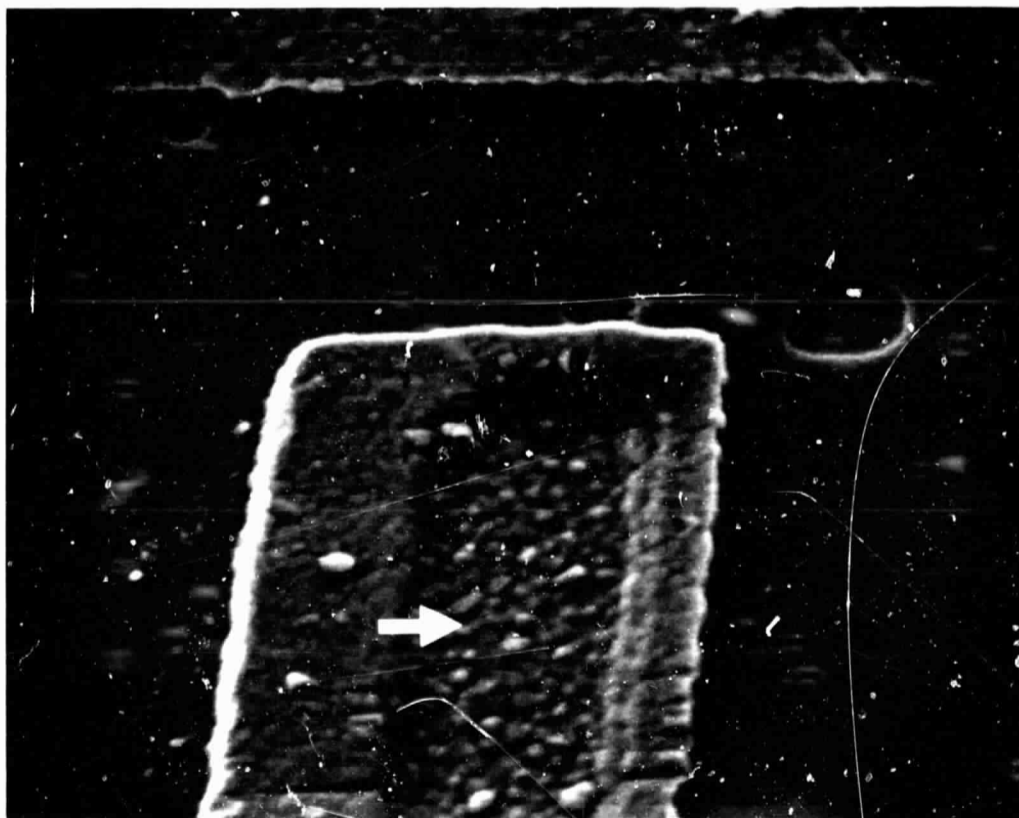
2000X S1035
 FIGURE 28. TYPE SN5451 MICROCIRCUIT, SPECIMEN 11, SHOWING
 GRANULARITY OF METALLIZATION SURFACE IN CONTACT
 WINDOW IN SECTION H3 (SE)

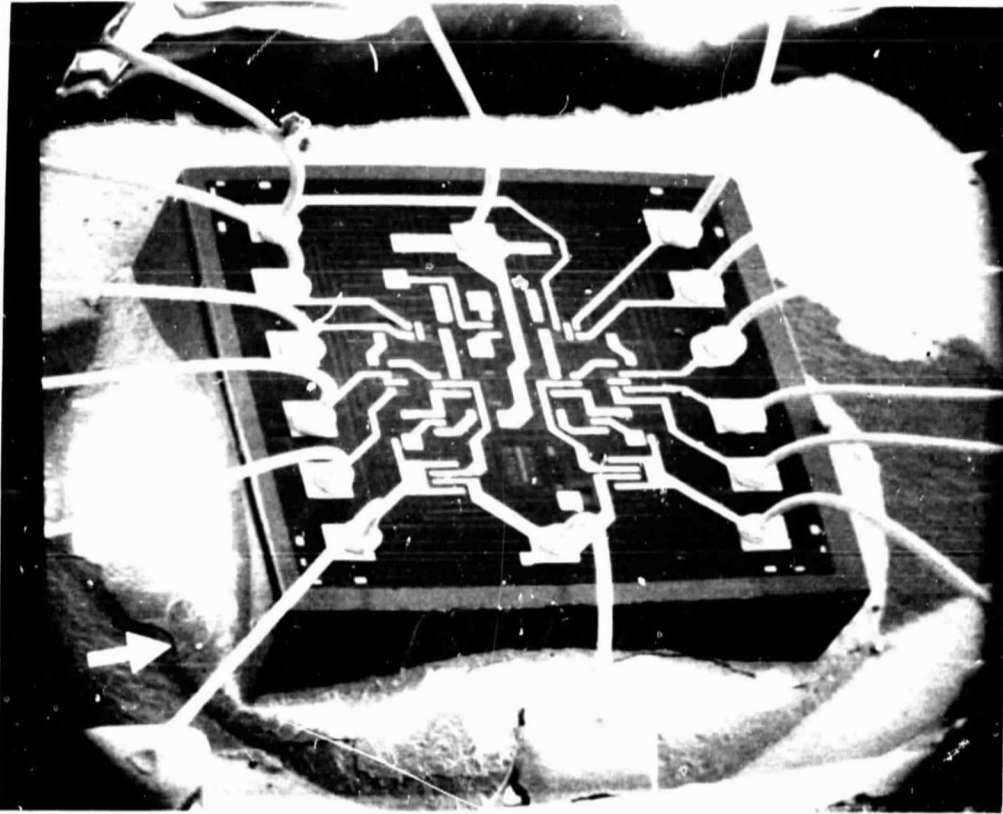
50X S1353
FIGURE 29. TYPE SN54L51 MICROCIRCUIT, SPECIMEN 22, SHOWING
DELAMINATION OF CHIP BONDING MATERIAL FROM
PACKAGE FLOOR (SE)

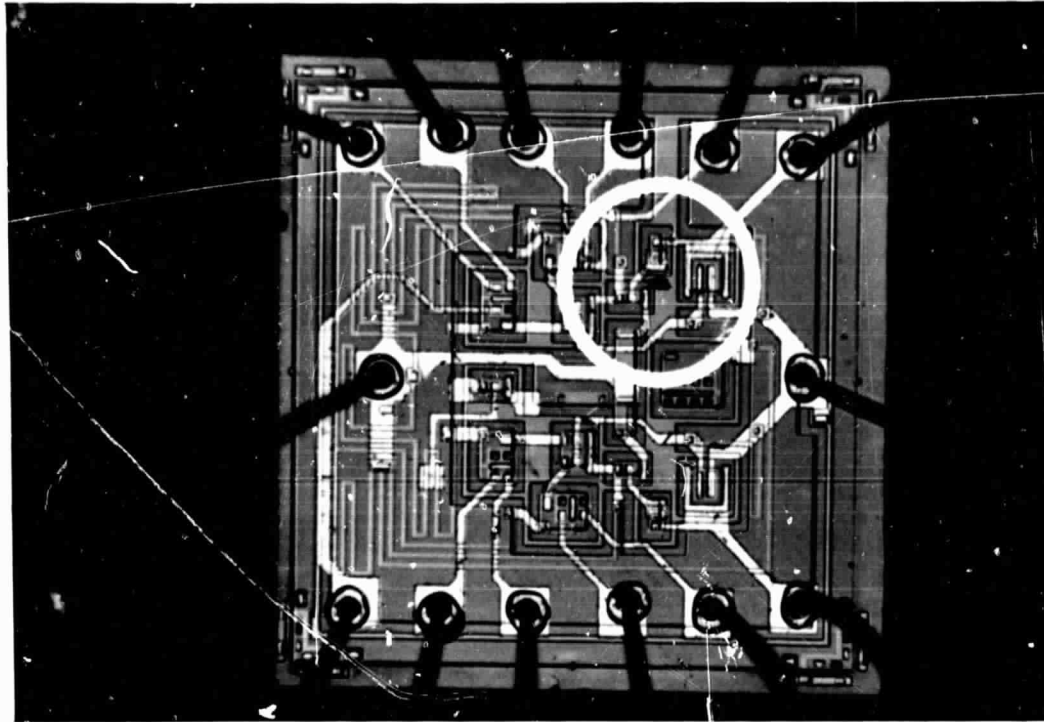
50X 1-5
FIGURE 30. TYPE SN54L51 MICROCIRCUIT, SPECIMEN 21, SHOWING
LARGE FOREIGN PARTICLE ON DIE SURFACE

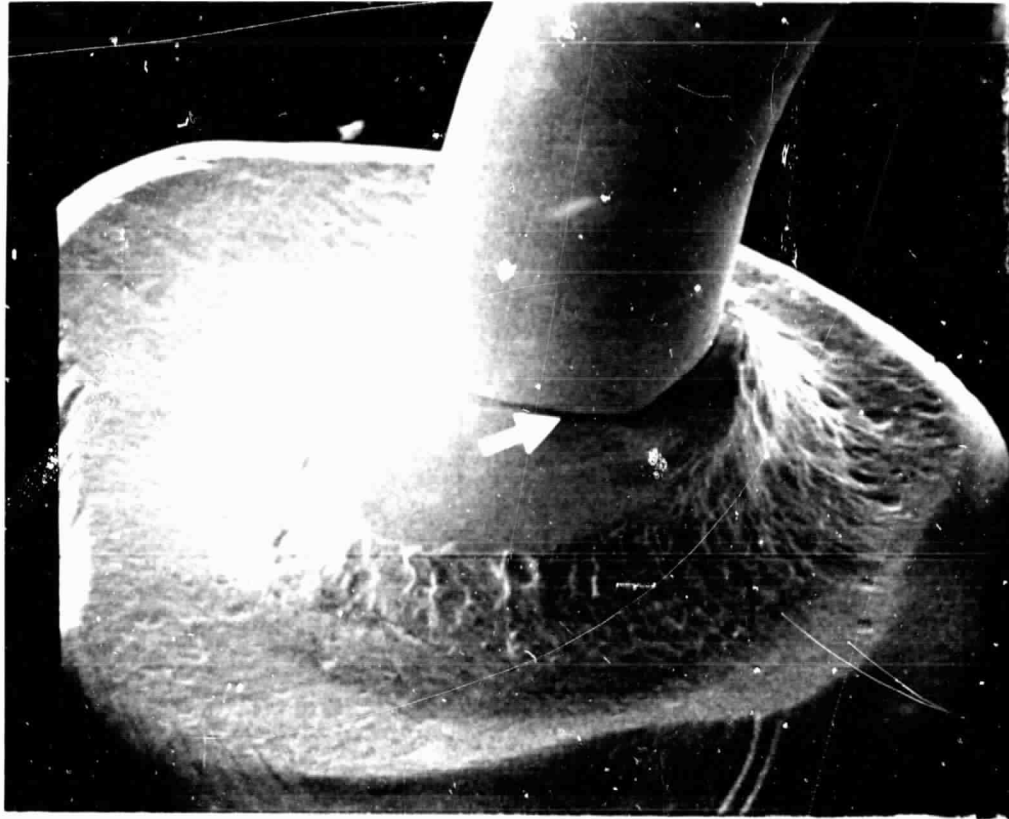
1000X S1117
FIGURE 32. BALL BOND IN SPECIMEN 24 SHOWING CRACK IN LEAD
WIRE AT TOP OF BALL (SE)

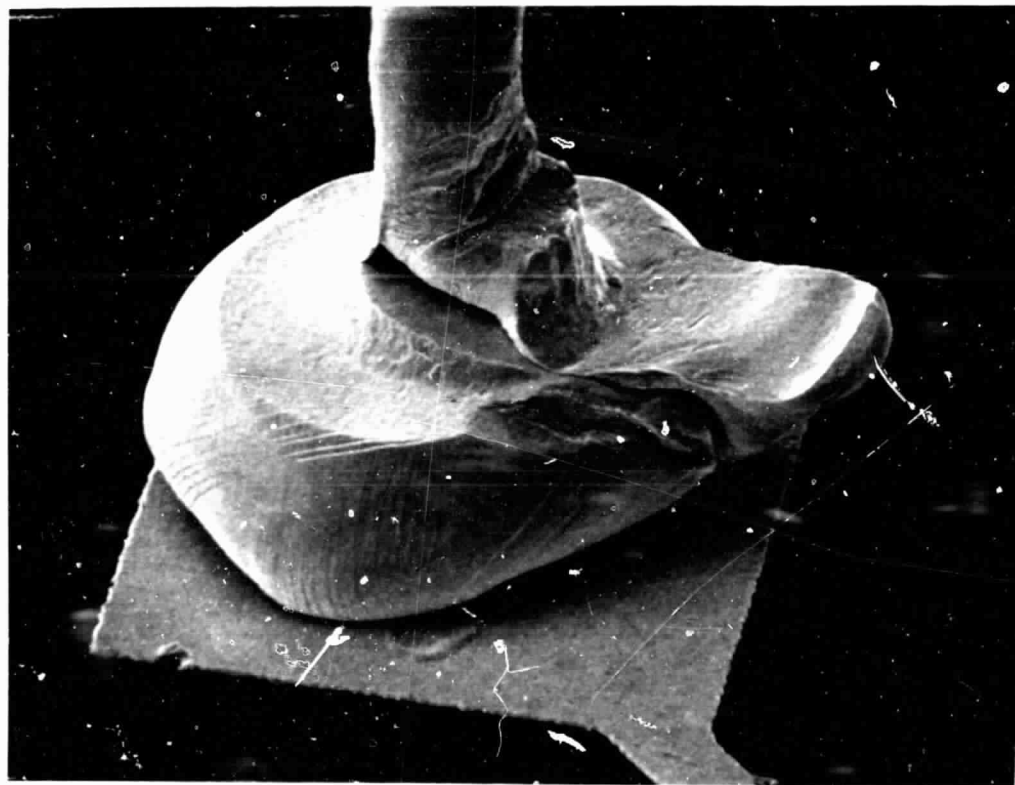
670X S1130
FIGURE 33. DEFECTIVE BALL BOND IN SPECIMEN 23 (SE)

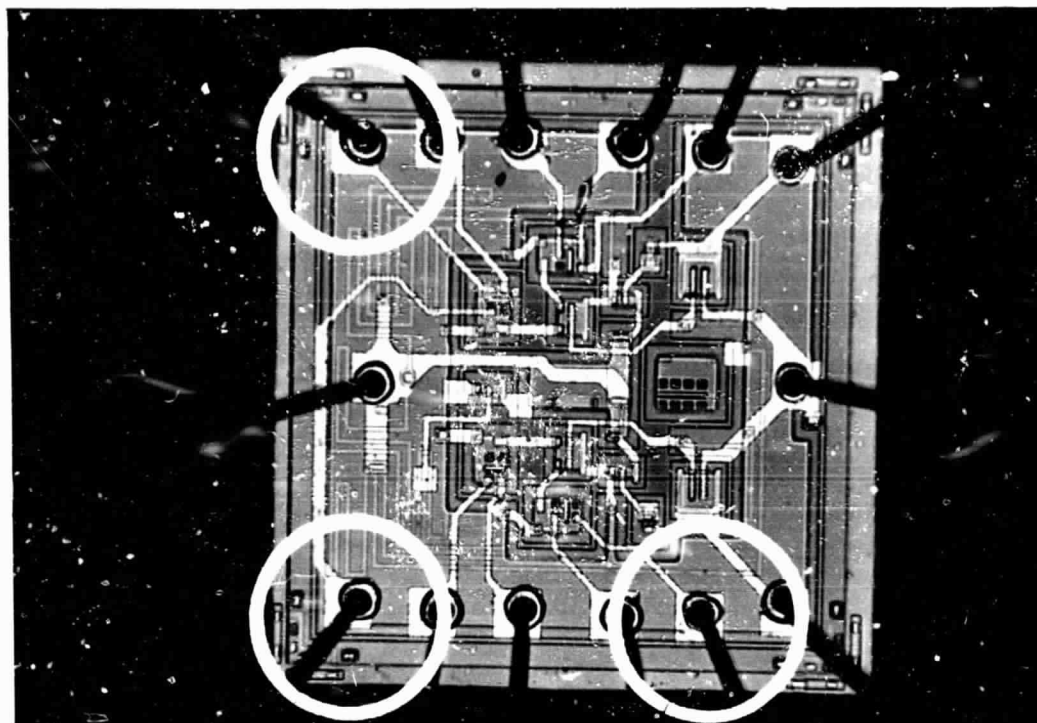
55X 1-6
FIGURE 34. TYPE SN54L51 MICROCIRCUIT, SPECIMEN 22, SHOWING THREE BALL BONDS (CIRCLES) OFFSET ON BONDING PAD AND COVERING METALLIZATION FILLET

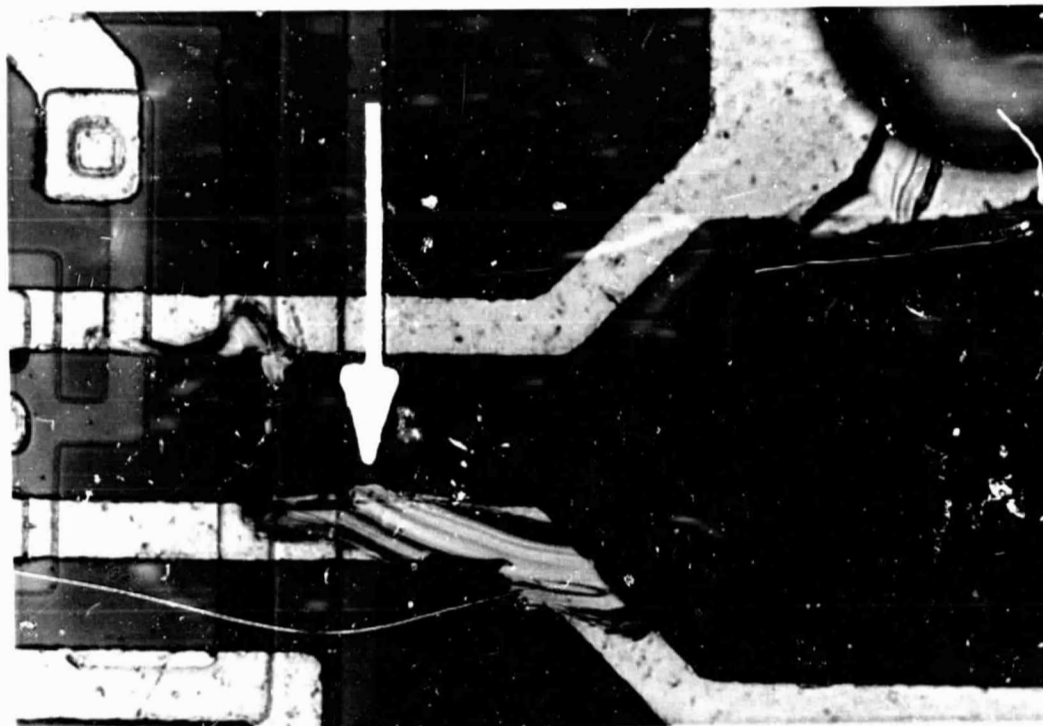
500X 2-5
 FIGURE 38. TYPE SN54L51 MICROCIRCUIT, SPECIMEN 22, SHOWING
 DEEP SMEAR IN METALLIZATION CAUSED BY BALL BOND
 IN SECTIONS I5, I6, AND J5
