General Disclaimer

One or more of the Following Statements may affect this Document

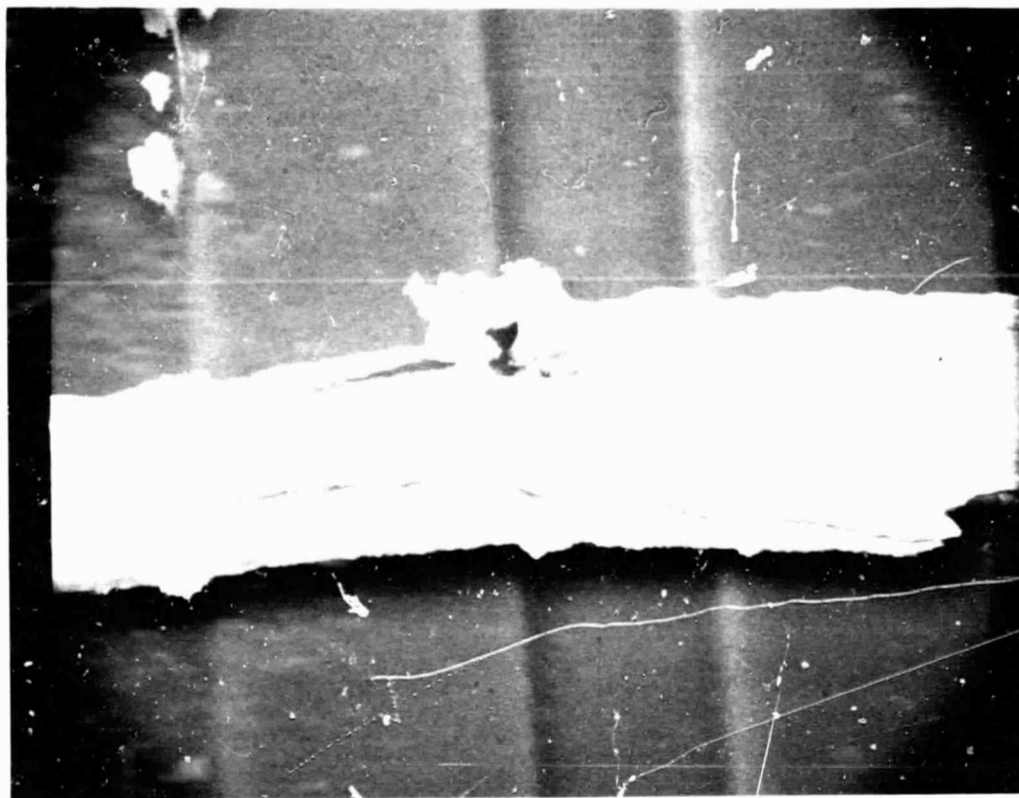
2000X S1354
 FIGURE 39. DETAILED VIEW OF FIGURE 38 SHOWING SMEARED METAL
 STRIPE (SE)

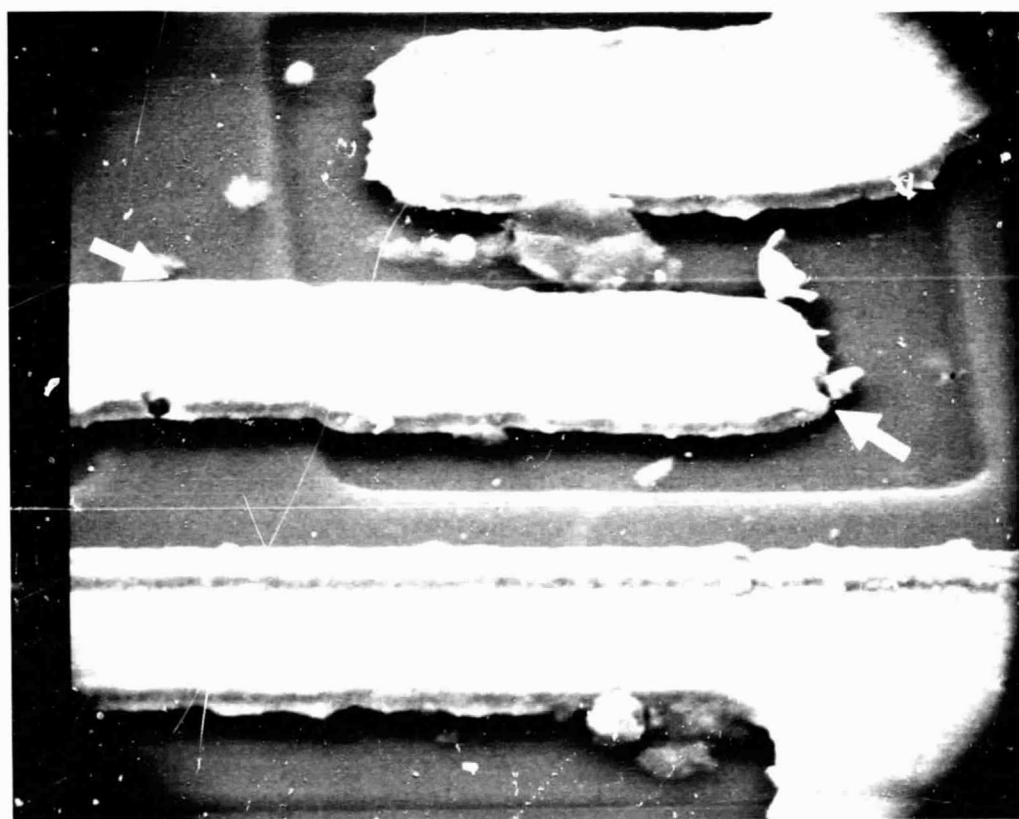
2000X S1123
FIGURE 41. DETAILED VIEW OF COSMETIC SCRATCHES IN FIGURE
40 (SE,

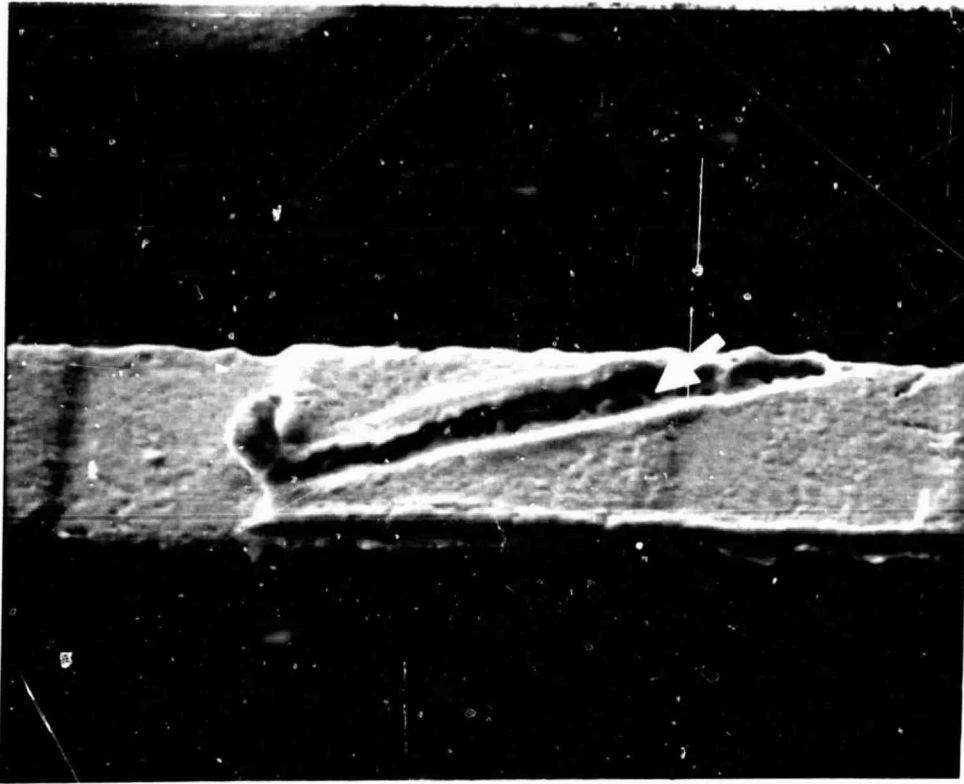
2000X S1351
 FIGURE 42. TYPE SN54L51 MICROCIRCUIT, SPECIMEN 21, SHOWING
 DEEP SCRATCH IN METAL STRIPE IN SECTION H5 (SE)

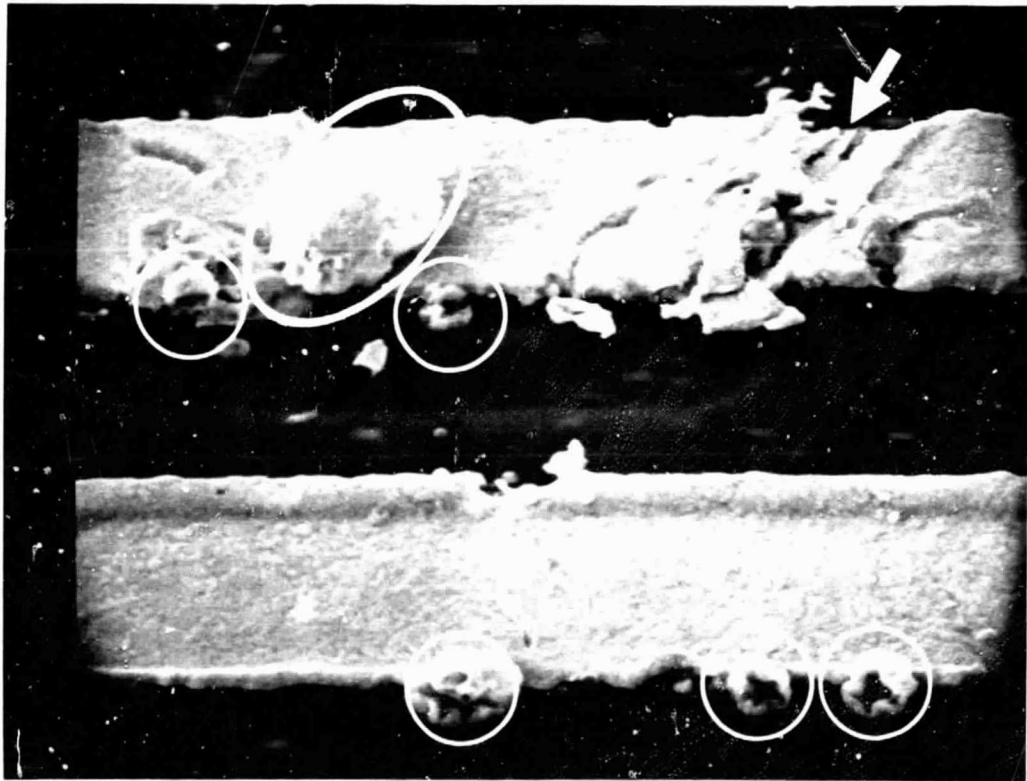
2000X S1125a
 FIGURE 43. TYPE SN54L51 MICROCIRCUIT, SPECIMEN 23, SHOWING
 DEEP SCRATCH IN METAL STRIPE (ARROW) AND CORROSION GROWTH ALONG SIDE OF METAL STRIPES (CIRCLES)
 IN SECTIONS G5 AND G6 (SE)

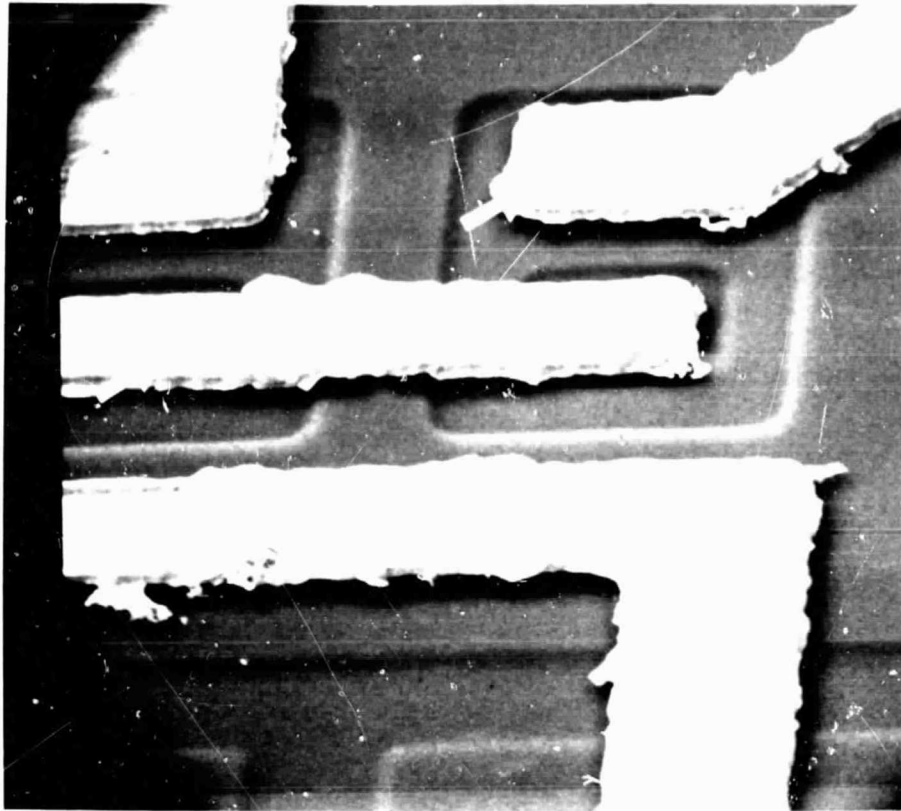
1000X S1356
FIGURE 44. TYPE SN54L51 MICROCIRCUIT, SPECIMEN 25, SHOWING
GRANULARITY IN METALLIZATION AT WINDOW CUT
PERIPHERY IN SECTIONS G5 AND G6 (SE)

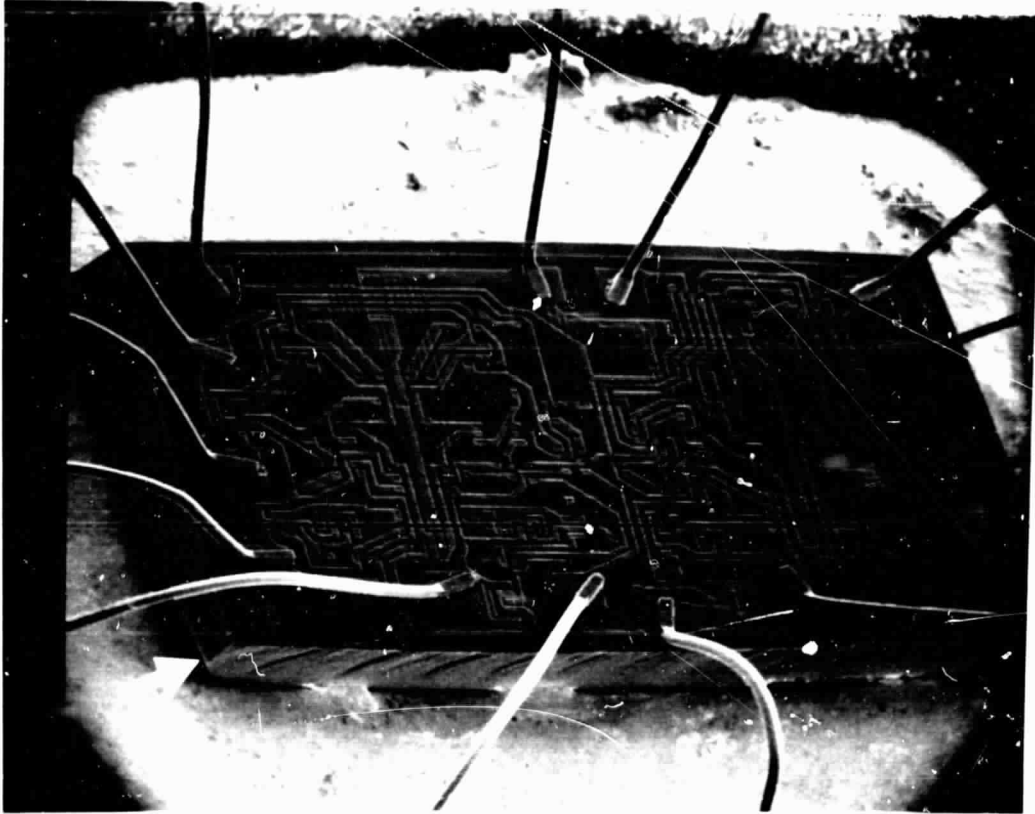
50X S1133
 FIGURE 45. TYPE SN54L78 MICROCIRCUIT, SPECIMEN 34, SHOWING
 APPARENT VOID IN CHIP-BOND MATERIAL (SE)

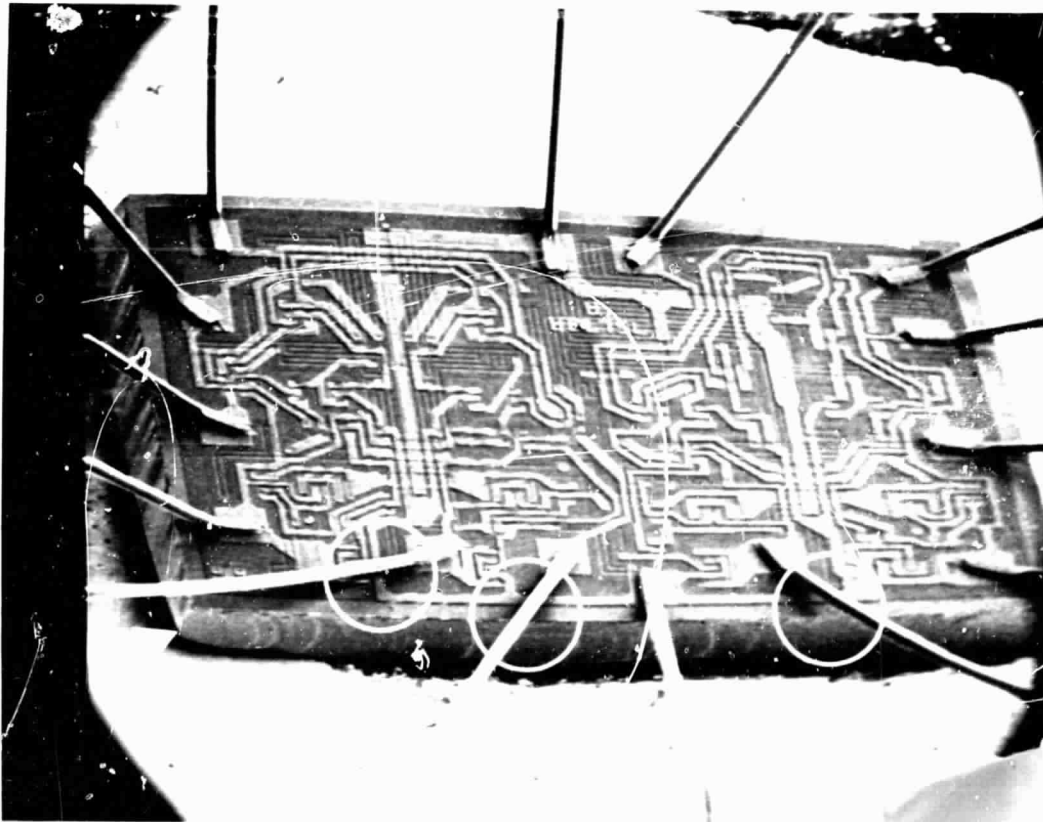
50X S1373
 FIGURE 46. TYPE SN54L73 MICROCIRCUIT, SPECIMEN 35, SHOWING
 APPARENT VOID IN CHIP BOND (ARROW) AND INADEQUATE
 CLEARANCE UNDER LEAD WIRES (CIRCLES) (SE)

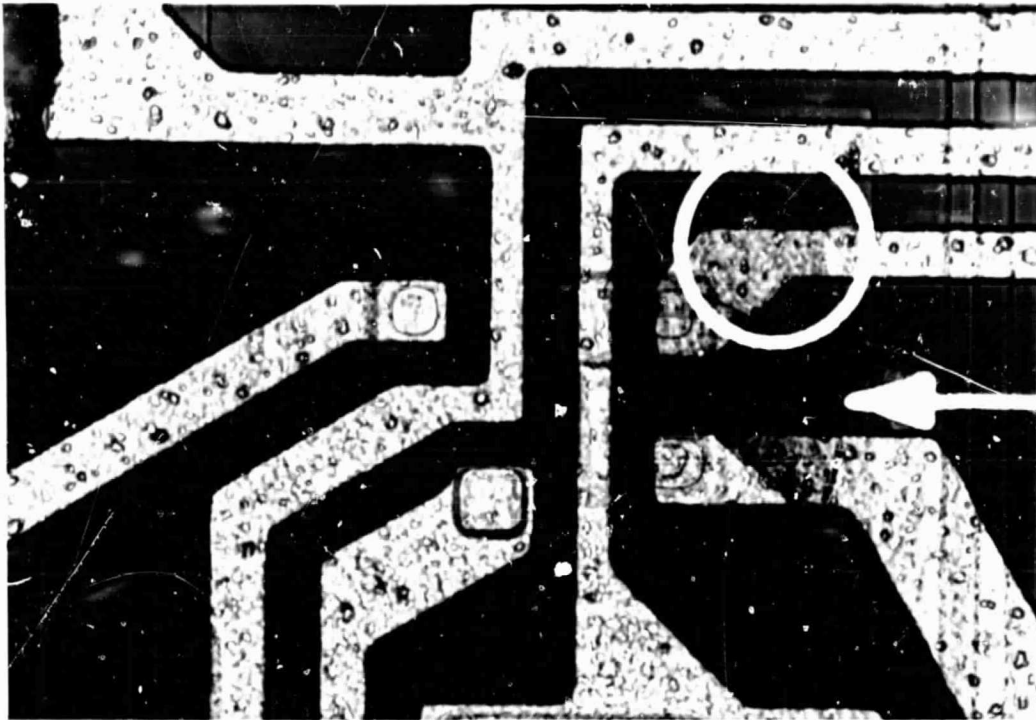
500X 6-3
FIGURE 47. TYPE SN54L73 MICROCIRCUIT, SPECIMEN 41, SHOWING ATTACHED FOREIGN MATTER (ARROW) AND OXIDE FAULT (CIRCLE) IN SECTION B2 AND C2

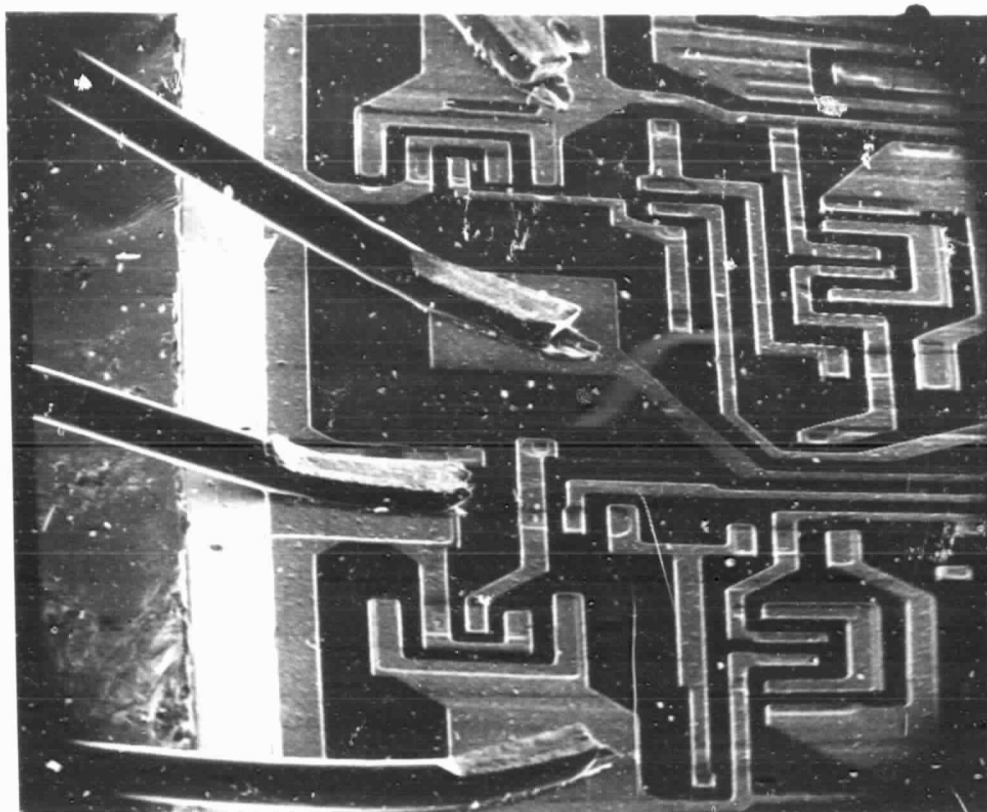
200X S1146
FIGURE 49. TYPE SN54L73 MICROCIRCUIT, SPECIMEN 44, SHOWING LOW ANGLE AND CLOSE CLEARANCE OF LEAD WIRE OVER GROUND STRIPE IN SECTION E7 (SE)

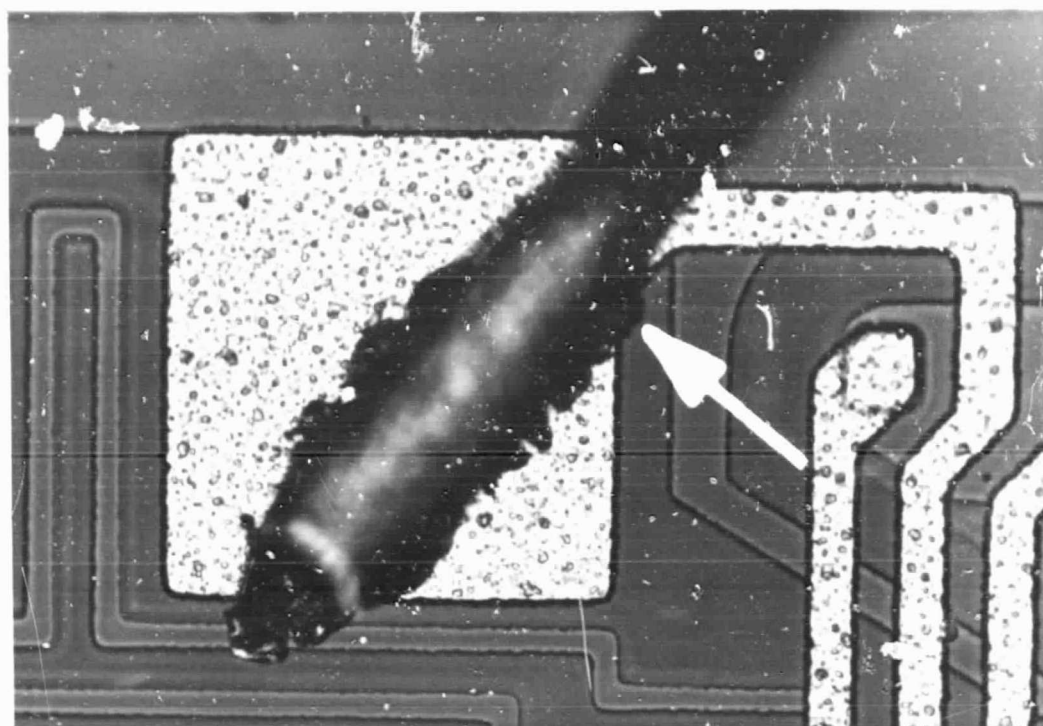
500X 7-3
FIGURE 51. TYPE SN54L78 MICROCIRCUIT, SPECIMEN 32, SHOWING
LEAD BOND COVERING METALLIZATION FILLET IN
SECTION G1

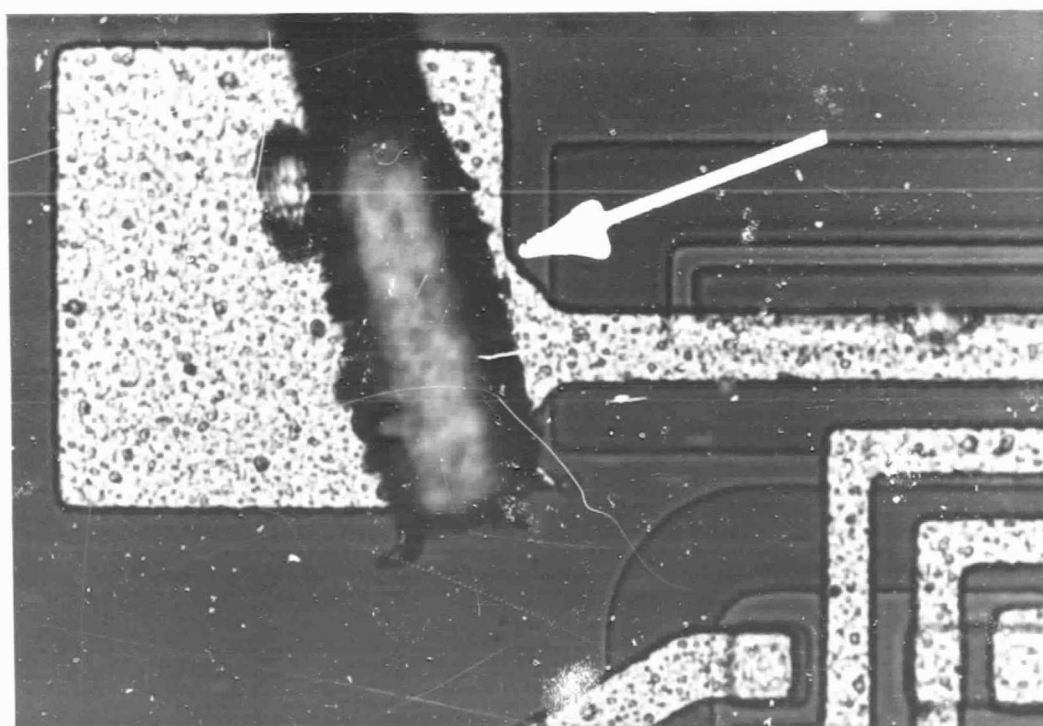
500X 6-13
FIGURE 52. TYPE SN54L78 MICROCIRCUIT, SPECIMEN 35, SHOWING
LEAD BOND WITH INADEQUATE CLEARANCE AT METALLI-
ZATION FILLET IN SECTION B1

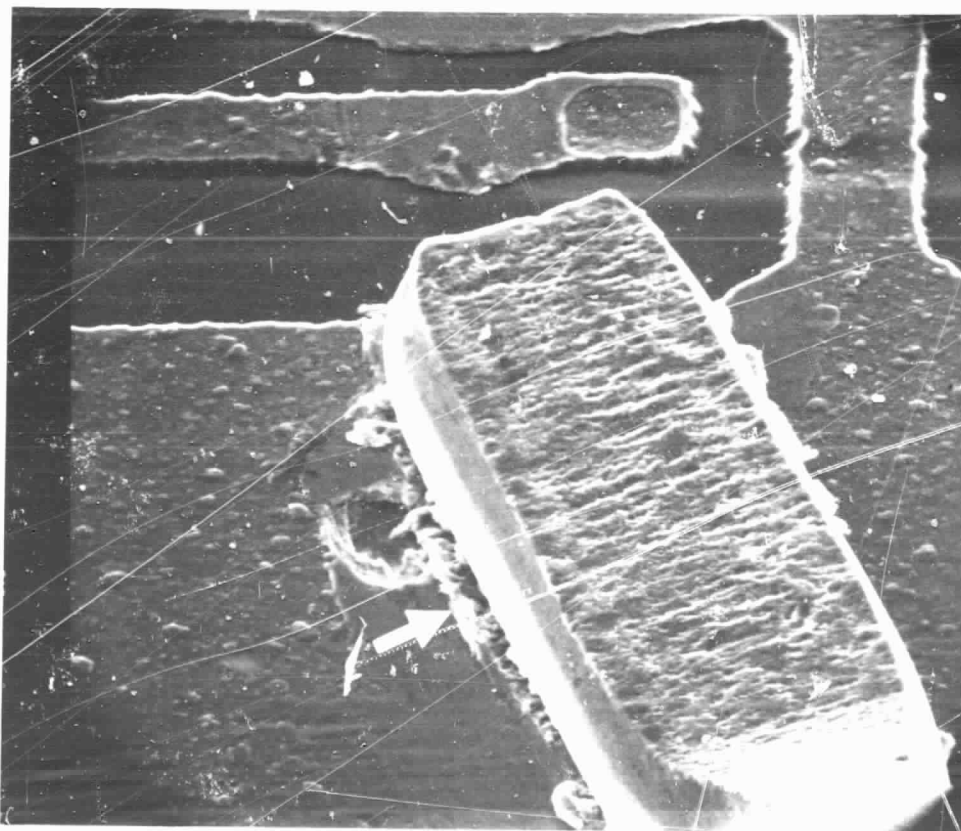
FIGURE 53. TYPE SN54L78 MICROCIRCUIT, SPECIMEN 32, SHOWING
DAMAGE TO METAL STRIPE IN FILLET AREA IN SECTION
I-3

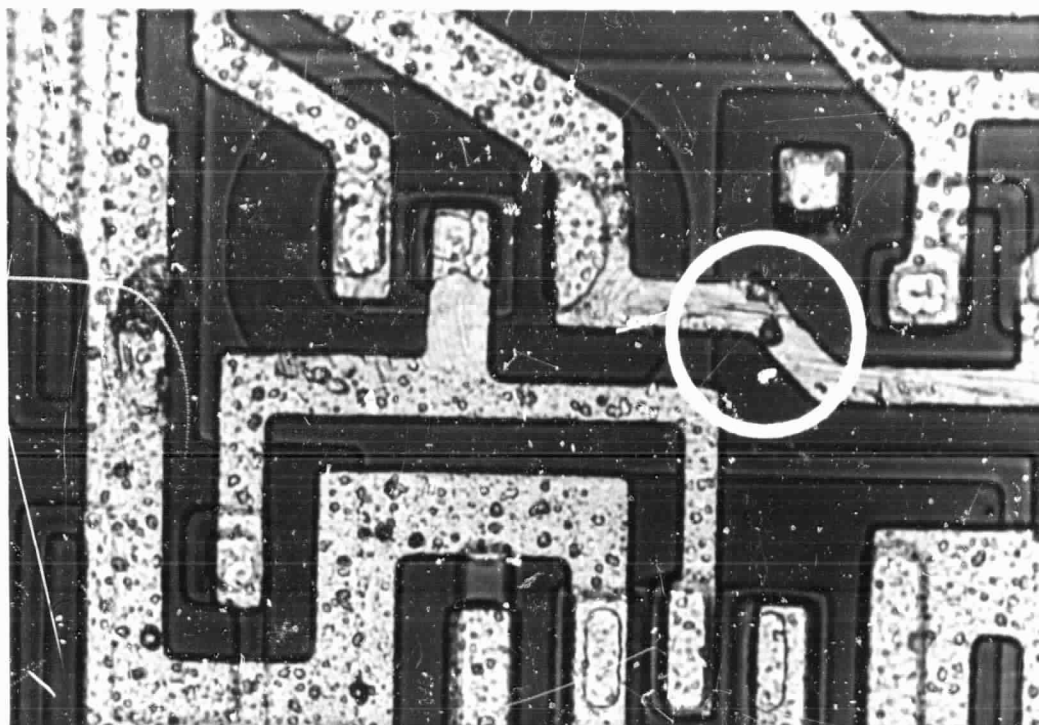
500X 6-1
FIGURE 55. TYPE SN54L73 MICROCIRCUIT, SPECIMEN 41, SHOWING
PHOTOLITHOGRAPHIC VOID IN METAL STRIPE IN
SECTION I6

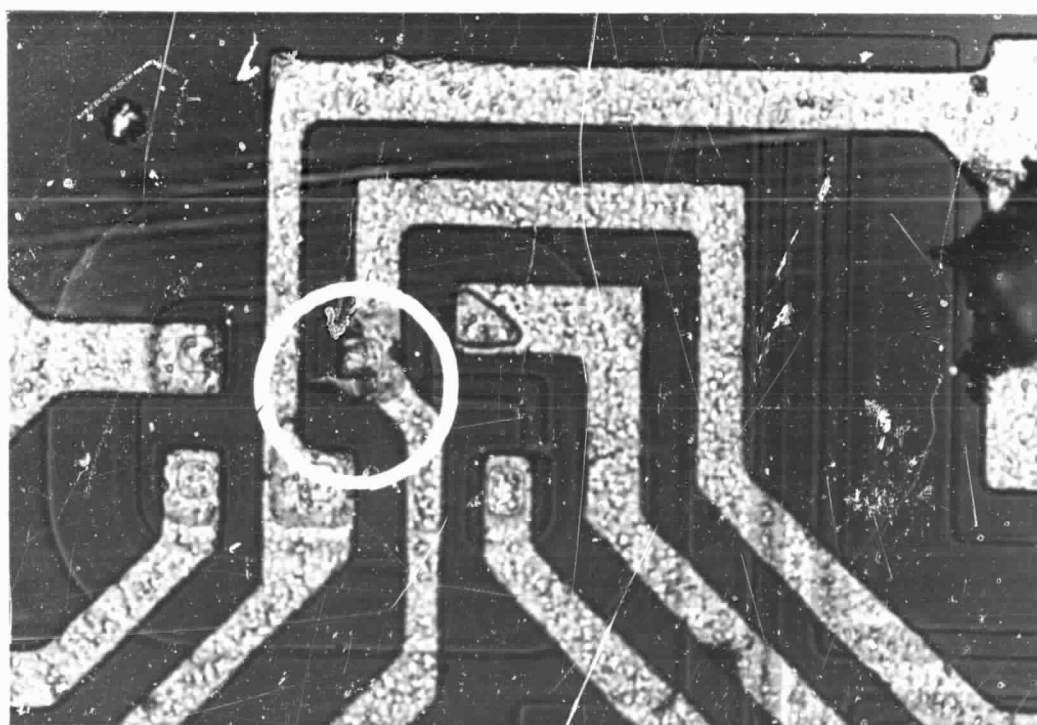
500X 5-17
FIGURE 56. TYPE SN54L73 MICROCIRCUIT, SPECIMEN 44, SHOWING
SPUR ON METAL STRIPE FROM INDUCED DAMAGE IN
SECTIONS A3 AND A4

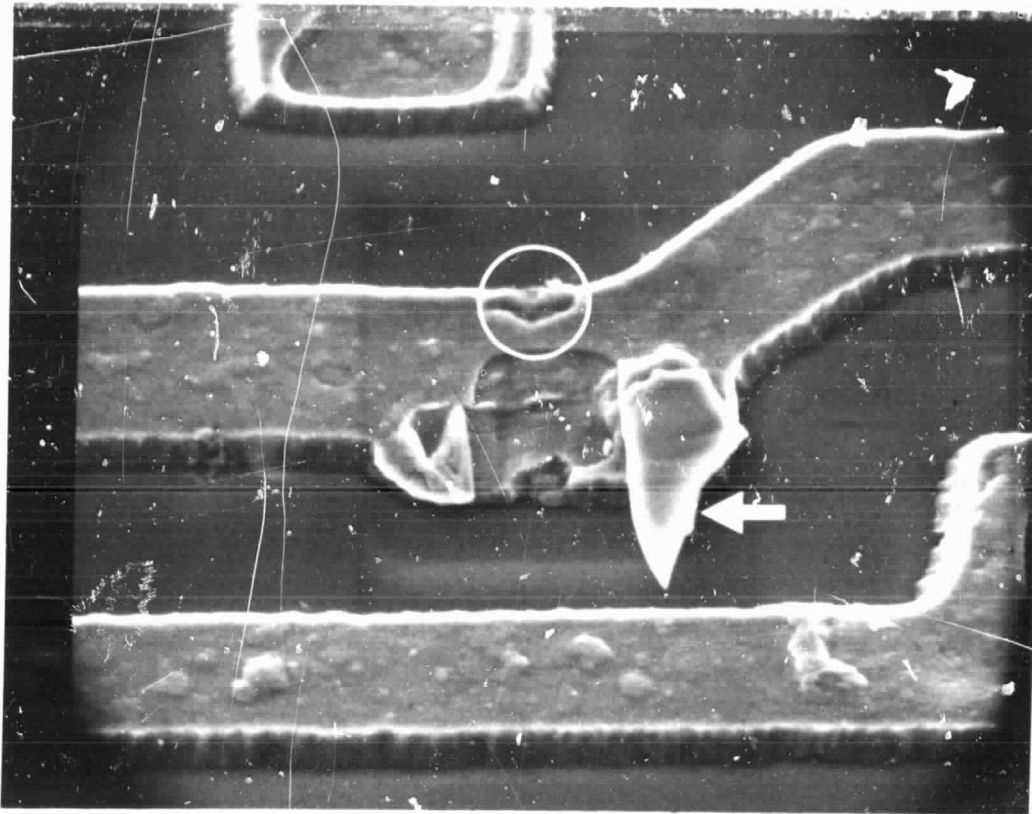
2000X S1142
FIGURE 57. DETAILED VIEW OF THE METAL SPUR (ARROW) IN
FIGURE 56 AND ADJACENT ETCH PIT (CIRCLE) (SE)

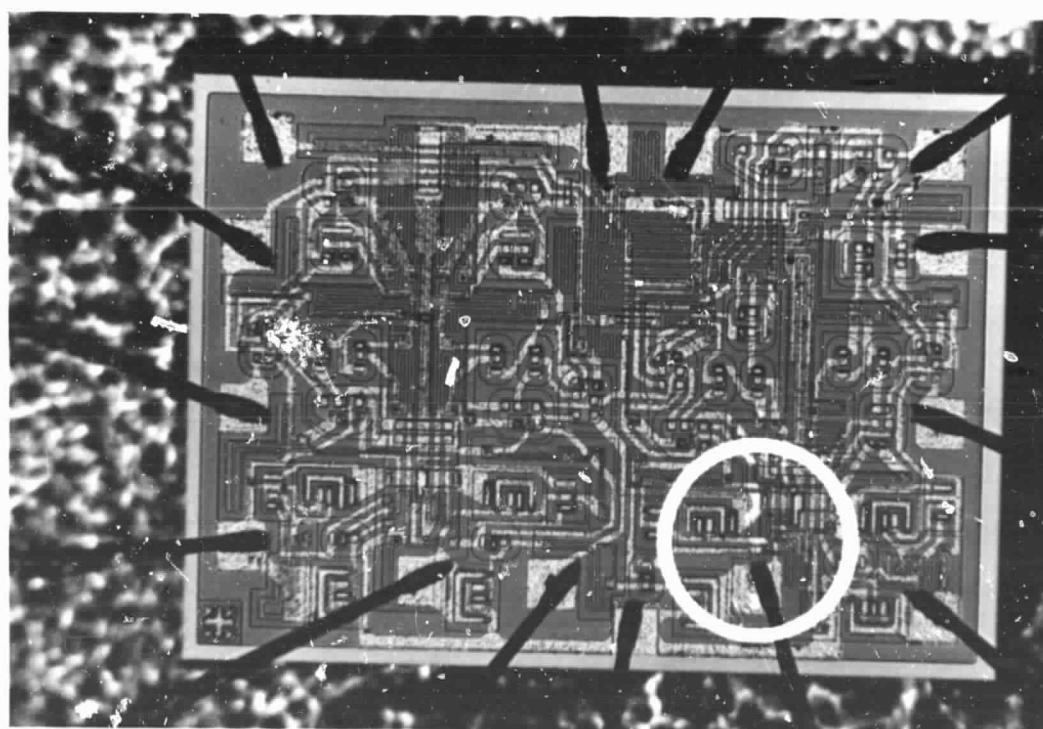
55X 5-4
FIGURE 60. TYPE SN54L78 MICROCIRCUIT, SPECIMEN 34, SHOWING
DEFECTIVE TYPE SMEAR IN METALLIZATION IN
SECTIONS G5, G6, H5, AND H6

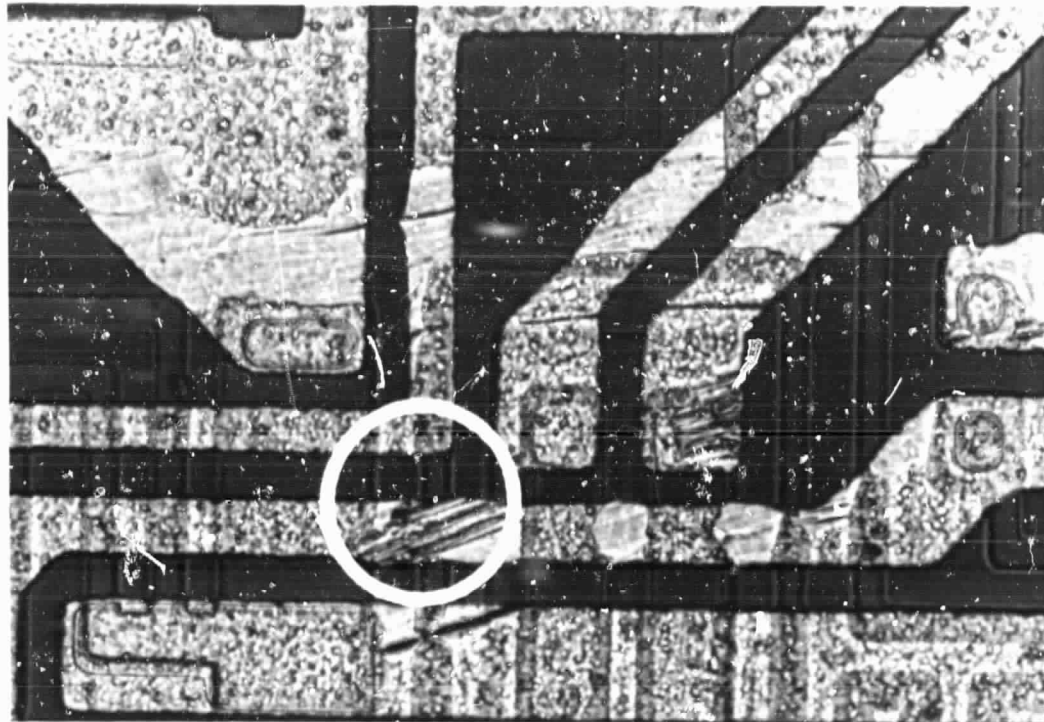
500X 6-15
FIGURE 61. DETAILED VIEW OF MOST SERIOUS AREA OF SMEAR IN
FIGURE 60

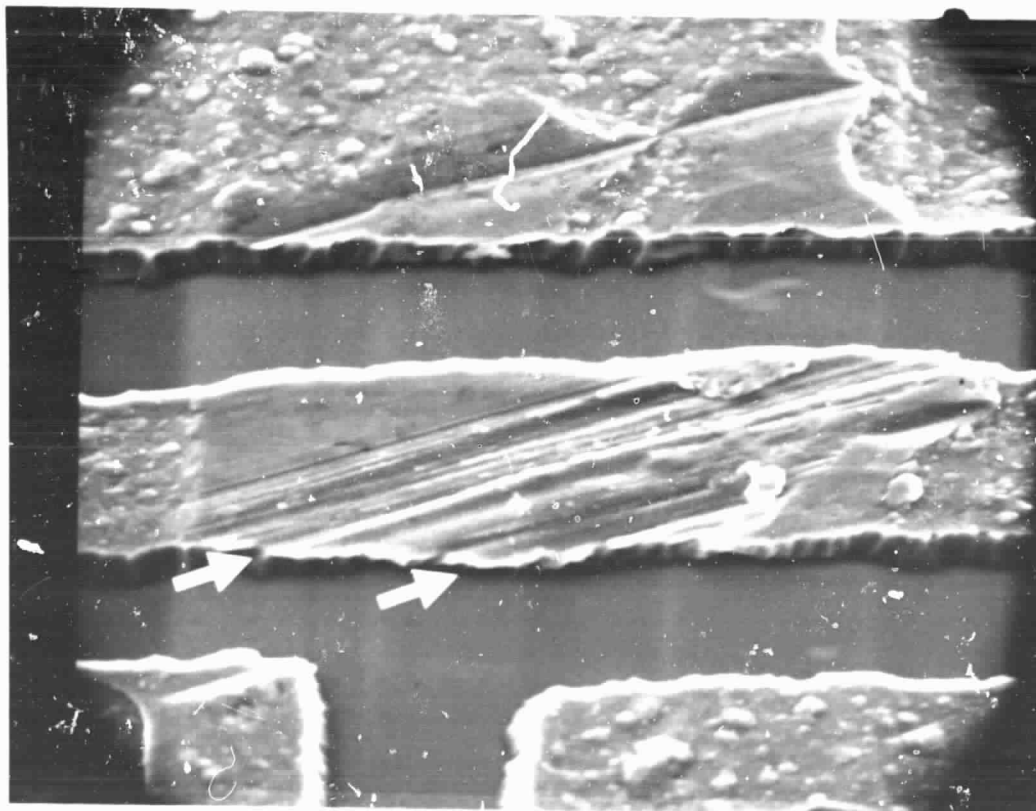
2000X S1136
FIGURE 62. SCANNING MICROGRAPH OF SCRATCH IN METAL STRIPE
ENCIRCLED IN FIGURE 61 (SE)

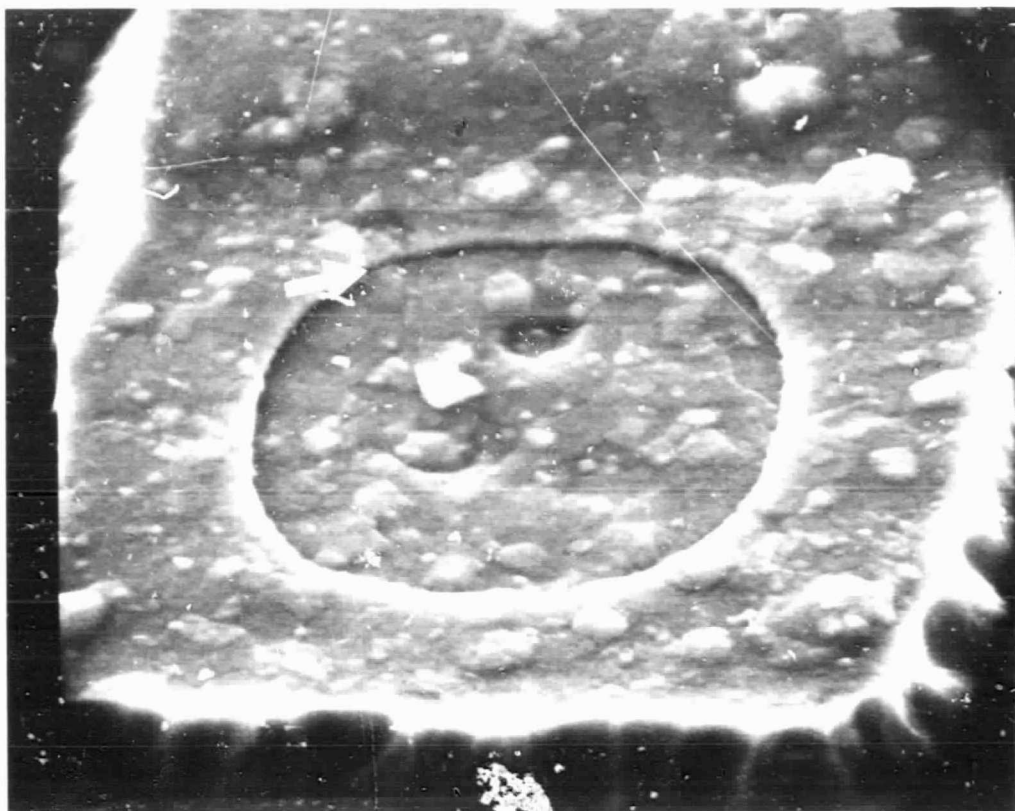
5000X S1368
FIGURE 63. TYPE SN54L78 MICROCIRCUIT, SPECIMEN 35, SHOWING
CRACK IN METALLIZATION AT OXIDE STEP IN WINDOW
CUT (SE)

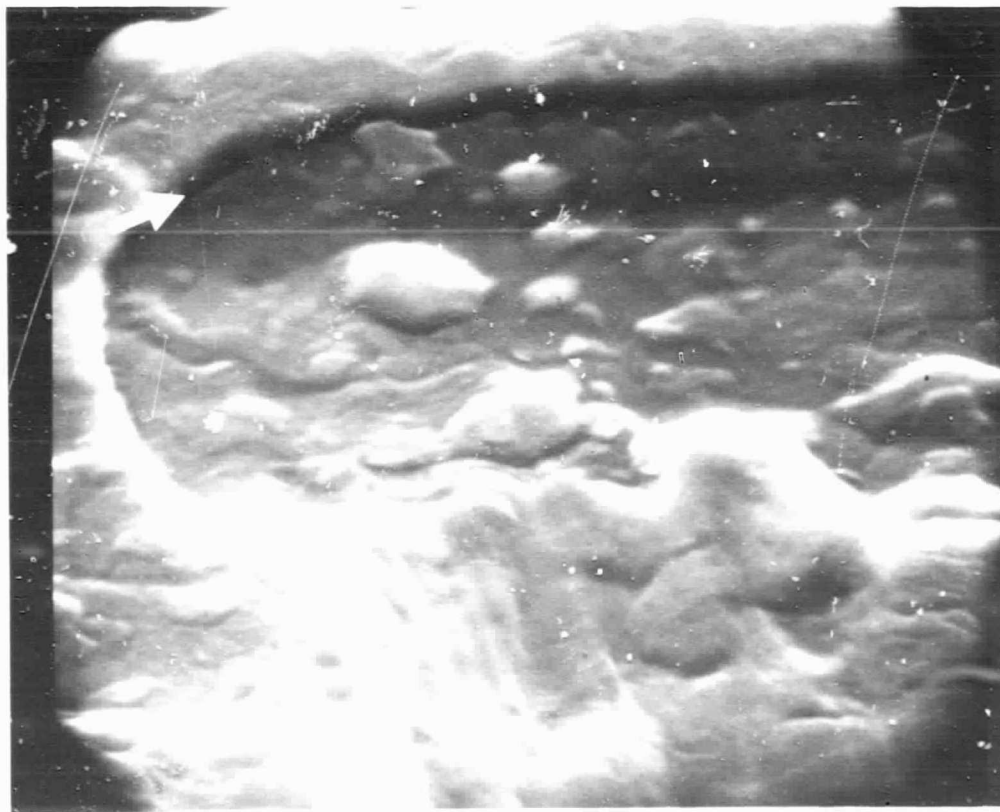
10,000X S1379
FIGURE 64. TYPE SN54L73 MICROCIRCUIT, SPECIMEN 45, SHOWING
CRACK IN METALLIZATION AT OXIDE STEP IN WINDOW
CUT (SE)

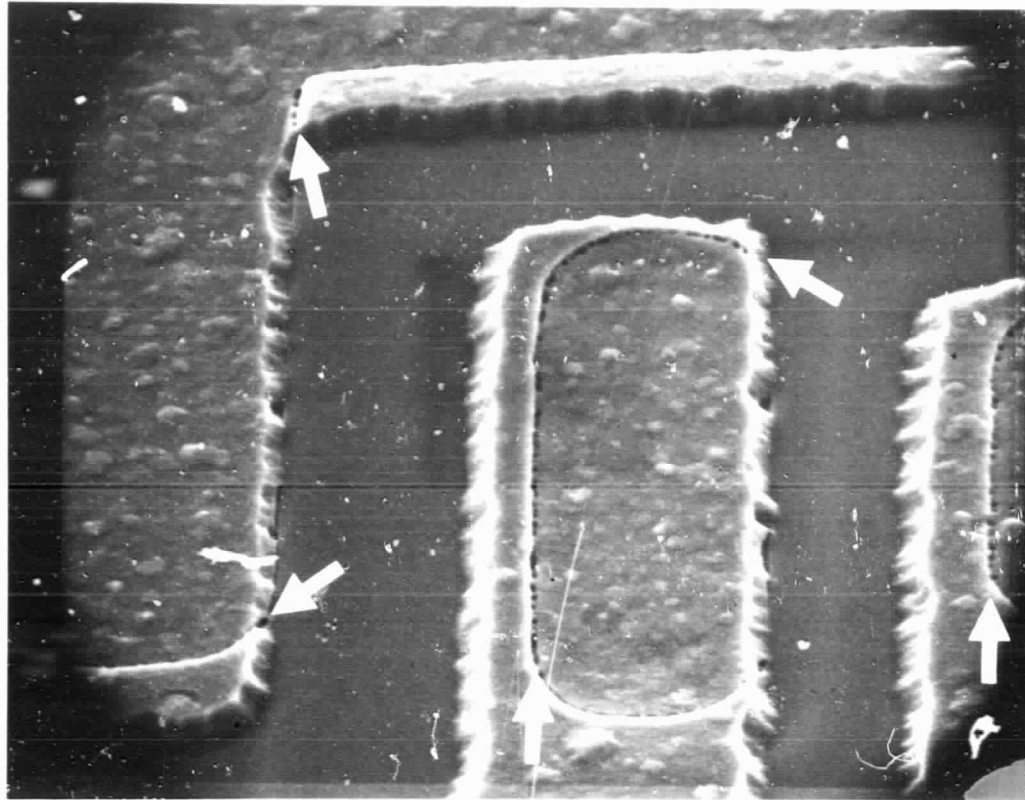
2000X S1364
 FIGURE 65. TYPE SN54L78 MICROCIRCUIT, SPECIMEN 33, SHOWING
 POROSITY IN METALLIZATION AT OXIDE STEP IN
 WINDOW CUT (SE)

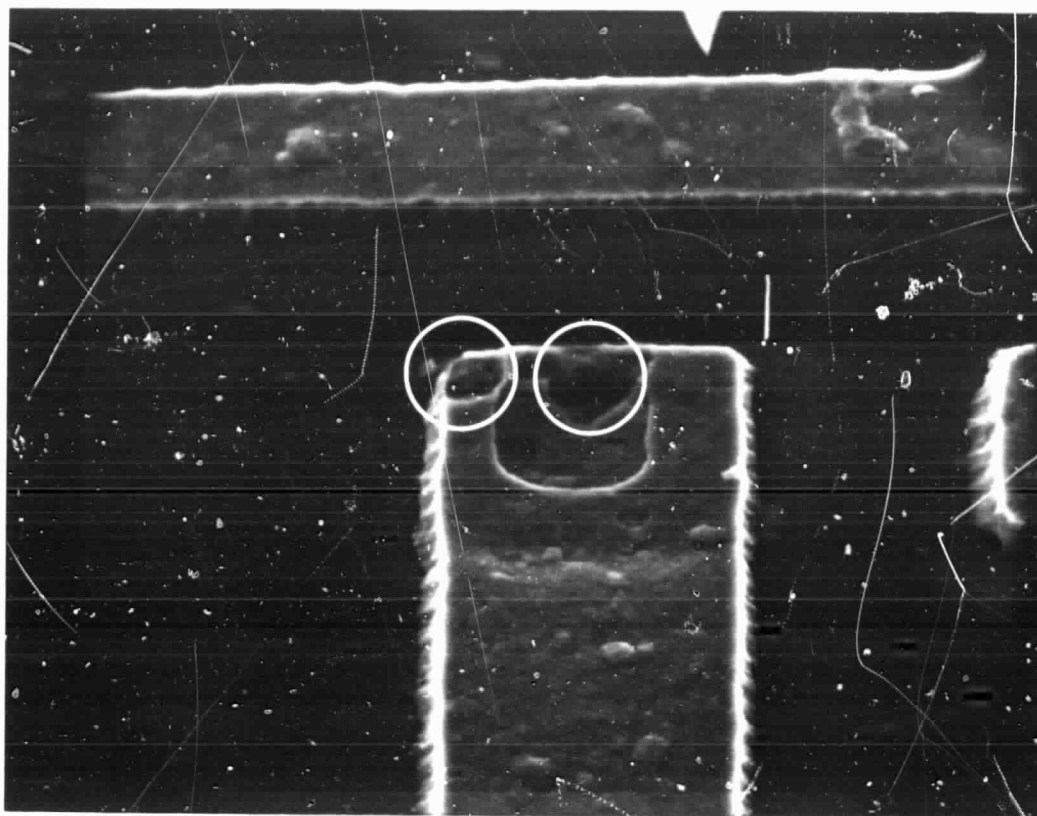
2000X S1143
 FIGURE 69. TYPE SN54L73 MICROCIRCUIT, SPECIMEN 44, SHOWING
 ETCH-TYPE PITS IN METALLIZATION AT CONTACT
 WINDOW IN SECTION A4

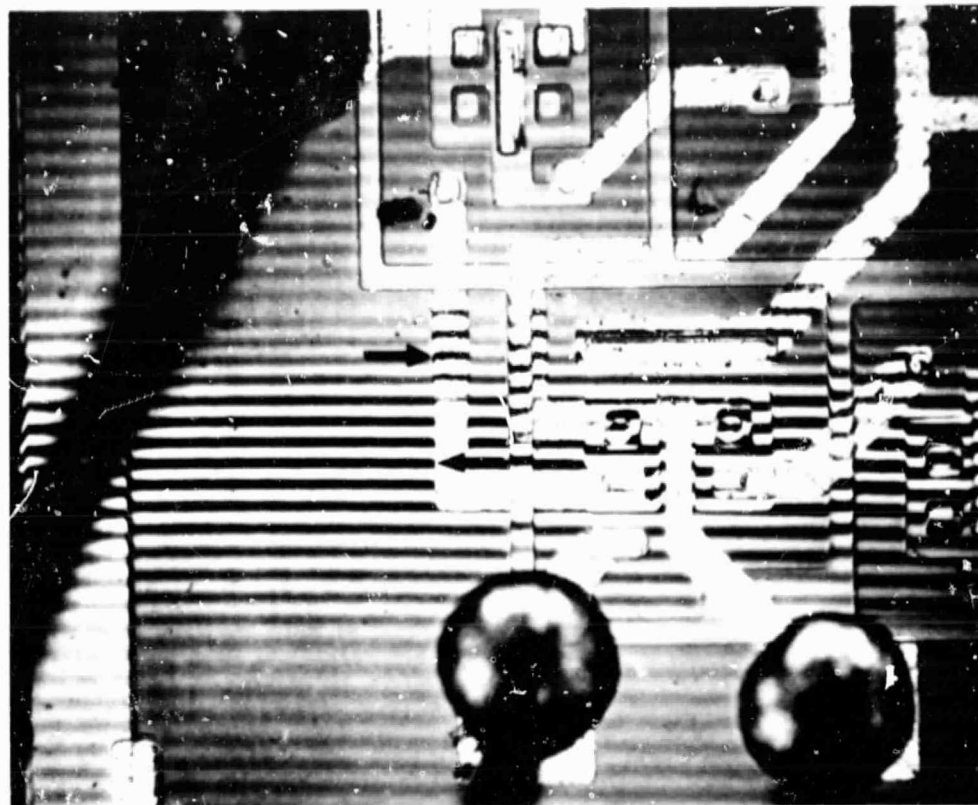
200X 5E919
FIGURE B-1. THE METALLIZATION THICKNESS ON SAMPLE 14
CORRESPONDED TO 5.2 TO 5.3 INTERFERENCE
FRINGES OR 1.56 TO 1.59 MICRONS

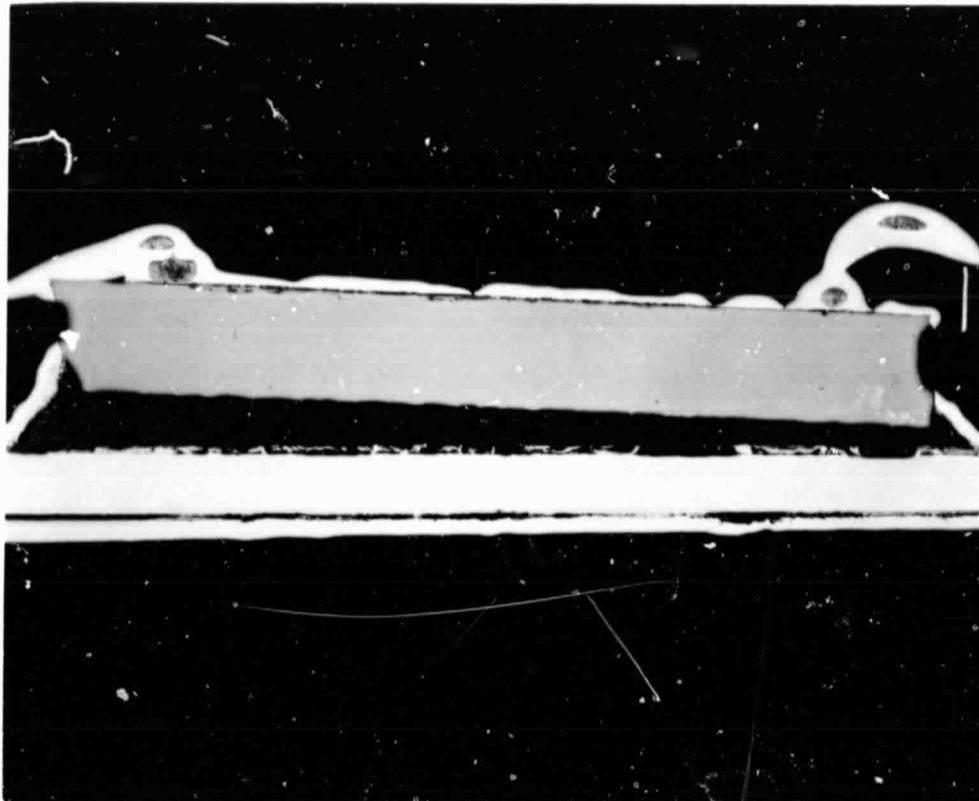
60X 5E974
FIGURE C-1. CROSS SECTION THROUGH SPECIMEN 23
