NASA CR-66946

# CONTINUATION OF NASA ROCKET MOTOR DEFECTS INVESTIGATION

CONTINUATION OF NASA ROCKET MOTOR DEFECTS INVESTIGATION

JUNE 1969 THROUGH MAY 1970

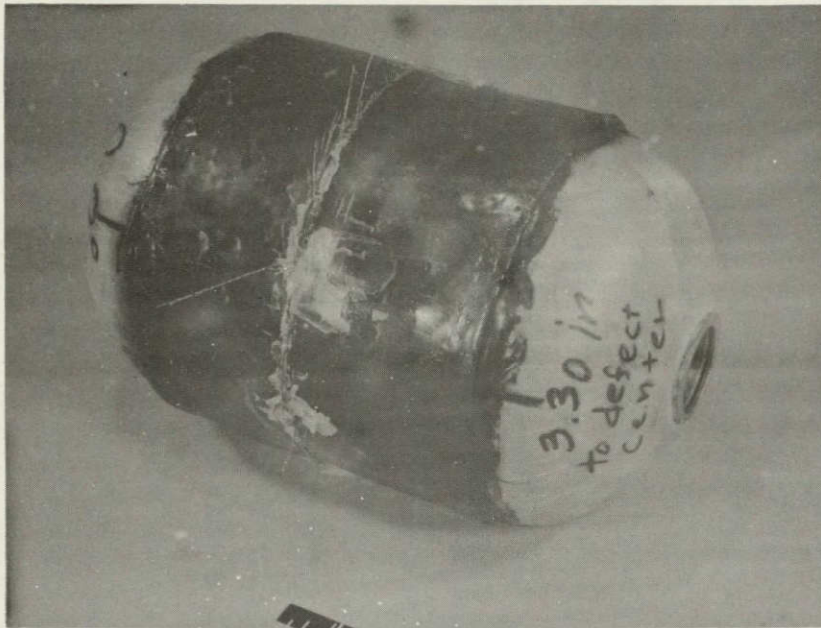
Figure 10. Bottle No. 3 - Post Test View of Three-Ply Tension Failure

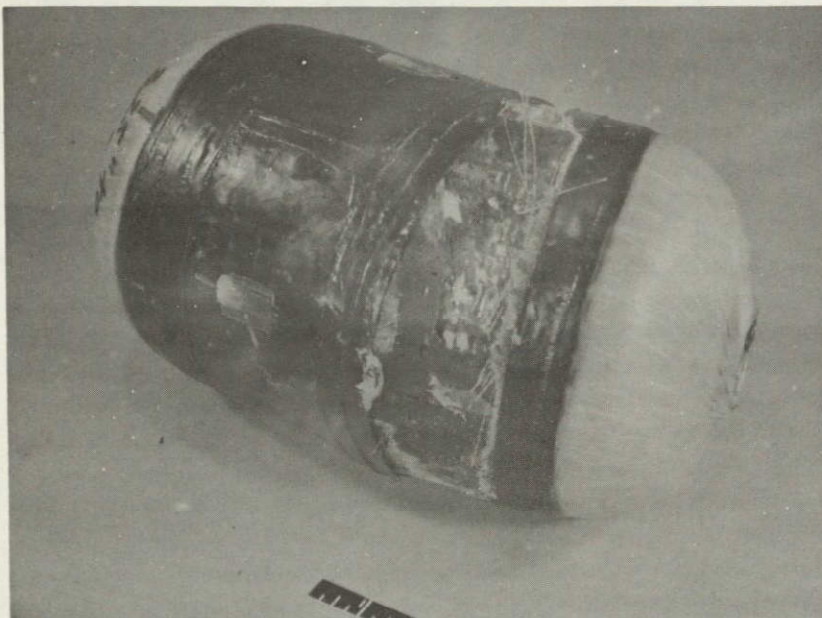
Figure 11. Bottle No. 4 - Post Test View of Four-Ply Shear Failure

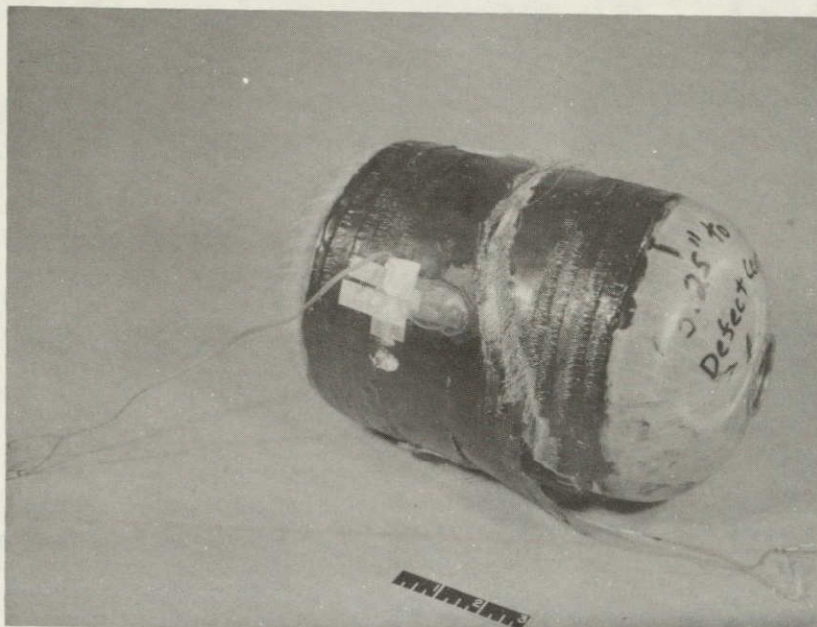
Figure 25. Post-burst View of Bottle No. 5 with Four-Ply Inverted Repair

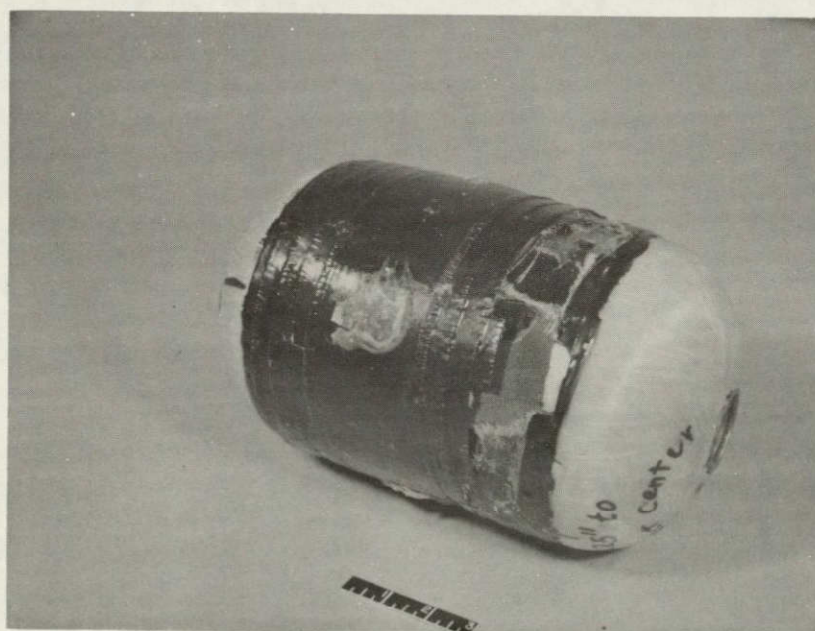
Figure 26. Post-burst View of Bottle No. 6 with Four-Ply Inverted Repair

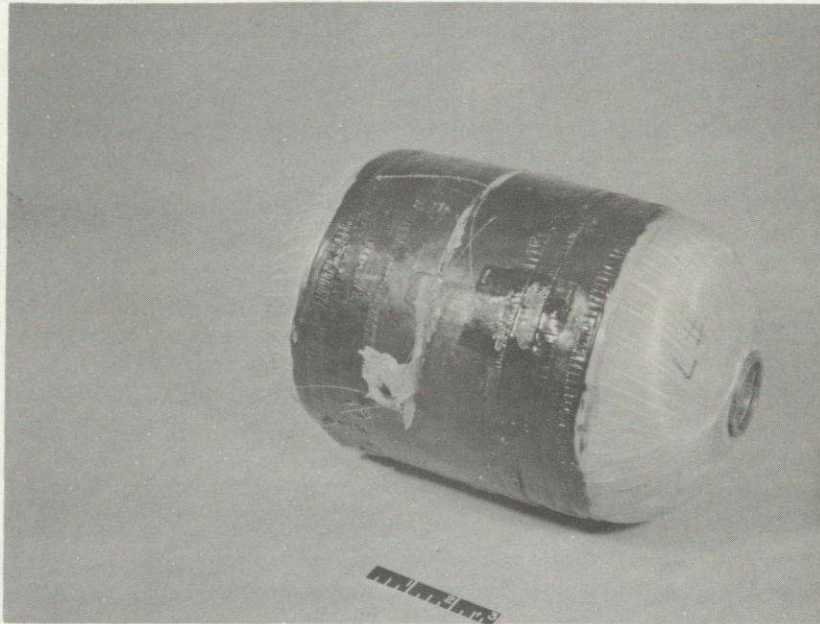
Figure 27. Post-burst View of Bottle No. 7 with Four-Ply Inverted Repair

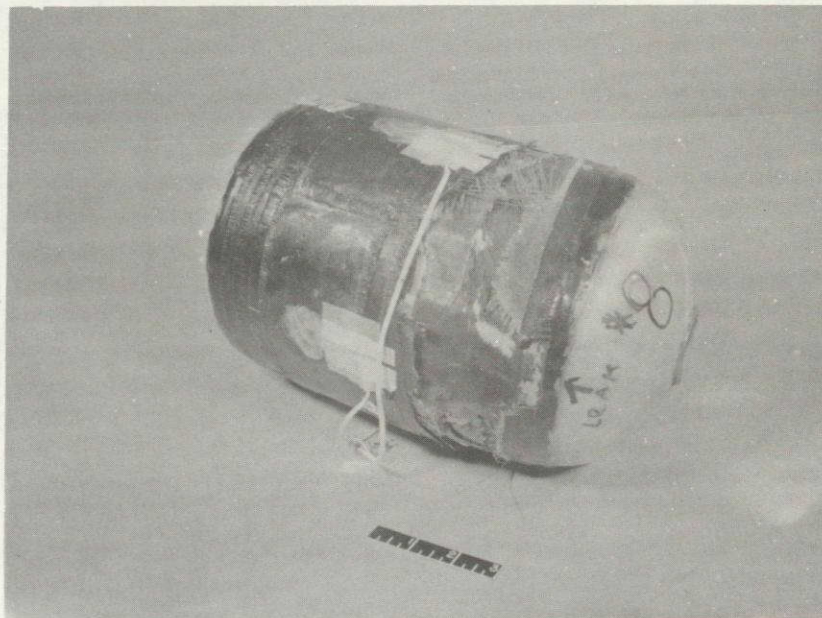
Figure 28. Post-burst View of Bottle No. 8 with Four-Ply Inverted Repair

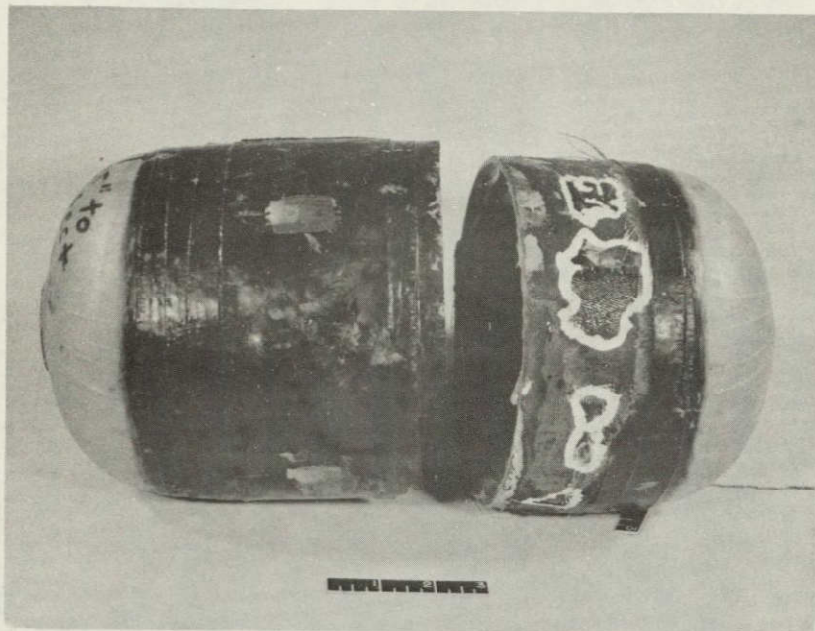
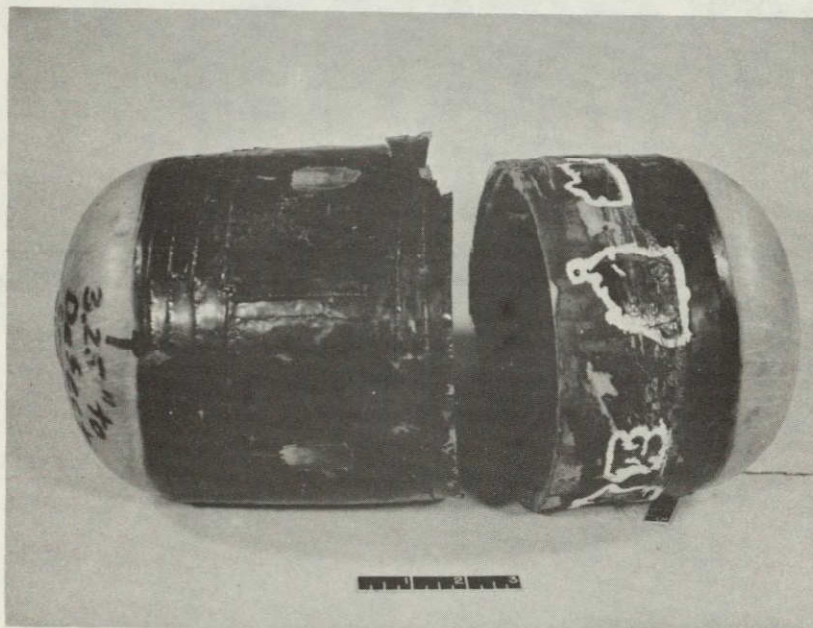
(5) For the best void-free application of a repair patch, individual plies must be applied separately. Except for the anti-fraying border, the resin must not be applied to any ply before positioning and rolling down the ply.

Figure 29. Void Areas in Bottle No. 4  
(Located inside white boundaries)

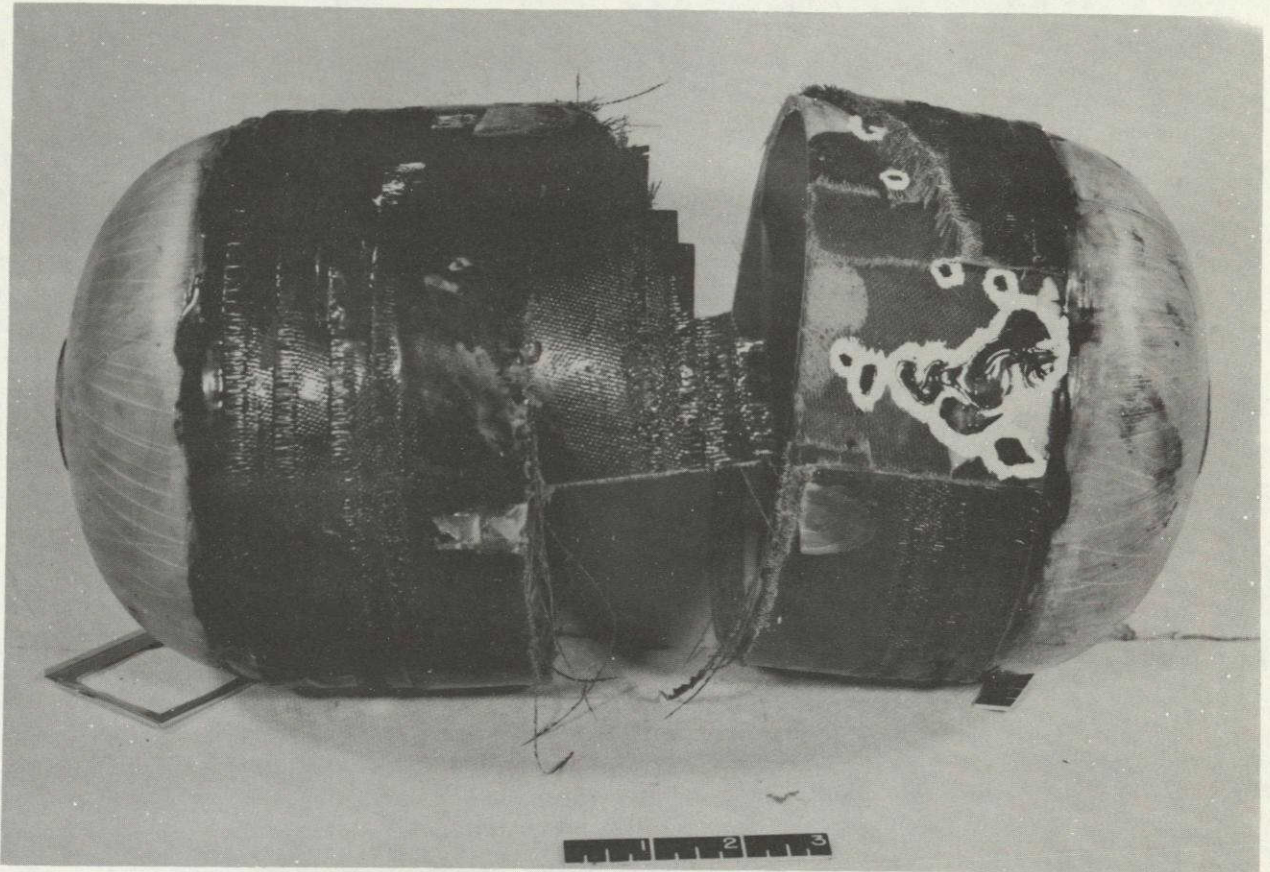
Figure 30. Void Areas in Bottle No. 5 (failure area located inside white boundaries at the 270° location)

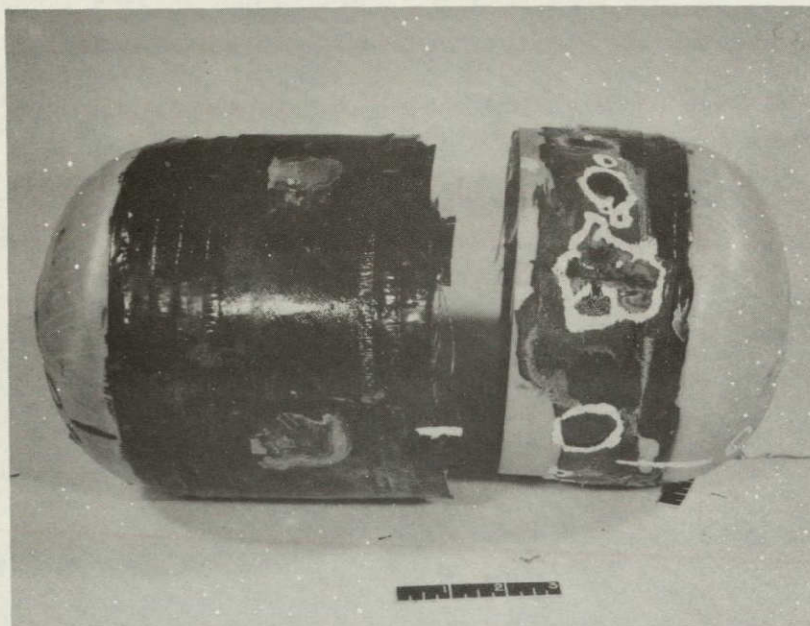
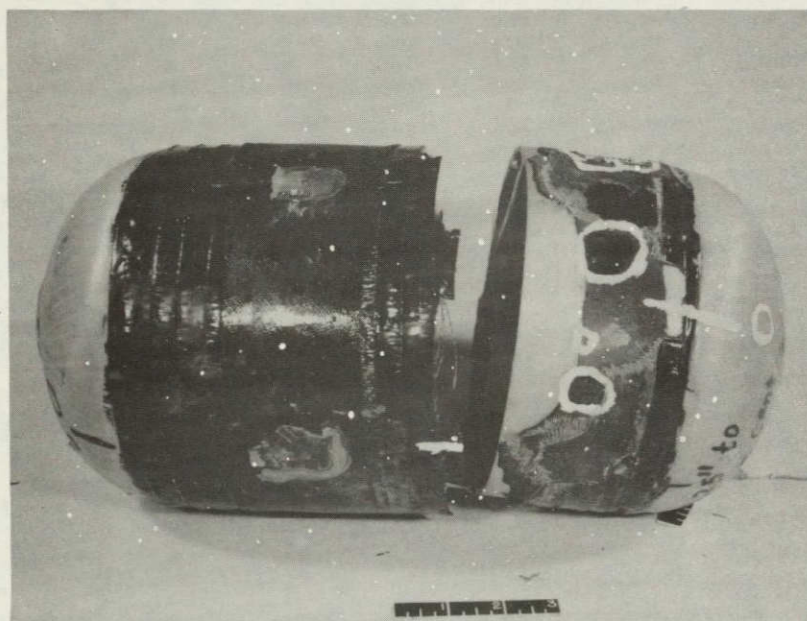
Figure 31. Void Areas in Bottle No. 6  
(located inside white boundaries)

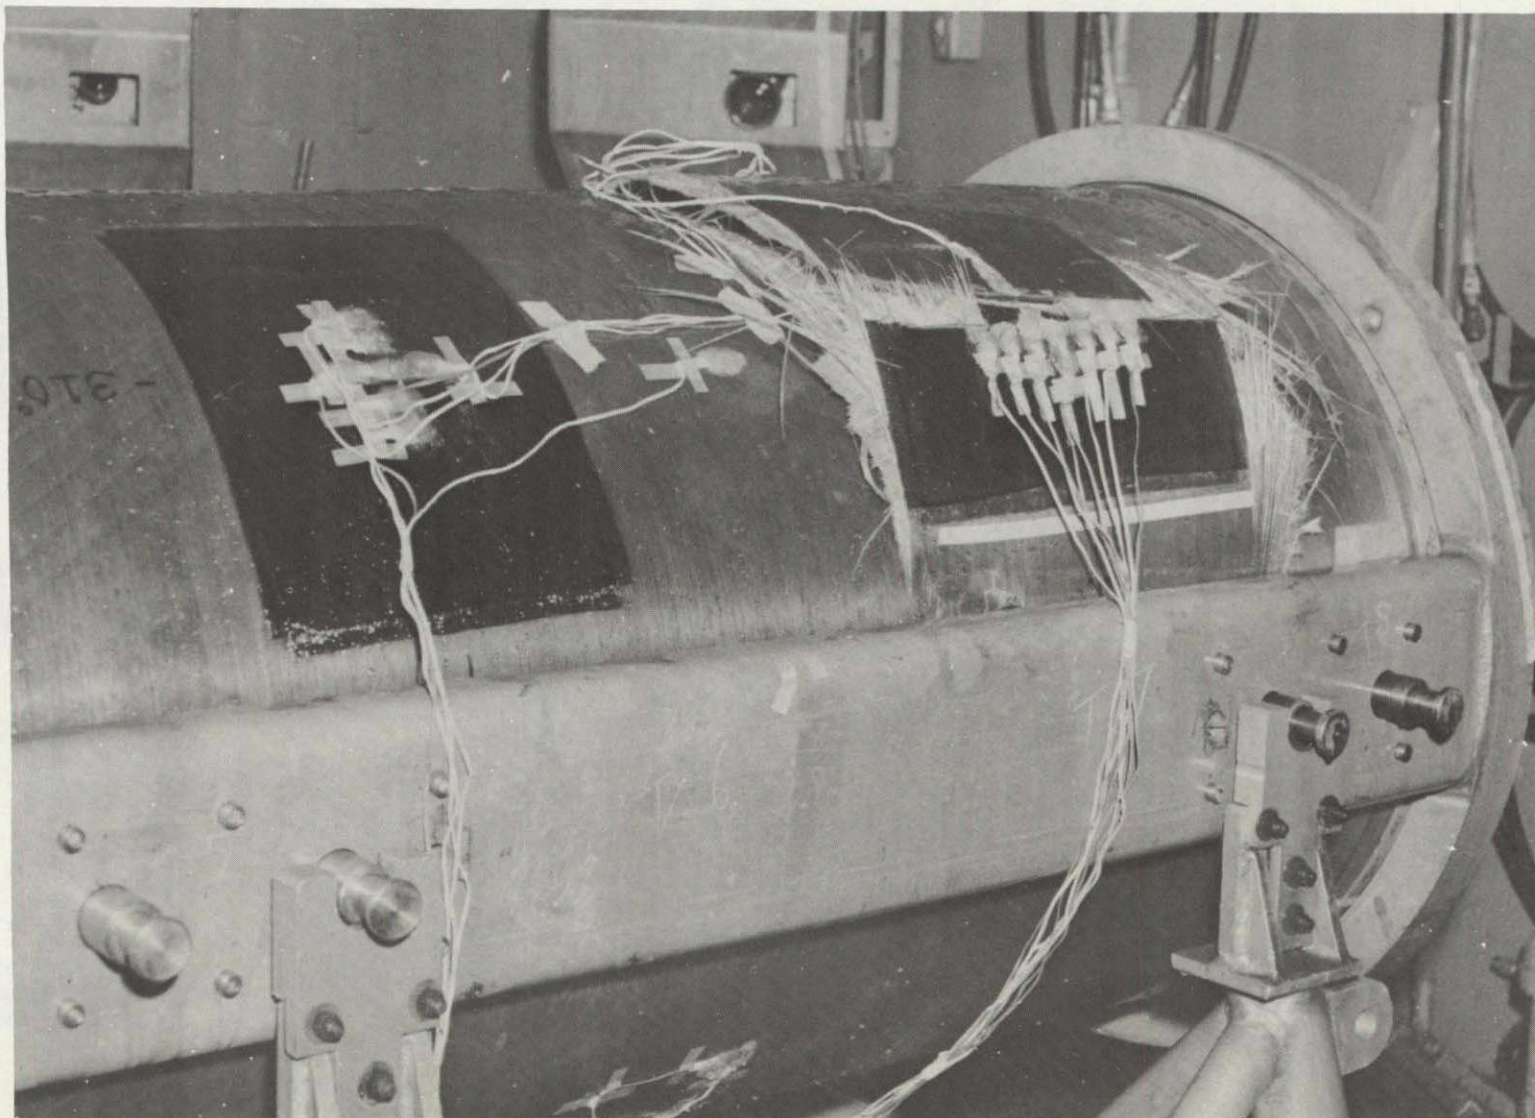
(2) The X259 hydrotest indicated that a four-ply patch of the tensile strength determined in this study was not capable of successfully repairing a 5.0-in. longitudinal defect completely through the cylindrical section of an X259 motor case. However, the repair of circumferential defects can be accomplished with the present repair technique.

Figure 74. Post-test View of Failure

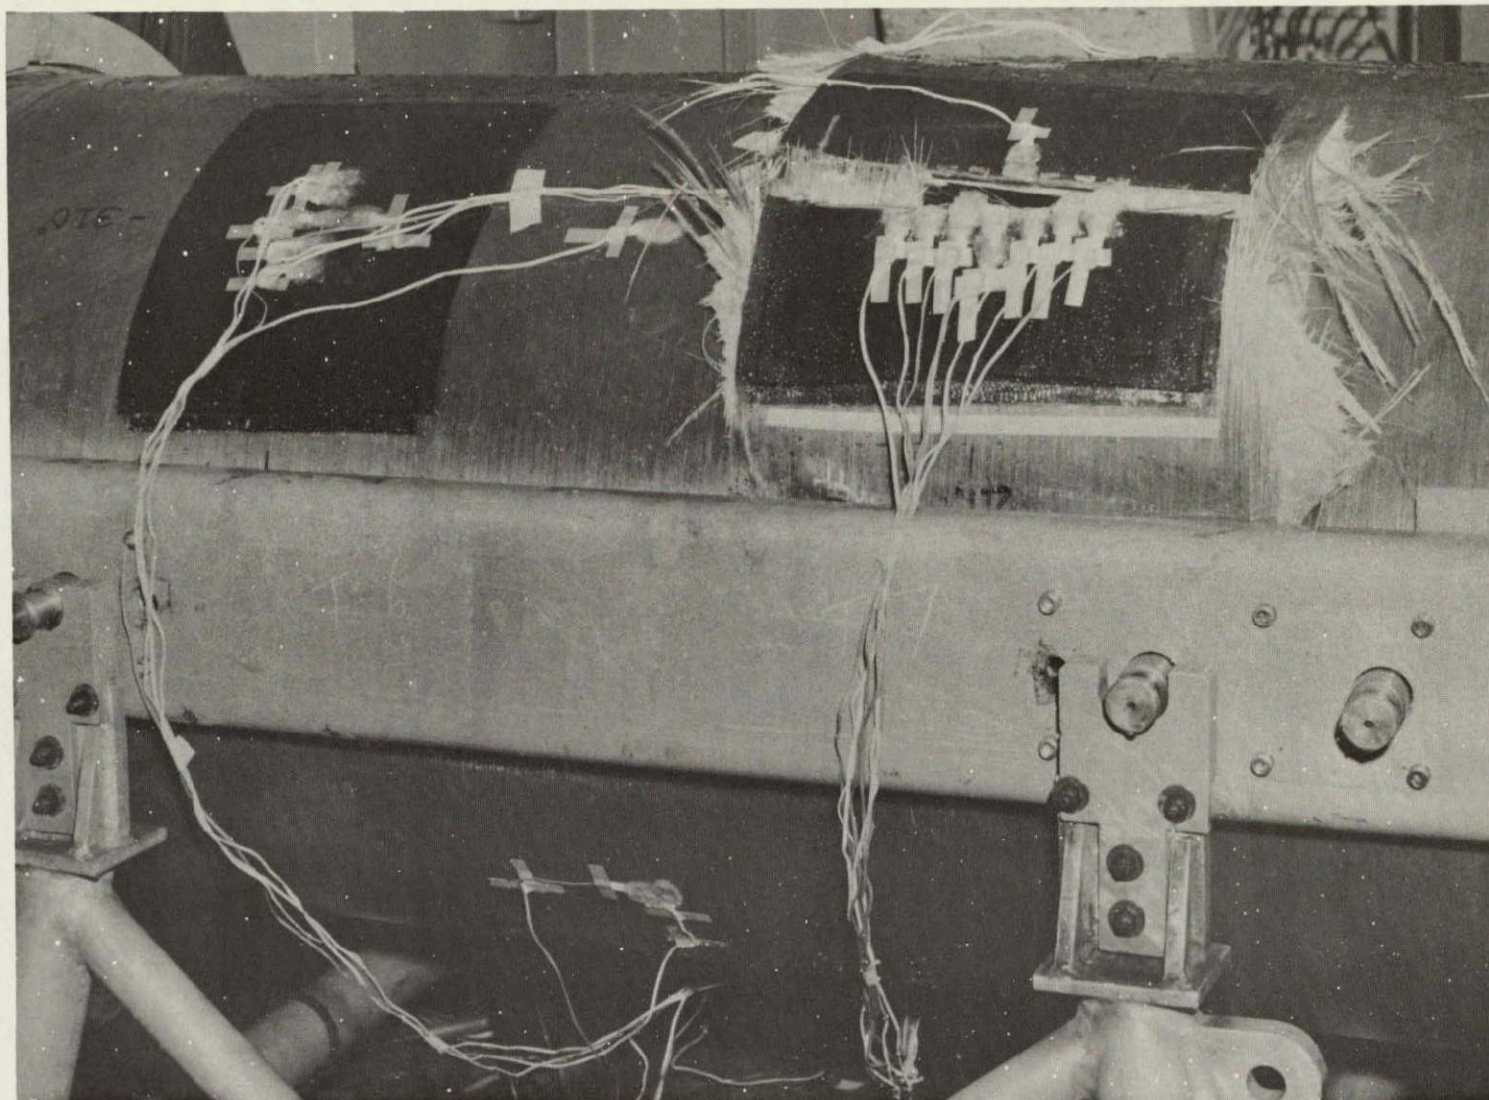
Figure 75. Post-test View of Failure

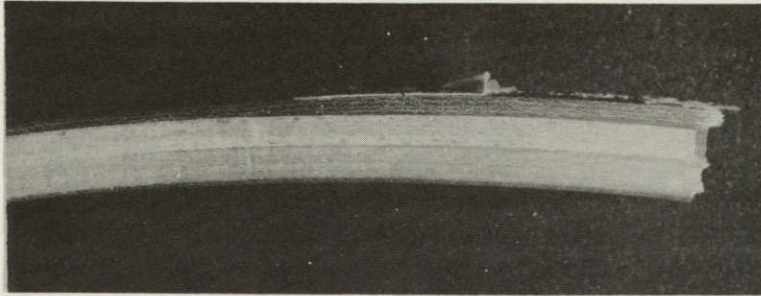
Figure 77. Center Section of Failed Defect (X 1)

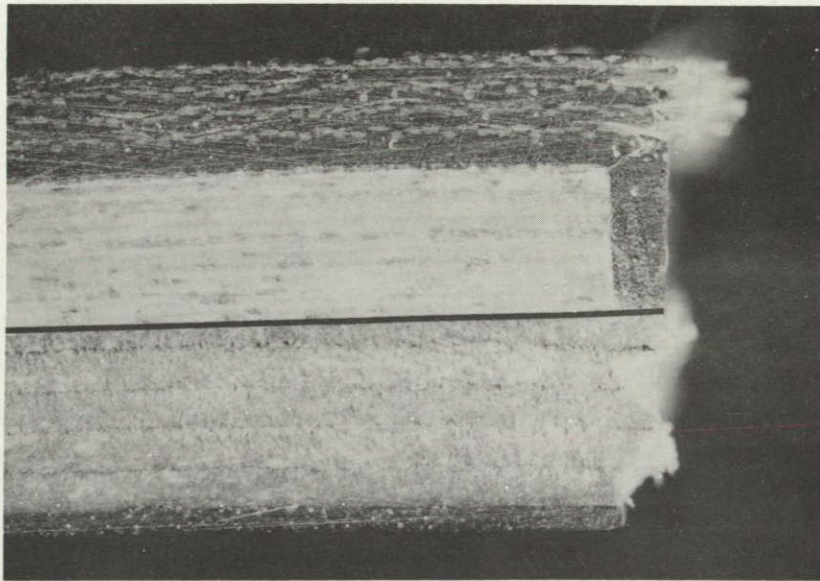
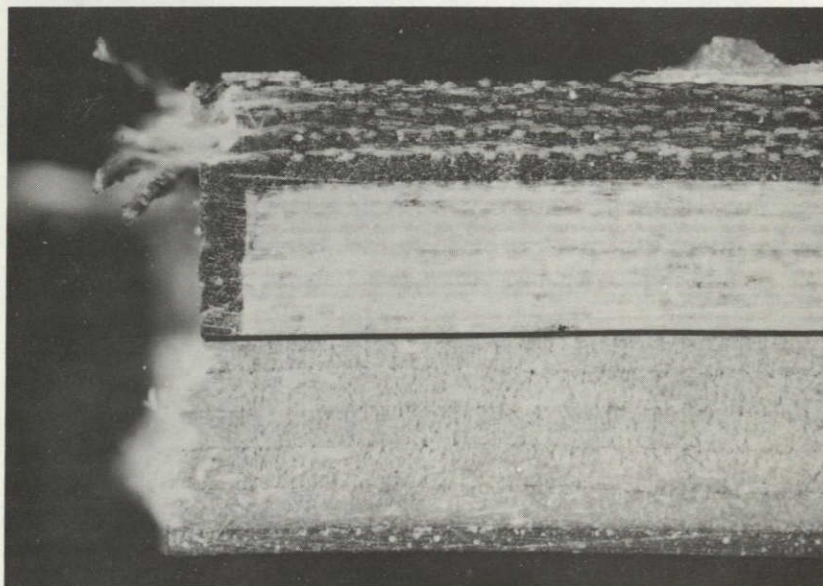
Figure 78. Center Section of Failed Defect (X 5)
