APOLLO PROGRAM

FINAL FLIGHT EVALUATION REPORT APOLLO 5 MISSION

OCTOBER, 1968

APOLLO 5

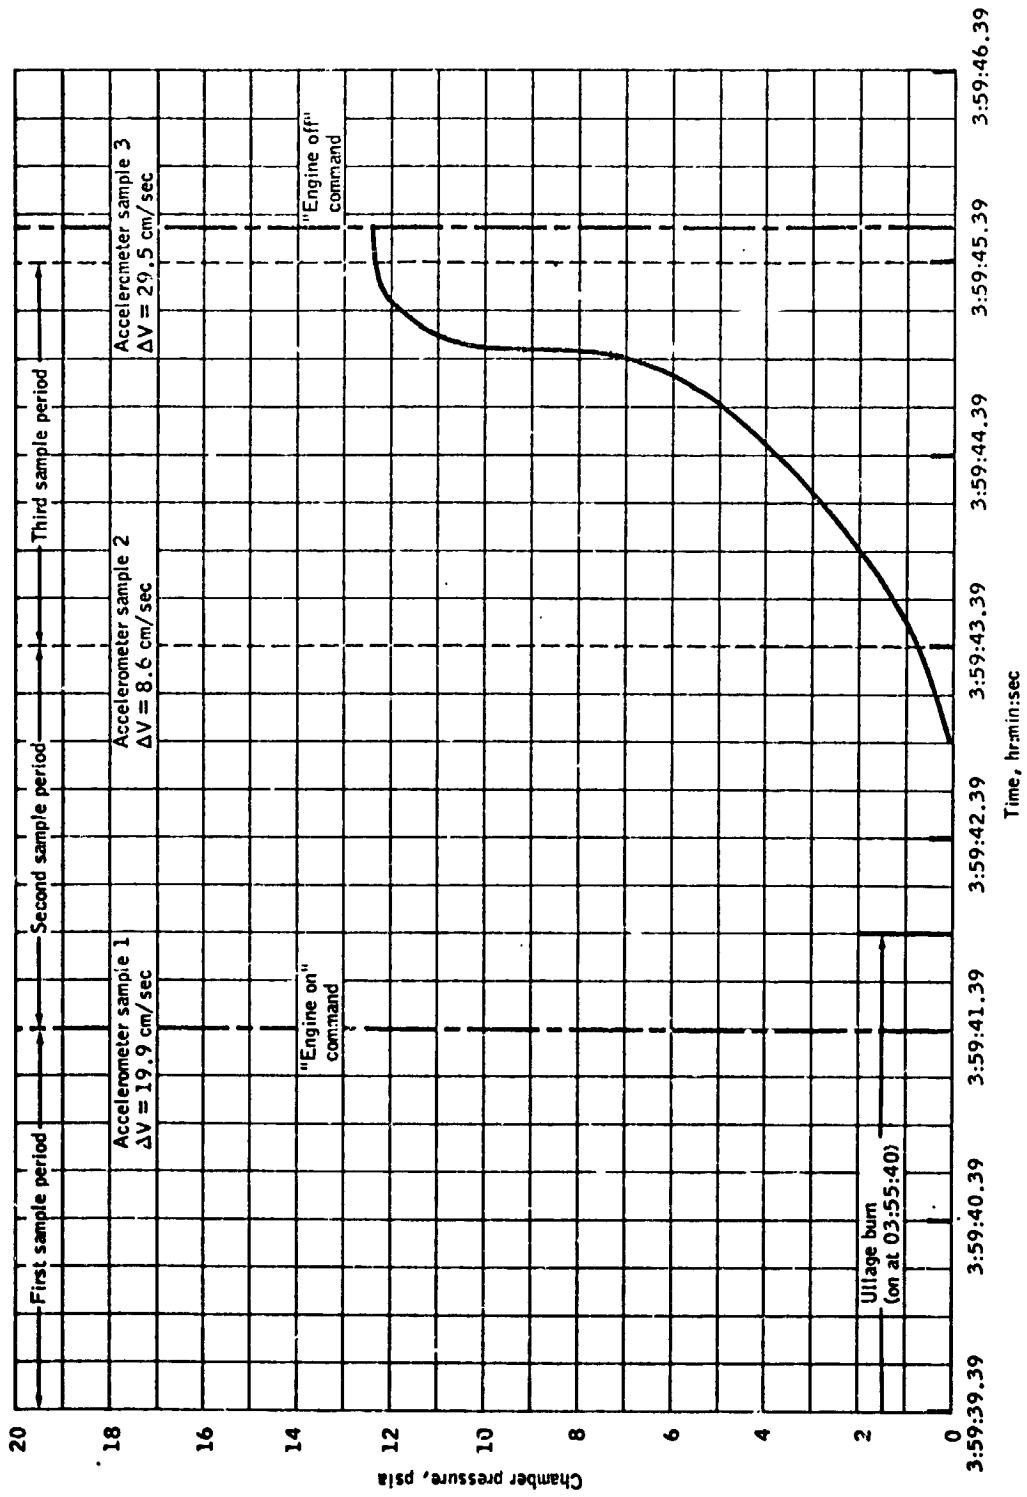
Figure 2.1-1

Because of the phasing established at Tign minus 30 seconds, the first accelerometer sample utilized by the thrust monitor was taken within 0.01 seconds after commanded "engine on" and represented only the velocity accumulation due to the LM reaction control system (RCS) thruster ullage orientation burn. The RCS thruster burn ended 0.5 second after commanded "engine on" and therefore the second sample, taken at Tign plus 2 seconds, represented a combination of velocity accrued from the RCS thruster burn and the start of the descent engine burn. The third sample, taken at Tign plus 4 seconds, was the first that represented descent engine velocity accumulation only. Fig. 2.1-1 shows the time phasing of the accelerometer samples with the descent engine chamber pressure rise. Because none of the three samples met the 45 cm/sec minimum criteria programmed in the LM guidance computer, the engine was commanded off by the computer.

Accelerometer/engine chamber pressure phasing during first descent propulsion burn.

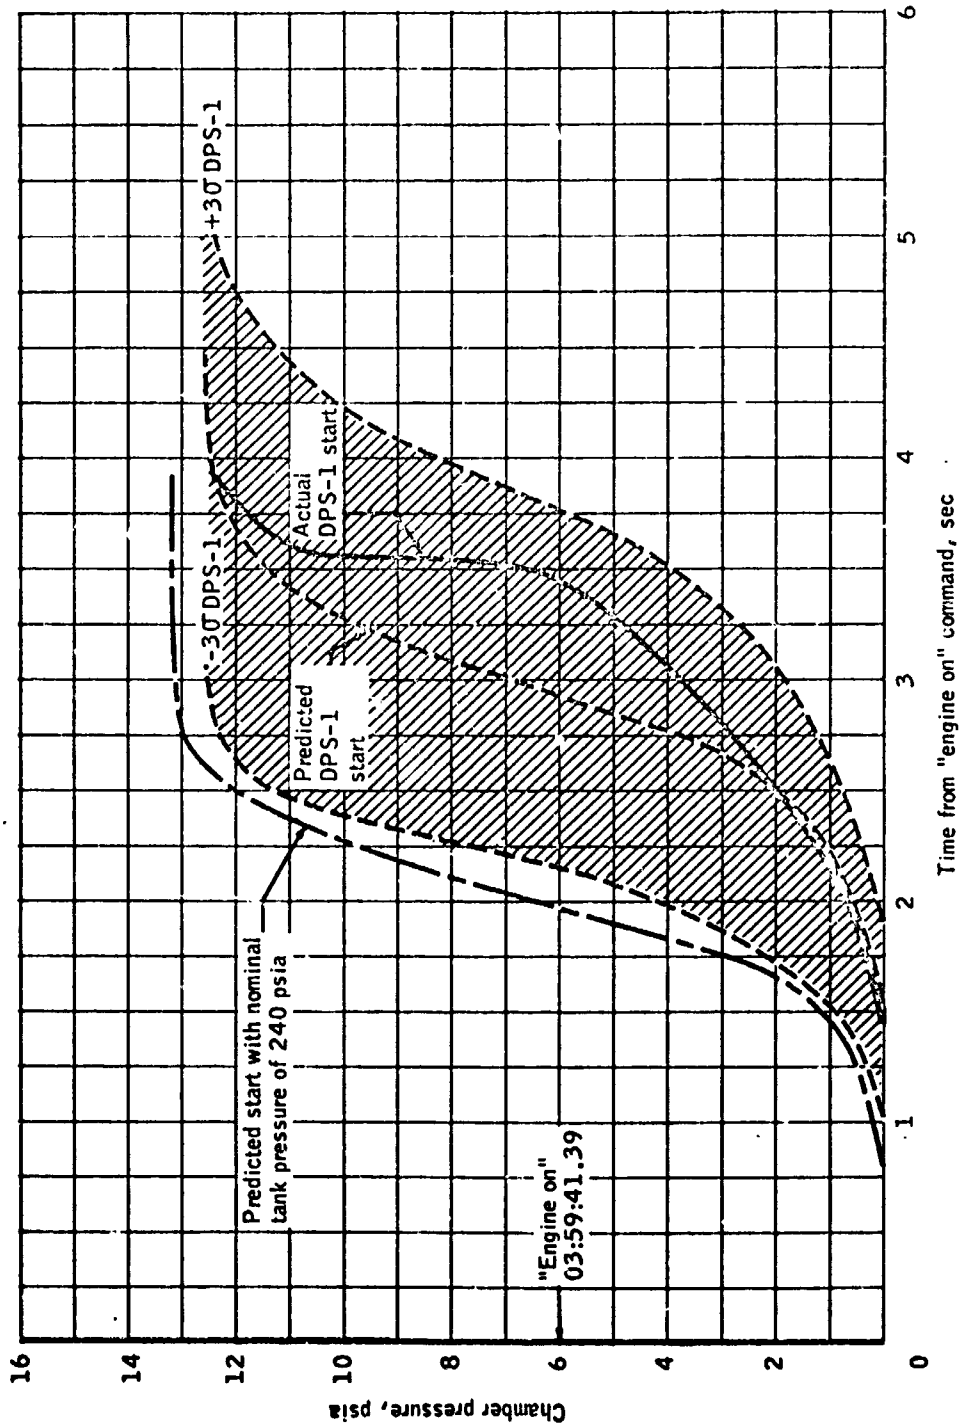
FIGURE 2.1-2 DPS-1 START TRANSIENTS

The effect of propellant tank pressures on the engine start characteristics is shown in Fig. 2.1-2, including the predicted characteristics for nominal tank pressures of 240 psia. The descent engine first burn start characteristics associated with fuel and oxidizer tank pressures of 132 and 126 psia, respectively, were within the 3-sigma band computed from pre-flight test data.

The LM-1 descent engine thrust monitor program utilized thrust buildup data based on nominal start characteristics for tank pressures of 240 psia instead of the actual fuel and oxidizer tank pressures of 132 and 126 respectively. The slower than normal thrust buildup resulted in failure of the engine to meet the thrust/time criteria programmed in the LGC.

2. All LGC logic and electrical circuits that could issue any engine cutoff or inhibit any engine start will be evaluated to determine which should be eliminated or altered and which should be retained within the software. The LGC shutdown capability is not incorporated in the computer logic on manned missions.

3. Software and hardware compatibility will continuously be reviewed for each LM flight to insure proper systems integration.

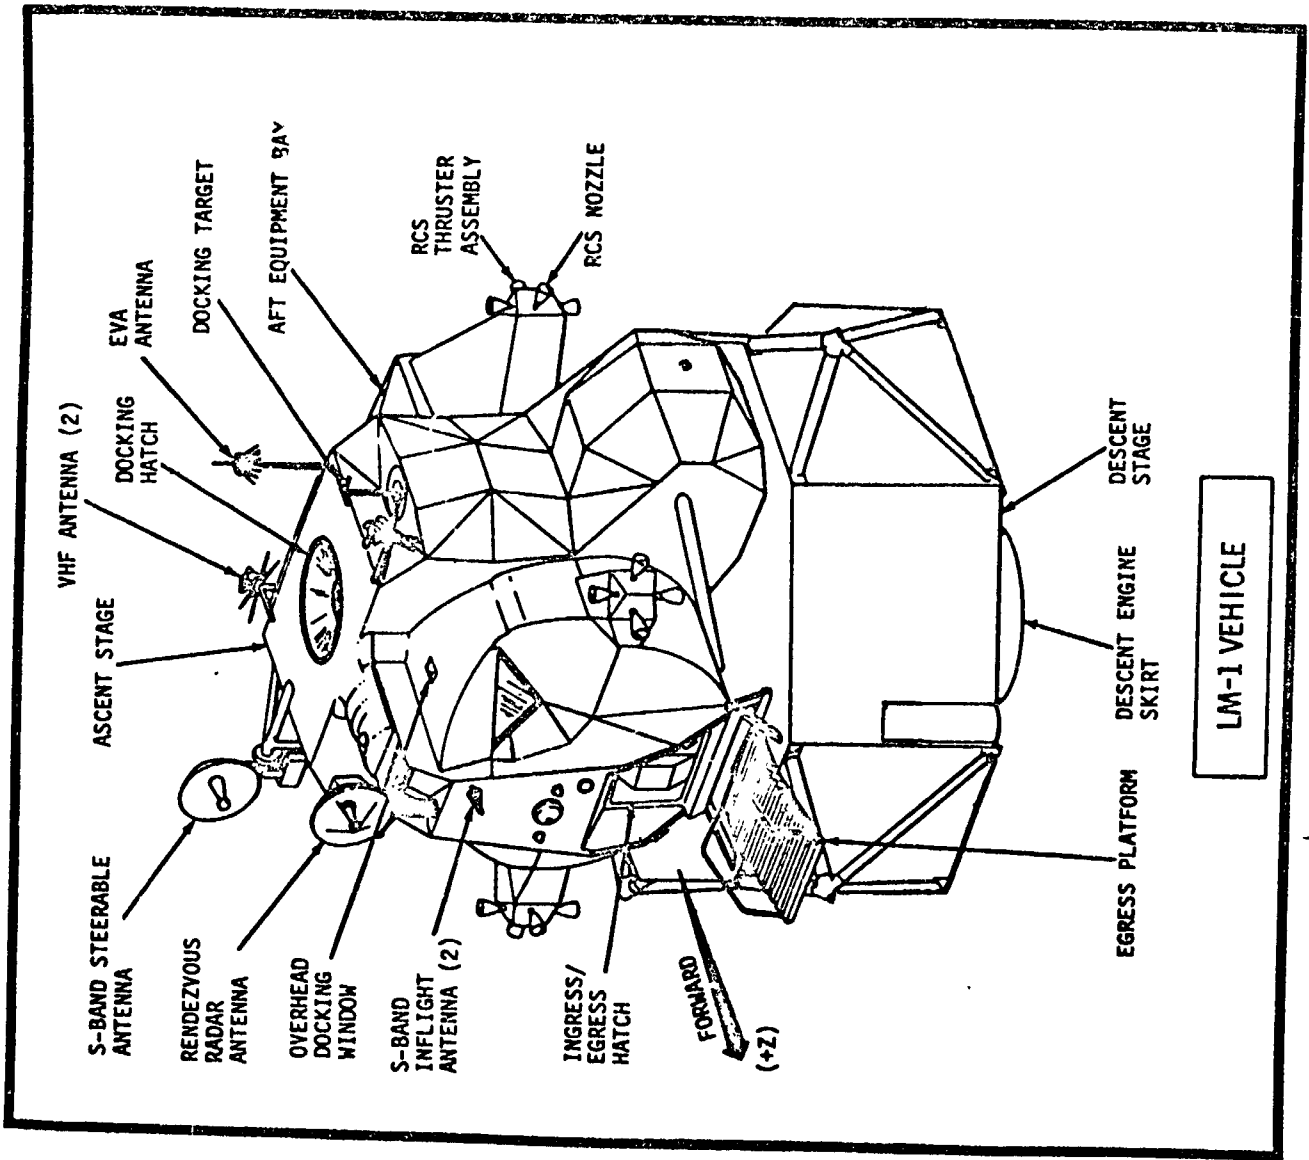
FIGURE 2.1-4

Because the vehicle mass in the DAP was configured for control of the unstaged LM (Fig.2.1-4), the RCS system was commanded to deliver propellant at a rate approximately 10,000 times greater than expected for control of the ascent stage (Fig.2.1-5). This caused the RCS to operate in severe off-limit conditions and resulted in failures in the system. Within 3.1 minutes, the A system propellant had been consumed to 27 percent and the system was isolated to conserve RCS propellant. The B system continued at a rapid duty cycle until propellant depletion 5 minutes later, at which time helium started leaking through the collapsed B system fuel bladder.

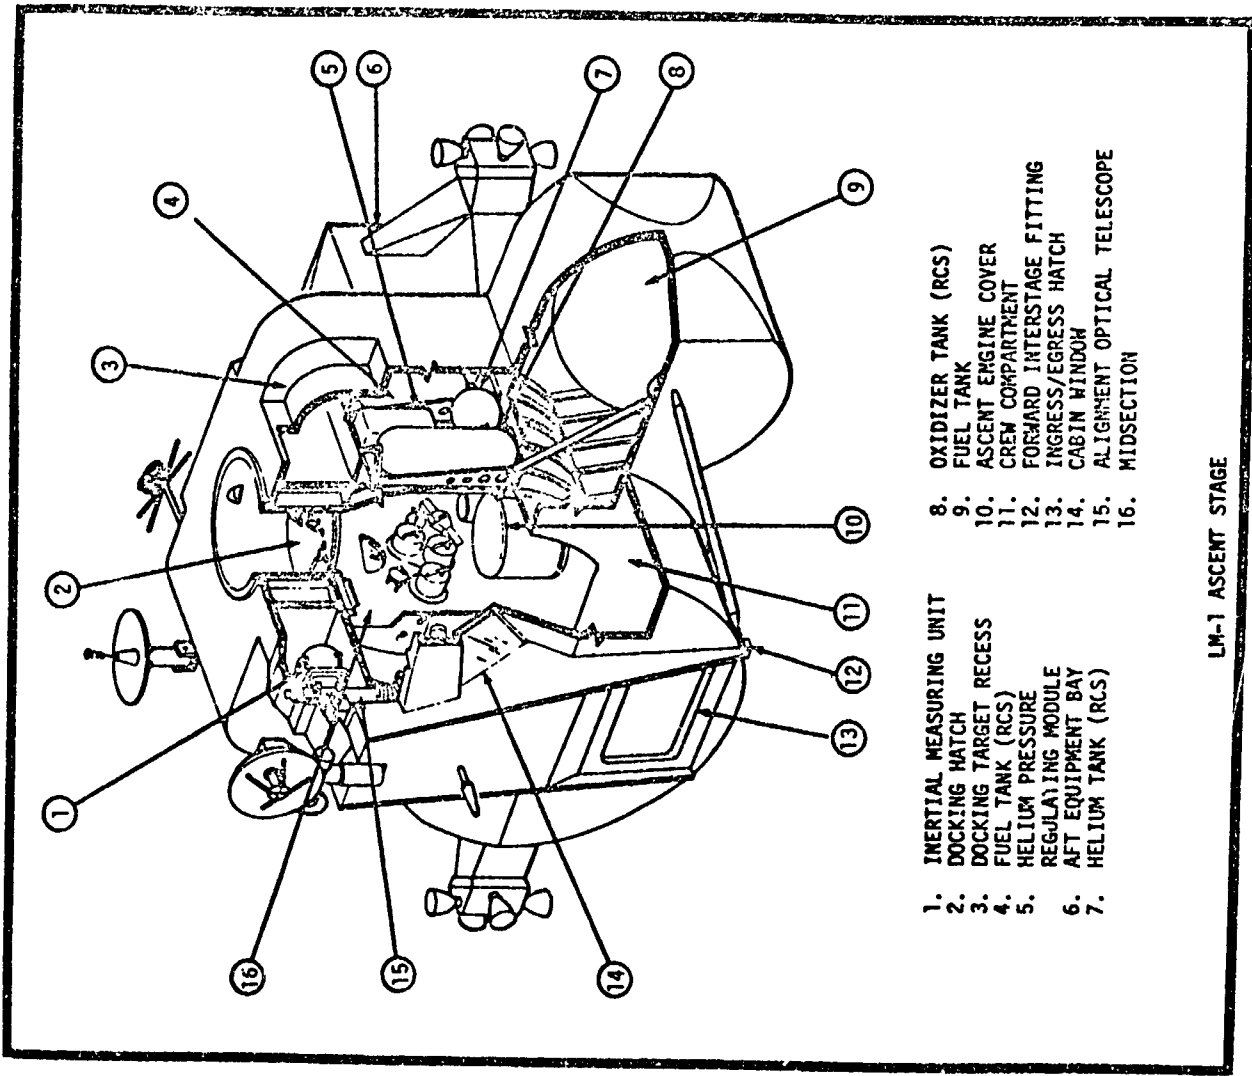
FIGURE 2.1-5

Satisfactory vehicle rates were restored due to the B system thrust reduction resulting from propellant depletion and by isolation of the A system propellant tanks, thereby compensating for the mass-constant error. While the B system was operating with two-phase oxidizer and helium-ingested fuel, engine 4-up failed (Anomaly 2.1.12). Just after the A system was reactivated, the main A oxidizer valve inadvertently closed because power had been applied to the valve's solenoid winding approximately 50 minutes versus an operational limit of 2 seconds maximum (Anomaly 2.1.11).

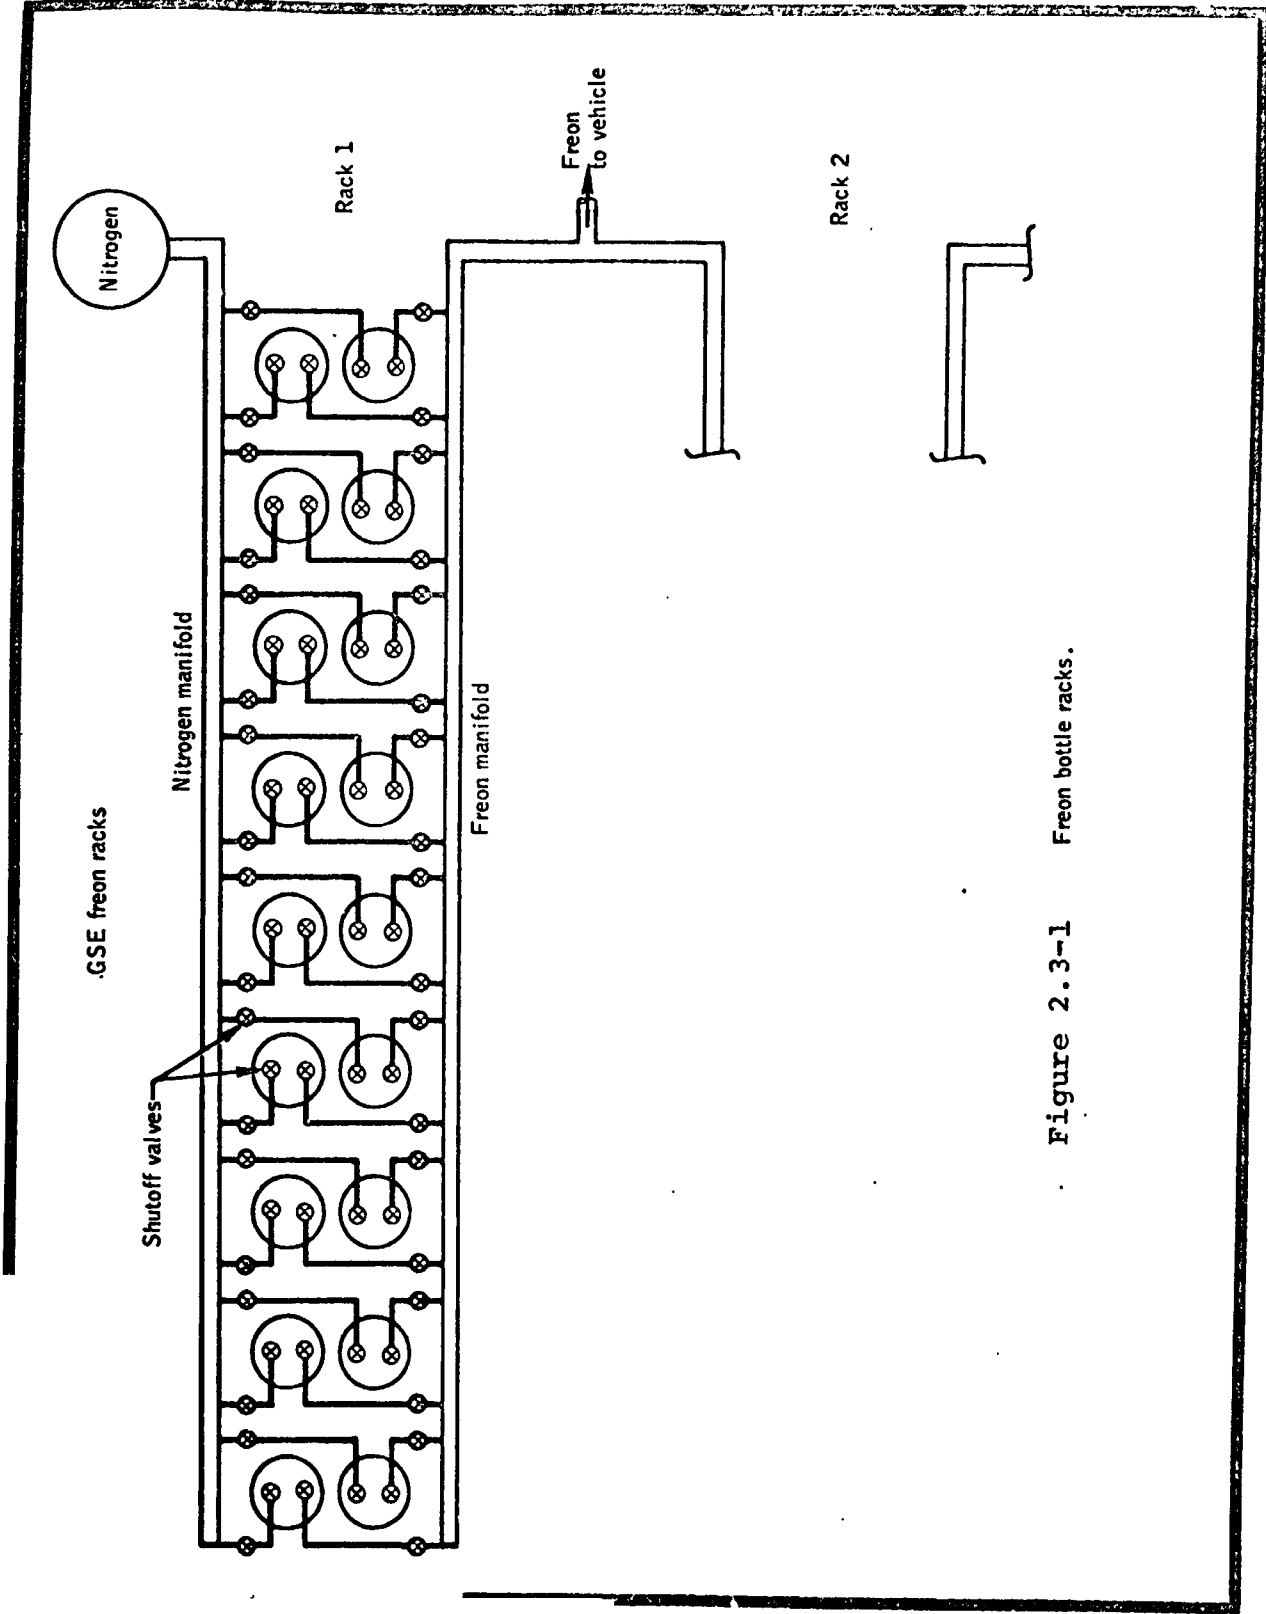
At T minus 3 hours freon delivery pressure to the LM dropped from 276 PSI to 146 PSI and the heat transport system coolant temperature began to increase from 50 to 64°, indicating loss of freon cooling. A hold was called at T minus 2.5 hours. The problem was isolated to rack 1 and rack 1 was shut off. The count has resumed using rack 2. At this time rack 1 was showing a weight loss of 60 LB/HR, which was half of the total freon flow, although the rack was turned off. No action was taken.

At approximately T minus 50 minutes with rack 1 showing a weight loss equivalent to two bottles, the problem recurred; flow rate increased, delivery pressure decreased and LM coolant temperature increased. By lowering freon flow rates to between 40 and 80 LB/HR, LM coolant temperatures were maintained at 50+ 5° F. This temperature was maintained within the prescribed limits until launch.

Figure 2.3-1 Freon bottle racks.

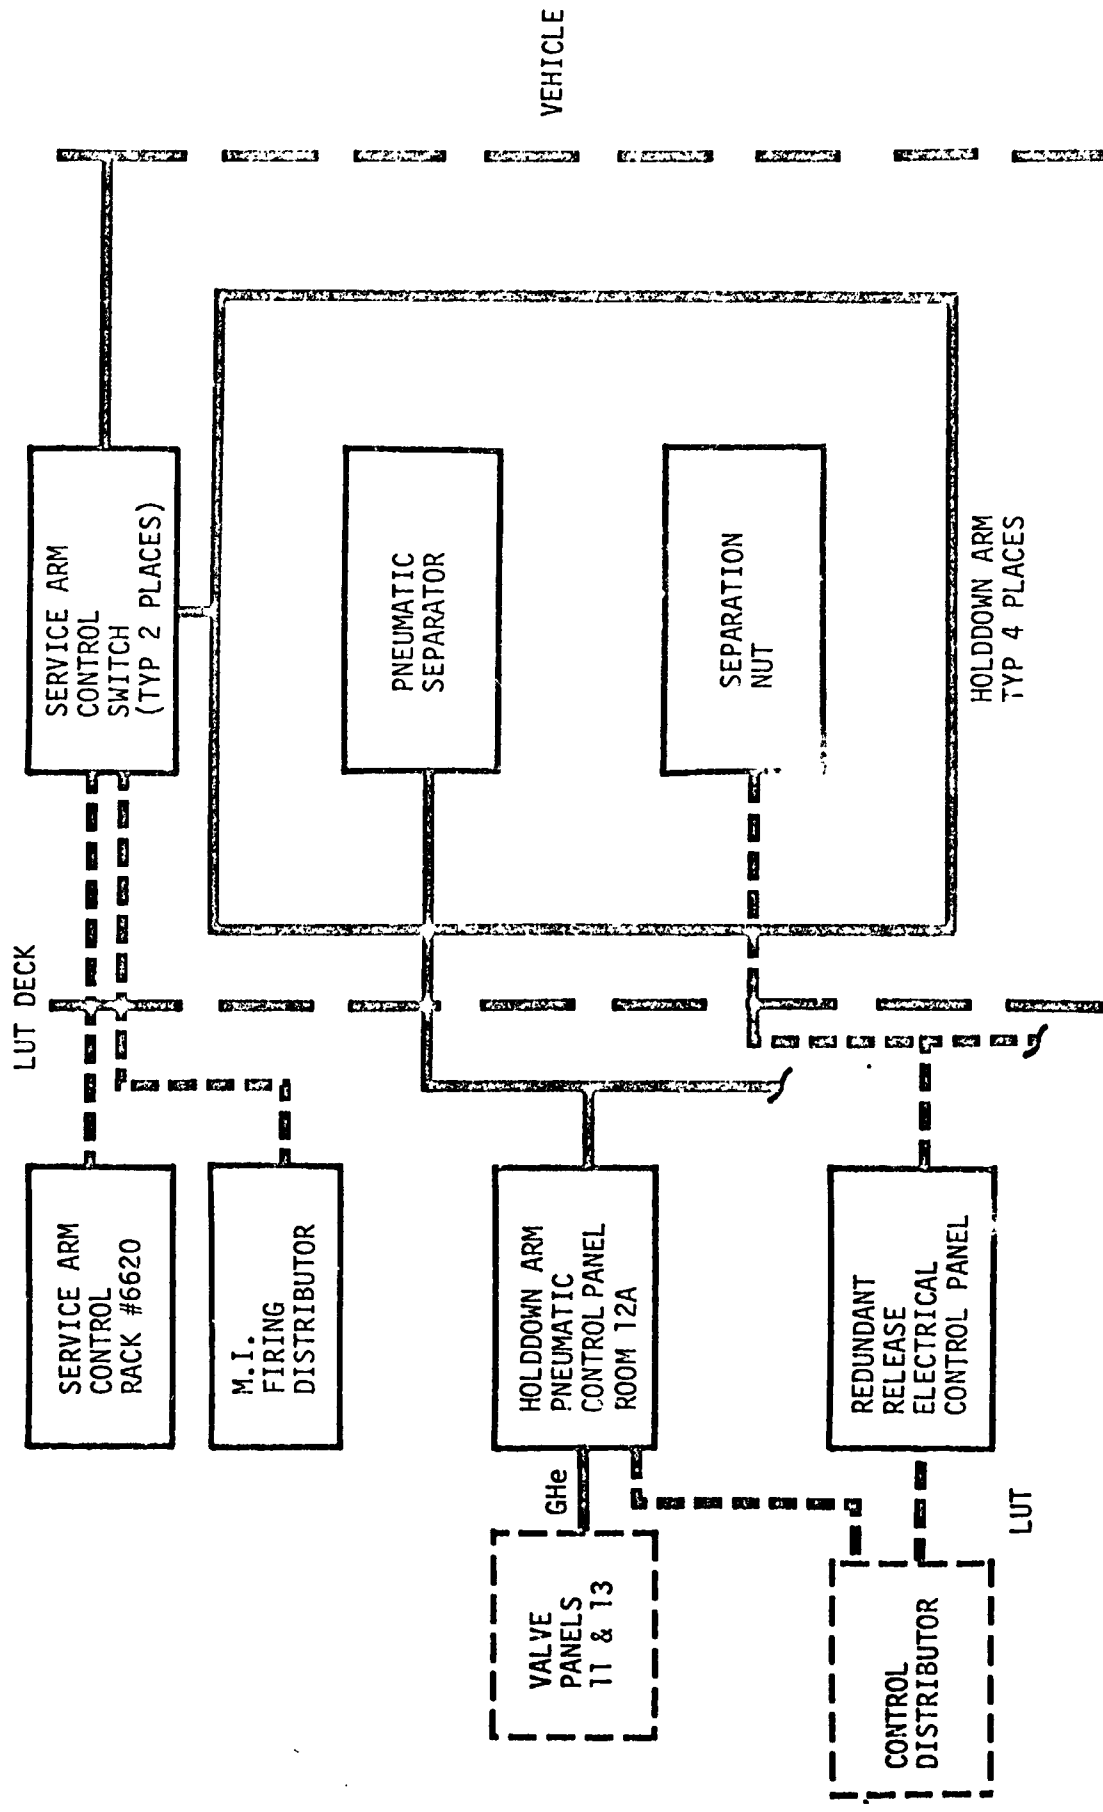
FIGURE 2.3-3 HOLDDOWN ARMS AND SERVICE ARMS CONTROL SYSTEM
FUNCTIONAL DIAGRAM

The holddown arms and service arms control system functional diagram is shown in Figure 2.3-3. A view of the arm links in vehicle restraining and release positions is shown in Figure 2.3-4.
