# APOLLO PROGRAM

## FINAL FLIGHT EVALUATION REPORT APOLLO 8 MISSION

FLIGHT EVALUATION REPORT - APOLLO 8 MISSION

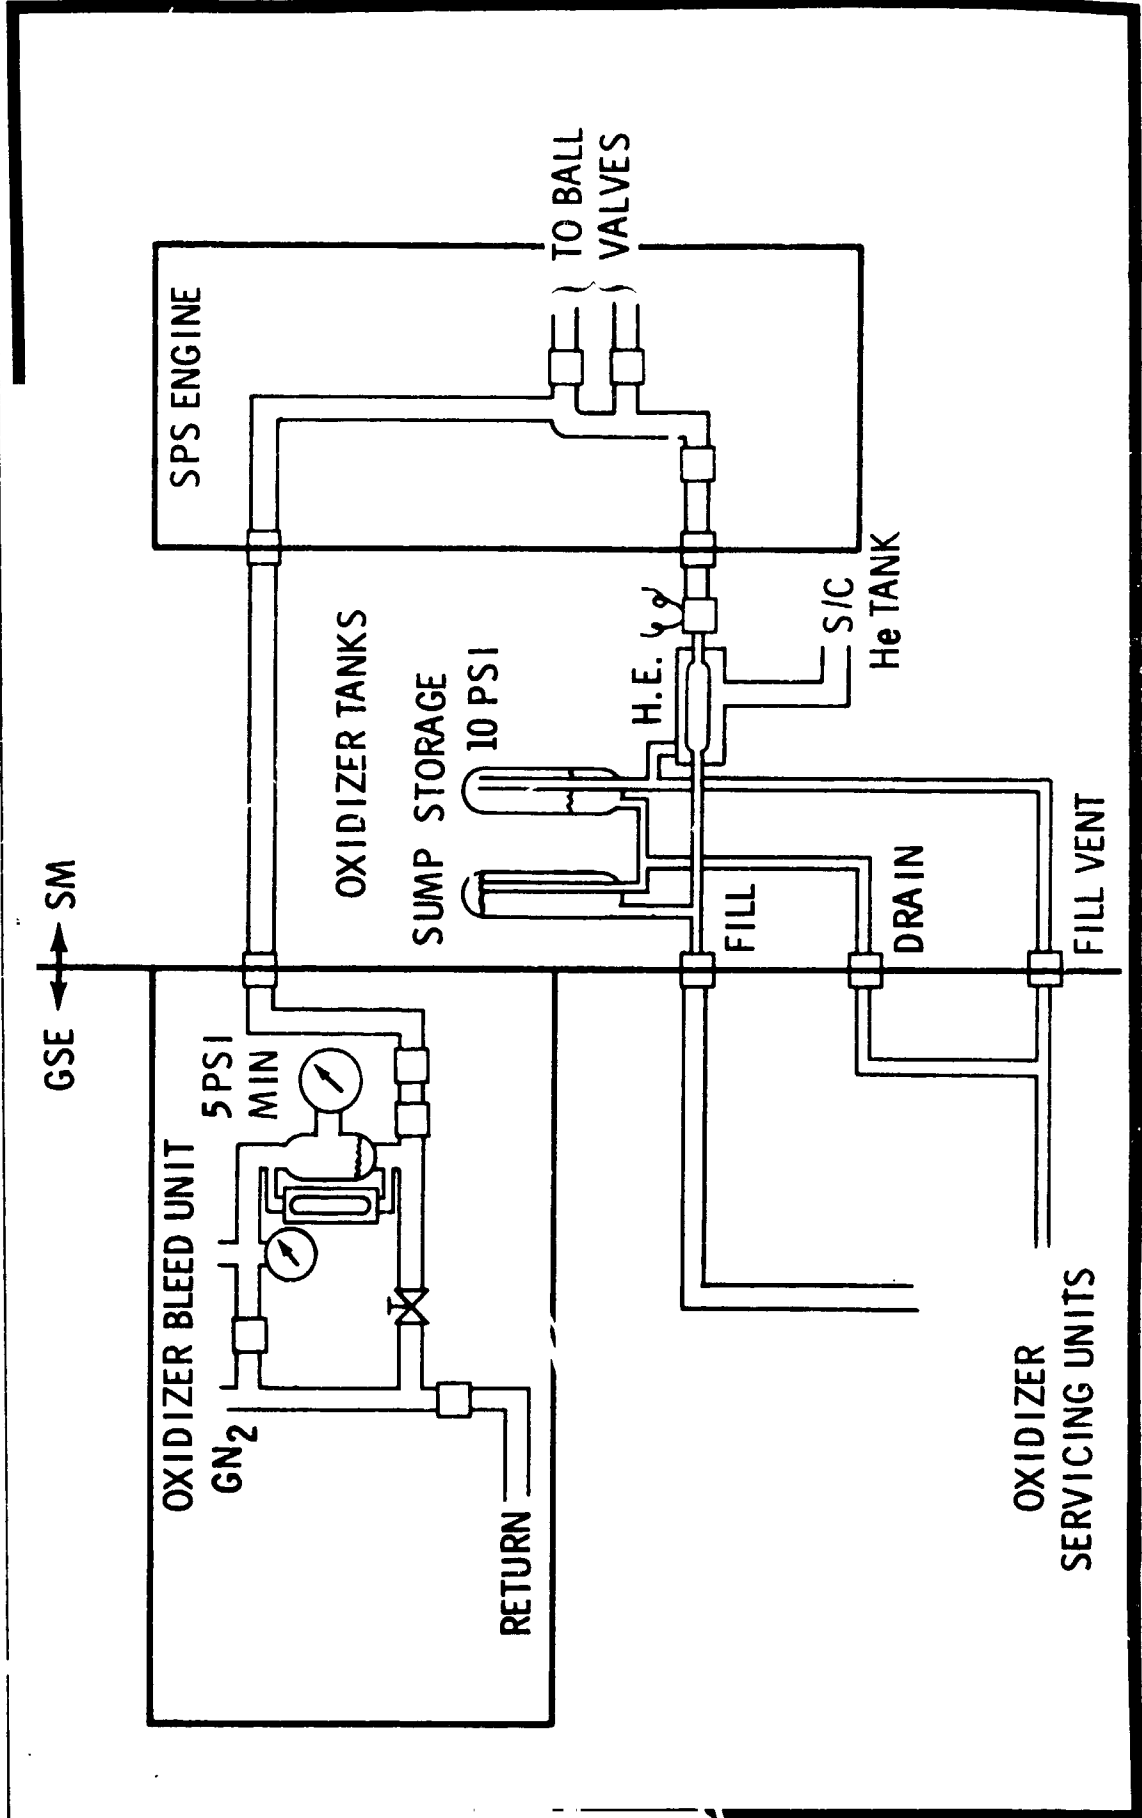
FIGURE 2.1.1-1 SPS OXIDIZER BLEED SCHEMATIC

NO. 2.1.1	TITLE: DROP IN CHAMBER PRESSURE DURING FIRST SPS BURN	MISSION: APOLLO 8
SYSTEM: SM		EVENT TIME: 10:59:58
SUBSYSTEM: SPS	<p><b>PROBLEM:</b> THE SPS ENGINE EXPERIENCED A MOMENTARY DROP IN CHAMBER PRESSURE FROM 94 PSI TO 50 PSI DURING THE SPS BURN FOR THE FIRST MIDCOURSE CORRECTION. THE DATA IS SIMILAR TO THAT EXPERIENCED DURING HELIUM INGESTION TESTS AT WSTF AND AEDC, AND IT HAS BEEN CONCLUDED THAT THE DROP IN CHAMBER PRESSURE WAS CAUSED BY A HELIUM BUBBLE IN THE OXIDIZER FEED LINE. THE CHAMBER PRESSURE WAS SATISFACTORY DURING THE REST OF THE BURN AND DURING THE THREE SUBSEQUENT SPS BURNS.</p>	
<b>ACTION:</b>	<p>THE CAUSE WAS INSUFFICIENT BLEED OF THE OXIDIZER SYSTEM BECAUSE OF A PROCEDURE WAIVER WHICH PERMITTED EQUAL PRESSURES BETWEEN THE SPACECRAFT TANK AND THE BLEED UNIT. CORRECT BLEED PROCEDURE WILL BE IMPLEMENTED FOR APOLLO 9 AND SUBSEQUENT FLIGHTS.</p>	
<b>ORGANIZATION:</b>	5-2490	DATE:

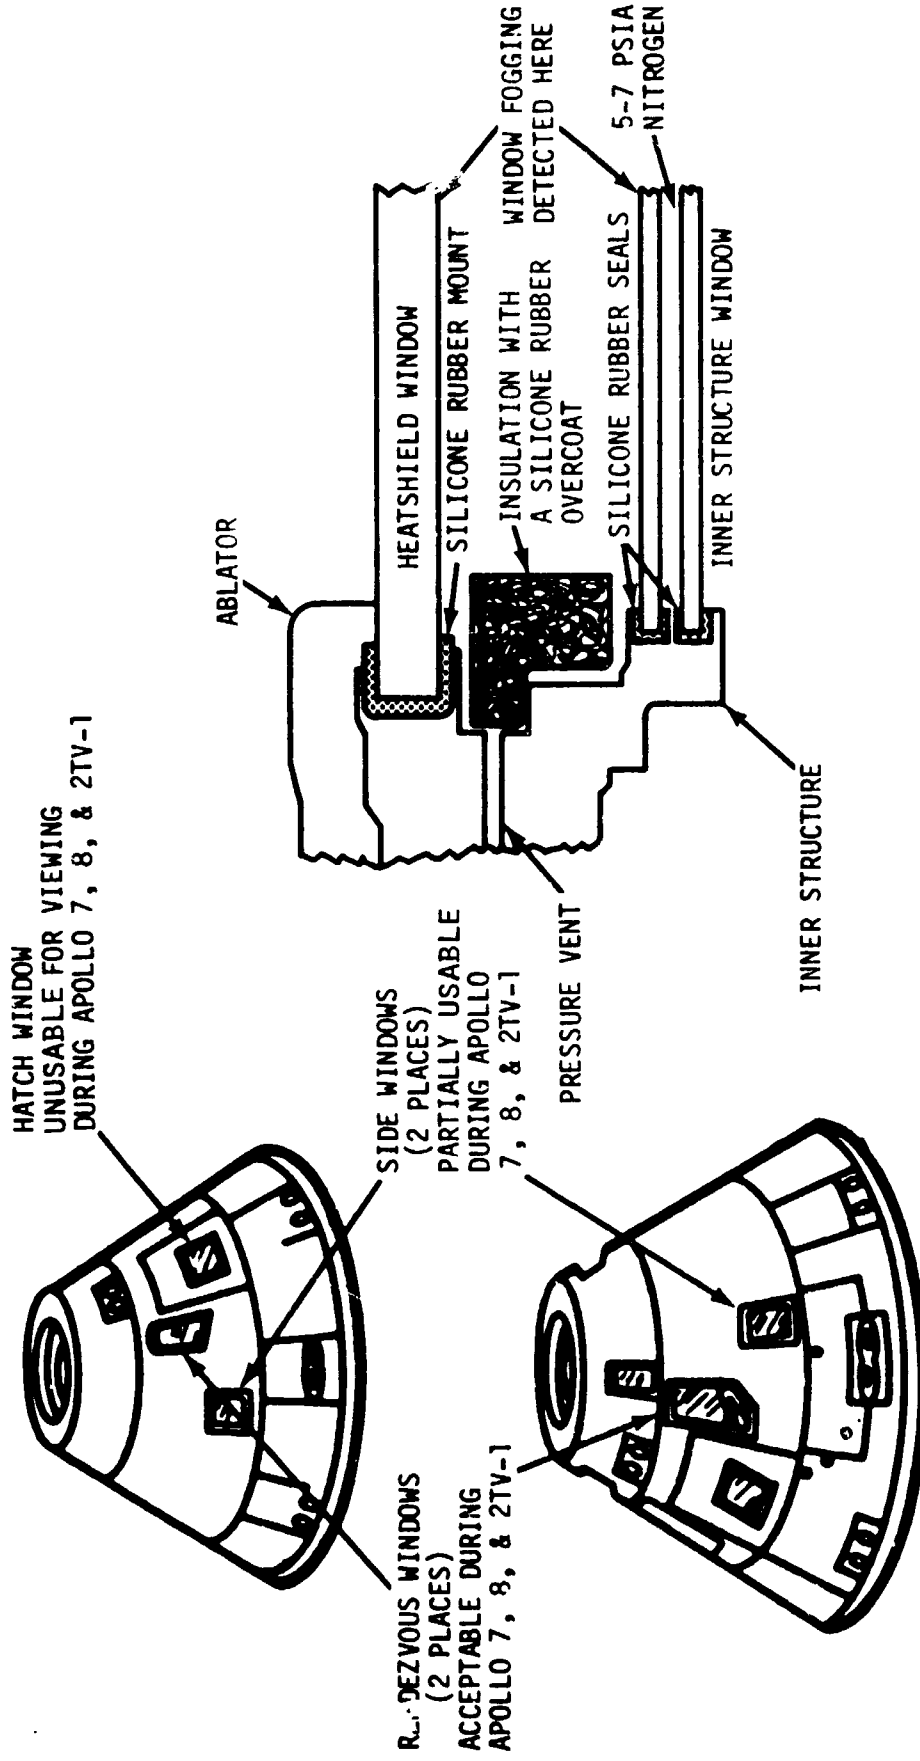
FIGURE 2.1.2-1 CM WINDOW DETAILS

NO. 2.1.1.2	TITLE: HATCH AND SIDE WINDOWS OBSCURED
SYSTEM: CM	MISSION: APOLLO 8
SUBSYSTEM: STRUCTURE	EVENT TIME: THROUGHOUT MISSION
PROBLEM:	THE HATCH WINDOW (WINDOW 3) BECAME OPAQUE BY APPROXIMATELY 6:00 HOURS GET. THE SIDE WINDOWS (WINDOWS 1 AND 5) WERE ALSO MODERATELY OBSCURED BY FOGGING. THEY WERE USABLE FOR VISUAL OBSERVATIONS BUT NOT FOR PHOTOGRAPHY. THE RENDEZVOUS WINDOWS (WINDOWS 2 AND 4) DID NOT BECOME FOGGED. THIS WINDOW FOGGING IS SIMILAR TO THE FOGGING EXPERIENCED ON APOLLO 7 AND 2TV-1. APOLLO 7 AND APOLLO 8 POSTFLIGHT ANALYSES SHOWED THE FILM TO BE A SILICONE COMPOUND RESULTING FROM THE OUTGASSING OF THE ROOM-TEMPERATURE-CURED ROOM TEMPERATURE VULCANIZING (RTV) COMPOUNDS USED IN THE WINDOW AREA ON THE EDGES OF THE INSULATION BETWEEN THE HEAT SHIELD AND THE PRESSURE VESSEL. (SEE FIGURE 2.1.2-1). THE OUTGASSING PRODUCT HAS BEEN DUPLICATED IN GROUND TESTS AT ALTITUDE AND ELEVATED TEMPERATURES. THE SAME TYPE OF SURFACE CONTAMINATION OCCURRED ON GEMINI FLIGHTS.

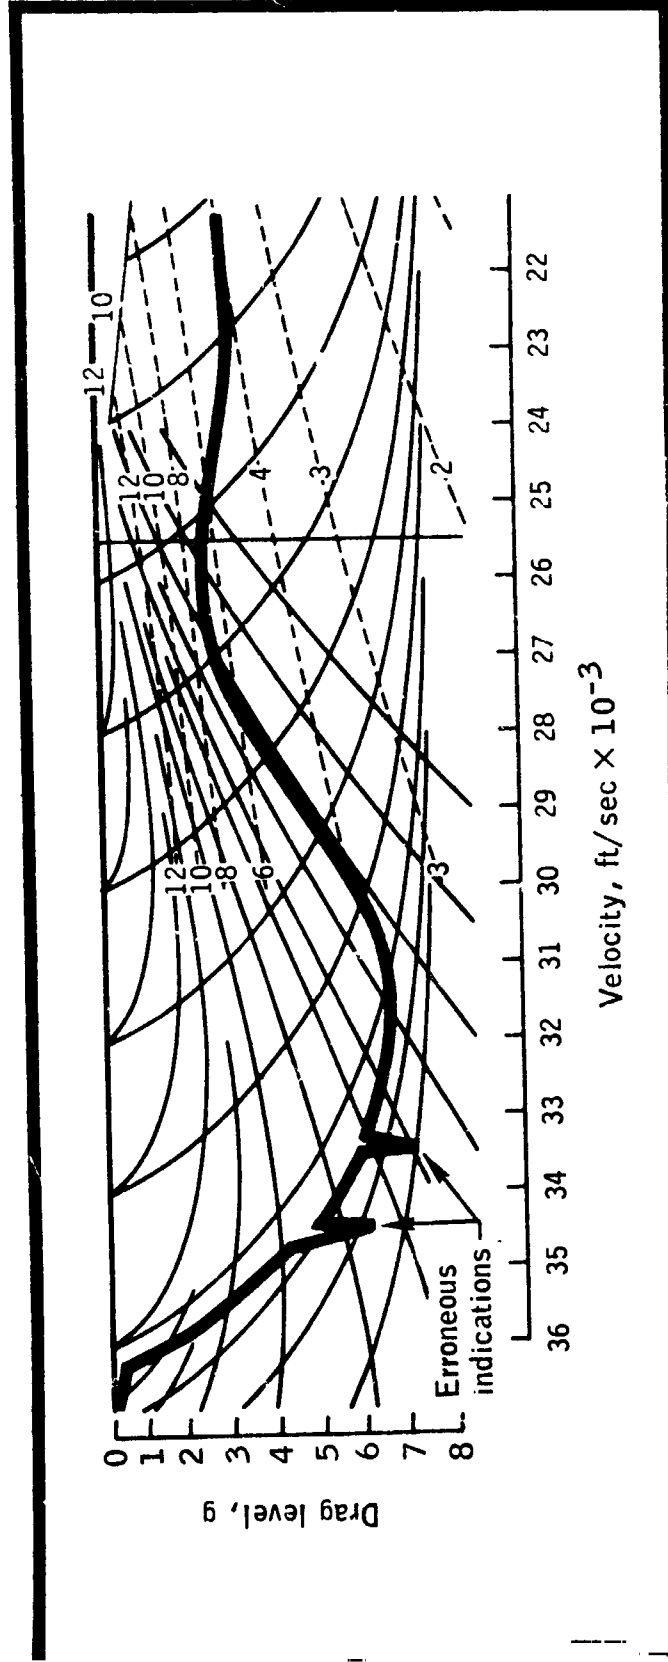
FIGURE 2.1.4-1 ENTRY MONITOR SYSTEM G/VELOCITY PLOT OF APOLLO 8 ENTRY

FOUR MALFUNCTIONS OF THE ENTRY MONITOR SYSTEM OCCURRED AT DIFFERENT TIMES DURING THE MISSION.

1. DURING THE SPACECRAFT/S-IVB SEPARATION SEQUENCE, THE  $\Delta V$  COUNTER JUMPED 100 FT/SEC. FOR THE THIRD MIDCOURSE CORRECTION, A  $\Delta V$  OF 5 FT/SEC WAS ENTERED INTO THE ENTRY MONITOR SYSTEM. THE SYSTEM COUNTED TO ZERO AT  $\Delta V$  CUTOFF; HOWEVER, IT CONTINUED TO COUNT AFTER THE MANEUVER UNTIL TURNED OFF BY THE CREW.
2. THE  $\Delta V$  COUNTER JUMPED 19 TO 20 FT/SEC AT TIMES WHEN THE MODE SWITCH WAS RAPIDLY SWITCHED FROM "STANDBY" TO "AUTOMATIC." THIS CONDITION IS CHARACTERISTIC OF THE DESIGN DURING RAPID MODE SWITCHING.
3. THE G/VELOCITY TRACE ON THE ENTRY SCROLL CONTAINED TWO SHORT, INCORRECT G-TRANSIENTS DURING THE INITIAL ENTRY PHASE (SEE FIGURE 2.1.4-1). OPERATION OF THE SCROLL ASSEMBLY WAS NORMAL IN ALL OTHER RESPECTS.

THE EMS HAS BEEN REMOVED AND TESTED. ABNORMAL X-AXIS ACCELEROMETER SIGNALS OCCURRED DURING THE TILT-TABLE TESTS; RANDOM 0.25G PULSES WERE PRODUCED AT APPROXIMATELY 0.8G. ANALYSIS BY THE VENDOR DETERMINED THAT A BUBBLE WAS PRESENT IN THE ACCELEROMETER DAMPING FLUID. THIS BUBBLE MAY BE ASSOCIATED WITH THE G-TRACE TRANSIENTS AND WITH THE FAILURE OF THE  $\Delta V$  COUNTER TO STOP AT ZERO. VELOCITY COUNTER JUMPS OF ABOUT 100 FT/SEC HAVE BEEN PRODUCED WHEN THE  $\Delta V$  COUNTER IS NEAR ZERO AND AN ORDERED SERIES OF POSITIVE AND NEGATIVE PULSES ENTER THE COUNTER LOGIC FROM THE ACCELEROMETER. CORRECTIVE ACTION THAT WILL BE TAKEN IS: (1) RUN ADDITIONAL ACCEPTANCE TESTS ON ACCELEROMETERS; (2) CHANGE THE ACCELEROMETER FLUID SEALING PORT DESIGN EFFECTIVE ON CM 106; (3) PREVENT  $\Delta V$  JUMPS BY BIASING THE  $\Delta V$  COUNTER OFF ZERO BY +100 FT/SEC FOR ALL  $\Delta V$  MONITORING EXCEPT FOR ENTRY. (4) ENTRY BANK ANGLES WILL BE FURNISHED TO THE CREW IF BOTH THE GUIDANCE AND NAVIGATION SYSTEM AND THE ENTRY MONITOR SYSTEM FAILS. MSC HAS DETERMINED THAT THIS PROBLEM DOES NOT CONSTRAIN APOLLO 9.

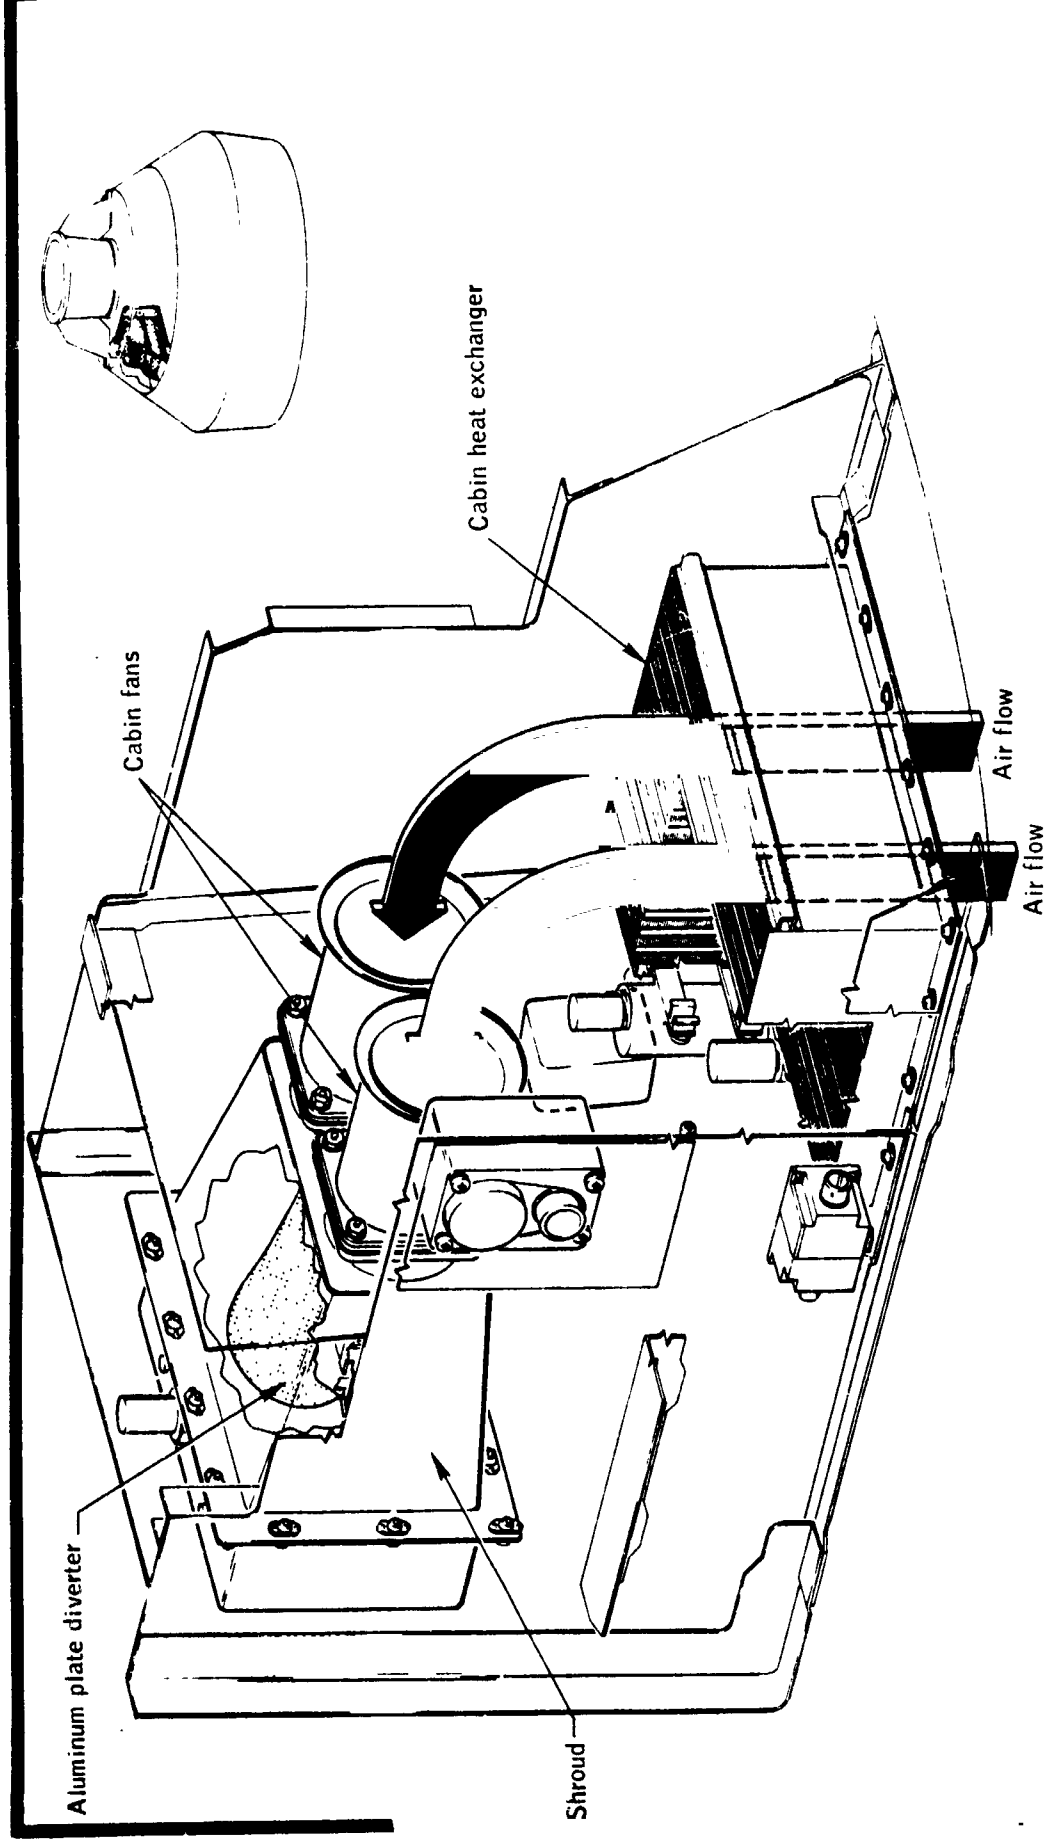
FIGURE 2.1.5-1  
CABIN FAN INSTALLATION

NO. 2.1.5	TITLE: NOISY CABIN FANS	MISSION: APOLLO 8
SYSTEM: CM		EVENT TIME: 126:52:00
SUBSYSTEM: ECS		
PROBLEM:	DURING THE SIXTH DAY OF THE MISSION, THE CABIN FANS (FIGURE 2.1.5-1) WERE MOMENTARILY TURNED ON, AND THE CREW REPORTED THAT BOTH FANS WERE NOISY. THE CREW DESCRIBED THE NOISE AS SOUNDING AS IF THE FANS HAD FAILED BEARINGS.	
ACTION:	THE ACOUSTIC LEVEL OF THE FANS, BOTH INDIVIDUALLY AND TOGETHER, WAS RECORDED WITH THE HATCHES CLOSED AT THE THREE HEAD POSITIONS ON THE COUCHES, AT THE WORK STATIONS, AND IN THE SLEEP POSITIONS. THE NOISE LEVEL IS CONSIDERED NORMAL COMPARED TO THE CABIN FAN NOISE PREVIOUSLY EXPERIENCED DURING CHECKOUT. THE BLADES MOVED SMOOTHLY AND STOPPED SLOWLY. THERE WAS NO EVIDENCE OF DAMAGED FAN BLADES OR OF LOOSE PARTS IN THE FAN ASSEMBLY AS OCCURED ON THE CM 101 FANS. THE NOISE LEVEL MAY HAVE BEEN CAUSED BY A RESONANT CONDITION WITHIN THE DUCT SYSTEM UNDER THE EXISTING ENVIRONMENT. HOWEVER, NO FURTHER INVESTIGATION IS NECESSARY; RESULTS OF APOLLO 7 AND 9 DEMONSTRATE THAT THE CABIN FANS ARE NOT REQUIRED FOR MAINTENANCE OF A COMFORTABLE ENVIRONMENT. THIS ANOMALY HAS BEEN CLOSED BY MSC.

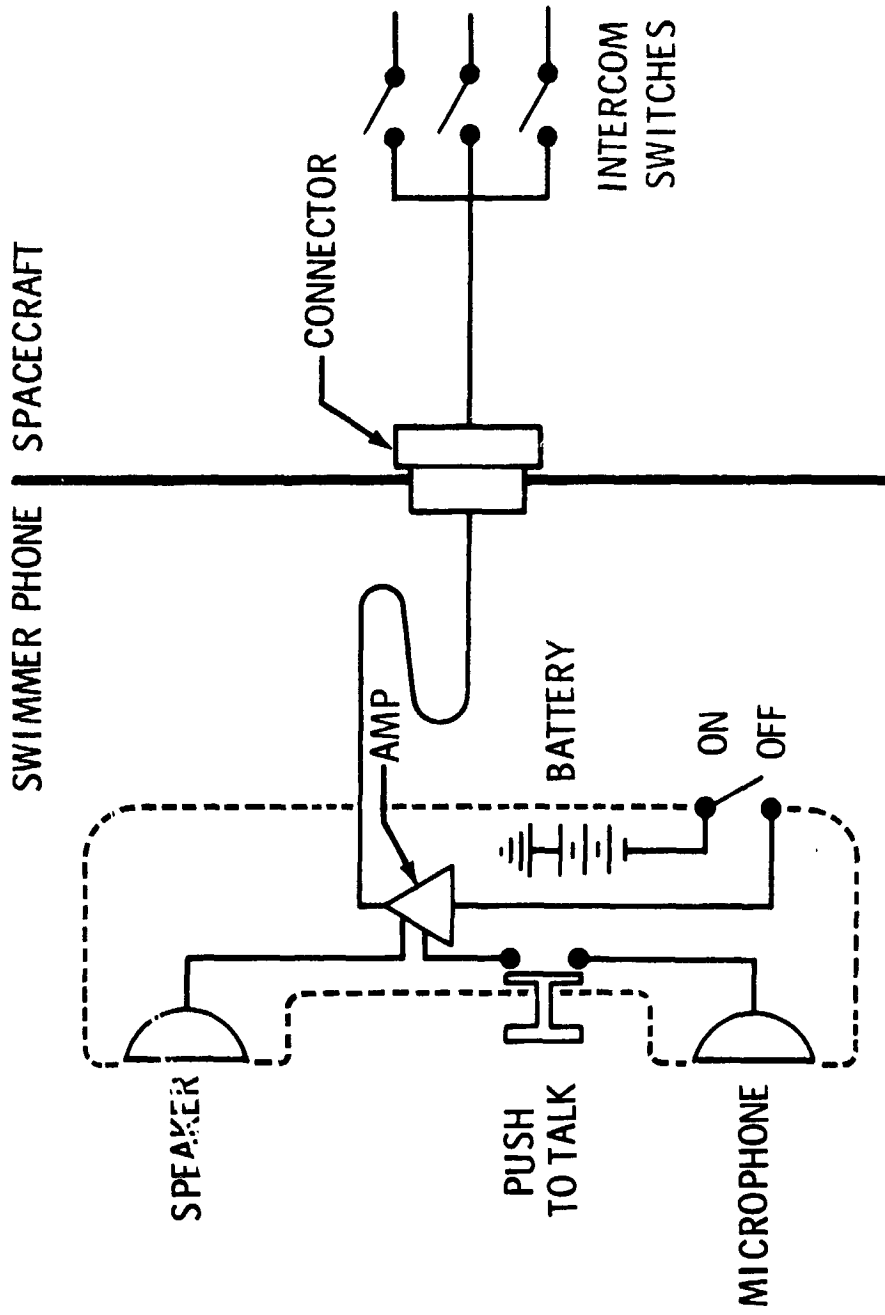
FIGURE 2.1.1.7-1

<b>NO.</b> 2.1.1.7	<b>TITLE:</b> INOPERATIVE SWIMMER'S INTERPHONE	<b>MISSION:</b> APOLLO 8
<b>SYSTEM:</b> CM		<b>EVENT TIME:</b> POST-LANDING
<b>SUBSYSTEM:</b> TELECOMMUNICATIONS	<b>PROBLEM:</b> THE RECOVERY TEAM WAS UNABLE TO COMMUNICATE WITH THE SPACECRAFT CREW OVER THE INTERPHONE USING THE SWIMMER'S UMBILICAL. THE RECOVERY TEAM ESTABLISHED COMMUNICATION BY USING SMALL PORTABLE RADIOS. THE CREW REPORTED THAT THE SPACECRAFT INTERCOM SWITCHES WERE IN THE PROPER POSITION. AS SHOWN IN FIGURE 2.1.1.7-1, THE SWIMMER'S PHONE, WHICH PLUGS INTO THE SPACECRAFT, HAS A PUSH-TO-TALK SWITCH AND AN ON-OFF SWITCH.	
<b>ACTION:</b>	THE INTERPHONE WAS TESTED TWICE, THE SECOND TIME WITH THE UMBILICAL CONNECTION SOAKED IN SALT WATER AND USING THE SWIMMER'S PHONE THAT WAS ACTUALLY USED DURING THE RECOVERY. THE INTERPHONE WORKED SATISFACTORILY DURING BOTH TESTS, WITH TWO-WAY COMMUNICATIONS ESTABLISHED TO ALL THREE CM CREW STATIONS. THE MOST PROBABLE CAUSE OF THE PROBLEM IS OUTSIDE THE SPACECRAFT AND ASSOCIATED WITH THE OPERATION OF THE SWIMMER'S PHONE. THE TRAINING PROCEDURES FOR OPERATION OF THE PHONE WILL BE EMPHASIZED. THIS ANOMALY HAS BEEN CLOSED BY MSC.

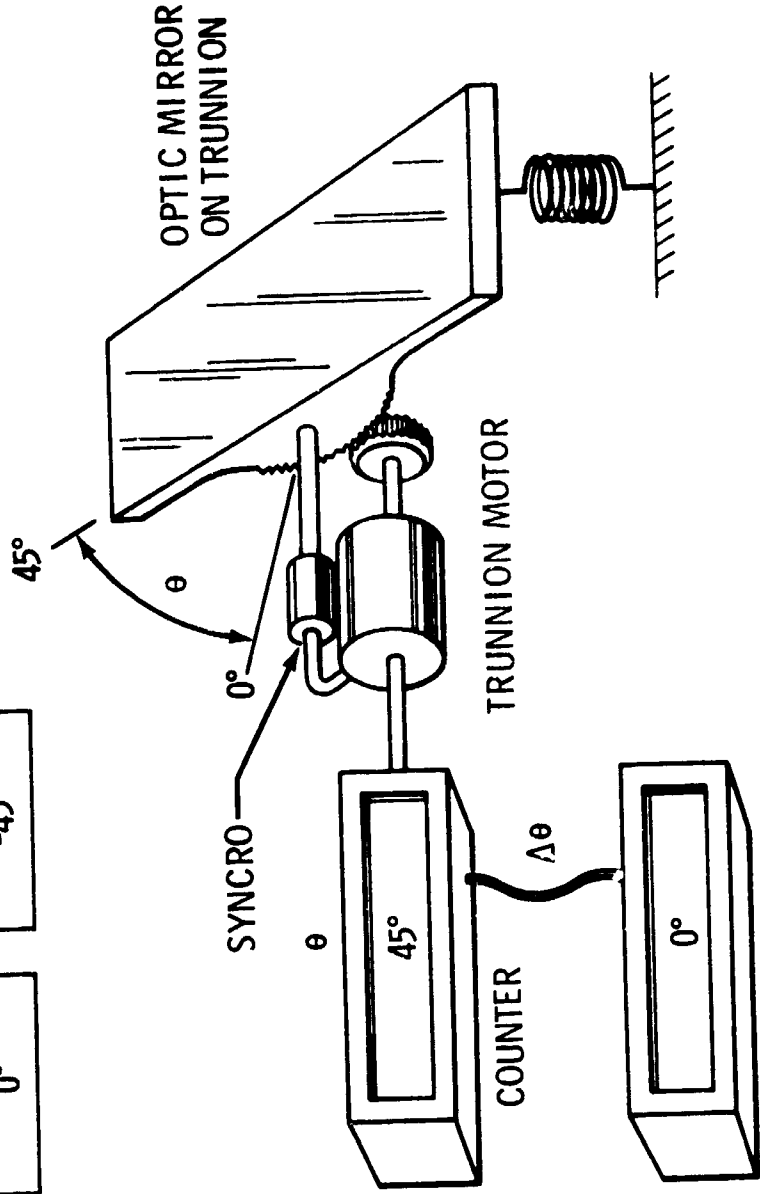
FIGURE 2.1.1.8-1 OPTICS DRIVE AND READOUT

<b>NO.</b> 2.1.1.8	<b>TITLE:</b> ABNORMAL SHIFTS IN COMPUTER READOUT OF OPTICS TRUNNION ANGLE	<b>MISSION:</b> APOLLO 8
<b>SYSTEM:</b> CM	<b>EVENT TIME:</b>	
<b>SUBSYSTEM:</b> PGNC	<b>PROBLEM:</b> SEVERAL TIMES DURING PERIODS OF NO OPTICS ACTIVITY, THE OPTICS TRUNNION ANGLE READ-OUT SHIFTED FROM 0 TO 45 DEGREES. IN EACH CASE, THE CORRECT READING WAS RESTORED WITH A NORMAL OPTICS ZEROING PROCEDURE, AND NO OPTICS UTILIZATION CAPABILITY WAS LOST.  <b>ACTION:</b> WHEN OPTICS POWER IS REMOVED FROM THE OPTICS, THE ANTI-BACKLASH SPRING WILL DRIVE THE SEXTANT TRUNNION AXIS TO A NEW POSITION (FIGURE 2.1.9-1). IF POWER IS RE-APPLIED WITHOUT ZEROING THE OPTICS COUPLING DATA UNIT (CDU), THE CDU COUNTER WILL TRACK THE ANGLE FROM THE NEW POSITION; THE COUNTER WILL CONTAIN AN ERROR WHICH IS THE DIFFERENCE BETWEEN THE NEW POSITION AND ZERO. THE CORRECTIVE ACTION CONSISTS OF: (1) ZEROING THE OPTICS CDU BEFORE USE; (2) INSERTING AN EXPLANATORY NOTE IN THE APOLLO OPERATIONS HANDBOOK. MSC DOES NOT CONSIDER THIS PROBLEM TO BE AN ANOMALY.

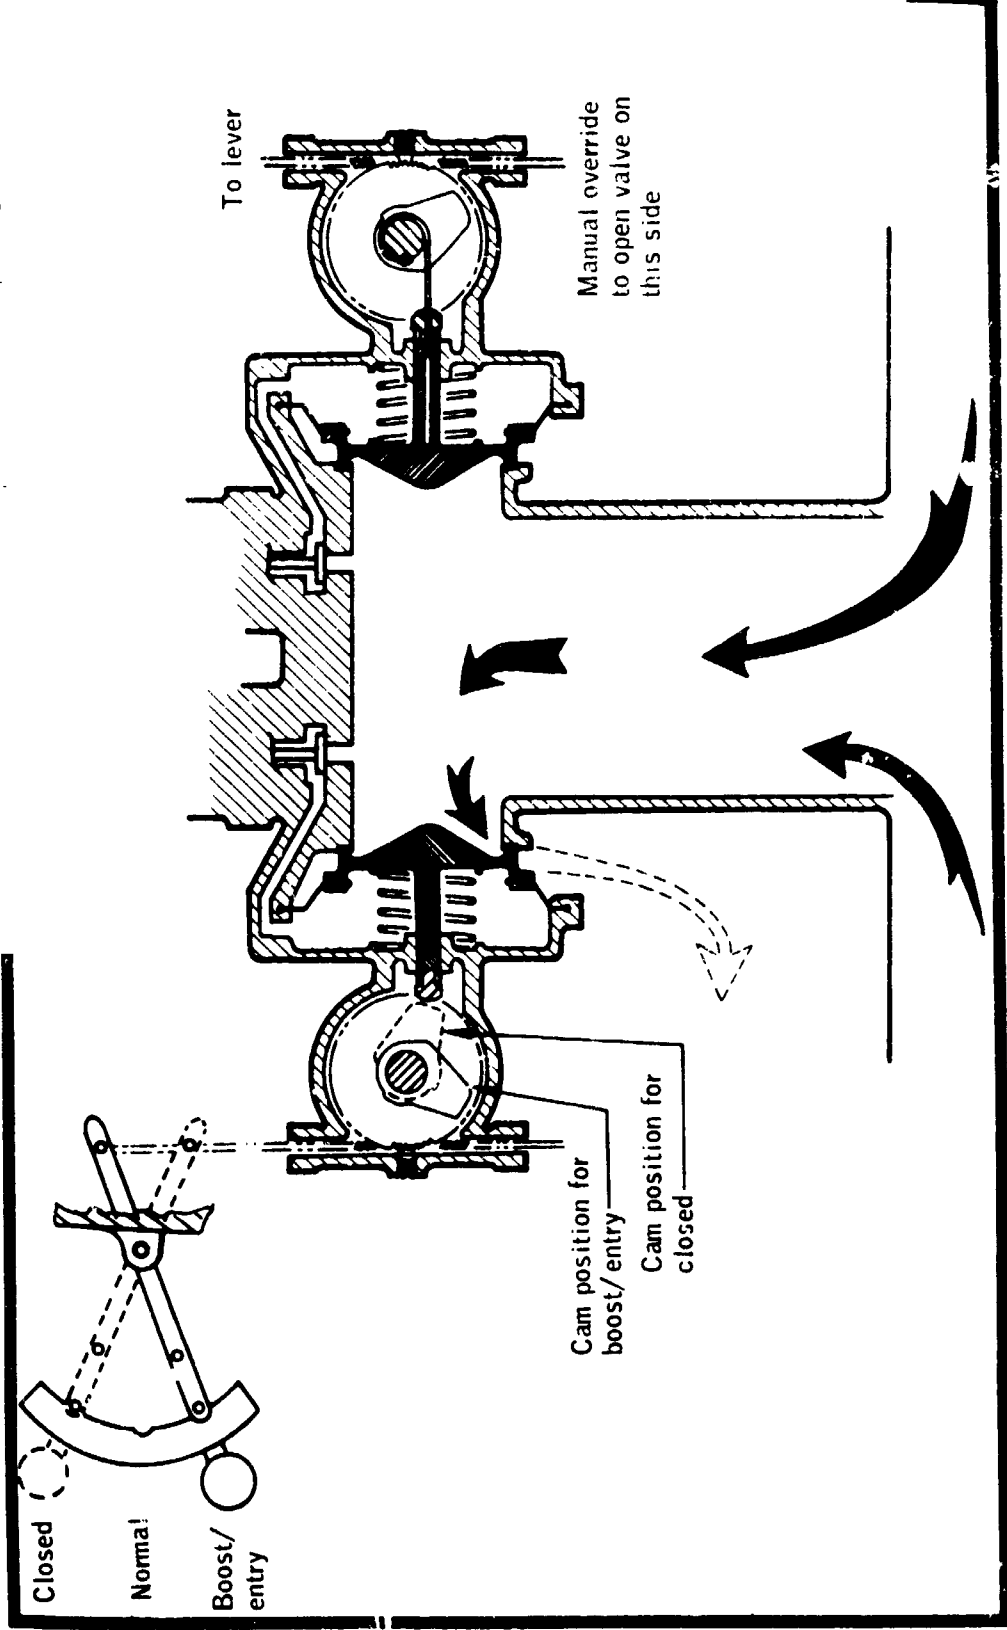
FIGURE 2.1.1.9-1

TITLE: SEA WATER INFLOW THROUGH CABIN PRESSURE RELIEF VALVE

ACTION: DURING POSTFLIGHT LEAKAGE TESTS AT A DIFFERENTIAL PRESSURE OF 13 PSI, THE RATE OF LEAKAGE MEASURED WAS WITHIN SPECIFICATION. INCREASING THE PRESSURE TO 25 PSIG CAUSED A FINE SPRAY AROUND THE VALVES. HOWEVER, THE VALVES DID NOT YIELD PERMANENTLY. ONLY A NEGLIGIBLE AMOUNT OF SEA WATER COULD ENTER BY RAM EFFECT AGAINST THE RELIEF VALVE. IN ADDITION, NO SALT DEPOSITS WERE EVIDENT IN EITHER VALVE (THE APOLLO 6 VALVE WAS FROZEN CLOSED BY SALT DEPOSITS). THE CAM AND LEVER RIGGING AND LEVER DETENT POSITIONS WERE VERIFIED, NO CORRECTIVE ACTION IS REQUIRED, SINCE THE PROCEDURES FOR CLOSING THE VALVES ARE INCLUDED IN THE CREW CHECKLIST, AND IF THE VALVES ARE NOT CLOSED AT LANDING, THE CREW WILL SEE THE WATER INFLOW AND TAKE APPROPRIATE ACTION. THIS ANOMALY HAS BEEN CLOSED BY MSC.

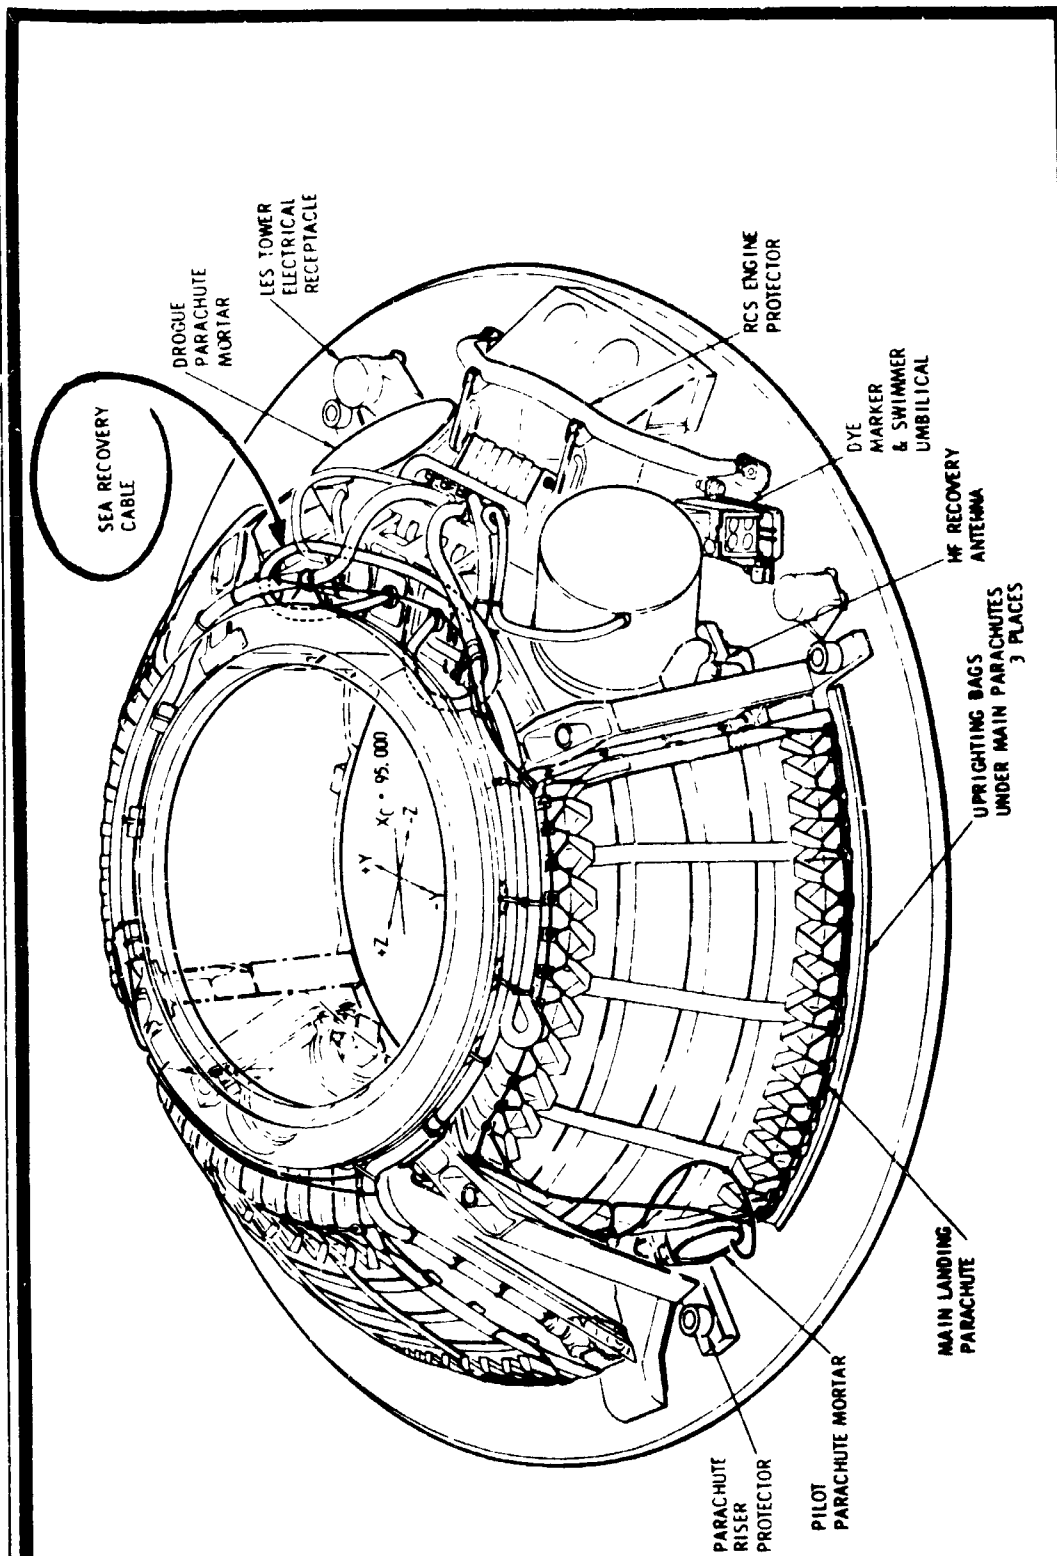
FIGURE 2.1.10-1 CM RECOVERY LOOP

<b>NO.</b> 2.1.10	<b>TITLE:</b> FAILURE OF CM RECOVERY LOOP	<b>MISSION:</b> APOLLO 8
<b>SYSTEM:</b> CM	<b>STRUCTURE</b>	<b>EVENT TIME:</b> RECOVERY
<b>PROBLEM:</b> TWO OF THE SIX STEEL CABLES IN THE COMMAND MODULE RECOVERY LOOP FAILED WHILE THE SPACECRAFT WAS BEING HOISTED FROM THE SEA. THE RECOVERY LOOP HAS EXPERIENCED NUMEROUS FAILURES DURING TESTS AT SNATCH LOADINGS EQUIVALENT TO A 32,000-POUND LOAD, AND AS A RESULT, AN AUXILIARY NYLON LOOP WAS PROVIDED FOR INSTALLATION BY THE SWIMMERS. THE NYLON LOOP ALONE HAS SUFFICIENT SAFETY MARGIN TO TAKE THE SNATCH LOADINGS EXPECTED.		
<b>ACTION:</b> FOR CM 108 AND SUBSEQUENT, THE STEEL CABLE WILL BE REPLACED WITH A NYLON RECOVERY LOOP SIMILAR TO THE NYLON AUXILIARY LOOP. UNTIL THEN, THE AUXILIARY NYLON LOOP, INSTALLED BY THE SWIMMERS, WILL BE USED. THIS ANOMALY HAS BEEN CLOSED BY MSC.		
<b>ORGANIZATION:</b> 5-2490	<b>RESOLUTION:</b> CLOSED	<b>DATE:</b>

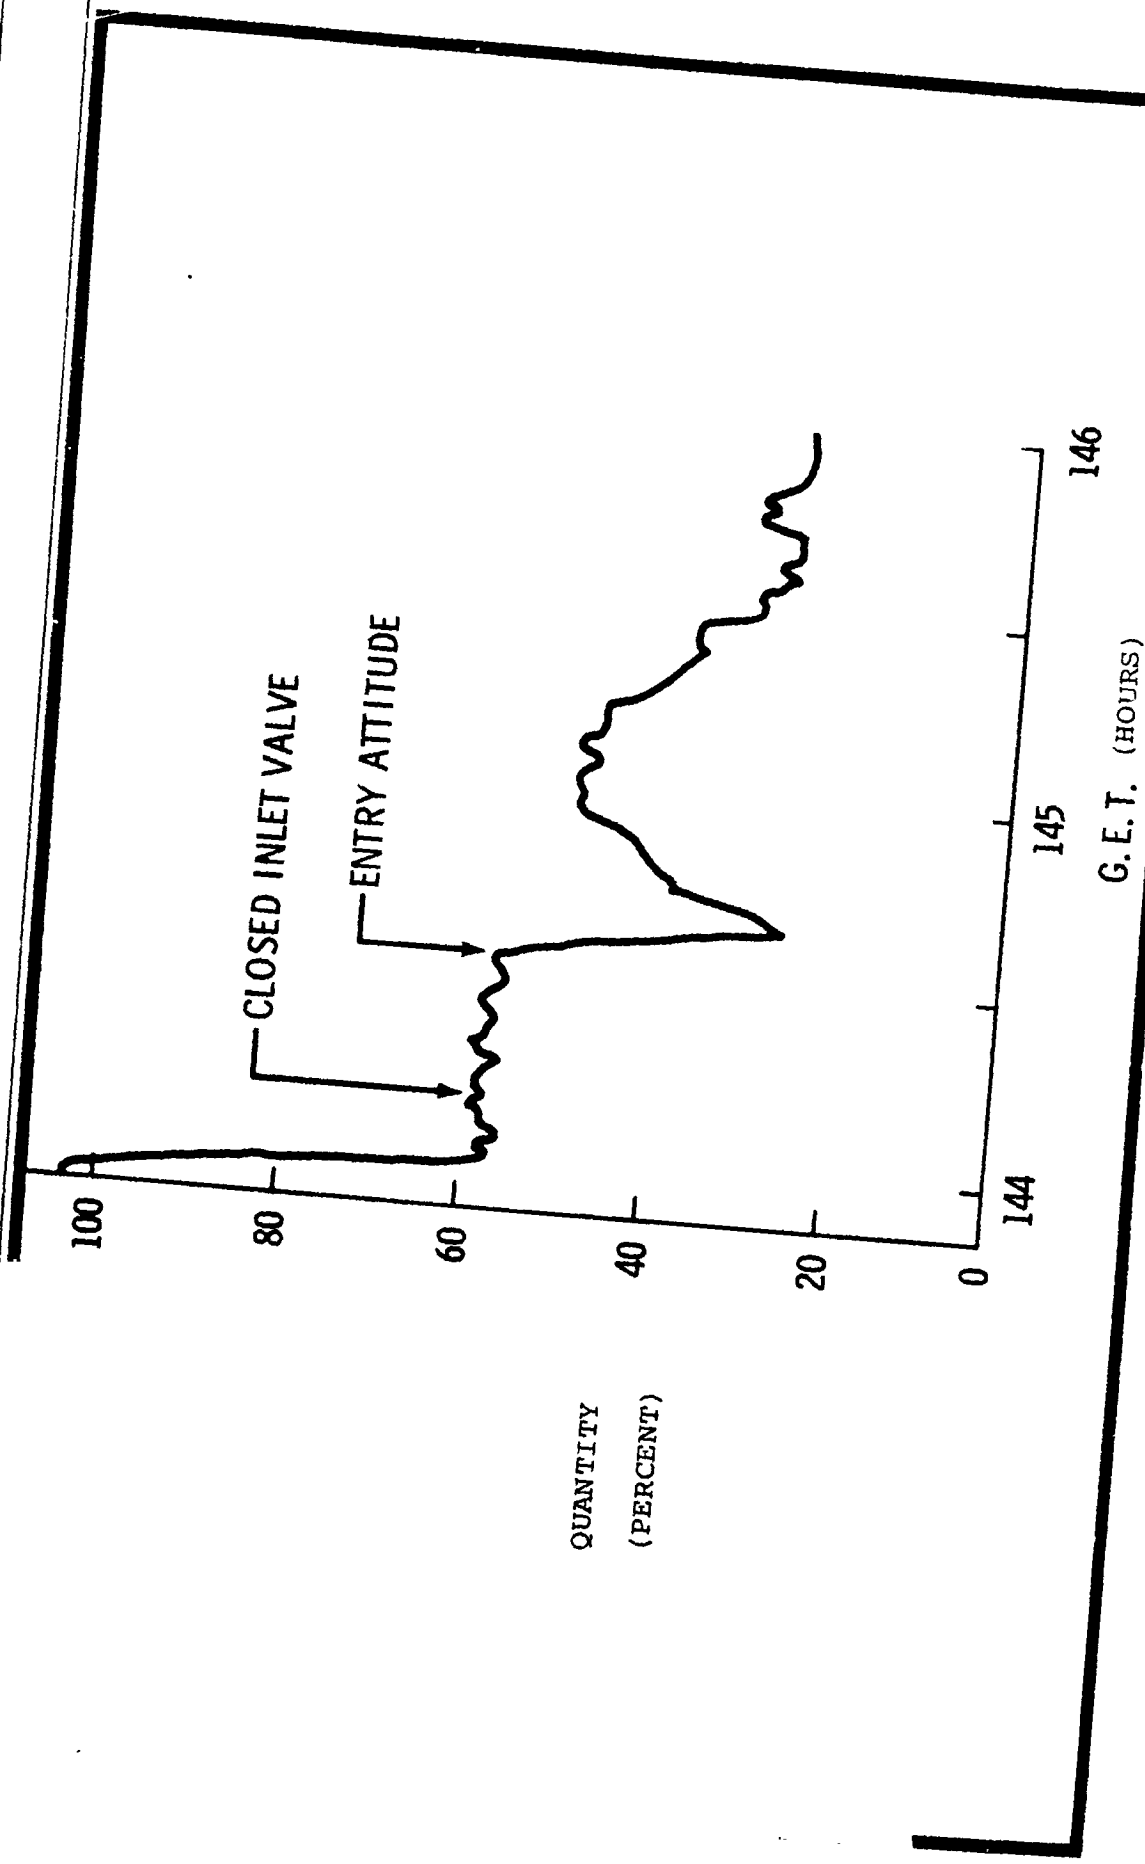
FIGURE 2.1.11-1 POTABLE WATER QUANTITY HISTORY

NO. 2.1.11	TITLE: ERRATIC POTABLE WATER QUANTITY MEASUREMENT	MISSION: APOLLO 8
SYSTEM: CM		EVENT TIME: 144:53:00
SUBSYSTEM: ECS		
PROBLEM:	THE POTABLE WATER TANK QUANTITY MEASUREMENT BECAME ERRATIC APPROXIMATELY TWO HOURS BEFORE LANDING. THE QUANTITY INDICATION DROPPED FROM 104% TO 58%, THEN TO 21%, RETURNED TO 50%, AND LATER DROPPED TO 25% (SEE FIGURE 2.1.11-1).	
ACTION:	THE POTABLE WATER SYSTEM DID NOT LEAK IN FLIGHT, AS CONFIRMED BY THE FACT THAT THE CORRECT AMOUNT OF WATER WAS DRAINED FROM THE POTABLE WATER TANK AFTER THE FLIGHT. THE SYSTEM WAS LEAK CHECKED AFTER FLIGHT AND FOUND TO BE WITHIN SPECIFICATION. THE MEASUREMENT INDICATES 50 PERCENT REGARDLESS OF ACTUAL QUANTITY. THE PROBLEM HAS BEEN ISOLATED TO THE SENSOR (FIGURE 2.1.11-2). EXAMINATION OF THE DISASSEMBLED UNIT REVEALED SALT DEPOSITS INSIDE THE BLADDER (DRY OXYGEN SIDE) AND INSIDE THE INDICATOR HOUSING. THE VARIABLE POTENTIOMETER AND PULLEY WERE CORRODED. THE ACTUATOR LINE WAS BROKEN, PROBABLY AS A RESULT OF POSTFLIGHT CALIBRATION WITH THE PULLEY AND POTENTIOMETER FROZEN. FREEZING OF THESE PARTS IS BELIEVED TO BE ASSOCIATED WITH SALT WATER WHICH ENTERED AT LANDING. FRESH WATER WAS FOUND ON THE POTENTIOMETER, AND THIS WAS SHOWN TO CAUSE ERRATIC READINGS. THE SOURCE OF THIS FRESH WATER HAS NOT BEEN DETERMINED. THE QUANTITY MEASURING SYSTEM IN THE WASTE WATER TANK (SAME TYPE AS IN POTABLE TANK) WAS ALSO DISASSEMBLED, BUT NO CORROSION WAS FOUND. A PROCEDURAL CHANGE HAS BEEN MADE TO AVOID FILLING THE TANK TO THE 100% LEVEL. THIS ANOMALY HAS BEEN CLOSED BY MSC.

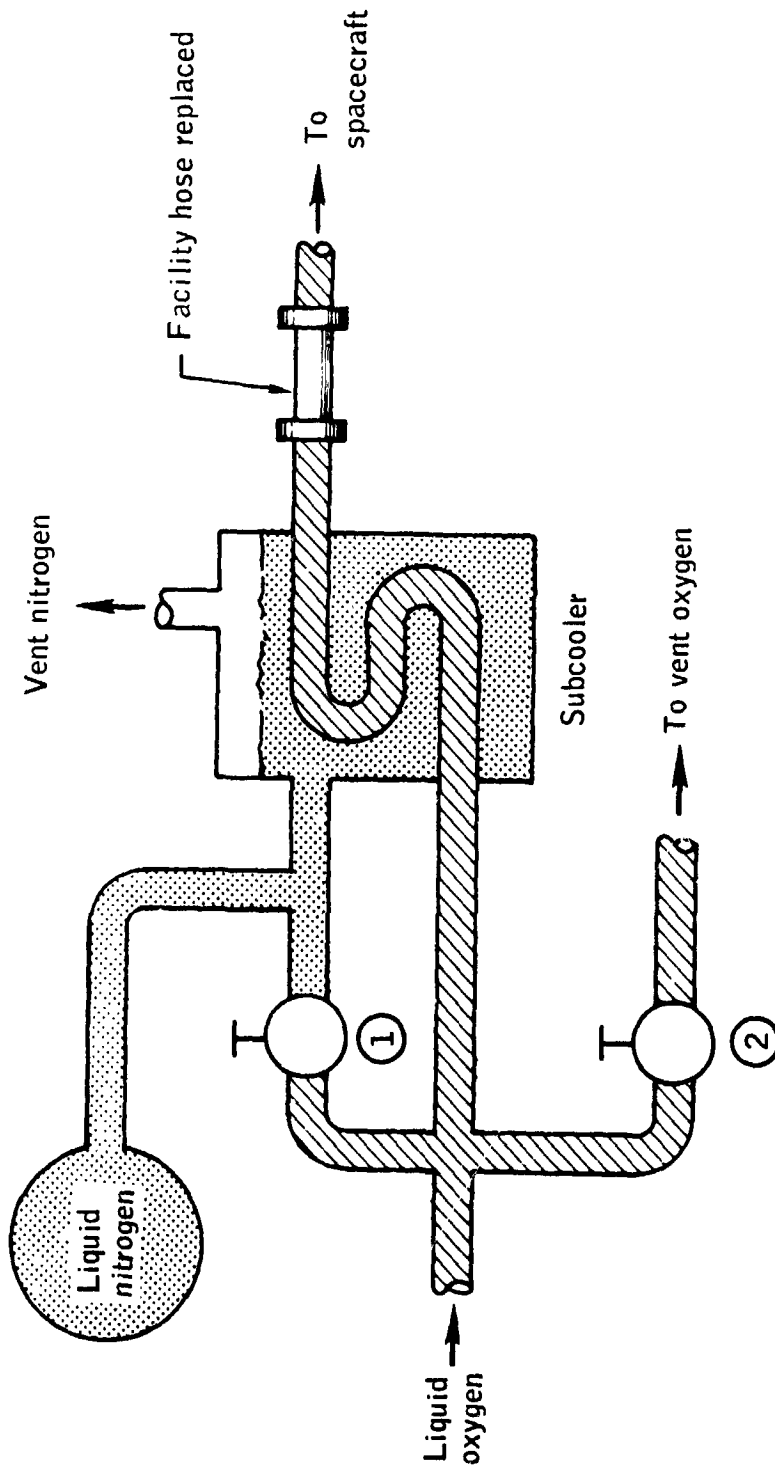
FIGURE 2.1.12-1 SIMPLIFIED SCHEMATIC OF GSE LOX SERVICING UNIT

NO. 2.1.12	TITLE: CONTAMINATION OF SPACECRAFT LOX	SYSTEM: GSE	MISSION: APOLLO 8
SUBSYSTEM: LOX SUPPLY	EVENT TIME: PRELAUNCH		
PROBLEM:	<p>WHILE SERVICING LIQUID OXYGEN, A LEAK DEVELOPED IN A FACILITY LIQUID OXYGEN LINE CAUSING A SAFETY SHUTDOWN. TO PRECLUDE OVERPRESSURIZATION DUE TO STAGNANT LIQUID OXYGEN, THE SYSTEM WAS VENTED USING THE NORMAL SHUTDOWN PROCEDURE. THIS PROCEDURE CONTAINED AN ERROR WHICH CALLED FOR OPENING VALVE 1 INSTEAD OF VALVE 2 (SEE FIGURE 2.1.12-1). THIS ALLOWED LIQUID NITROGEN TO FLOW THROUGH VALVE 1 INTO THE LIQUID OXYGEN SUPPLY LINE. A GASEOUS OXYGEN PURGE OF THE LINES WAS MADE PRIOR TO LOADING THE SPACECRAFT. LATER DURING THE COUNTDOWN, FUEL CELL #3 OUTPUT CURRENT DROPPED. THE TROUBLE WAS ISOLATED TO NITROGEN CONTAMINATION OF ABOUT 8000 PPM OF THE SPACECRAFT LOX (30 PPM IS ALLOWABLE). THE LN<sub>2</sub> IN THE GROUND SUBCOOLER WAS REPLACED WITH LOX, AND THE SPACECRAFT LOX WAS DRAINED AND RELOADED. AT T-10 HOURS, THE RELOADING HAD RESOLVED THE PROBLEM, WITH THE NITROGEN LEVEL AT 12 PPM.</p>

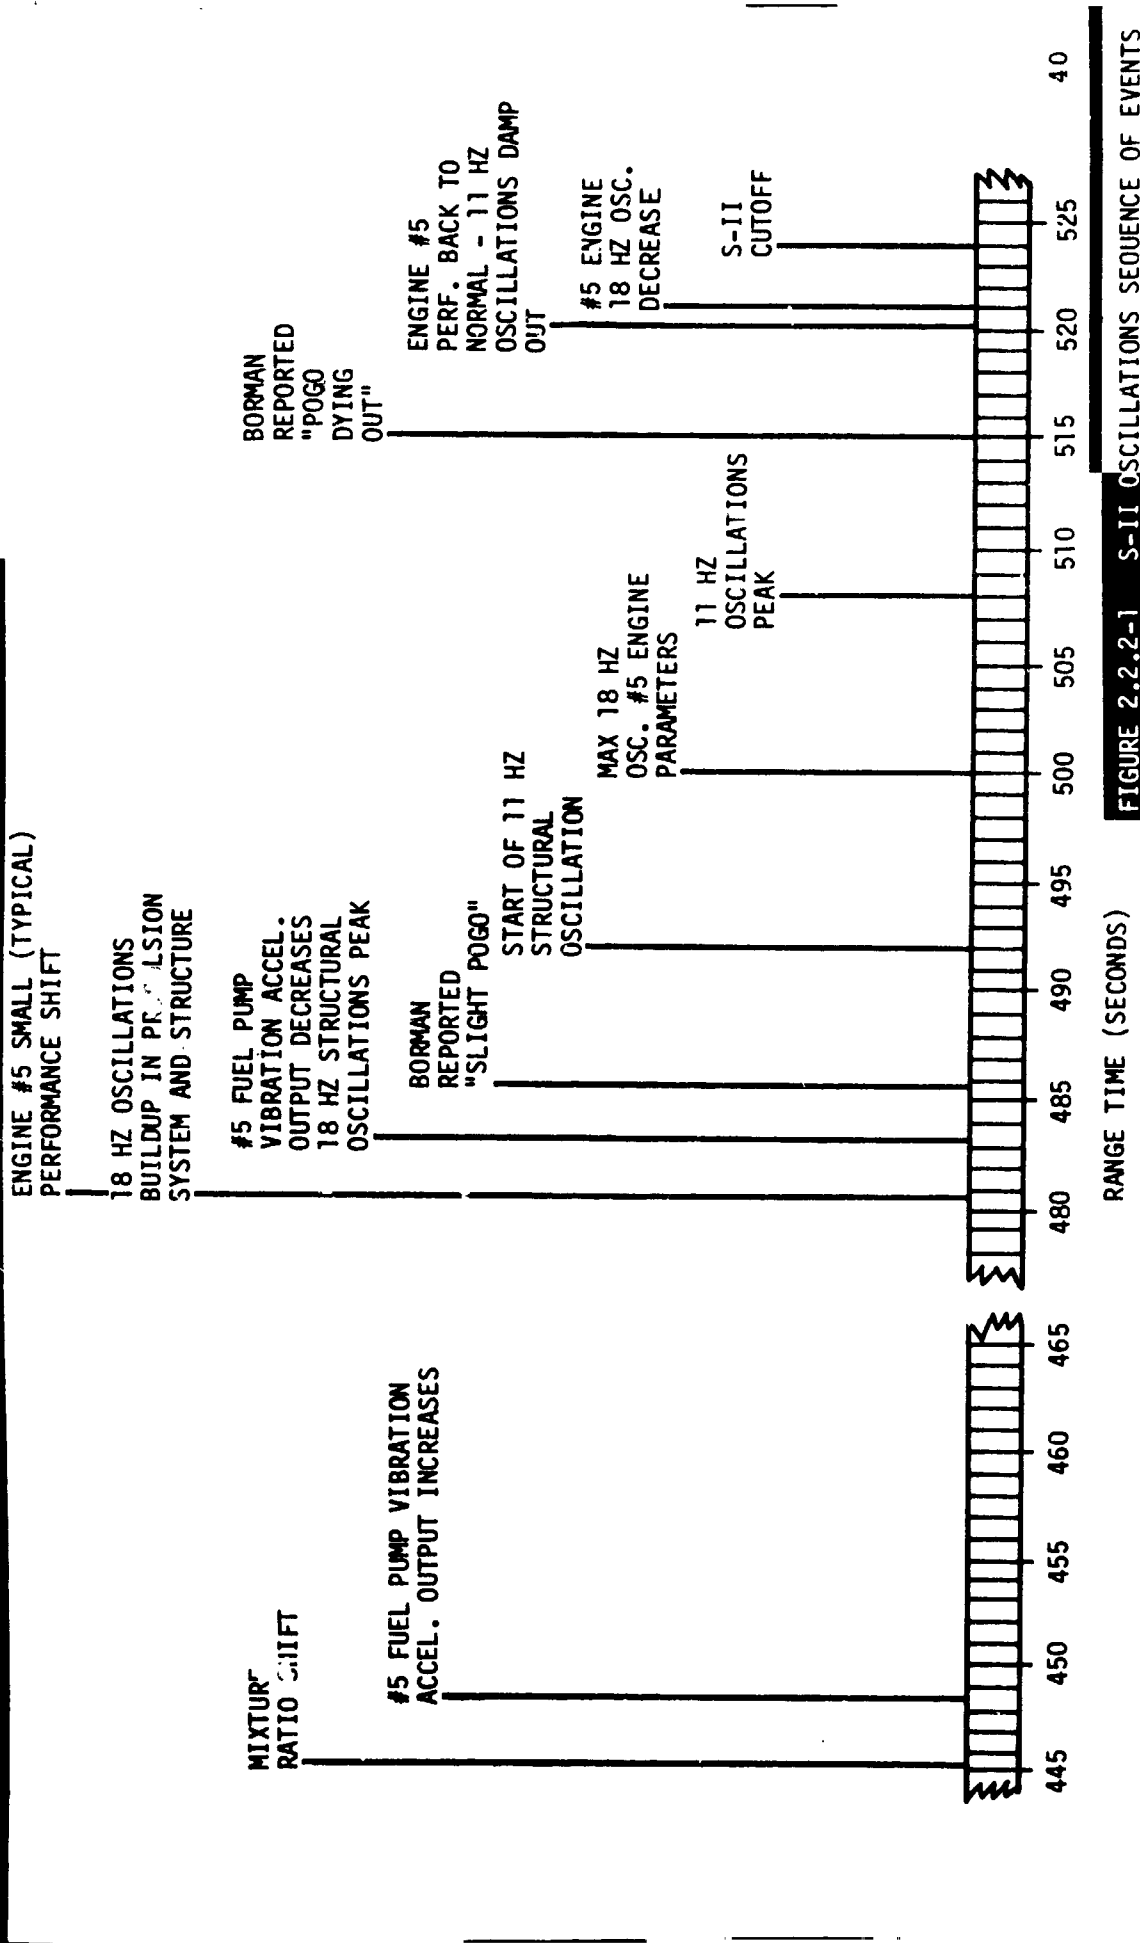
FIGURE 2.2.2-1 S-II OSCILLATIONS SEQUENCE OF EVENTS

NO. 2.2.2	TITLE: S-II ENGINE OSCILLATIONS	MISSION: APOLLO 8	EVENT TIME: 0:07:31
SYSTEM:	S-II		
SUBSYSTEM:	PROPULSION		
PROBLEM:	<p>18 HERTZ OSCILLATIONS WERE EVIDENT IN ENGINE AND SUPPORTING STRUCTURE BEGINNING AT APPROXIMATELY 451 SECONDS, AND THEY BECAME MORE PROMINENT AT ABOUT 480 SECONDS WHEN A SMALL DROP IN ENGINE NO. 5 PERFORMANCE OCCURRED. DESIGN ANALYSIS AND TESTING DID NOT COVER THE 18 HZ OSCILLATORY CONDITION ENCOUNTERED ON THE APOLLO 8 FLIGHT. THE 18 HZ FREQUENCY AND AMPLITUDES OF OSCILLATION WERE NOT PREDICTED FOR THE ENGINE AND SUPPORT STRUCTURE OR THE LINES AND HARDWARE ATTACHED TO THESE.</p>		
ACTION:	<p>AN INTENSIVE INVESTIGATION IS BEING CONDUCTED TO DETERMINE THE CAUSE OF THESE OSCILLATIONS AND THE POSSIBLE EFFECT OF SUCH AN ENVIRONMENT ON FUTURE MISSIONS. THE DATA SHOWS THAT THE FORWARD ENGINE OPERATED AS EXPECTED. THE 18 HZ OSCILLATION IS AN ENGINE-GENERATED PHENOMENON POSSIBLY AMPLIFIED BY STRUCTURAL INTERACTION. THE PROBABLE CONTRIBUTING FACTORS ARE: LOX NPSH, PU VALVE POSITION, AND CROSS BEAM NATURAL FREQUENCY. THE MECHANICS OF THIS INTERACTION ARE NOT UNDERSTOOD, AND INSTRUMENTATION IMPROVEMENTS HAVE BEEN MADE ON APOLLO 9 (ECP 6208 AND 6204) IN ORDER TO OBTAIN BETTER DATA. TESTING IS UNDERWAY AT MSFC AND ROCKETDYNE, BUT IT WILL NOT BE COMPLETED PRIOR TO APOLLO 9 LAUNCH. THE LOX TANK ULLAGE PRESSURE WILL BE INCREASED DURING THE LATTER PORTION OF THE S-II BURN, WHICH WILL RAISE THE LOX NPSH (ECP 6237). THE EFFECT OF THIS WILL BE TO REDUCE THE CAVITATION TENDENCY OF THE LOX PUMP AND REDUCE THE OSCILLATIONS RESULTING THEREFROM. MSFC IS DEVELOPING A DETAILED ANALYTICAL MODEL FOR DETERMINING THE CAUSE OF THE S-II STAGE OSCILLATIONS AND THE EFFECT OF INCREASED LOX TANK ULLAGE PRESSURE. STATUS AND RESULTS OF THE ANALYSIS AND TEST PROGRAMS WERE PRESENTED TO THE APOLLO PROGRAM DIRECTOR BEFORE APOLLO 9 LAUNCH.</p>
