# APOLLO PROGRAM

## FINAL FLIGHT EVALUATION REPORT APOLLO 8 MISSION

FLIGHT EVALUATION REPORT - APOLLO 8 MISSION

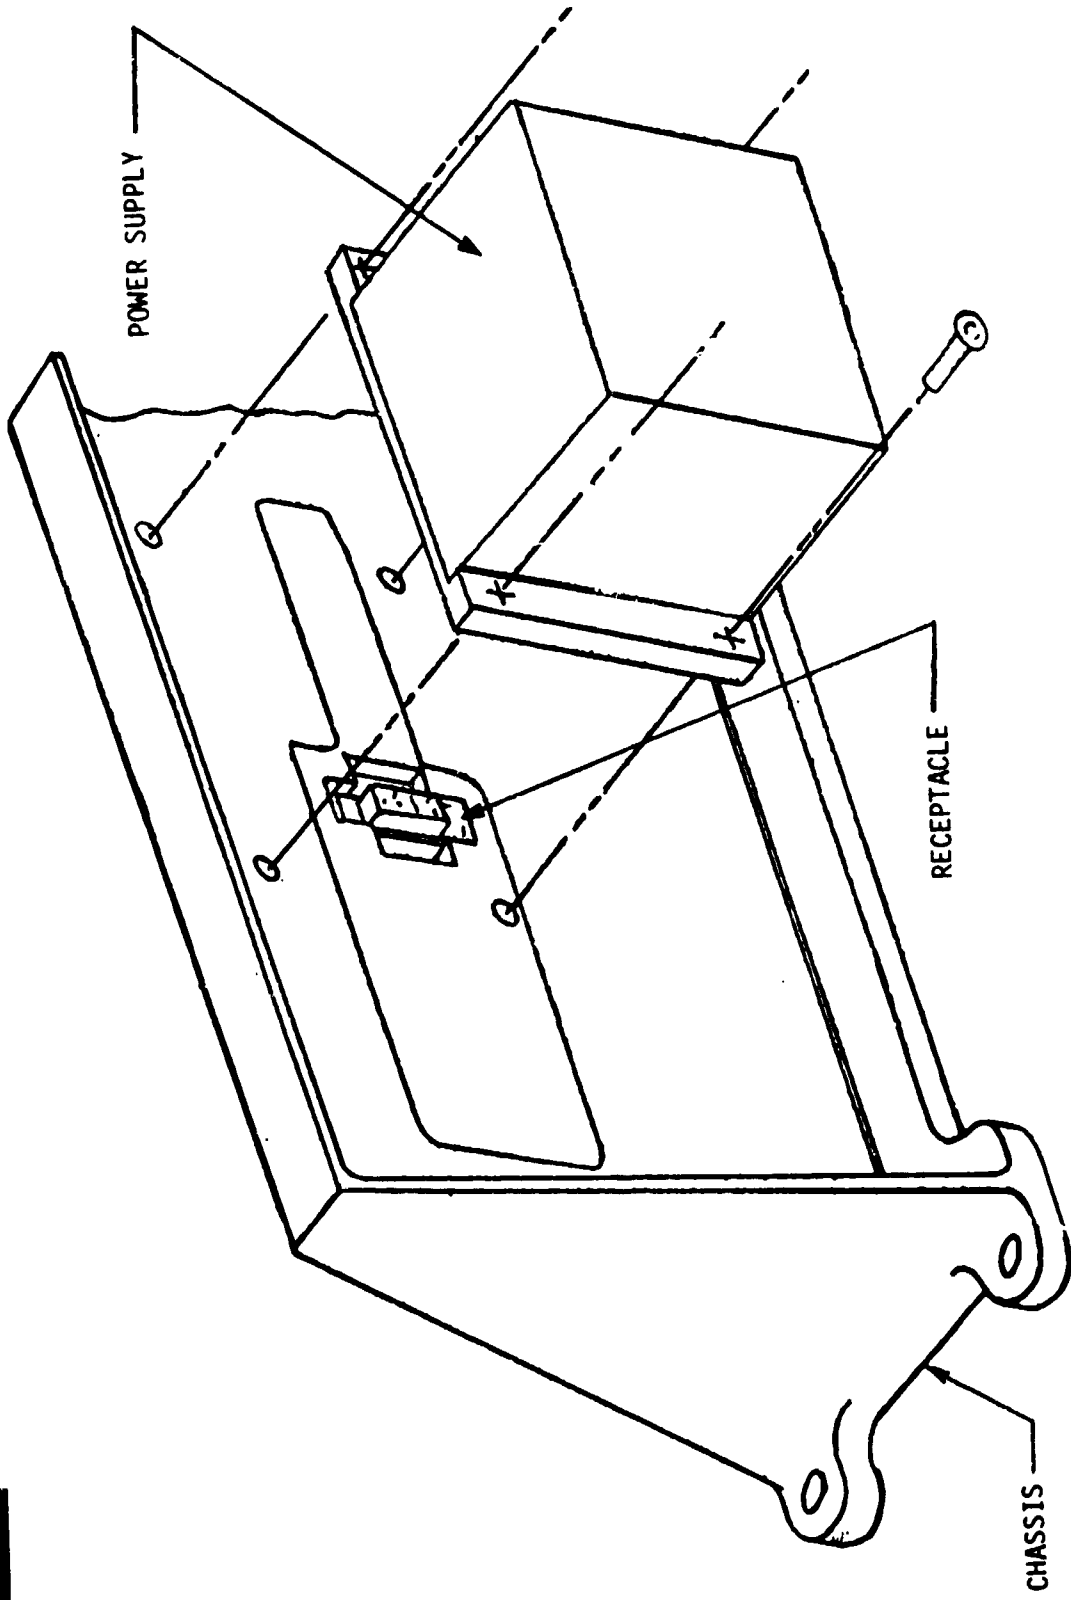
Figure 2.2.3-1 Typical Power Supply Installation

NO. 2.2.3	TITLE: INTERMITTANT OPERATION OF S-II POWER SUPPLIES
SYSTEM: S-II	MISSION: APOLLO 8
SUBSYSTEM: INSTRUMENTATION	EVENT TIME: 0:01:08 and 0:07:23
PROBLEM:	TWO OF THE FIFTEEN S-II TEMPERATURE BRIDGE POWER SUPPLIES OPERATED INTERMITTENTLY FOR APPROXIMATELY 30 SECONDS DURING MAX Q. ONE TEMPERATURE BRIDGE POWER SUPPLY OPERATED INTERMITTENTLY FOR APPROXIMATELY 30 SECONDS AFTER THE LOW PU STEP. THE INTERMITTENT OPERATION WAS CAUSED BY A DIMENSIONAL TOLERANCE BUILDUP BETWEEN THE POWER SUPPLIES AND THE CHASSIS RESULTING IN IMPROPER PIN ENGAGEMENT OF THE MATING CONNECTOR (SEE FIGURE 2.2.3-1) DURING PERIODS OF HIGHER THAN AVERAGE VIBRATION.
ACTION:	TO AVOID ANY IMPACT ON THE APOLLO 9 LAUNCH, NO ACTION WILL BE TAKEN ON AS-504; THE RISK OF LOSING TEMPERATURE DATA ON APOLLO 9 HAS BEEN ACCEPTED SINCE IT PRESENTS NO OPERATIONAL HAZARD. ON AS-505 AND SUBSEQUENT, THE POWER SUPPLIES WILL BE INSPECTED AND THE CONNECTORS WILL BE SHIMMED AS REQUIRED (ECP 6201). MSFC DOES NOT CONSIDER THIS PROBLEM TO BE AN ANOMALY.
