SPACE SHUTTLE RELATED MAINTENANCE EXPERIENCE WITH THE
X-15 AIRCRAFT

Vincent N. Capasso, Jr.

NASA Flight Research Center
Edwards, California

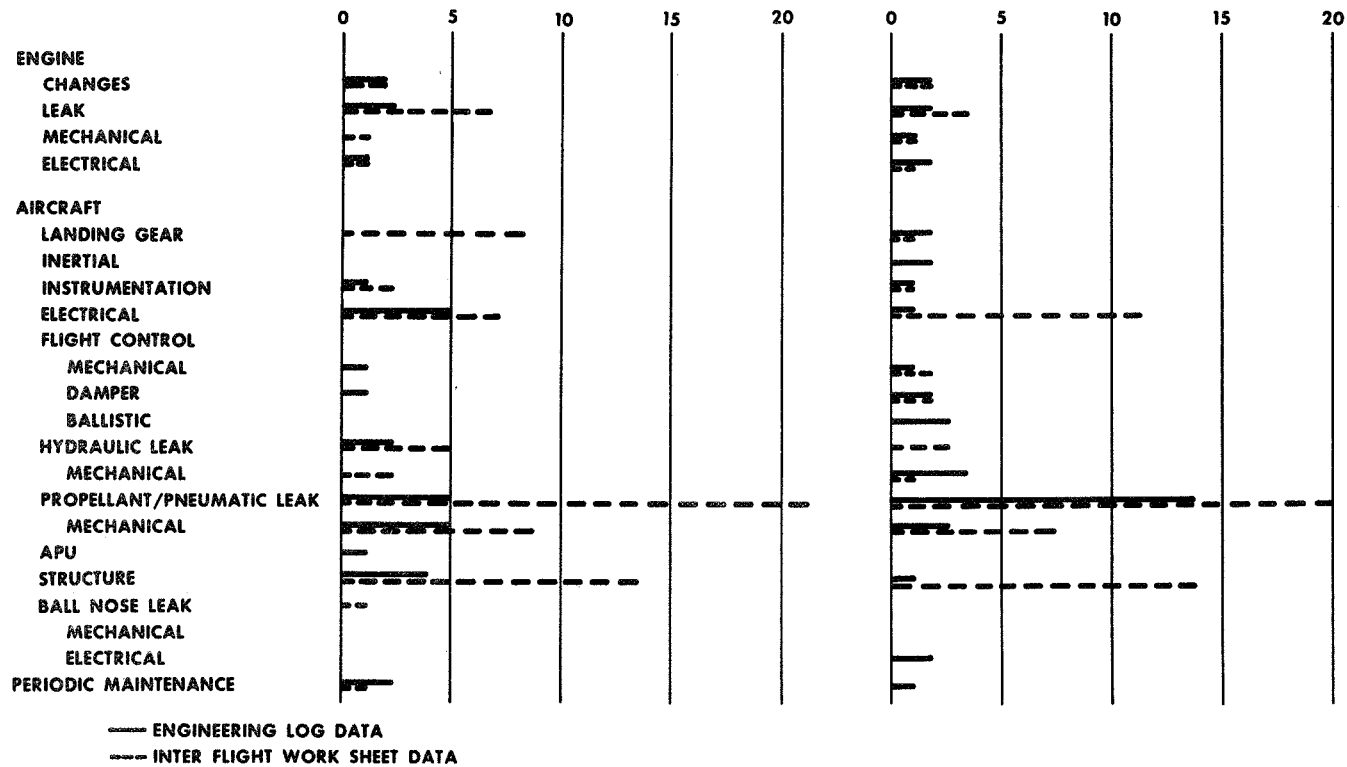
Figure 5

Two periods were selected to analyze the X-15 maintenance history. The periods were selected on the basis of a series of similar flight plans with almost the same aircraft and instrumentation configuration. The first period, July 8, 1964, to April 23, 1965, covers preparations for flights 31 to 41 for the X-15-3 airplane. This was a series of heat transfer flights with similar flight plans and some minor research instrumentation changes. The ballistic control system was not required or used for these flights. The second period was April 4, 1968, to December 20, 1968, and covers the last 7 flights of the X-15-1 airplane. These flights were all altitude flights which required an operating ballistic control system. In figure 5 a 5-flight sample of the two periods was analyzed by aircraft systems to show the problem areas.

The figure shows many more items from the inter flight work sheets than from the engineering log, which corresponds with the sheets containing the routine items taken care of by the aircraft crew. Where the engineering log number approaches the IFWS number, as under propellant/pneumatic system leaks, it means that the problems usually affected the flight schedule or increased the effort required to retain the schedule.

Propellant/pneumatic system leaks were the most troublesome problems, probably because they usually occurred or were found during pre-flight functional activity or flight servicing. Many of the leaks were due to O-ring or gasket failures, both in the system plumbing and in the components. Although the number of structural repair items was high, most were minor and were found during post-flight inspection, which permitted them to be considered in the flight schedule. The electrical wiring in the X-15-3 airplane was becoming a serious problem during the period considered and the aircraft was subsequently rewired to eliminate the problem.

3. Question. What percentage of leaks were in the LOX system?
Answer. Of the 41 leaks listed in figure 5, 15 were H₂O₂ system, 1 LOX, 3 NH₃, 16 He, 2 LN₂ cooling, 4 GN₂ (cooling and inflatable seals), and 1 pilot's breathing O₂ (not counted in the 41). Engine leaks were counted separately under engine system.

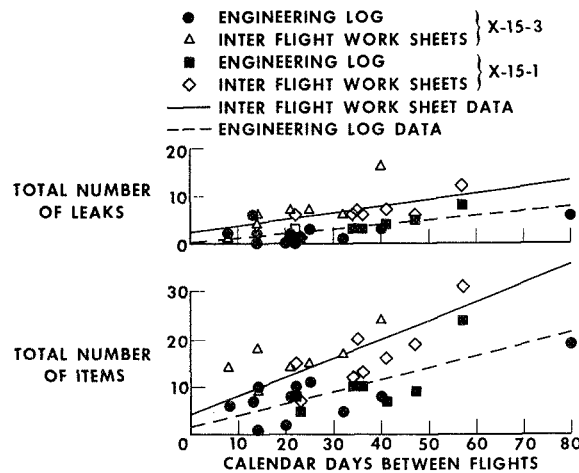
Figure 6

The number of leaks in all systems and the total number of items required versus the calendar days between flights for the time periods considered in the discussion related to figure 5 are presented in figure 6. Complete inter flight work sheet data were not available. It is well known by those who work around aircraft that an airplane that does not fly in a reasonable time develops problems, usually leaks due to drying out of seals and O-rings. For example, the B-52 airplane has a series of inspection requirements of increasing severity, depending on the number of calendar days since the last flight. The X-15 functionals were designed to exercise and test all the systems and were sometimes performed to exercise the system during long periods of lay up. The 30-day seat inspection (fig. 4) is an example.

The figure shows the trend of increasing number of items versus calendar days and the higher number of inter flight work sheet items. The question naturally arises, "Did the number of items between flights determine the calendar days, or did the calendar days determine the number of items?" The X-15 experience was usually the latter, particularly during the last year of flying (X-15-1 data) when coordination for one of the experiments determined the flight schedule date and time, which was somewhat inflexible.

The fact that the lines do not go through the origin points out that there were normally items to be repaired when the aircraft returned from flight.
