FURNACE-TUBE CONTAMINATION  
NASA Grant NGR 05-010-041  
Dept. of Electrical Engineering  
Univ. of Calif., Santa Barbara

## FURNACE-TUBE CONTAMINATION

NASA Grant NGR 05-010-041  
Department of Electrical Engineering\*  
Solid-State Laboratory  
University of California, Santa Barbara

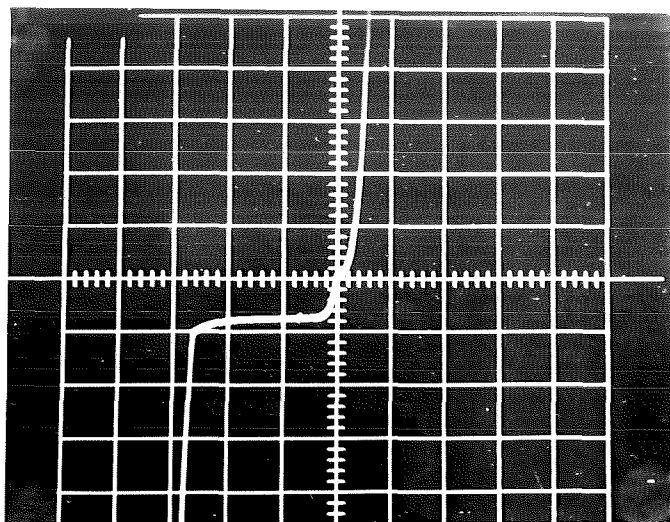
Two sets of diodes were fabricated using the oxidation furnace for oxide growth and the  $\text{POCl}_3$  predeposition furnace for the predeposition and drive. One set was gettered. The results are shown in Figs. 8 through 10. The gettering improved the characteristics slightly. Figure 10 shows one of the worst devices. At this point it was not known if the contamination was from the  $\text{N}_2$  line or the old furnace tubes.

Fig. 8 n<sup>+</sup>-p (Phosphorous predeposition furnace, oxide grown in oxidation furnace.)

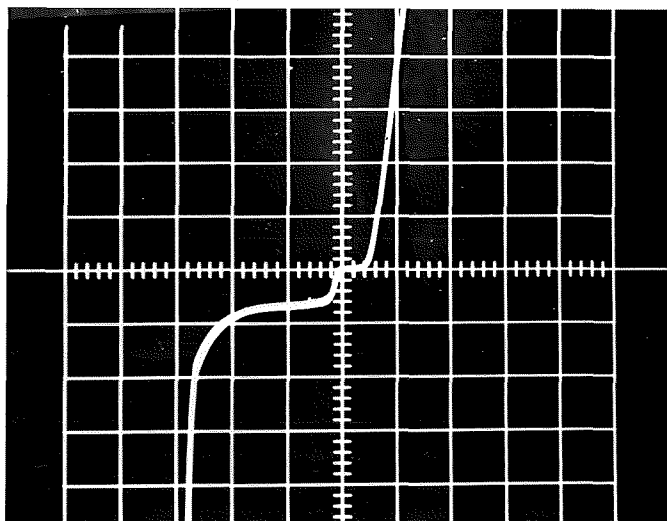
Fig. 9 n<sup>+</sup>-p Gettered junction (Otherwise, same as Fig. 8)

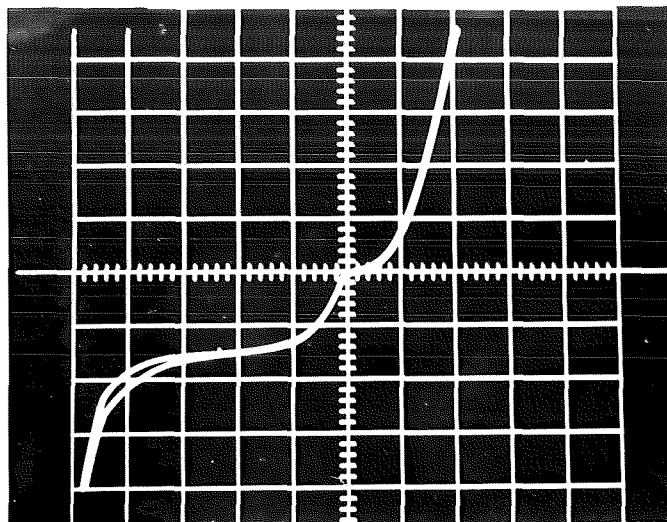
Fig. 10  $n^+ - p$  (Phosphorous predeposition, oxide grown in oxidation furnace)

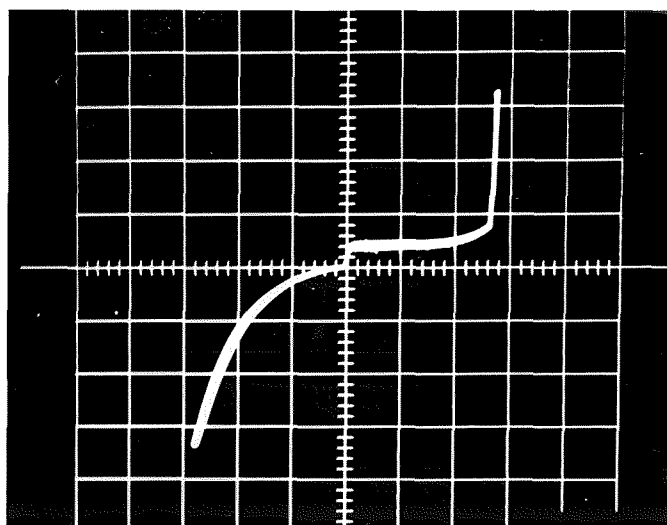
Next, three more sets of diodes were made using the same substrate wafer and the same  $\text{POCl}_3$  predeposition furnace for predeposition and drive. Two groups had the oxide grown in the oxidation furnace, one with wet  $\text{O}_2$  (Fig. 11) and one with dry  $\text{O}_2$  (Fig. 12). The oxide for the third group was grown in the boron drive furnace, which was expected to be clean (Fig. 13). Since all three groups had channel currents, it was concluded that the  $\text{POCl}_3$  predeposition furnace was contaminated.

Fig. 11  $n^+ - p$  junction (Wet- $O_2$ , oxidation furnace)

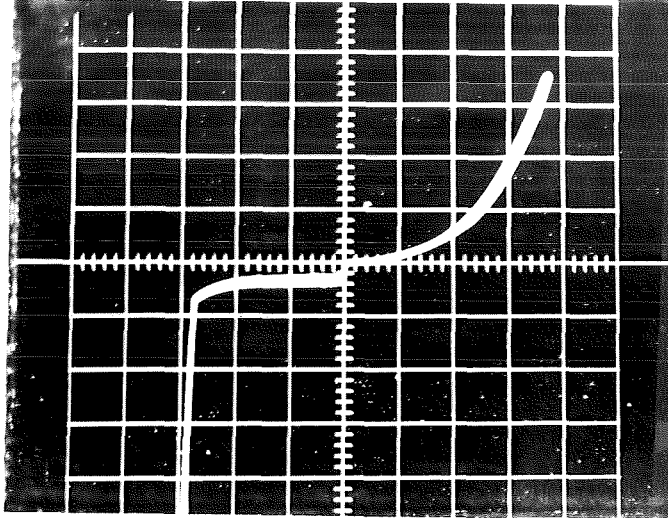
Fig. 12  $n^+$ -p junction (Dry  $O_2$ , oxidation furnace)  
(same substrate wafer and phosphorous pre-  
deposition furnace as for Fig. 11.)

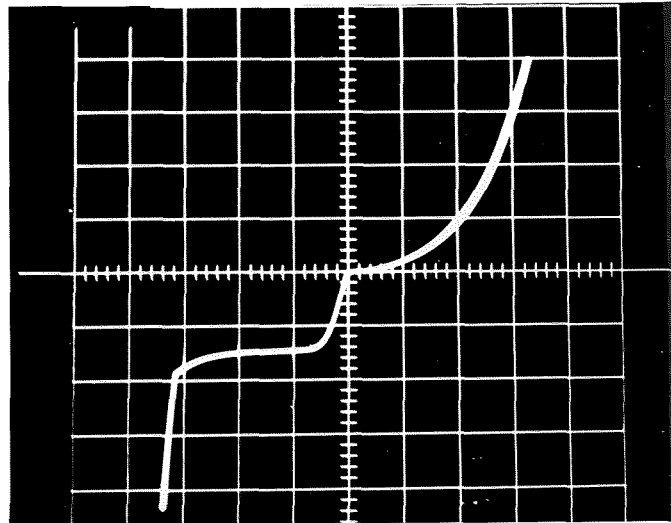
Fig. 13  $n^+$ -p junction (Dry  $O_2$ , boron drive furnace)  
(same substrate wafer and phosphorous prede-  
position furnace as for Fig. 11.)

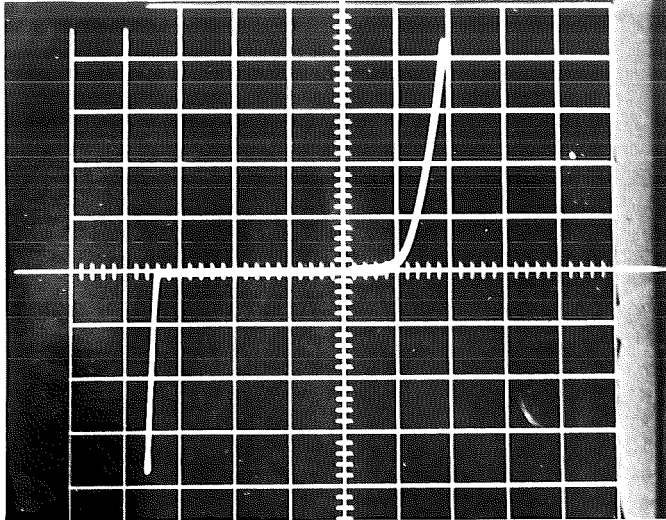
The cleanliness of the  $\text{N}_2$  line was next investigated by comparing diodes from the  $\text{BCl}_3$  predeposition furnace with a set from a new and clean  $\text{BBr}_3$  predeposition furnace. Oxides were grown in the boron drive furnace (new tube and no  $\text{N}_2$ ). A separate  $\text{N}_2$  bottle was connected to the  $\text{BCl}_3$  furnace (new tube). The  $\text{BBr}_3$  furnace also had a new tube but previously had "house" nitrogen flowing through it. The results are shown in Figs. 14 and 15 and were nearly identical. According to Grove<sup>2</sup>, Fig. 6.28, a one-sided step junction with a substrate resistivity of  $1.0 \Omega\text{-cm}$  or  $5 \times 10^{15}$  impurities/ $\text{cm}^3$  should have a breakdown of about 100 volts. Considering

junction curvature, Fig. 6.31,<sup>2</sup> the breakdown should be between 50 and 70 volts for a junction depth of 2-3  $\mu$ . (After predeposition for  $\text{BBr}_3$ , V/IA2; for  $\text{BCl}_3$ , V/IA8; predeposition was followed by one-hour oxidation in dry  $\text{O}_2$  at 1150°C.) If the junction is not one-sided, the breakdown will be slightly higher. Since the observed breakdown is in the expected range, it was felt that the "house" nitrogen line was clean.

Fig. 14 p<sup>+</sup>-n junction (BCl<sub>3</sub> predeposition furnace, oxide grown in boron drive furnace) 0.45 μa leakage current @ 20v.

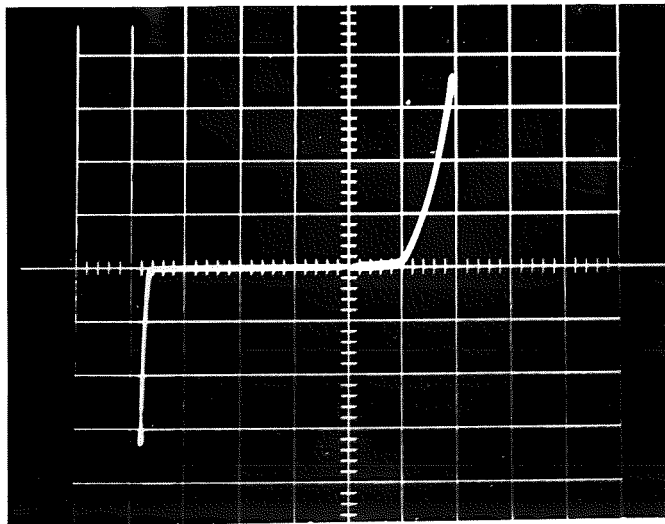
Fig. 15 p<sup>+</sup>-n junction (BBr<sub>3</sub> predeposition furnace, oxide grown in boron drive furnace) 0.45 μa leakage @ 20v.

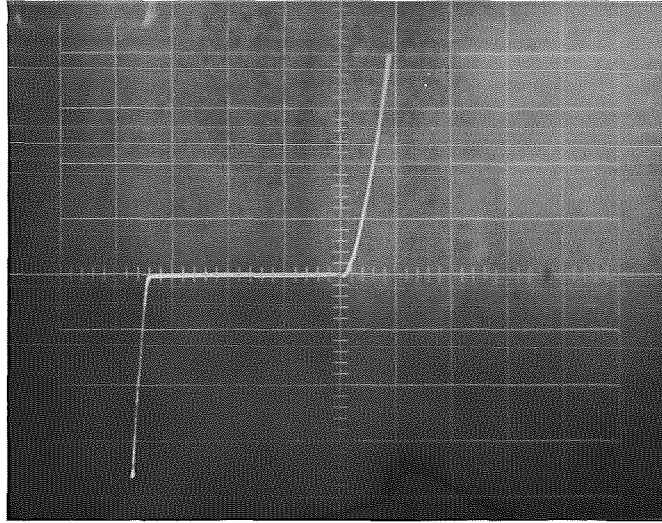
Fig. 16  $p^+$ -n junction ( $BCl_3$  predeposition furnace, same as for Fig. 14)

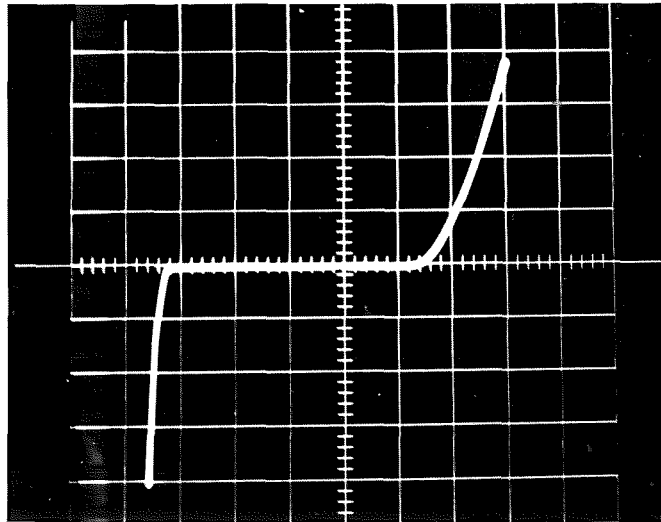
The condition of the oxidation furnace was next determined. Figures 17 through 21 show the characteristics of junctions made on the same substrate wafer and using the same  $\text{BCl}_3$  predeposition cycle. Figure 17 represents the control group using the boron drive furnace for oxide growth. Oxides on the other two sets were grown in the oxidation furnace with wet  $\text{O}_2$ . One group (Figs. 20 and 21) was placed in the  $\text{POCl}_3$  predeposition furnace and gettered in the contaminated tube. These could not be distinguished electrically from their counter group which had not been gettered (Figs. 18 and 19). In both of these groups, about half of the diodes had "soft" characteristics and about half had "hard" characteristics. The contamination evidently results from use of the oxidation furnace.

Fig. 17  $p^+$ -n junction ( $BCl_3$  predeposition furnace) (oxide grown in boron drive furnace) 0.43  $\mu$ a leakage @ 20v.

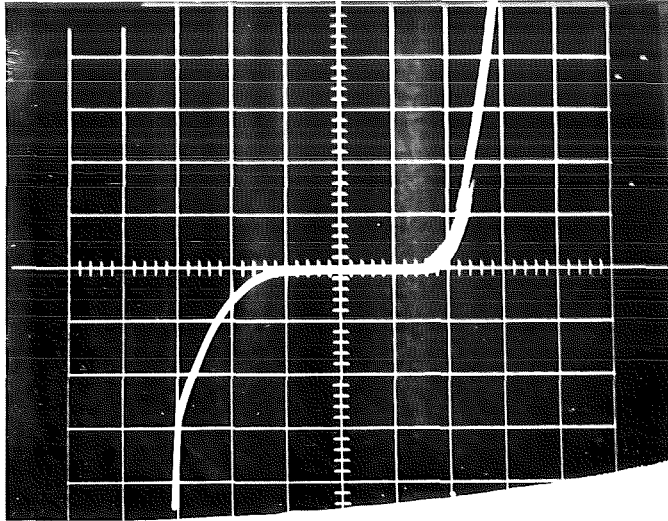
Fig. 18 p<sup>+</sup>-n junction (BCl<sub>3</sub> predeposition furnace, Wet O<sub>2</sub>, oxidation furnace) (same substrate wafer and predeposition as for Fig. 17)

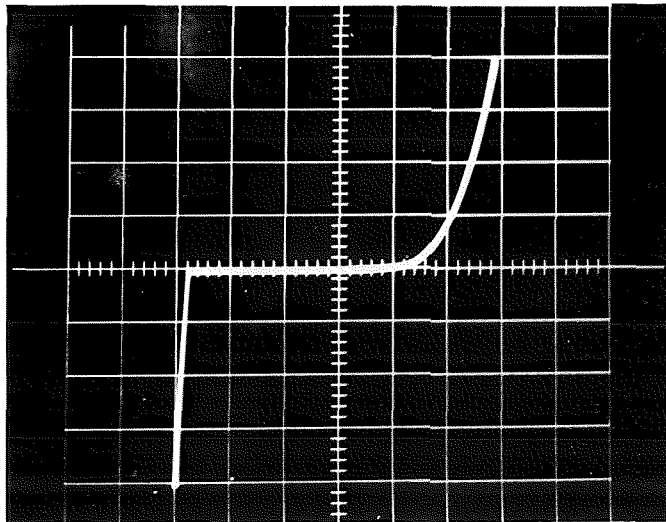
Fig. 19 Different junction on same wafer. Otherwise identical to Fig. 18

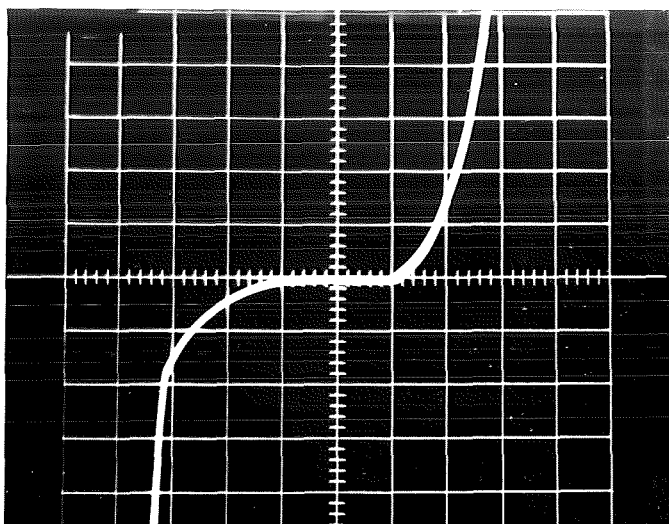
Fig. 20  $p^+n$  junction - "phosphorous gettered"  
(Otherwise identical to Fig. 18)

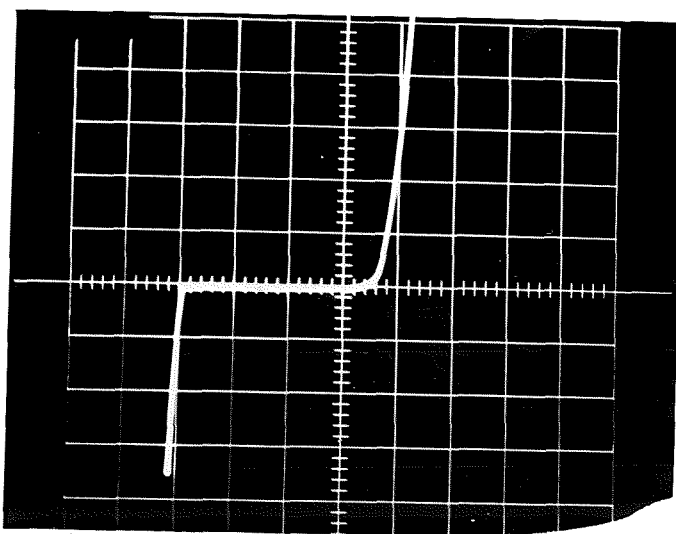
Fig. 21 Different junction on same wafer. Other-  
wise identical to Fig. 20.

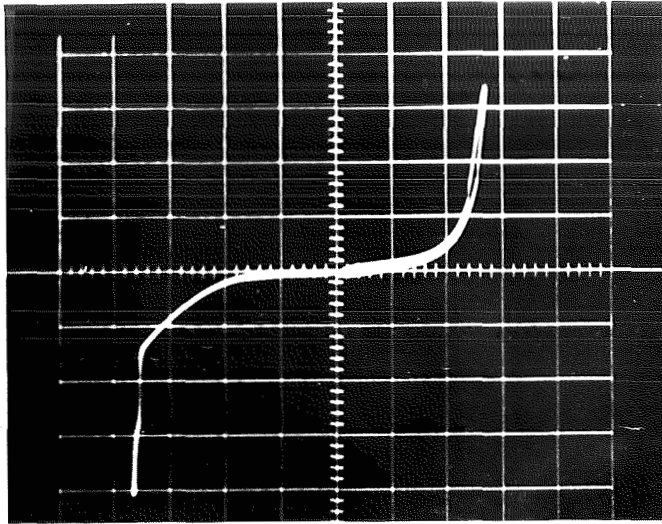
In an attempt to eliminate the contamination in the oxide furnace, a new tube was installed. Figure 22 shows the results from a  $\text{BBr}_3$  predeposition and oxide grown with wet  $\text{O}_2$  in the oxidation furnace. Since the oxidation furnace was running at  $950^\circ\text{C}$ , the junctions remained shallow. The resulting sharp curvature of the junction probably is responsible for the low breakdown voltage. However, the soft breakdown does indicate contamination. In an effort to eliminate the contamination, all glassware was recleaned and the solenoid valves bypassed with Teflon tubing. The result of this process is shown in Fig. 23. The leakage current at 20-volts reverse bias was 60 nanoamps. While this level of reverse leakage current is considered to be satisfactory, some improvement is possible by the use of higher-resistivity water for the wet- $\text{O}_2$  oxidation.

Fig. 22 p<sup>+</sup>-n junction (oxide in oxidation furnace)  
leakage current @ 20 v. - 1μa.

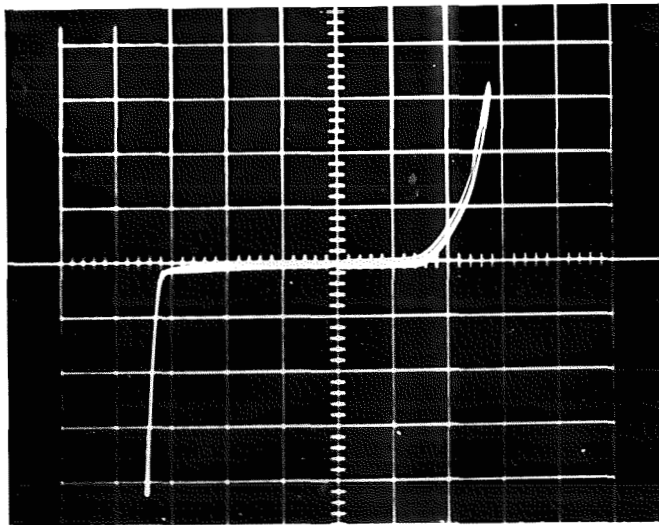
Fig. 23 p<sup>+</sup>-n junction (solenoid valves of oxidation  
furnace by-passed) leakage current @ 20v. -  
60 na.

It was found that jungling on the  $\text{POCl}_3$  predeposition furnace allowed pressure to build up and force liquid  $\text{POCl}_3$  into the valves and flow meters. This was felt to be responsible for the degraded results when using the  $\text{POCl}_3$  predeposition furnace. Solenoid valves were eliminated and the jungling simplified and correct. A leaky valve was probably responsible for the poor results from the  $\text{BCl}_3$  furnace. Additional checks on the  $\text{BBr}_3$  and the two drive furnaces indicated that they were still clean.
