# REPORT OF APOLLO 13 REVIEW BOARD

**APPENDIX B - REPORT OF MISSION  
EVENTS PANEL**

**APPENDIX C - REPORT OF MANUFACTURING  
AND TEST PANEL**

**APPENDIX D - REPORT OF DESIGN PANEL**

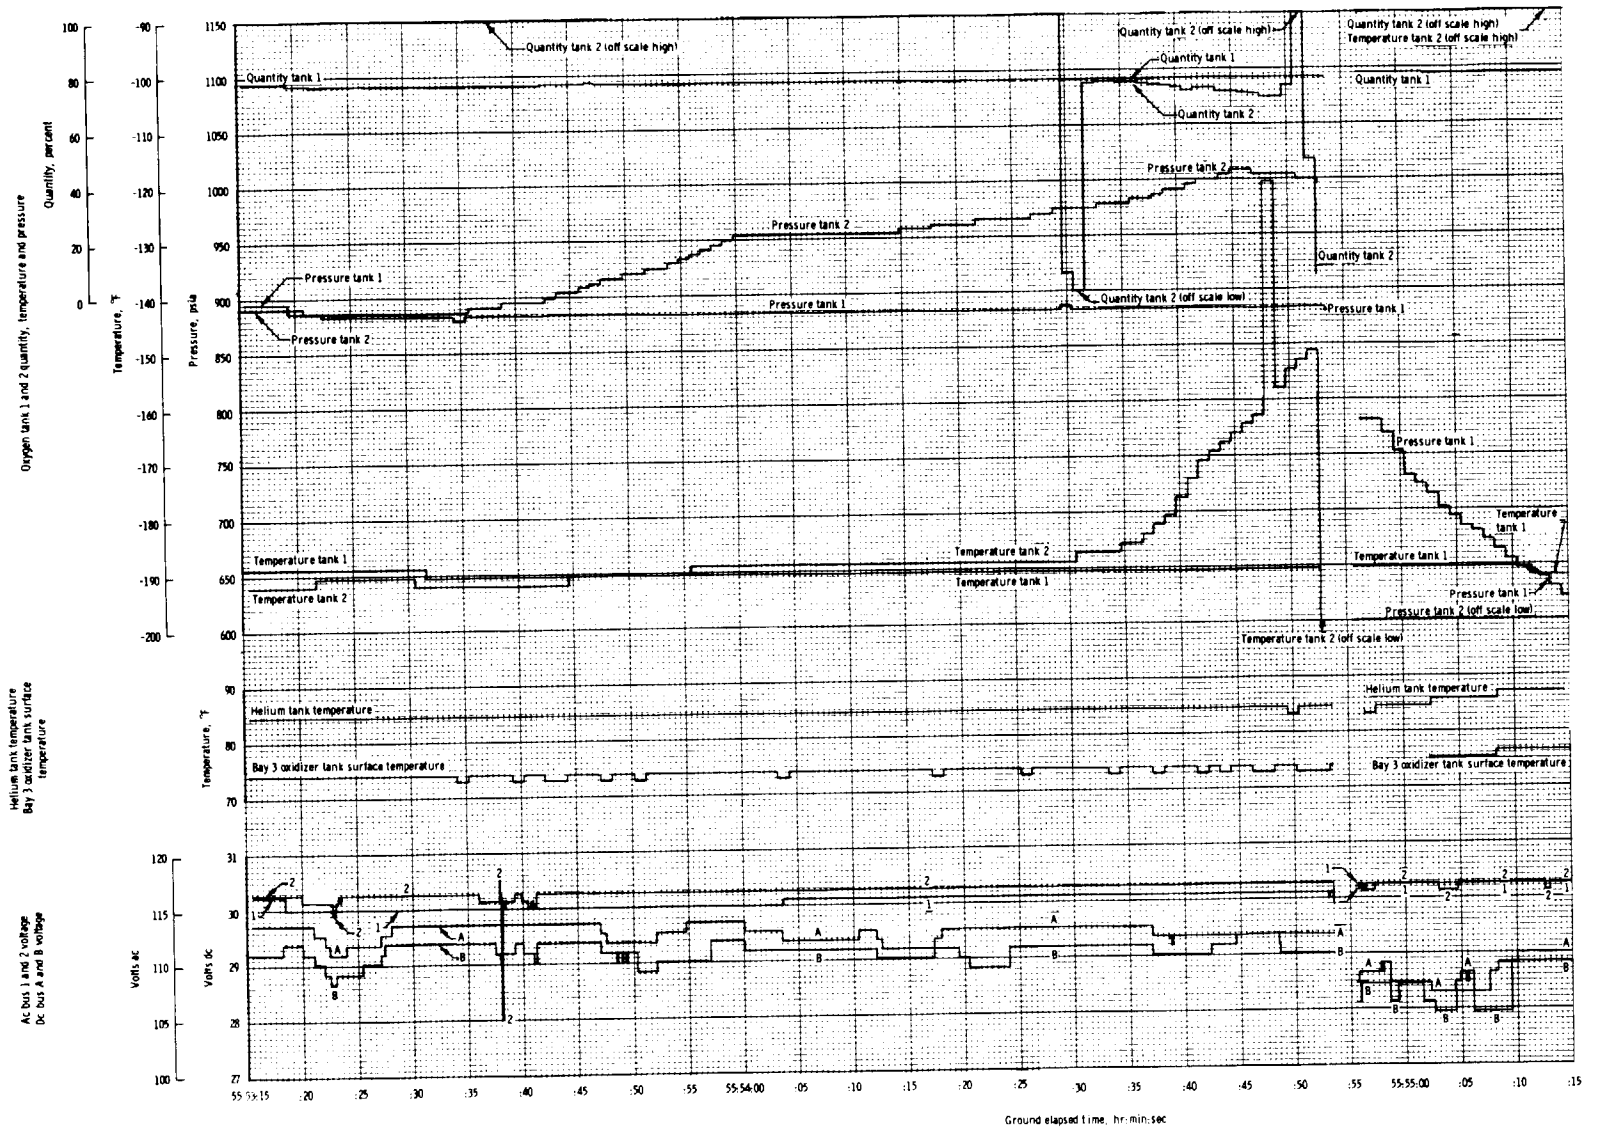
Figure B5-3(a).- Telemetered parameters during anomaly.

The most probable cause of the electrical disturbances between 55:53:22 and 55:53:42 is that a short circuit occurred in the electrical

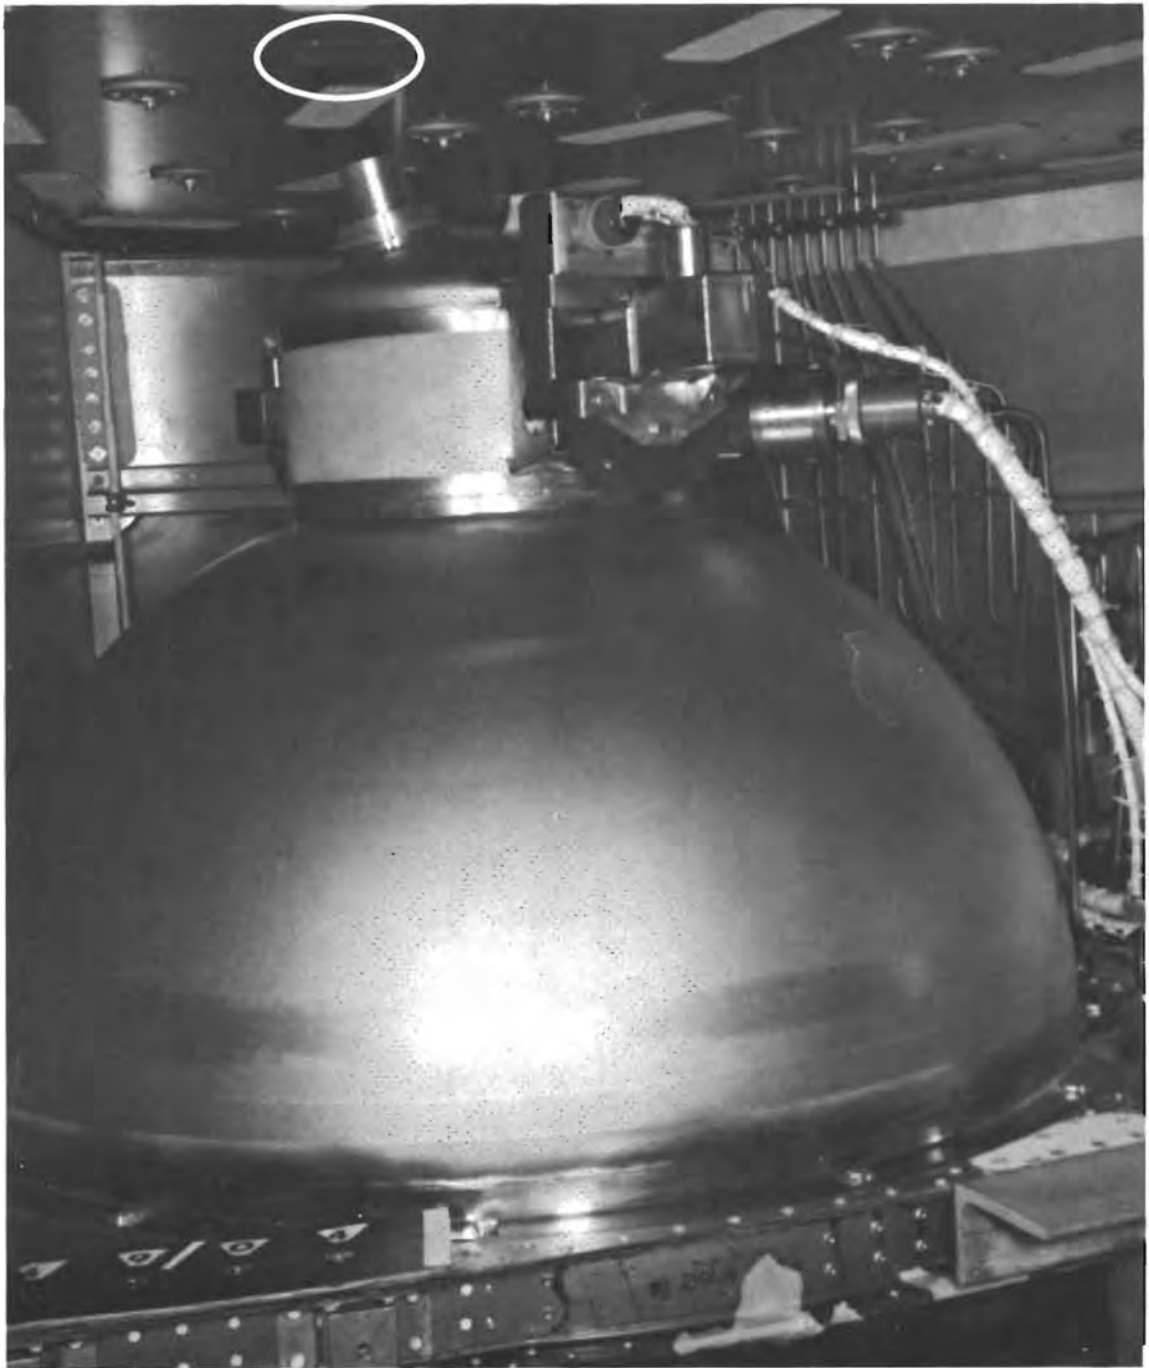
Figure C4-54.- Replacement oxygen shelf installed in Service Module 106. Note repairs to fuel cell snelf over oxygen tank no. 2.

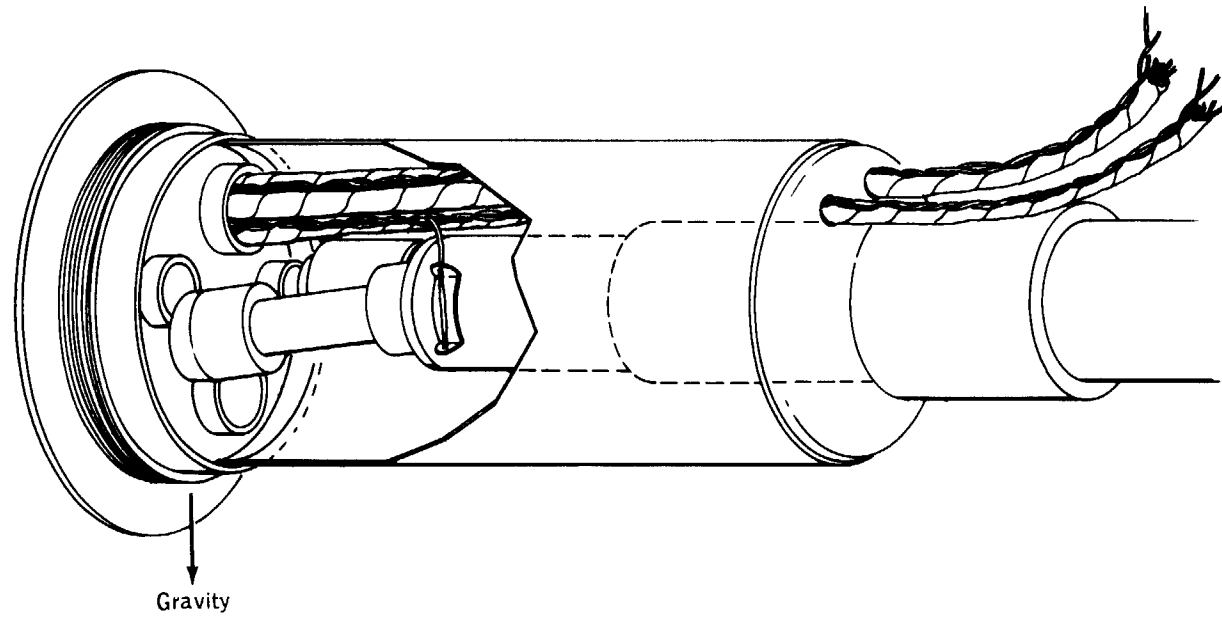
Figure C4-64.- Isometric sketch of quantity probe head as oriented during SM transportation.

It appears pertinent to this review to note that during SM transportation the fill tube segments within the upper portion of the oxygen tank no. 2 quantity probe assembly lay with the tank-exit end of the fill tube segments about 20 degrees above the horizontal, if they were still in place after previous handling and the "shelf drop." Neither the wires nor the feed line filter were below it to restrict rotation of the fill tube about the central tube of the quantity probe (fig. C4-64).

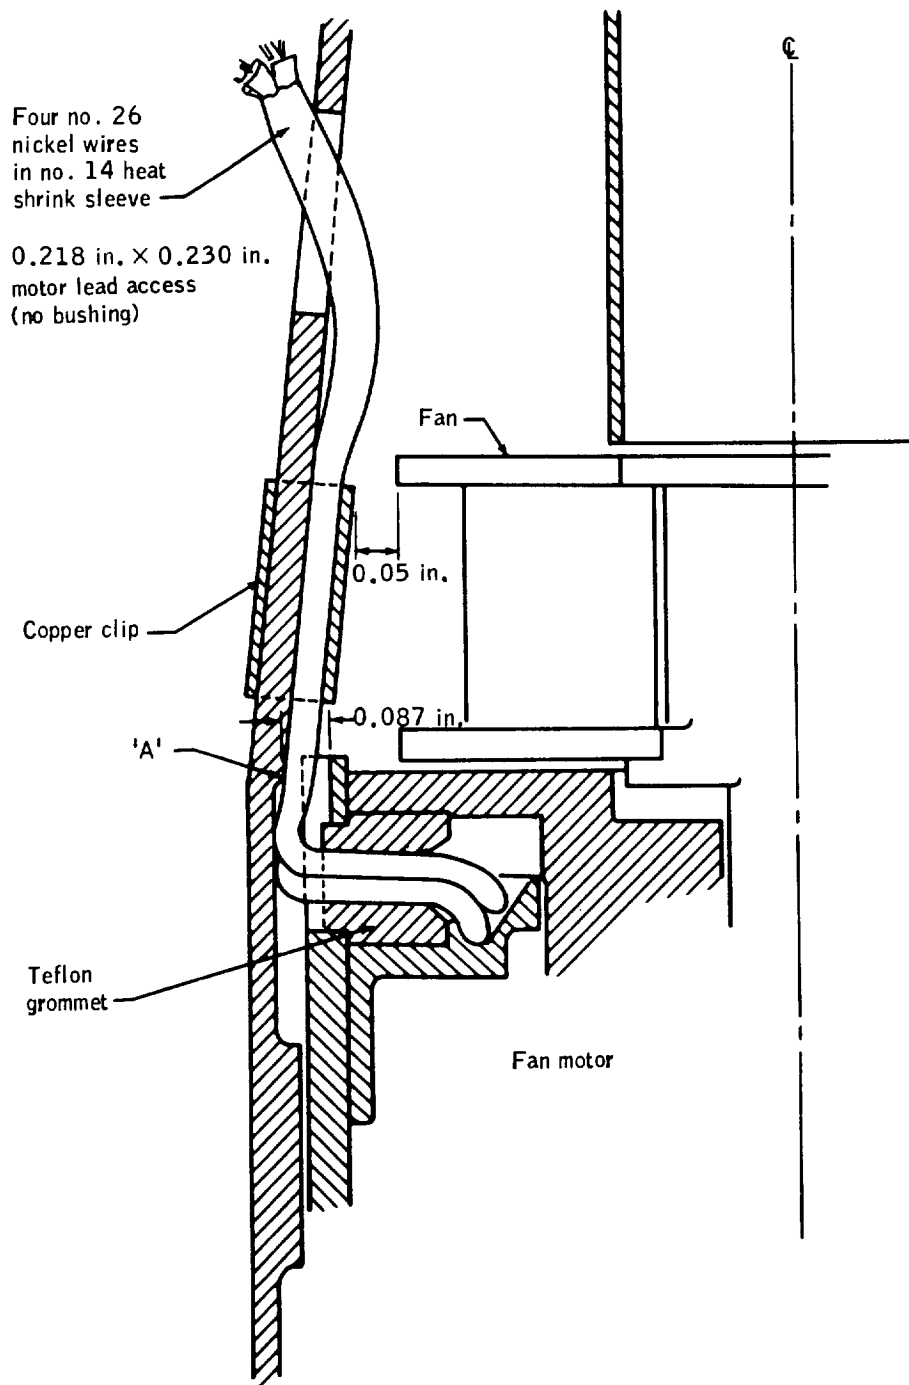
Figure D3-17.- Typical wire routing for fan motor (four times full size).

The stator windings are fabricated with number 36 American Wire Gage (AWG) wire, using a Teflon-coated ceramic insulation. The ceramic insulation is brittle and subject to breakage if proper tension is not used in fabricating windings or if sharp bends are made at the winding
