NASA TM X-2290

**SOLDER-CIRCUITRY SEPARATION
PROBLEMS ASSOCIATED WITH
PLATED PRINTED CIRCUIT BOARDS**

by A. M. Pasciak

George C. Marshall Space Flight Center

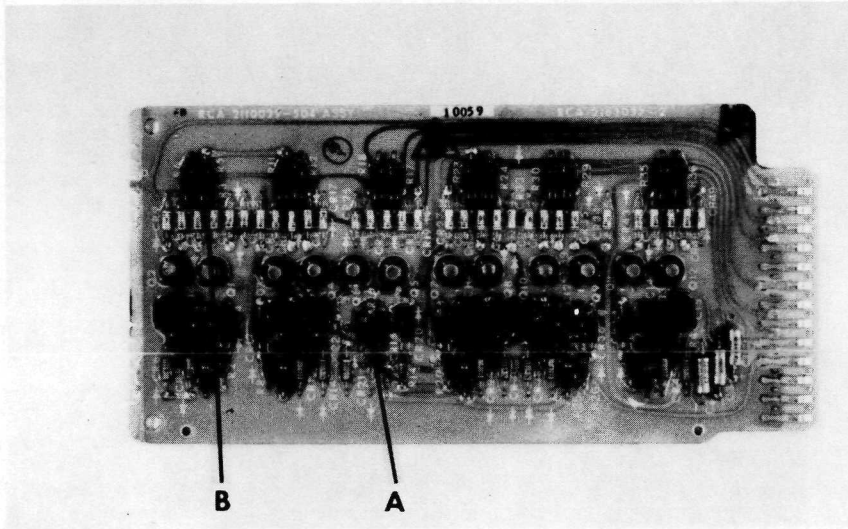
Figure 1. Component side of the initial problem board. (Arrow A indicates the "clustering" of components and area of failure; arrow B indicates the area with less component density.)

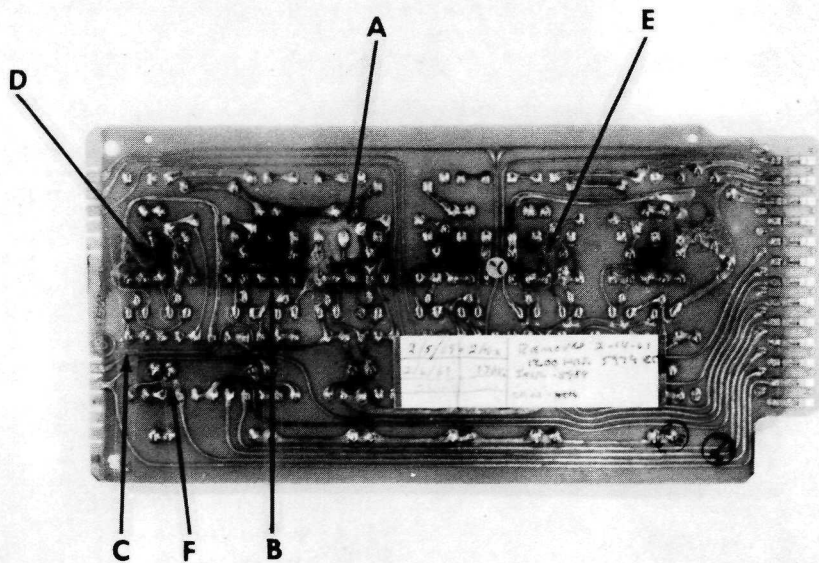
Figure 2. Circuit side of the initial problem board. (Arrows A through F pinpoint areas evaluated, with A and F corresponding to arrows A and B of Figure 1, respectively.)

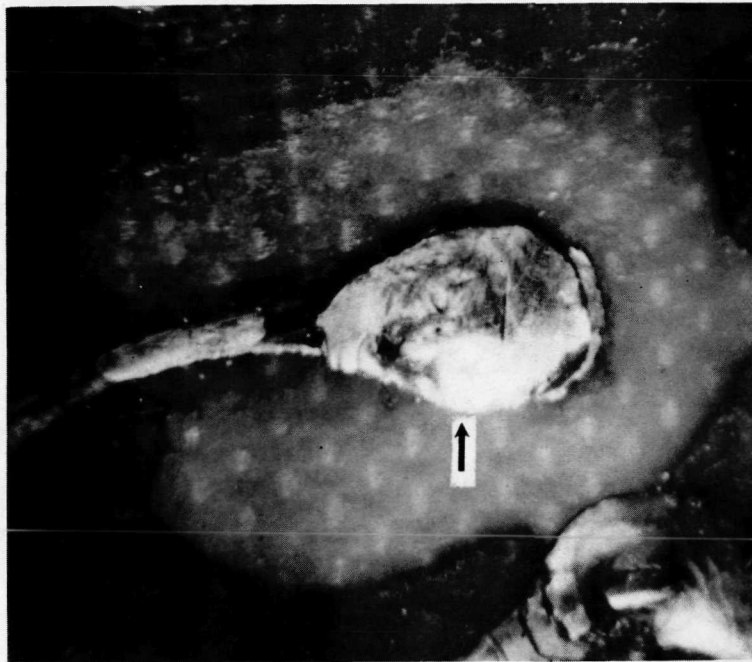
This board (type 2110029, S/N 10059), normally referred to as a driver, was evaluated, and the failure was isolated to a soldered connection of a diode, CR21, located in a cluster of components. A slight probe pressure exerted upon this diode produced a discontinuity in its circuit. The double-sided board displayed discoloration of the urethane conformal coating and the substrate in the area of the clustered components, an indication of elevated temperature. The circuit side was wave soldered and the component side was hand soldered. Overall views of both sides of this board and the point of failure are shown in Figures 1 and 2. A higher magnification of the diode connection after urethane removal is shown in Figure 3.

Figure 3. Connection that caused computer failure. (Reference arrow A, Figure 2.) (7X magnification)

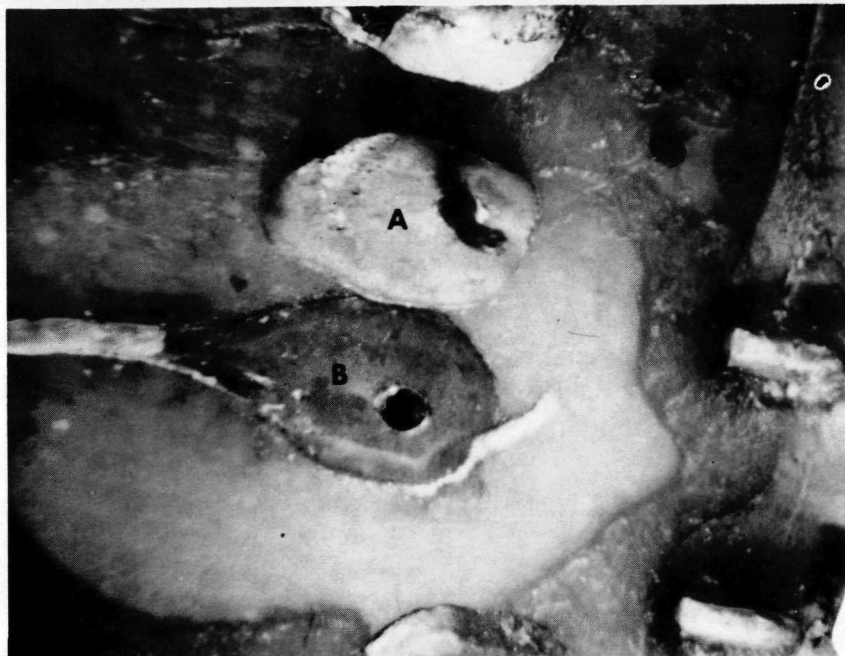
The lead on the component side of this connection was cut and a slight force was applied to its free length; the clinched lead portion and the solder mass were raised completely off the solder pad (Fig. 4). The copper is bare except for a few small areas that exhibit some adherence of solder. This separation is a classic example of solder-circuitry interfacial deterioration and is not a result of differential thermal expansion forces.

Figure 4. Discrepant connection showing removed soldered lead (A) from its associated pad (B). (7X magnification)

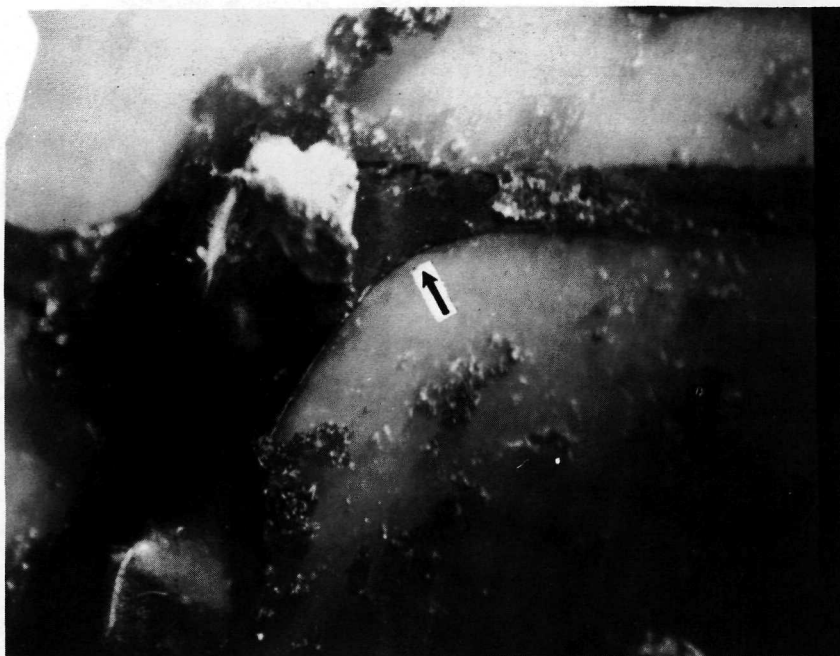
Figure 5. Solder coat lifted during urethane removal operation.
(10X magnification)

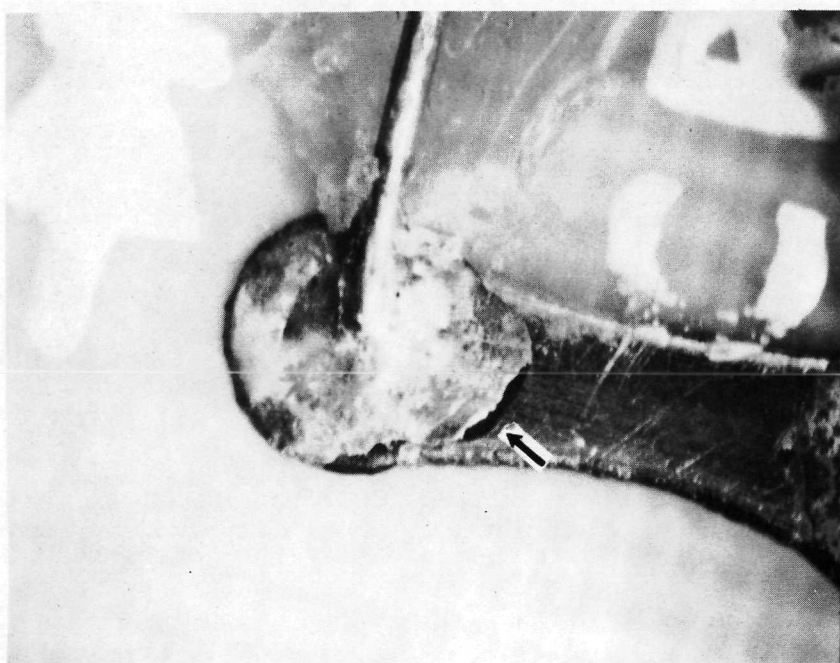
The only evidence of solder connection deterioration visually observed on the gold plated boards were darkened gold areas adjacent to the solder. An example of this condition is shown in Figure 6. The metallographic examination of this connection confirmed that the darkened gold areas were indicative of solder-circuitry separation.

Figure 6. Darkened gold plating adjacent to a soldered connection.
(10X magnification)

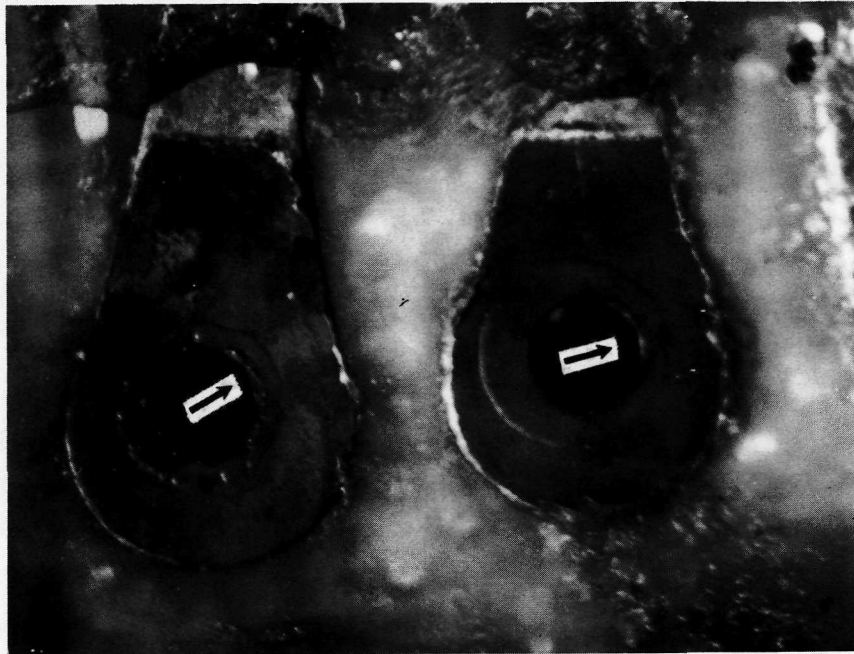
Figure 7. Gross solder separation from solder pad and from hole plating.
(Photo was taken immediately after the pull test.) (15X magnification.)

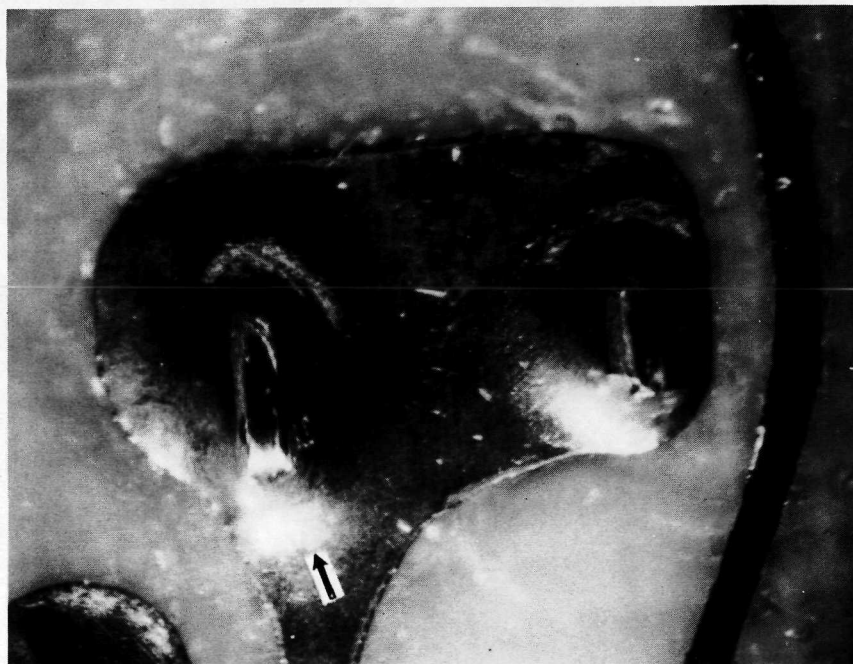
Figure 8. An acceptable connection by visual criteria. (10X magnification)

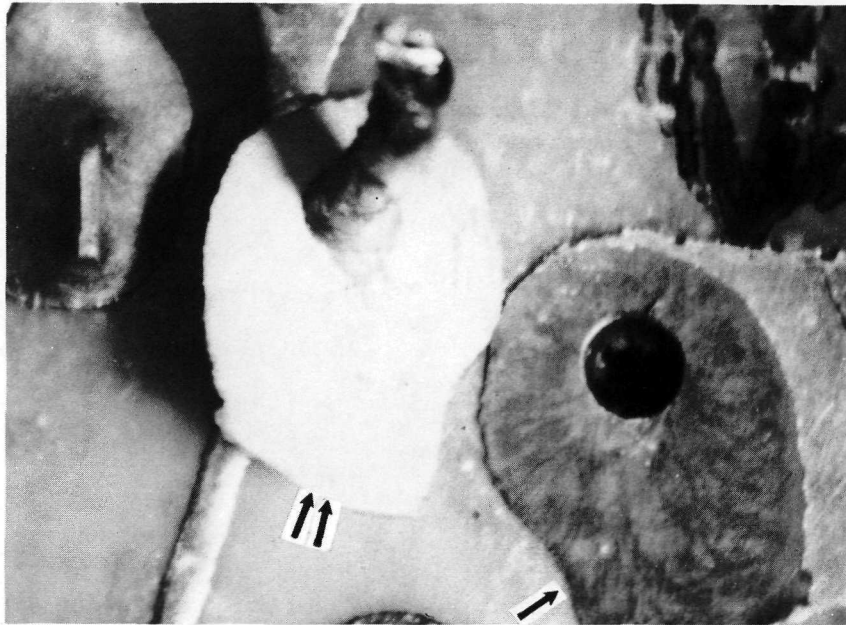
of the solder, or pads would lift along with the solder and leads, or the leads would bend; all of which is indicative of good solder-circuitry bonding. However, on the gold-plated component side, widespread solder-circuitry separation was observed. The separation was similar to that shown in Figure 9.

Figure 9. Connection, shown in Figure 8, after push test. (10X magnification)

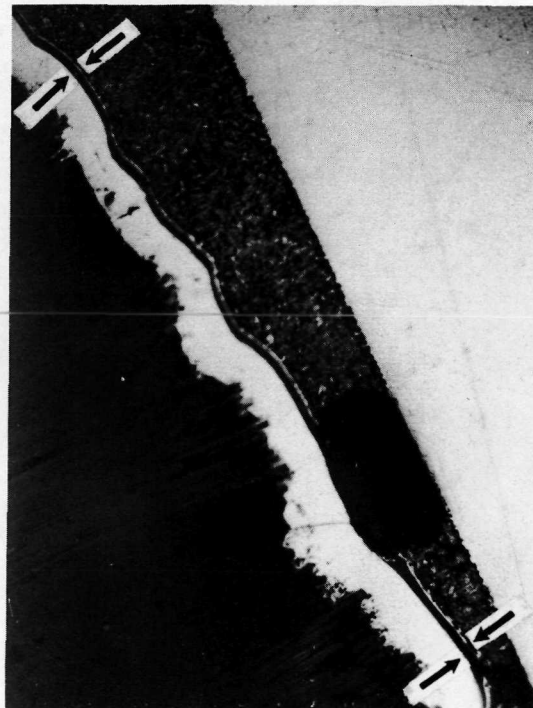
Plated-Through-Holes — With Copper Brightener Additives. A cross section of a plated-through-hole revealing a complete solder-circuitry separation is shown in Figure 10. Associated solder pads also showed similar solder separation. Note the irregular plated surface that caused mechanical restriction during pull tests and accounted for greater strength readouts. The connection shown in Figure 6 displayed a dark discoloration between the solder and the gold plating. Metallographic examination (Fig. 11) showed a gold rich solder as evidenced by acicular crystals dispersed throughout the solder mass. The gold-tin intermetallic shows separation from the copper and from the gold plating.

Figure 10. Complete solder separation from the hole plating of a gold-over-plated copper (with brightener additives) plated-through-hole.
(185X magnification)

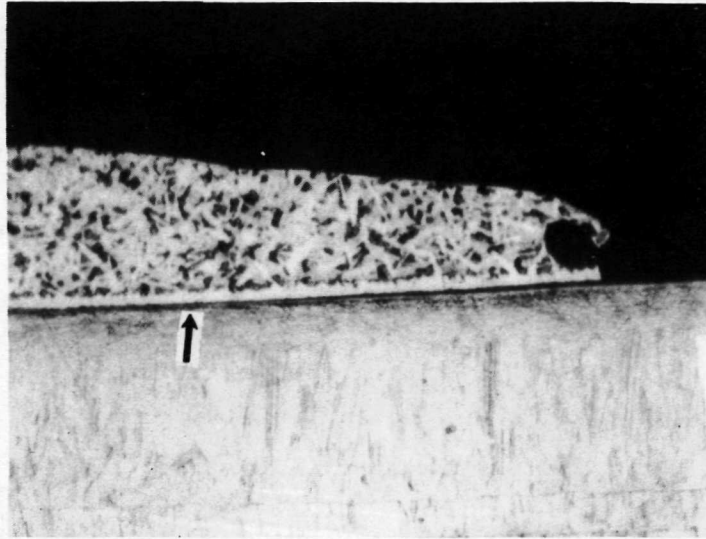
Figure 11. Solder separation from both the gold and the copper on the component side of connection. (Reference Figure 6. Arrow pinpoints gold plating termination.) (240X magnification)

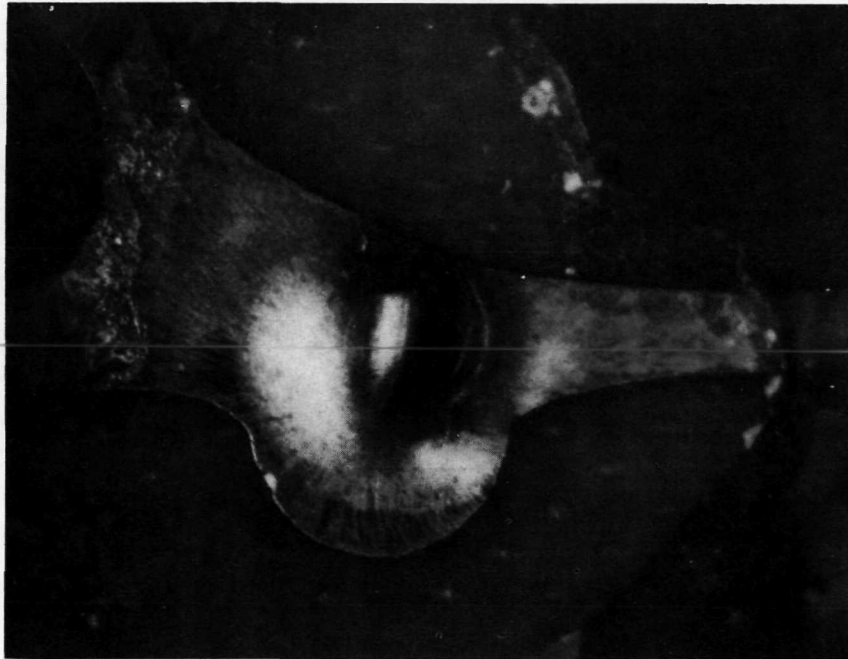
Figure 12. Overall view of a visually acceptable connection in darkened area of a single sided connection. (10X magnification)

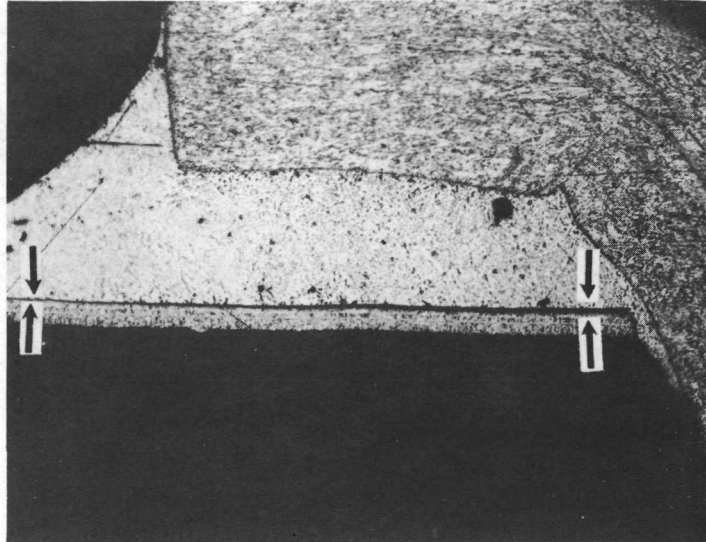
Figure 13. Cross section of connection shown in Figure 12. (The solder separation is shown between the arrows.) (50X magnification)

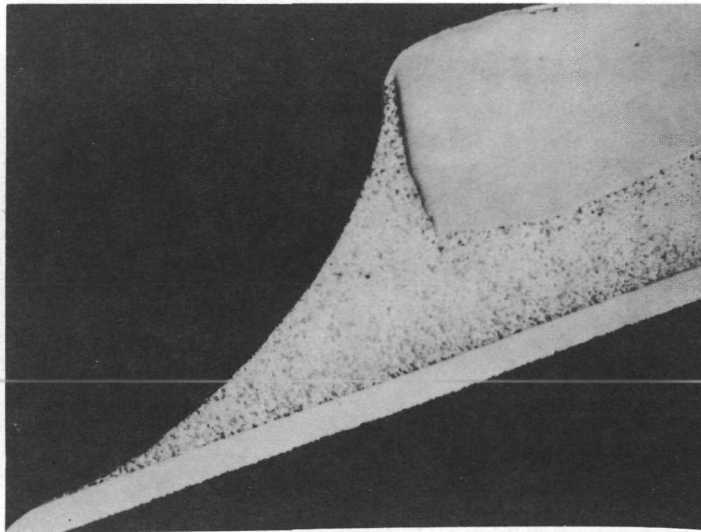
component clusters was selected. This connection was CR9 from the initially failed board. A cross section of this connection is shown in Figure 14. The integrity of this connection was not compromised during its operating life span, which was judged to be in excess of 5 years. This is indicative of the effect of temperature as a factor in the solder-circuitry separation.

Figure 14. Connection showing acceptable solder bond. [This was taken from an area that showed no discoloration by heat. Gold-over-plated copper (with brightener additives).] (55X magnification)

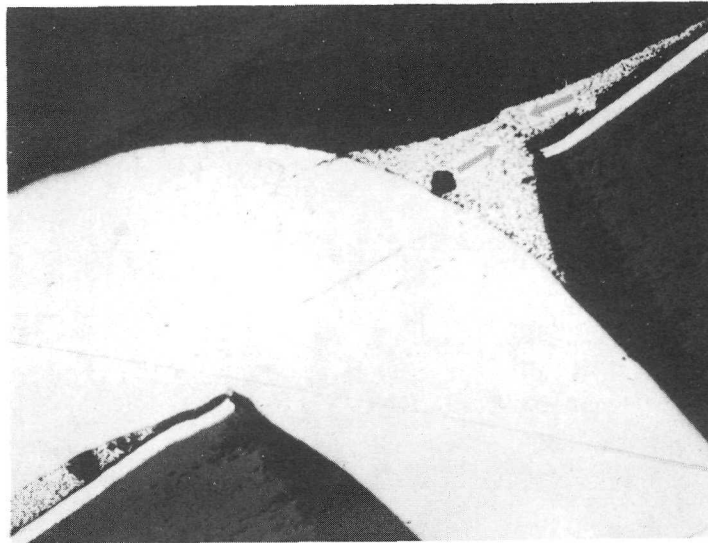
A connection with a solder crack at the heel of a lead clinch from an area of discoloration was investigated, and it is shown in Figure 15. To result in such a crack, the solder bond to the copper pad was greater at this time than the strength of the solder. After exposure to increased temperatures, even the strain relieved solder eventually separated from its pad.

Figure 15. Cracked solder at heel of the clinched lead. (This indicates that the bond of solder to the pad was greater than the strength of the solder. This solder separated from the pad after the crack relieved the strain.)
(35X magnification)

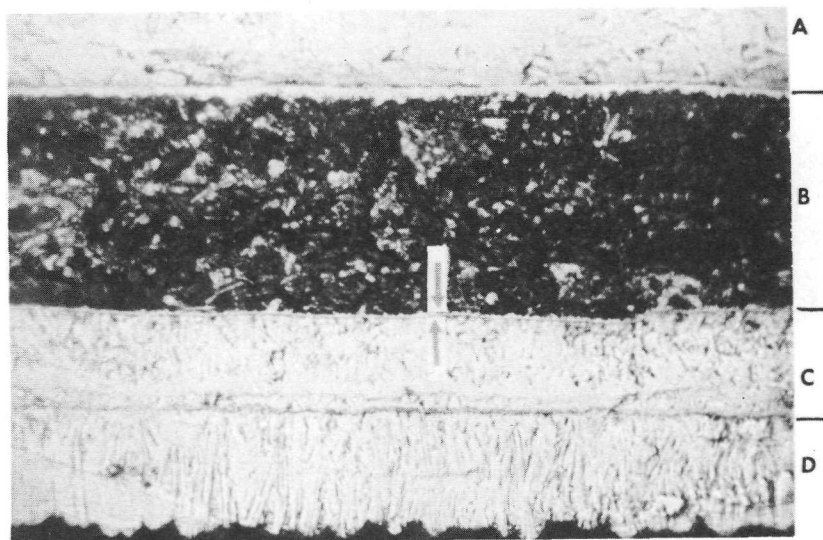
Plated-Through-Holes — Without Copper Brightener Additives. The "new generation" connections on the circuit side revealed acceptable bonding, as shown in Figure 16. This photomicrograph identifies the lead, solder, copper-tin intermetallic compound, plated copper, and laminate copper. Similar acceptable conditions existed in the plated-through-hole. However, on the component side, the separation was gross, as shown in Figure 17. A photomicrograph at higher magnification is shown in Figure 18. Note that some gold is still adhered to the copper. This photomicrograph is a classic example of the solder structure observed during metallographic examinations of connections on the component side of all gold plated boards. It is indicative that gold was not removed for the soldering operation.

Figure 16. Photomicrograph of a soldered connection on circuit side from discolored area of "new generation" board — gold-over-plated pyrophosphate copper without brightener additives. (The lead is identified by A, the solder by B, plated copper by C, and laminate copper by D. Arrows pinpoint the copper-tin intermetallic bond to the solder pad.)
(500X magnification)

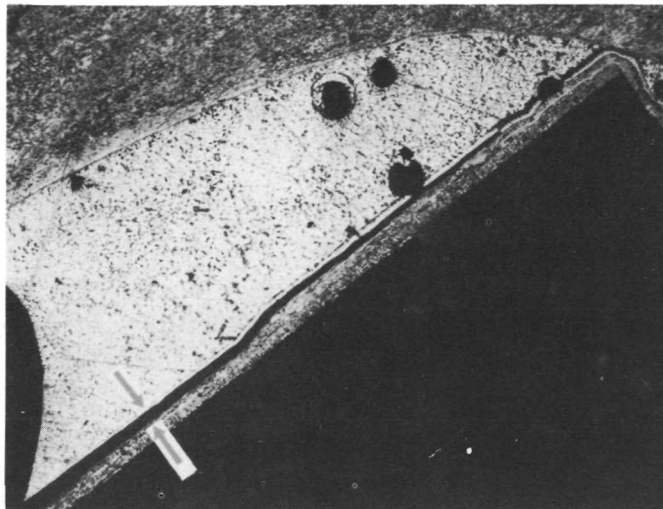
Figure 17. Component-side connection exhibiting separation under component lead at the solder-copper pad interface shown by arrows.
(35X magnification)

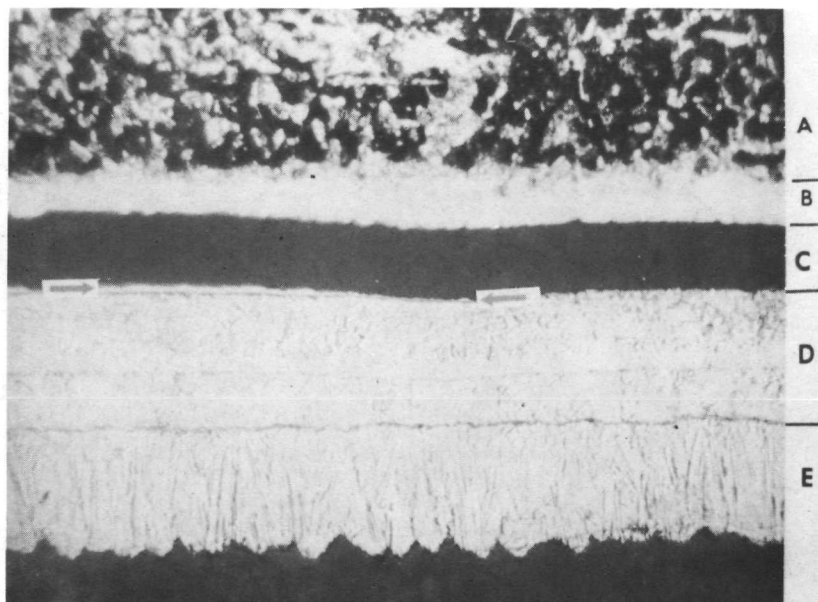
Figure 18. 500X magnification of connection shown in Figure 17. (Solder is identified by A, tin-gold intermetallic compound by B, separation by C, two plated thicknesses of copper by D, and laminate copper by E. Gold on the copper surface is indicated between arrows.)

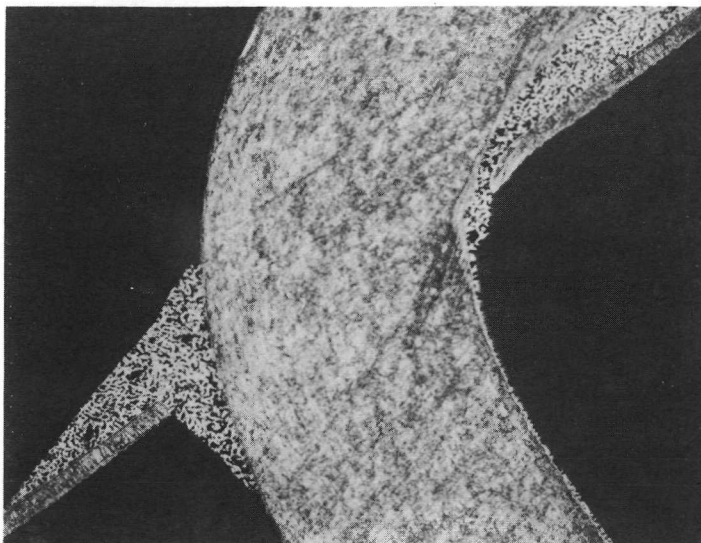
Figure 19. Cross section of a connection from a discolored area of a non-gold-plated board. (A good solder to copper bond is indicated.) (35X magnification)

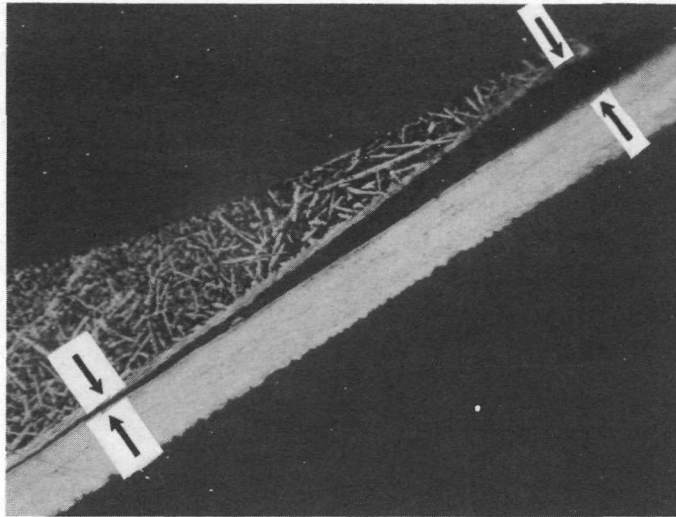
Figure 21. Cross section of connection shown in Figure 20, revealing the solder-circuitry separation. (130X magnification)

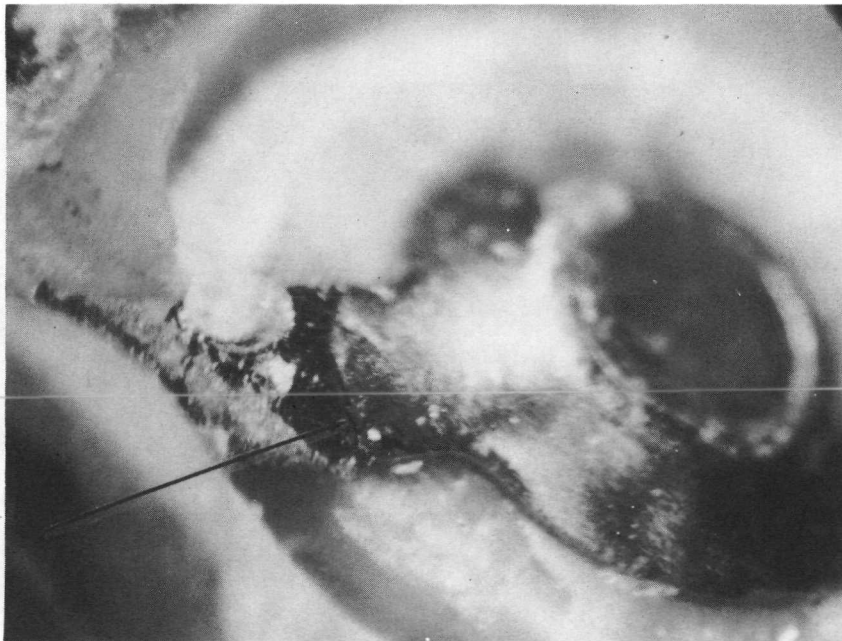
Figure 22. Solder fillet termination on a gold-plated circuit exhibiting a dark band. (25X magnification)

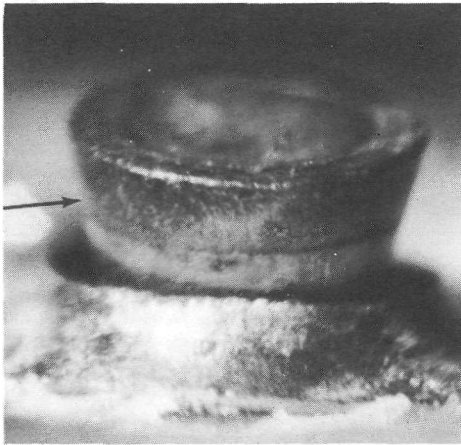
The evaluation performed on gold-plated, single-sided circuitry boards was associated with the malfunctions occurring on Saturn V telemetry (270 Multiplexer) equipment. Again as observed on pc boards of other equipment, when connections were soldered to the gold, joints showed a "dark banding" condition and partial solder-to-gold separation where the solder terminates on the gold-plated surface. A dark band between solder and gold plating is shown in Figure 22. Metallographic examination of this connection revealed a condition similar to that shown in Figure 21. The circuitry on this board was laminate copper. A "push tested" connector showing "clean bond line separation" is shown in Figure 23. Metallographic examination of this separated connector showed the separation to be between the gold plating on this terminal and the gold-tin intermetallic.

Figure 23. Push tested gold-plated terminal exhibiting solder separation. (25X magnification)

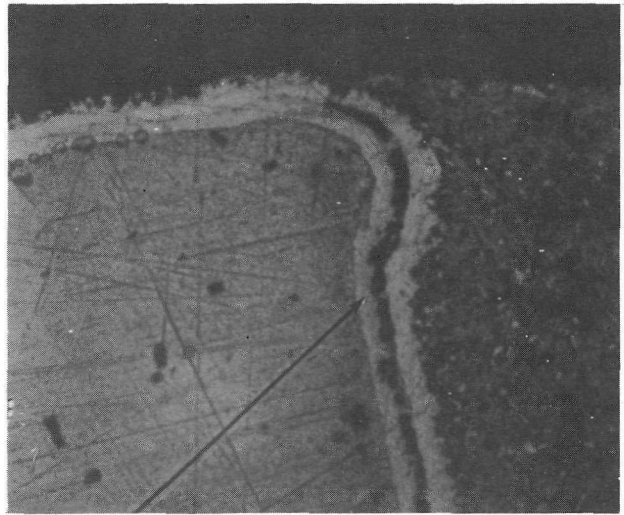
A terminal that exhibited no visual surface defects was also metallographically examined. A gross solder-terminal separation was observed during this examination, and it is shown in Figure 24. This separation occurred between the remaining gold plating on the terminal and the gold-tin intermetallic.

Figure 24. Gold-plated terminal that exhibited no visible surface defects. (Metallographic examinations show gross separation between the gold-plated terminal and the gold-tin intermetallic.) (410X magnification)

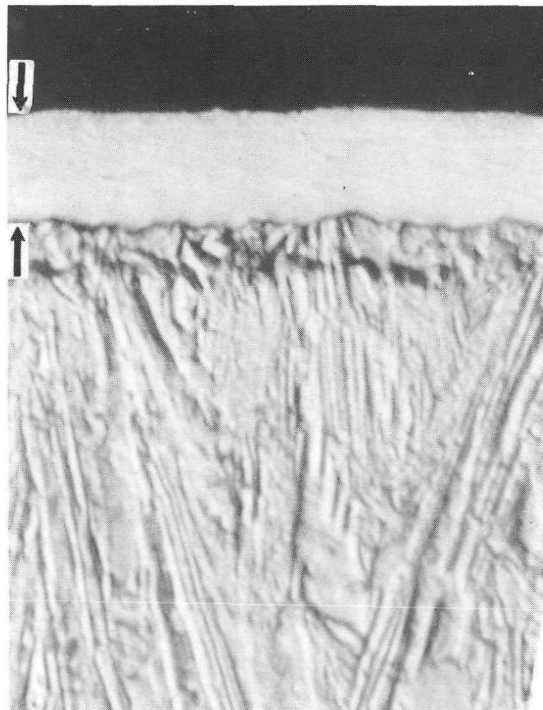
Upon completion of the test (2230 hours), attempts were made to separate the gold plating from the copper on an unsoldered conductor. Roll-backs, peeling, probing, and tape tests failed to separate it. Metallographic examination of the plating-copper interface revealed the plating to be acceptably bonded to the copper similar to that shown in Figure 25.

Figure 25. Cross section of gold-plated board before thermal testing. (Gold plating thickness approximately 0.00064 cm.) (2000X magnification)

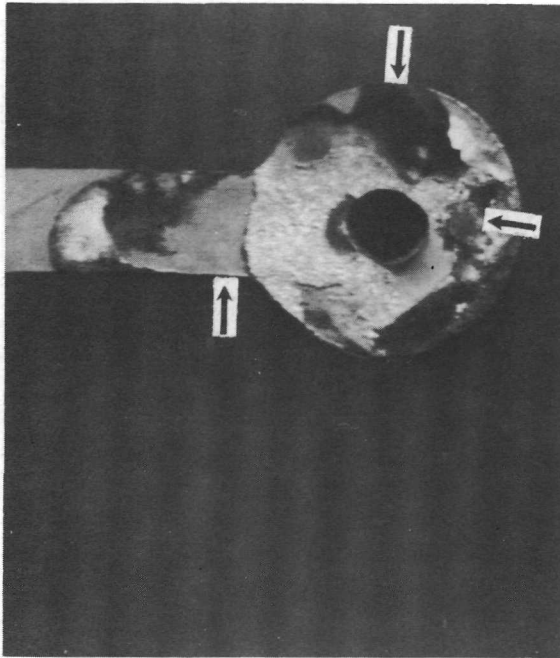
Figure 29. Partial solder separation, indicated by arrows, after 166 hours exposure to 100°C temperature. (10X magnification)

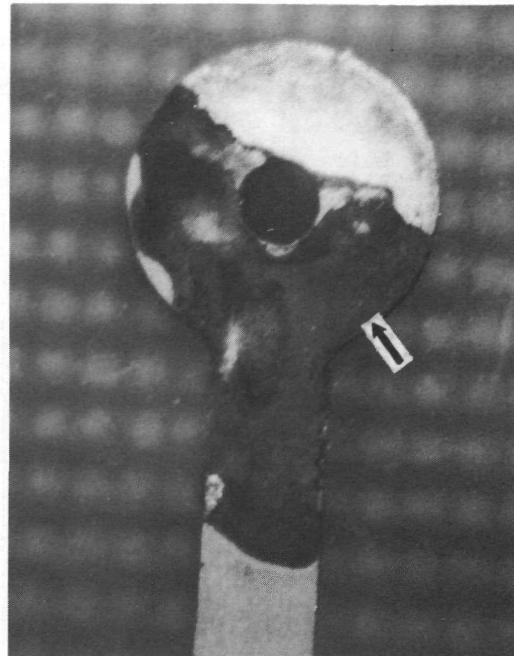
Figure 30. Solder separation from gold-plated laminate copper after 658 hours in test. (Bare copper is pinpointed by arrow.) (10X magnification)

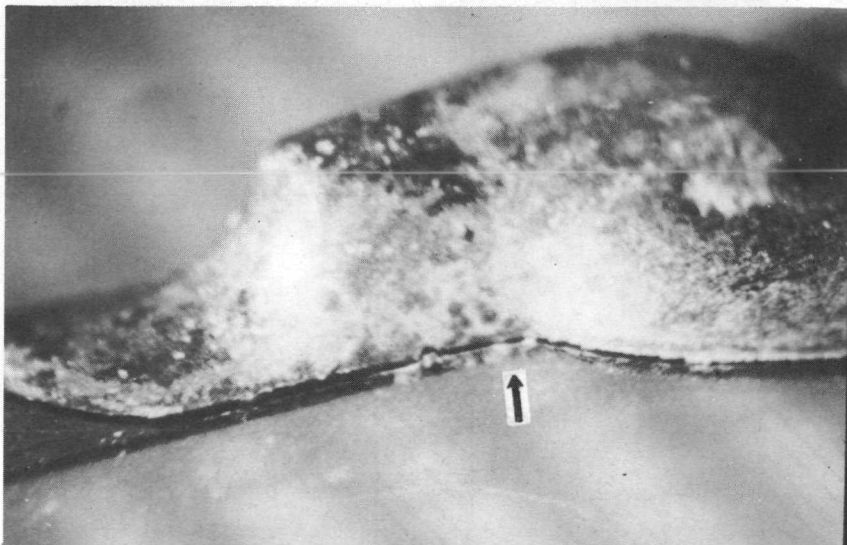
Figure 31. Solder separation from gold-plated copper after 658 hours exposure to 100°C temperature. (Solder is still bonded to the unplated side of the pad.) (25X magnification)

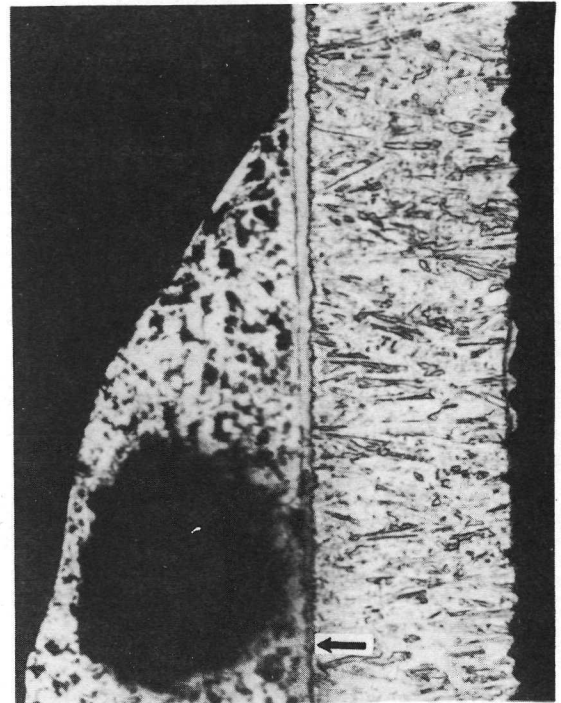
Group B connection
(Arrow indicates gold termination.)

Figure 32. Metallographic views of soldered connections of test board groups prior to tests. (400X magnification)

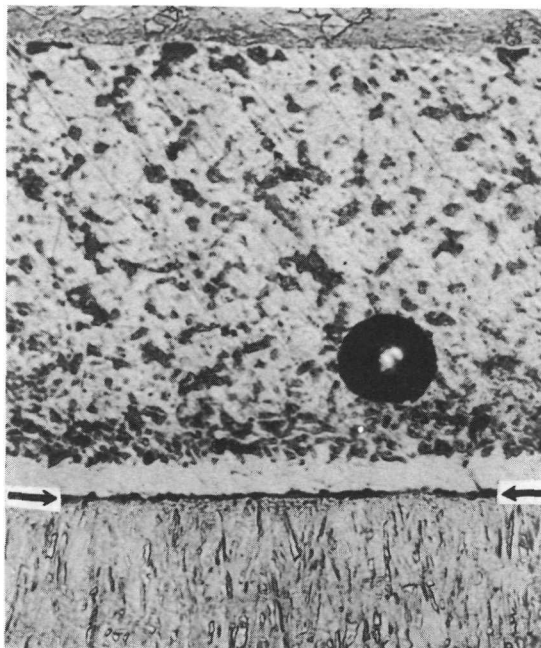
Solder separation was first observed at the second evaluation interval (166 hours), and then only on the solder-to-gold B — group boards. This separation, shown in Figure 33, is approximately 0.00025 cm thick. Separations of varying degrees were observed on these boards until termination of the test. The connections on the bare copper and the erased gold boards have shown acceptable bondings throughout the examinations. Normal growth of the tin and the lead phases in the solder was observed as the test progressed. These connections after 2230 hours are shown in Figures 34 and 35. The increased thickness of copper-tin intermetallic is also a normal condition associated with elevated temperatures. Figure 36 shows a solder/gold

Figure 33. Initial indication of solder separation observed after 166 hours in temperature test. (400X magnification)

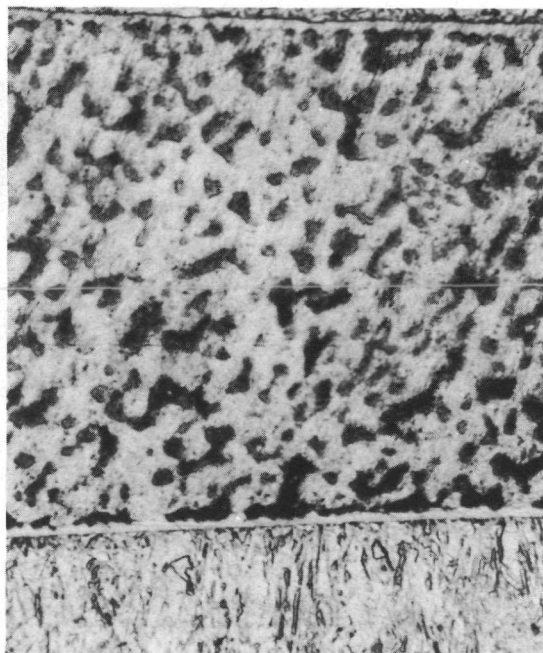
Figure 34. Group A connection upon test completion. (400X magnification)

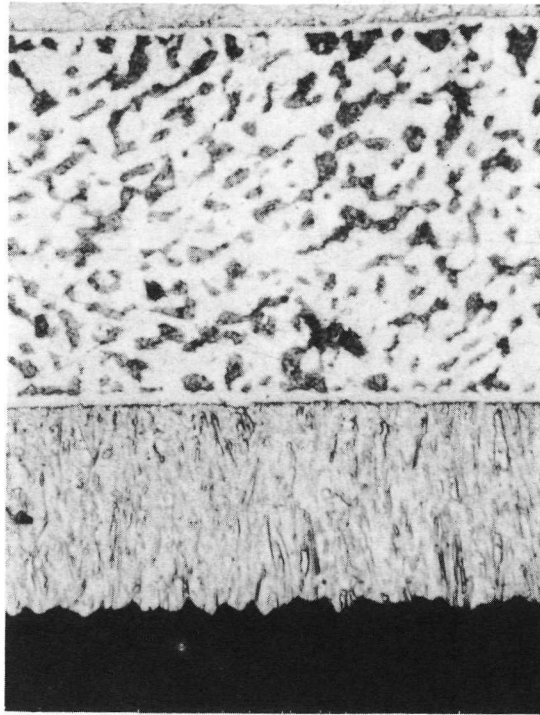
Figure 35. Group C connection upon test completion. (400X magnification)

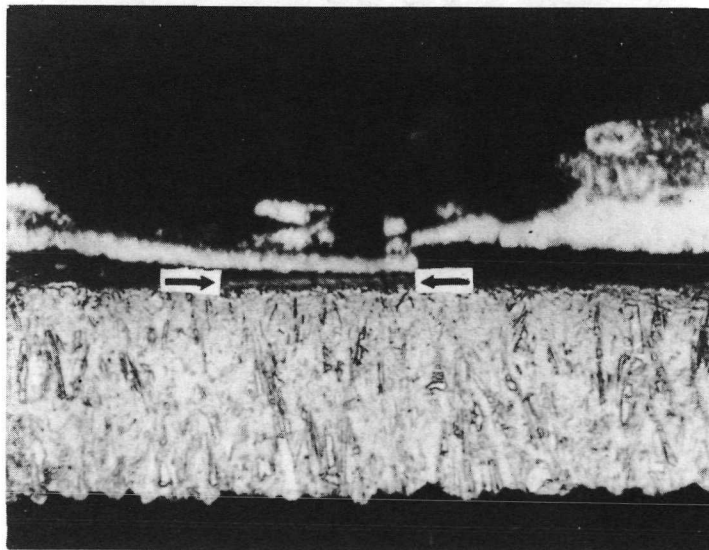
separation on the C board, away from the erased area. Note the gold plating still on the copper as shown between the arrows. Not all the connections on the soldered-to-gold B boards revealed completely unbonded solder. An erratic separation pattern was noted with dark bands adjacent to the solder in many instances. Photomicrographs of B board separations that were more commonly seen are shown in Figures 37 and 38. Voids and widespread porosity in the solder beneath the clinched lead are in evidence. Note the bare copper surface between the arrows in Figure 38.

Figure 36. Group C solder away from erased gold area.
(400X magnification)

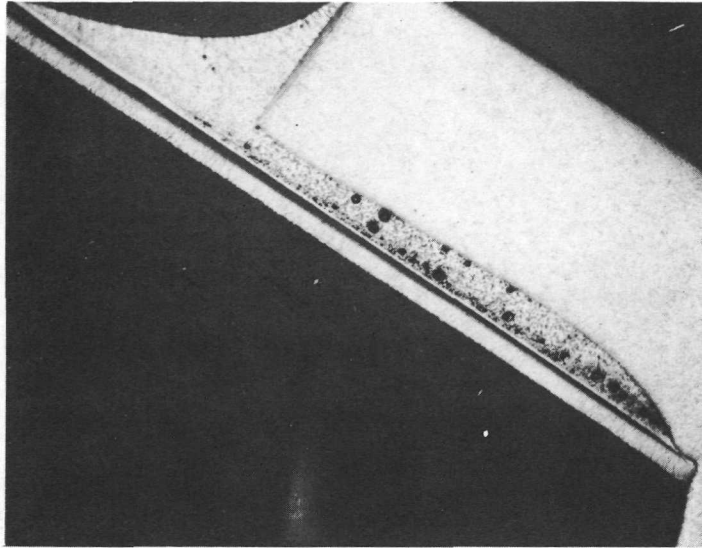
Figure 37. Connection soldered to gold — Group B — upon test completion.
(Note outgaseous voids.) (35X magnification)

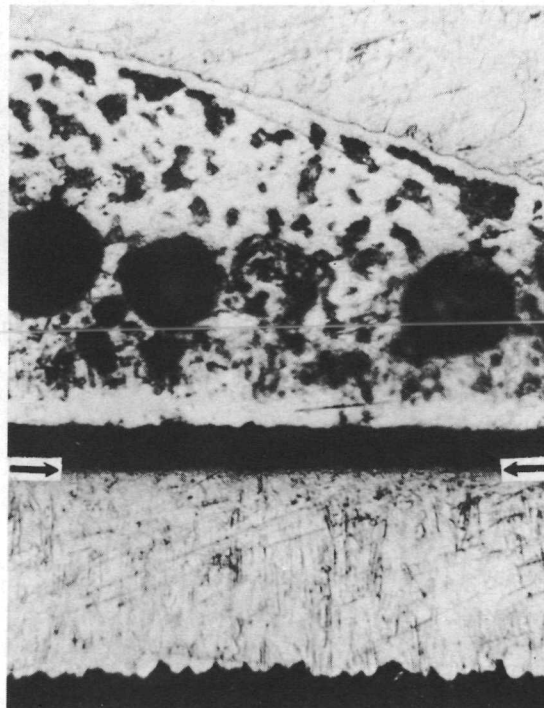
Figure 38. 400X magnification, showing bare copper, of connection shown in
Figure 37.

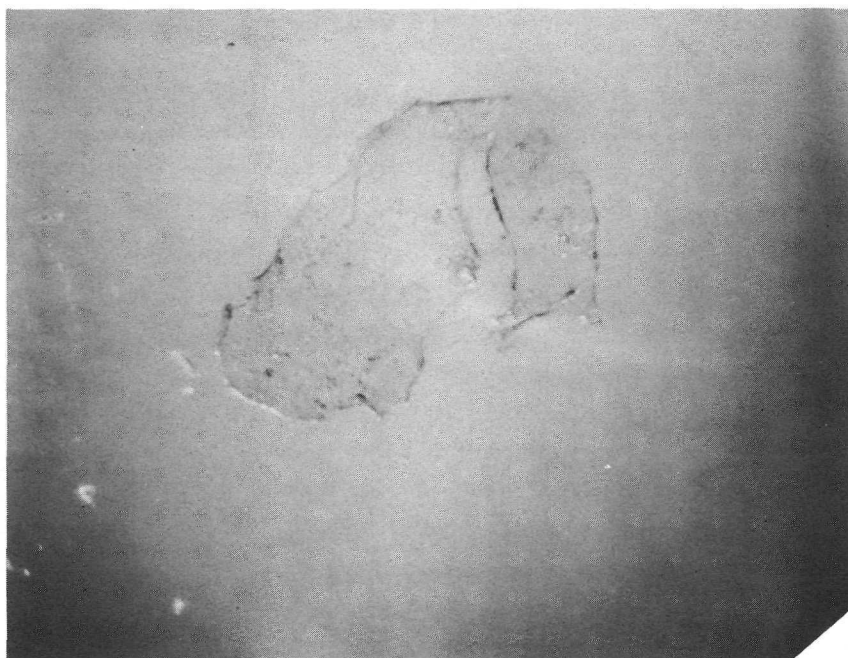
Figure 39. Transparent polymer isolated from a solder separated gold plating. (40X magnification)
