# SPACE-STORABLE OXIDIZER VALVE

FINAL REPORT  
NOVEMBER 1970

McDonnell Douglas Astronautics Company—West  
McDonnell Douglas Corporation  
5301 Bolsa Avenue  
Huntington Beach, California 92647  
for

NASA Lewis Research Center  
Cleveland, Ohio  
R.E. Grey, Project Manager  
Liquid Rocket Technology Branch  
NATIONAL AERONAUTICS AND SPACE ADMINISTRATION

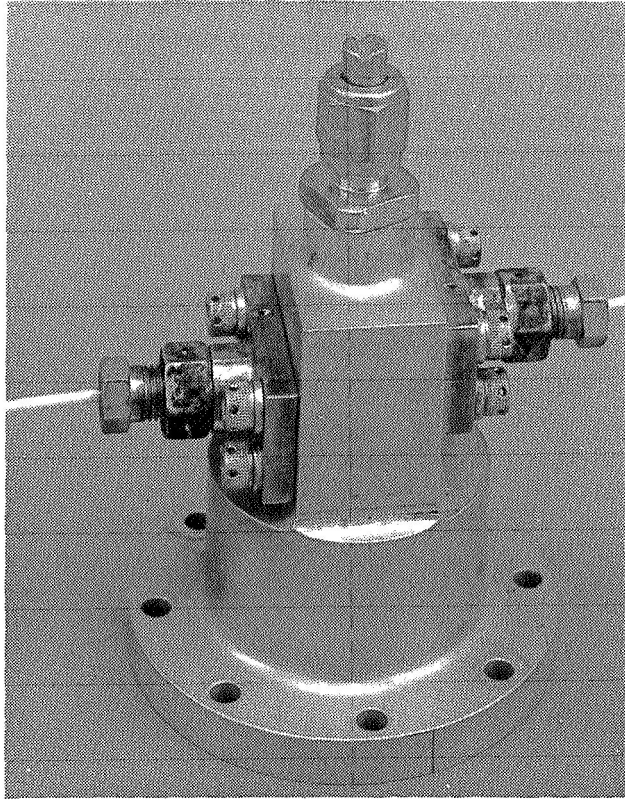
Figure 3-14. -1 Valve Actuator Cap After Task III Testing

A preliminary visual inspection of the valve exterior showed some black deposits on the position indicator bosses and lock nuts (Figure 3-14). Otherwise, the valve's appearance was normal. The appearance of the valve's inlet and outlet flanges, internal cavities, and static seals after removal of the test adapters was also normal. The valve was disassembled, noting the tightening torque of each bolt or screw before removal. All torque values were found to be within specification. Removal of the actuator cap revealed black soot deposits around the entire circumference of the piston seal and the seal recess in the actuator cap (Figures 3-15 and 3-16). Also, two grooves were burned in the teflon seal where it contacted the piston (Figure 3-17). Later removal of the position indicator bosses and seals showed no evidence of damage or leakage. From this it is concluded that all external  $\text{GF}_2$  leakage was through the actuator vent port. Next, the indicator nut, actuator piston, inner and outer springs, piston shims, and the actuator housing were removed. All of these parts were in good condition, showing no signs of fire damage. Minor impact marks on the actuator piston face, and spring scratches inside the actuator housing were the result of operation at the proof-pressure condition (Figures 3-18 and 3-19). At this time, the valve inlet was pressurized with 20 psig ( $1.38 \times 10^5$  pascals) GHe, producing audible leakage around the poppet shaft. The bellows adapter seal appeared to be leak-tight. Also, movement of the poppet shaft from side to side changed the intensity of the audible leakage, a strong indication that the poppet-shaft bellows seal was cracked. Finally, the poppet and the seat assemblies were removed (Figures 3-20 and 3-21). These parts and their associated static seals were in excellent condition. The mating flanges and seal recesses of the valve body and the seat showed some discoloration (Figures 3-22 and 3-23), but

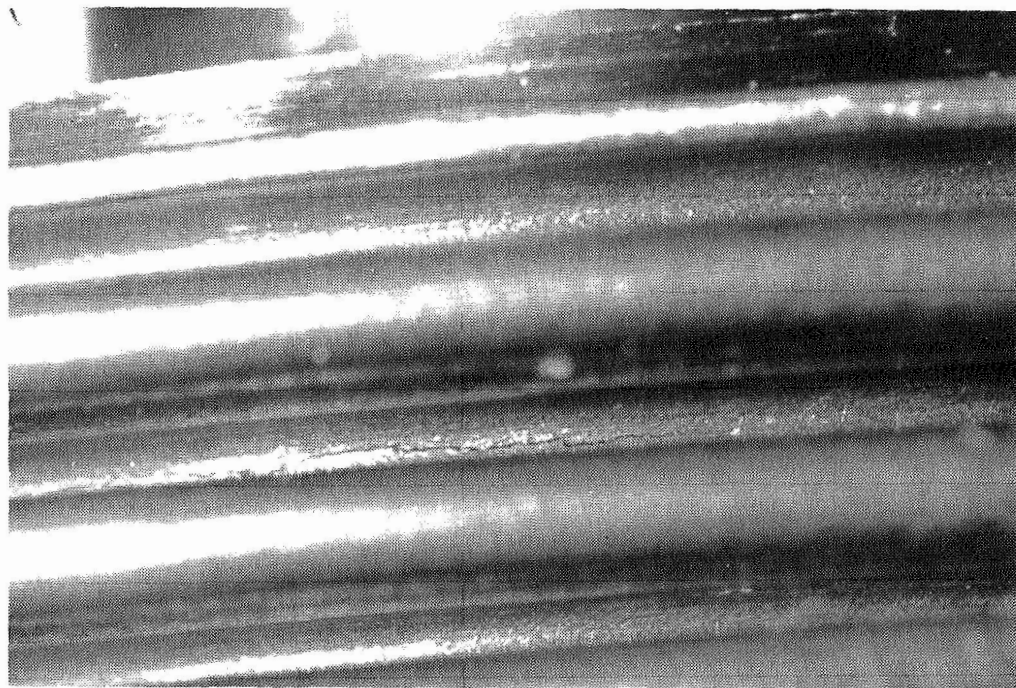
Figure 3-27. -1 Valve Poppet-Shaft Bellows Fatigue Crack

the design-integrity proof pressure of 250 psig ( $1.73 \times 10^6$  pascals). A fatigue crack occurred in the poppet-shaft bellows seal after 571 cycles. The crack, caused by a ringing vibration of the poppet shaft when the actuator piston repeatedly reached the limit of its travel during valve closing, is an explainable failure at the stringent off-design pressure condition of the test. Subsequently, both valves were exposed to a series of environmental tests.

The -1 valve was returned to Parker Hannifin Corp. for repair of the damaged bellows seal, and also for rework of the static seal recesses. The latter work was required in connection with a special test of external seal leakage. Although internal leakage rates for this valve were well within specification before rework, they became excessive after the rework. The difficulty, traced to imperfectly lapped poppet and seat sealing surfaces, was eventually solved by relapping the -1 seat and installing the -501 poppet assembly. A test to verify satisfactory external leakage characteristics of the static seals at  $\text{LN}_2$  temperature was accomplished by installing the -1 valve in an evacuated tank and monitoring vacuum decay. External leakage rates of less than  $1.2 \times 10^{-5}$  ccs were measured with the valve inlet pressurized to 100 psig ( $6.90 \times 10^5$  pascals) and  $2 \times 10^{-4}$  ccs with both the inlet and outlet portions of the valve pressurized.

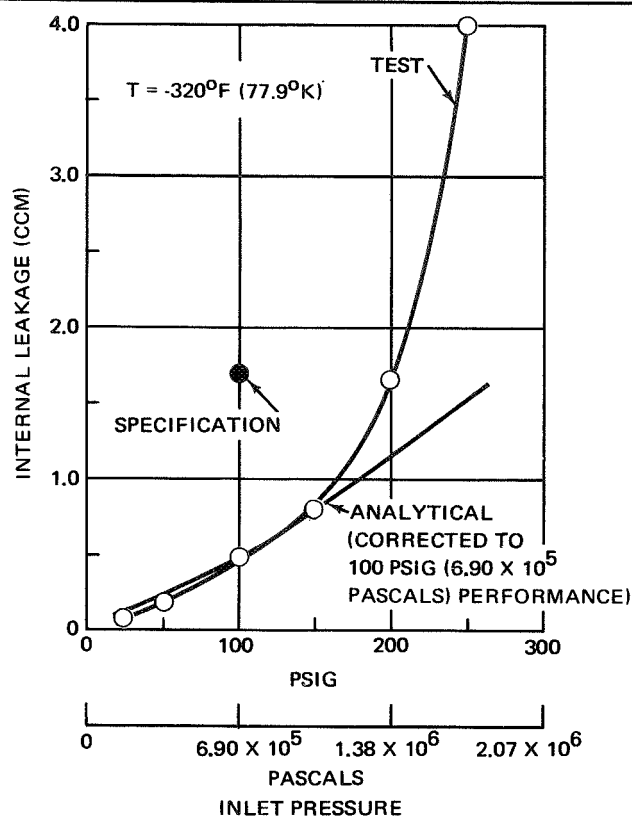
Figure 3-28. Low-Temperature Internal Leakage of -501 Valve After 373 Cycles

As expected, the -501 valve showed an improvement in internal leakage with cycling. The initial leakage of 0.27 ccm ( $4.51 \times 10^{-3}$  ccs) dropped to 0 at ambient temperature conditions at the end of the test (307 cycles), and the low-temperature data showed a drop from an unacceptable 2.85 ccm ( $4.76 \times 10^{-2}$  ccs) to an acceptable 0.47 ccm ( $7.85 \times 10^{-3}$  ccs) after cycling. This decrease in leakage appears to have occurred during the first few cycles in  $\text{LF}_2$ , with the leakage rate remaining fairly constant for the duration

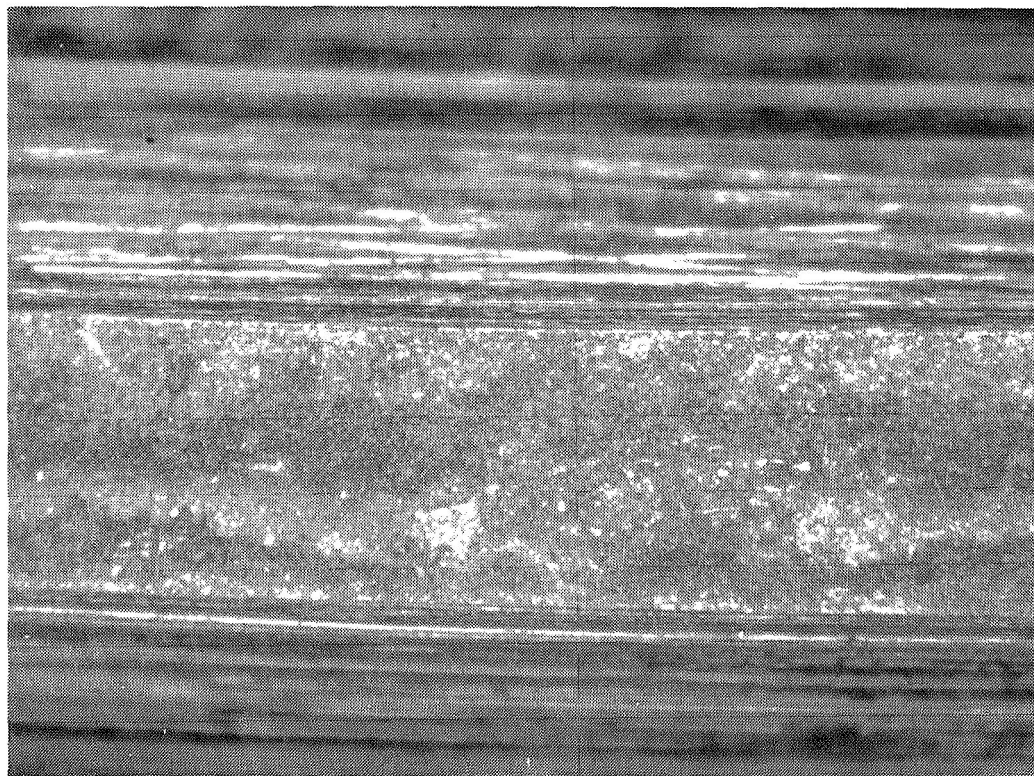
Figure 3-48. Sealing Surface of -1 Valve Seat After Vibration Tests (100X)

Finally, the valve was subjected to sinusoidal and random vibration loading profiles while exposed to 100 psig ( $6.90 \times 10^5$  pascals)  $\text{LF}_2$ . Posttest leakage checks and valve disassembly showed that the valve successfully withstood the imposed vibration loads, and demonstrated that the design is sound. Internal valve leakage rates below the NASA goal of  $10^{-8}$  lbm/sec ( $4.54 \times 10^{-9}$  kg/sec) of GHe at  $-320^\circ\text{F}$  ( $77.9^\circ\text{K}$ ) and 100 psig ( $6.90 \times 10^5$  pascals) (equivalent to  $10^{-7}$  lbm/sec [ $4.54 \times 10^{-8}$  kg/sec] of  $\text{GF}_2$  at  $-290^\circ\text{F}$  [ $94.4^\circ\text{K}$ ] and 100 psig [ $6.90 \times 10^5$  pascals]) were consistently demonstrated for both valve configurations.
