FINAL REPORT

1970 SOLAR-TRACKER
BALLOON FLIGHTS
3055, 3056, 3057

November 1970

JPL Contract No. 952879

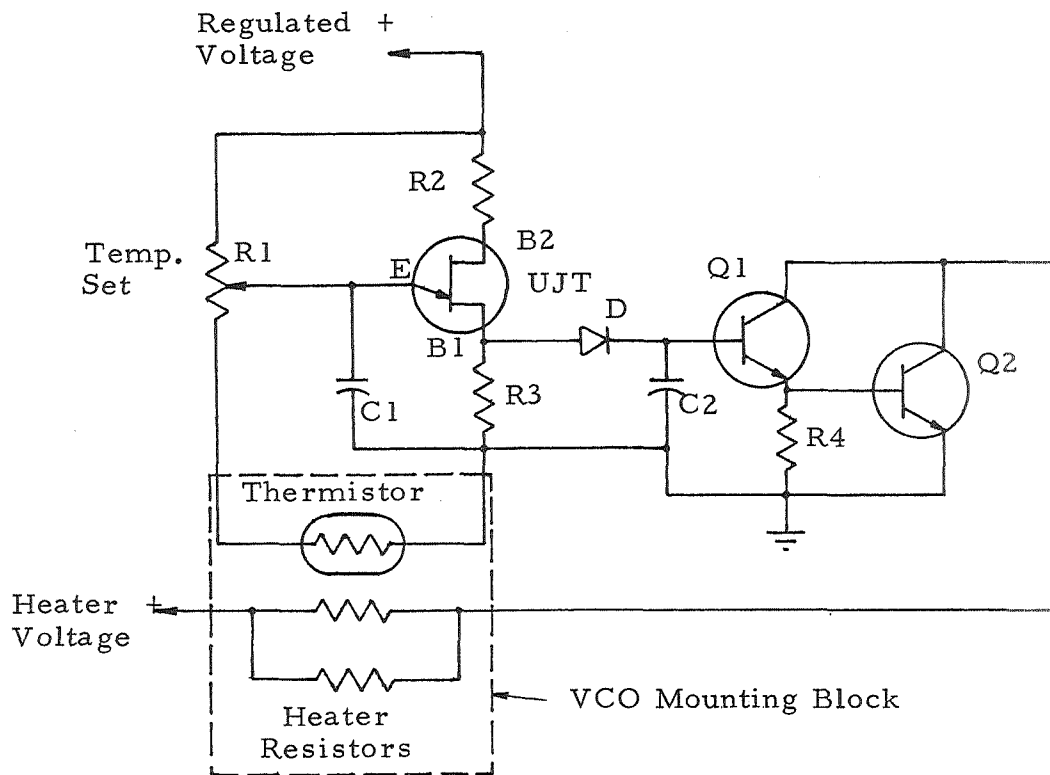
One area where a circuit modification would result in a significant improvement in system accuracy is in the VCO temperature control circuit. The present circuit consists of a heating resistor and a bimetal thermostat mounted within the VCO module. Although the thermostat has an operating differential of 1°C , when all thermal paths are considered, the actual thermal circuit differential is greater than 1°C . A more difficult problem has been the reliability of the thermostat. Over the last three years thermostats have failed several times on flights and during checkout between flights. A solid state circuit replacement for the bimetal thermostat will reduce temperature differential and improve reliability. A variety of circuit configurations can be used to replace the thermostat. A trigger circuit containing a negative temperature coefficient thermistor is currently being used for an application similar to this one. The circuit diagram is shown below:

The trigger device in this circuit is a unijunction transistor (UJT) that changes abruptly from a nonconductive to a conductive state when a critical voltage is reached at its emitter (E) terminal. The ratio of the voltage dropped across the thermistor and R1 can be adjusted by R1 so that the UJT conducts at the desired temperature. Since thermistor resistance increases as temperature decreases, the voltage across the thermistor increases until the UJT conducts. When the thermistor's temperature is below the control point, the UJT does not conduct continuously but oscillates at a frequency determined primarily by the R1-C1 time constant. The oscillator pulse output appears across R3 and is coupled through a diode (D), charging capacitor C2. The voltage across C2 is primarily d-c and turns on amplifier stage (Q1) which in turn drives a power amplifier transistor (Q2). The Q1-Q2 amplifier has high current gain so that whenever the UJT stage oscillates full power is applied to the

heater resistors. To complete the thermostat cycle, the thermistor senses the heat from the power heater resistors through the mounting block. This heat lowers the resistance of the thermistor reducing the voltage at the emitter of the UJT to return it to a nonconduction state.

The circuit described above is very similar to the "On-Sun" circuit also used in Box #2 except that the photoresistive sun sensor is replaced with a temperature sensitive resistor (thermistor). It is recommended that the above circuit as well as one or two similar circuits incorporating integrated circuitry be evaluated during preliminary preparations for future calibration flights. A highly sensitive and reliable circuit could be selected, evaluated and installed to replace the bimetal thermostat.

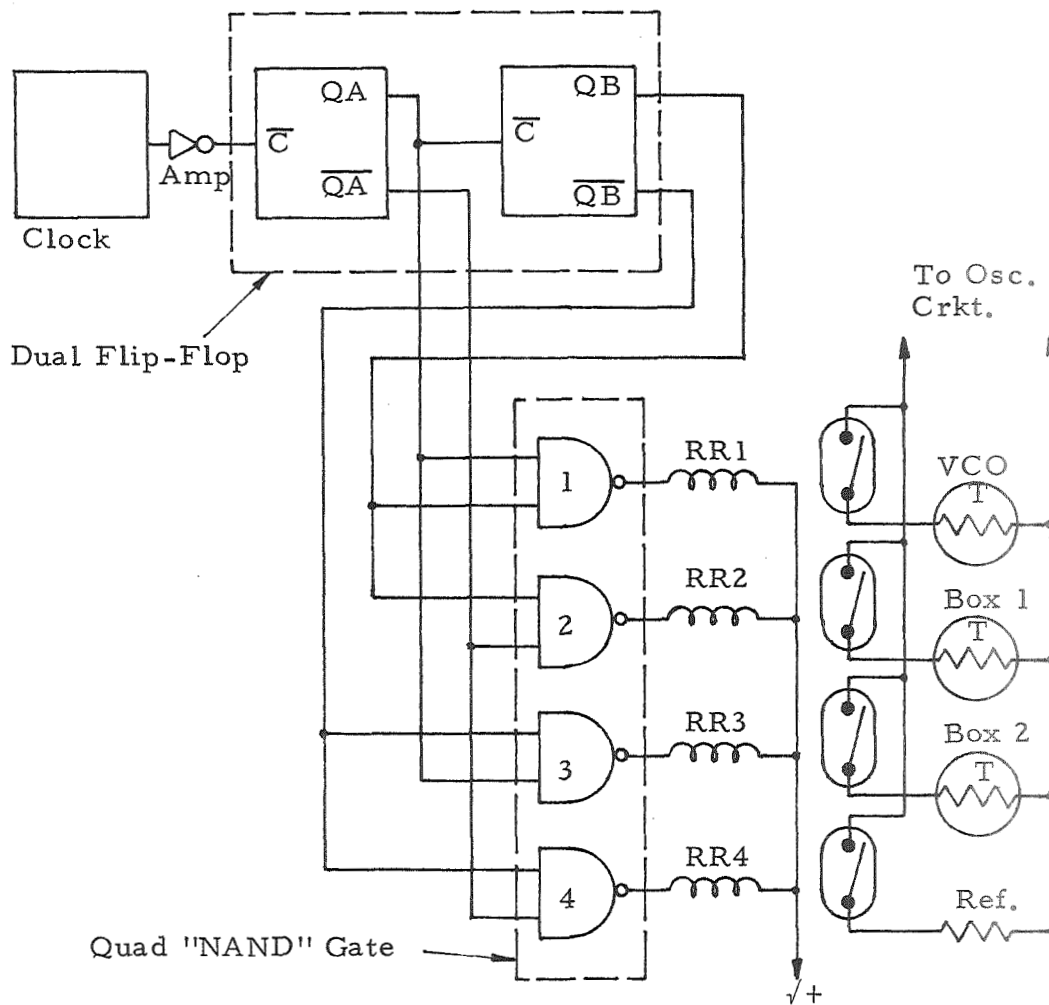
The electromechanical switch used to commutate the secondary temperature data has failed or become intermittent during flight a significant number of times. A small size, low cost alternative to this motor driven switch has not been available in the past. A number of solid state switching circuits or solid state driver/reed relay circuits are potentially suitable as high reliability commutator replacements. To make this task practical it is necessary to reduce the number of separate commutator steps from the present 8 to a maximum of 3 to 5. Since the present 8 channel arrangement includes 2 channels for VCO and 2 for reference frequencies, a 6 channel system would provide for all present temperature data. To achieve a less complex circuit, elimination of the ambient air sensor, the tracker back plate temperature sensor and/or the Box #2 chassis temperature sensor could be considered. These sensor readings are normally not vital to the success of a flight.

Assuming a 4 channel capacity, there are integrated circuit packages available that contain both the digital circuitry and the field-effect switching transistors necessary to multiplex four inputs onto a single output line. Unfortunately, there are some disadvantages using these devices in this application. The devices now available require both negative and positive supply voltages. The output transistors also require bias voltages and impedance levels that are not compatible with the existing thermistor controlled multivibrator circuitry. A circuit that uses sealed-in-glass

reed switch relays for output signal coupling is compatible with the existing system. The reed switches are theoretically not as reliable as a completely solid state system but a life rating of over 50 million cycles is standard which would not affect flight reliability in any way. A logic diagram of the suggested circuit is shown below:

The "clock" stage consists of a temperature compensated unijunction transistor producing a trigger pulse every 15 sec. This pulse is shaped, inverted and applied to an integrated circuit dual flip-flop counter. The counter has four outputs used to sequentially actuate four gate circuits in another integrated circuit package. Each "NAND" gate drives a single

pole reed-switch relay. The relays have low power consumption and are each about the size of an integrated circuit package. The common terminal of each relay contact set are connected together and to the common return side of the secondary frequency oscillator. The normally open contact of each of the four relays are connected to a sensing thermistor or reference resistance. The opposite end of each thermistor or reference resistance is then attached to the high input side of the secondary frequency oscillator to complete the circuit. The counter and gate stages are wired for operation of one of the four relays in a sequential manner providing complete electrical isolation between channels and between the secondary frequency oscillator and the commutator driving circuitry.
