TEST AND EVALUATION OF THE

SURVEYOR III TELEVISION CAMERA

RETURNED FROM THE

MOON BY APOLLO XII

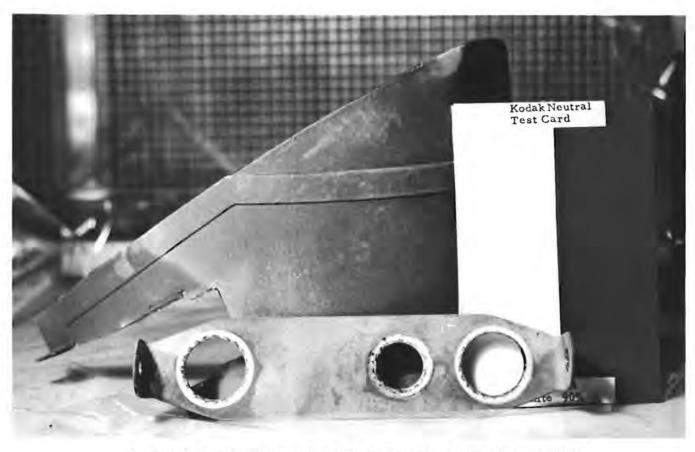
Figure 3-19. Color Variations on Sunshade and Connector Bracket (Photo 70-5166)

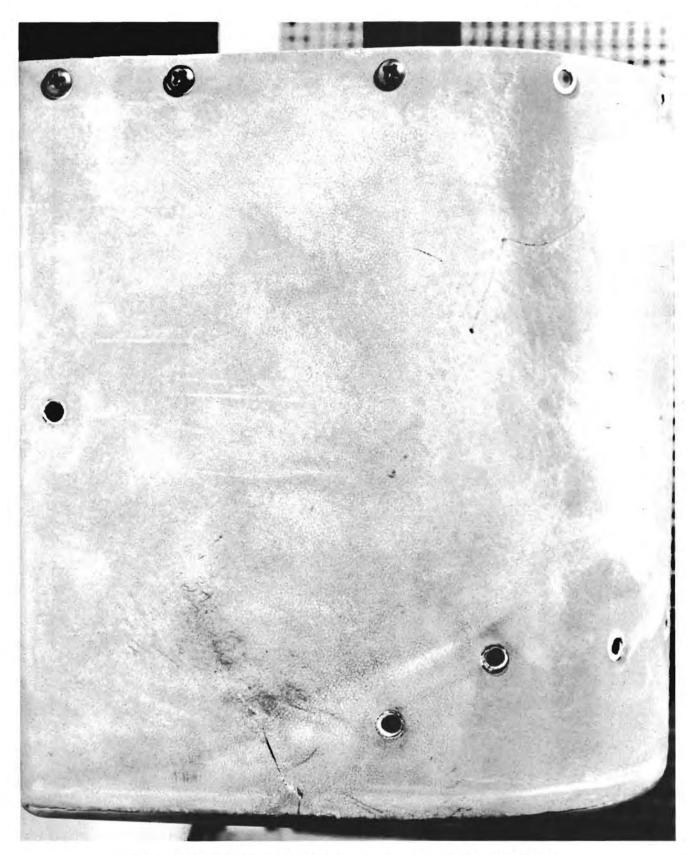
Figure 3-20. Evidence of "Mud Cracking" on Lower Shroud (Photo 4R14276)

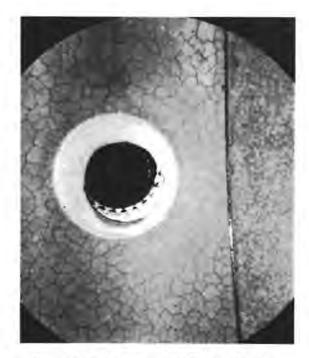
Figure 3-21. Variations in "Mud Cracking" on Lower Shroud Area (Photo M917861)

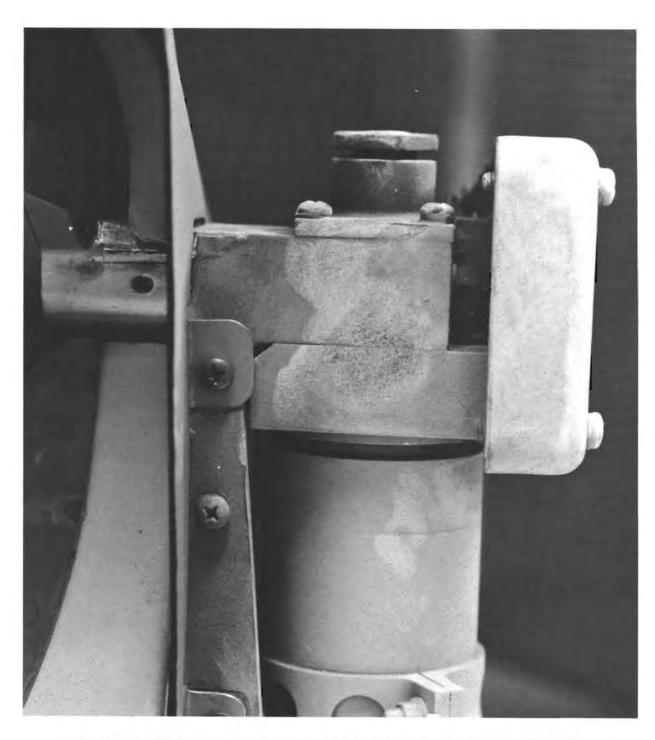
Figure 3-22. "Sandblasting" and Erosion on Elevation Drive Motor Housing (Photo 00545-31)

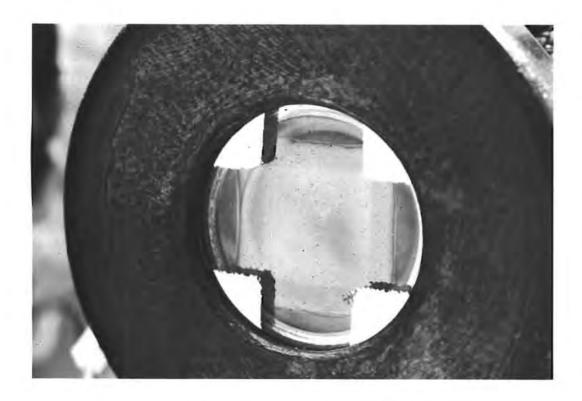
a) Showing Discoloration (Photo 70-4865)

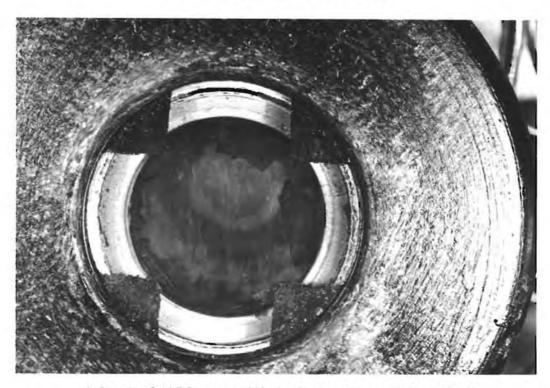
b) Showing Grid 5 Damage and Missing Photoconductor (Photo 70-4862)

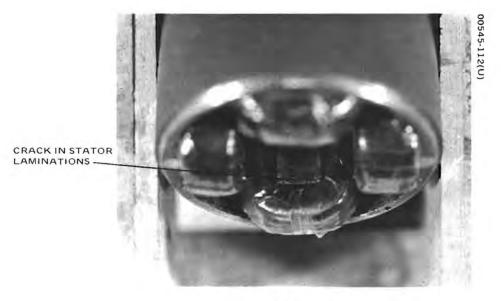
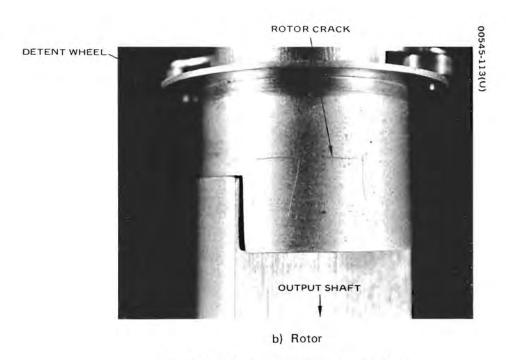
Figure 8-1. Apparent Cracks in Abrams Motor

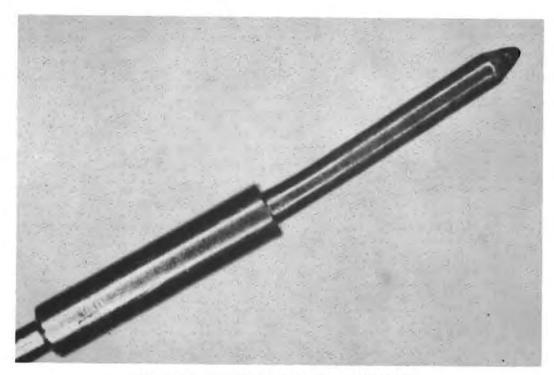
Figure 8-2. Bent Connector Pin (Photo 00545-114)

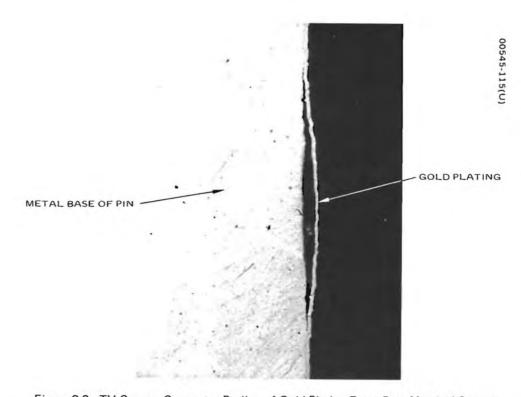
Figure 8-3. TV Camera Connector Peeling of Gold Plating From Base Metal of Contact

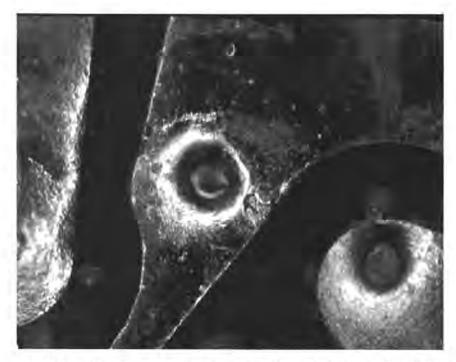
Figure 10-2. Solder Flux on Cordwood Module of Chassis A1 (Photo 00545-171)

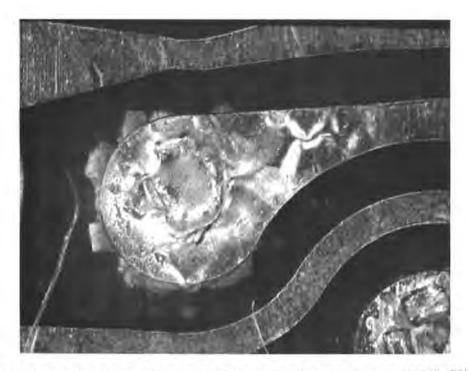
Figure 10-3. Wrinkled Solder Joint on Mother Board of Chassis A1 (Photo 00545-172)

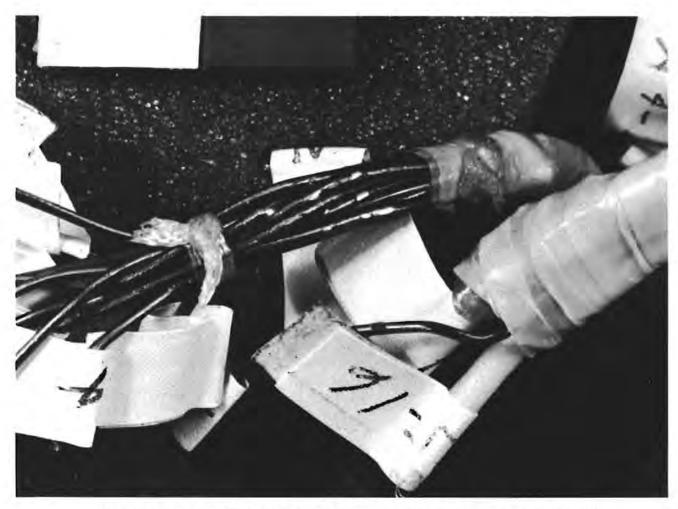
Figure 10-7. Flaking of ML Coating From Surveyor III Internal Wire Harness (Photo 70-5497)

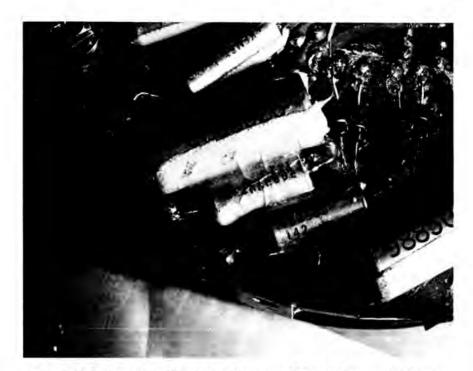
Figure 10-9. Cracking of Conformal Coating on ECU of Surveyor III Camera (Photo 00545-181)

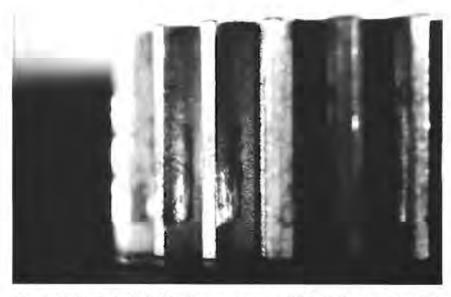
Figure 10-19. Galled Teeth Surfaces on Focal Length Potentiometer Spur Gear (17X Magnification) (Photo 00545-193)

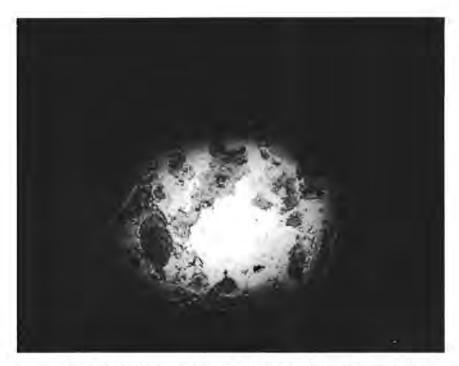
Figure 10-21. Pitting of Bearing Balls of Focal Length Potentiometer (200X Magnification) (Photo 00545-195)

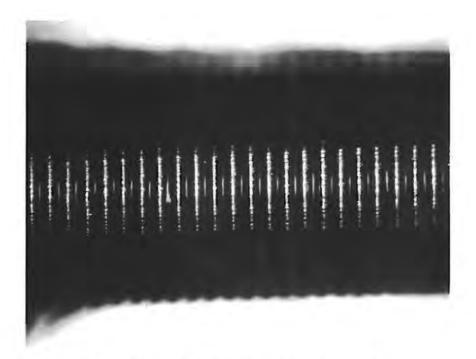
Figure 10-24. Wear Track on Wires of Surveyor III Focal Length Potentiometer Winding (65X Magnification) (Photo 00545-198)

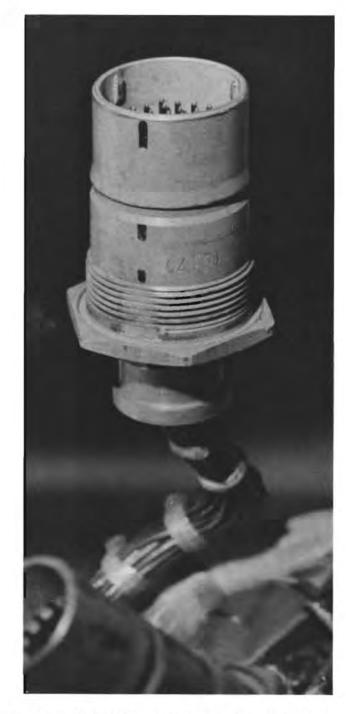
Figure 12-1. J2 Connector Showing Area of Suspected Cold Weld (Photo 00545-202)

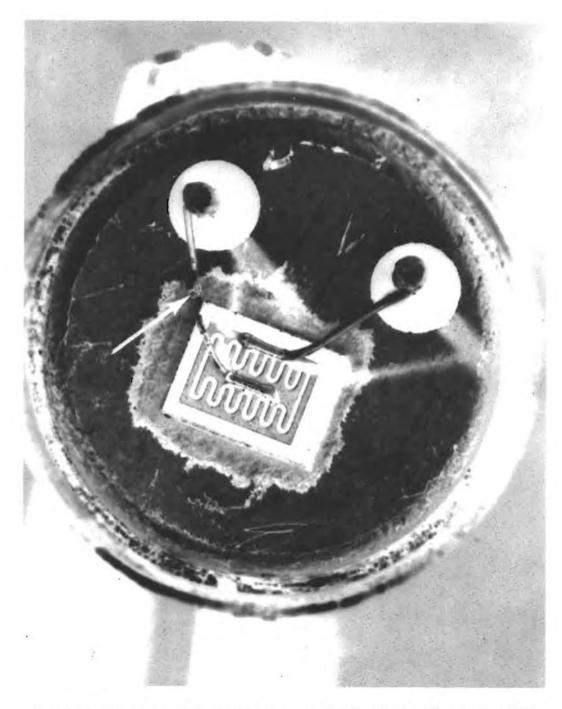
Figure 12-8. Failed Shutter Solenoid Drive Transistor (Q5) Showing Open Emitter Lead (10X Magnification) (Photo 00545-209)

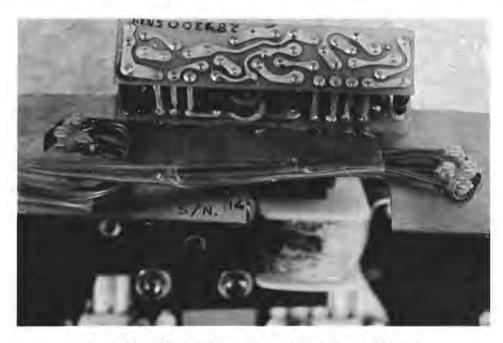
Figure 12-9. Damaged Shutter Solenoid Coil (Photo 70-4885)

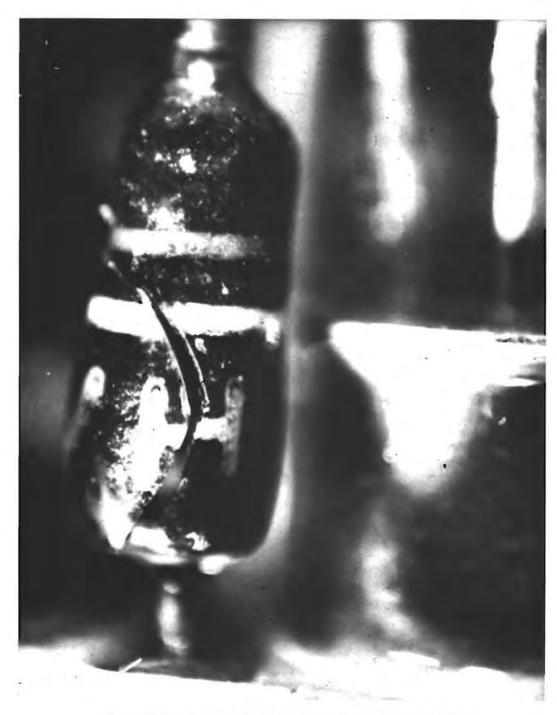
Figure 12-11. Cracked Diode Glass Envolope (Photo 00545-212)

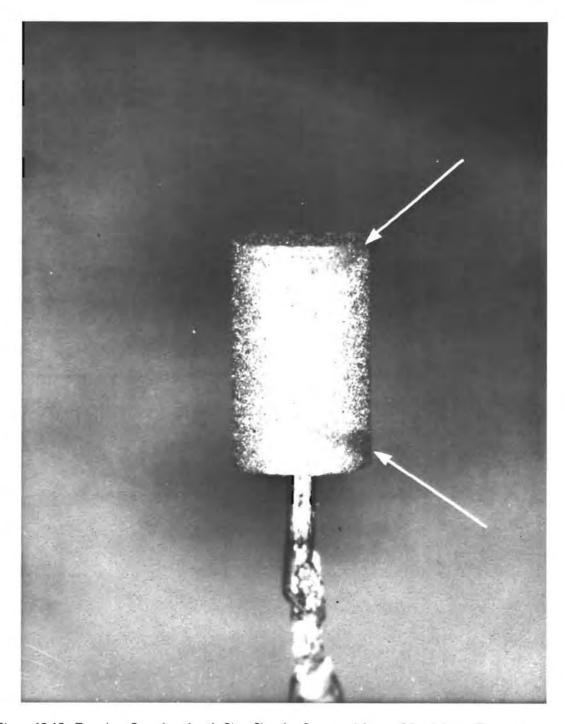
Figure 12-13. Tantalum Capacitor Anode Slug, Showing Suspected Areas of Breakdown (Photo 00545-214)

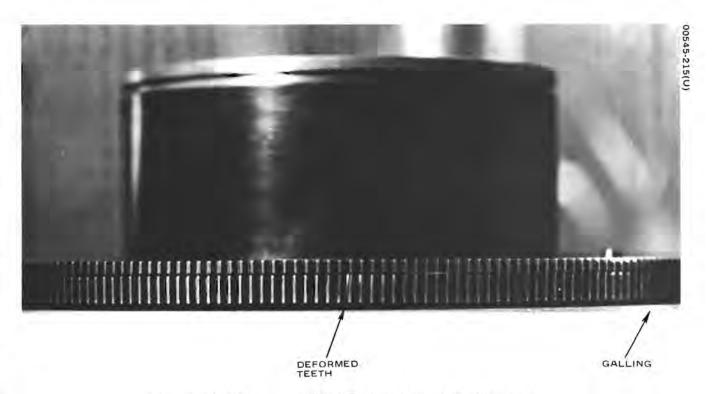
Figure 12-14. Deformed and Galled Teeth of Azimuth Drive Gear Train

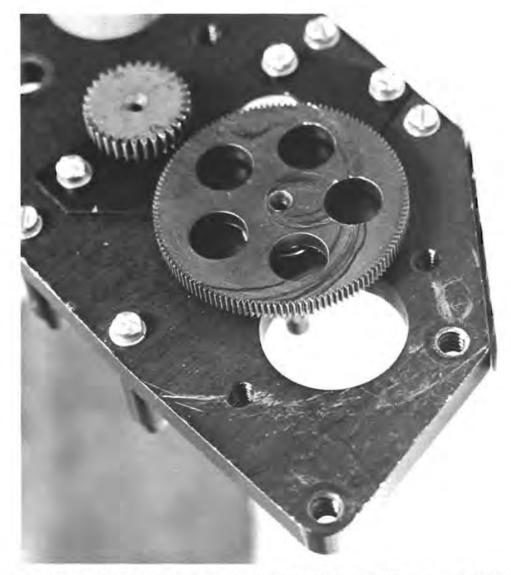
Figure 12-15. Scratch Marks on Filter Wheel Gear Caused by Broken Safety Wire (Photo 4R15019)
