NASA CR-1897

**DESIGN AND APPLICATION OF  
POLYCARBONATE CAPACITORS IN  
AEROSPACE AC POWER SYSTEMS**

*by J. F. Gosda, A. C. Elles, and R. R. Bailey*

TRW

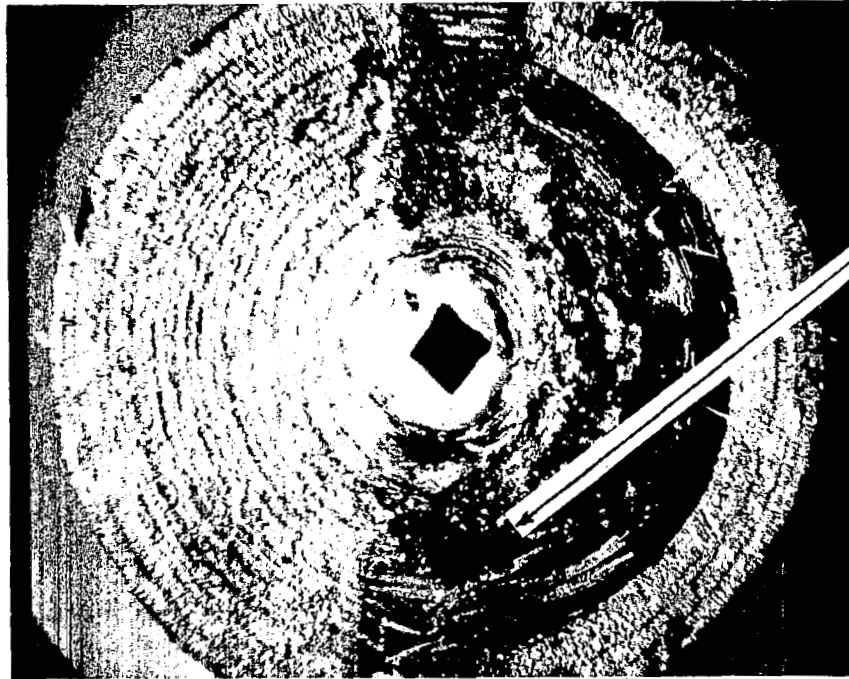
Ser. No. 42XB06

- a. Design B-1 See performance curves in Figures 21, 22, and 23, photograph Figure 24 and refer to Failure Analysis 41 in Appendix B. The increase in DF with time is apparent when reviewing the curve of Figure 22. This was caused by a deteriorating termination which resulted in excess heat at the termination and led to eventual failure.

Note: Carboni-  
zation resulting  
from excess heat

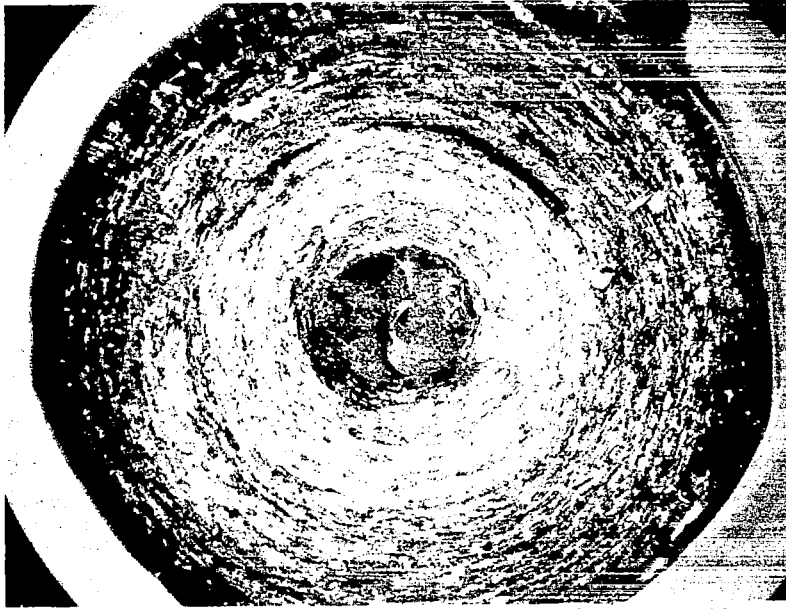
Ser. No. 42XA03

Note: Total  
carbonization  
resulting from  
excess heat

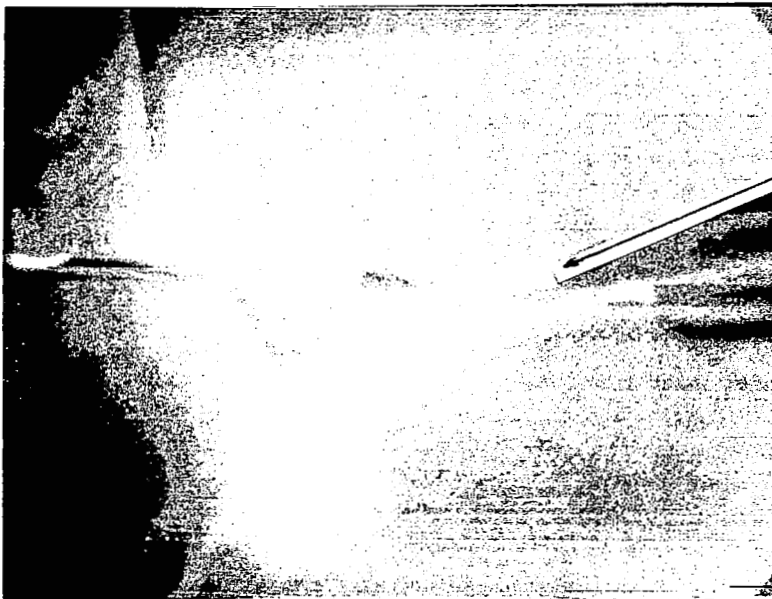
Ser. No. 47XA02

Note: Notice the deposit of metallizing on the layer of plain polycarbonate film.

FIGURE 47. Weakened dielectric due to the presence of corona is the cause for part failure (Design A-3). Refer to Failure Analysis #7. Magnification is 5.25X.
