DIVISION	CR-72920
TM	3710:71-650
DATE	9 June 1970
W.O.	1475-80-201

TECHNICAL MEMORANDUM

TITLE: Evaluation of SNAP-8 Alternator P/N 094069, S/N 481490 after 23,130 Hours of Endurance Testing in the Electrical Component Test Facility (ECTF).

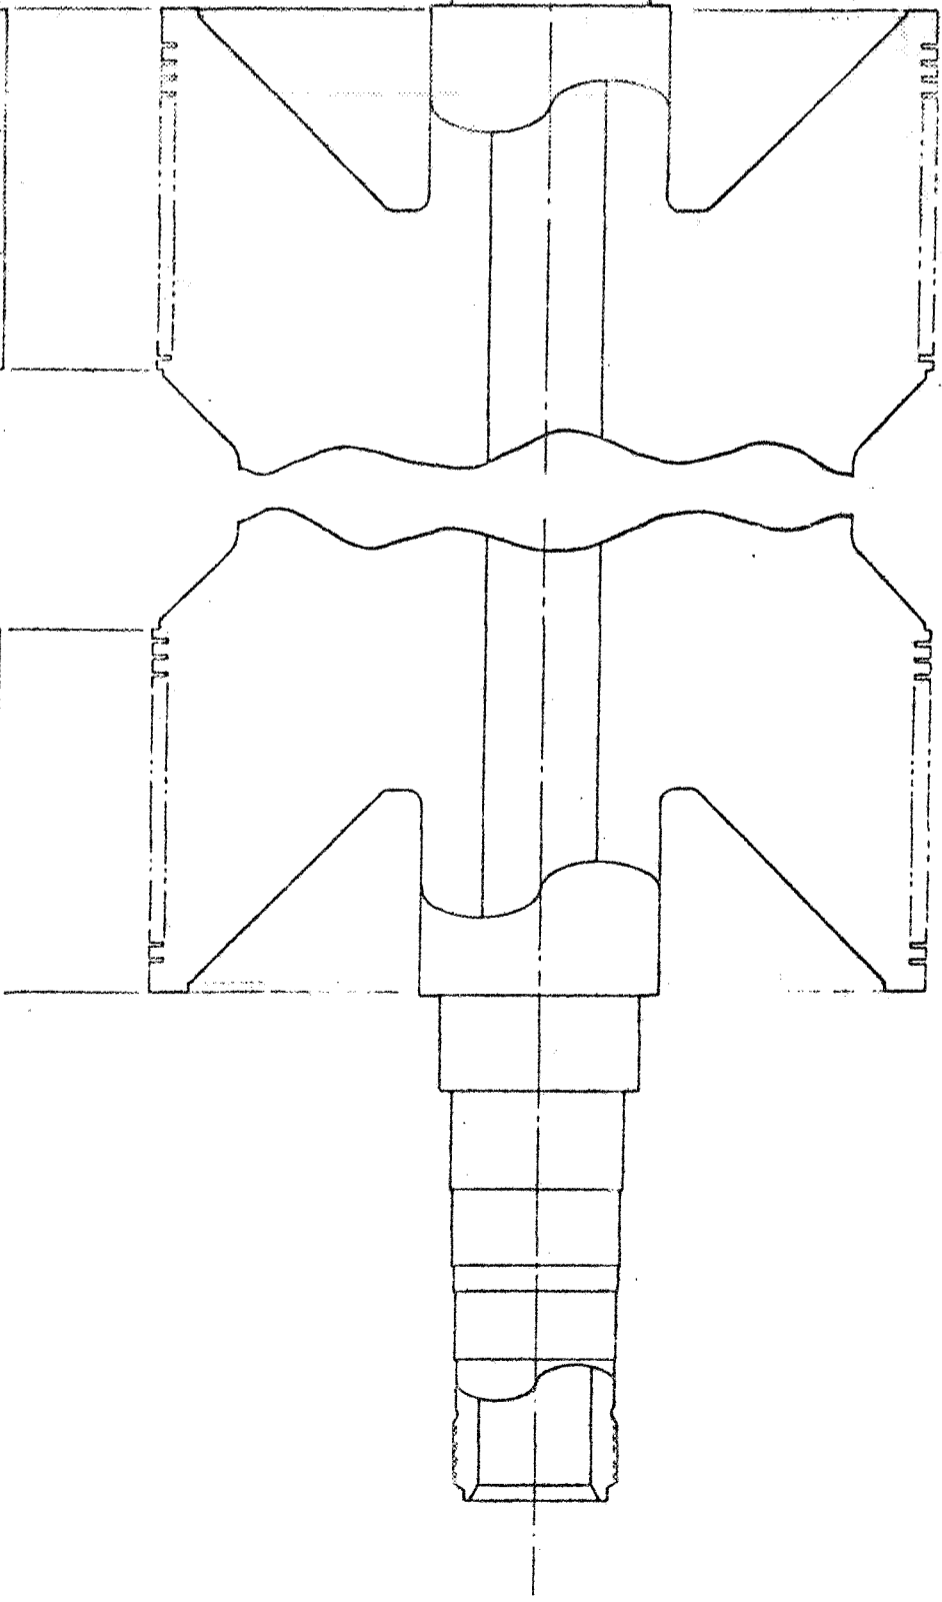
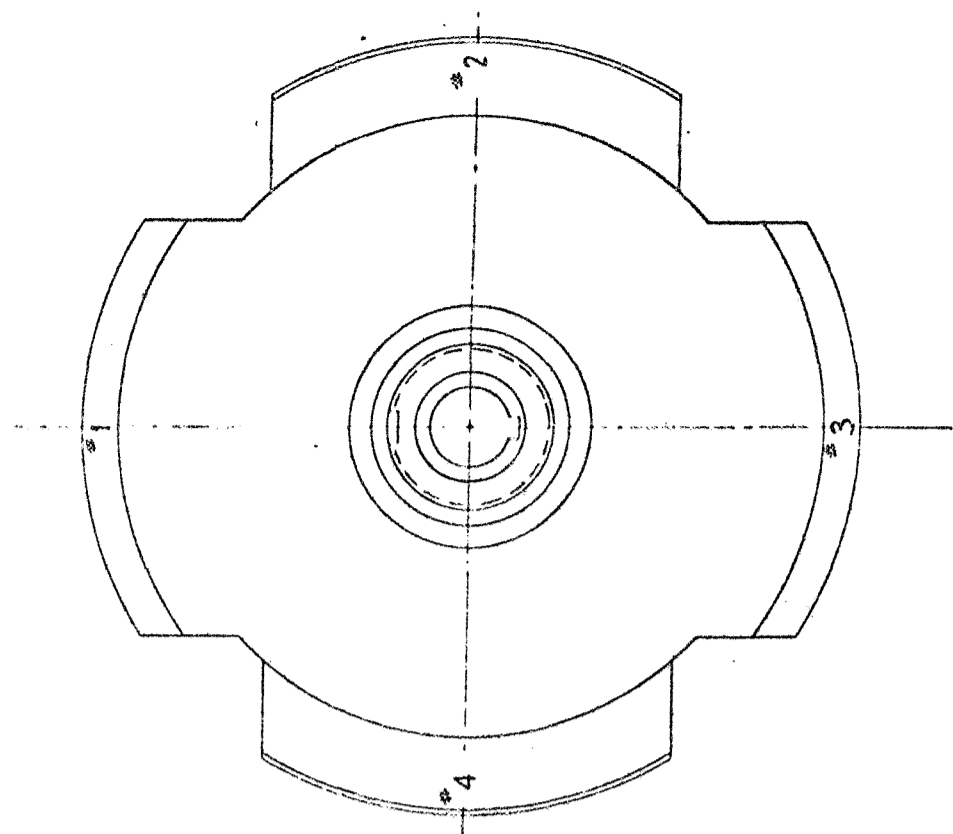
Rotor growth occurred in all operational SNAP-8 alternators. The ECTF alternator, S/N 481490, was found to have a rotor enlarged by .002 inches in diameter at the 2553 hour inspection. At the final inspection the growth had increased to .0058 inches, maximum. Figure 5 shows various rotor diameters at different inspections.

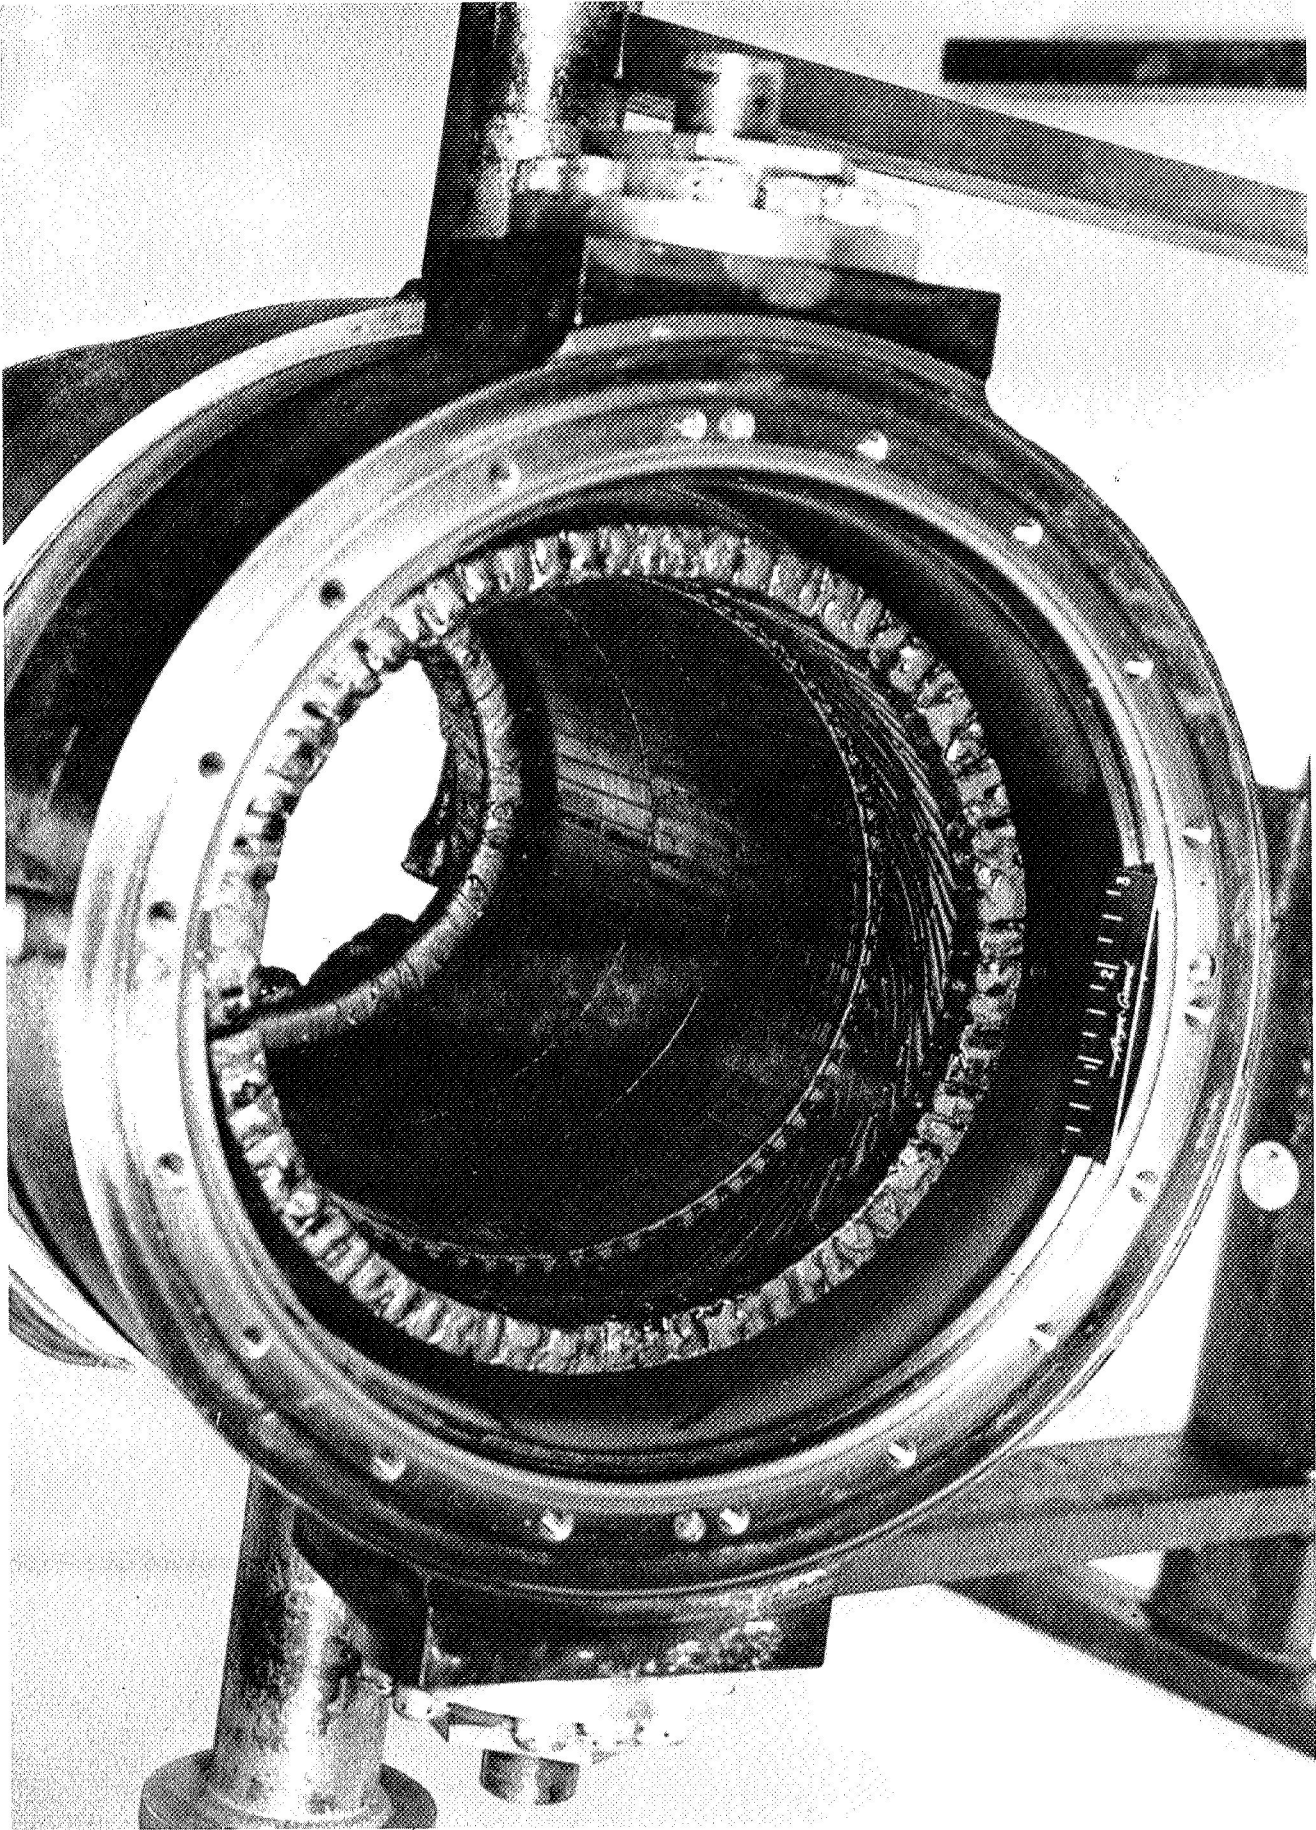
The alternator stator appeared to be in good condition, (see Figures 6 and 7). The darkening of the insulation material had progressed. The electrical resistance inspections at various stages of assembly are tabulated in Table I. These show no degradation. Figure 8 shows a plot of field to frame resistance and stator to frame resistance versus time displaying a wide spread of values over the test period. Moisture presence and lubricant effects soaking the stator are known to cause some differences in the ground resistance measurements.

SNAP-8 ALTERNATOR P/N 094069 · S/N 481490 AFTER 23130 HOURS IN ECTF
VIEW OF DRIVE END OF THE STATOR

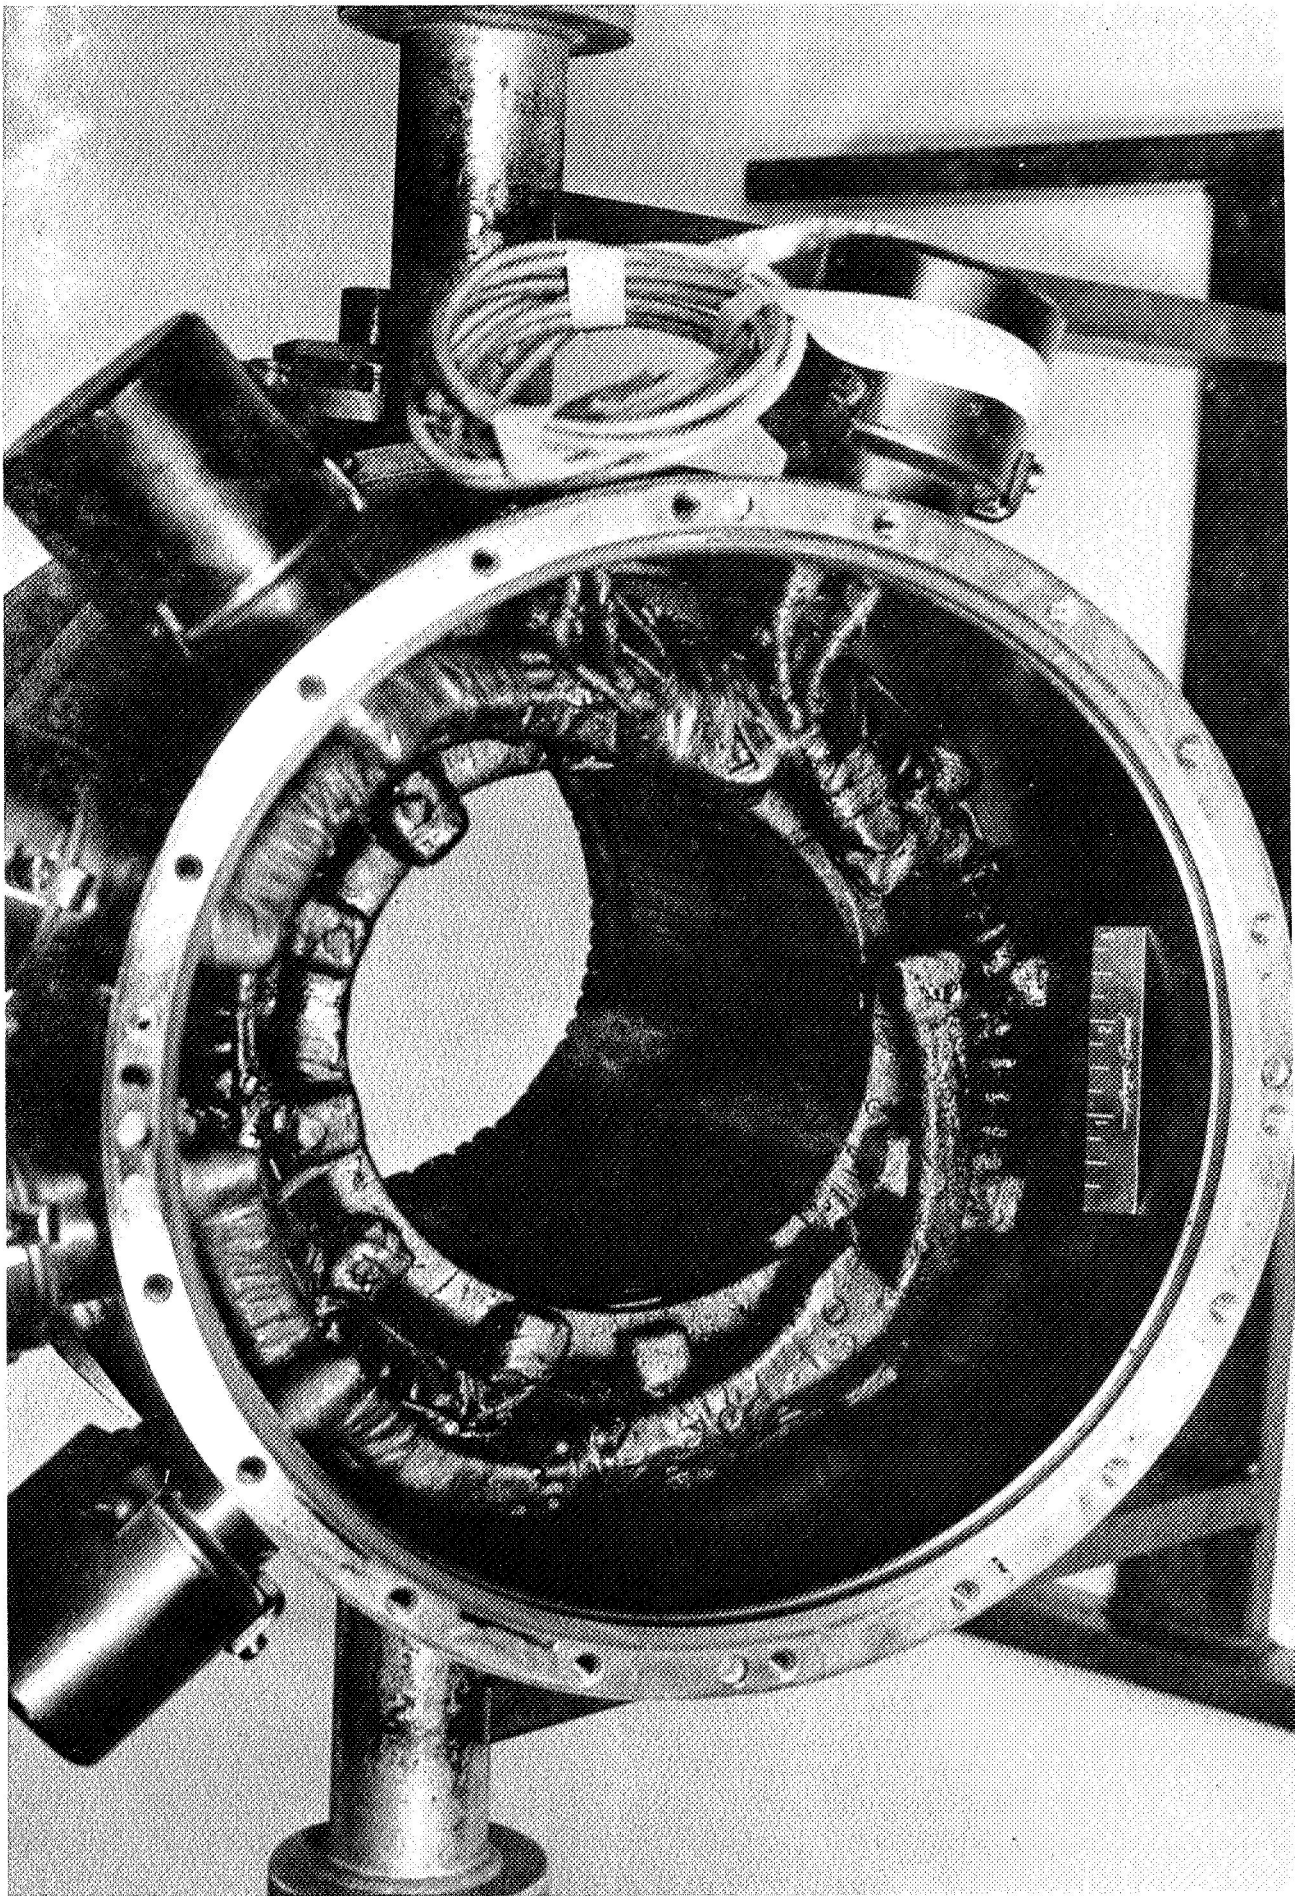
SNAP-8 ALTERNATOR P/N 094069 S/N 481490 AFTER 23130 HOURS IN ECTF
VIEW OF ANTIDRIVE END OF THE STATOR

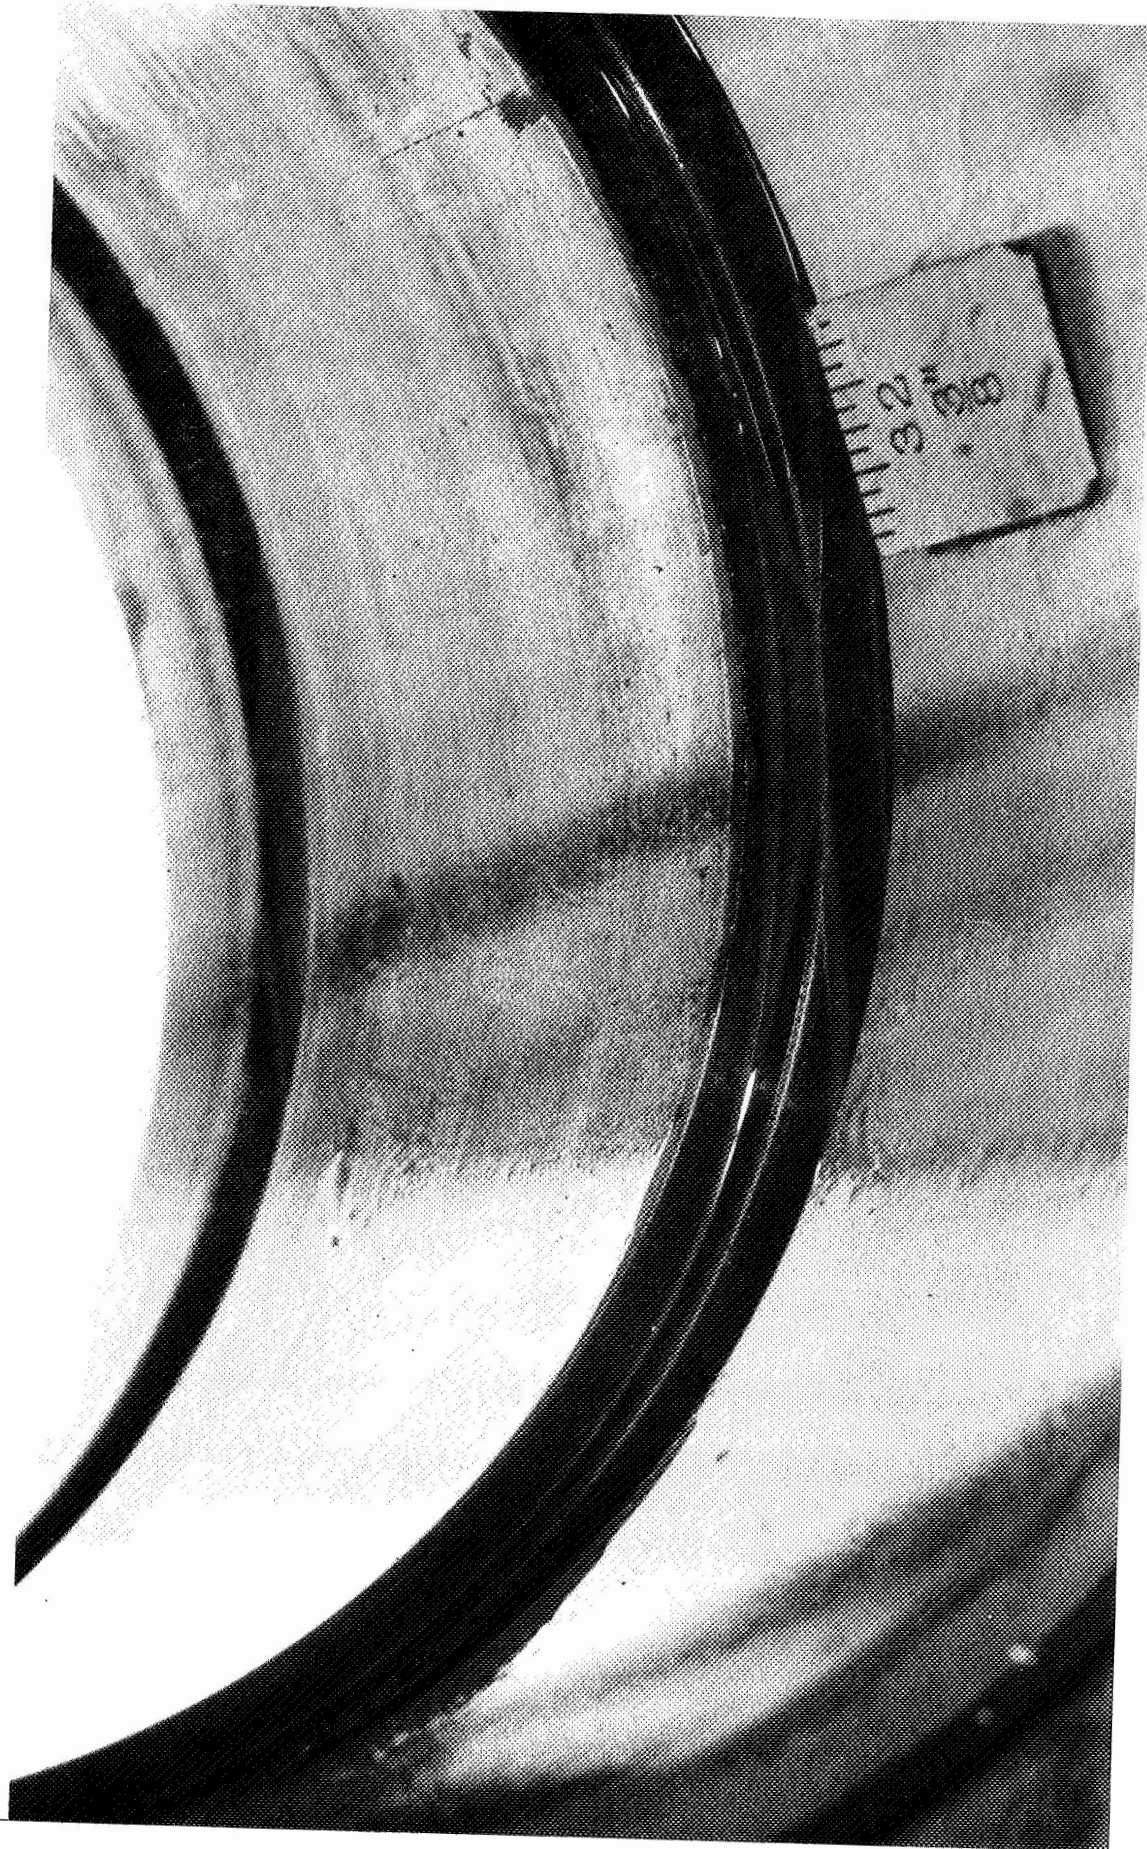
Figure 9

SNAP-8 ALTERNATOR P/N 094069 S/N 481490 AFTER 23130 HOURS IN ECTF
CLOSE UP VIEW OF END BELL FOR D. E.
SHOWING VARNISH ACCUMULATION AT SLINGER DISCHARGE GROOVE

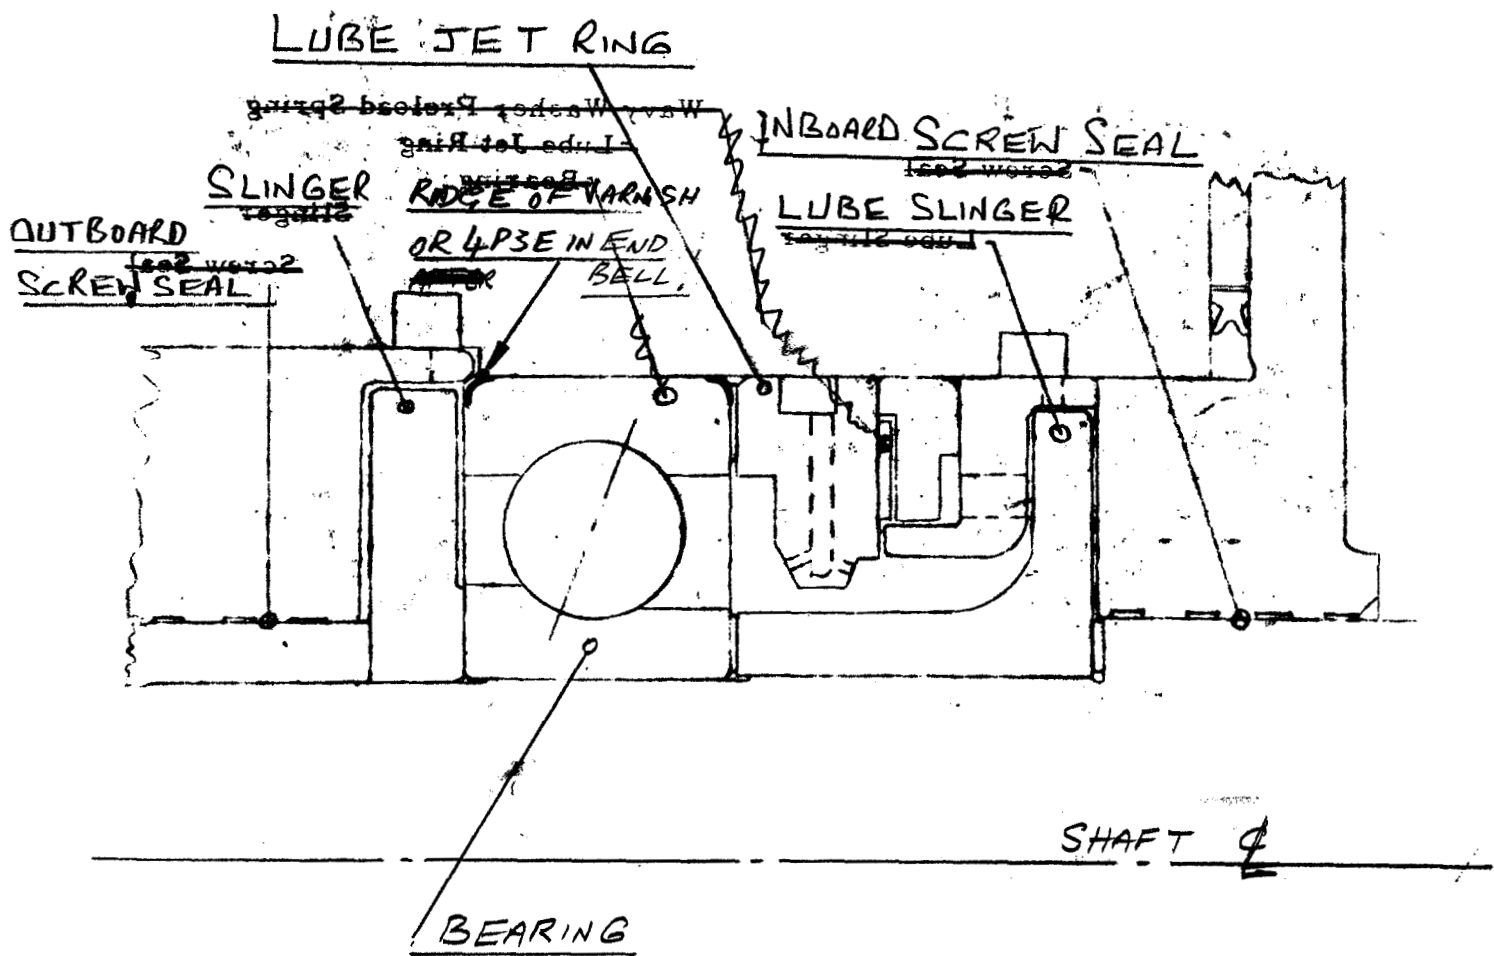
FIG 10 ALTERNATOR DRIVE END SHOWING LOCATION
OF RIDGE OF VARNISH OR 4P3E RESIDUAL
OBSERVED AFTER 23,130 HOUR ENDURANCE TEST.

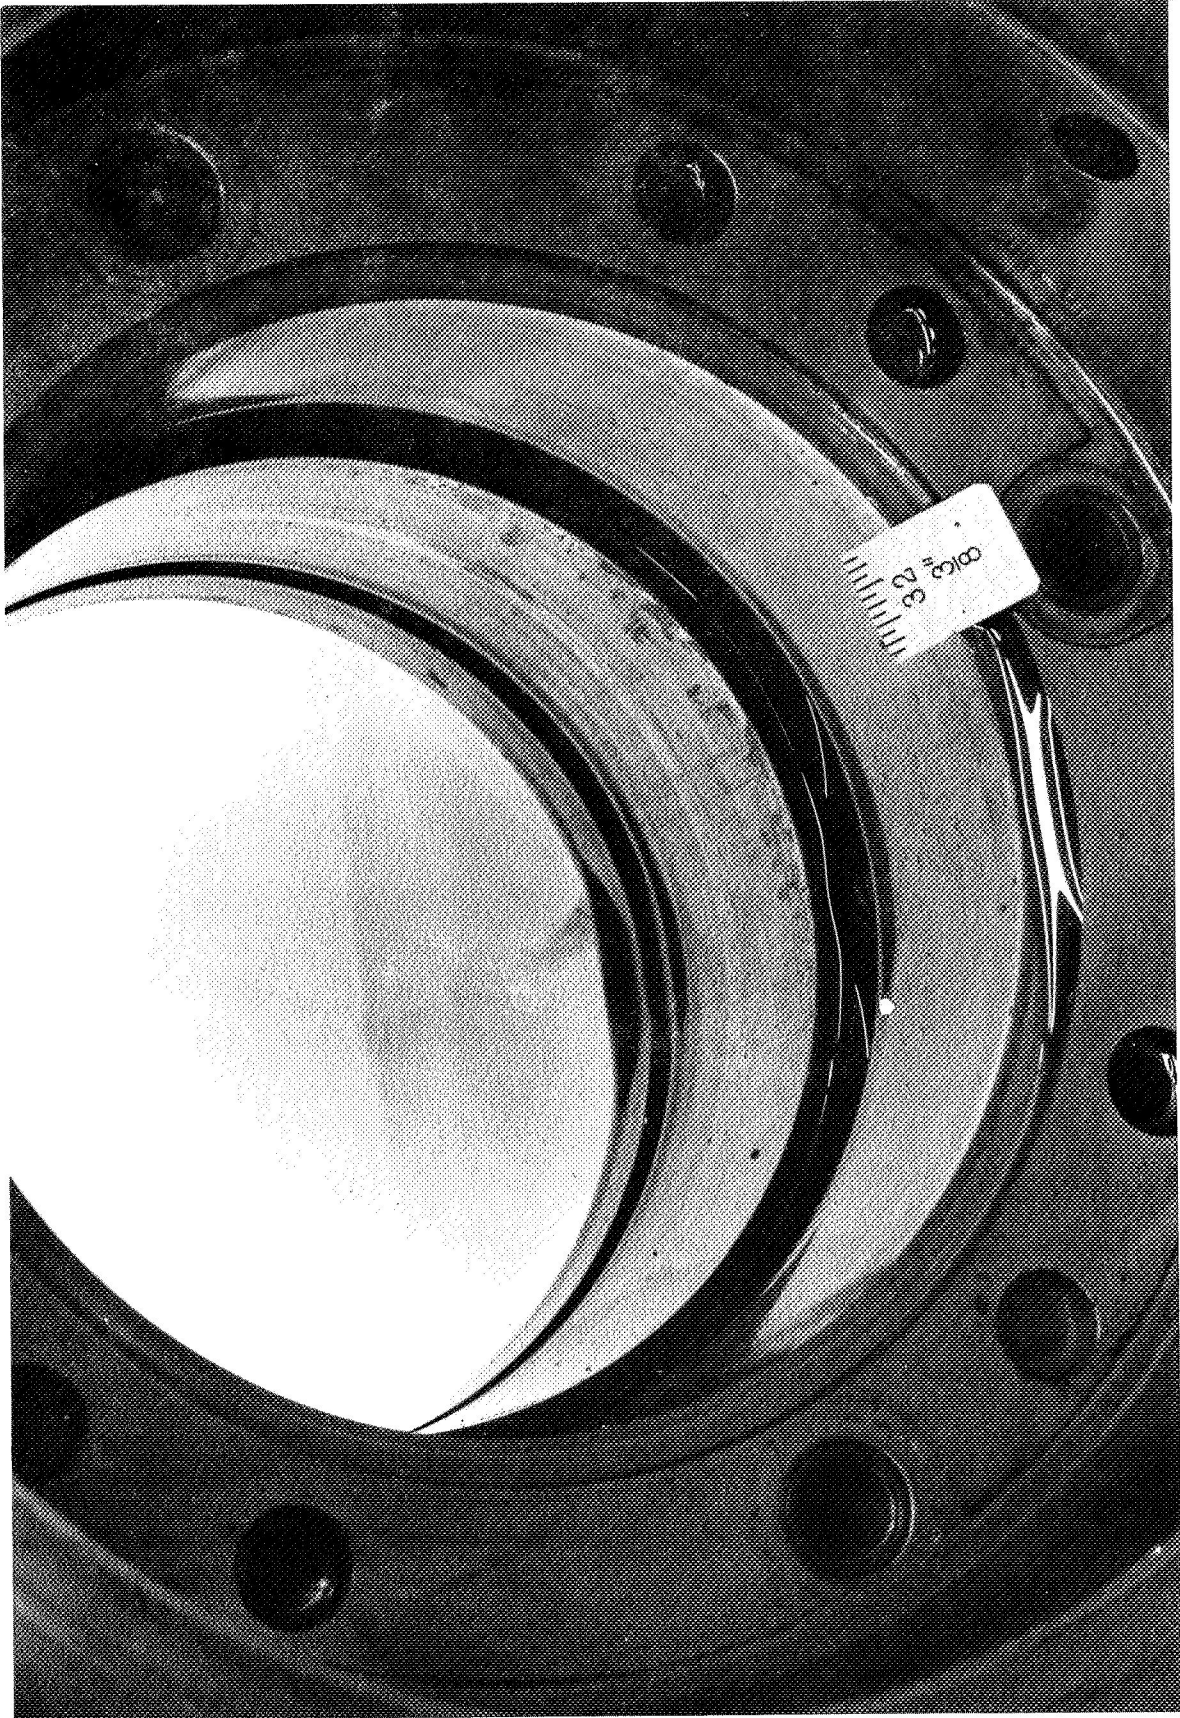
SNAP-8 ALTERNATOR P/N 094069 S/N 481490 AFTER 23130 HOURS IN ECTF
VIEW OF END BELL FOR P06
SHOWING VARNISH ACCUMULATION AT SLINGER DISCHARGE GROOVE

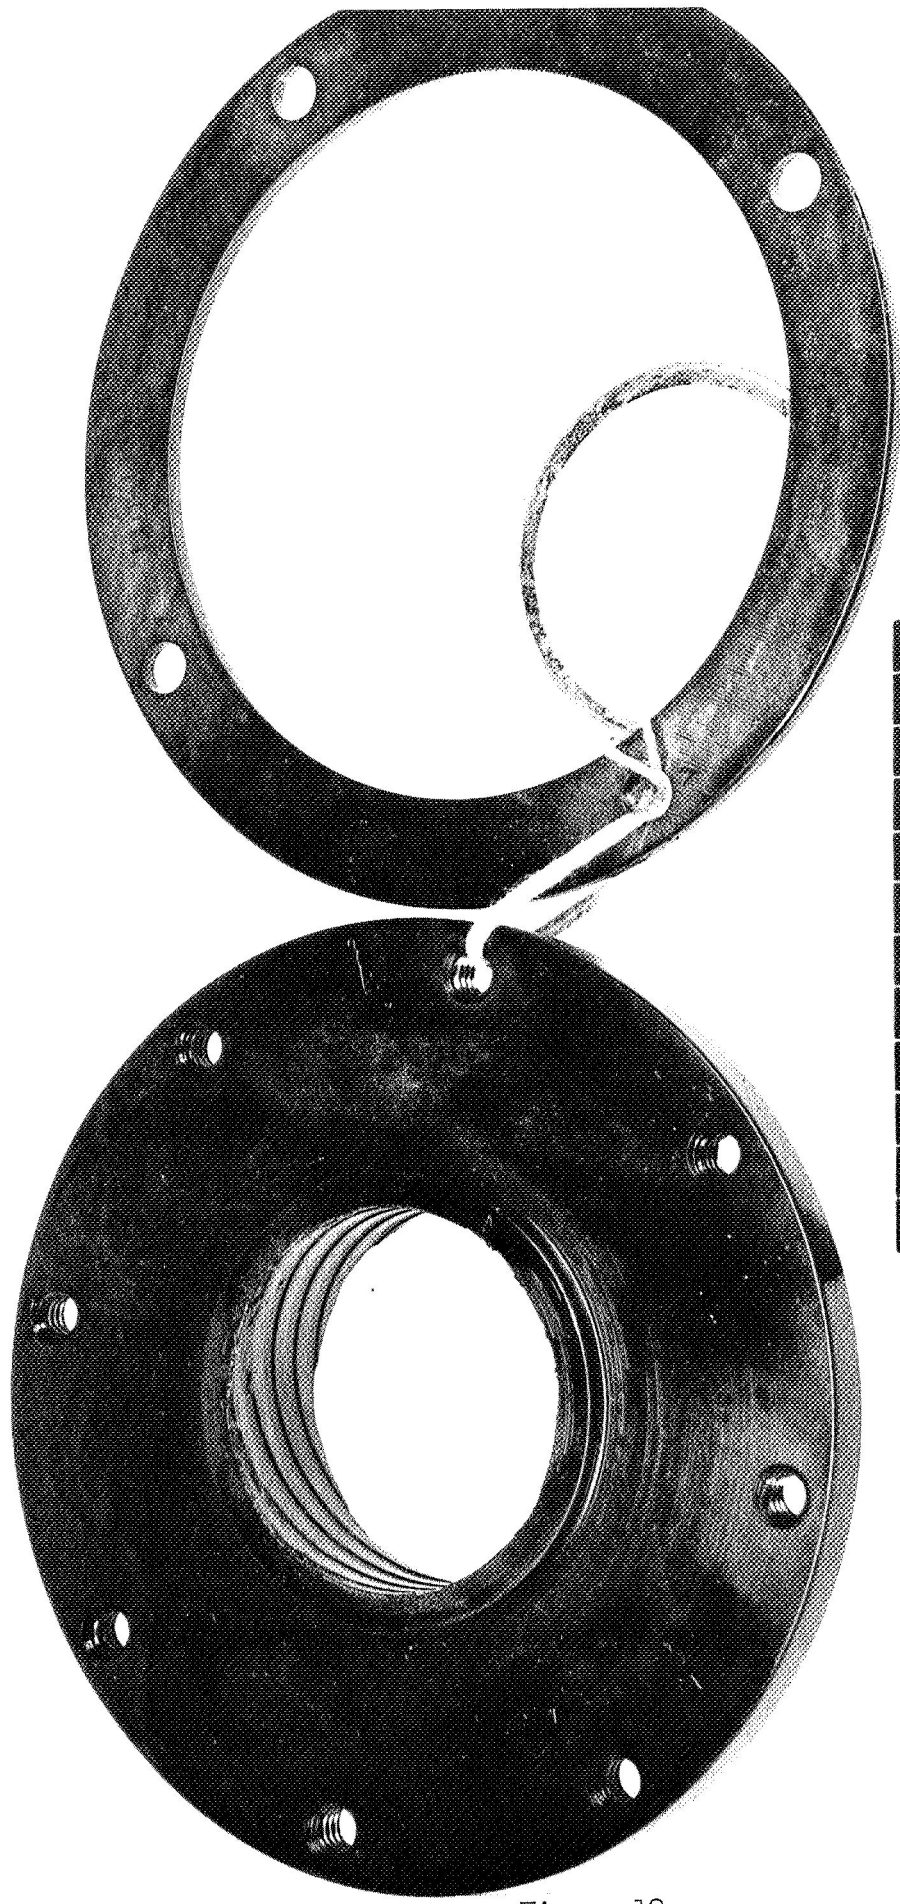
Figure 12

The rotor was heavily wiped at the inboard drive end screw seal and less heavily at the outboard drive end seal which faces a sleeve on the rotor. A light contact had occurred at the anti-drive end screw seal. The damage at the drive end was so extensive that the rotor was noticeably bent in line with the heaviest damage. The area in contact apparently heated up severely and yielded under compression thermal stresses. Maximum shaft runout was found to be .0052 inches. This prevented a balance reading of the shaft from being meaningful since the bending and displaced metal would cause forces an order of magnitude greater than the balancing tolerances. Figure 4 is a plot of shaft runouts. Figure 5 is a table of rotor diameter at each inspection and shows that one half of the rotor growth occurred in the first 2553 hours. The largest growth was in the undercut portions of the lobes which suggests that both dynamic stresses and manufacturing stress relaxation may have occurred. Since no balance measurement would be meaningful with the shaft bent, only the balance data from the 2553 hours inspection is available. This had indicated a moderate change which would increase the bearing loads but still not significantly effect the bearing life. Since only half of the geometric changes occurred in the first 2553 hours of the test, we can assume that changes in rotor balance during the 2553 hours to 23,130 hours portion of the testing were similar to the changes in the early part of testing. Five pounds change in total unbalance load on each bearing would be a good estimate. In addition, visual inspection of the bearings showed no evidence of unbalance loading. However, unbalance loading of less than 10 pounds might not be distinguishable because of the relatively large load capacity of these bearings.

SNAP-8 ALTERNATOR P/N 094069 S/N 481490 AFTER 23130 HOURS IN ECTF
INBOARD SCREW SEAL FOR D.E. SHOWING OUTBOARD FACE AND DAMAGED THREADS
AOC

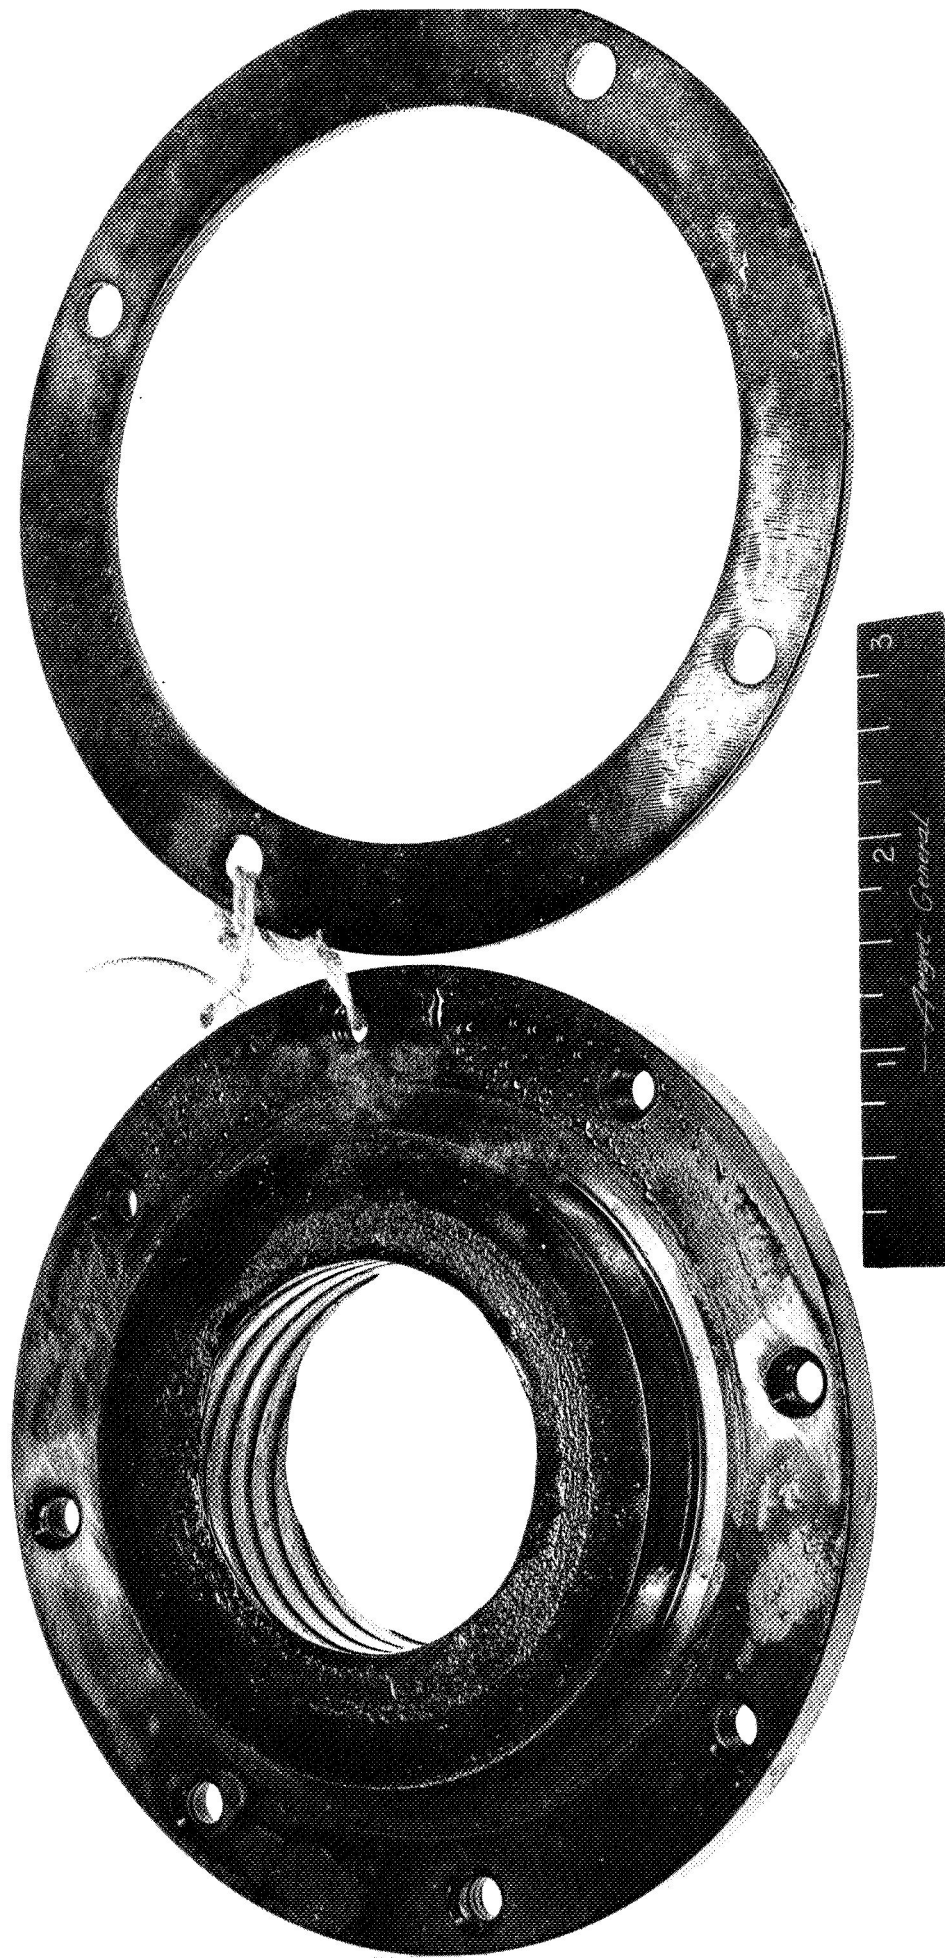
Figure 17
43

SNAP-8 ALTERNATOR P/N 094069 S/N 481490 AFTER 23130 HOURS IN ECTF
INBOARD SCREW SEAL FOR D. E. SHOWING VARNISH BUILDUP ON OUTBOARD FACE

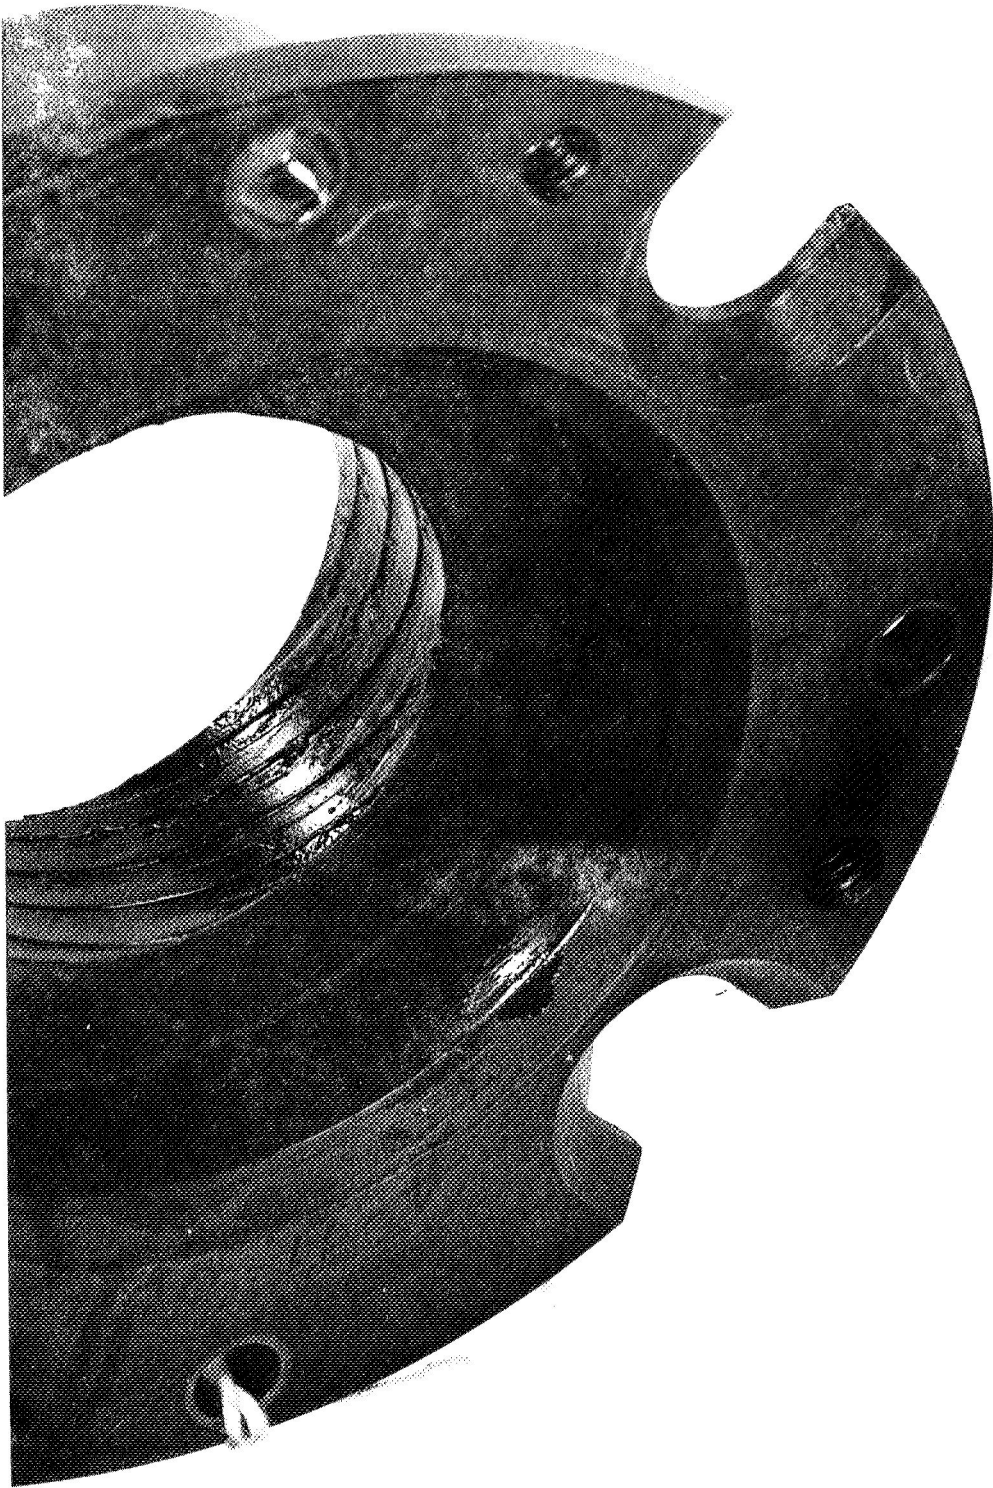
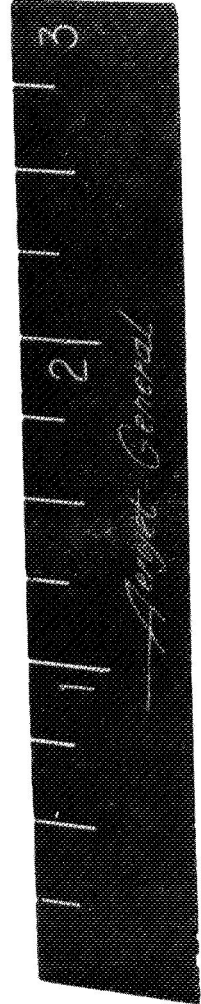
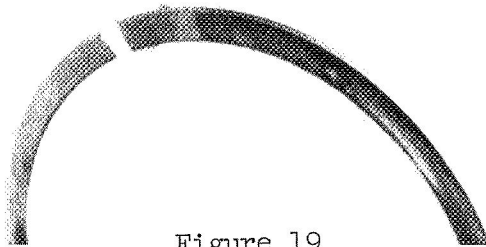
Figure 19
45

SNAP-8 ALTERNATOR P/N 094069 S/N 481490 AFTER 23130 HOURS IN ECTF
A. D. E. OUTBOARD SCREW SEAL SHOWING DAMAGED THREADS

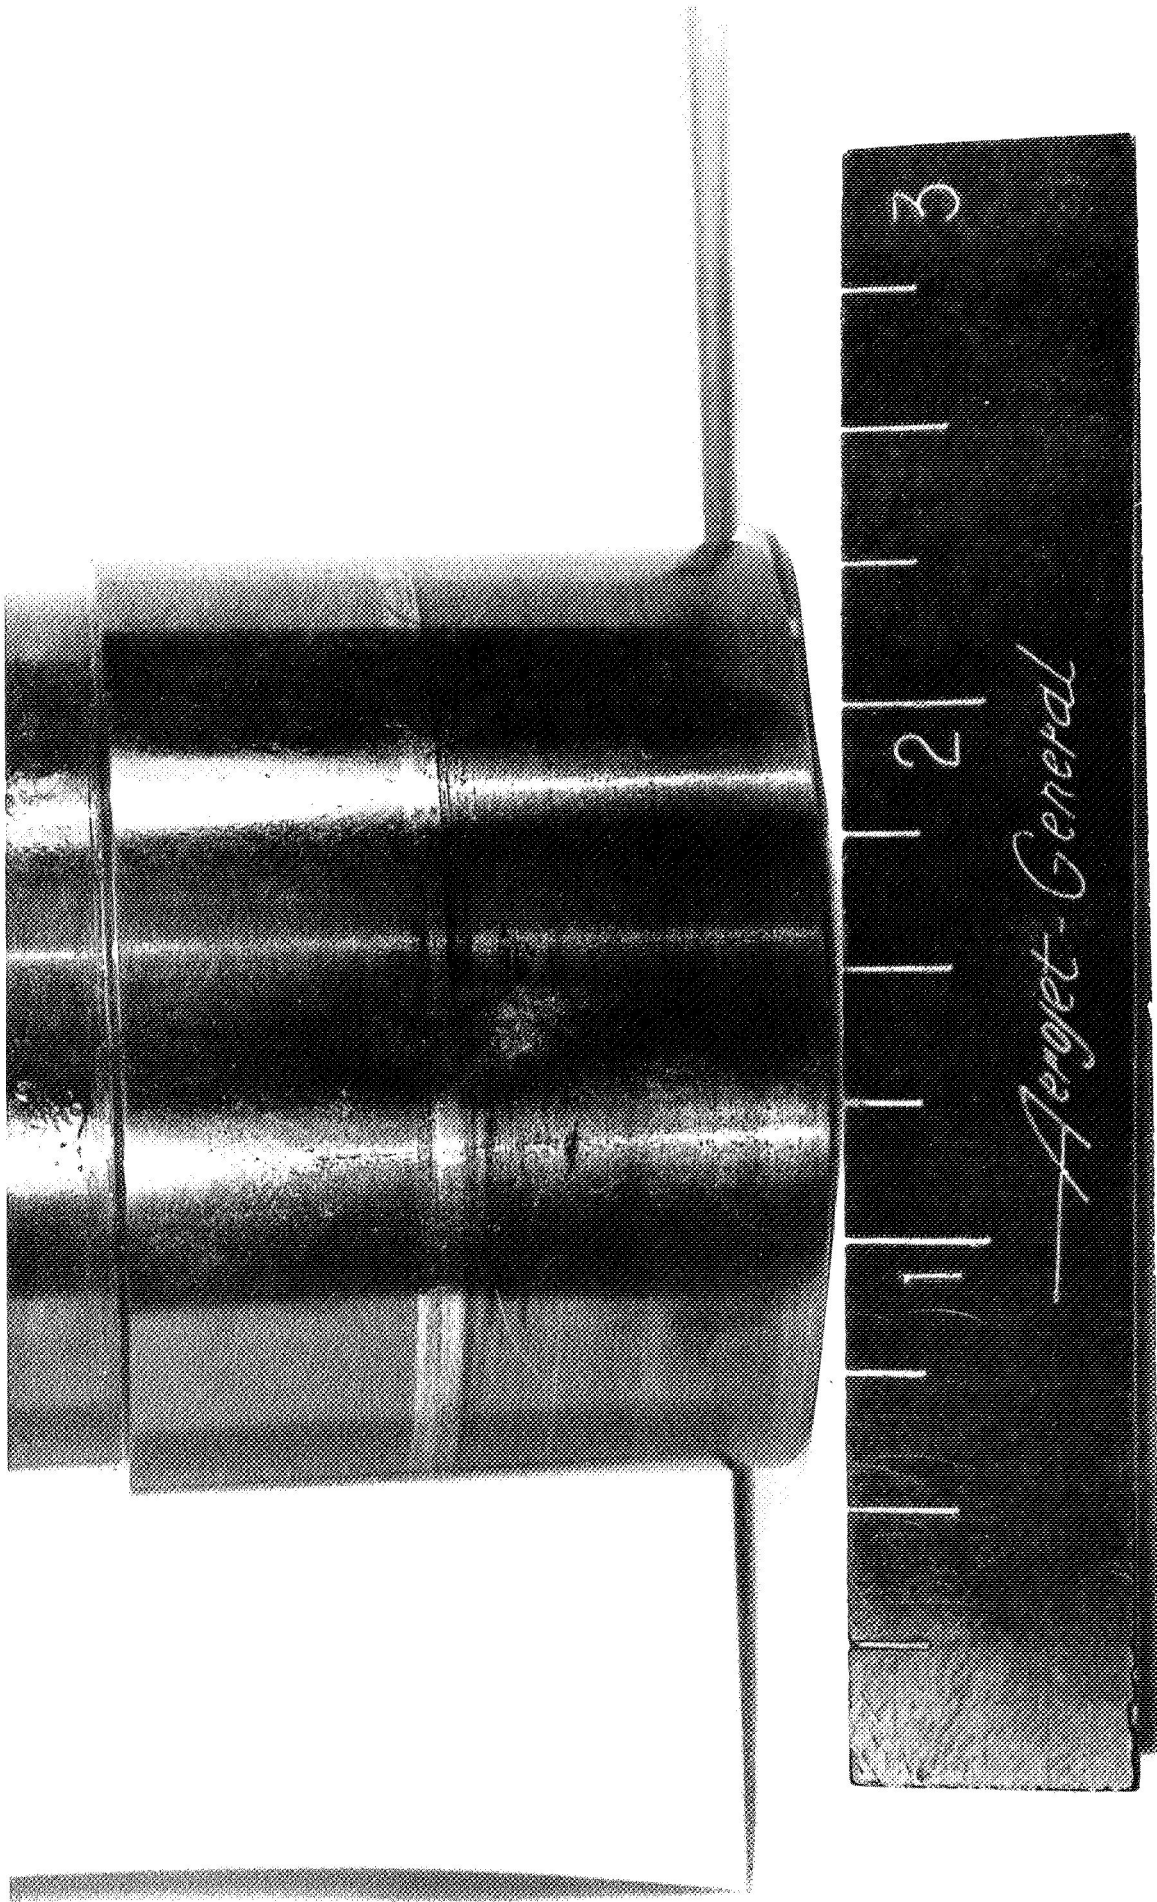
Figure 21
47

SNAP-8 ALTERNATOR P/N 094069 S/N 481490 AFTER 23130 HOURS IN ECTF
SHAFT SLEEVE FOR A. D. E. OUTBOARD SCREW SEAL SHOW LIGHT CONTACT DAMAGE
