DIVISION	CR-72920
TM	3710:71-650
DATE	9 June 1970
W.O.	1475-80-201

TECHNICAL MEMORANDUM

TITLE: Evaluation of SNAP-8 Alternator P/N 094069, S/N 481490 after 23,130 Hours of Endurance Testing in the Electrical Component Test Facility (ECTF).

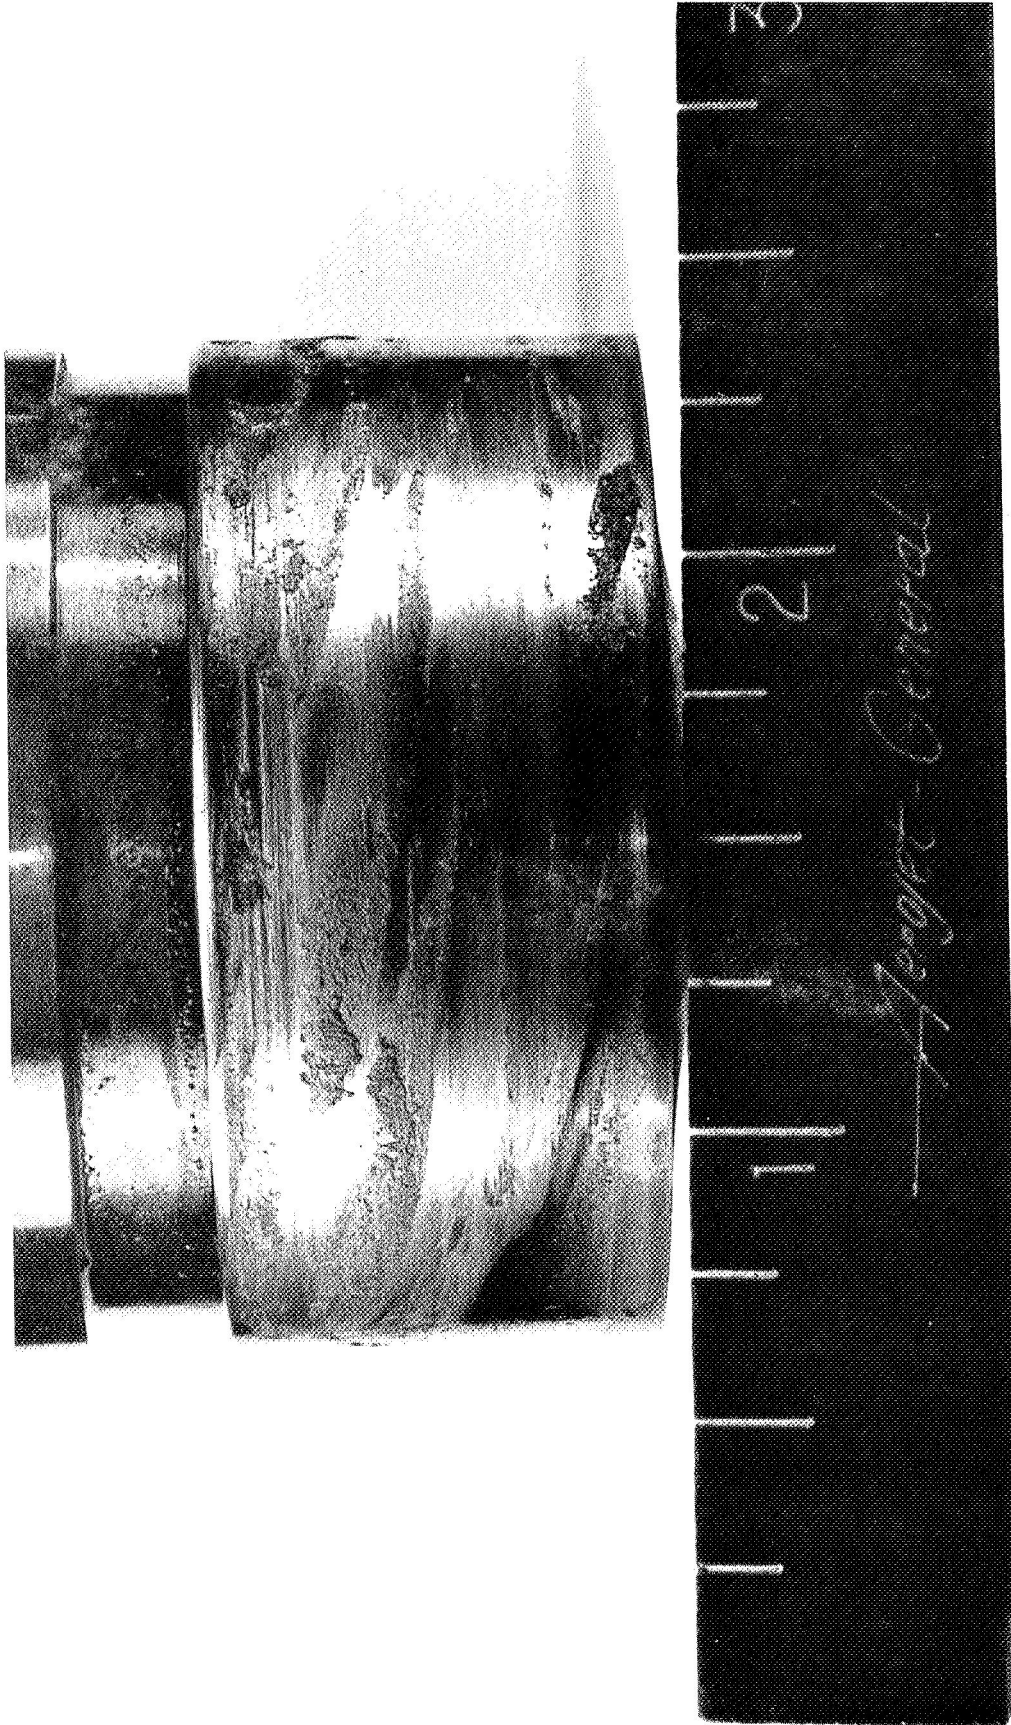
Figure 22
48

The rotor was heavily wiped at the inboard drive end screw seal and less heavily at the outboard drive end seal which faces a sleeve on the rotor. A light contact had occurred at the anti-drive end screw seal. The damage at the drive end was so extensive that the rotor was noticeably bent in line with the heaviest damage. The area in contact apparently heated up severely and yielded under compression thermal stresses. Maximum shaft runout was found to be .0052 inches. This prevented a balance reading of the shaft from being meaningful since the bending and displaced metal would cause forces an order of magnitude greater than the balancing tolerances. Figure 4 is a plot of shaft runouts. Figure 5 is a table of rotor diameter at each inspection and shows that one half of the rotor growth occurred in the first 2553 hours. The largest growth was in the undercut portions of the lobes which suggests that both dynamic stresses and manufacturing stress relaxation may have occurred. Since no balance measurement would be meaningful with the shaft bent, only the balance data from the 2553 hours inspection is available. This had indicated a moderate change which would increase the bearing loads but still not significantly effect the bearing life. Since only half of the geometric changes occurred in the first 2553 hours of the test, we can assume that changes in rotor balance during the 2553 hours to 23,130 hours portion of the testing were similar to the changes in the early part of testing. Five pounds change in total unbalance load on each bearing would be a good estimate. In addition, visual inspection of the bearings showed no evidence of unbalance loading. However, unbalance loading of less than 10 pounds might not be distinguishable because of the relatively large load capacity of these bearings.

SNAP-8 ALTERNATOR P/N 094069 S/N 481490 AFTER 23130 HOURS IN ECTF
SHAFT SLEEVE FOR D. E. OUTBOARD SCREW SEAL SHOWING DAMAGE

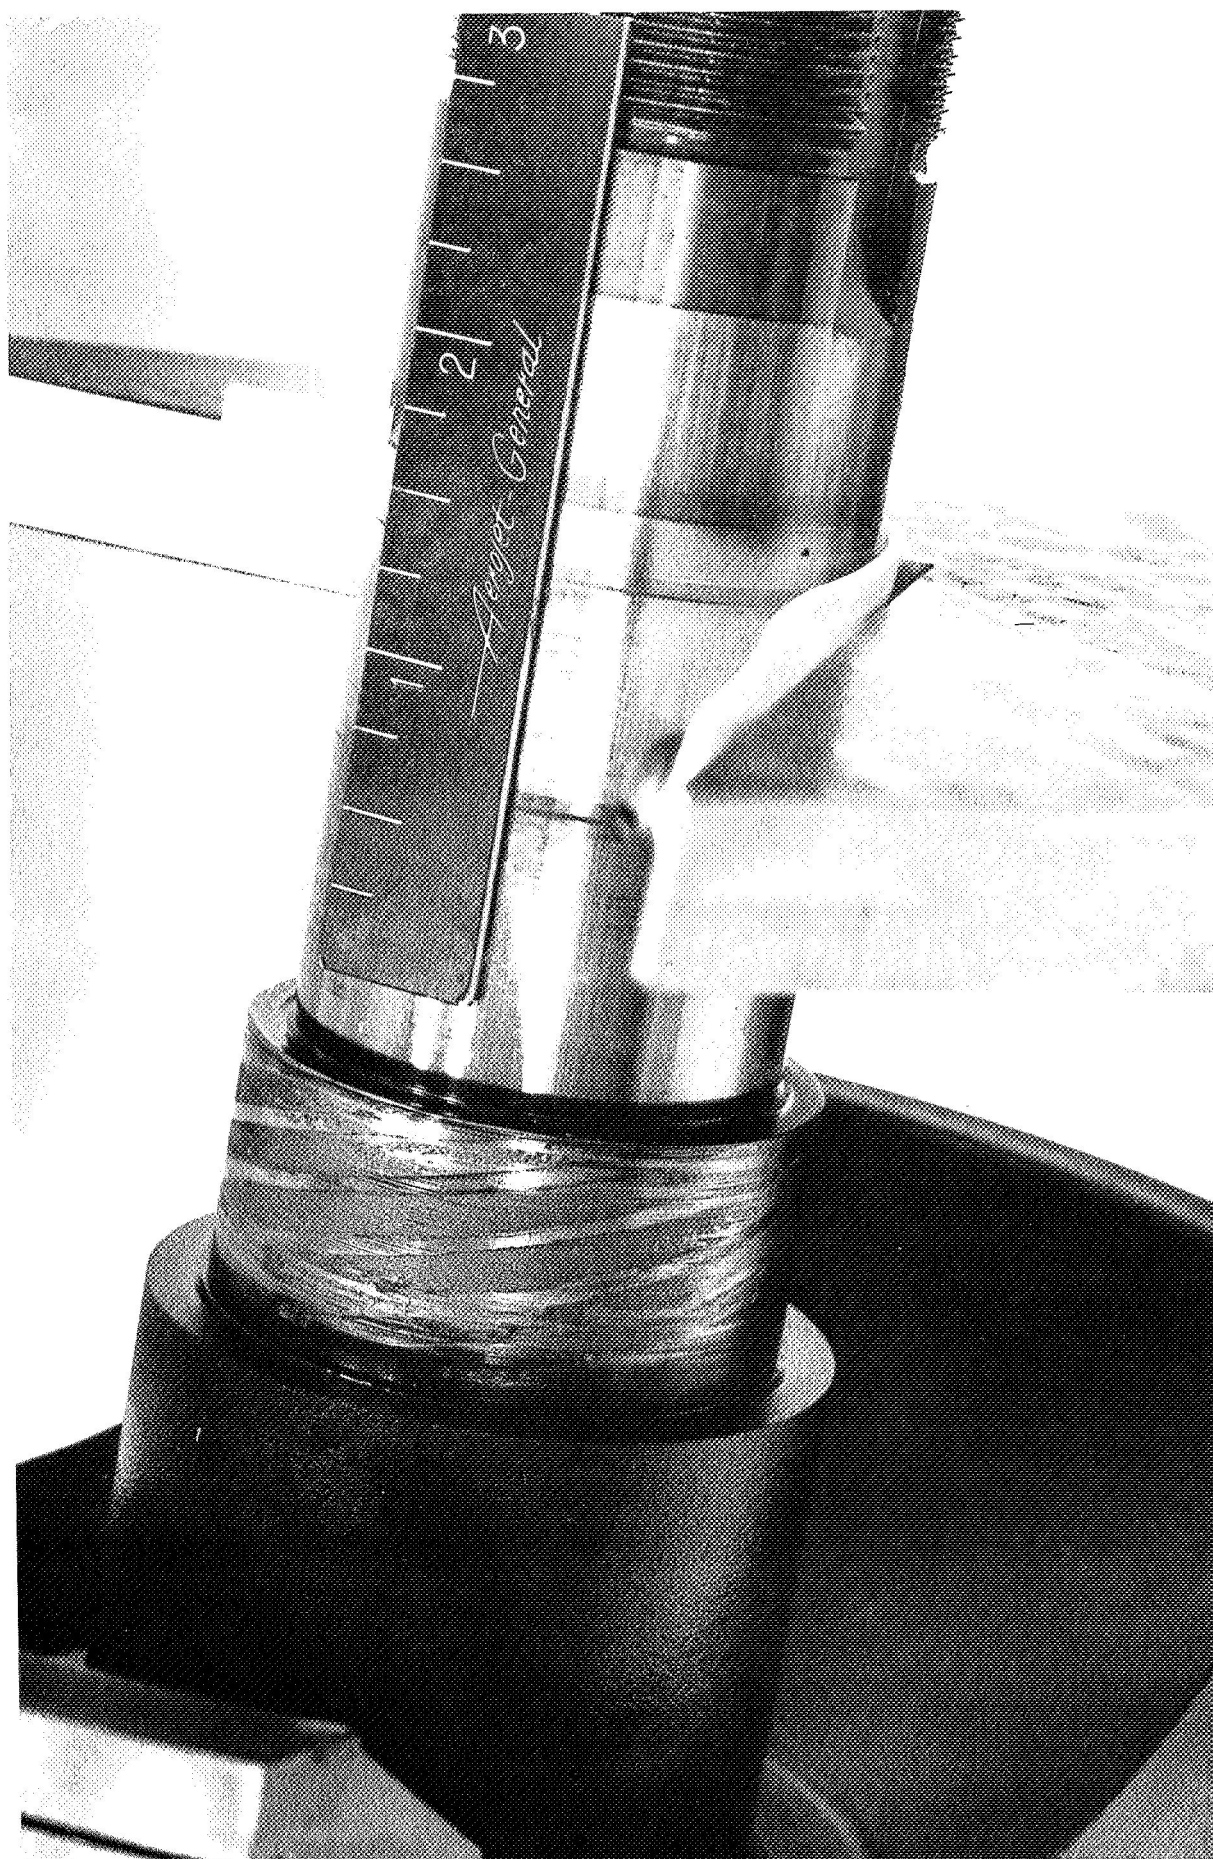
Figure 23

It was concluded that the seizure occurred due to a loss of preload in the angular contact ball bearings supporting the rotor, resulting in the rotor orbiting due to the increased bearing radial clearance. This effect was compounded by rotor deflections as a result of the large centrifugal forces causing a rub to occur between the rotor and the stationary parts of the screw seals.

SNAP-8 ALTERNATOR P/N 094069 S/N 481490 AFTER 23130 HOURS IN ECTF
CLOSE UP VIEW OF ROTOR DAMAGE

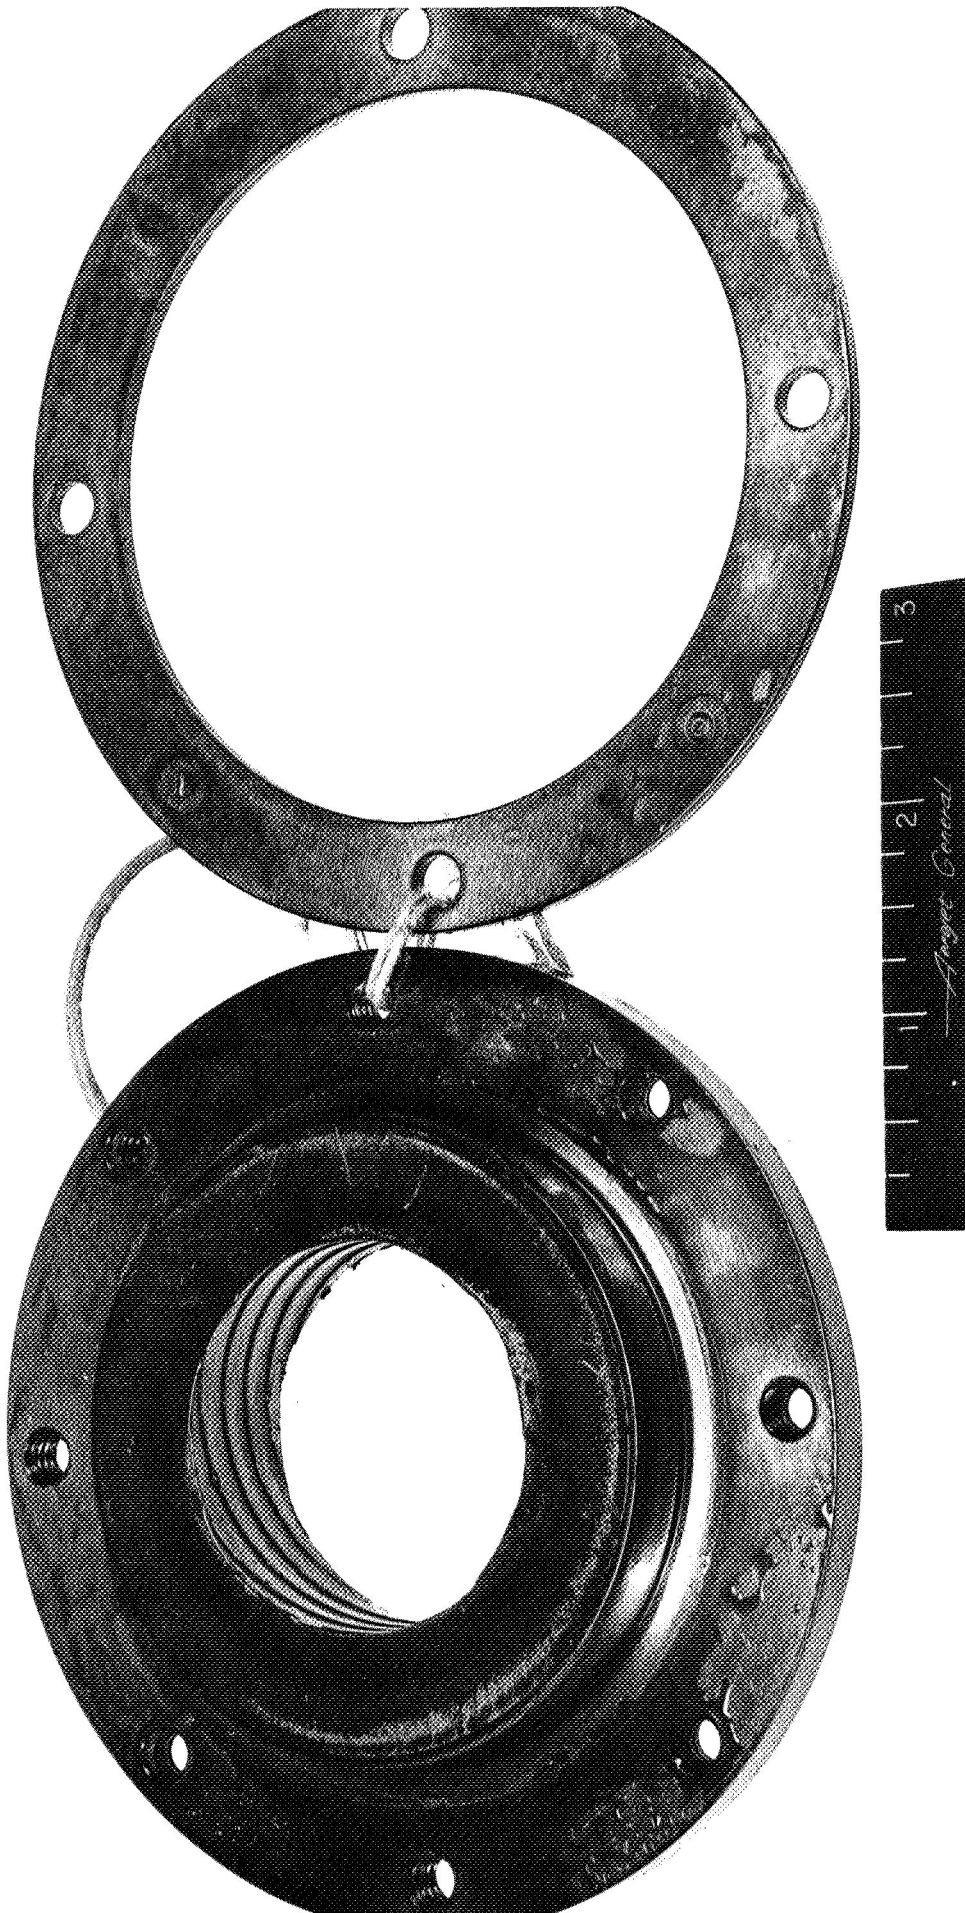
Figure 26
52

SNAP-8 ALTERNATOR P/N 094069 S/N 481490 AFTER 23130 HOURS IN ECTF
INBOARD SCREW SEAL FOR D. E. SHOWING VARNISH BUILDUP
ON OUTBOARD FACE AND DAMAGED THREADS

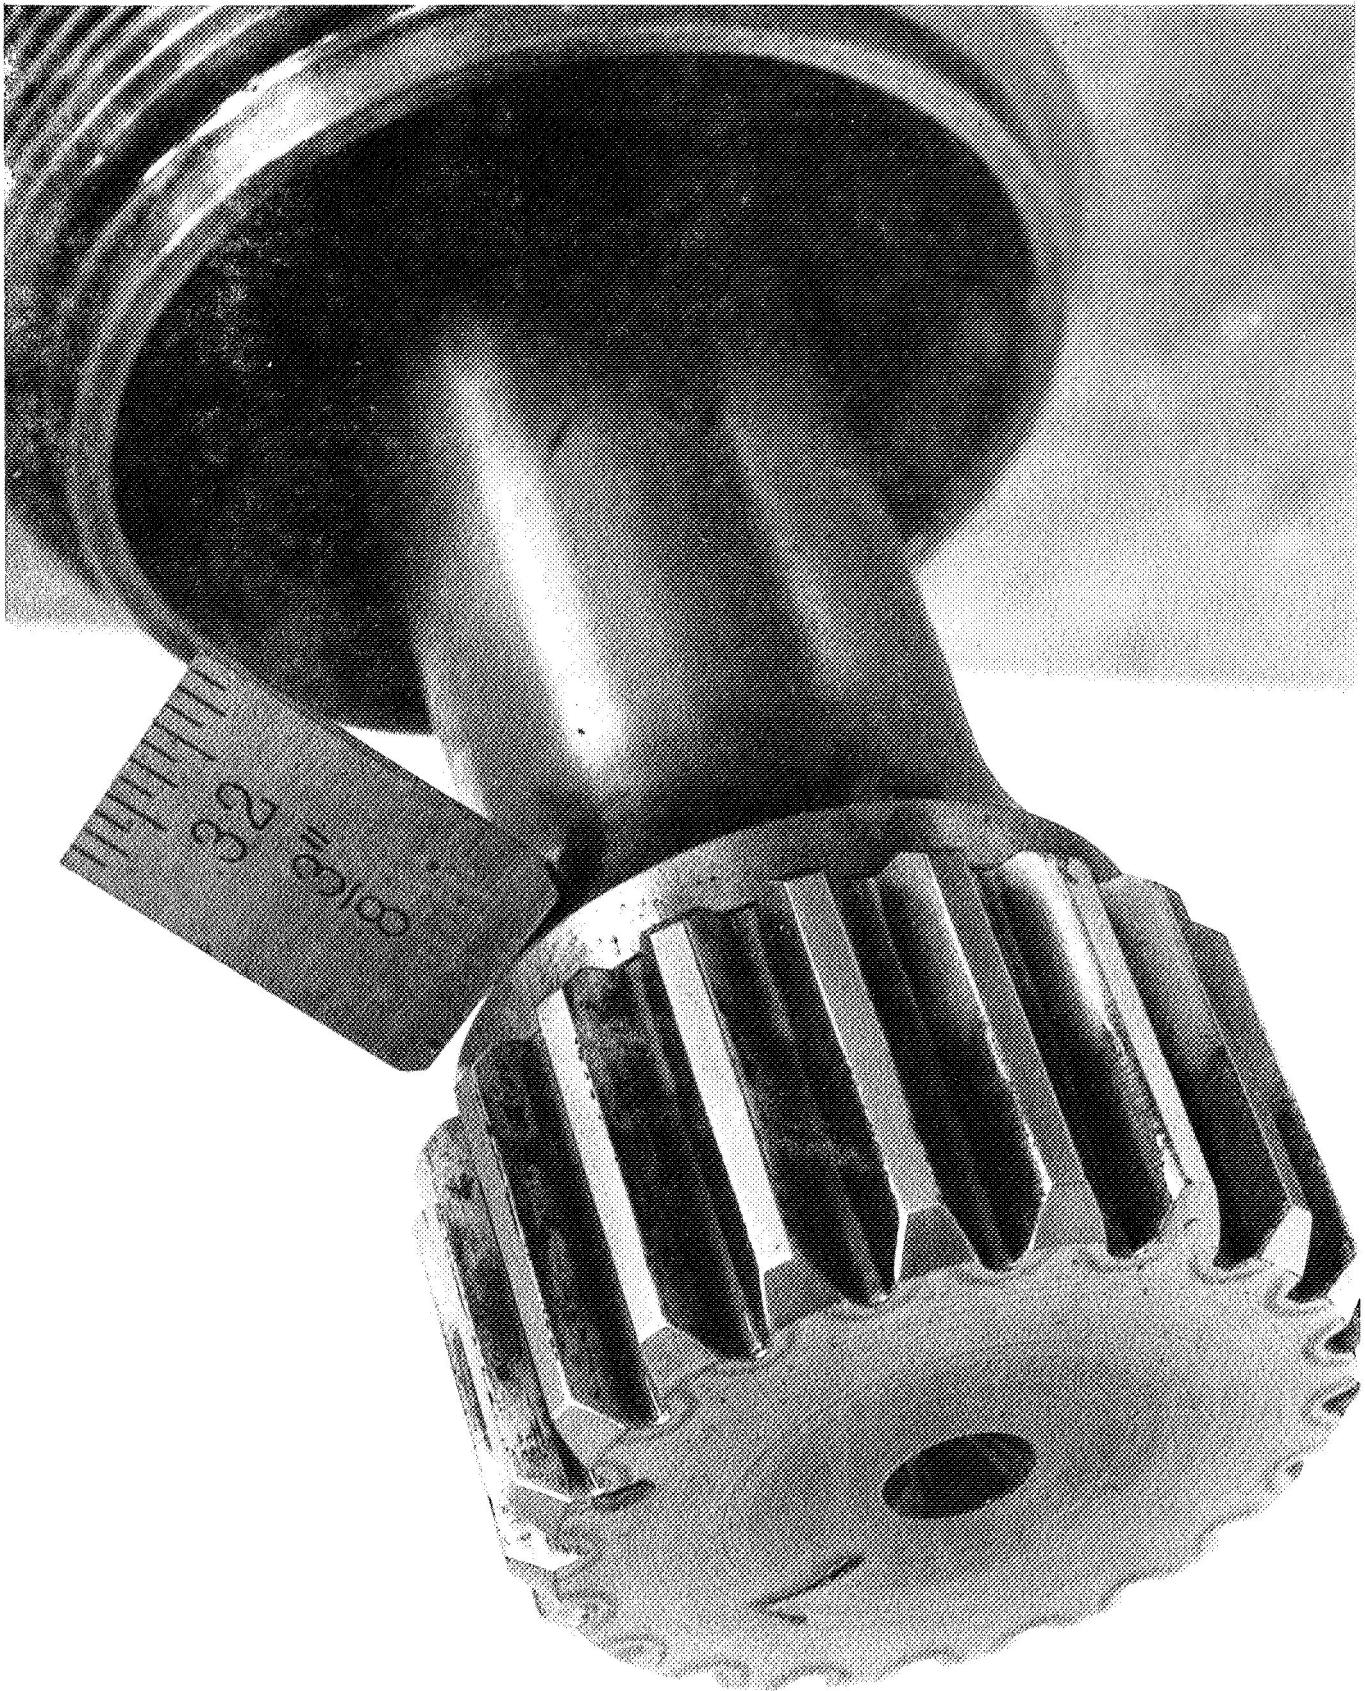
The spline on the quill shaft is subject to wear. The inspection data reveals that this was only minor in nature (see Table II). This inner shaft is one of a batch which was manufactured with a chrome flash (electrolizing) on the teeth which were nitrided Nitralloy. Some of the batch became badly chipped and flaked under light loading and due to light impact loads. The teeth on this shaft were only moderately worn or chipped after long service. The major portion of the plating wear had occurred in the first test period. The overall condition of the spline was considered satisfactory even with the loss of chrome plating (see Figures 27, 28, and 29).

SNAP-8 ALTERNATOR P/N 094069 S/N 481490 AFTER 23130 HOURS IN ECTF
VIEW OF SPLINE TEETH ON QUILL SHAFT

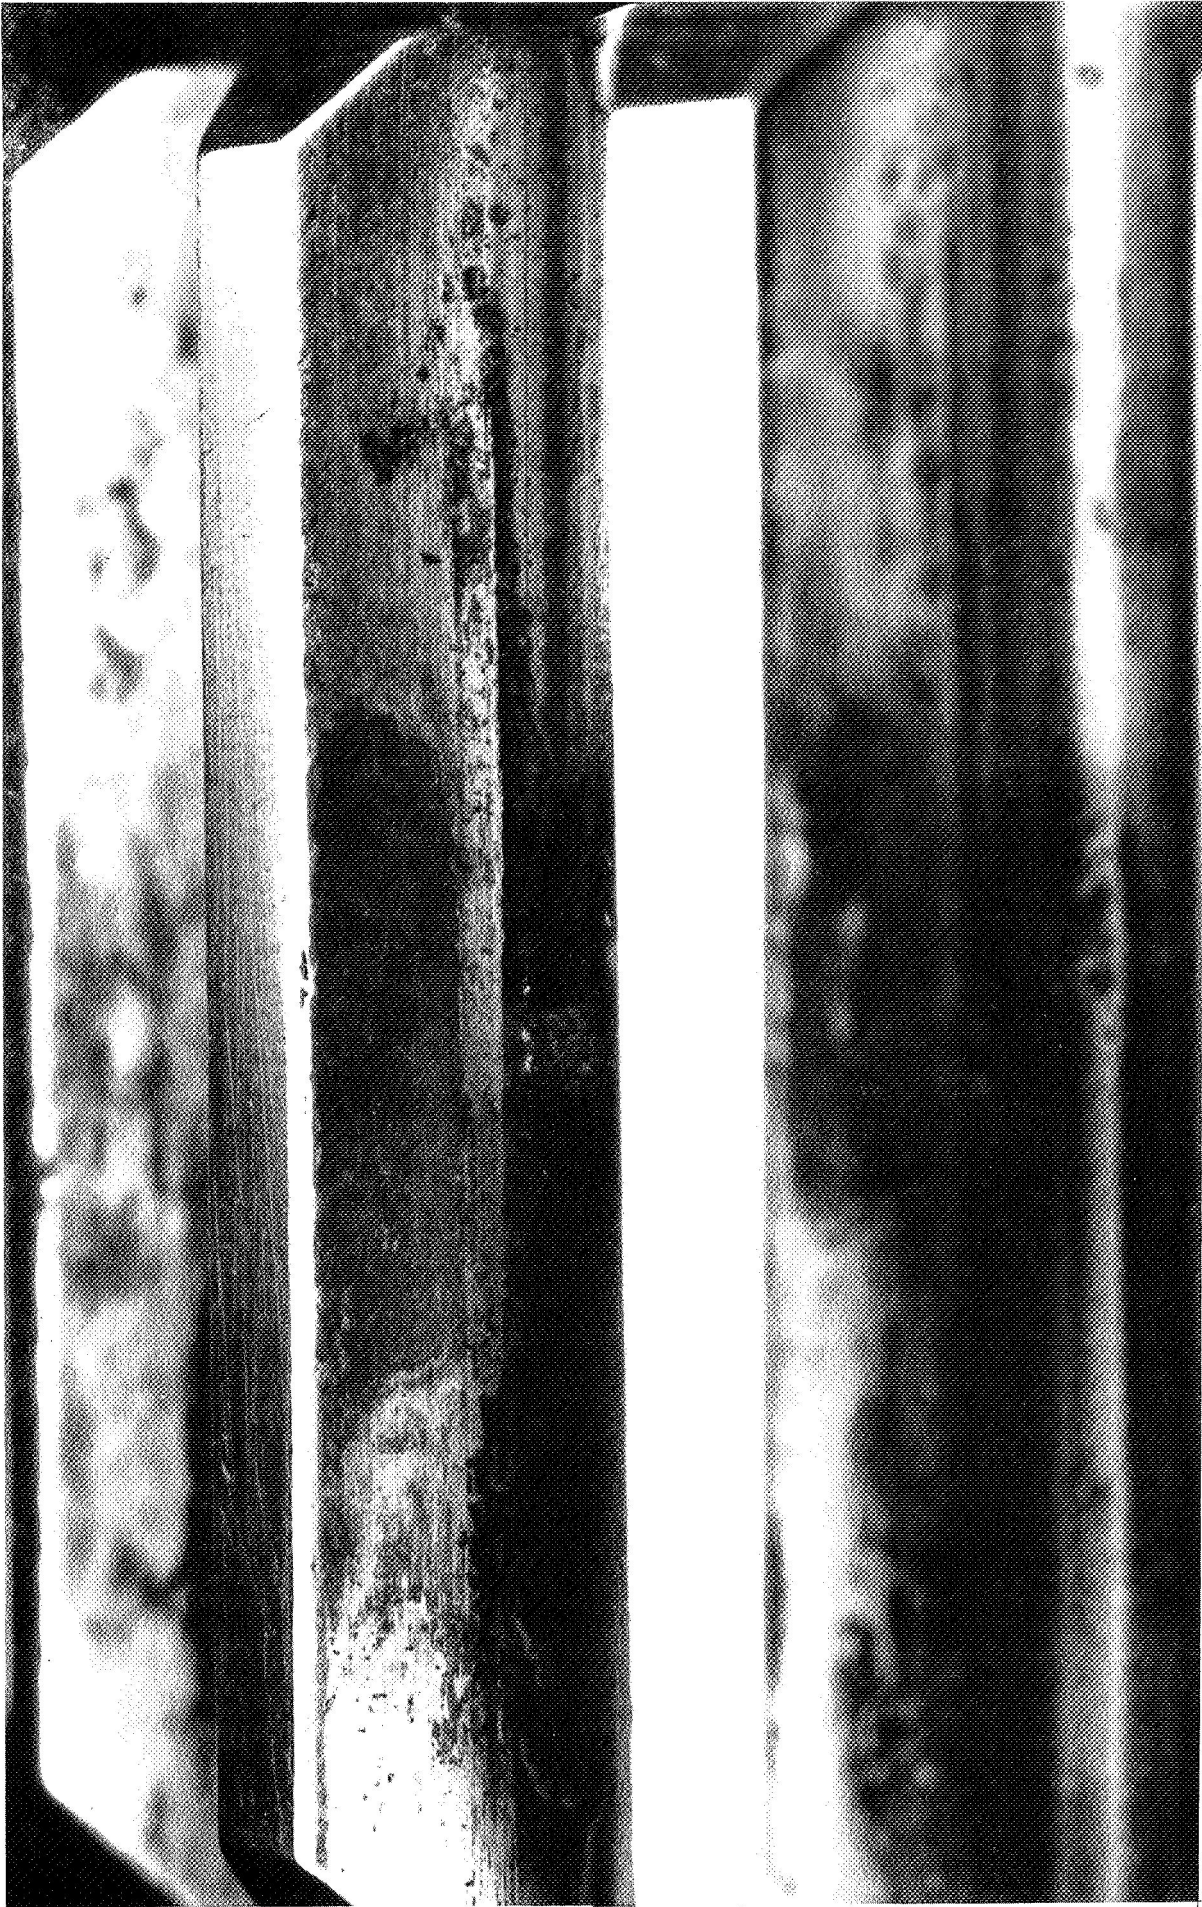
Figure 28
54

SNAP-8 ALTERNATOR P/N 094069 S/N 481490 AFTER 23130 HOURS IN ECTF
SPLINE TOOTH WEAR

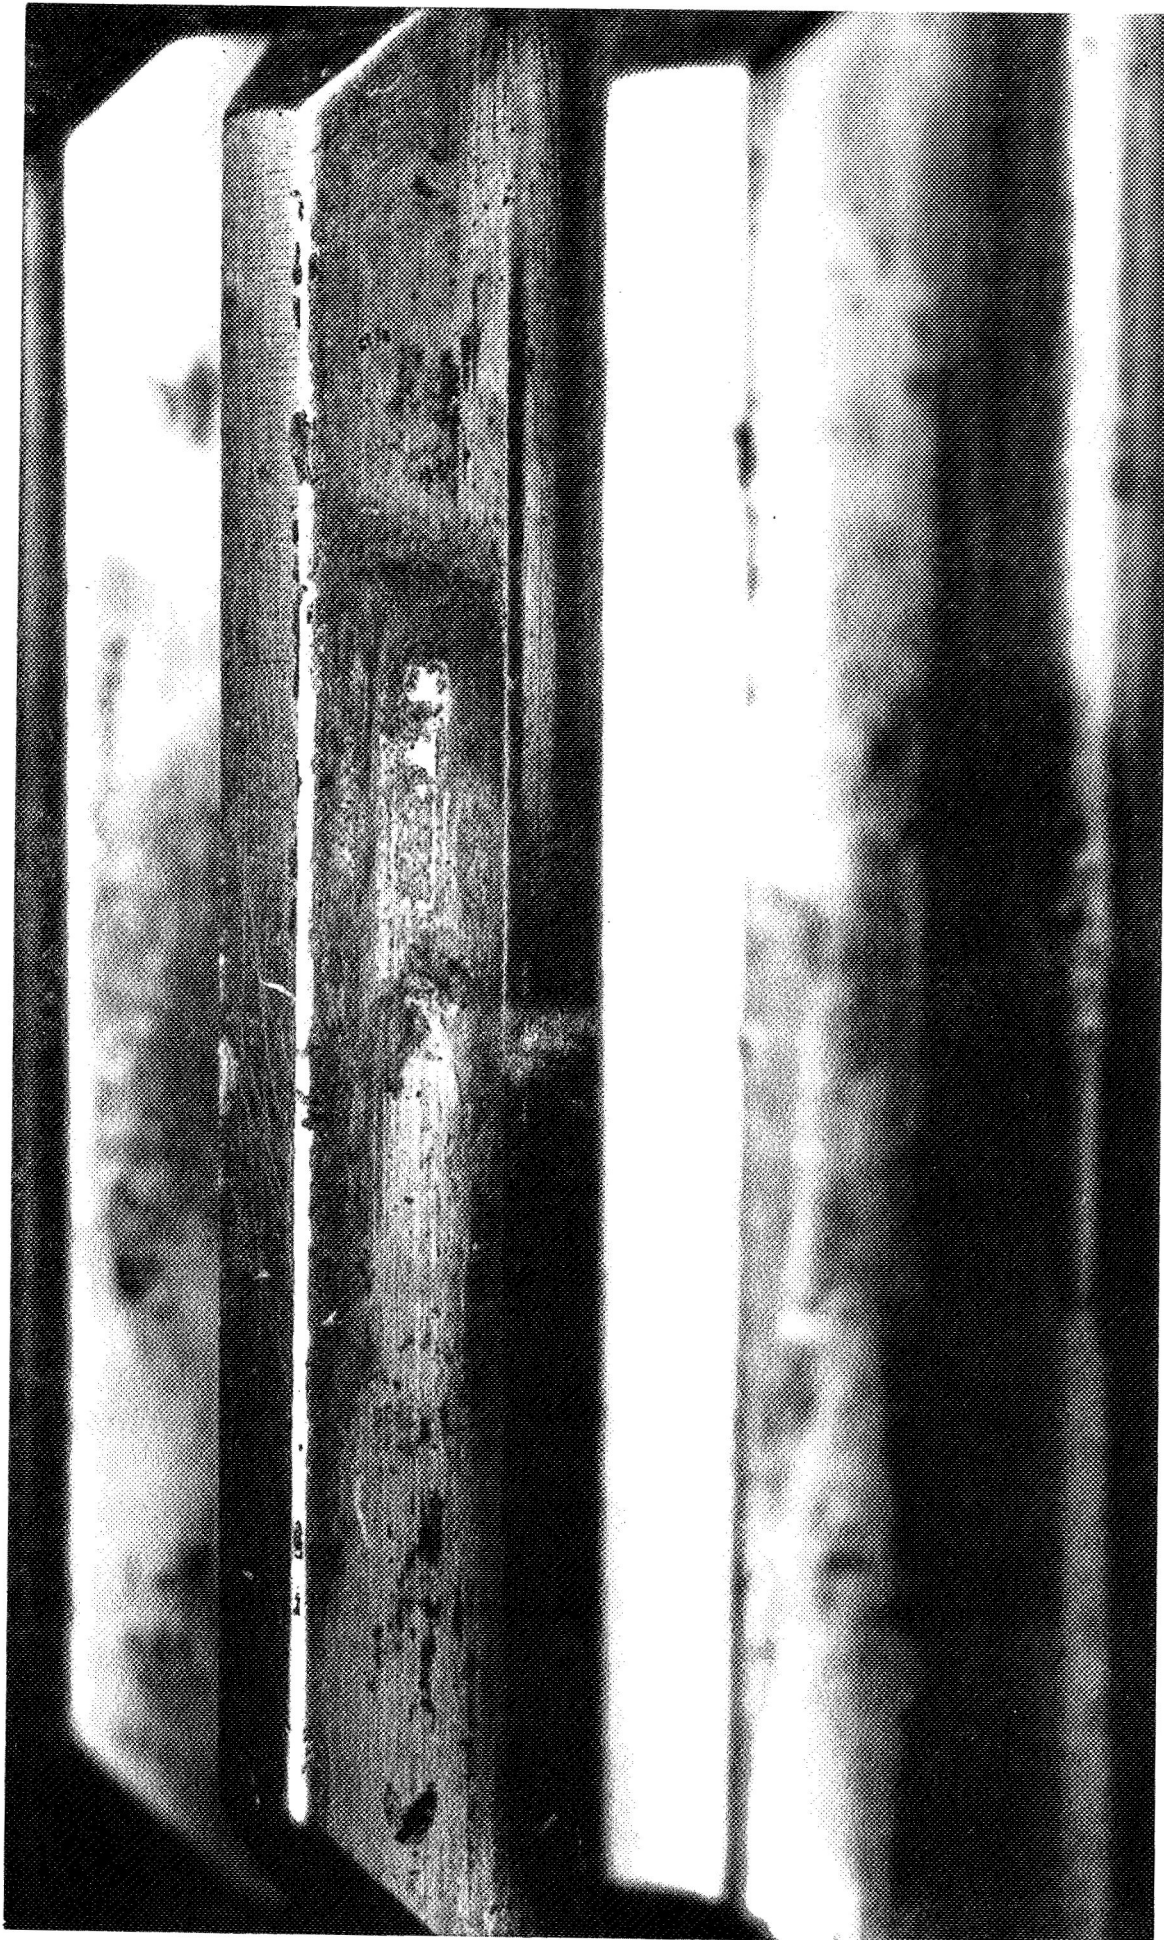
Figure 29

SNAP-8 ALTERNATOR P/N 094069 S/N 481490 AFTER 23130 HOURS IN ECTF
SPLINE TOOTH WEAR

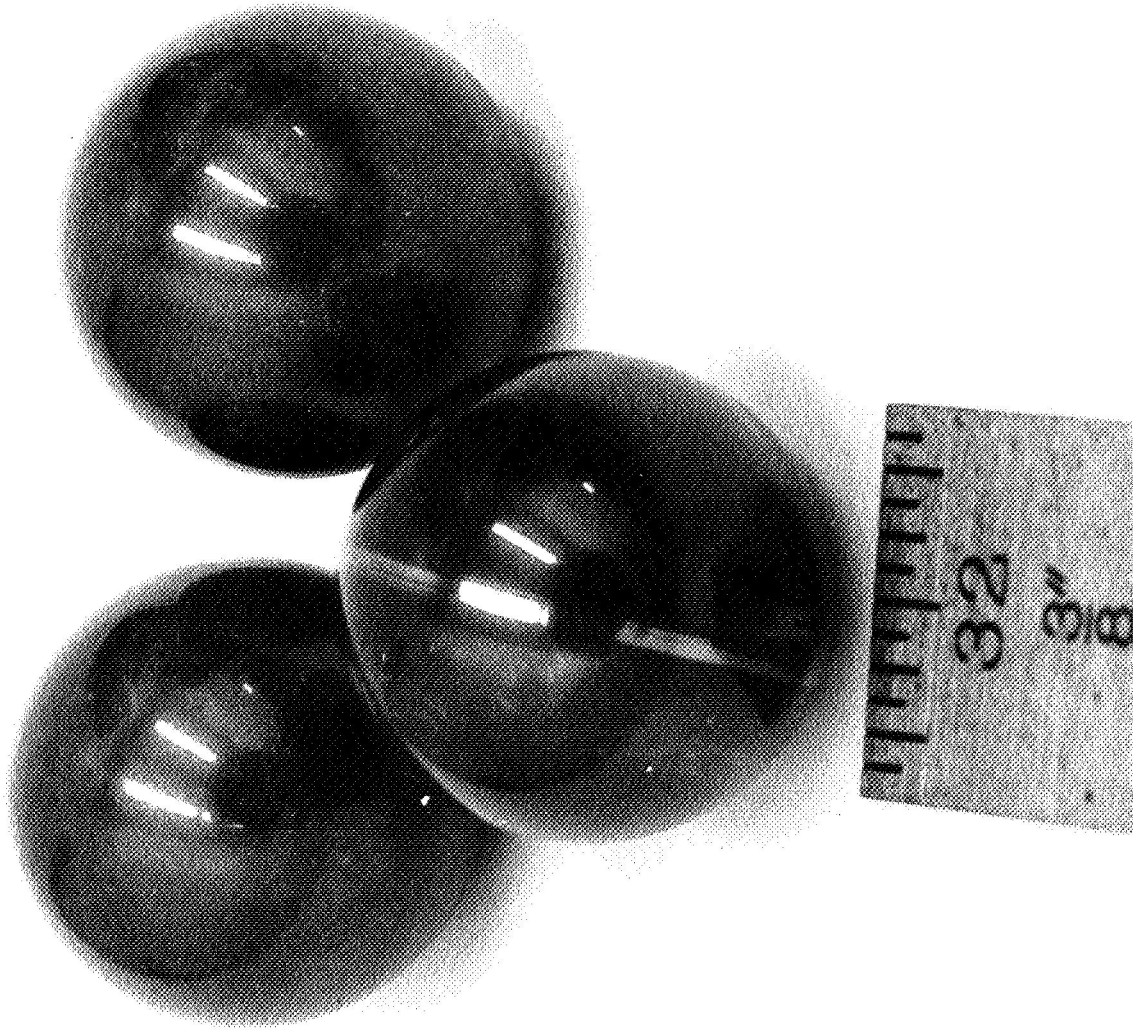
Figure 39

The balls were stained dark brown with a blue cast. One ball had a flat or dent .030 inches in diameter with a heat stain in the center. One ball showed two elliptical dents .045 inches long in close proximity. One ball was scratched equatorially .020 inches wide. The scratch was rough and very bright but of no significant depth. No signs of fatigue or heavy ball banding were noted. The separator was normal in every respect. There were no outside diameter or inside diameter contact patterns in the heat stain. The ball pockets had the "dumb bell" contact pattern with a minimum height of .030 inches. The site of the ball scratch particle was not located (see Table IV for inspection details).

SNAP-8 ALTERNATOR P/N 094069 S/N 481490 AFTER 23130 HOURS IN ECTF
BALL BEARING P/N 095355 S/N A-54 D.E.
VIEW OF THREE BALLS INCLUDING SCRATCHED BALL (20630)

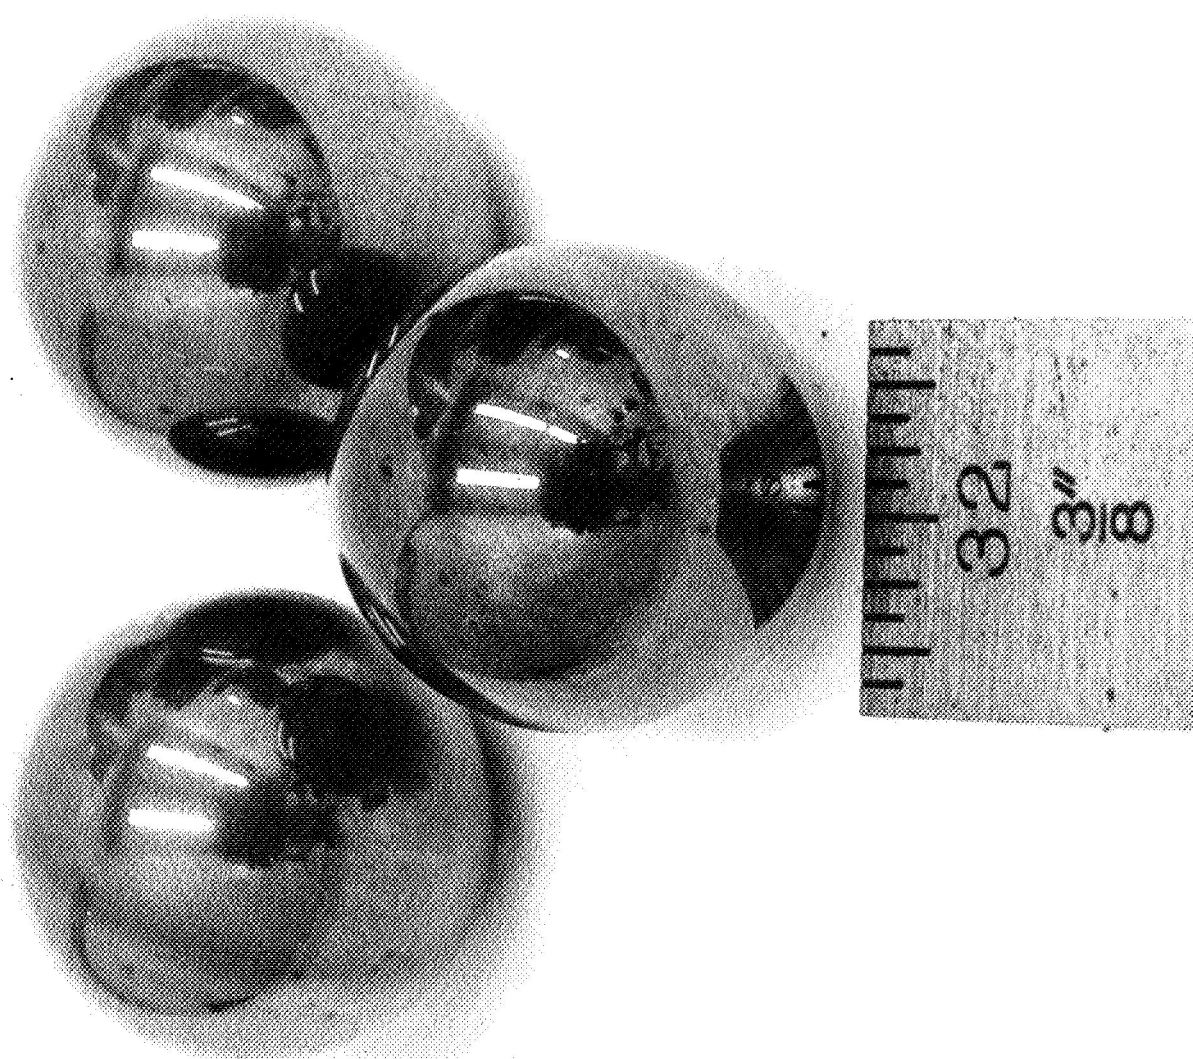
Figure 45

The balls had very minor scratches and were lightly stained all over. Banding could be discerned on some balls. One ball was distinctly banded and 40 micro-inches out of round with wear occurring in an equatorial path. Another ball was similarly but less extensively banded and was 28 micro-inches out of round. The remaining balls were in good condition measuring less than 20 micro-inches out of round.

SNAP-8 ALTERNATOR P/N 094069 S/N 481490 AFTER 23130 HOURS IN ECTF
BALL BEARING P/N 095355 S/N A-48 A.D.E. THREE TYPICAL BALLS

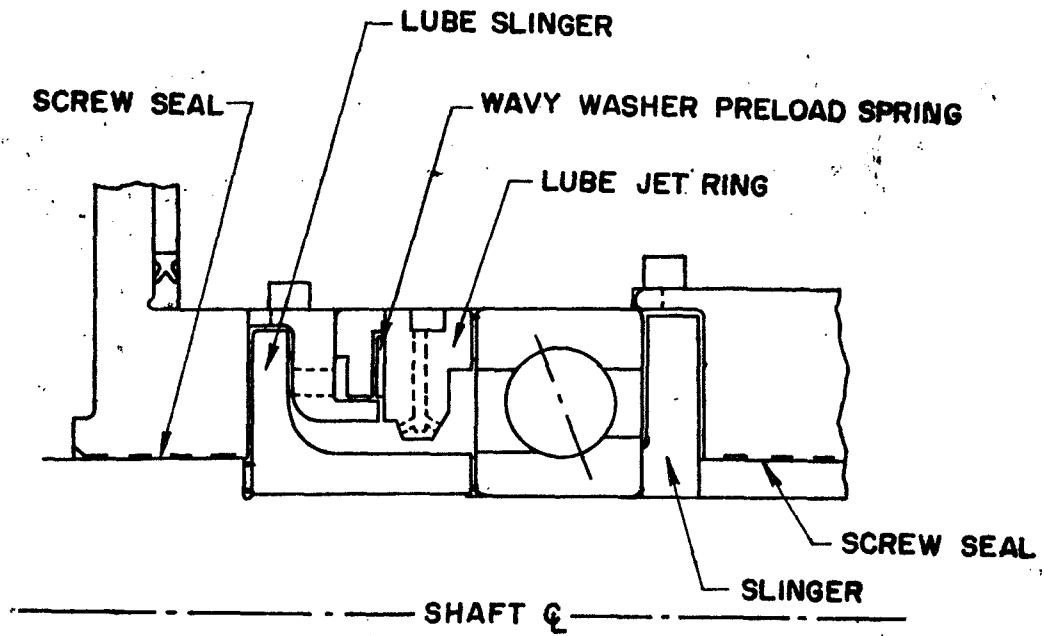
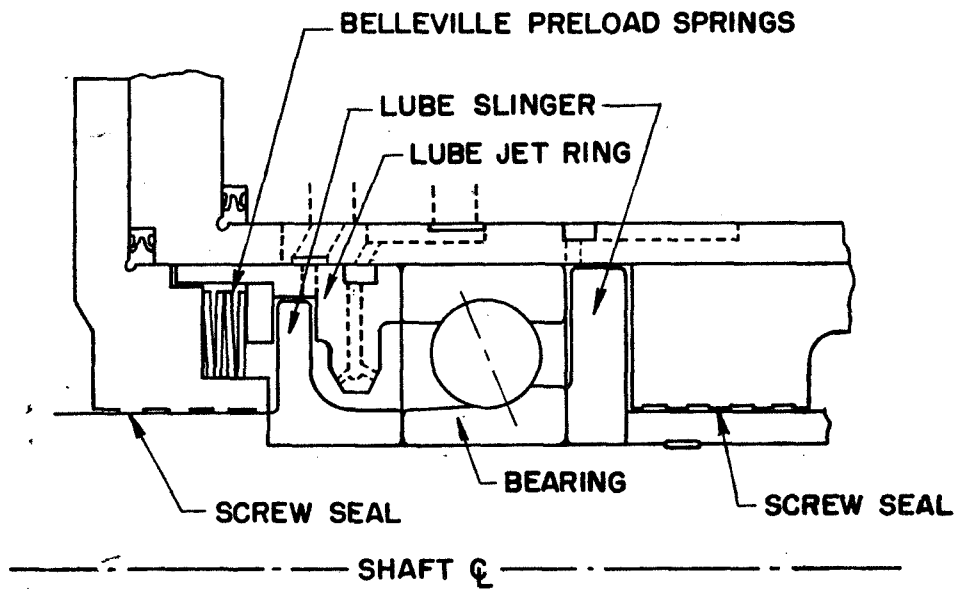
ALTERNATOR BEARING PRELOAD SYSTEM - CURRENT DESIGN.

ALTERNATOR BEARING PRELOAD SYSTEM - PROPOSED DESIGN.

Failures of this nature had occurred previously and a modified design with improved bearing preload system had already been made, but not implemented in existing hardware.
