AUTHOR(S): M. G. Cherry

TITLE: Mod-C PROGRAM, TURBINE VISCO SEAL CAVITATION TESTSABSTRACT

Mod-C, Visco Pump, Cavitation

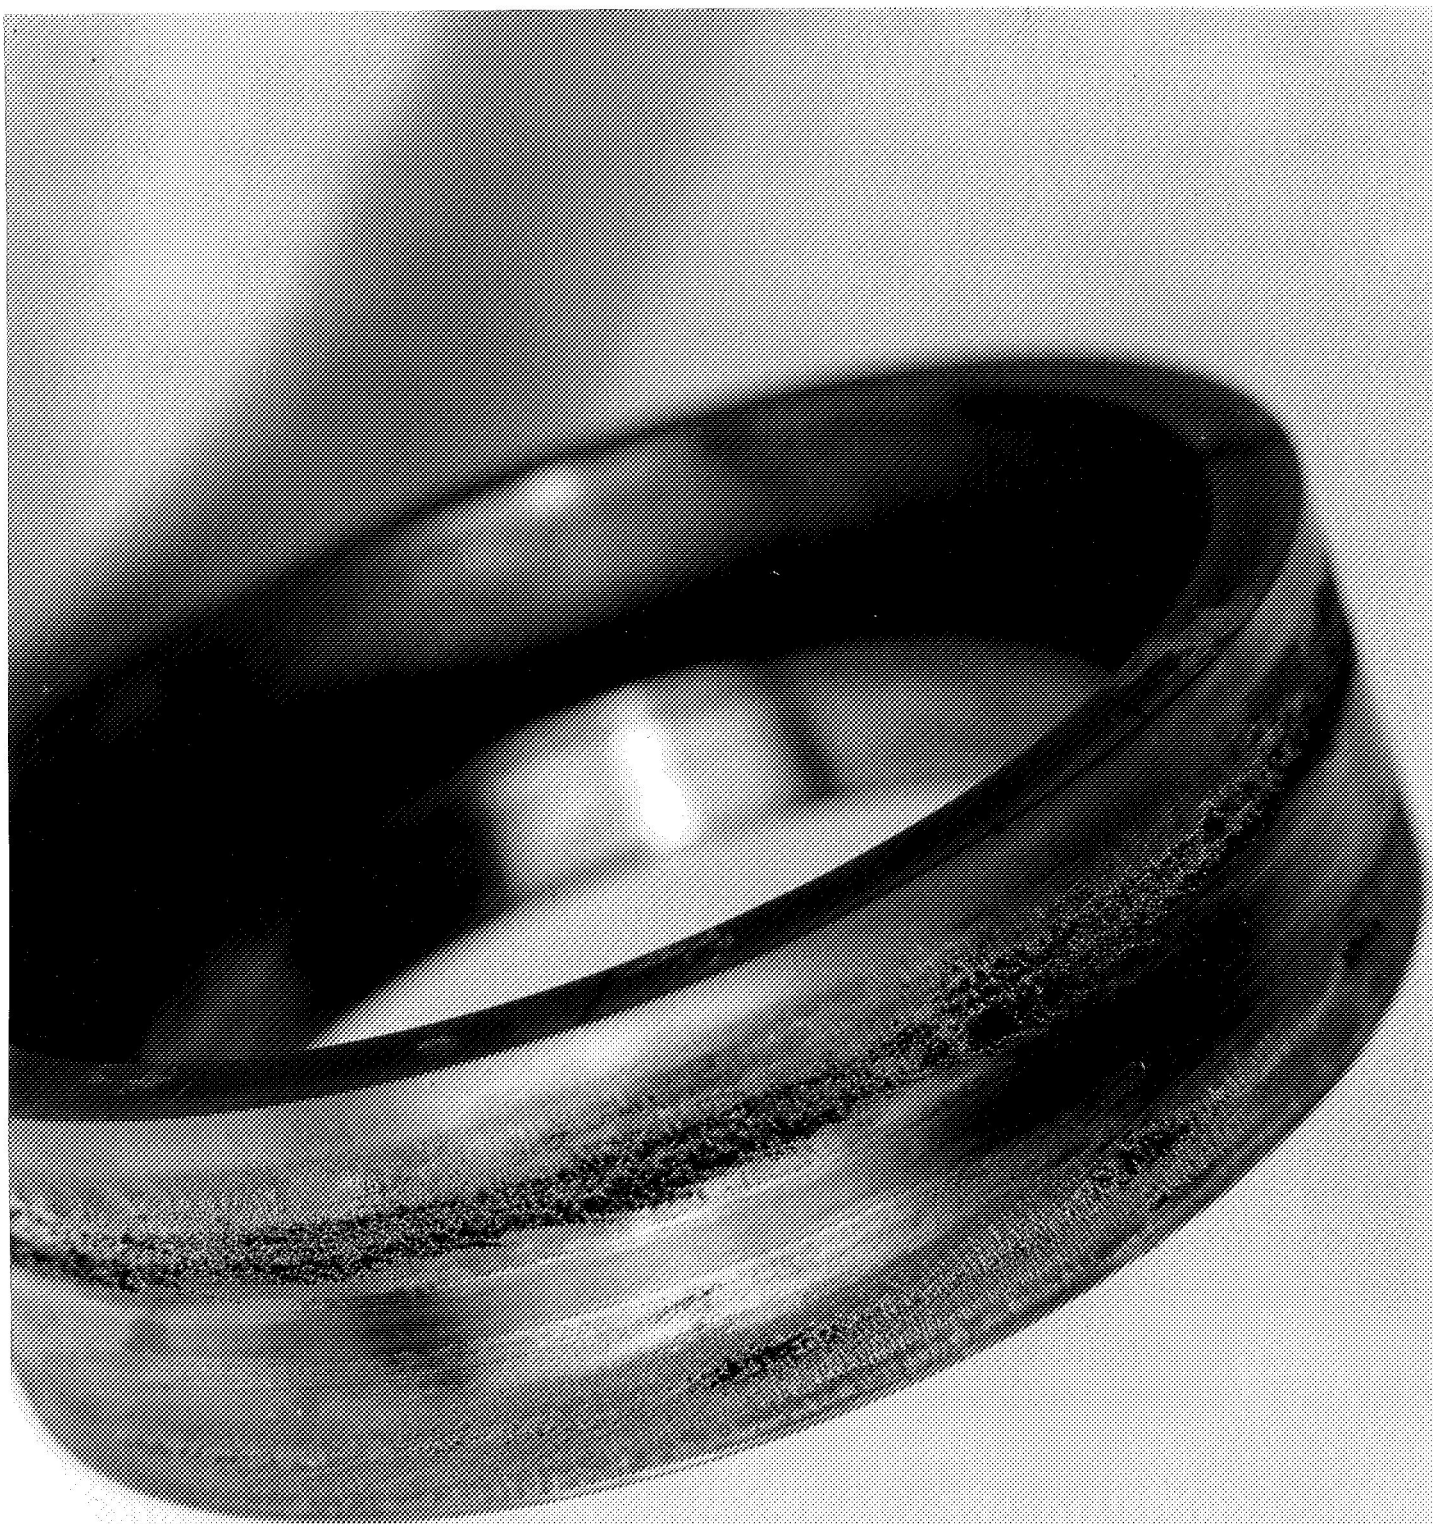
Figure 2

Tests of the final configuration of space seal over a period of 1,018 hours demonstrated (Ref. 23) low leakage rates which extrapolated to a loss of less than 1.0 lb. mercury in  $10^4$ /hours. It was observed on this particular case and on several others tested that although good sealing characteristics were obtained that varying degrees of cavitation and erosion damage were sustained on both the running ring, and on the housing of the visco pump. Figures 2, 3, and 4 indicate the degree of damage.

Mod-'C' Visco Ring After Approximately 1300 Hours in the TAA Seal Simulator Test

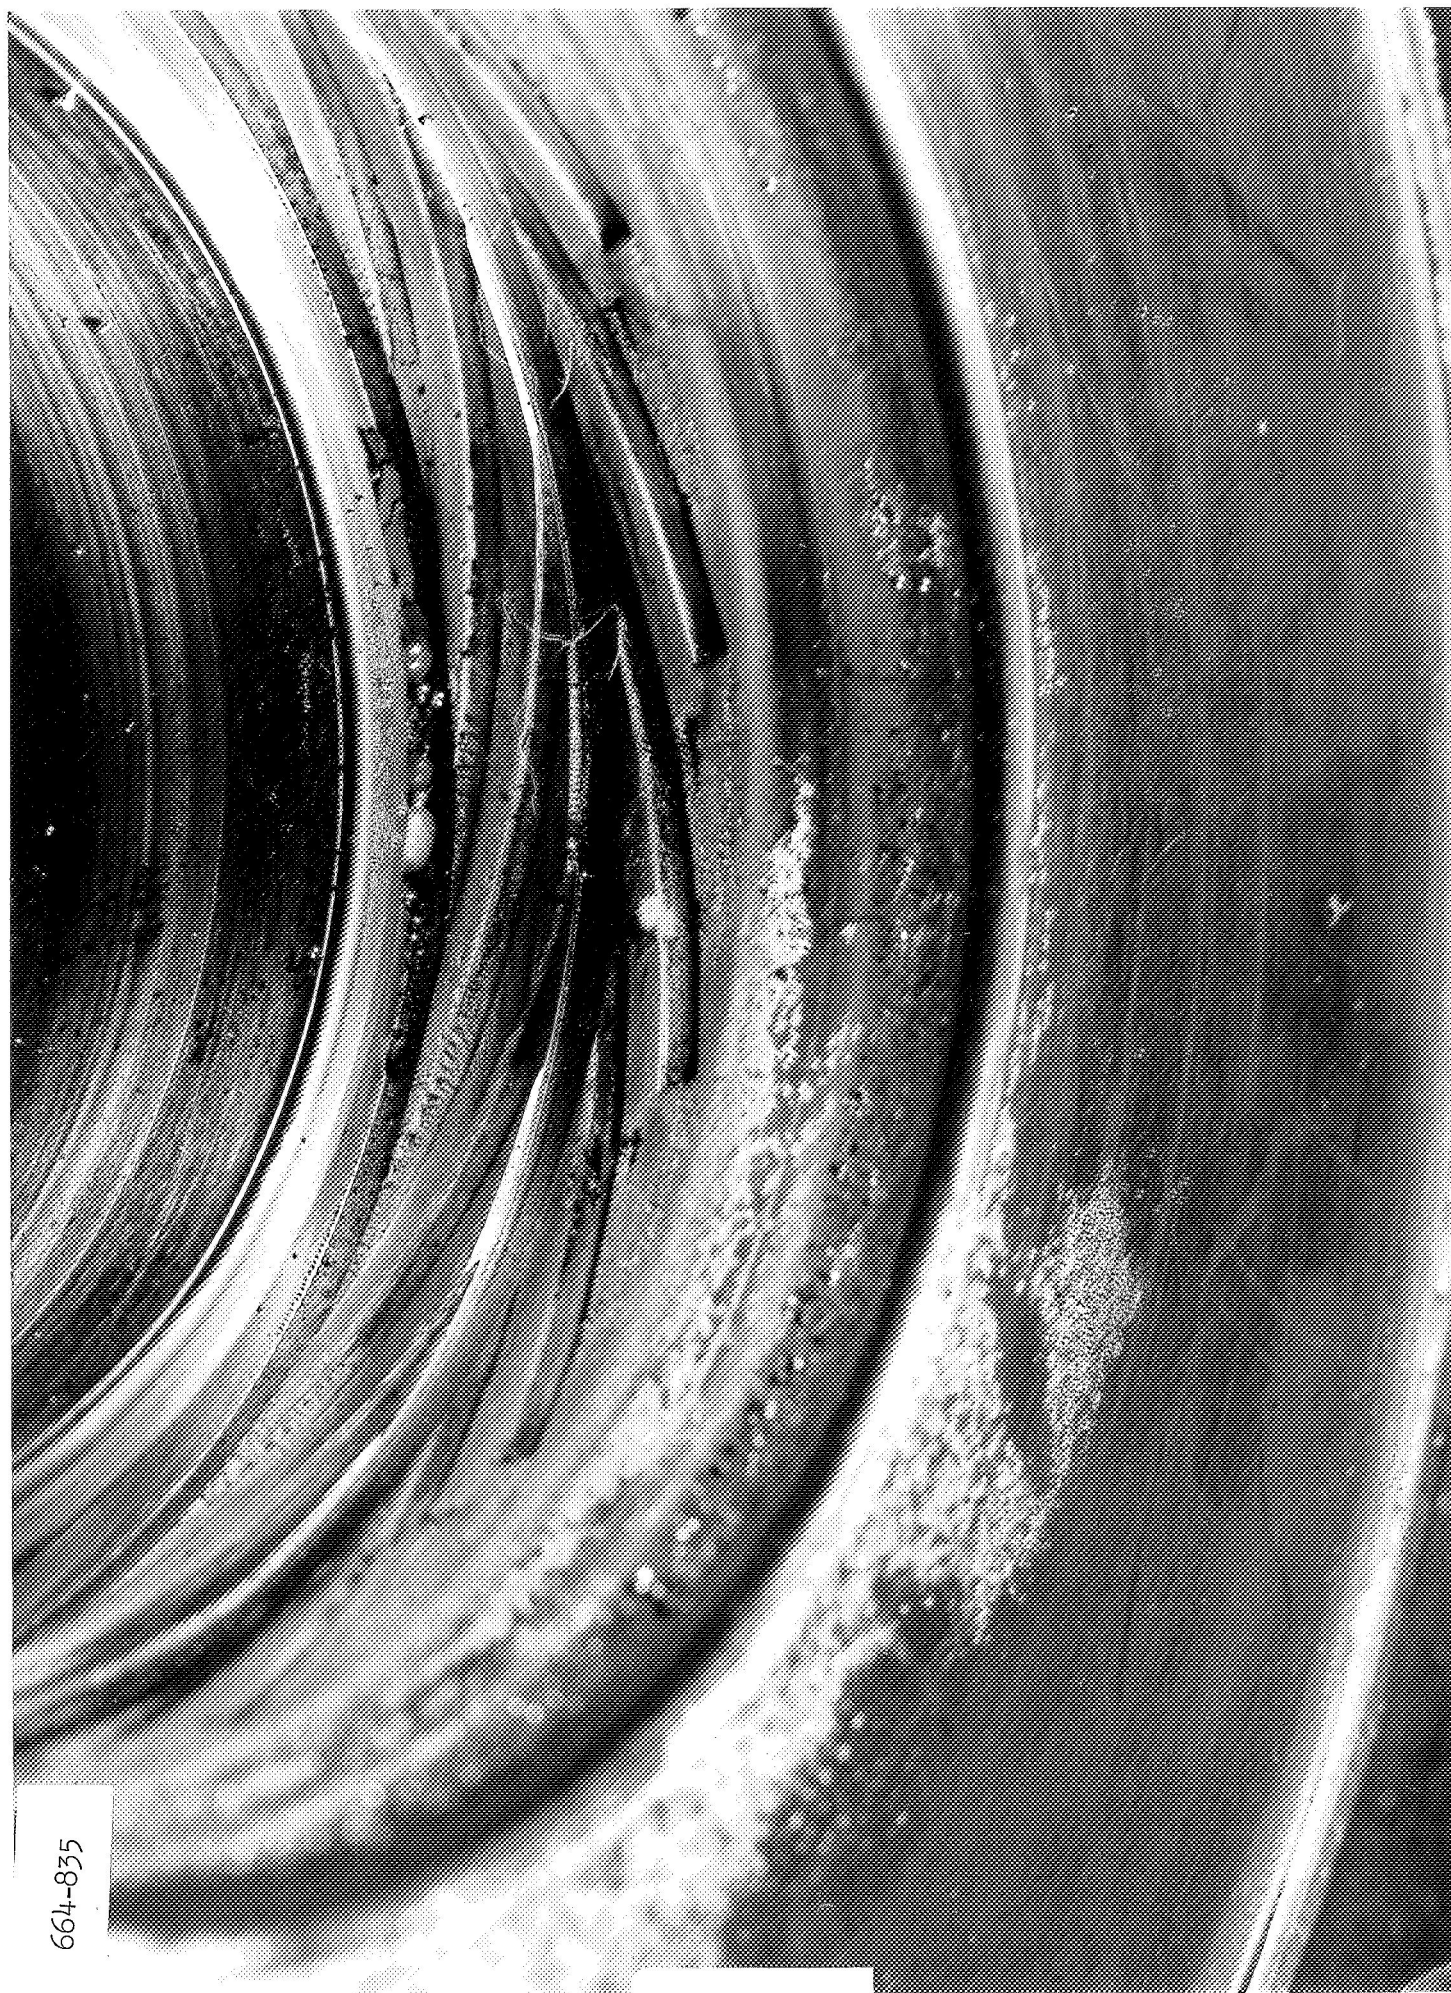
Figure 3

Housing from Mod-'B' Test

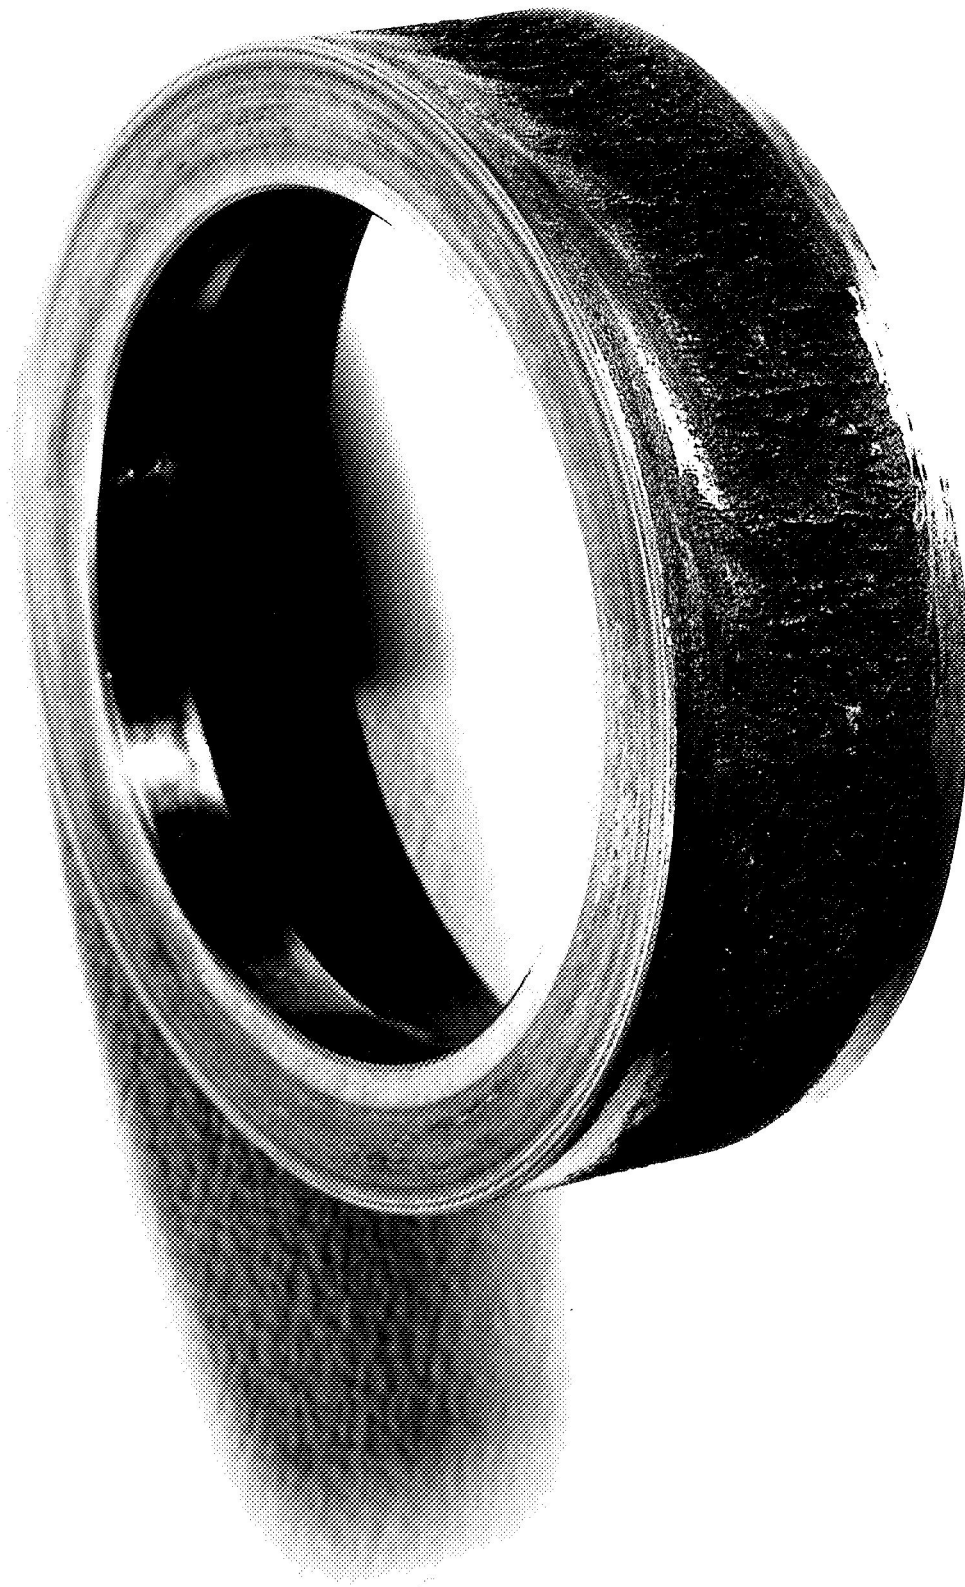
Figure 5

The visco seal of TAA 3/2 showed severe damage by cavitation (Figure 5) and there was a light reflection of this damage on the visco seal grooves in the turbine housing. Observation of this degree of damage prompted the following changes for all subsequent TAA units:

The decision to proceed with a development program was made after observation of the excessive cavitation damage demonstrated on TAA 3/2 visco ring after only 820 hours of operation.

Visco Seal Ring on TAA 3/2

2. An increase in the radial clearance to balance the pumping coefficients and place the turbine end vapor/liquid interface more directly under the oil heat exchanger (thereby providing improved cooling for the liquid plug); this change also placed the new mercury vapor/liquid interface on the radial slinger face instead of on the cylindrical surface. TAA's 6/1 through 5/3, consequently, showed little or no damage (Figures 6 through 11). What damage there was appears to be similar to a light etching of the surface.

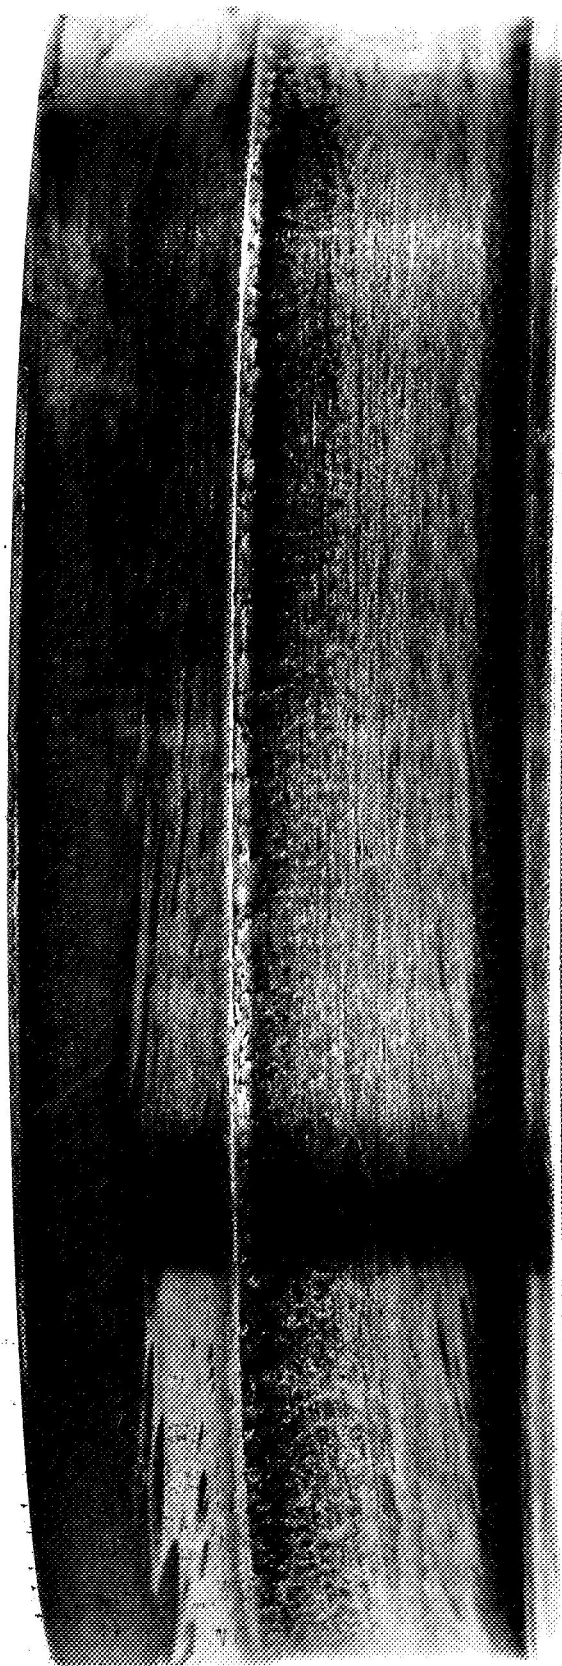
Figure 6

RUB MARKS AND CAVITATION DAMAGE  
ON VISCO SEAL RING  
TA 1 / 5 AFTER SHUTDOWN 4-25-67

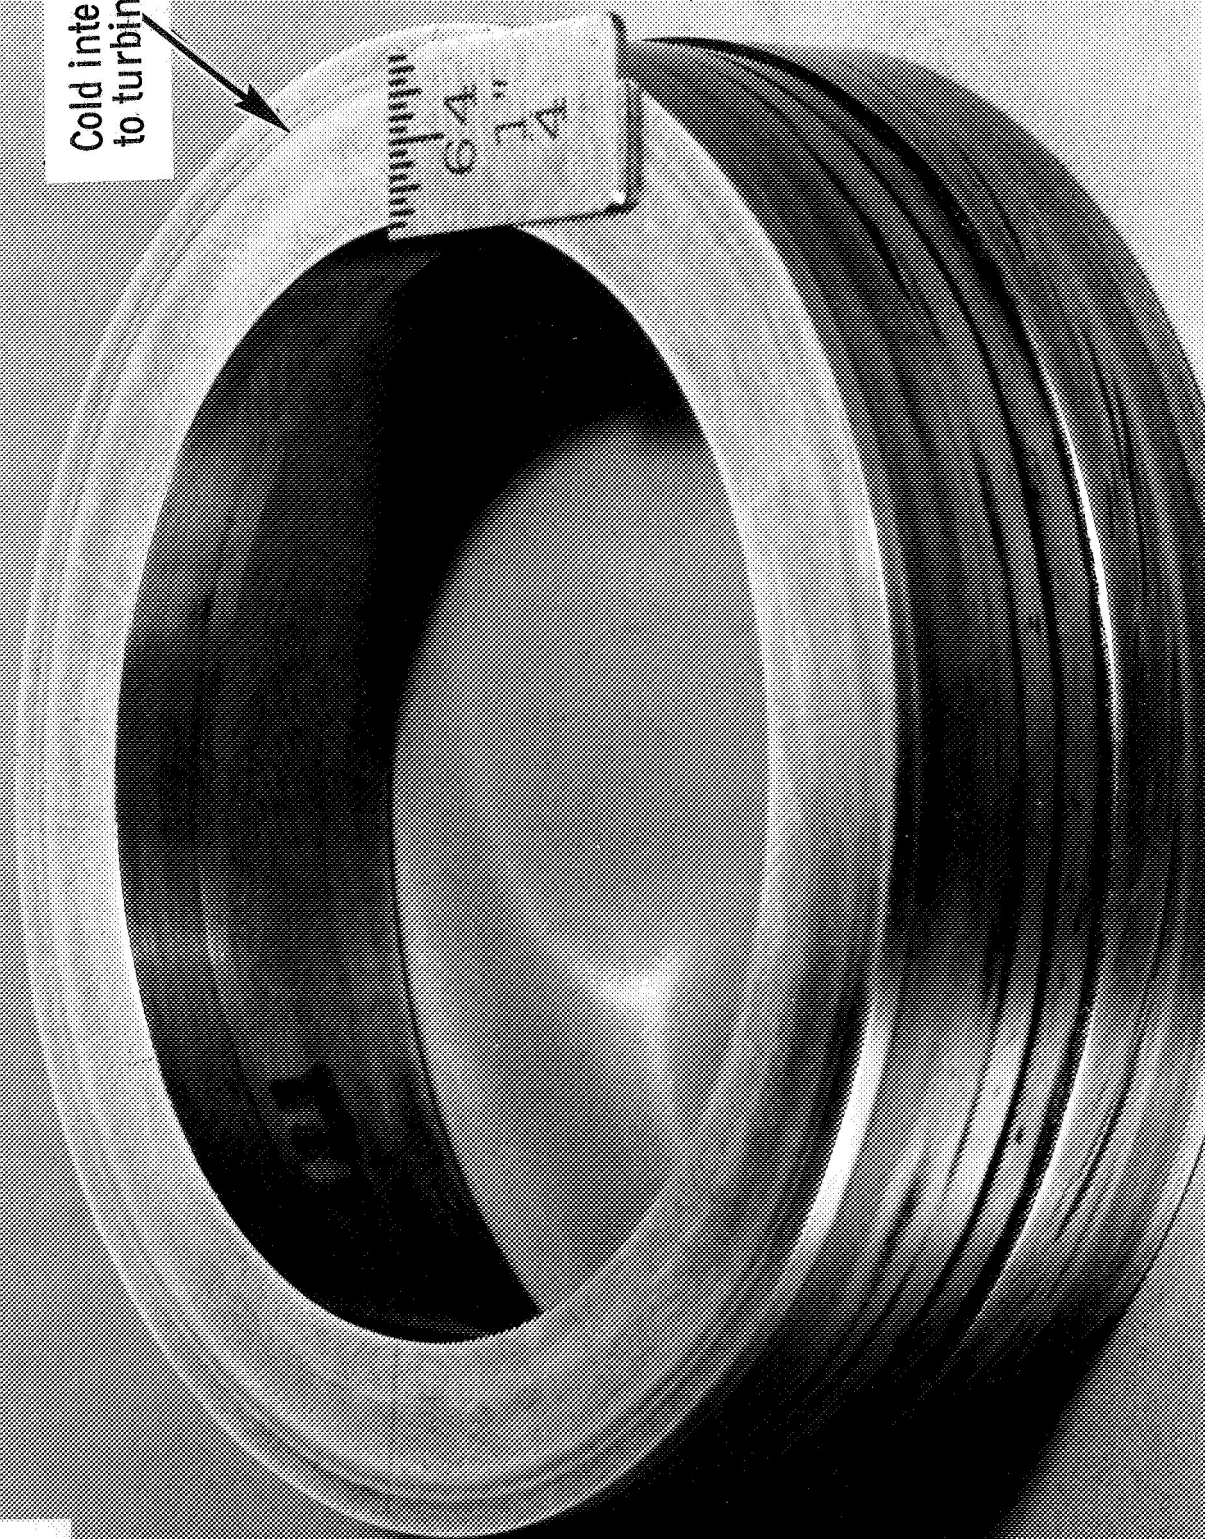
Figure 21

VISCO SEAL RING (STELLITE 6B) FROM MOD C TEST RIG NO. 1  
SHOWING CAVITATION DAMAGE AFTER APPROXIMATELY  
45 TEST HOURS (P/N 098084, S/N A-11)

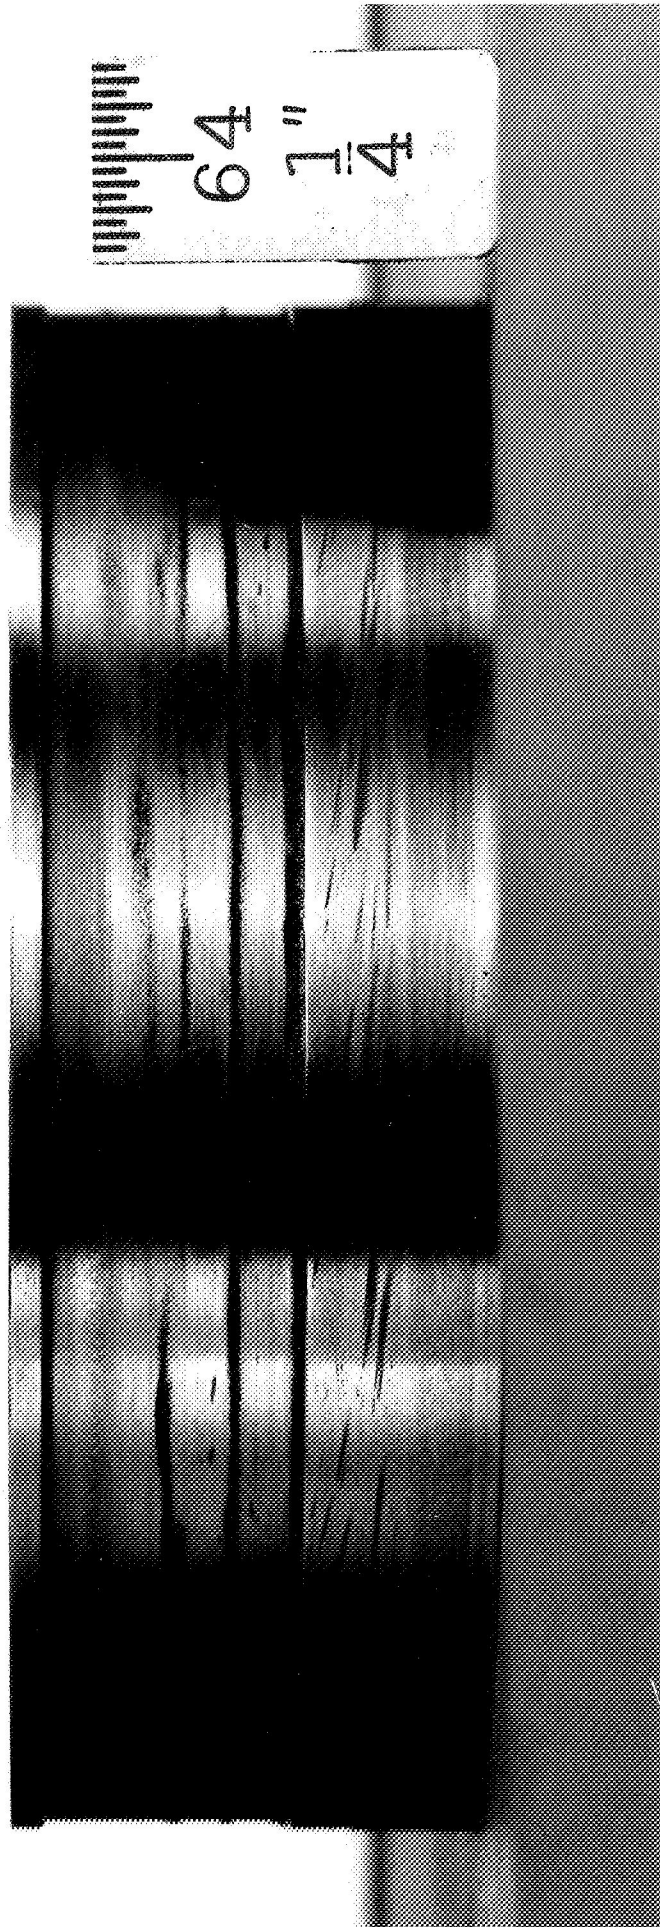
VISCO SEAL RING (STELLITE 6B) FROM MOD C TEST RIG NO. 1  
SHOWING CAVITATION DAMAGE AFTER APPROXIMATELY  
45 TEST HOURS (P/N 098084, S/N A-11)

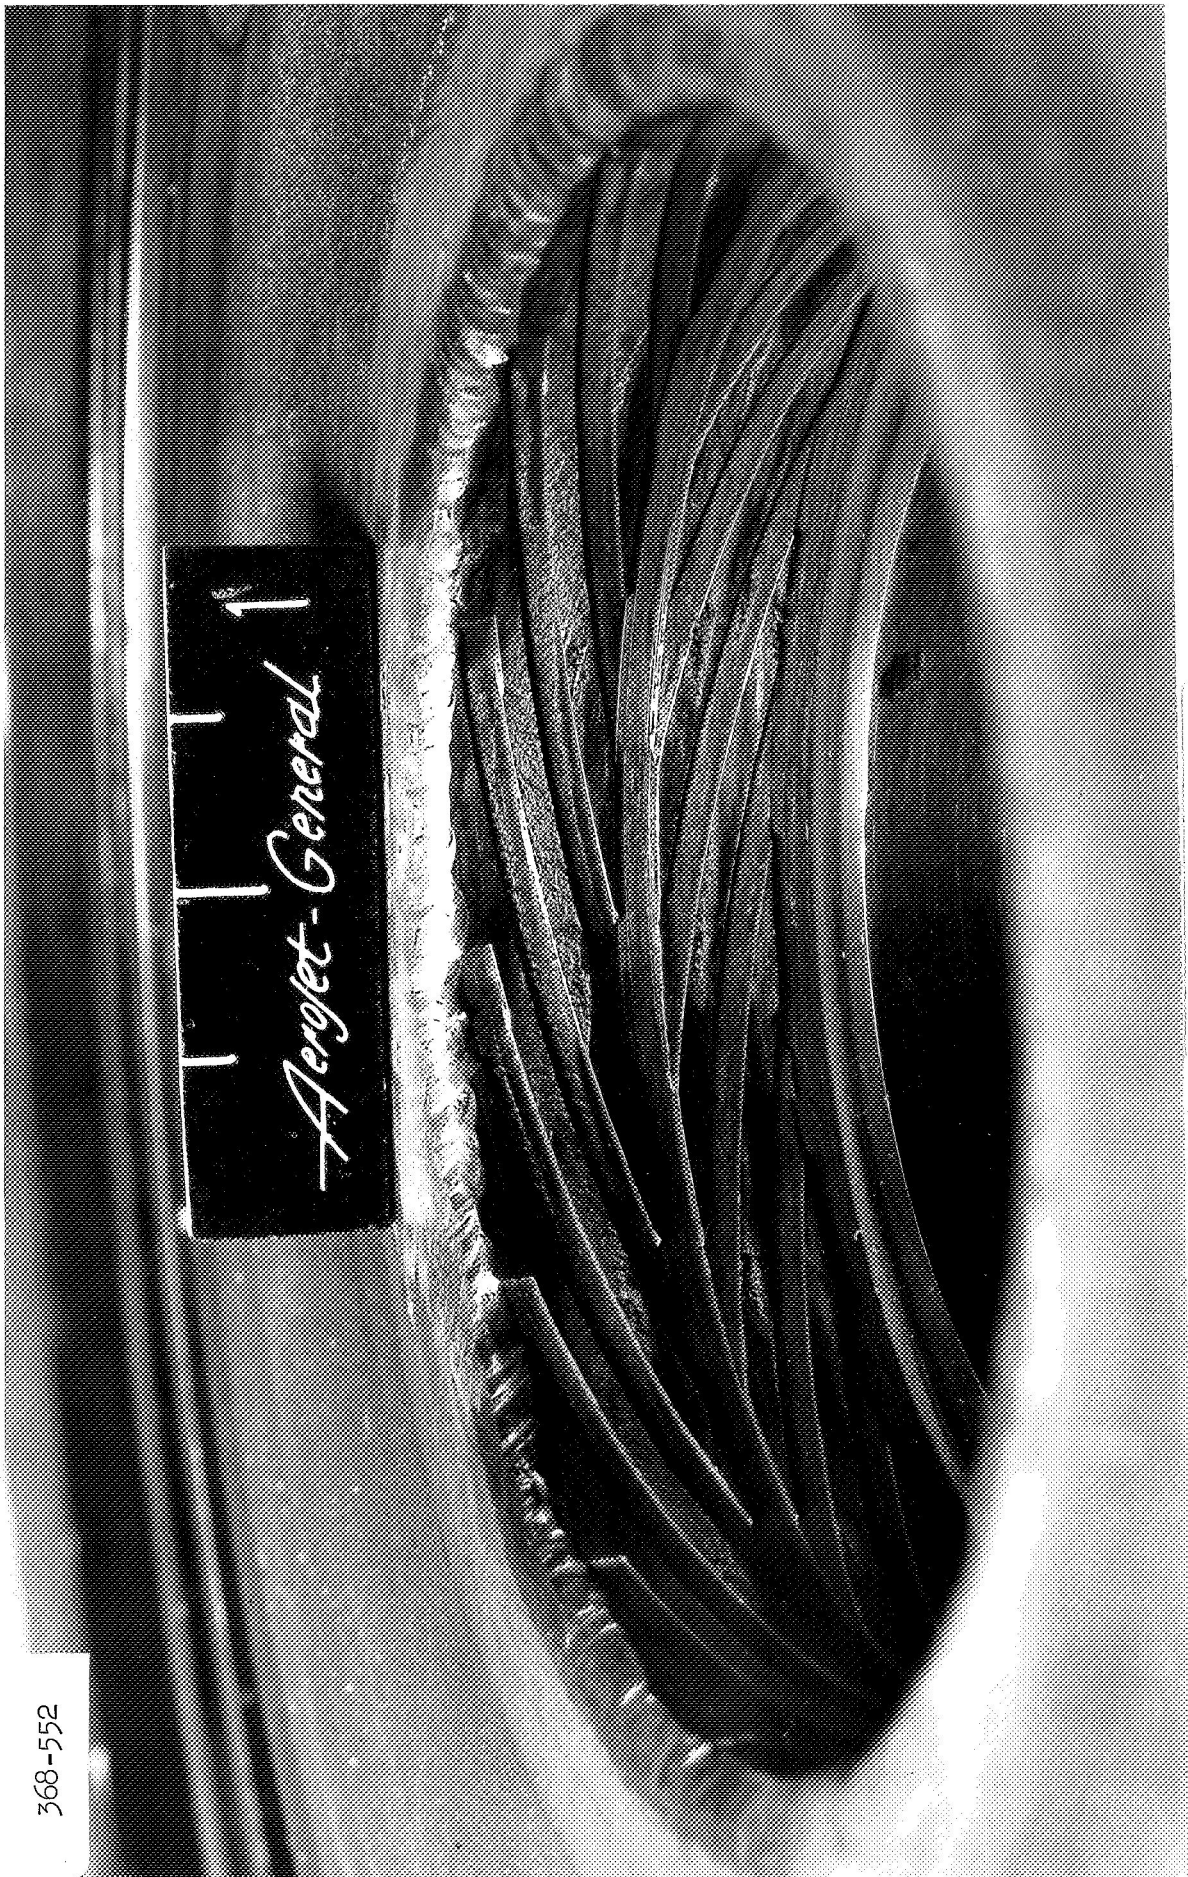
SNAP-8 MOD-C SEAL TEST RIG NO. 1  
CAVITATION DAMAGE ON MILD STEEL HERRING BONE PUMP  
AFTER APPROXIMATELY 154 TEST HOURS (3-26-68)

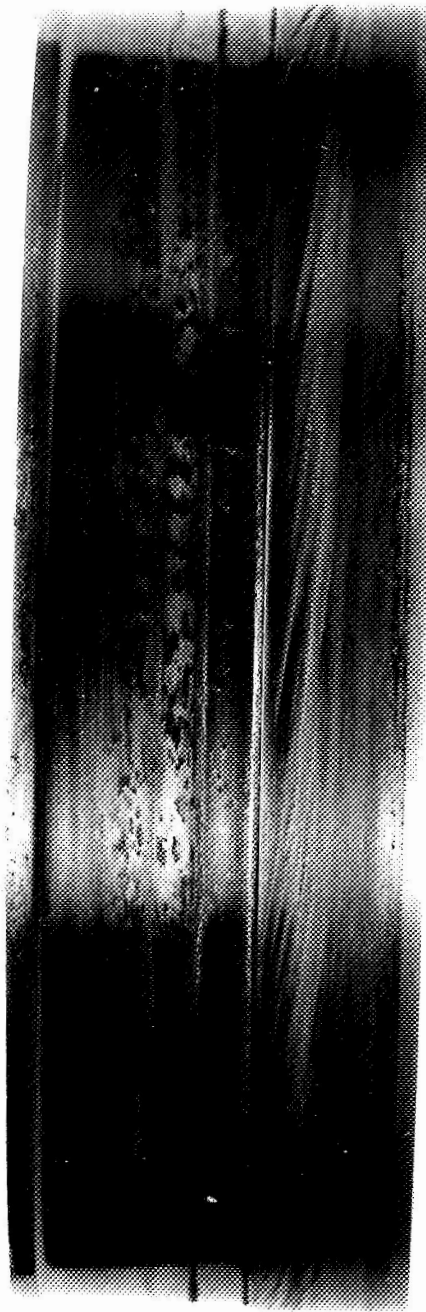
Figure 24

VISCO SEAL RING (STELLITE 6B) FROM MOD-C TEST RIG NO. 1  
SHOWING CAVITATION DAMAGE AFTER APPROXIMATELY  
154 TEST HOURS (P/N 098084, S/N A-11) (3-26-68)

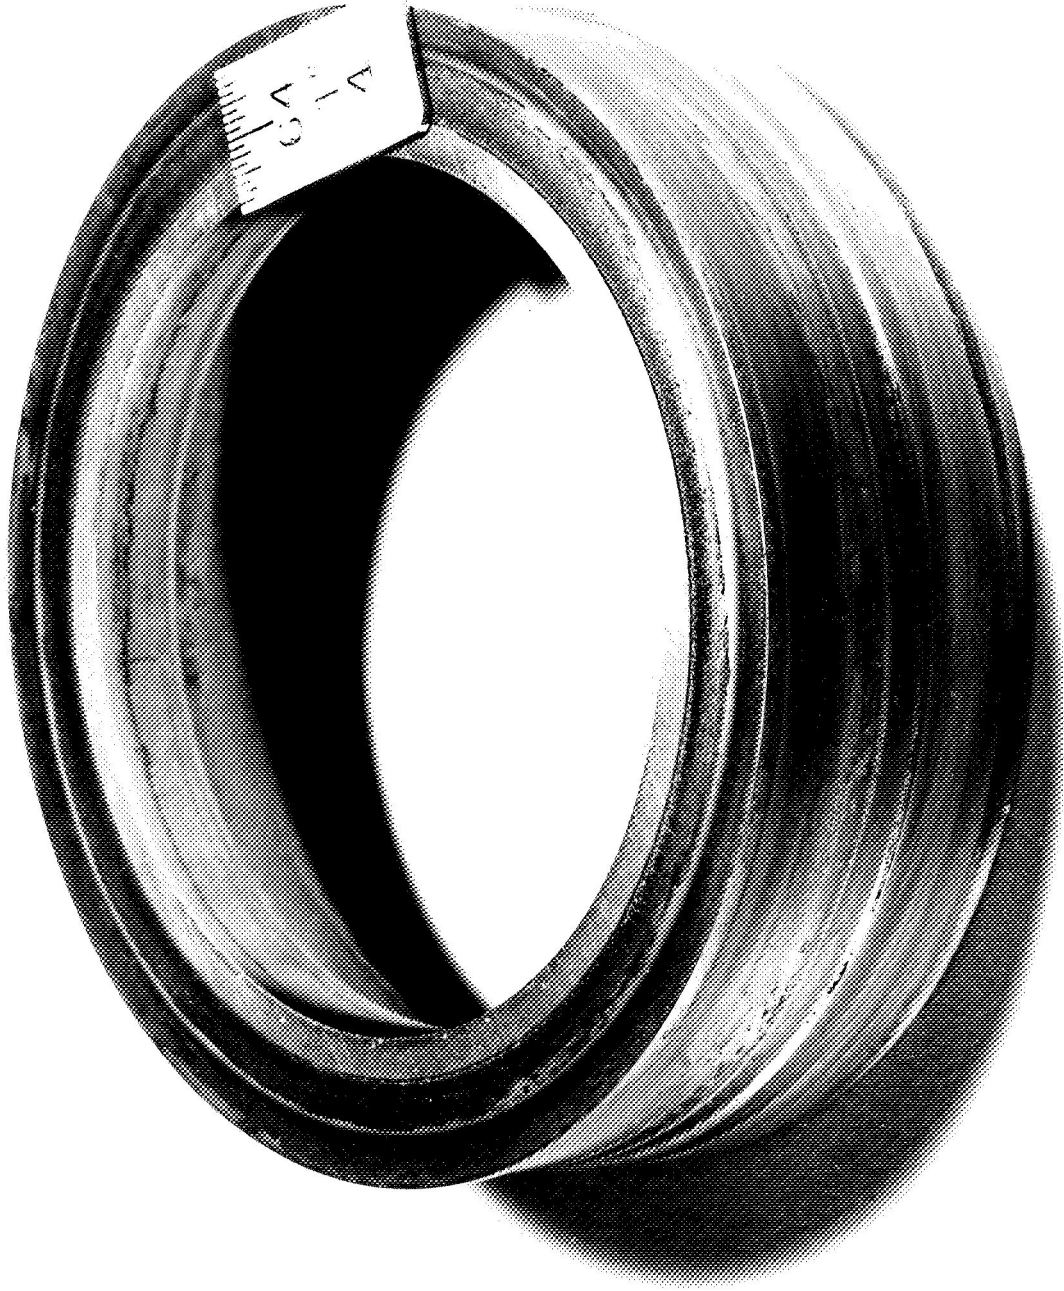
VISCO SEAL RING (STELLITE 6B) FROM MOD-C TEST RIG NO. 1  
SHOWING CAVITATION DAMAGE AFTER APPROXIMATELY  
154 HOURS (P/N 098084, S/N A-11) (3-26-68)

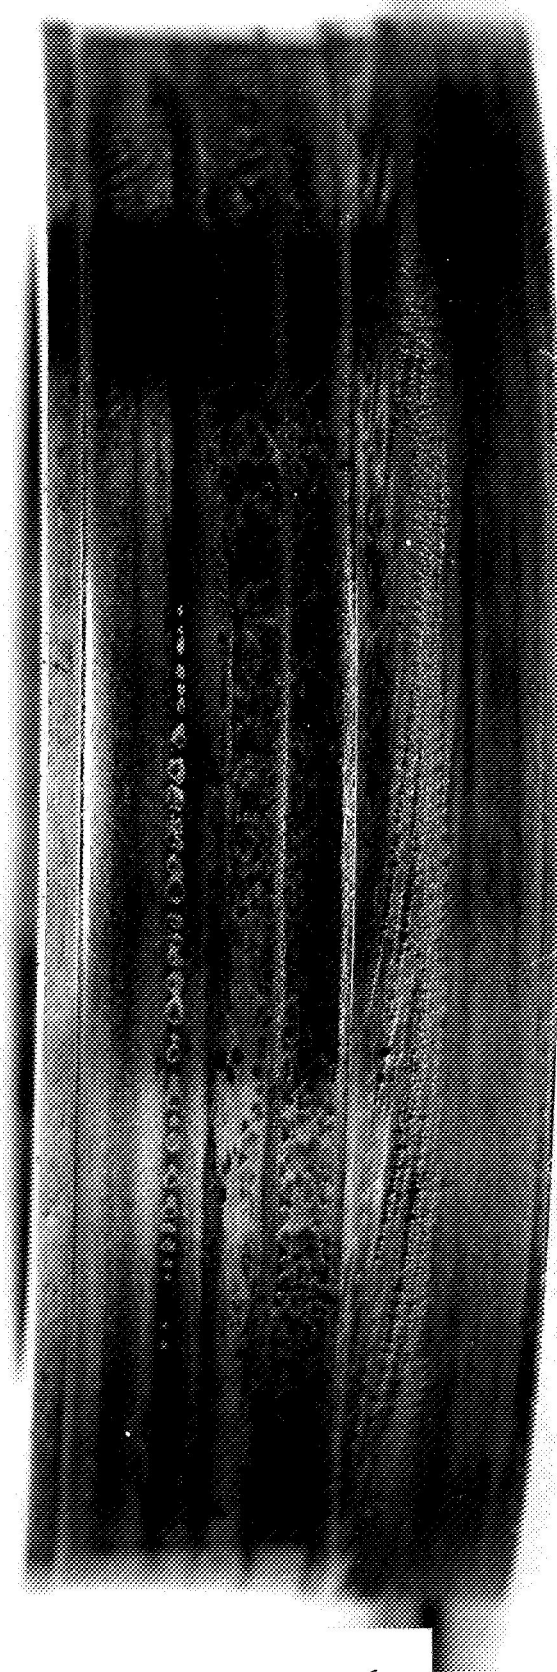
Figure 26

VISCO SEAL RING (STELLITE 6B) FROM MOD-C TEST RIG NO. 1  
SHOWING CAVITATION DAMAGE AFTER APPROXIMATELY  
501 HOURS 4 MINUTE TEST (P/N 098084, S/N A-11) 4-23-68

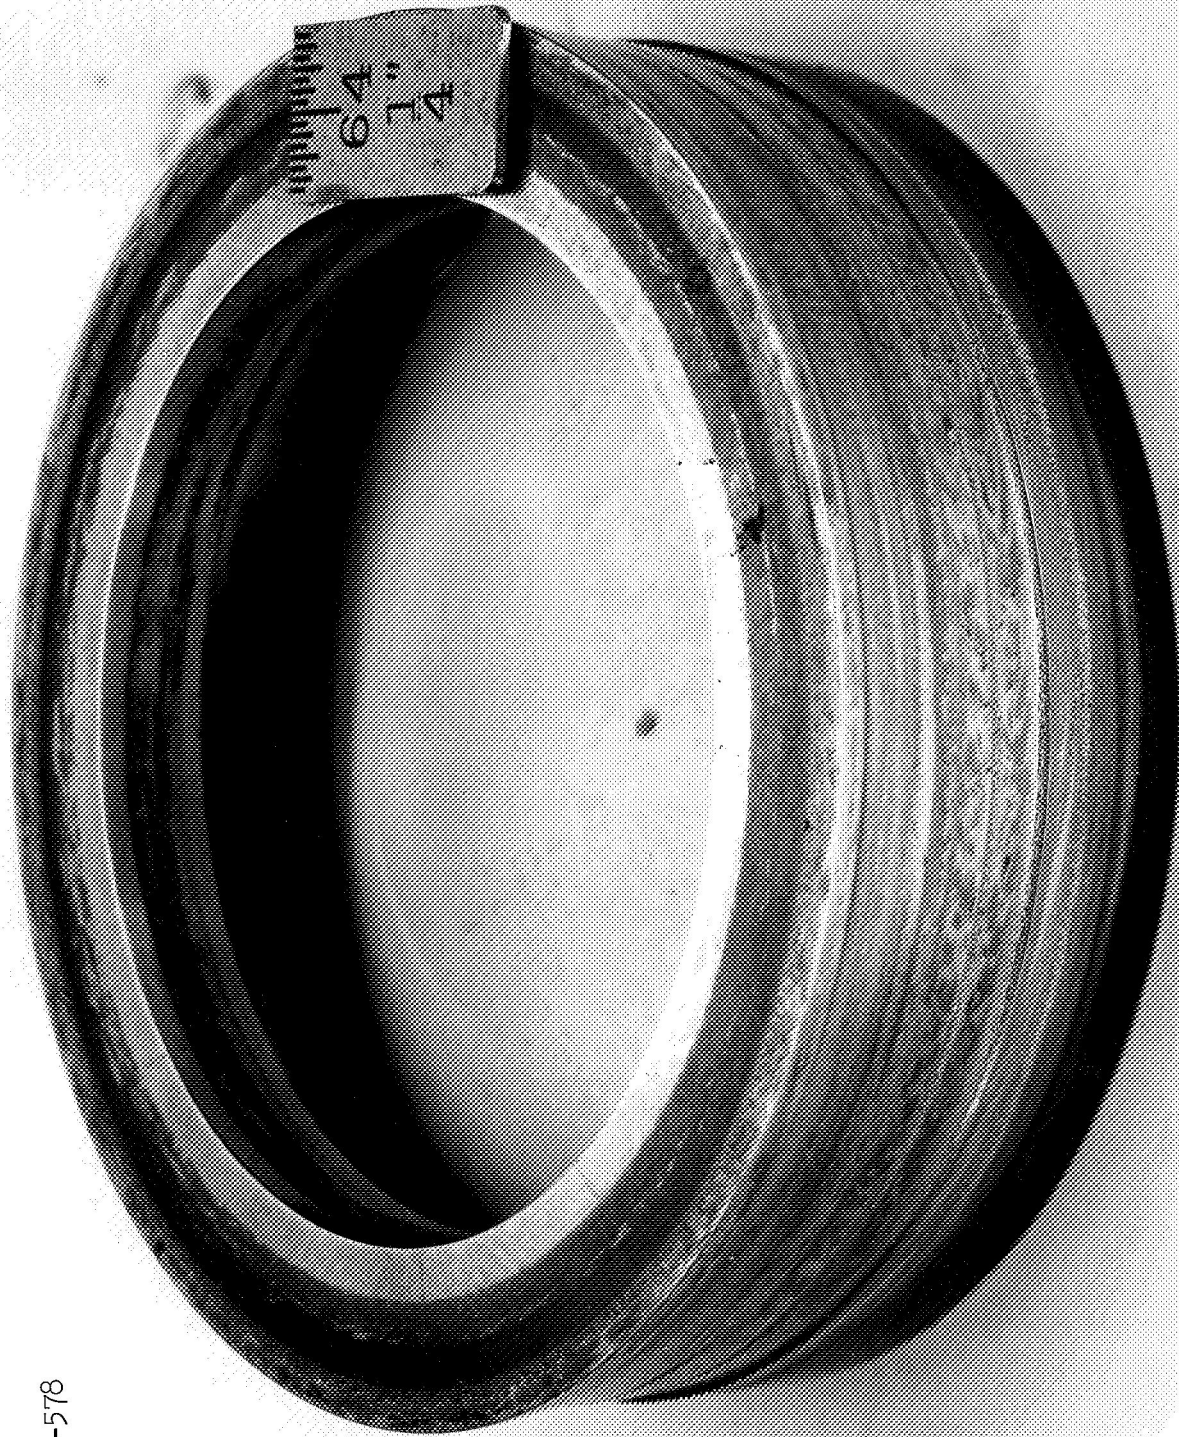
Figure 27

VISCO SEAL RING (STELLITE6B) FROM MOD-C TEST RIG NO. 1  
SHOWING CAVITATION DAMAGE AFTER APPROXIMATELY  
501 HOURS 4 MINUTES TEST (P/N 098084, S/N A-11) 4-23-68

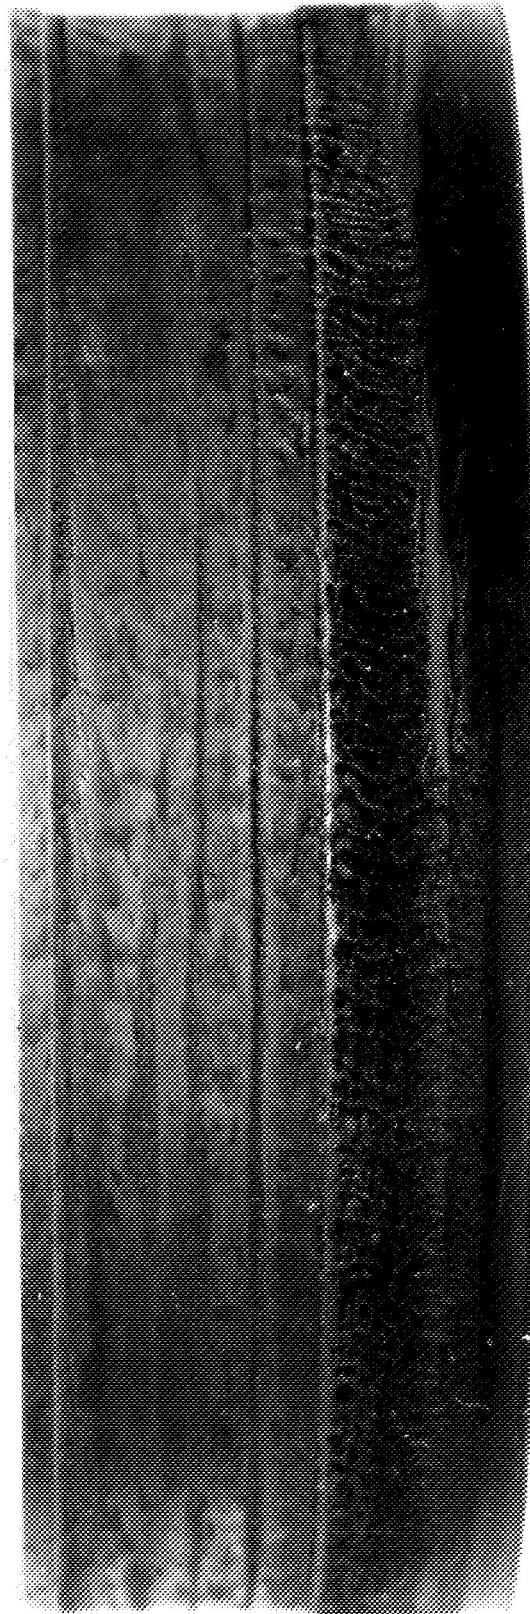
VISCO SEAL RING (STELLITE 6B) FROM MOD C TEST RIG NO. 1/6  
SHOWING CAVITATION DAMAGE AFTER 1844 HOURS OPERATION  
(P/N 098084-3 S/N A-11) 7-17-68

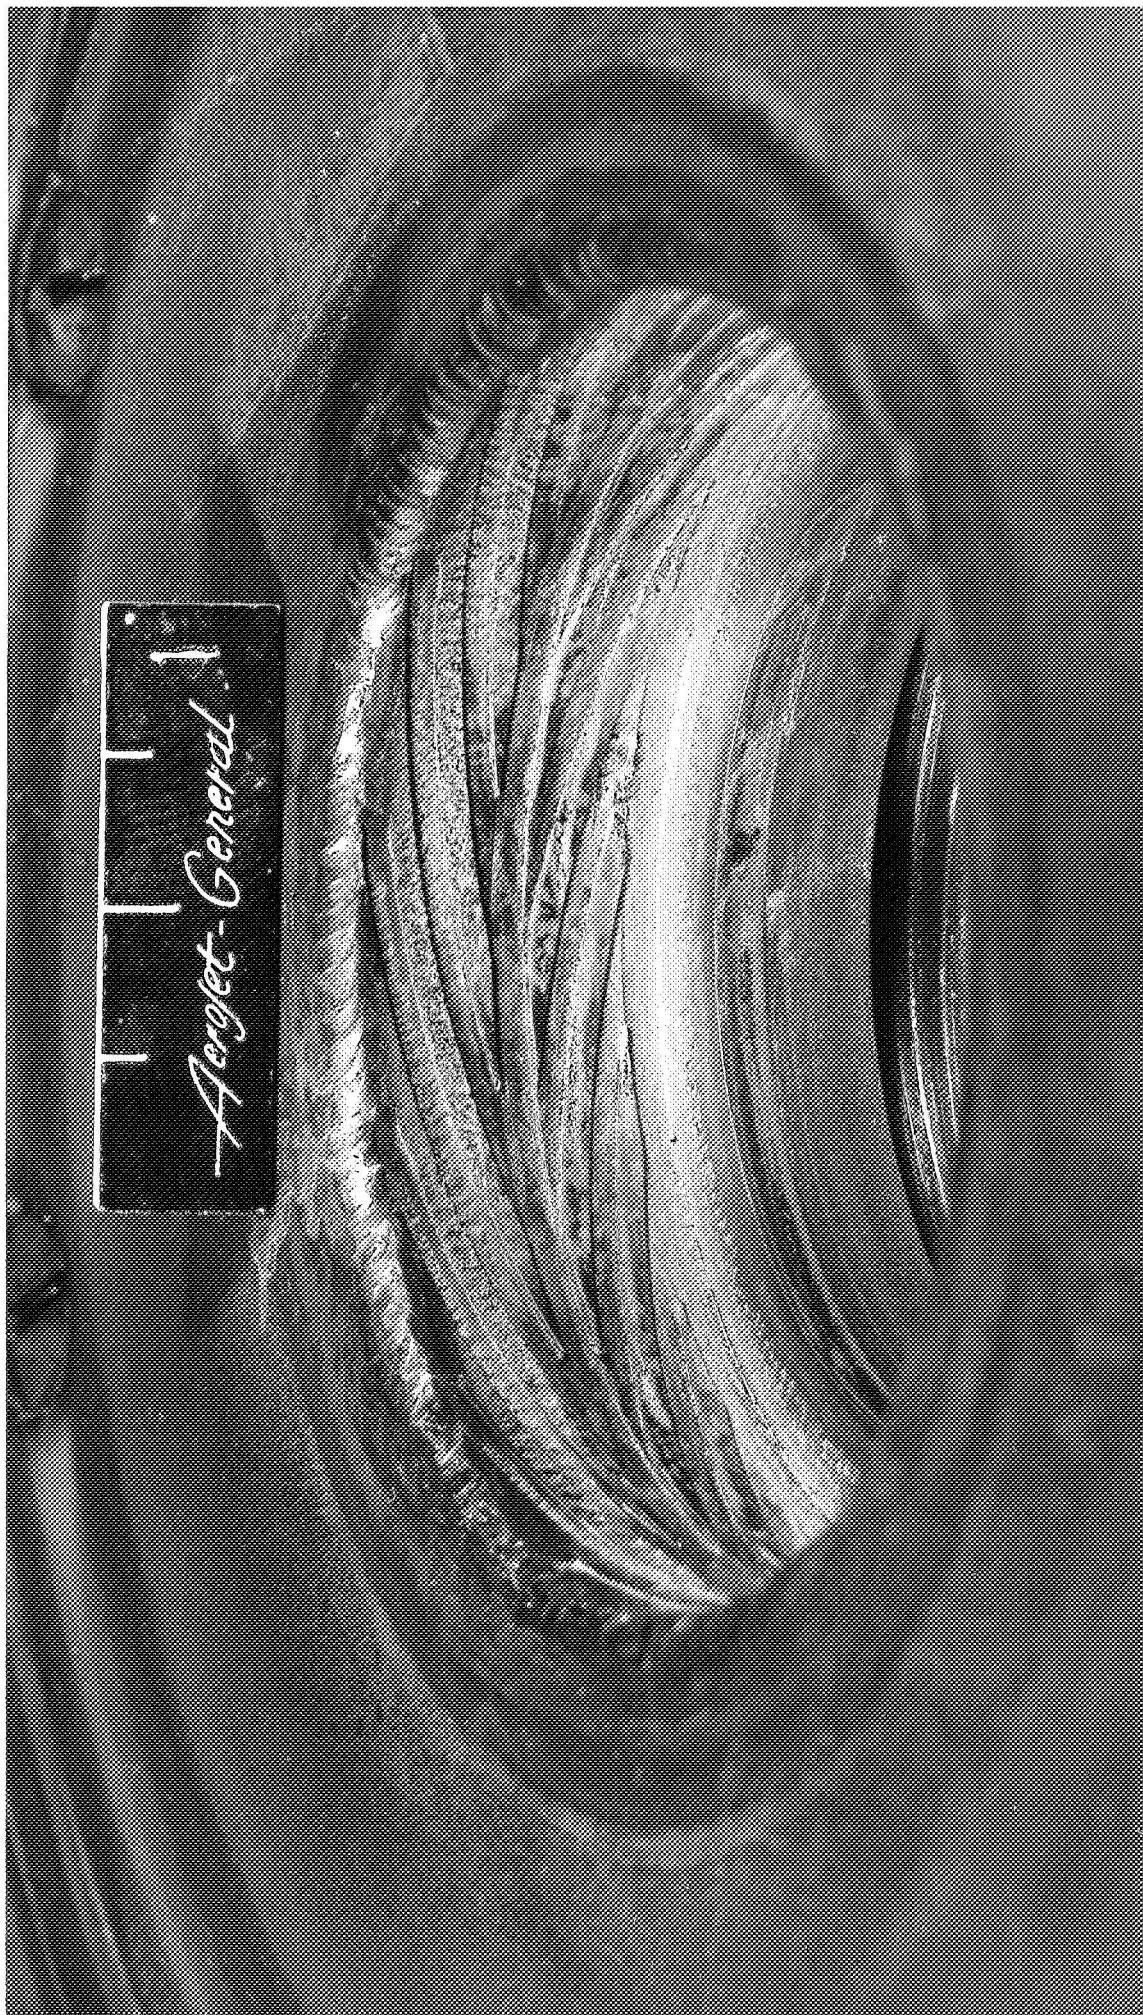
SNAP-8 MOD C SEAL TEST RIG NO. 1/6  
SHOWING CAVITATION DAMAGE ON MILD STEEL HERRING BONE PUMP  
AFTER 1844 HOURS OPERATION 7-17-68

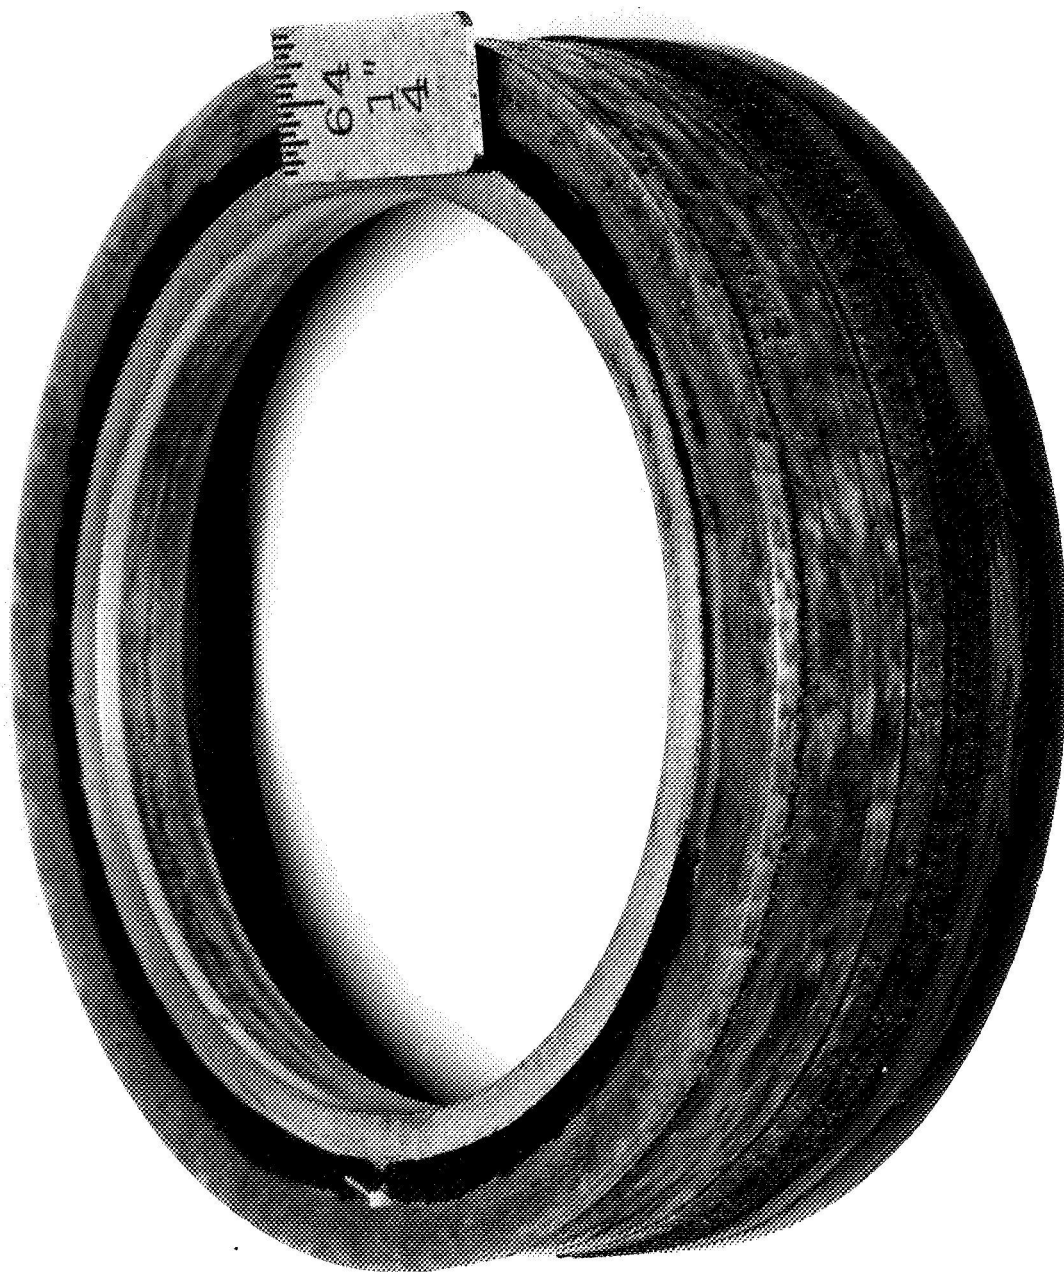
VISCO SEAL RING (STELLITE 6B) FROM MOD C TEST RIG NO. 1/6  
SHOWING CAVITATION DAMAGE AFTER 1844 HOURS OPERATION  
(P/N 098084-3 S/N A-11) 7-17-68
