AUTHOR(S): M. G. Cherry

TITLE: Mod-C PROGRAM, TURBINE VISCO SEAL CAVITATION TESTSABSTRACT

Mod-C, Visco Pump, Cavitation

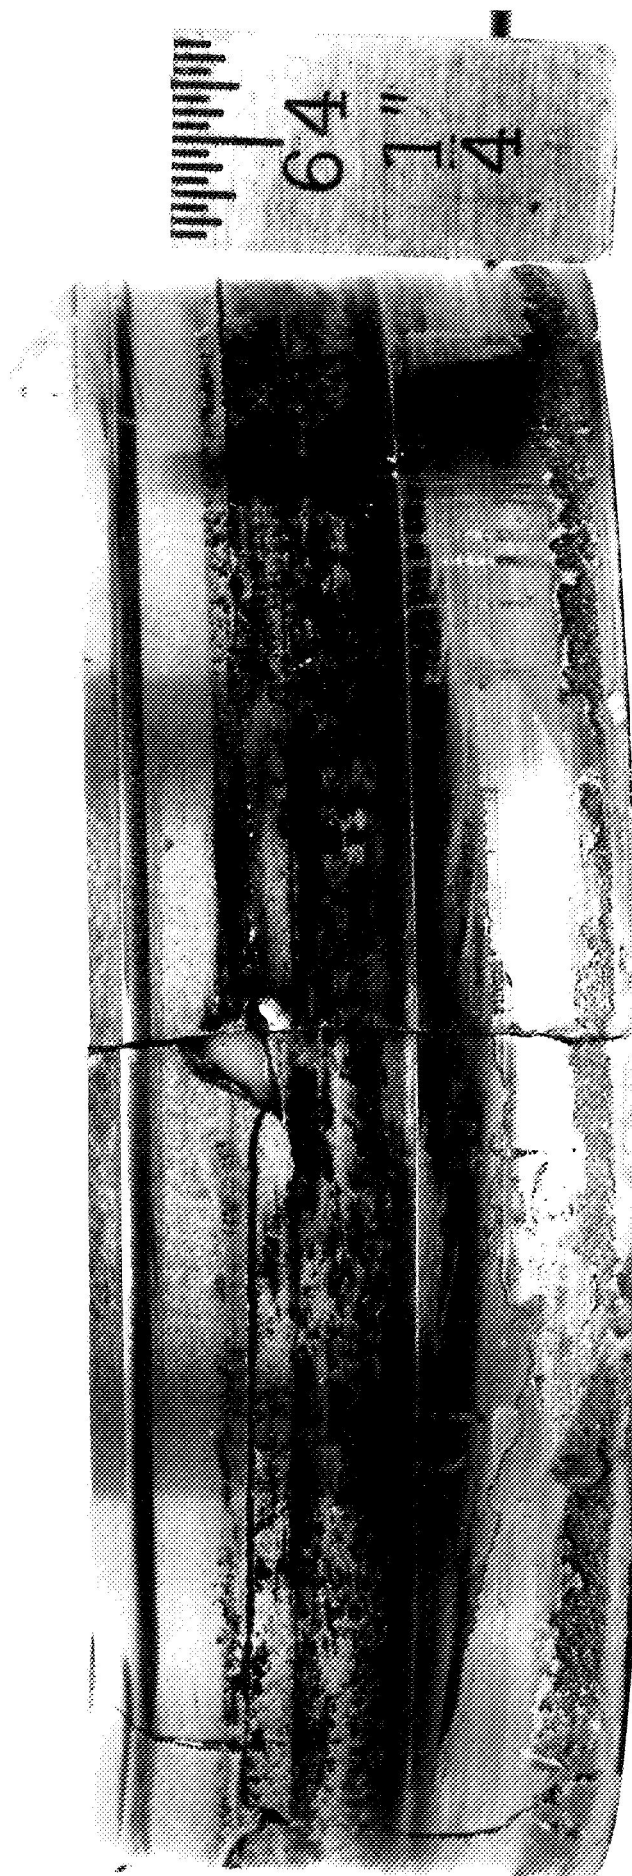
Figure 35

Hexagonal close packed (HCP) form Stellite 6B was included as the reference material in the earlier SNAP-8 turbines due to its good erosion resistant characteristics. This material however is brittle ( $< 2\%$  ductility). The two fractures of the visco ring which occurred in Mod-C were attributed to this brittleness.

Examination of the first failed ring revealed a series of cracks. One of the cracks was completely through the ring, both radially and axially (Figure 35). The other cracks were much smaller and were generally located at the free end of the visco ring. Some of these cracks penetrated the entire ring thickness; others were restricted to the outer surfaces. The rub marks indicated that the large crack had existed before the last shutdown. Rubbing was restricted to only one side of the crack.

VISCO SEAL RING (STELLITE 6B) FROM MOD C TEST RIG NO. 414  
AFTER 120 HOURS (P/N 098084-3 S/N A9) 8-9-68  
TEST WAS TERMINATED DUE TO RING SEIZURE IN HOUSING

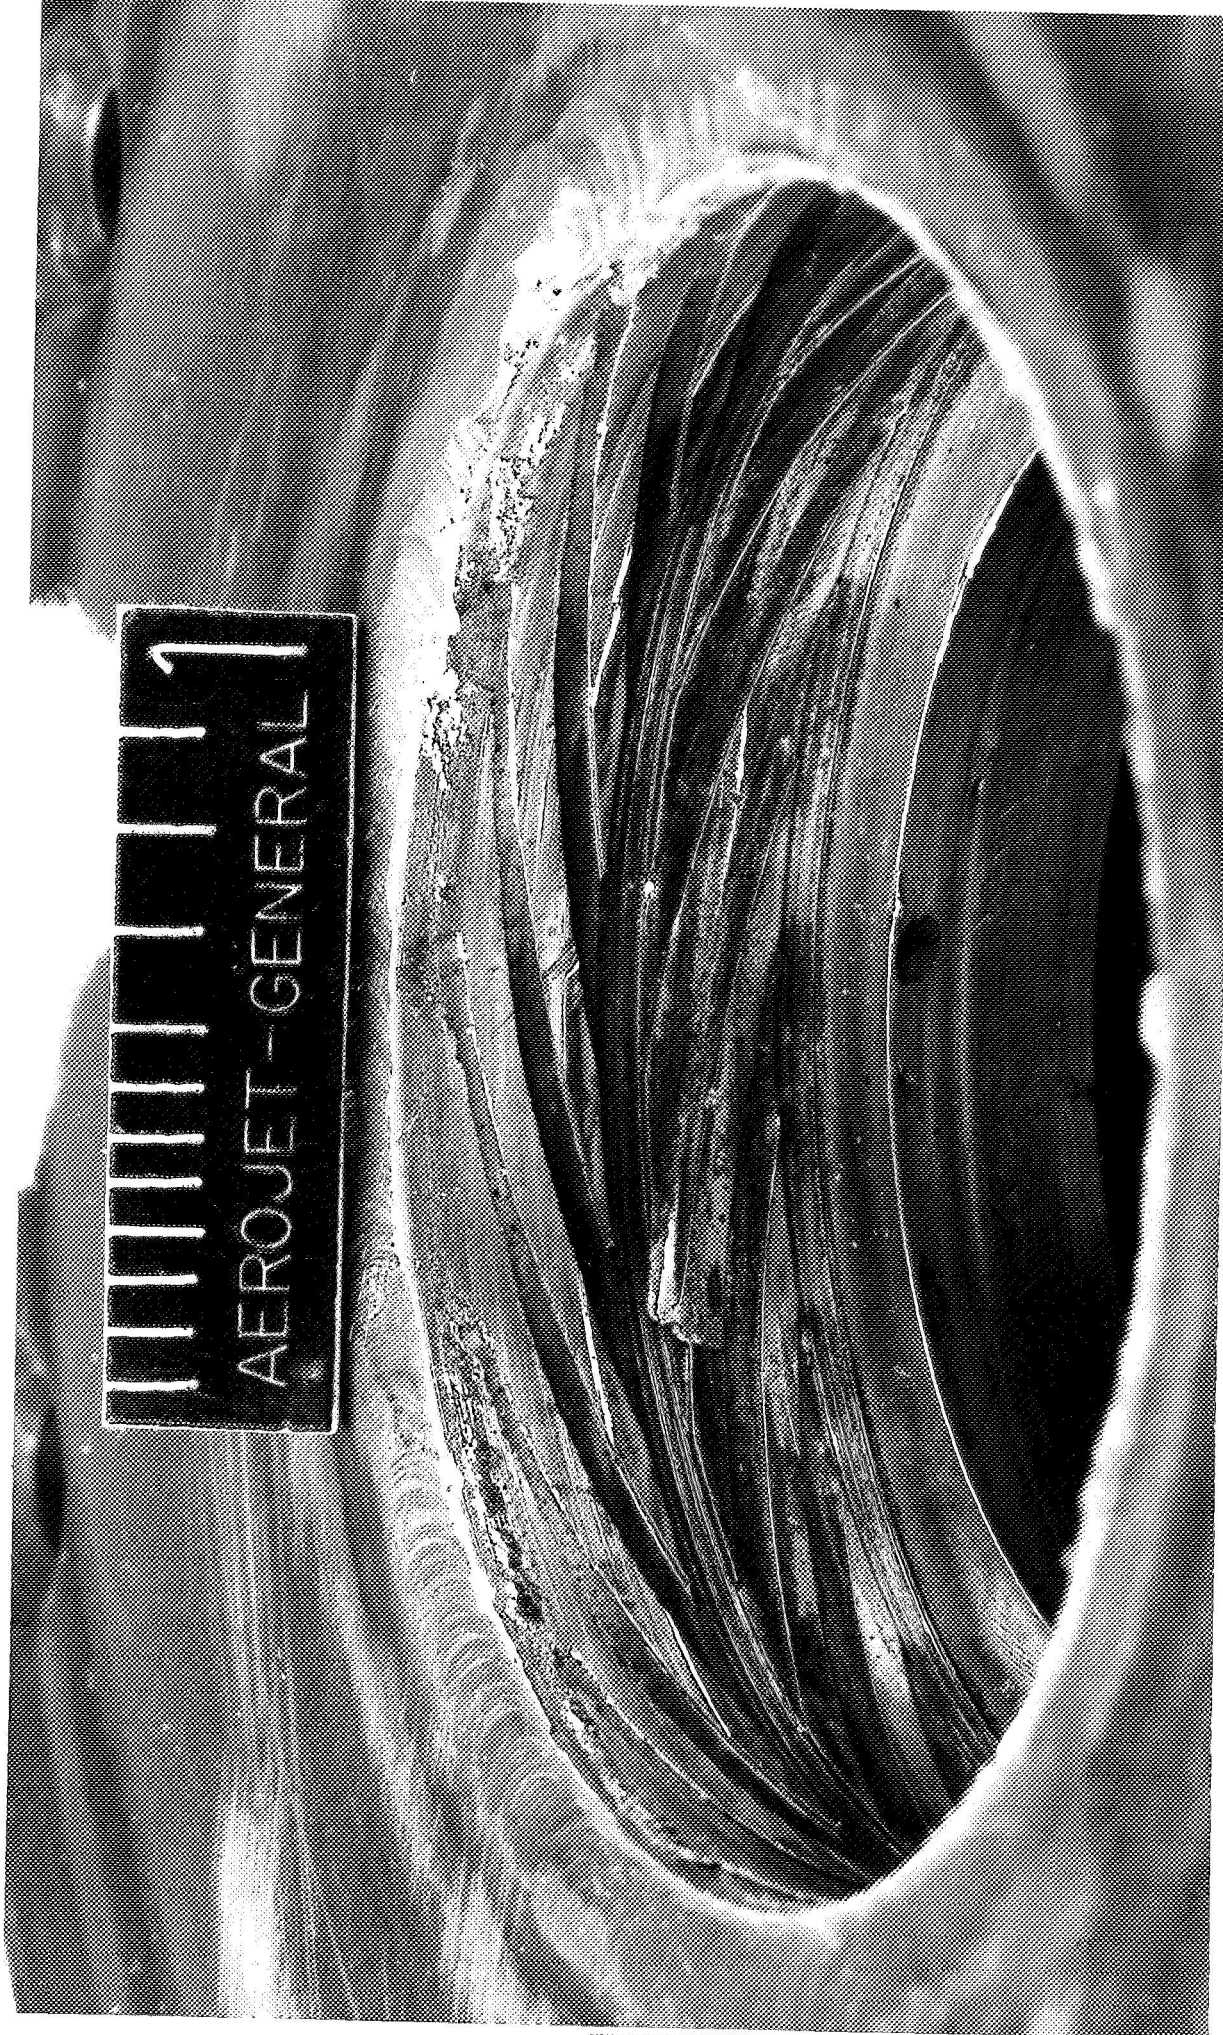
Figure 36

SNAP-8 MOD C SEAL TEST RIG NO. 4/4 SHOWING MILD STEEL  
HERRING BONE PUMP AFTER 120 HOURS OPERATION 8-9-68  
TEST WAS TERMINATED DUE TO RING SEIZURE IN HOUSING

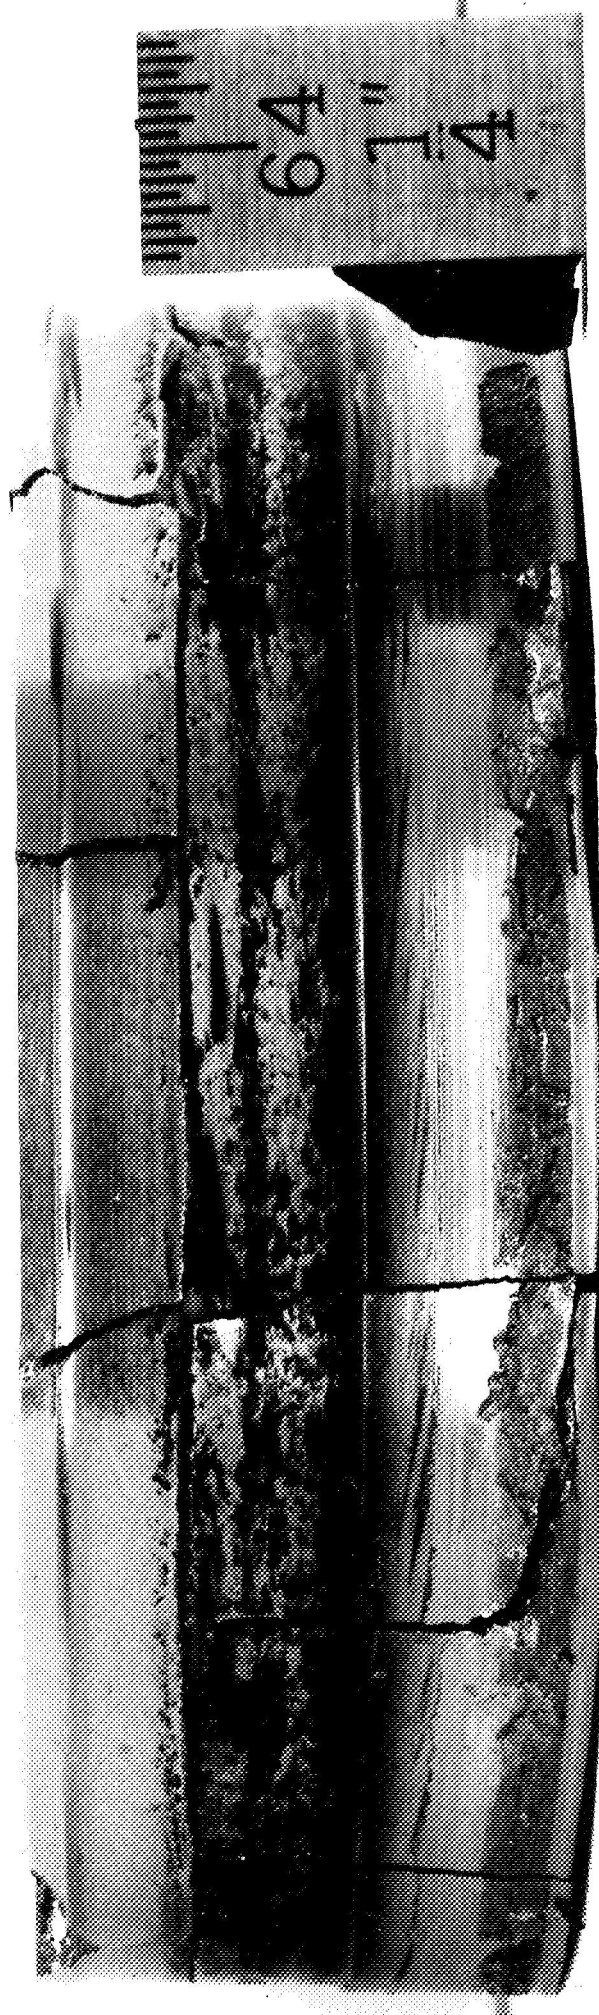
Figure 37

VISCO SEAL RING (STELLITE 6B) FROM MOD C TEST RIG NO. 4/4  
AFTER 120 HOURS (P/N 098084-3 S/N A9) 8-9-68  
TEST WAS TERMINATED DUE TO RING SEIZURE IN HOUSING

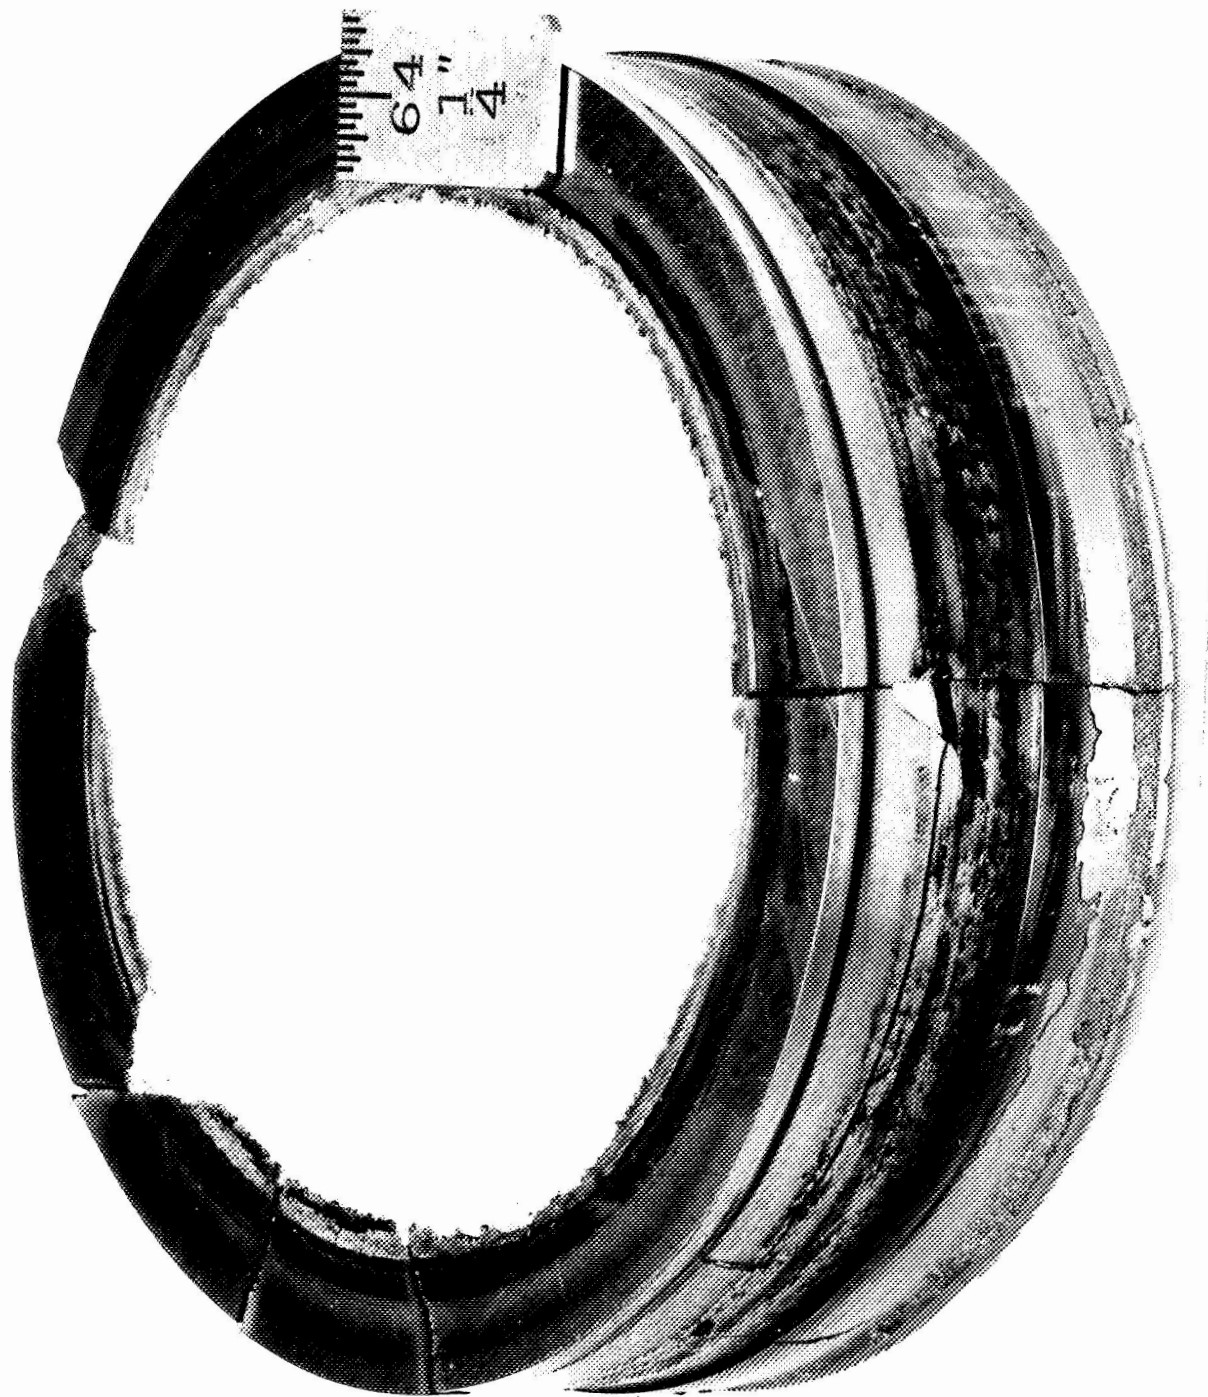
Figure 38

VISCO SEAL RING (STELLITE 6B) FROM MOD C TEST RIG NO. 4/4  
AFTER 120 HOURS (P/N 098084-3 S/N A9) 8-9-68  
TEST WAS TERMINATED DUE TO RING SEIZURE IN HOUSING

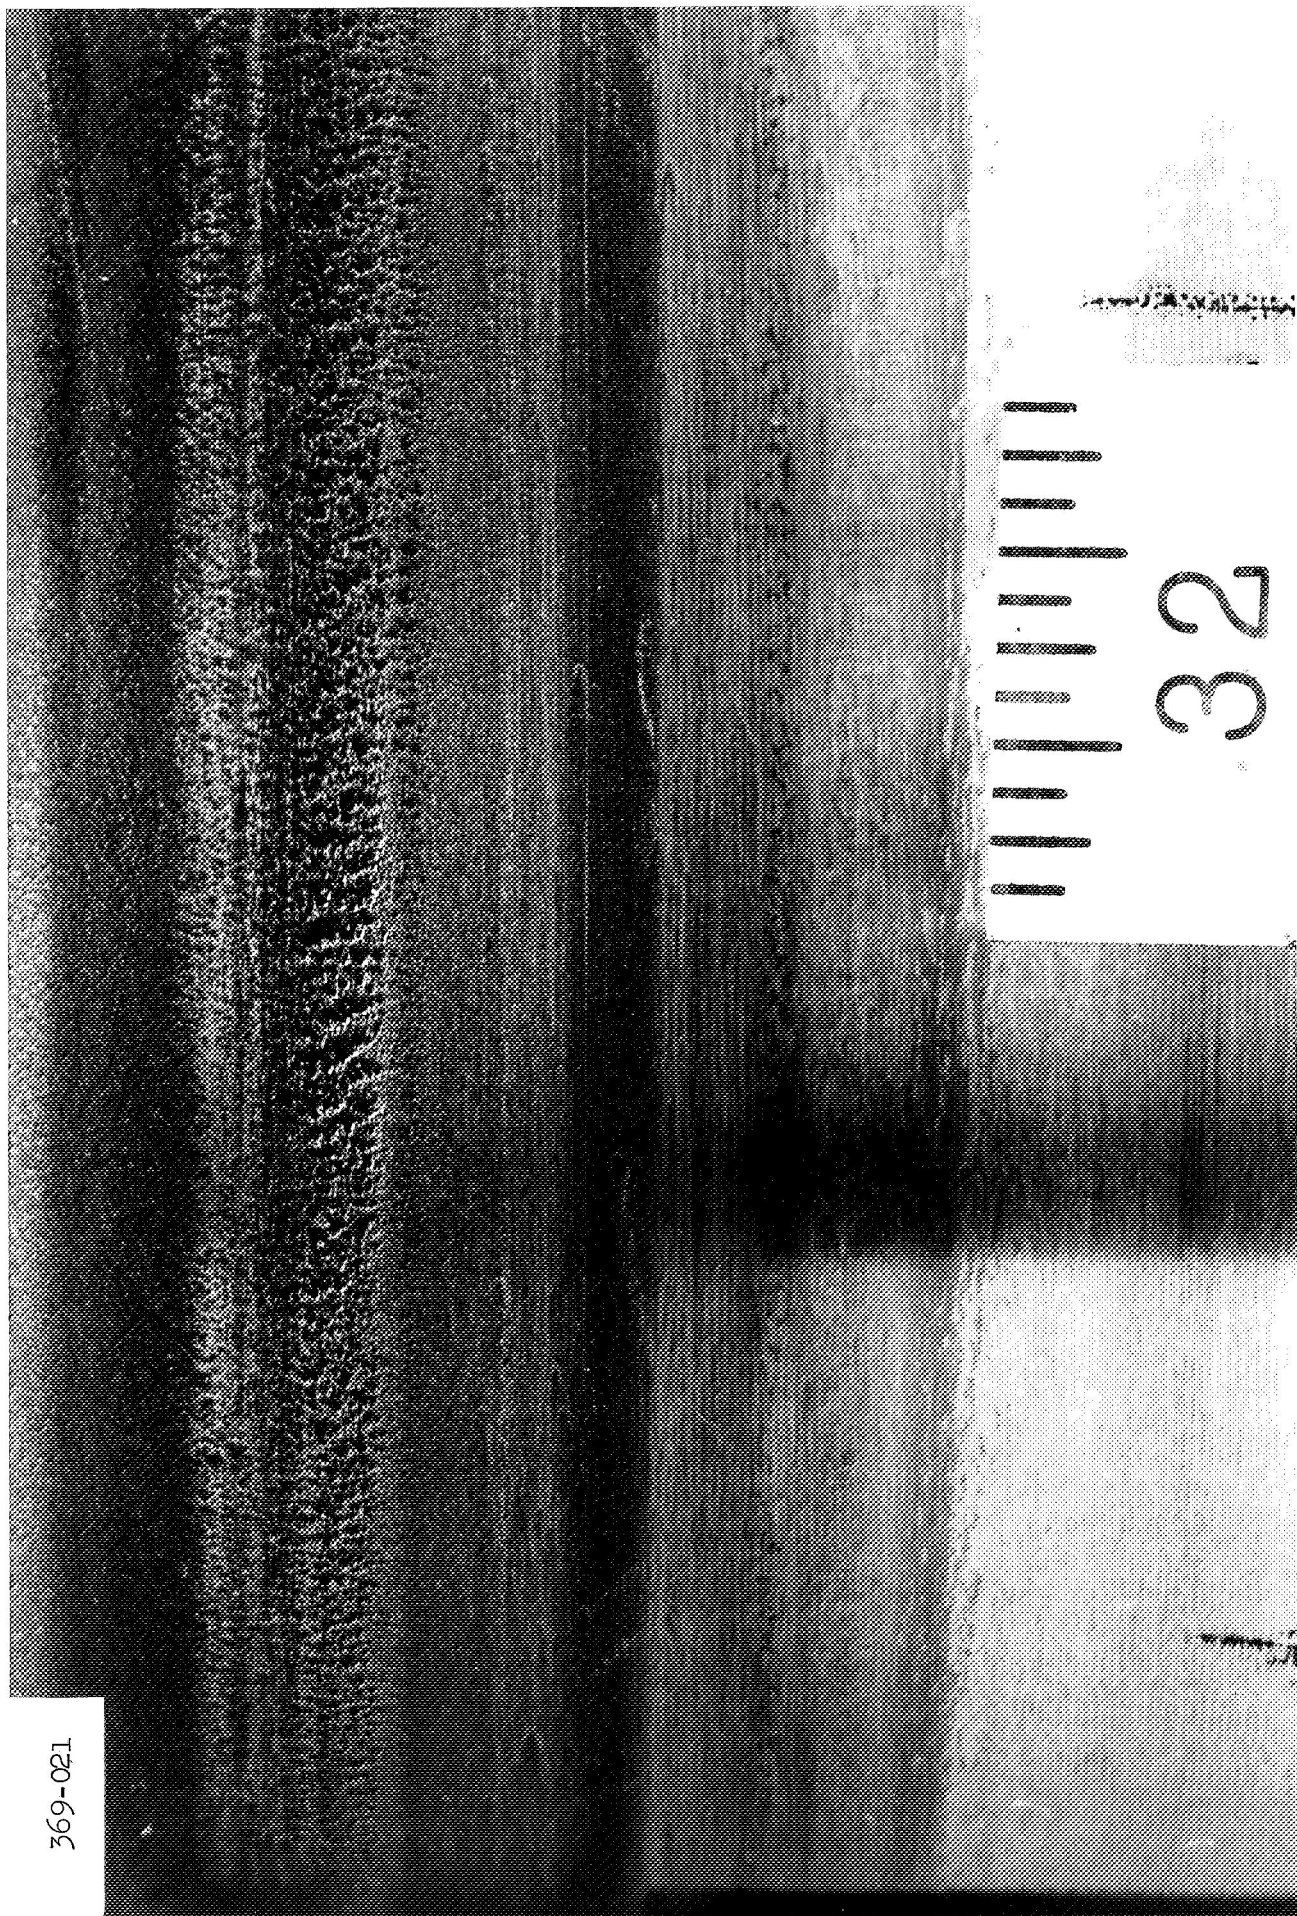
Figure 50

MOD-C (MINOR MOD) 2001 HOURS OF OPERATION  
20 FEBRUARY 1969 VISCO RING DAMAGE (3)

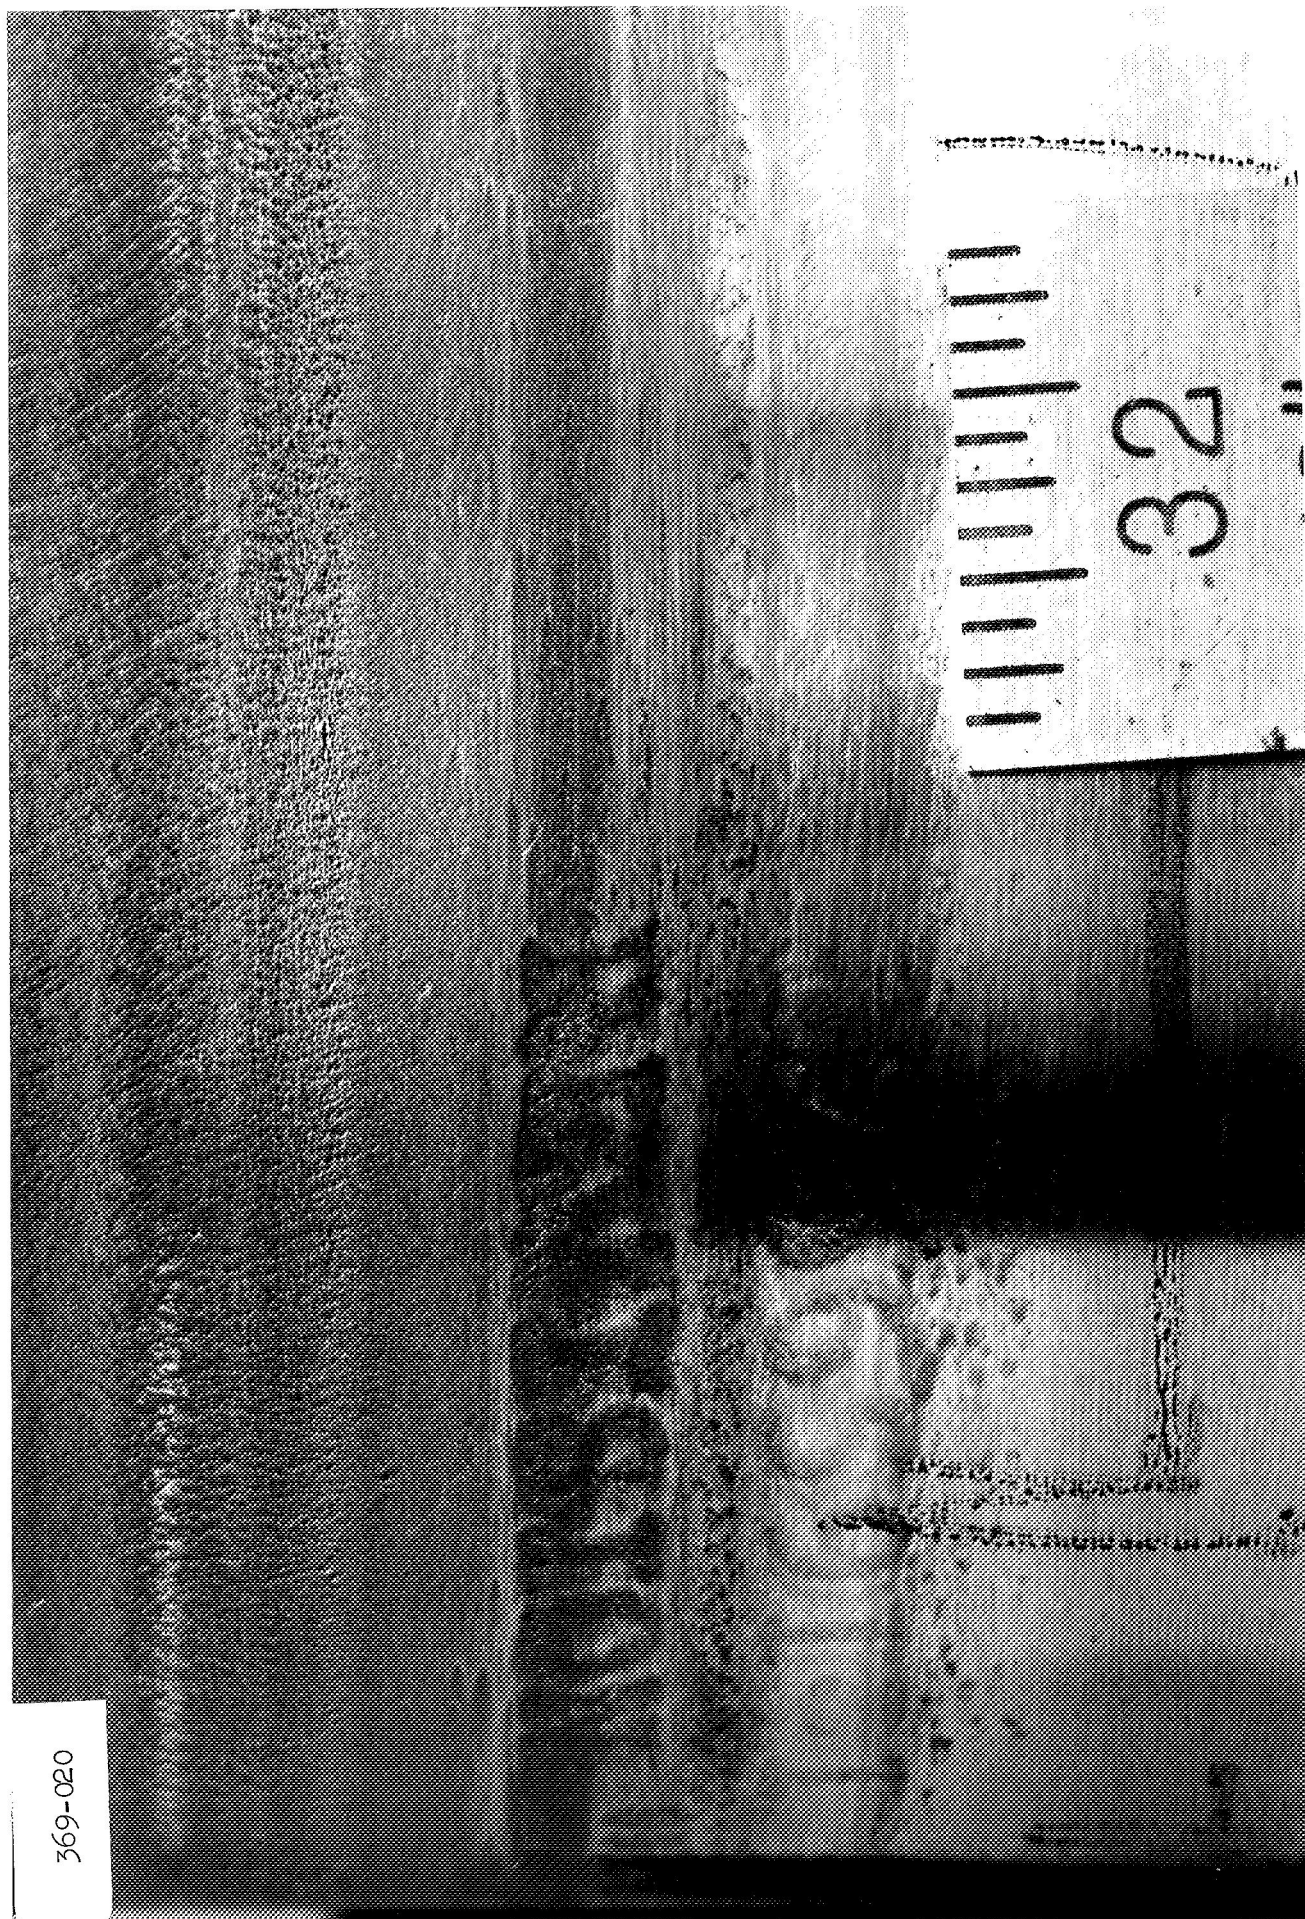
MOD-C (MINOR MOD) 2001 HOURS OF OPERATION  
20 FEBRUARY 1969 VISCO RING DAMAGE (4)

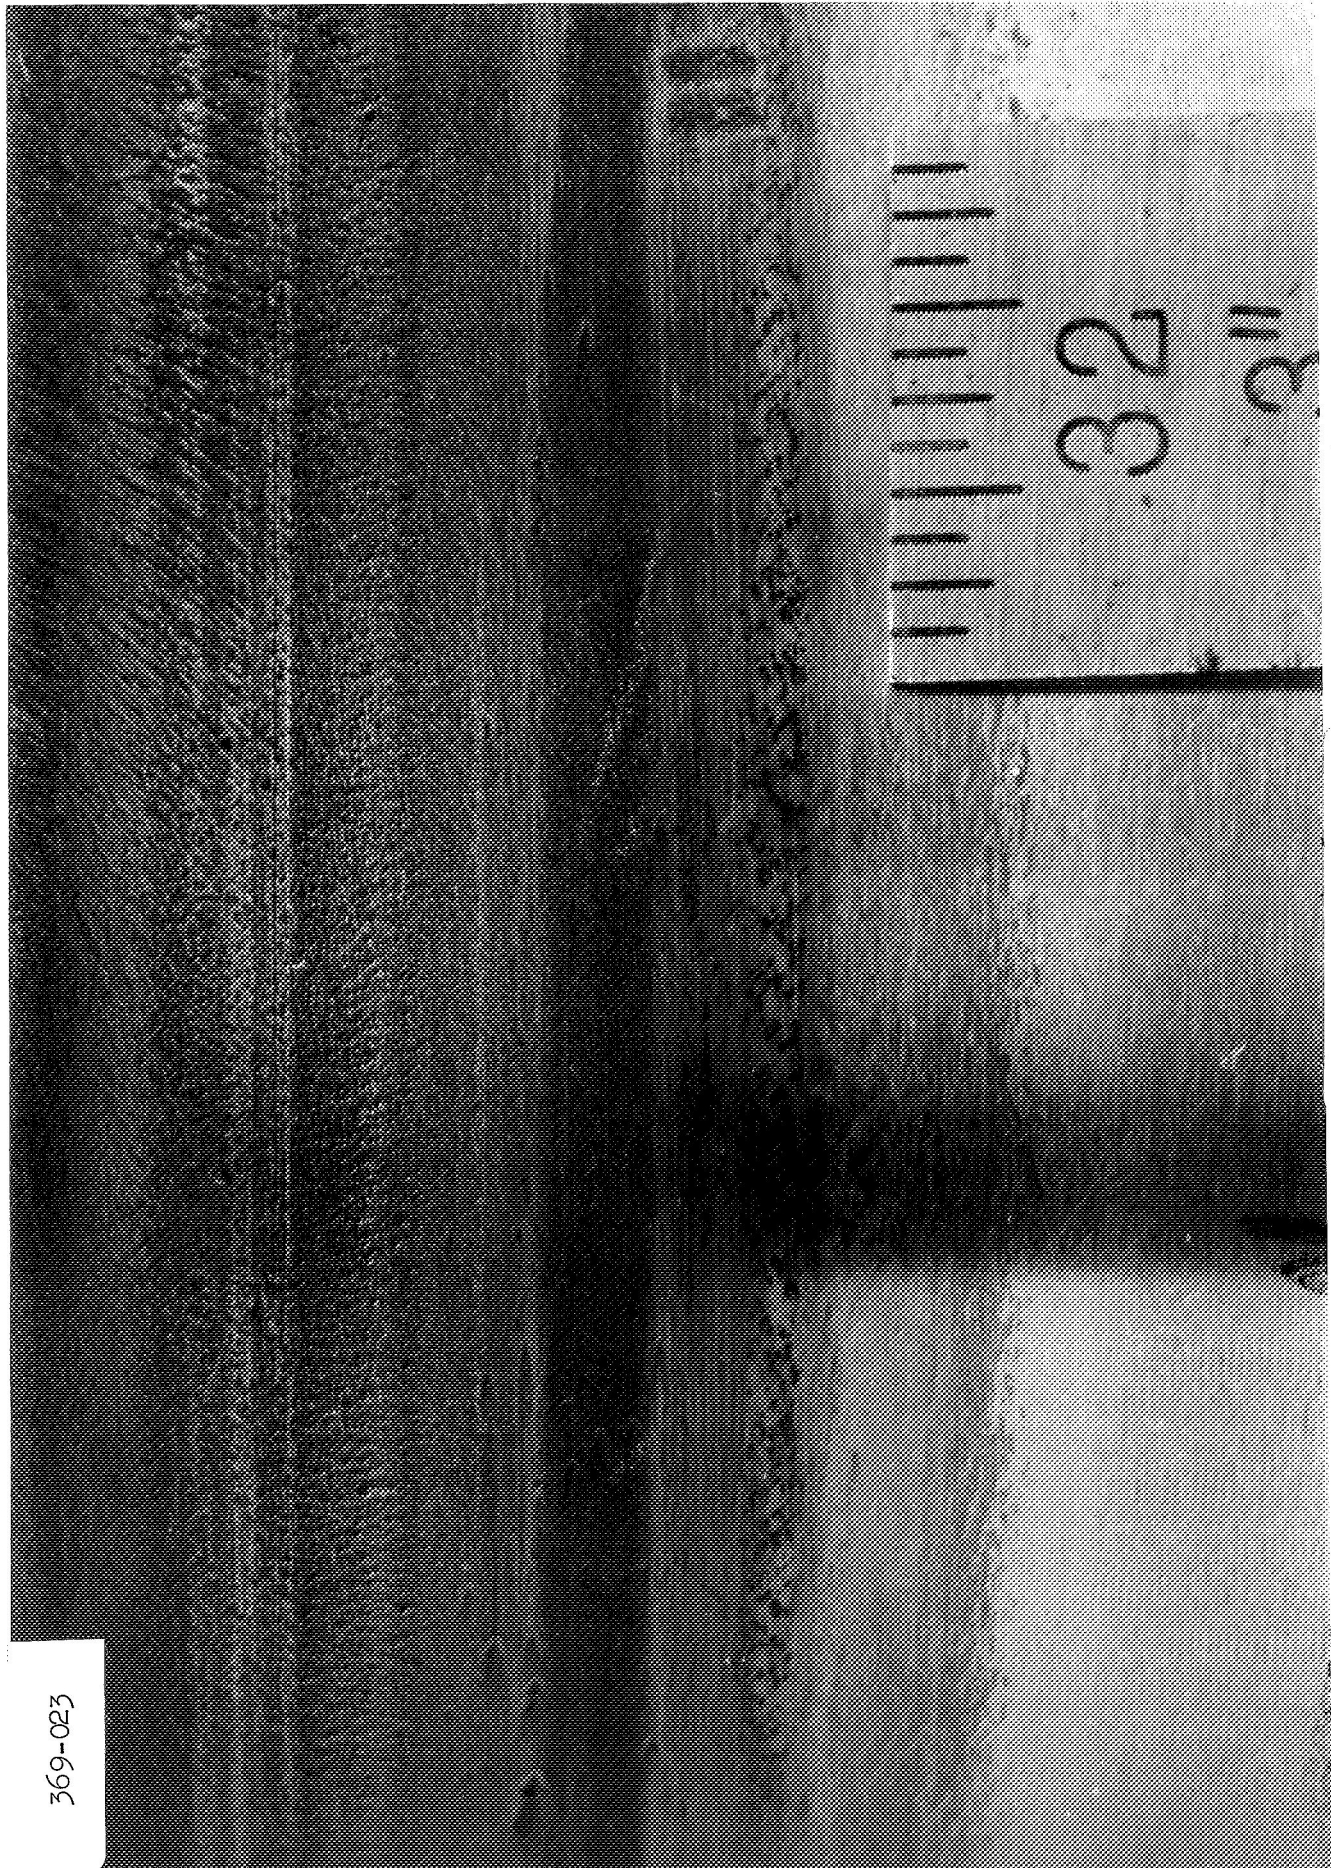
MOD-C (MINOR MOD) 2001 HOURS OF OPERATION  
20 FEBRUARY 1969 VISCO RING DAMAGE (1)

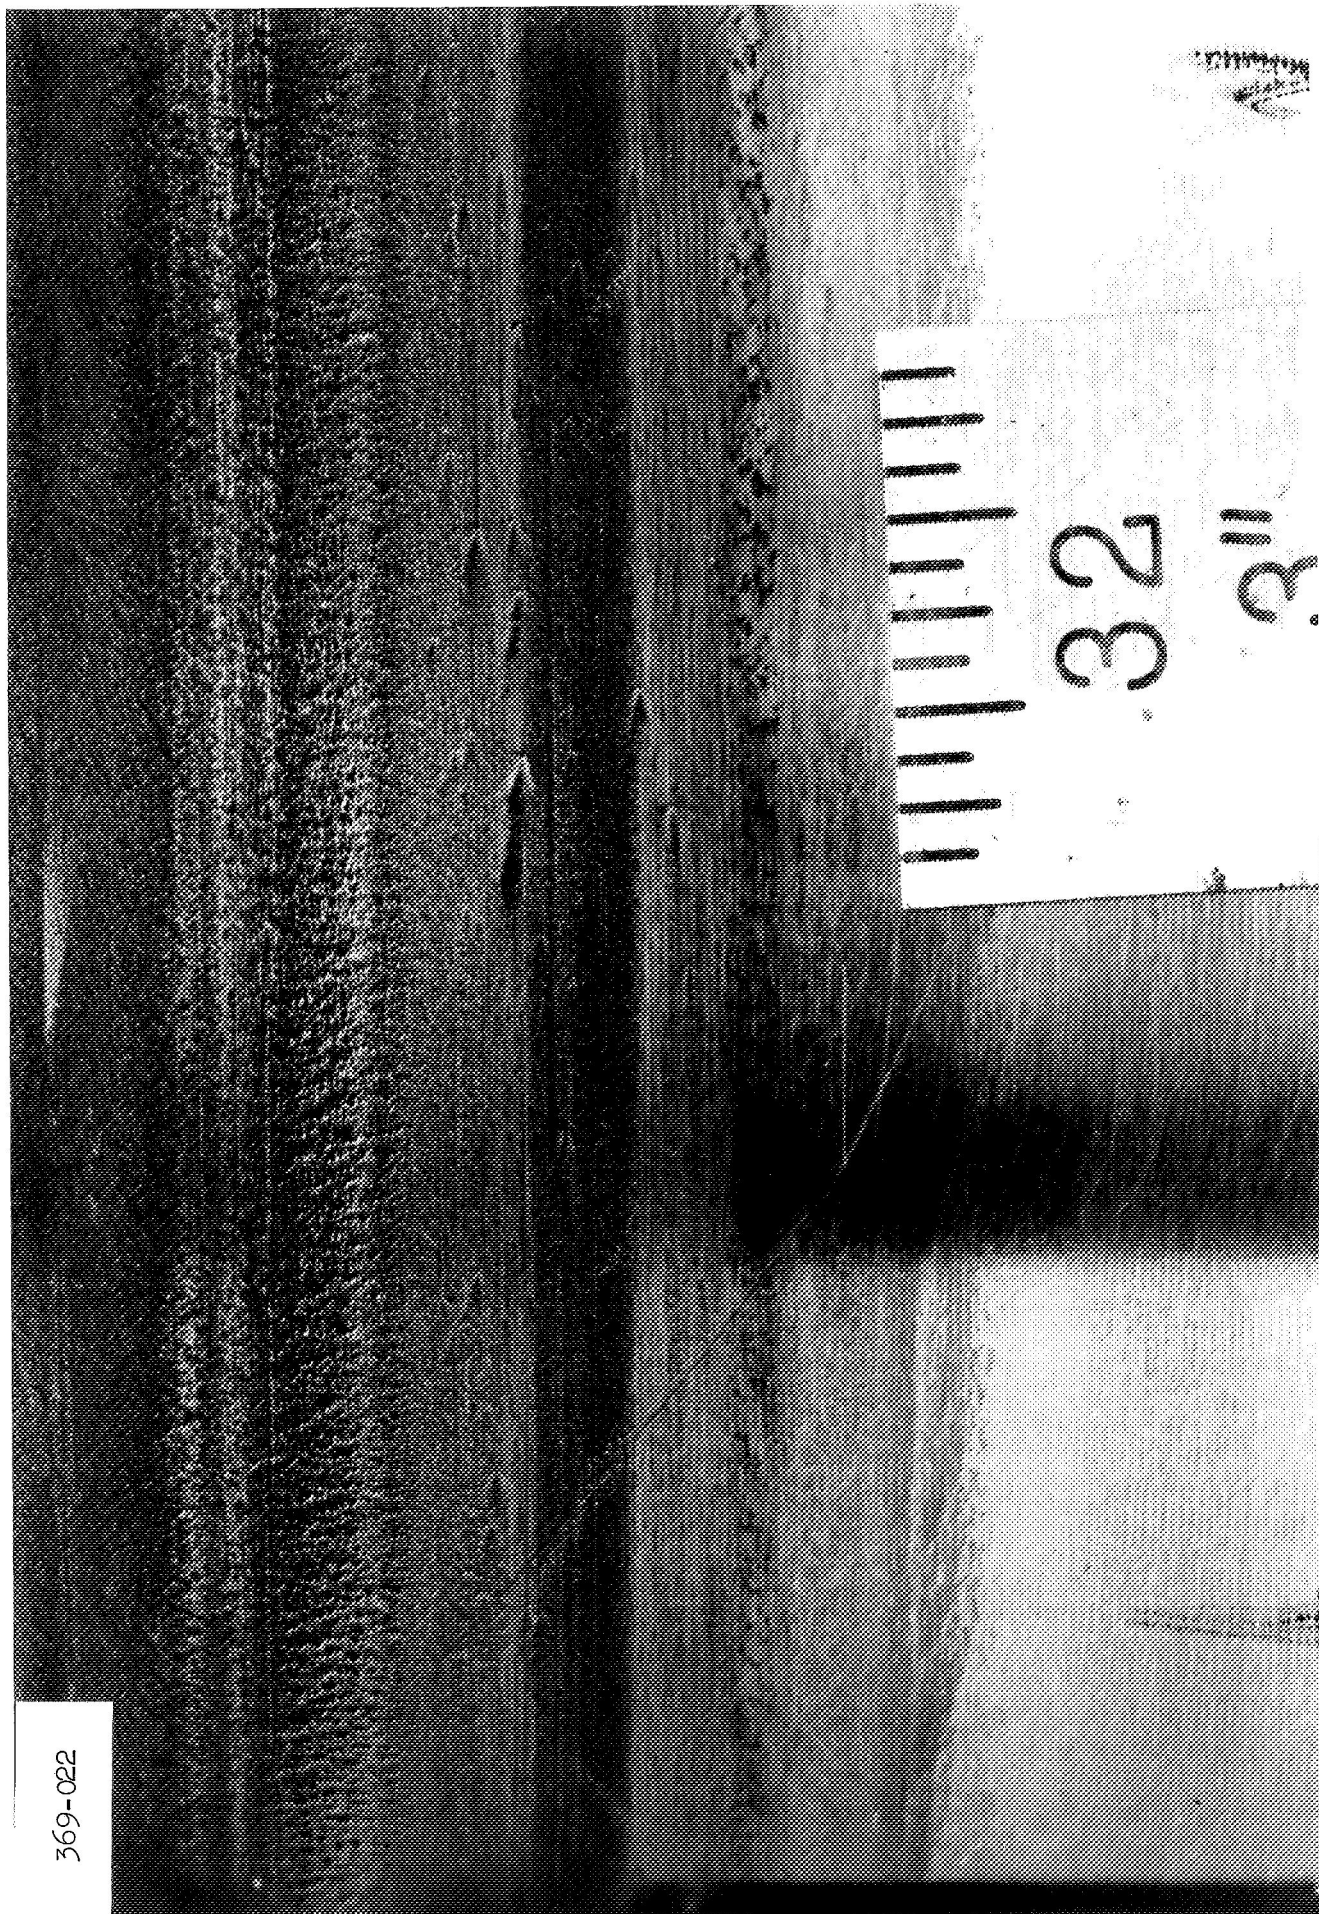
MOD-C (MINOR MOD) 2001 HOURS OF OPERATION  
20 FEBRUARY 1969 VISCO RING DAMAGE (2)

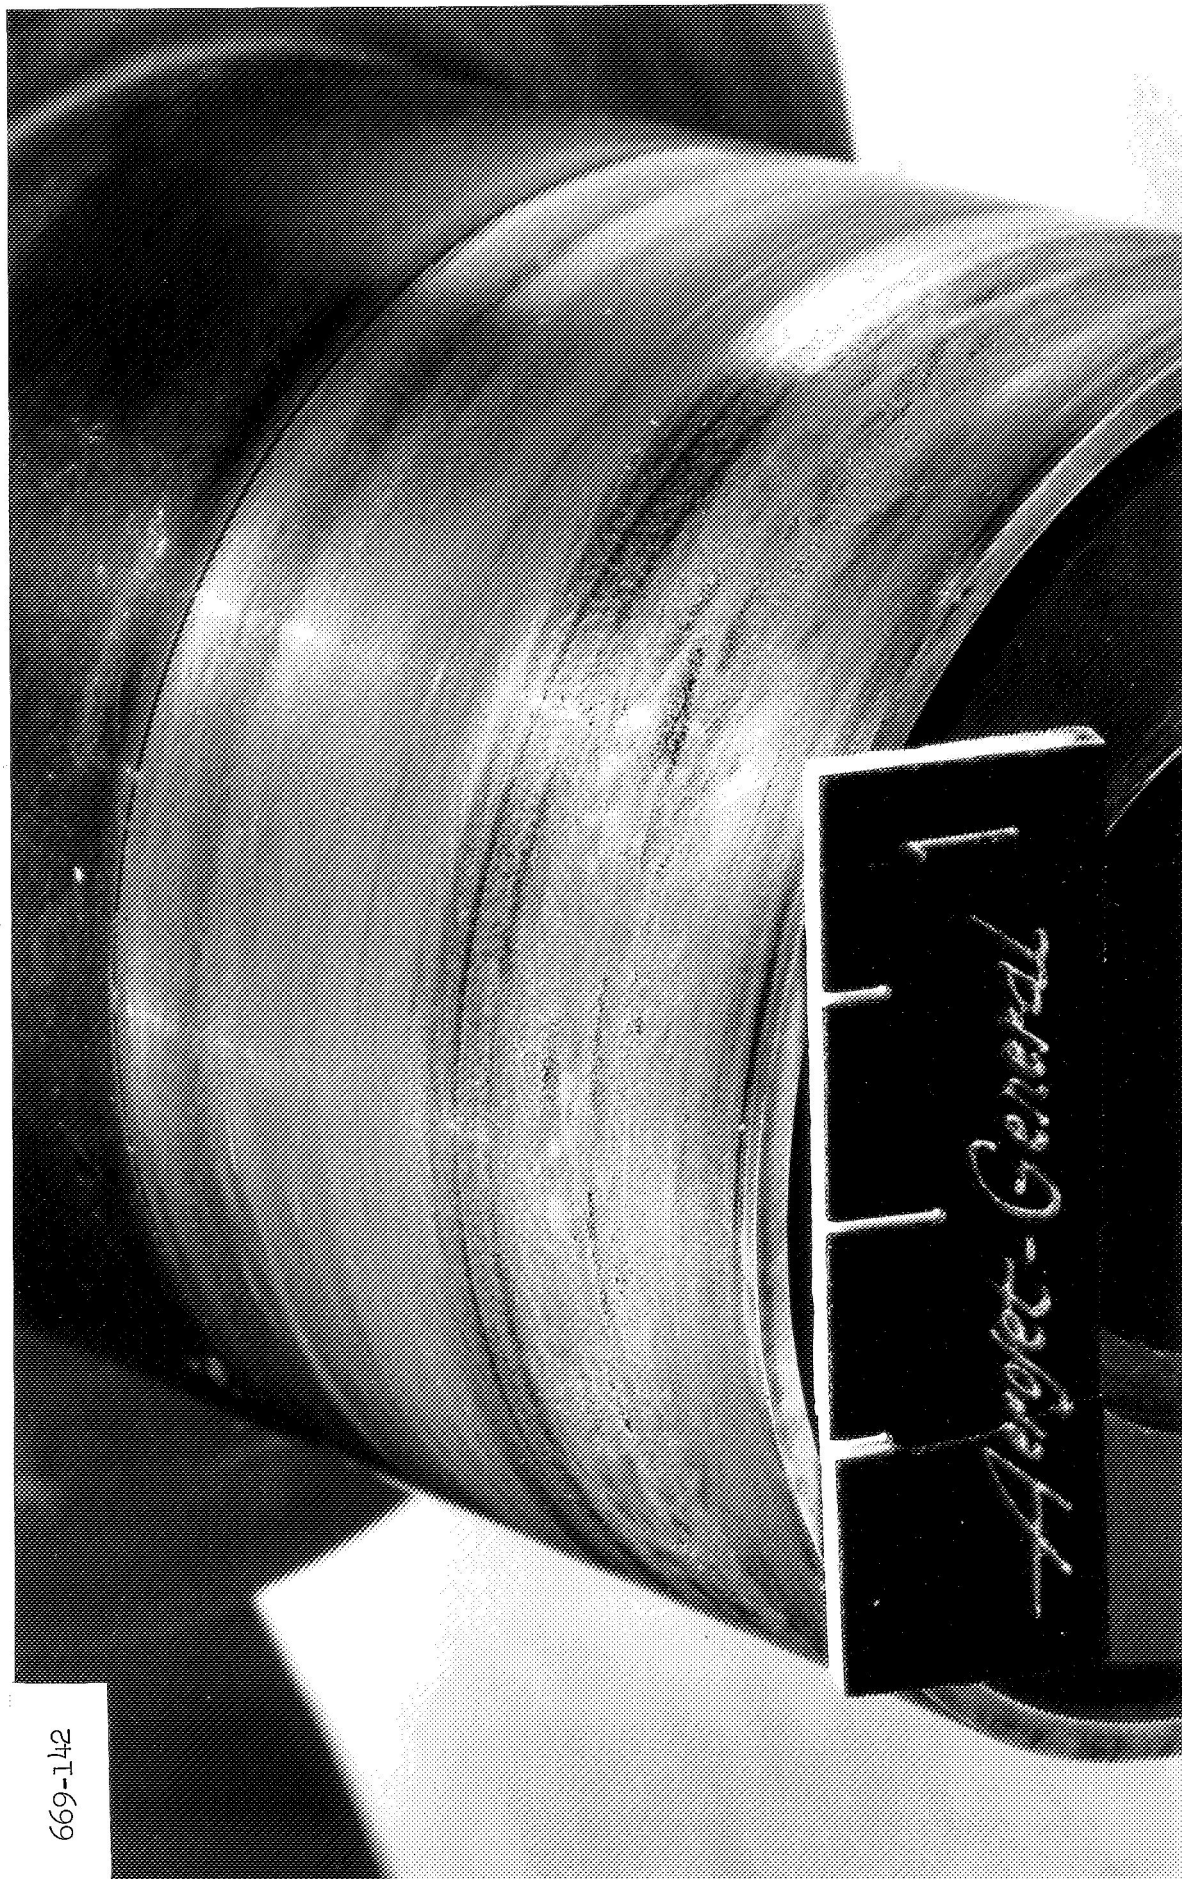
Figure 61

MOD-C, MAJOR MOD.  
VISCO SEAL RING DAMAGE  
1580 HRS. OF OPERATION, 4 JUNE 1969

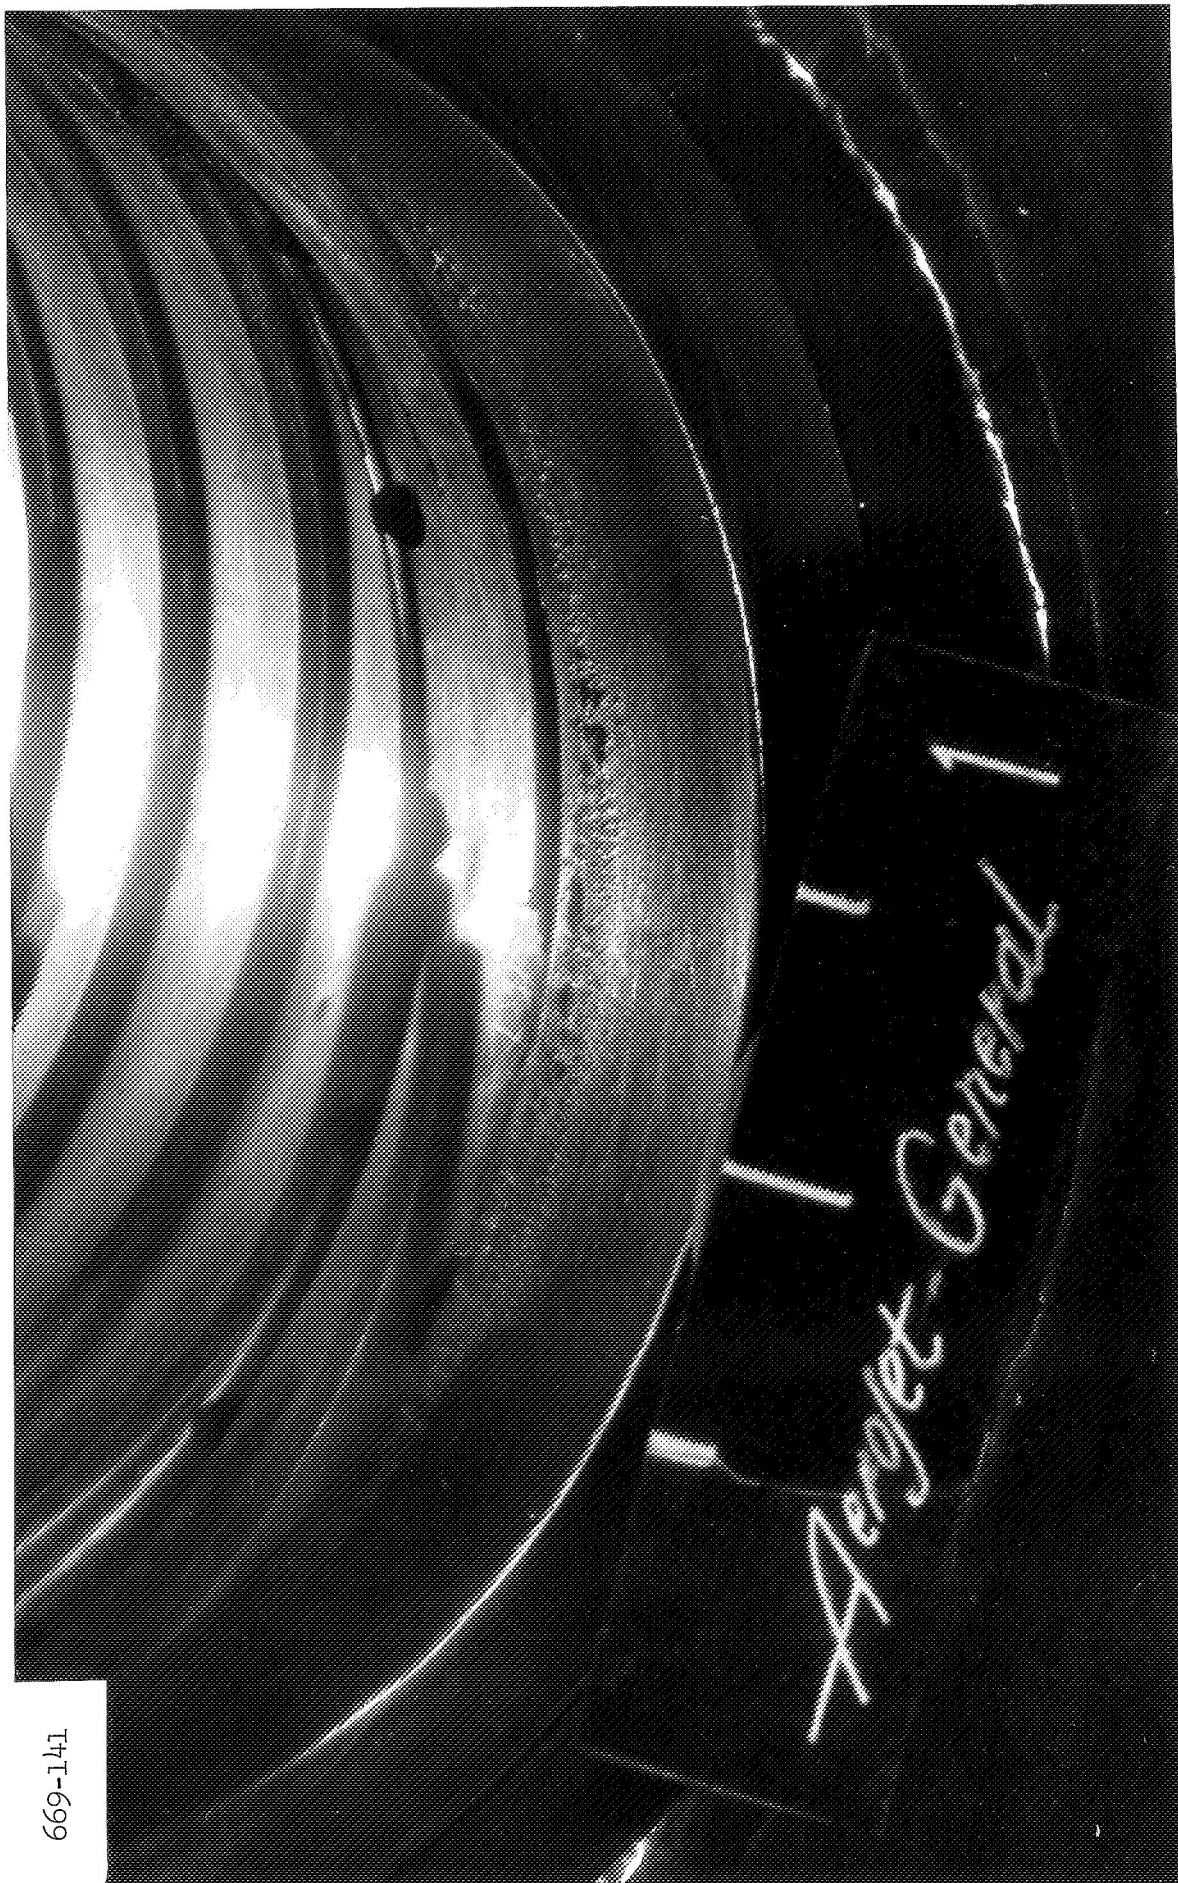
MOD-C, MAJOR MOD.  
VISCO SEAL HOUSING DAMAGE  
1580 HRS. OF OPERATION, 4 JUNE 1969
