AUTHOR(S): M. G. Cherry

TITLE: Mod-C PROGRAM, TURBINE VISCO SEAL CAVITATION TESTSABSTRACT

Mod-C, Visco Pump, Cavitation

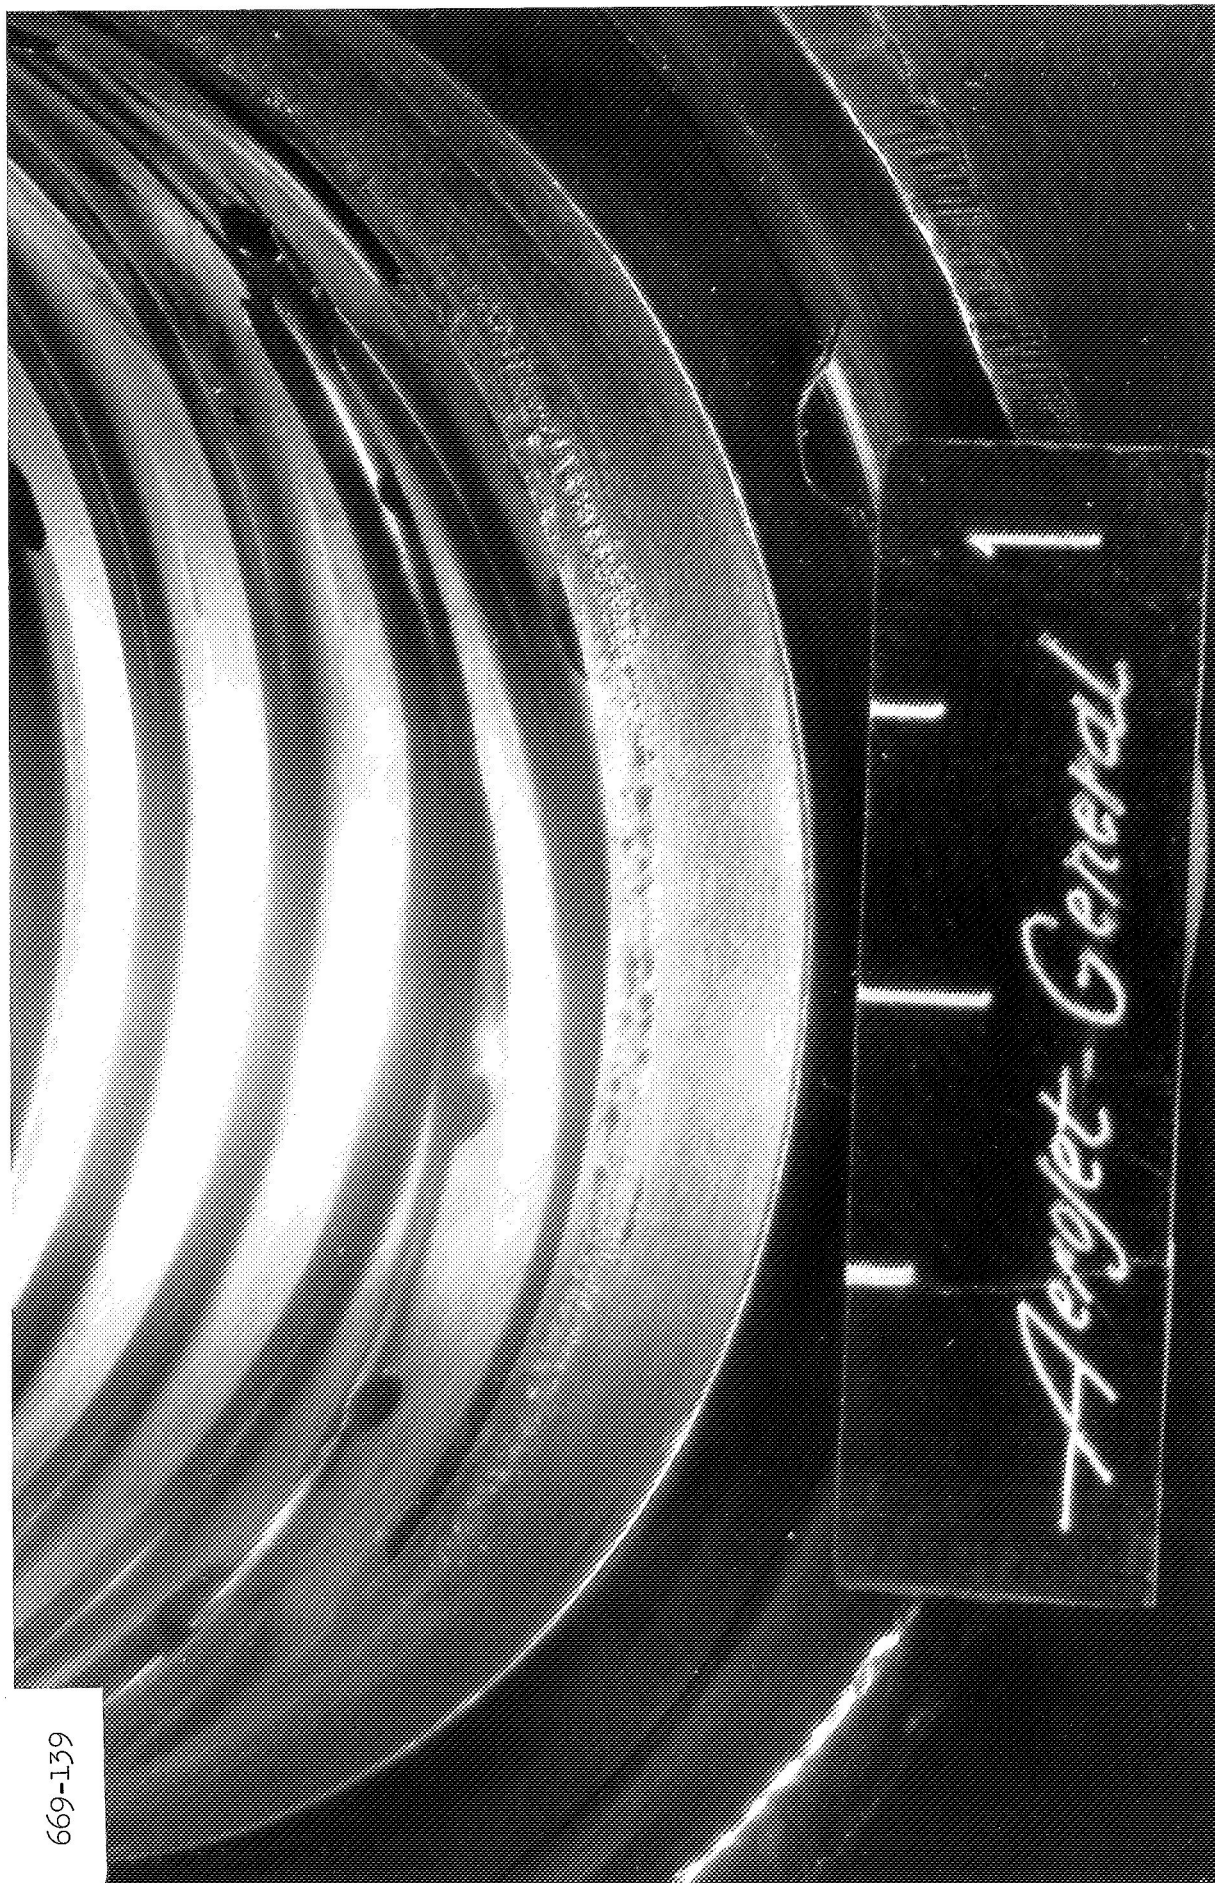
Figure 64

MOD-C, MAJOR MOD.  
VISCO SEAL HOUSING DAMAGE

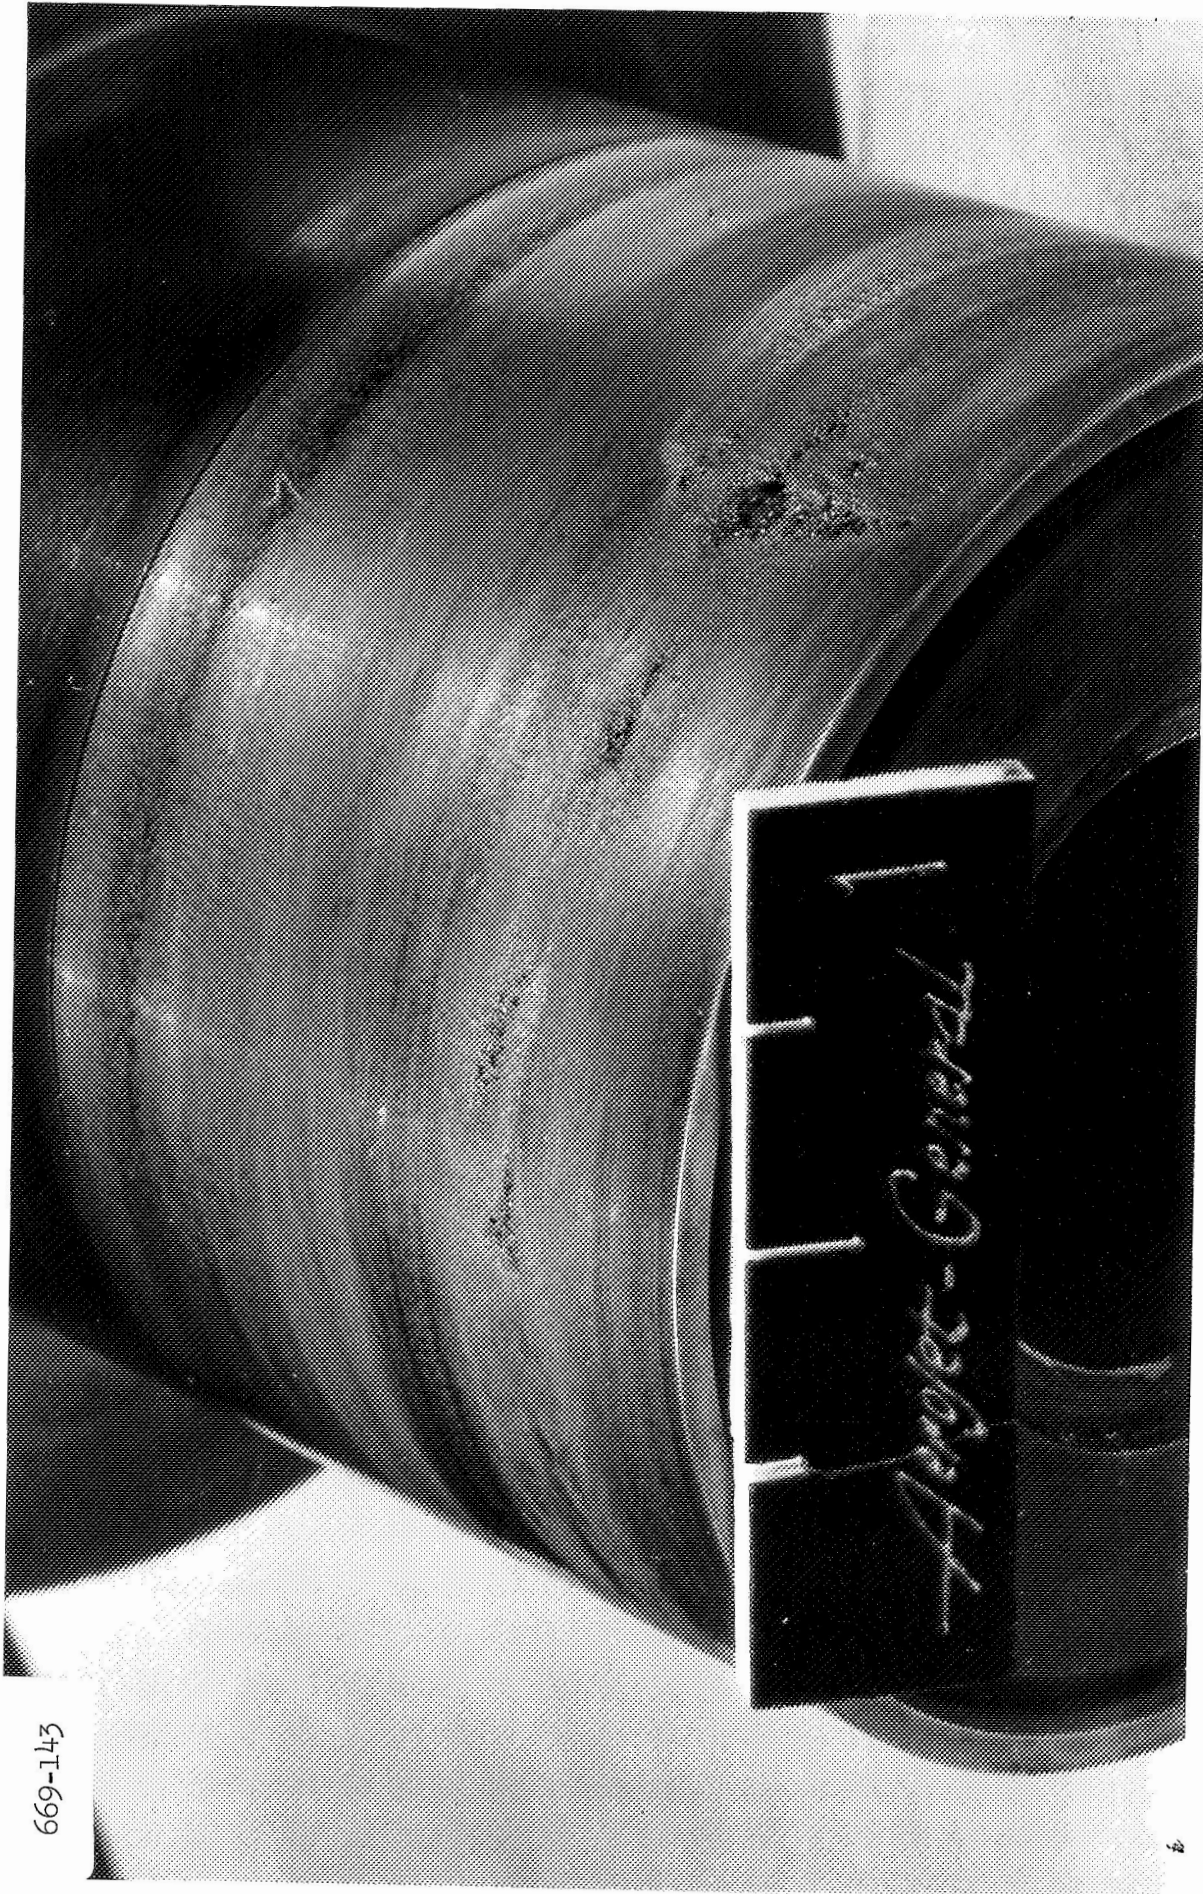
MOD-C, MAJOR MOD.  
VISCO SEAL RING DAMAGE  
1580 HRS. OF OPERATION, 4 JUNE 1969

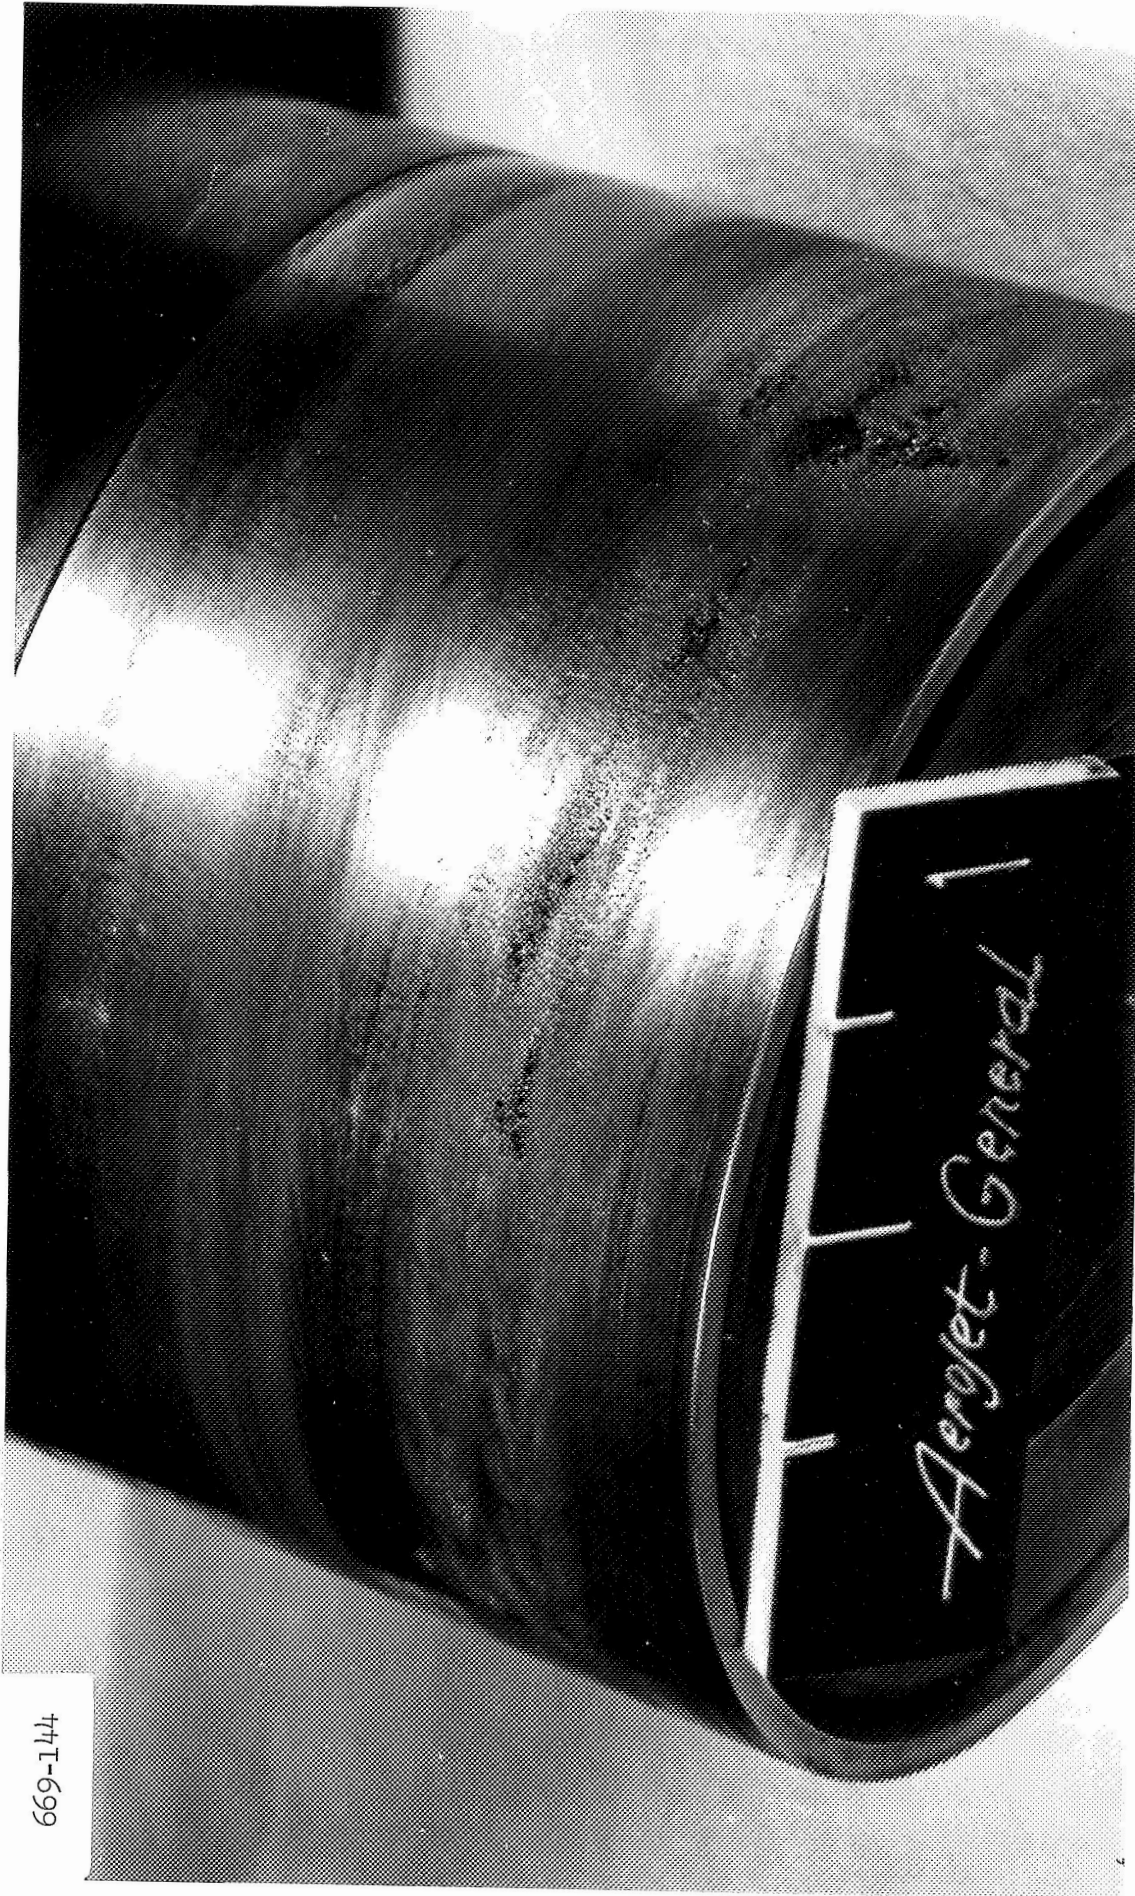
Figure 66

MOD-C, MAJOR MOD.  
VISCO SEAL RING DAMAGE  
1580 HRS. OF OPERATION, 4 JUNE 1969

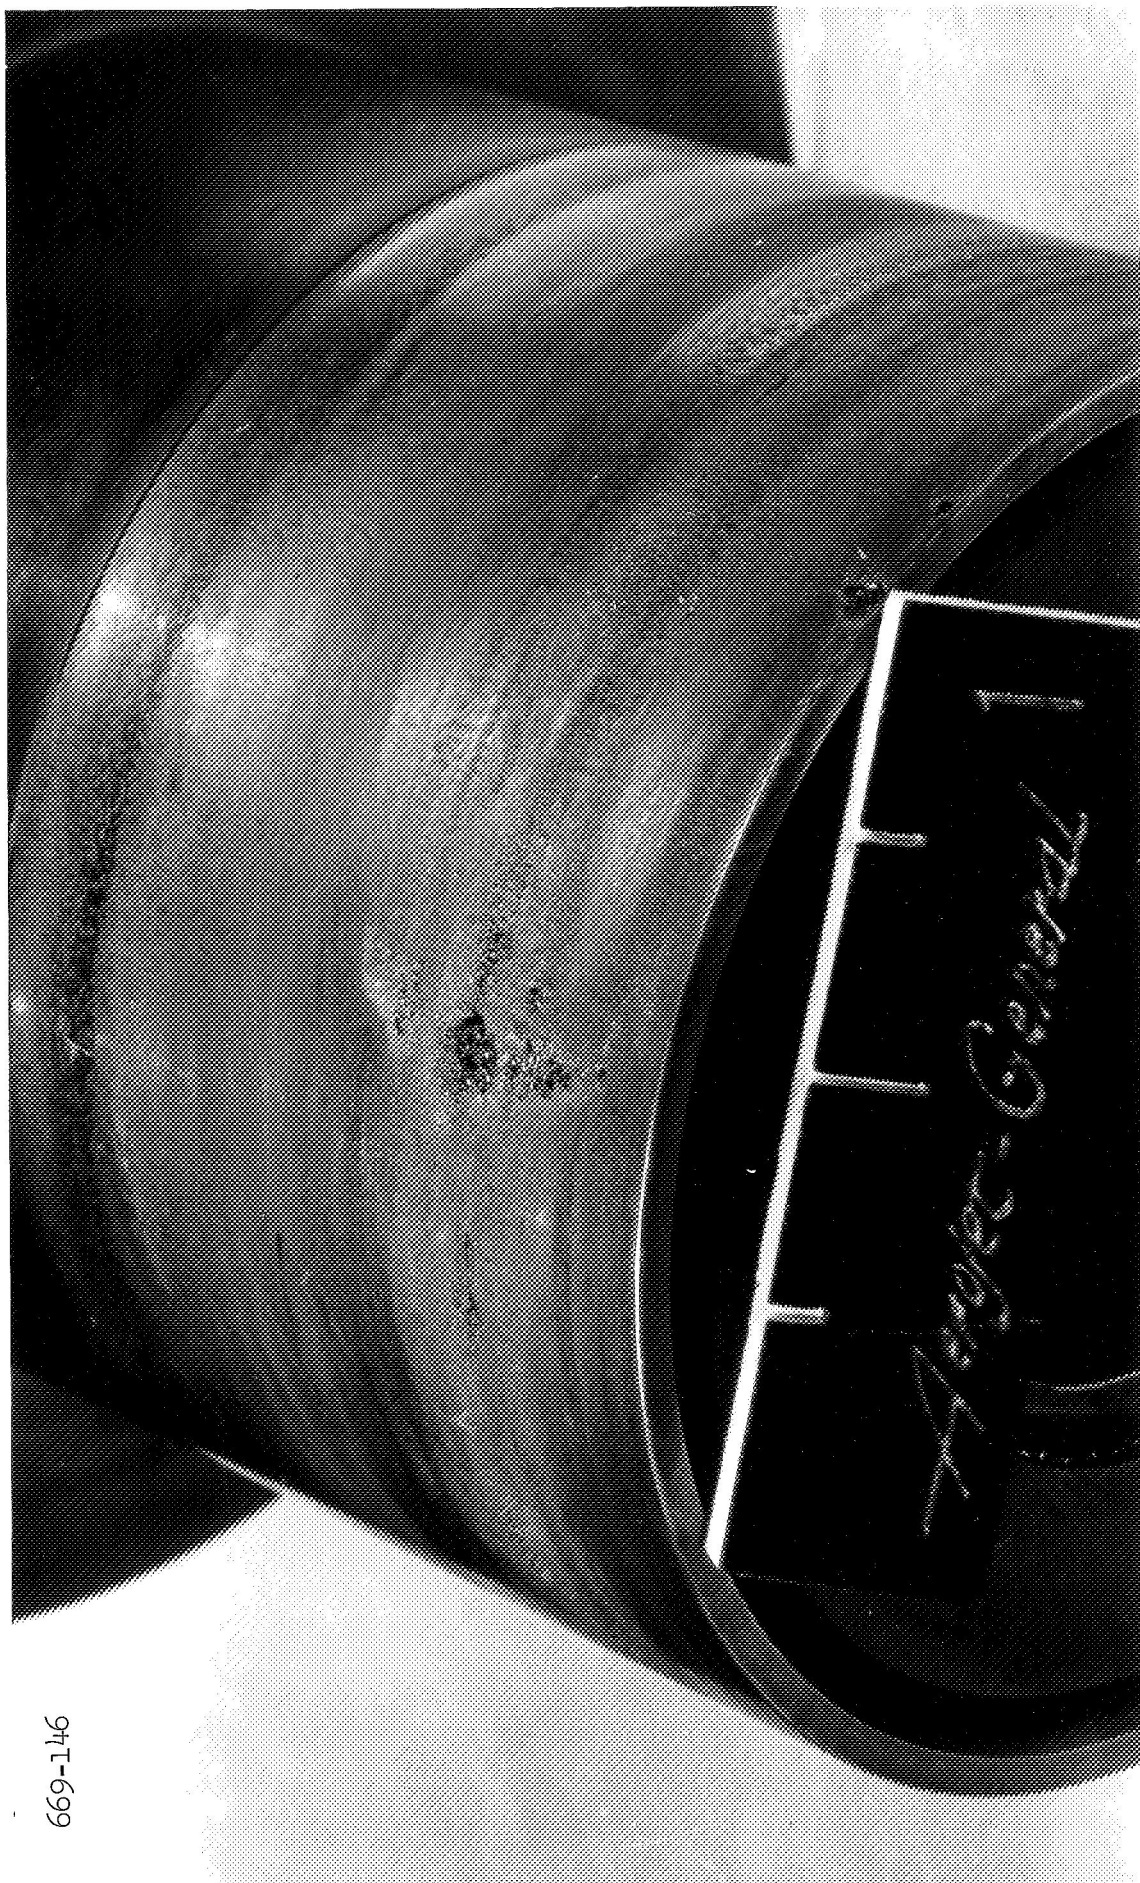
MOD-C, MAJOR MOD.  
VISCO SEAL RING DAMAGE  
1580 HRS. OF OPERATION, 4 JUNE 1969

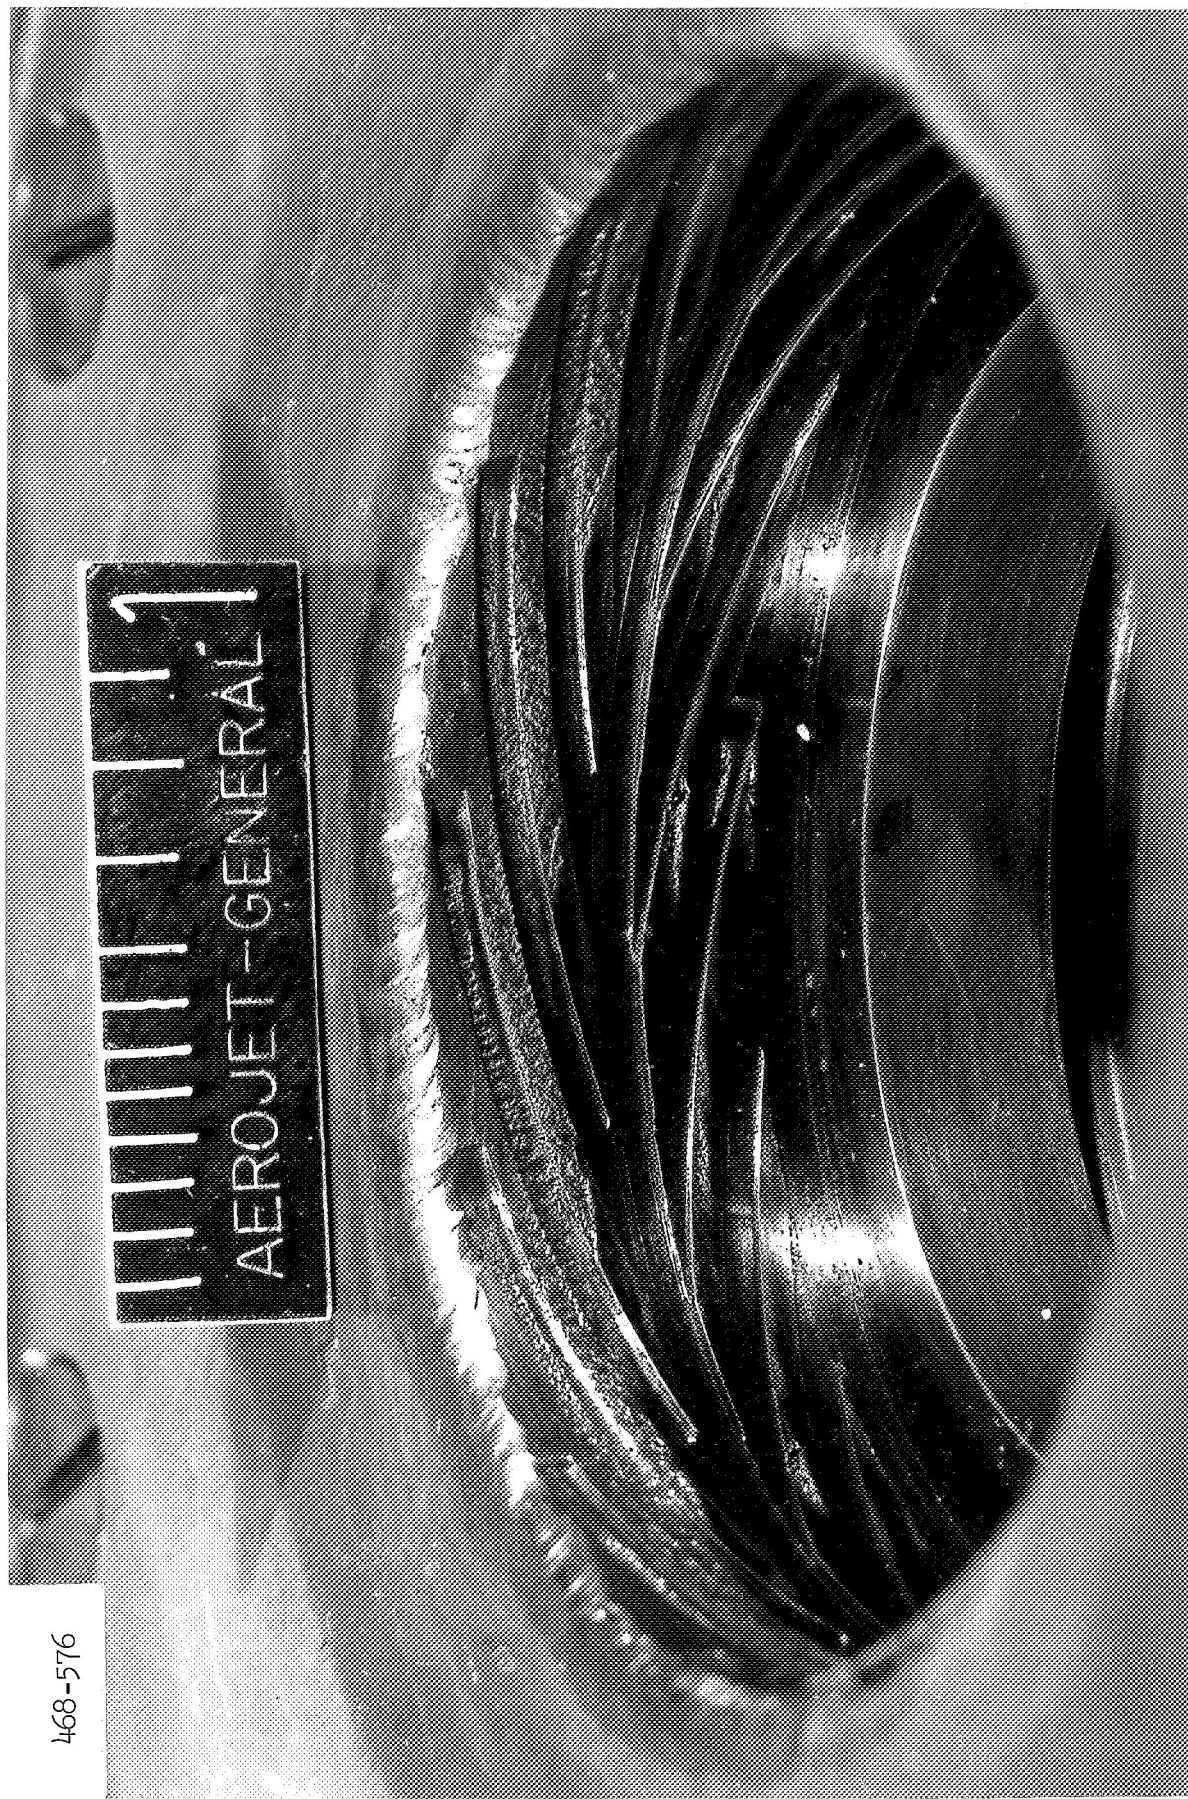
Figure 68

SNAP-8 MOD-C SEAL TEST RIG NO. 1  
CAVITATION DAMAGE ON MILD STEEL HERRING BONE PUMP  
4-23-68
