16. XLR99 ENGINE OPERATING EXPERIENCE (U)

By Richard G. Leiby
Air Force Flight Test Center

Donald R. Bellman, and Norman E. DeMar
NASA Flight Research Center

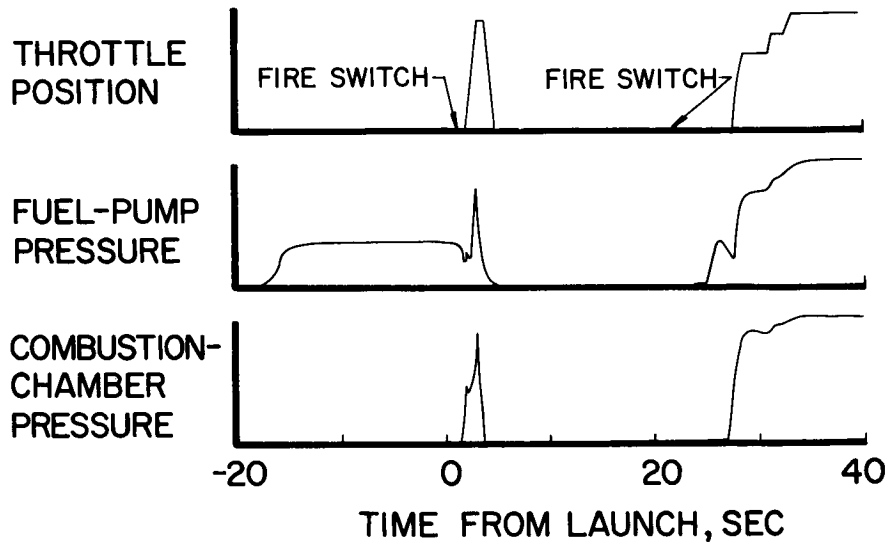
Figure 7 is interesting as an indication of the times involved in recovery from a malfunction shutdown after launch. These data are taken from a flight made by Major Robert W. White in April 1961 in which a malfunction shutdown occurred almost immediately after launch. Shown are throttle position, fuel-pump pressure, and chamber pressure plotted against time. The igniter idle switch was actuated approximately 20 seconds before launch and pump discharge is up. The fire switch was actuated 1.3 seconds after drop and the throttle was advanced. Pump discharge and chamber pressures were rising when malfunction shutdown occurred. Restart must be delayed to completion of the purge and engine reprime. The fire switch was actuated at 21.9 seconds. When the pilot saw the pump pressure rise he advanced the throttle. It is interesting to note that the throttle motion was stopped as the pilot checked his chamber pressure as he neared the desired thrust level and the two pressure traces clearly reflect this event. The sequence from launch involved approximately 30 seconds and an altitude loss of 8,000 feet as against a good start drop of about 2,000 feet.

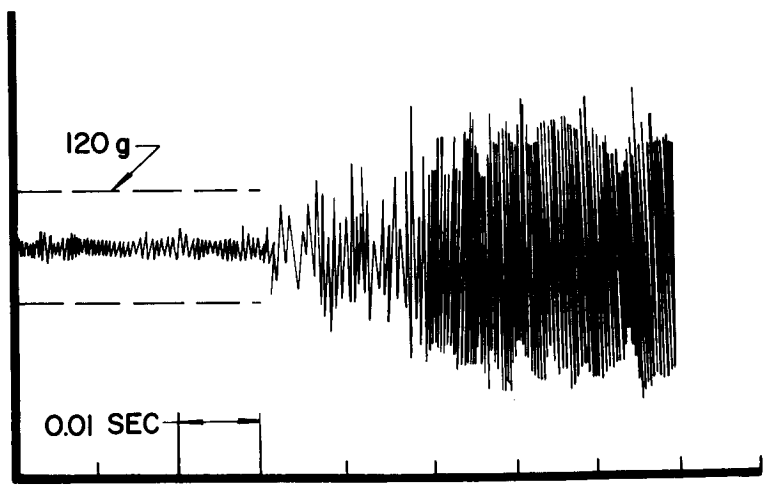
Figure 8

The most pernicious problem encountered has been the 1,600 cps vibration. A typical trace of the accelerations at one of the engine mounting points is shown in figure 8. The initial accelerations are

low and build up. If the vibration does not exceed 100g at the pickup location, damping occurs. Between 100 and 200g, either damping or divergence can result. Above 200g, divergence always occurs. Therefore, a vibration cutoff was installed to shut down the engine in event of vibration levels above 120g. Inasmuch as there is the possibility of damping in this range, the cutoff includes a 50-millisecond delay to permit this damping and avoid unnecessary shutdowns. The mechanics of this phenomenon have not been determined; however, the incidence rate is known to increase in the higher performing engines and is also aggravated by operation at mixture ratios below design. The incidence rate has been contained within 2 to 4 percent of start attempts through installation of vibration isolators and a quick-change orifice device which permits operations at proper mixture ratios at all times. An interesting facet of this phenomenon is discussed subsequently with regard to compatibility. The vibration situation has not directly delayed flight operations, but is the major contributor to the malfunction shutdown rate during ground operations. A vibration shutdown has not yet occurred in flight.
