17. DEVELOPMENT OF IMPROVED CERAMIC COATINGS TO INCREASE

THE LIFE OF XLR99 THRUST CHAMBER (L)

By Lawrence N. Hjelm
Aeronautical Systems Division, U.S. Air Force

ABSTRACT

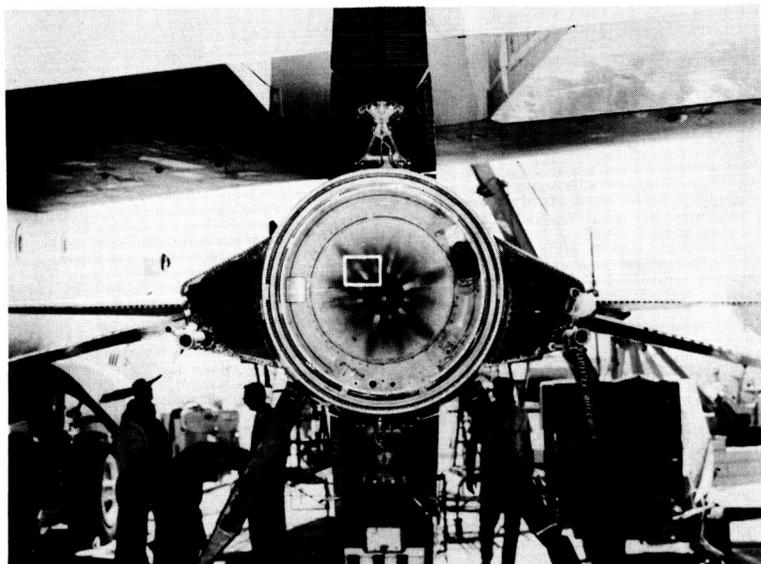
Figure 1

The XLR99 engine which powers the X-15 airplane, shown in figure 1 as viewed from the rear of the vehicle, is a liquid oxygen, anhydrous ammonia, regeneratively cooled engine. The combustion chamber or nozzle, shown with its characteristic star pattern, is a brazed assembly of 347 stainless steel tubes, formed to shape, through which the anhydrous ammonia flows longitudinally as a coolant. Figure 2 is a photograph of this section showing its construction. The interior surface of the chamber is coated to provide insulation and protection for the tubes from the 5,000° F flame. This coating is generally made up of 0.005 inch of a Nichrome flame-sprayed undercoat with 0.010 inch of Rokide Z flame-sprayed zirconia as an insulating, erosion-resistant top coating.

REAR OF X-15 AIRPLANE WITH SLR99 ENGINE

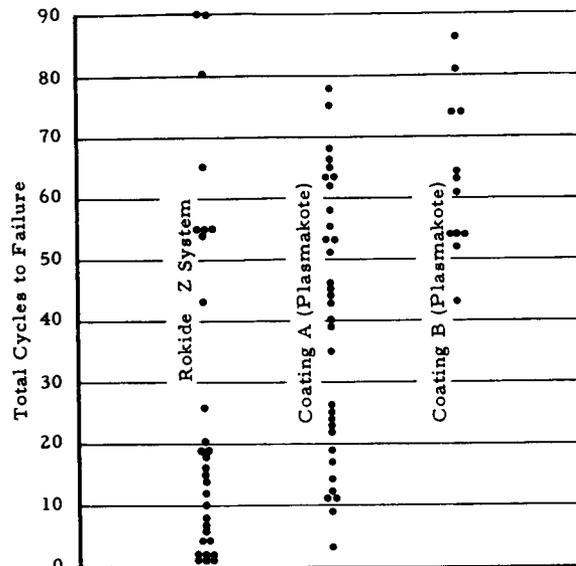
Figure 8

It should be noted that the only difference between the two graded coatings is the primer used over the stainless steel tubes. The thermal shock-test results, in which the two graded coatings were compared with Rokide Z, are illustrated in figure 8 as the number of cycles to failure.

The extreme spread in life of the Rokide Z system and the high concentration of early failures agreed with engine experience and perhaps indicates nonuniformity in the coating itself. Coating A appears to offer some improvement in life. This can be thought of as an improvement due to coating technique since the materials are the same. However, with coating B a significant improvement is obtained. There were no failures below 43 cycles. This improvement over coating A can only be due to the use of molybdenum as a primer which apparently results in a more adherent, shock-resistant coating.

THERMAL SHOCK-TEST RESULTS

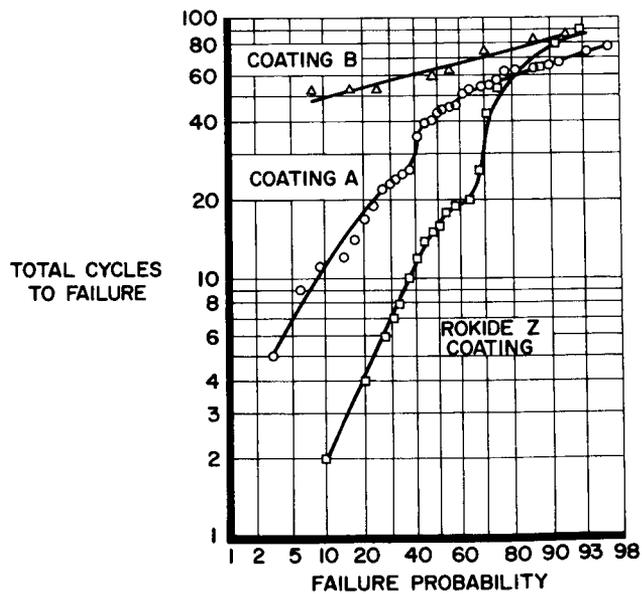
Figure 9

These same test results are plotted in figure 9 to indicate probability of failure at any given number of cycles.

PROBABILITY OF THERMAL-SHOCK FAILURE

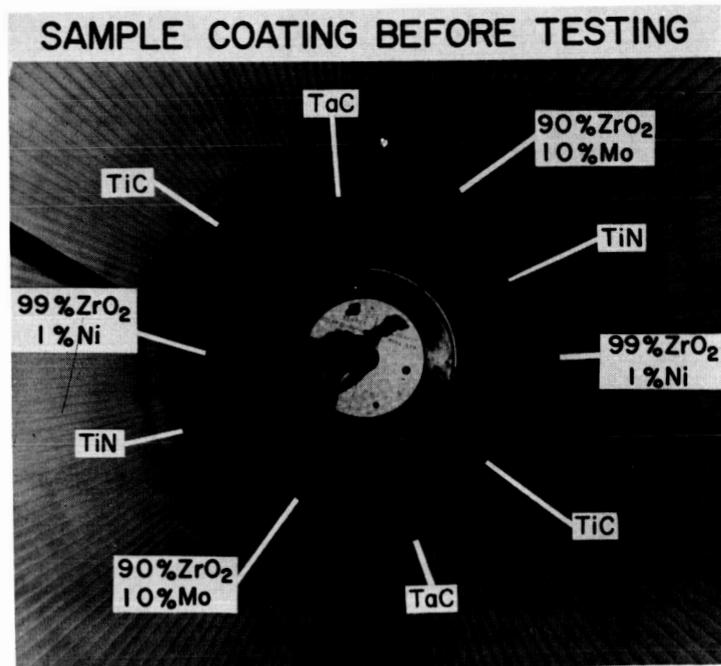
The gradated coating system applied was chemically similar to the original Rokide Z in that its surface was zirconia backed up by Nichrome. It was therefore assumed that interaction between the coating and combustion products would be similar. In normal operation of this engine, 12 "hot streaks" occur longitudinally through the engine, producing the star pattern mentioned previously. Characteristically, these hot streaks have a white, chalk like surface which may be due to thermal shock of the zirconia particles or hydrogen reduction of the surface with subsequent reoxidation. Several "top coats" of various materials were applied in two circumferential strips just aft of the throat. These were used to determine if the exhaust gases were locally oxidizing and if a more erosion resistant material than zirconia could be used in the engine. These strips consisted of overcoats of tantalum carbide, titanium carbide, titanium nitride, zirconia with 10-percent molybdenum, and zirconia with one percent nickel. Figure 13 is a photograph of the coated chamber, as viewed from the exit cone, showing these test strips.

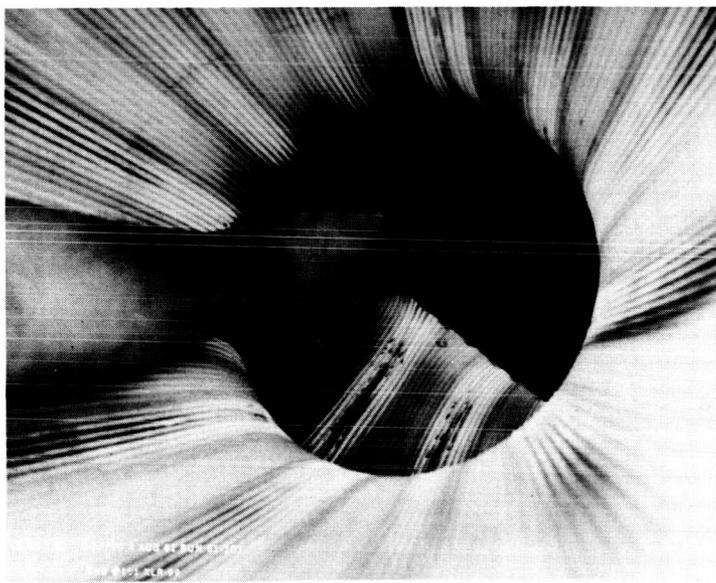
Figure 15

Prior to the testing of the gradated coating system, a used chamber with a new Rokide Z coating was tested in an old engine to provide directly comparable coating life data. The firing procedure designed for coating evaluation is included in table III. The test data from firing this engine are included in table IV. Loss of the Rokide Z coating in the throat was visible after the second run and progressed until after the seventh start and a total running time of about $5\frac{1}{2}$ minutes. A total of 25 square inches of coating was lost during the test. This progression is illustrated in figures 14 to 16.

ROKIDE Z COATING AFTER FOUR STARTS AND 2 MINUTES
(8-1/2 SQ IN. OF ROKIDE Z LOST)

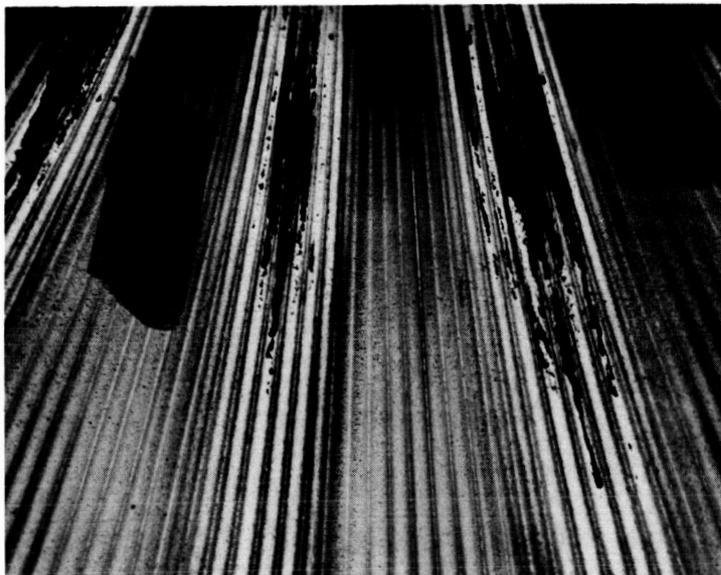
Figure 16

ROKIDE Z COATING AFTER TEST - SEVEN STARTS AND
5-1/2 MINUTES
(25 SQ IN. OF ROKIDE Z LOST)

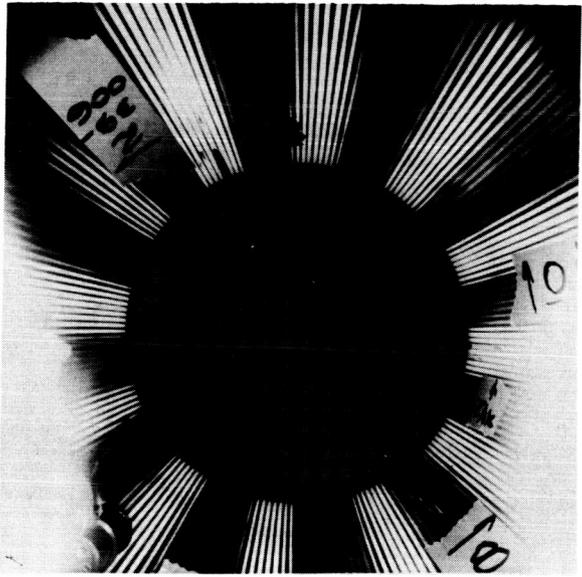
Figure 17

The gradated coating was then tested in a similar manner to produce comparable results. The test data from the firing of the gradated coating system are included in table V. As was mentioned previously, this chamber had been leaking and the cracked tubes were welded. After the second run two leaks were evident with no coating loss. Subsequent runs produced

some coating loss around previously leaking areas but none in nonleaking throat areas. After six starts and a total of $5\frac{3}{4}$ minutes, 3 square inches of coating were lost from the leaking areas, slight erosion was evident in nonleaking areas, and chipping of coating surface was evidenced upstream of the throat. This progression can be seen in figures 17 and 18. Due to difficulties, the tests on this engine were stopped.

GRADATED COATING AFTER THREE STARTS AND 2 MINUTES
(1 SQ IN. OF COATING LOST)

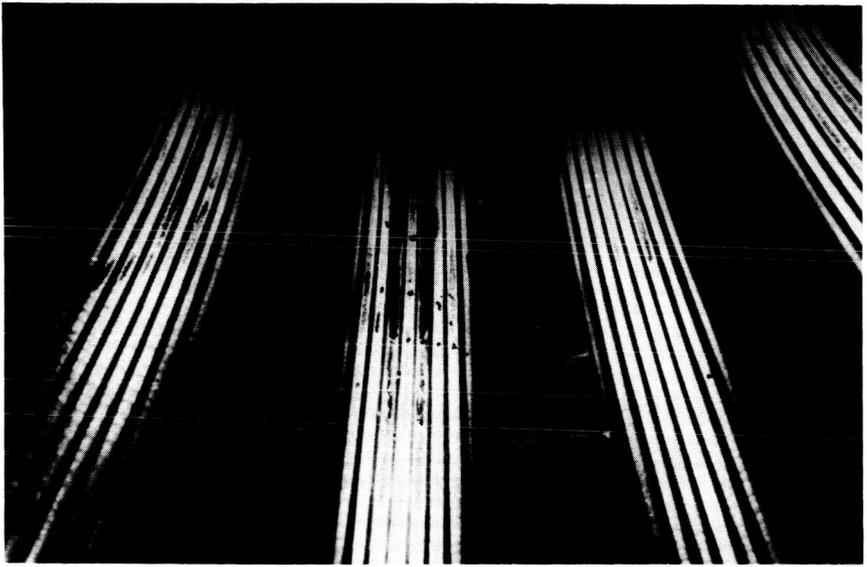
Figure 18

GRADATED COATING AFTER TEST - SIX STARTS AND 5-3/4 MIN
(3 SQ IN. OF COATING LOST)

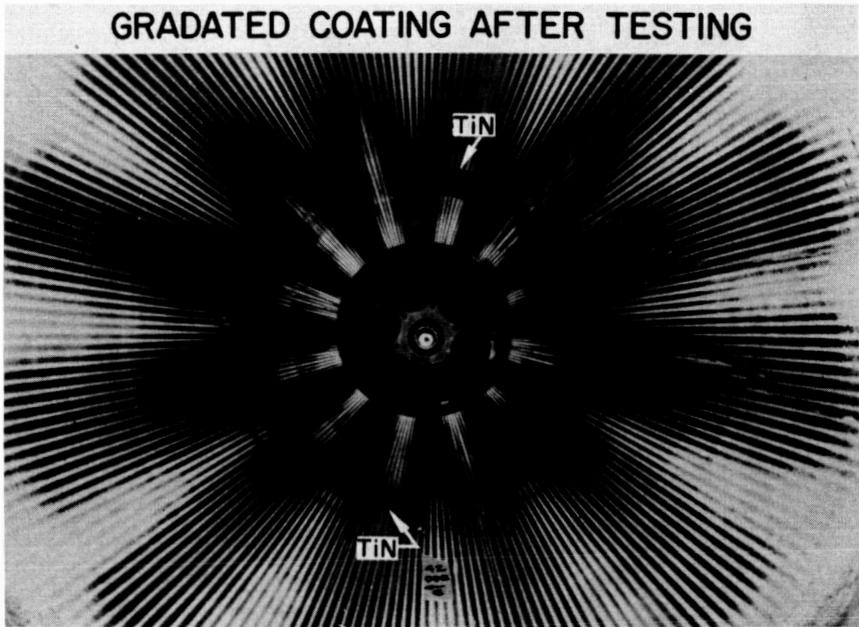
Figure 19 shows this engine after the test series and illustrates the blackening of the coating that was initiated during the first run. This blackening appeared to be Nichrome "bleed through," since the coating was found to be electrically conductive along its surface. Figure 19 also shows that one top coat, the titanium nitride, did protect the zirconia surface by stopping the chalking action.

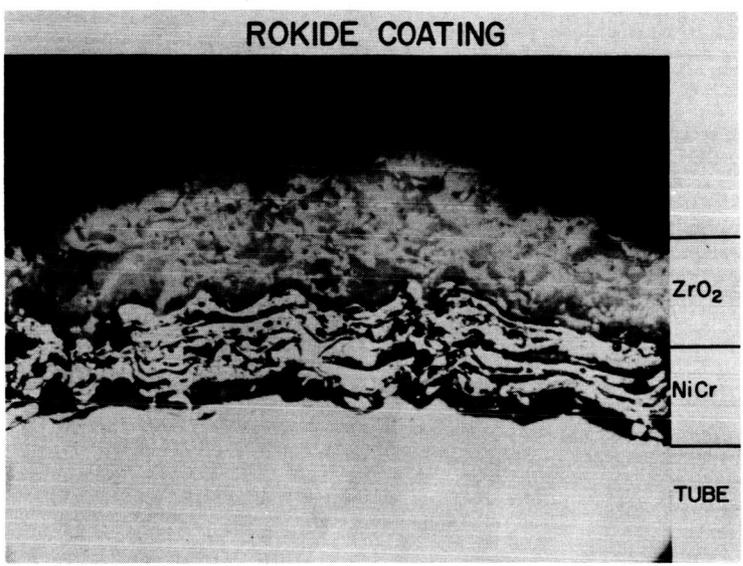
A metallographic study was made of sections of this chamber to determine the effectiveness of the top coats and whether there was metal bleed through in the coating. Figure 20 illustrates the character of the original two-layer Rokide Z coating from an old engine. Figure 21 is a section from the throat of the test engine showing the molybdenum primer and Nichrome gradated to a zirconia surface. The top coat of zirconia appears somewhat thin but there is no evidence of metal bleed through. Figure 22 shows the gradated systems with a top coat of zirconia and 10-percent molybdenum used to determine whether molybdenum would oxidize or react in this environment. There is no evidence of attack indicated and the system appears compatible.

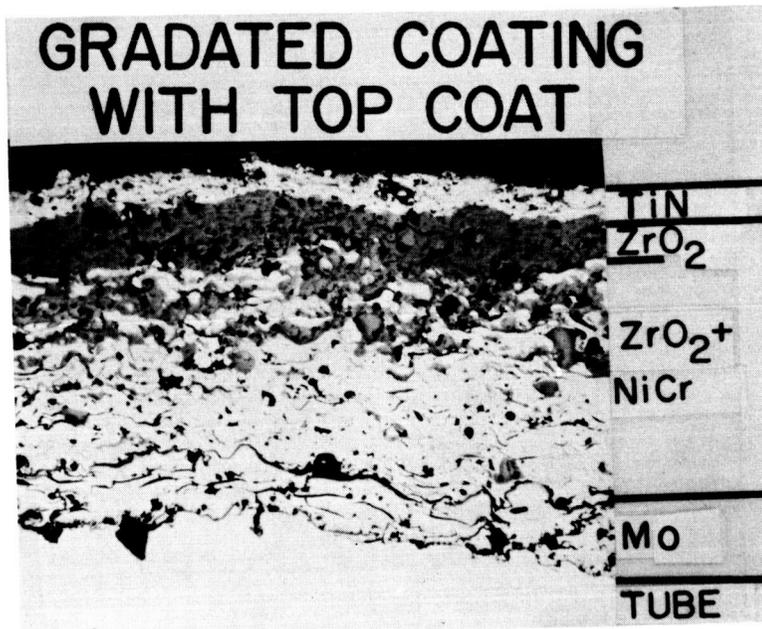
Figure 23 shows the gradated system with the titanium nitride top coat which appeared to offer some protection for the zirconia. It can be seen from these photomicrographs that the zirconia had turned black, including areas under the top coats, with no evidence of metal bleed through. It is known, however, that zirconia is easily reduced by hydrogen which causes it to turn black. Moreover, zirconia will dissolve up to 1-percent chromium and in doing so will turn black and become electrically conductive. This would account for the electrical conductivity of the coating and its blackness without any evidence of metal bleed through.
