NASA TM X-67945

SHOCK AND VIBRATION TESTS OF A SNAP-8 NaK PUMP

by A. J. Stromquist, R. B. Nelson, and Lawrence Hibben
Lewis Research Center
Cleveland, Ohio
October, 1971

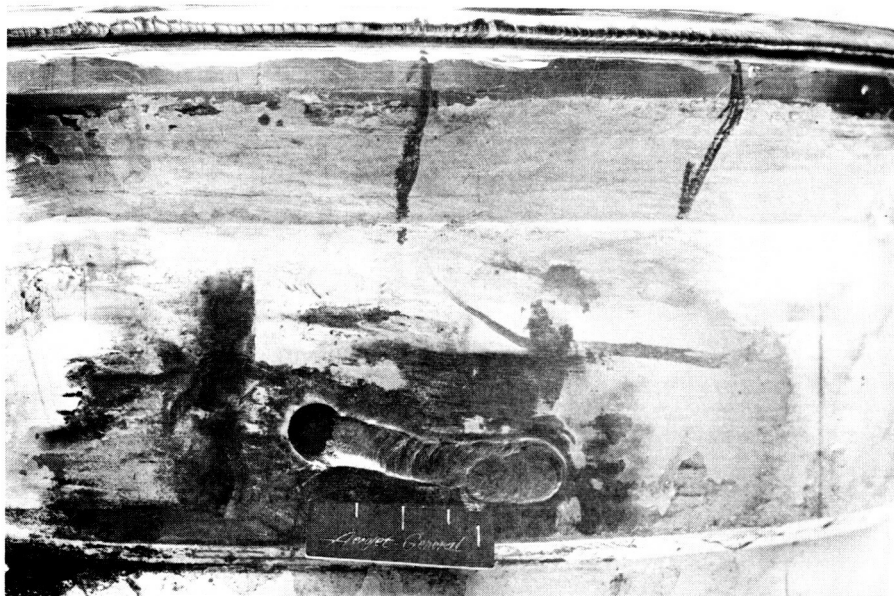
The general outside condition of the unit revealed the vent valve on the stator housing had broken off at the tube to housing weld joint. The stator housing was deformed around the base mount locating hole (fig. 5) as a result of the failure of the holding strap allowing the stator housing to bounce against the pin in the base. Both of the thermocouple header locating lugs are loose but still intact. A subsequent helium leak check of the winding area showed no leakage to be present. This indicates the ceramic was not cracked through in the lug area. All three pump housing to motor housing pin to lug joints were frozen. Rapping these with a hammer did not dislodge the pins. Dye penetrant inspections of all bolt covers showed no defects.

Figure 5. - Result of stator housing bouncing on base mount locating pin during environmental testing.

1. Design a prototype mounting system that will thermally isolate the pump from the structure while allowing thermal growth and still preload the pump sufficiently to prevent any free motion and consequent amplification of the vehicle loads.

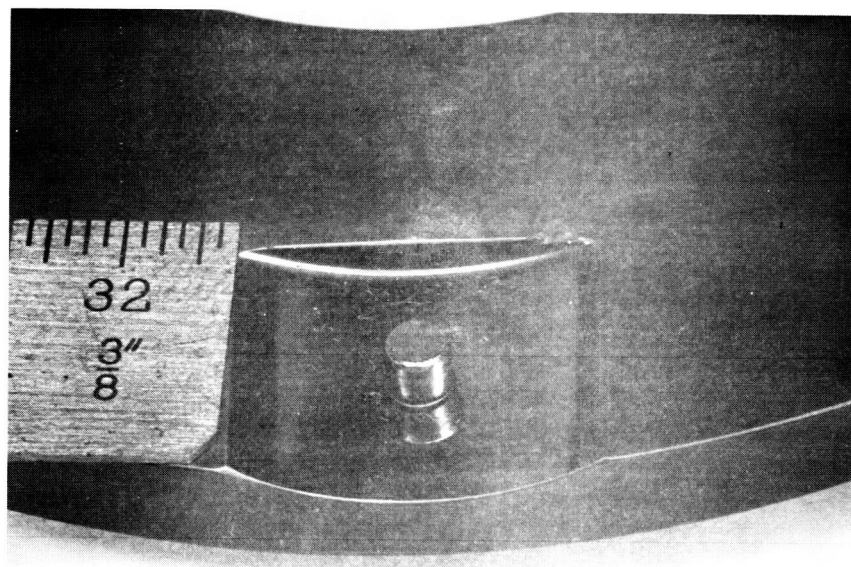
The thrust runner, support rings, and thrust pads show no signs of damage. However, the gimbal ring was chipped in both socket areas which mate with the bearing support ring as shown in figures 6 and 7. The backplate had numerous burnish marks at the interface to the housing. The housing had matching burnish marks related to the backplate and also radial indentations approximately 0.005 of an inch deep in four places matching the configuration of the backplate. The pins at the two socket joints (the side that mates with the support ring) of the motor end thrust bearing gimbal ring have both been partially sheared in the same direction. One pin was loose on the backplate mating side as seen in figures 8 and 9. The motor end backplate and housing have similar damage points as the housing and backplate on the opposite end. The antirotation pins in both housings (pins that keep the backplates from rotating during operation) were both worn to a cone shape as seen in figure 10.

Figure 6. - Thrust bearing gimbal ring.

2. A minor redesign of the thrust bearing antirotation and pivot pins to strengthen them.

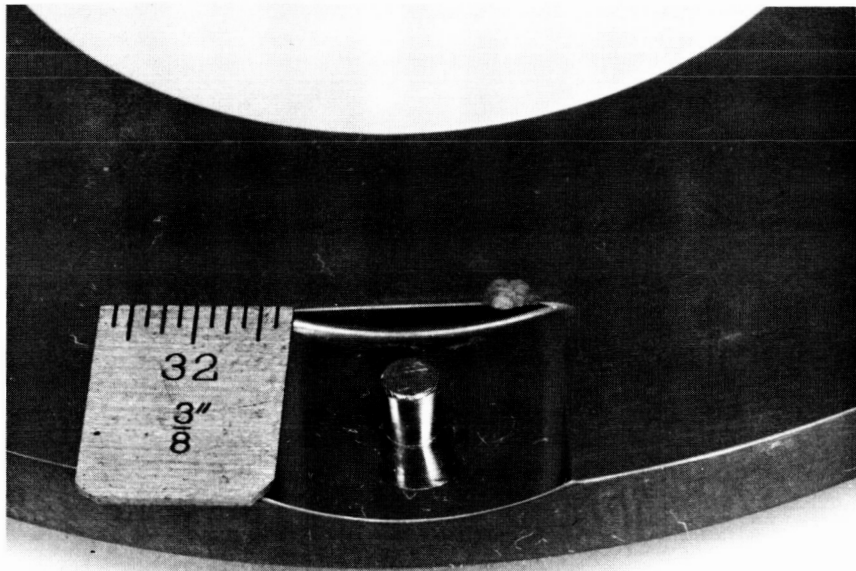
Figure 7. - Pump end thrust bearing gimbal ring.

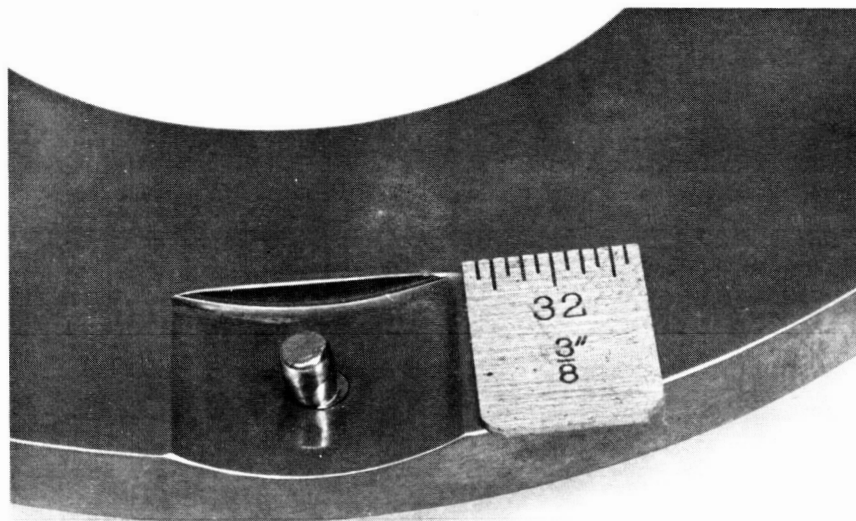
It is problematical whether the gimbal bearing support pins which were partially sheared and bent could remain intact through a long endurance test with hot NaK. It is also problematical whether the debris found as a result of this damage would have eventually found its way into the bearings and caused further damage. It is possible the recirculation system, which contains a filter, may have removed the debris.

Figure 8. - Motor end thrust bearing gimbal ring with partially sheared and bent pin.

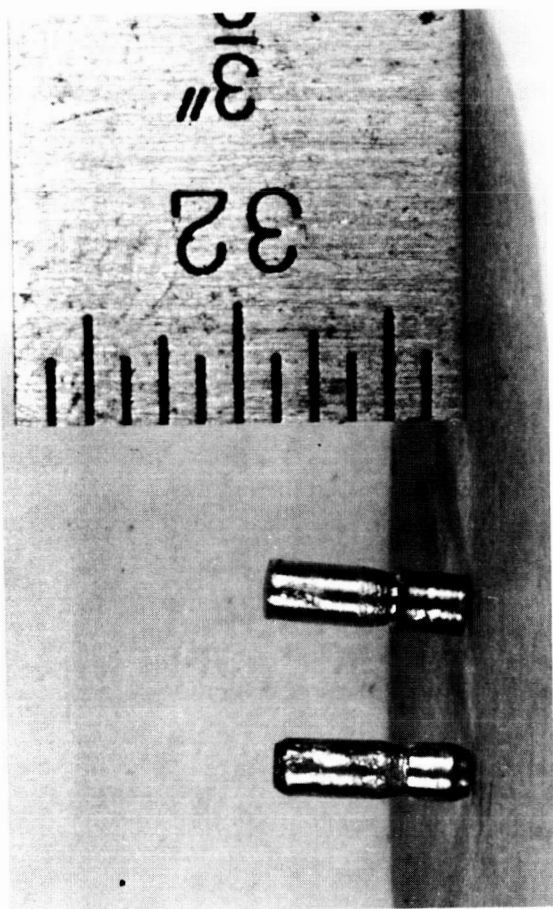
Figure 10. - Pump end thrust bearing anti-rotation pins. Wear produced by action on end plate. Bottom part of pins were in the housing.

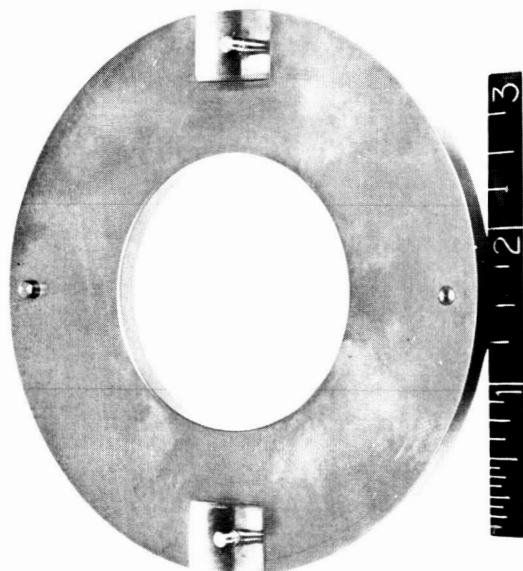
Figure 9. - Motor end thrust bearing gimbal ring showing loose pin.

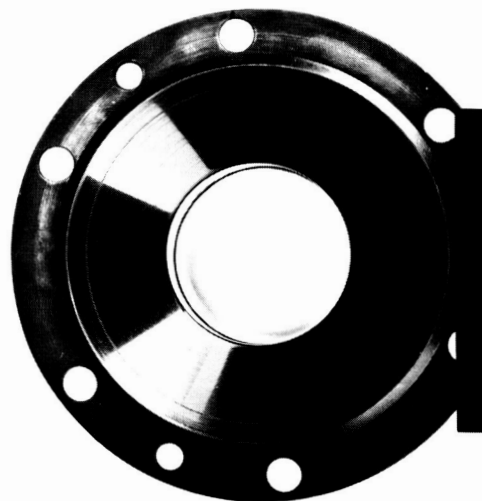
The suction housing and impeller vane faces showed marks that were produced by foreign particles getting between the interfaces. The suction housing has one significant scratch approximately π radians (180°) across the face (fig. 11). All other components of the pump motor assembly showed no sign of damage as a result of the environmental test.

Figure 11. - Suction housing of NaK pump showing scratches.
