APOLLO 14 MISSION

INABILITY TO DISCONNECT MAIN BUS A

ANOMALY REPORT 2

**December 1971**

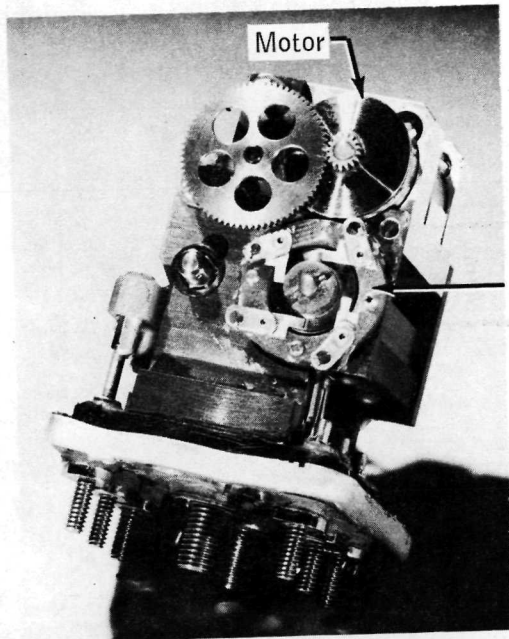
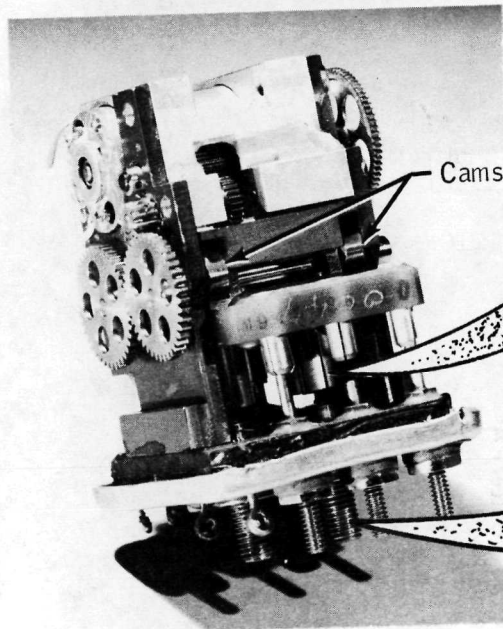
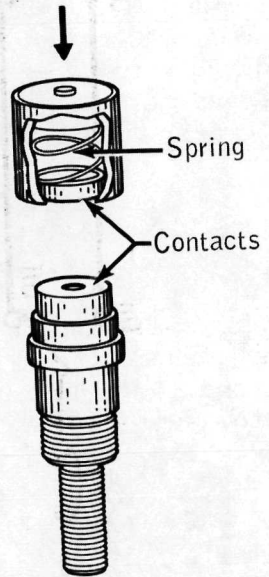
Figure 1.- Motor switch assembly.

The motor switch stalled at a position just before the transfer point of the internal motor control switch. The main power contacts were closed and the contact springs were applying their maximum load through the cams and the gear train to the motor (fig. 1). With the motor control contacts closed and the motor stalled, motor current increased to about 8 amperes (twice normal). Consequently, the motor windings fused open. Since the main power contacts were still closed, main bus A remained energized (figure 2).

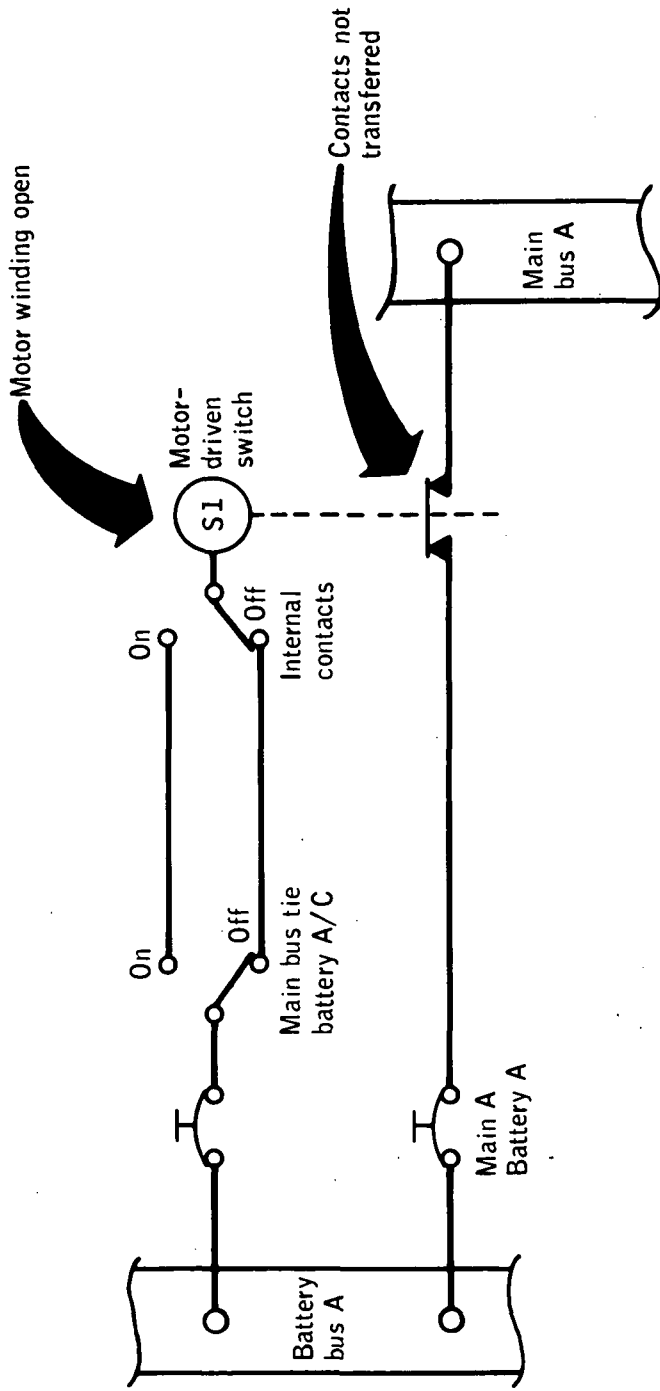
Figure 2.- Bus-tie circuitry.

During entry, the Apollo 14 spacecraft busses should have de-energized when the main bus-tie motor switches were switched to the "off" position. One motor switch did not transfer and main bus A remained energized until the battery bus-tie circuit breakers were opened after landing.

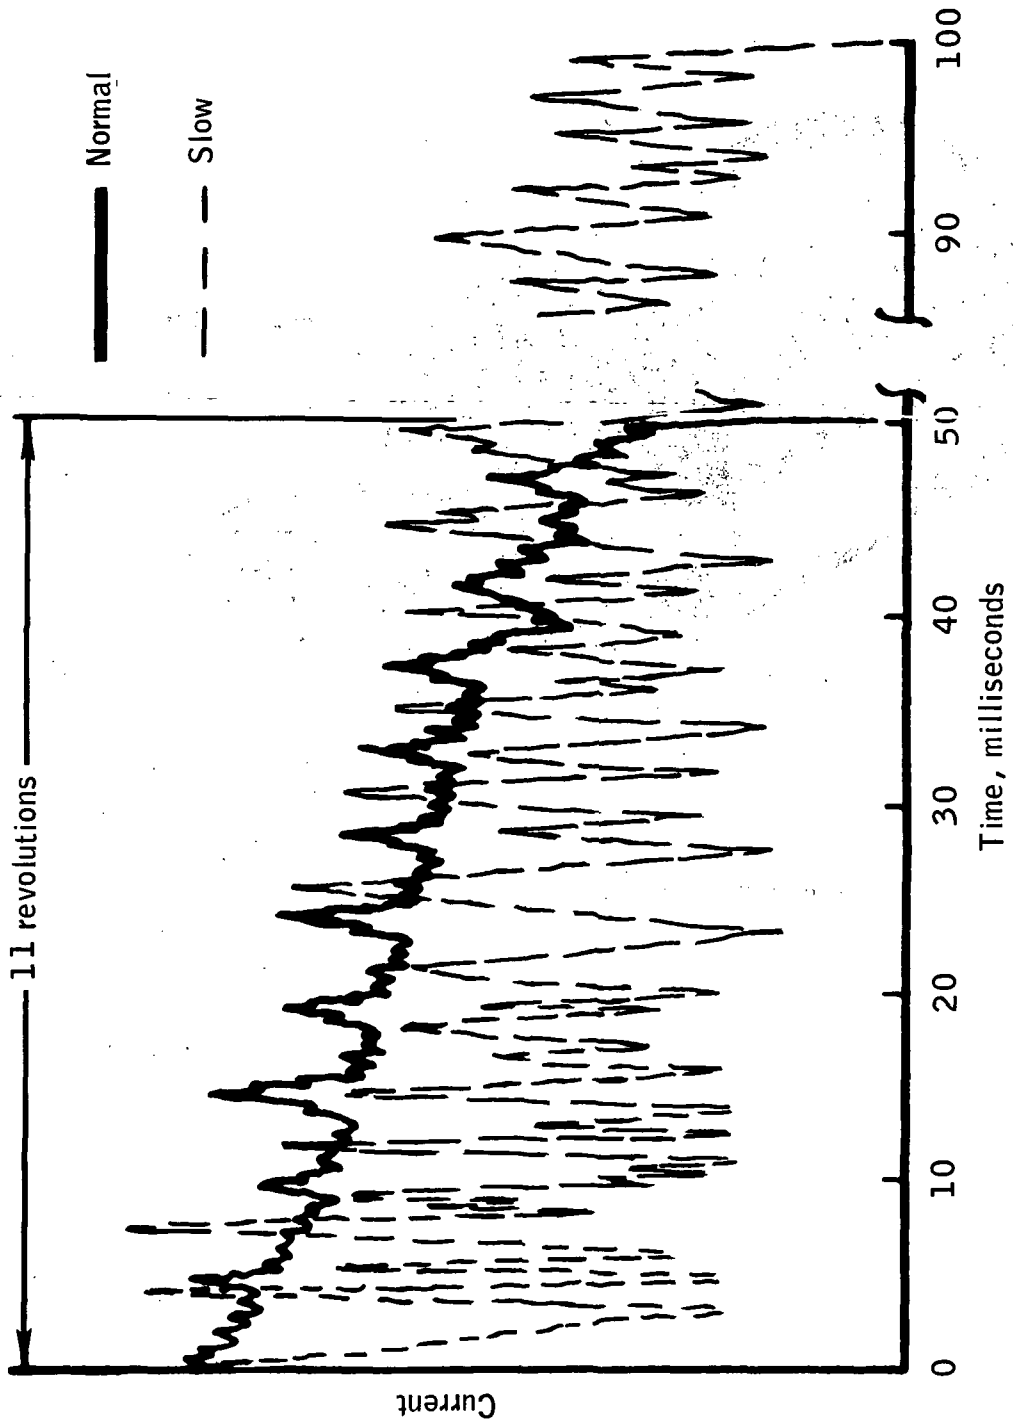
An identical motor switch failure occurred during tests of the Apollo 15 command and service module at the launch site. Another motor switch on the Apollo 15 vehicle required 100 milliseconds to transfer; whereas, normal transfer time is 50 milliseconds. A motor current signature was taken for one switching cycle of the slow-operating switch and compared to a similar signature taken prior to delivery. The comparison revealed degraded and erratic contact resistance between the brushes and commutator. Figure 3 shows current signatures for a normal switch and one which operates slowly. In all three cases, the gear train, cams, internal control switch, and power contact assembly were completely normal.

Figure 3.- Comparison of normal and slow motor traces .

Motor operating current traces are useful in detecting switches which are developing high contact resistance; consequently, for Apollo 15, 16, and 17, and Skylab spacecraft, current traces will be taken for each motor switch. Any switch displaying degraded motor-commutator resistance will be replaced.

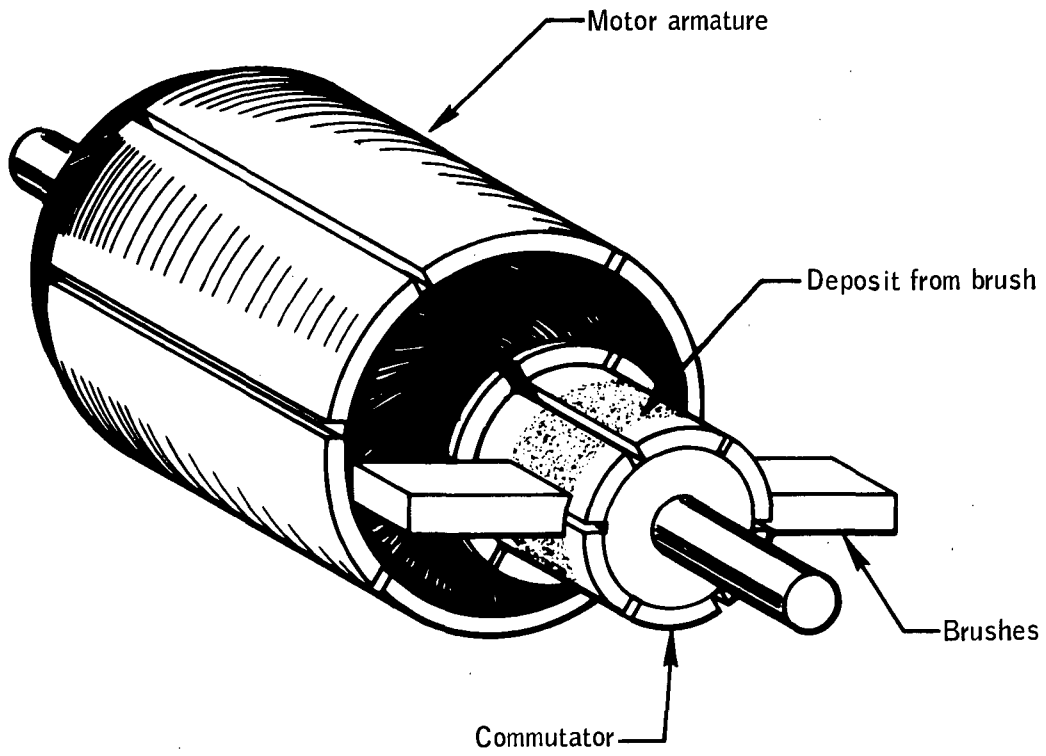
Tracks of black deposits were found on the commutator, of the three motors (fig. 4). The deposits contained brush material (carbon and silver), organic silicone and bearing oil. Furthermore, the brush terminal pin seals which insulate the terminal pins from the bearing retainer plate (fig. 5) had reverted to a gummy state in all three motors.

Residual catalyst caused the terminal pin seals to revert to a gummy state. Resulting reversion products then migrated to the motor commutator and caused brush degradation, increased and erratic commutator resistance, and reduced motor torque. The motor stalled when available motor torque was reduced below that required to drive through the maximum torque point of the switch.

Figure 4.- Brush deposits on commutator.

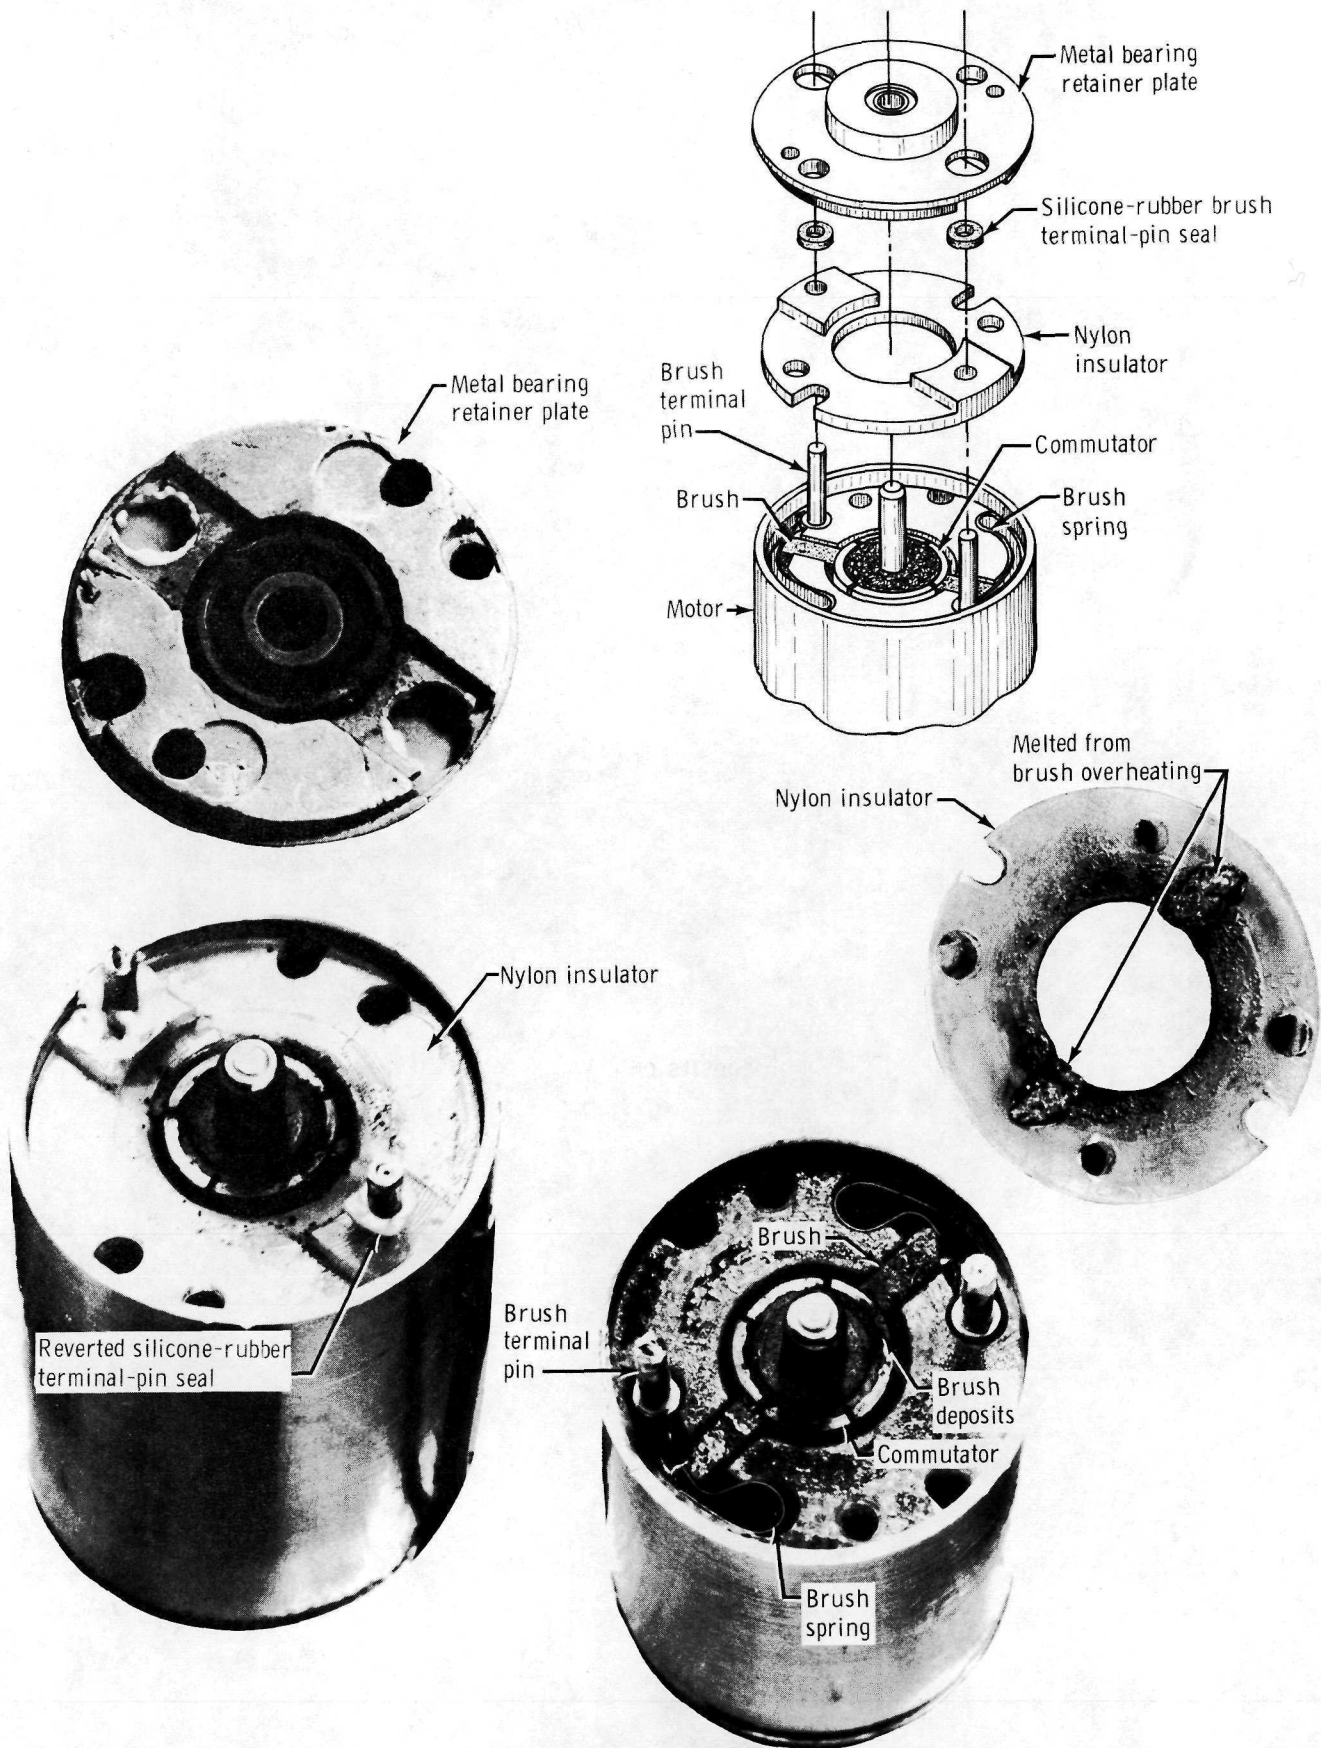
Figure 5. - Motor brush assembly.

The brush terminal pin seals were molded from silicone rubber by the switch manufacturer and the rubber was properly cured at room temperature. However, the seals were not subjected to a post-cure forced air bake at 185° F, as recommended by the rubber manufacturer to remove the residual rubber catalyst. If the residual catalyst is not removed, the rubber gradually reverts to a gummy state. Tests showed that when the reversion products from the seals were introduced on the surface of the commutator and the motor operated, deposit buildup and increased contact resistance occurred. When the reversion products were absent, neither deposit buildup nor increased contact resistance occurred.
