NASA TECHNICAL NOTE

NASA TN D-6721  
c.1

# APOLLO EXPERIENCE REPORT - WINDOW CONTAMINATION

*by L. J. Leger and R. W. Bricker*  
*Manned Spacecraft Center*  
*Houston, Texas 77058*

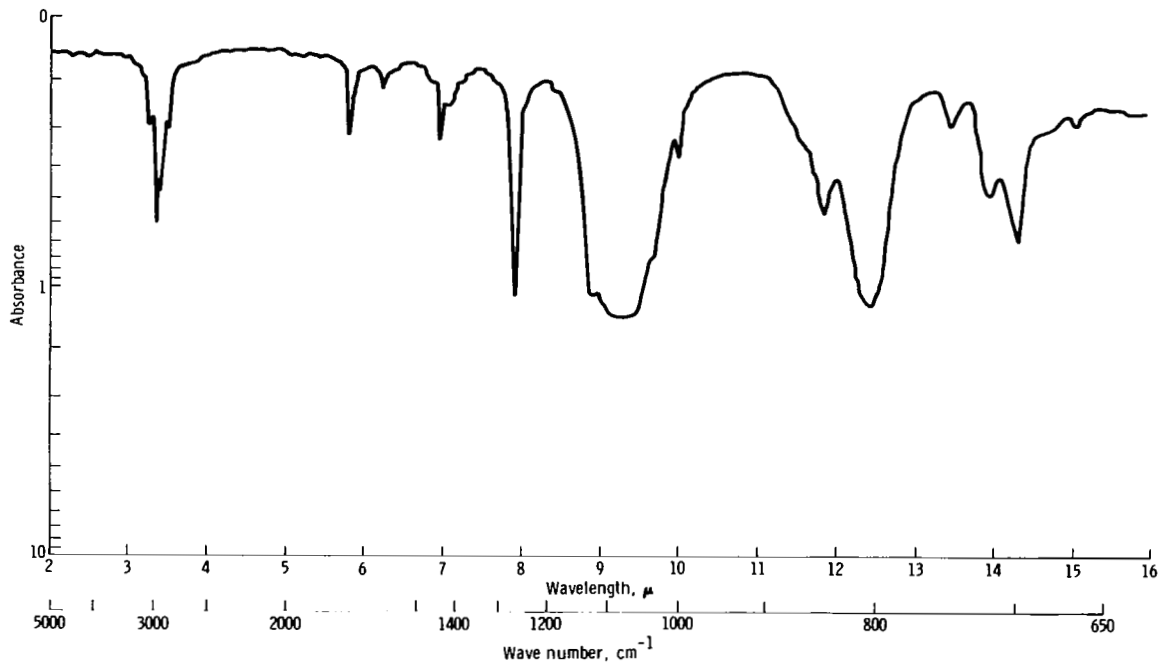
The infrared spectra of contamination collected from surfaces 2 and 3 on the windows of the Apollo 7 and 8 spacecraft were typical of organosilicon high-molecular-weight compounds. A representative spectrum of this contamination is shown in figure 8; the spectrum contains absorption bands common to the methyl-phenyl silicone structure. The same type of contamination was identified on the window of an Apollo CM (2TV-1) that was used for thermal-vacuum testing at the NASA Manned Spacecraft Center.

Figure 8. - Typical infrared spectrum of contaminations from surfaces 2 and 3 on the Apollo 7 and 8 CM's.

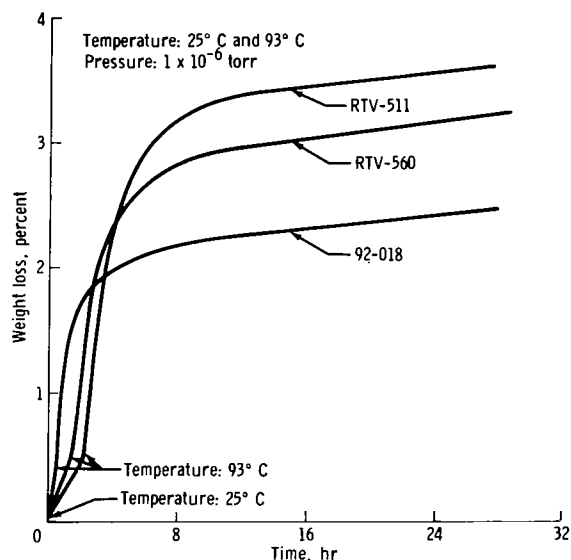
Isothermal-vacuum weight loss of the problem materials was determined by use of a continuous-recording vacuum balance. The vacuum weight loss of these materials at 93° C is shown in figure 9. This temperature was the maximum temperature expected in flight for materials that were used in the window area. Samples of all three materials had large initial weight-loss rates (approximately 1.25 percent/hr) that subsequently, after 15 hours, decreased to a much smaller rate (approximately 0.01 percent/hr).

Figure 9. - Vacuum weight loss of window materials that caused contamination on surfaces 2 and 3.

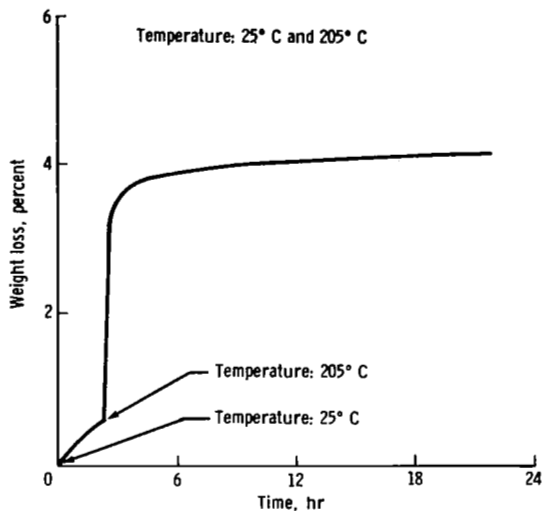
Figure 10.- Vacuum weight loss of RTV-560 at temperatures used in the manufacturing process at  $1 \times 10^{-6}$  torr.

Because the weight-loss rates for the problem materials were small after exposure to vacuum at elevated temperatures, an apparent solution to the silicone-outgassing problem was to bake the manufactured parts in a vacuum before installation in the spacecraft. This process was used with success in reducing the Gemini window contamination (ref. 3). In applying a vacuum bake, it is desirable to use as high a temperature as possible in the thermal-vacuum exposure. However, at high temperatures (approximately 250° C), polymer degradation is possible. Therefore, a temperature of 205° C was chosen as the maximum allowed in the vacuum bake. At this temperature, the weight loss levels off (fig. 10). This condition indicates no major thermally induced polymer degradation has occurred.

Further considerations of the corrective action indicated that the vacuum bake should be conducted at low pressures and for long periods of time. However, because of limited chamber availability, a maximum pressure of  $1 \times 10^{-1}$  torr was allowed, and an exposure time of  $1.72 \times 10^5$  seconds (48 hours), divided into two  $8.64 \times 10^4$ -second (24 hours) steps, was used. The weight loss during and after exposure of the materials

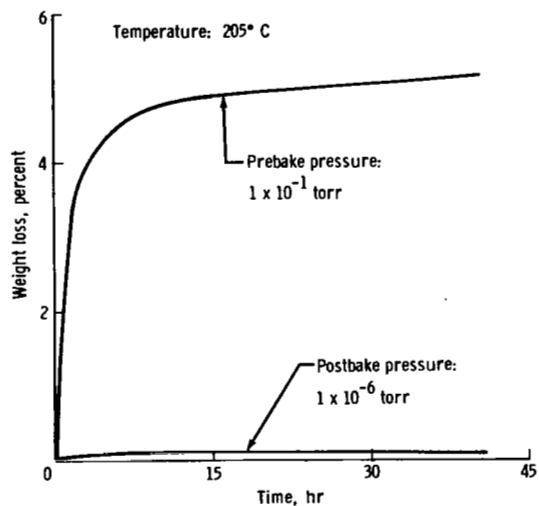
Figure 11.- Vacuum weight loss of RTV-560 for manufacturing cycle simulation.

to a vacuum of  $1 \times 10^{-1}$  torr at  $205^{\circ}\text{C}$  is shown in figure 11. Because the total weight loss after the vacuum bake is small (approximately 0.08 percent) and because only a small amount (approximately 0.008 percent) of this weight loss is condensable material at  $25^{\circ}\text{C}$ , a vacuum bake at the conditions selected ( $1 \times 10^{-1}$  torr for two  $8.64 \times 10^4$ -second periods) was considered adequate to prevent contamination of the spacecraft windows.

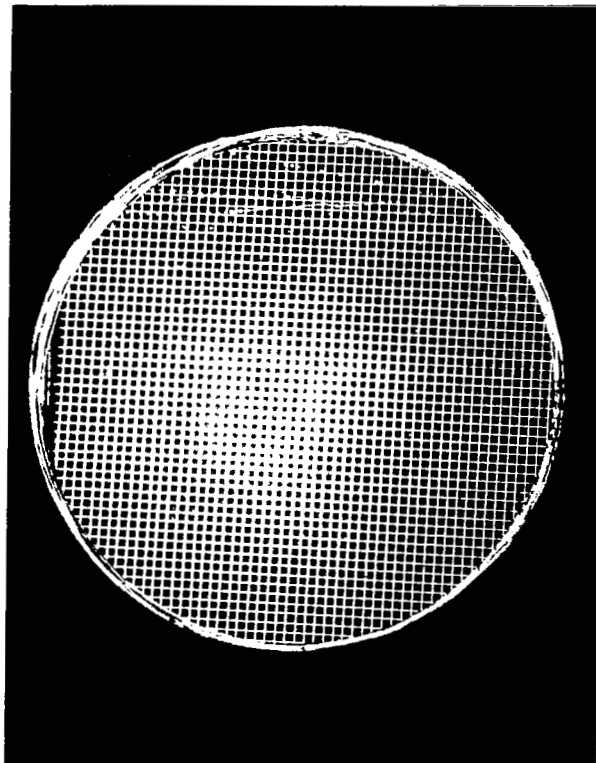
Crewmember reports and the postflight examination did not indicate any contamination problems on the windows made of baked parts. The rendezvous windows, however, were contaminated slightly. This problem did not cause major concern because subsequent flights would involve the use of baked parts for all windows. A photograph (fig. 12) of the hatch window of 2TV-1 (a test vehicle that revealed window contamination similar to that found on the Apollo 6, 7, and 8 flights) is compared with a grid photograph (fig. 13) of the Apollo 9 hatch window after recovery. In figure 13, the grid, which is behind the window assembly, is shown clearly. Conversely, large amounts of contamination over the entire window are shown in figure 12. In this photograph, condensation of the contamination had accumulated to such an extent that droplet streaks were detectable. Although the photographs were not taken under the same conditions (the 2TV-1 photograph had no grid), they both indicate that a significant improvement was obtained by the use of vacuum-baked parts.

Figure 13. - Apollo 9 hatch window.

The Apollo 9 mission was the first flight on which vacuum-baked parts were used. The rendezvous windows had no contamination problems on earlier flights; therefore, it was decided to use baked parts only on the hatch and side windows.
